Case Study: Concrete Pavement

Florida Department of Transportation, District Seven

Presented by: Richard Frank
FDOT Interstate Construction Project Manager

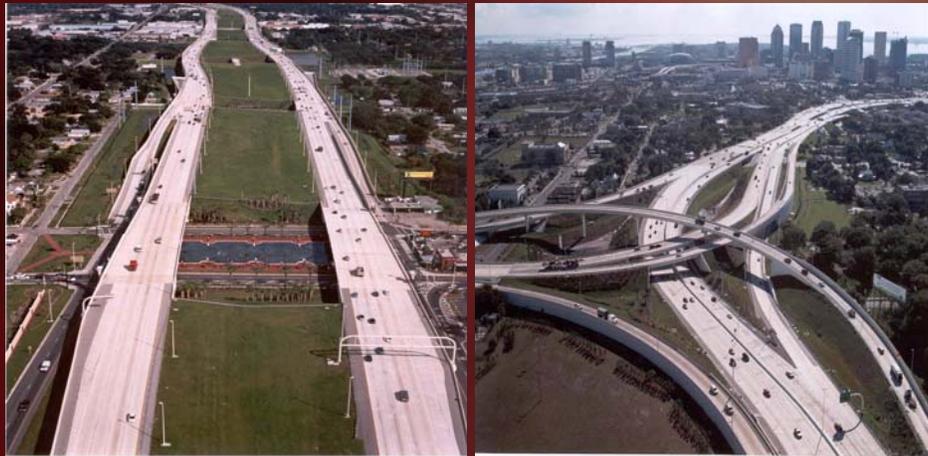
- Reconstructed Urban Interstates utilized Concrete for pavement structure

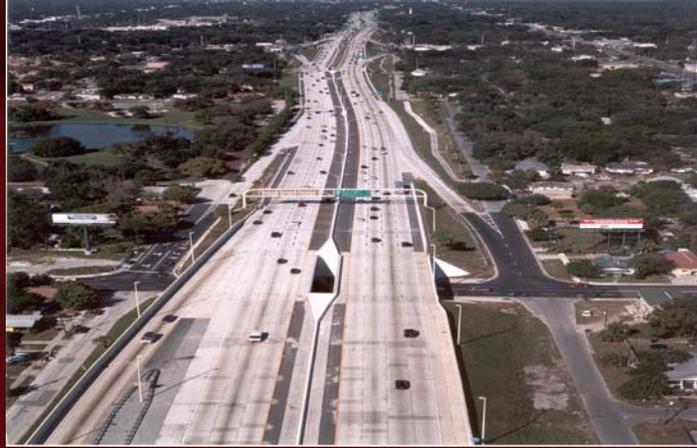
- Non-reconstructed Interstate received rehabilitation of existing concrete pavements and safety enhancements

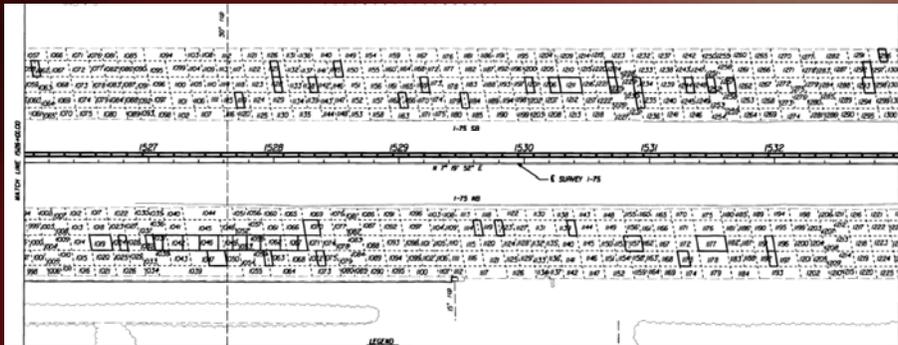
- Required designers to evaluate in the field and identify slabs during the design process

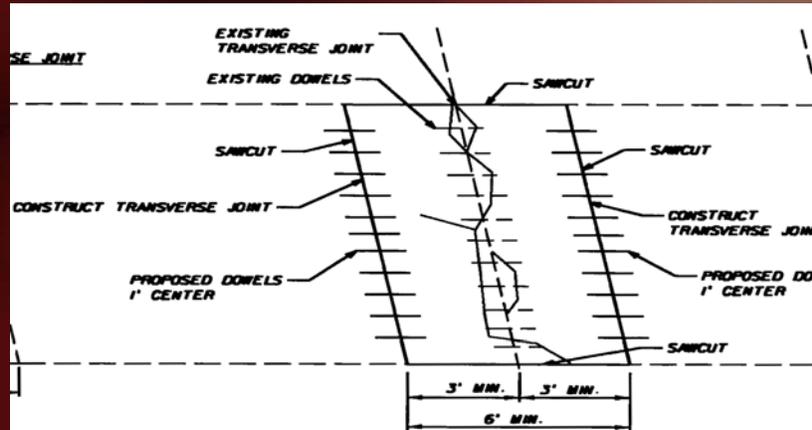
- Center 6 foot (min.) on the joint

- Use of Maturity Meters for compressive strength
- Past Rigid Pavement guidelines noted that a distressed joint would require a full width 6 foot replacement on each side of the joint
- **Made a change to rehab the joint by centering the 6 foot slab on the joint**
- **Both sides of the joint rehabilitated**

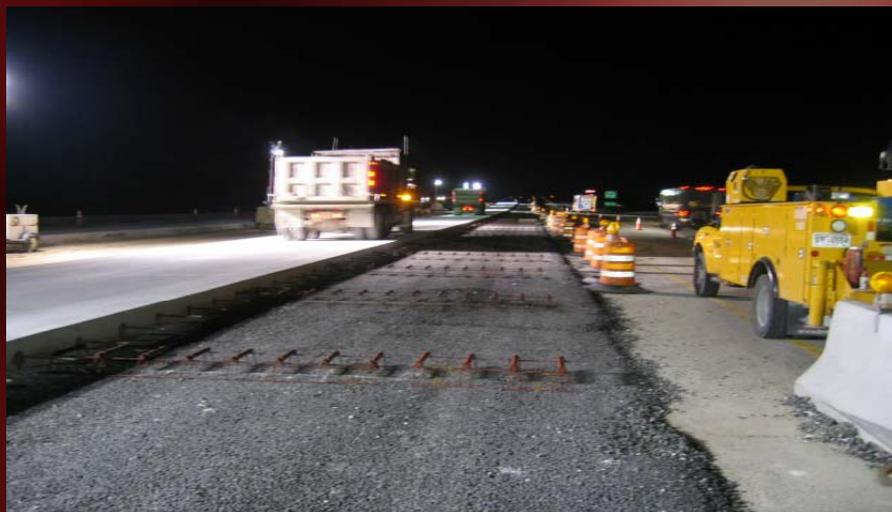
Asphalt Treated Permeable Base (ATPB)

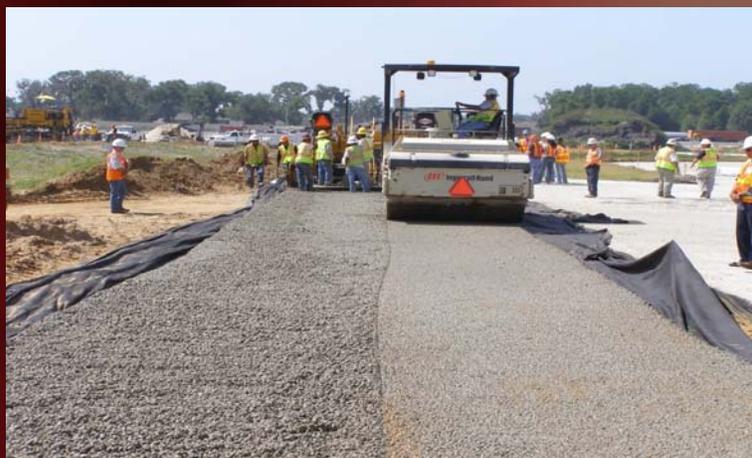
Compacting CTPB

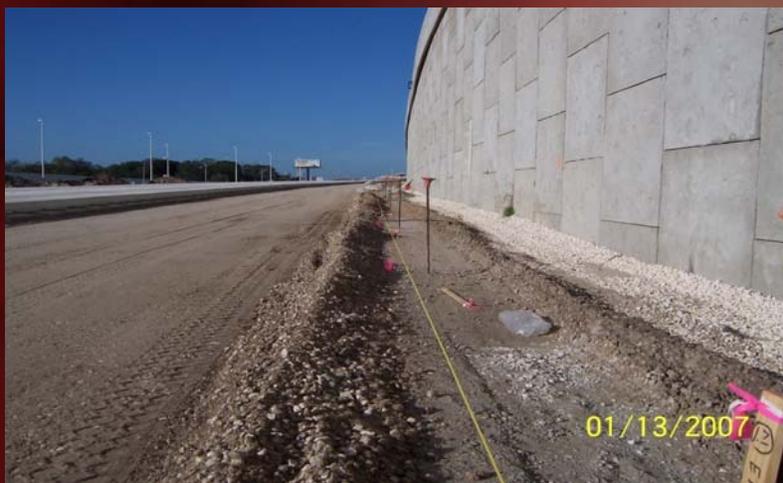
Control Wire Line

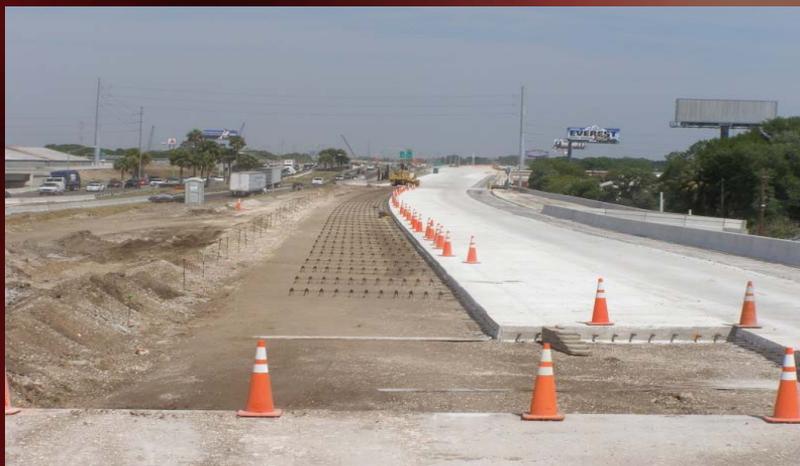
Dowel Baskets

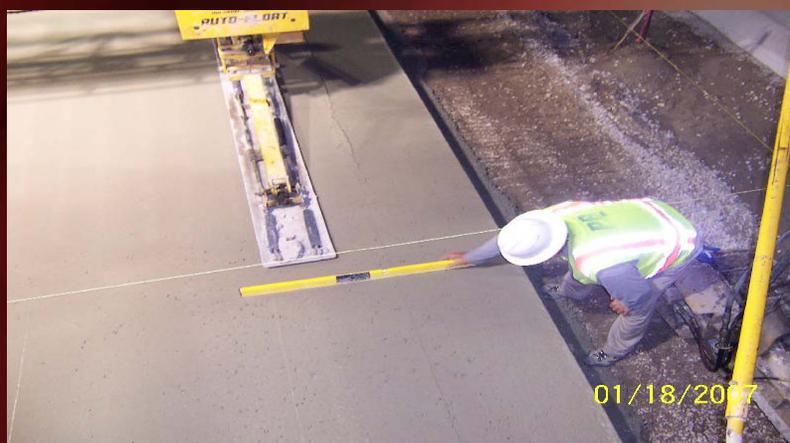
Cross Slope Check

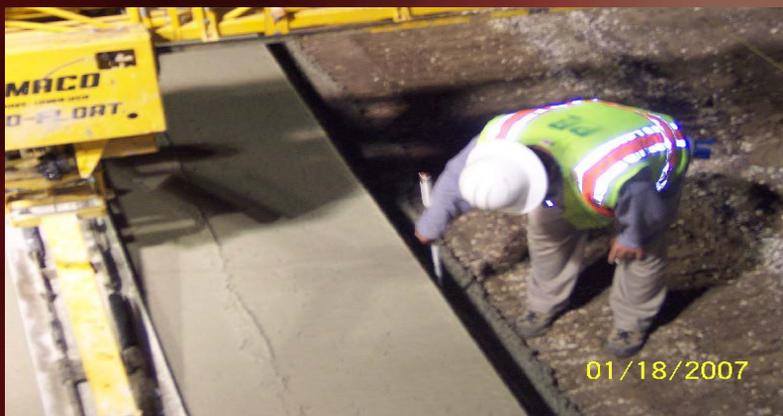
Depth Check

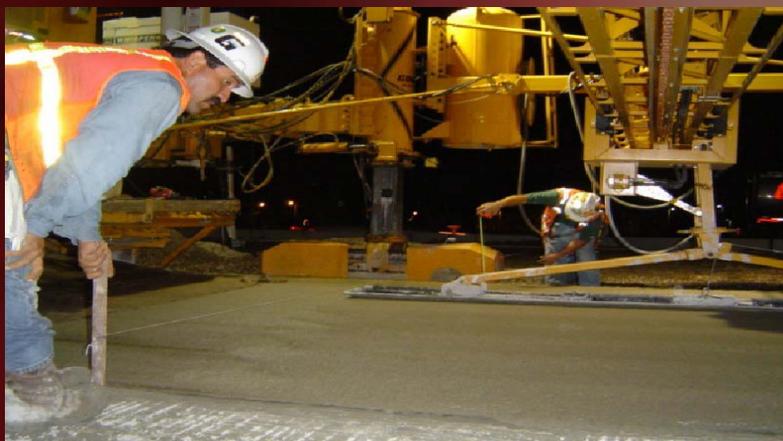
Top Elevation

200mm offset

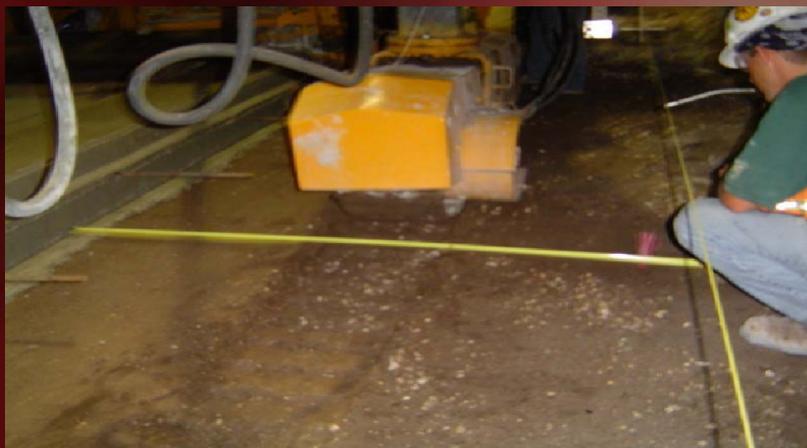
Checking Alignment

1.7 m offset

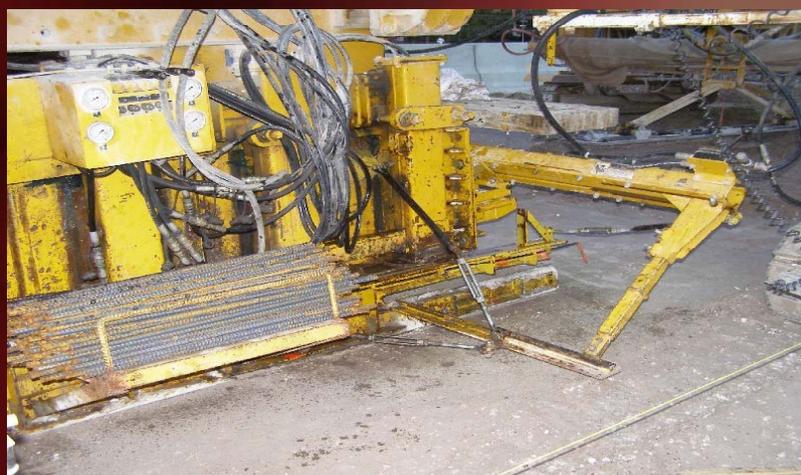
Bar Shooter

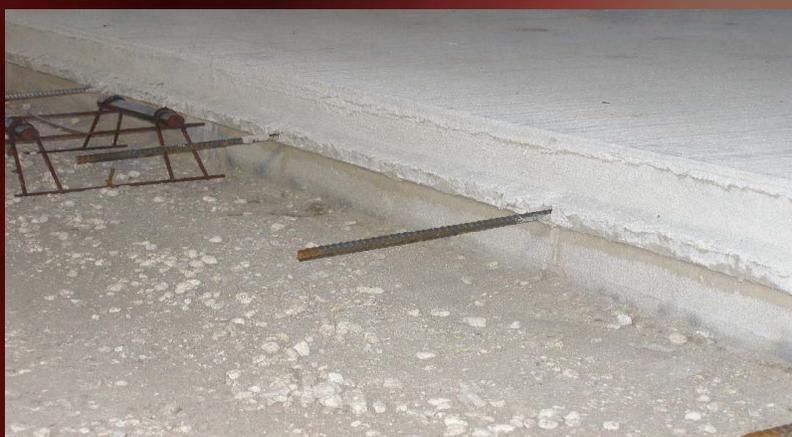
Keyway and Lane Tie Bar

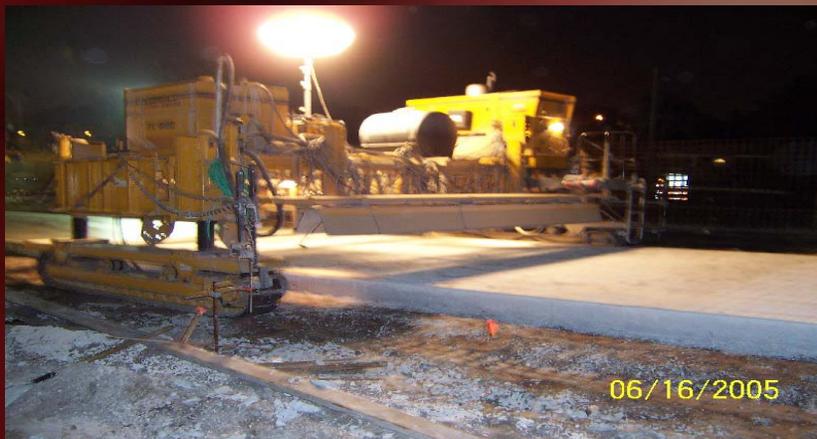
Curing Compound 200 Sq Ft per gallon

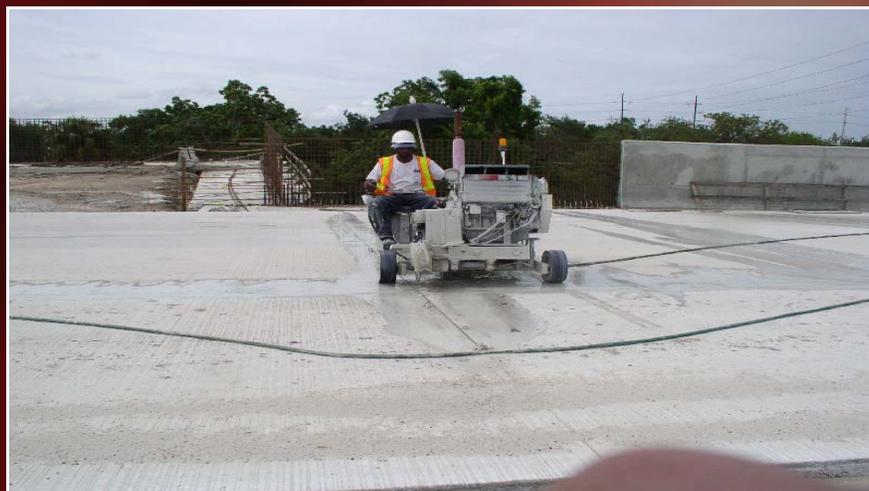
Saw Cutting Joints

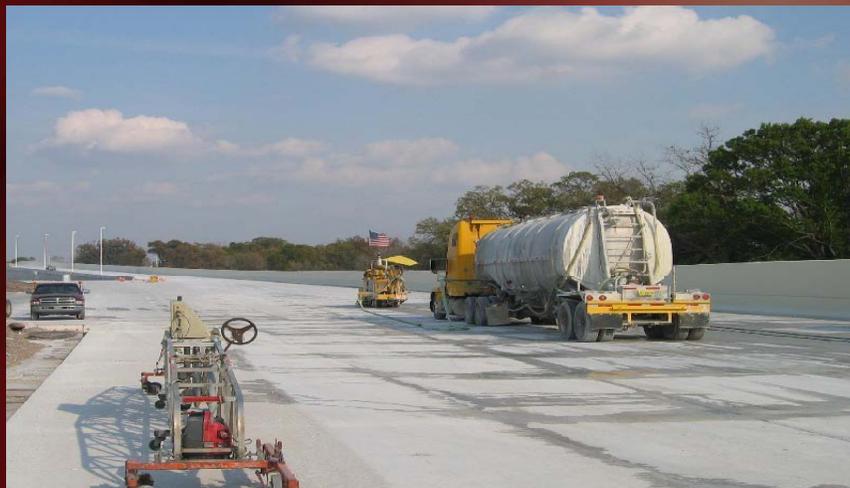
Profilograph and Grind

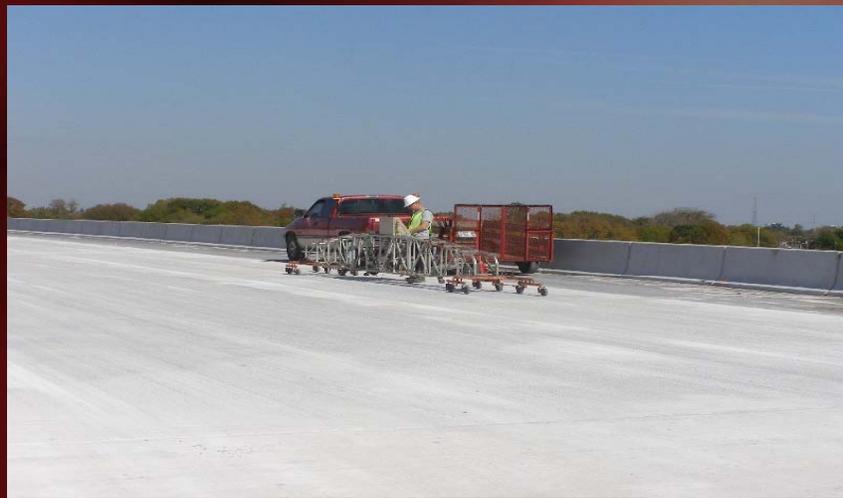
Profilograph

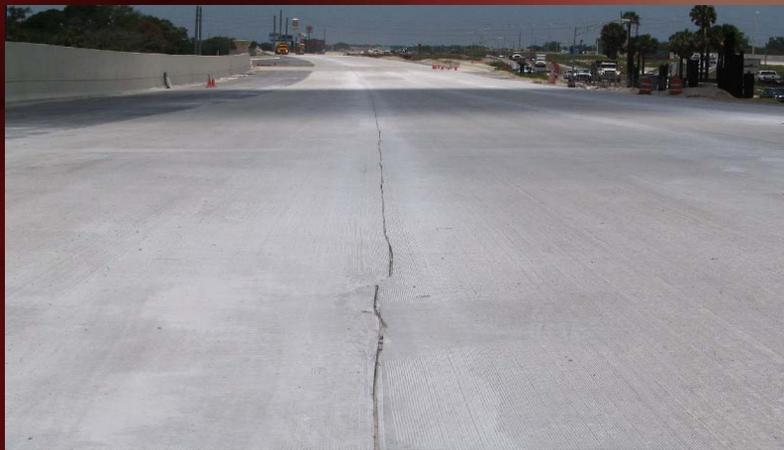
- Crooked Joints

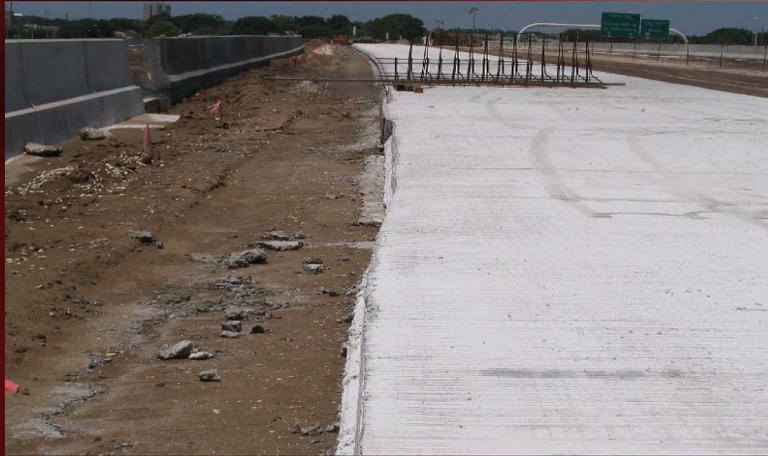
- **Ragged Edge**

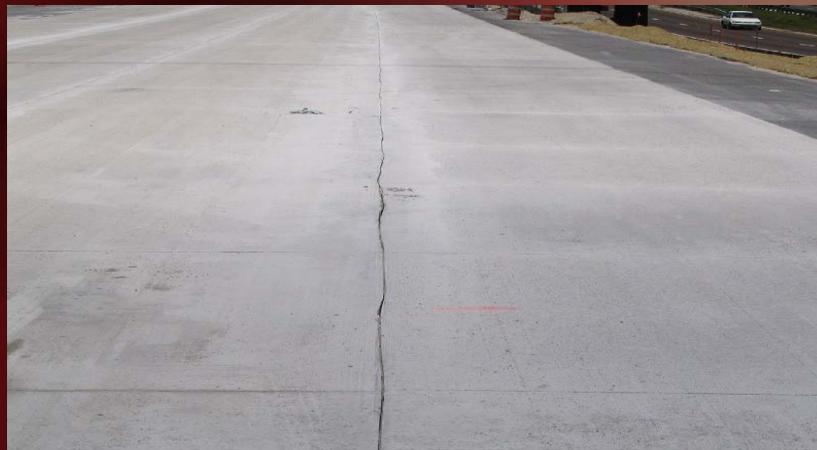
- **Bad Saw Cuts**

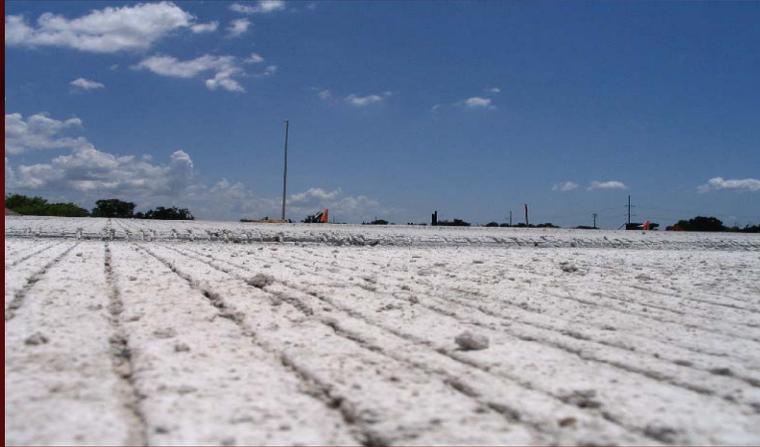
- Lane to Lane Joint

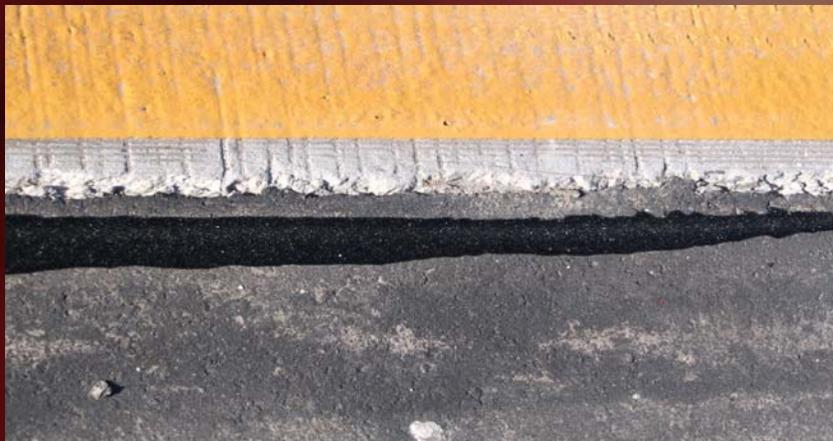
- Saw Cut in the Wrong Spot

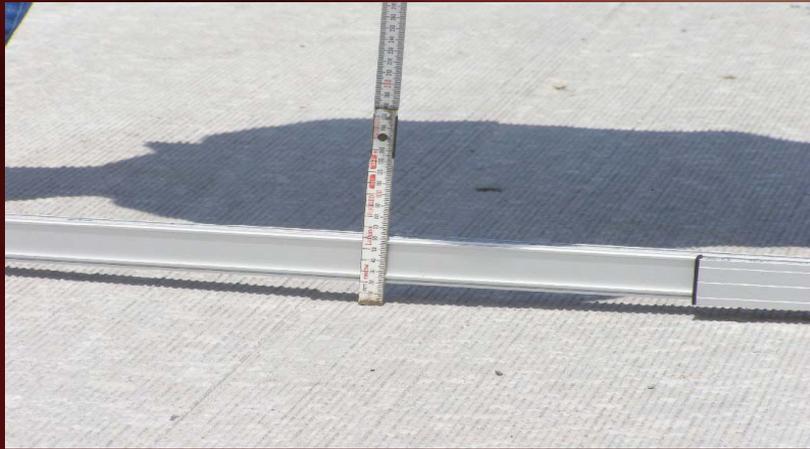
- Grinding to Deep

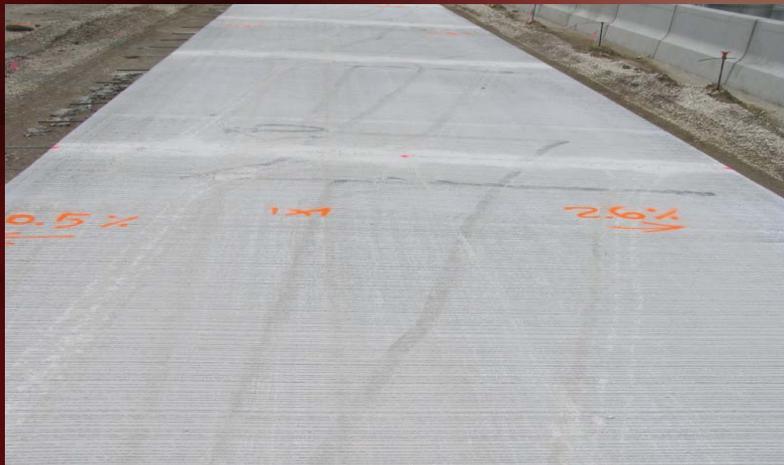
- Inconsistent Cross Slope

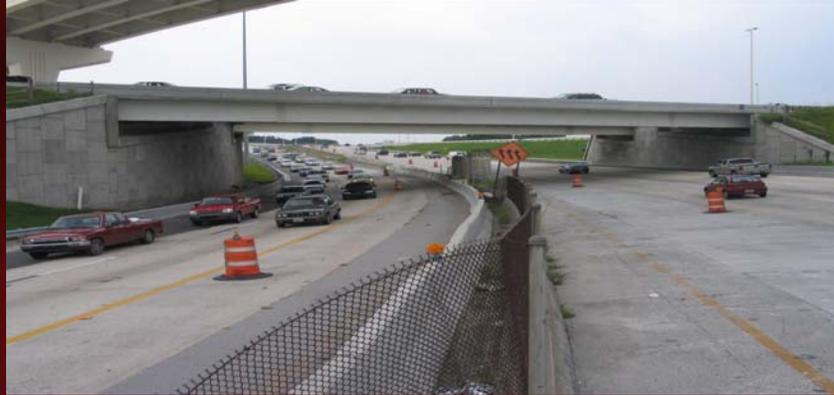
- Mixture of new pavements and existing pavements

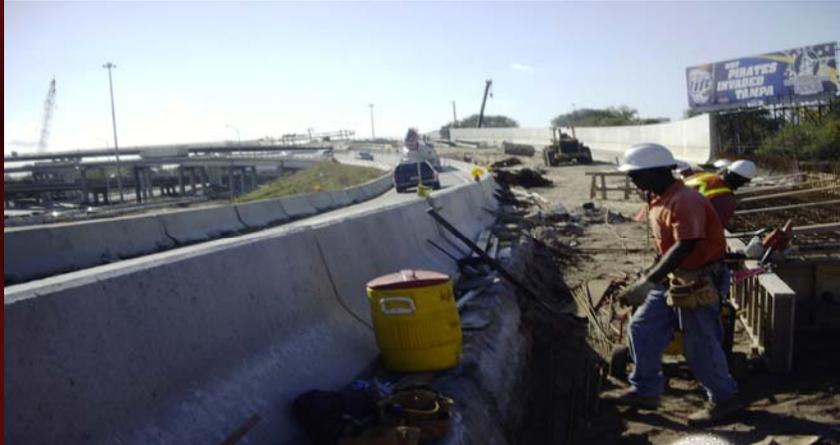
- Variable widening

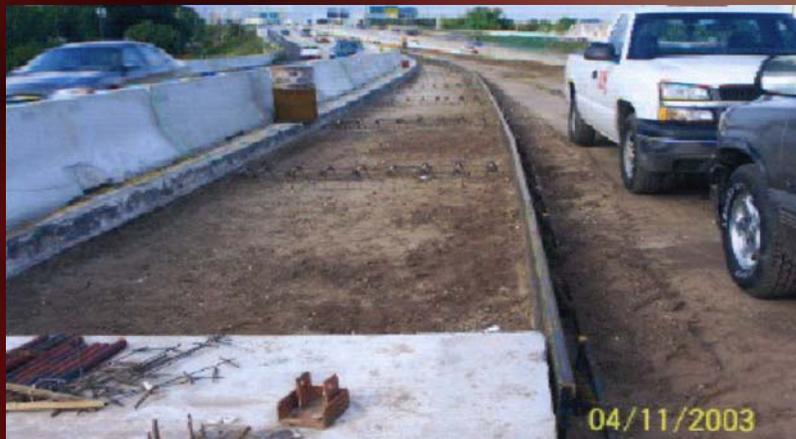
- Variable widening
