## **Session 20**

# Sunshine Skyway Bridge

*Yesterday, Today and Tomorrow*

*FDOT Design Conference: August 2006*  
*Orlando, Florida*

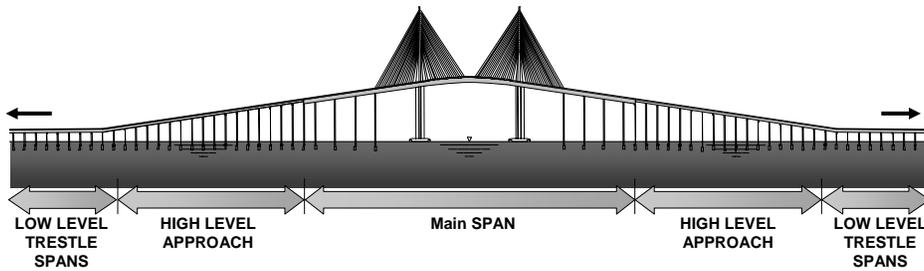
## Bridge Geometry

**Total Bridge length: 4.14 miles**

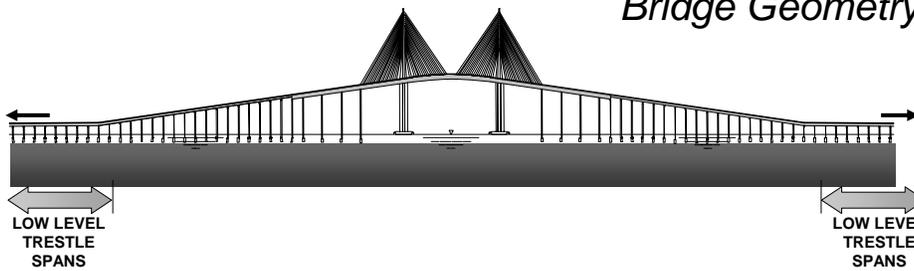
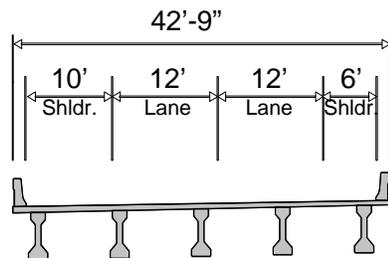
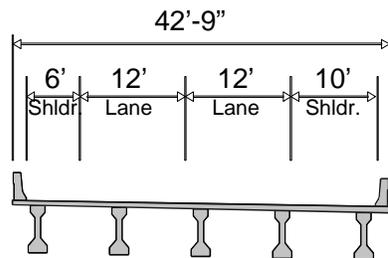
**Total Length: 13,000 ft**

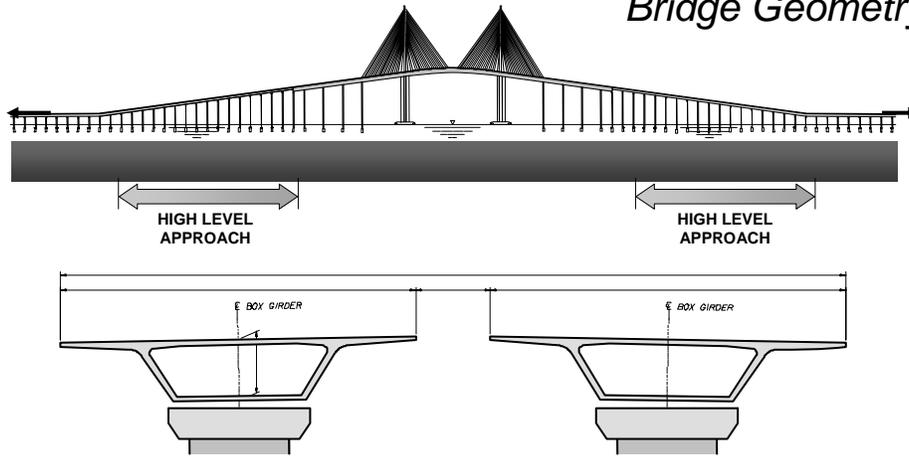
## Bridge Geometry

- Total length: 5,000 ft
- Post-Tensioned Segmental Box Girders
- Vertically Post-Tensioned Segmental Columns

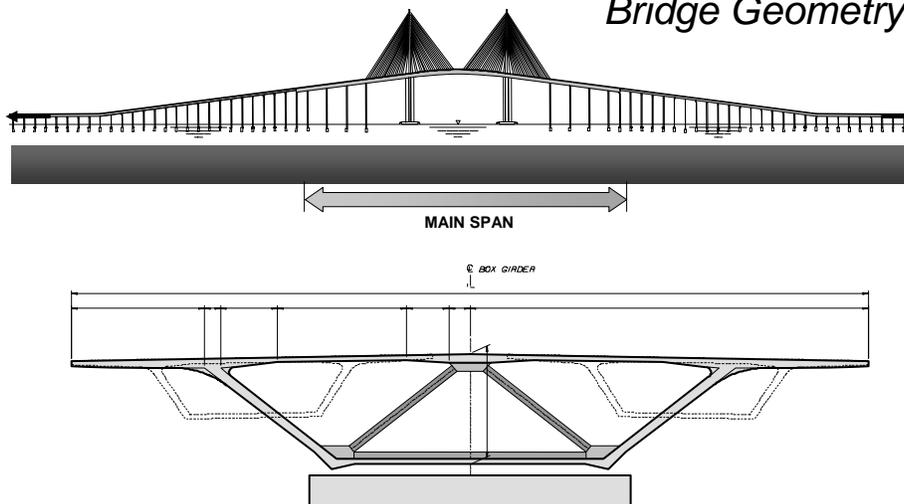
## Bridge Geometry

- Total length: 4,000 ft
- Post-Tensioned Precast Segmental Box
- 42 Continuous Stay Cables, 21 per Pylon

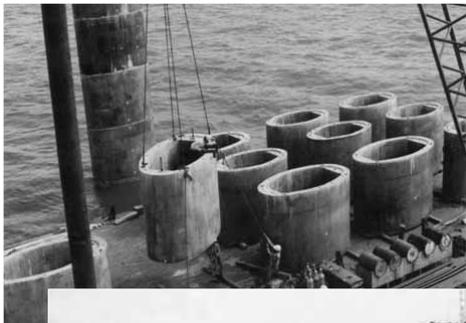
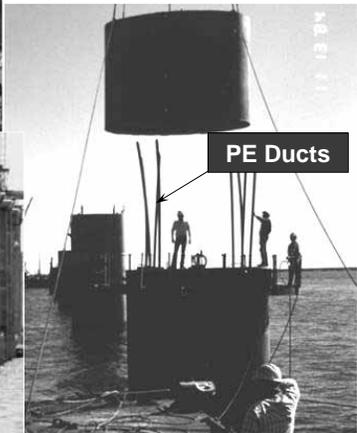
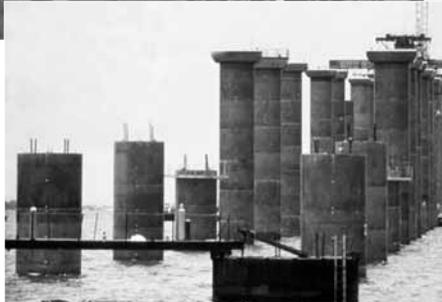
High Level Approaches  
Pre-Cast Column  
PT Segments

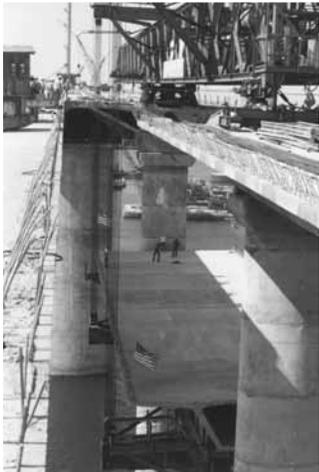
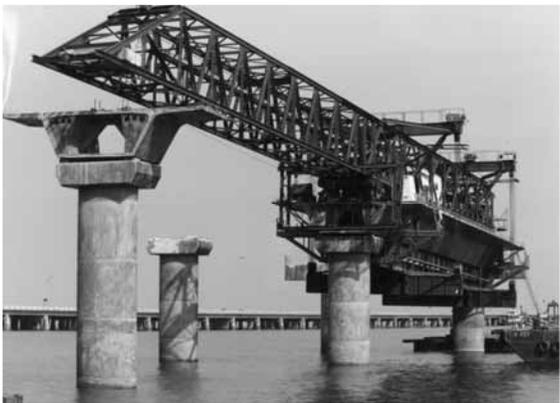
High Level Approaches  
Superstructure  
PT Segmental Construction

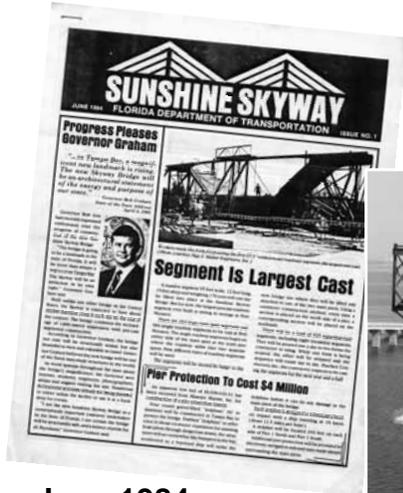
Main Span  
Pre-Cast  
PT Segments

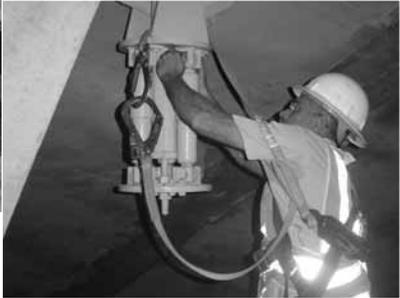
*Stay Cable Dampners*

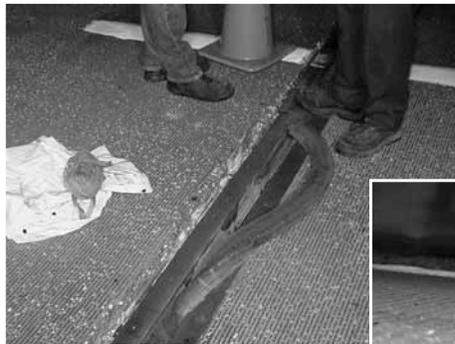
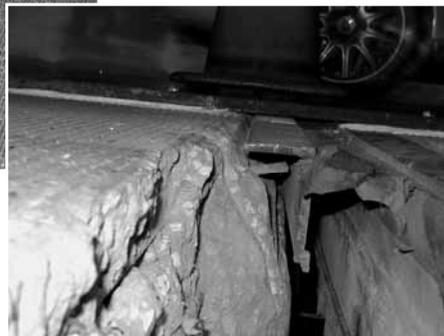
### *Armored Joint*

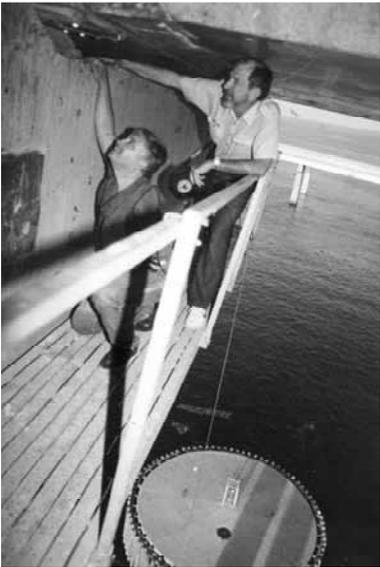
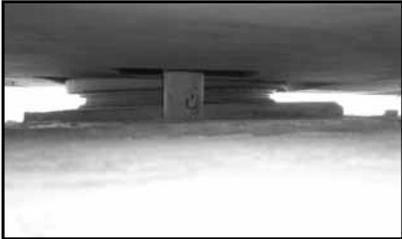
**Teflon Bearings**

Replacement 1993

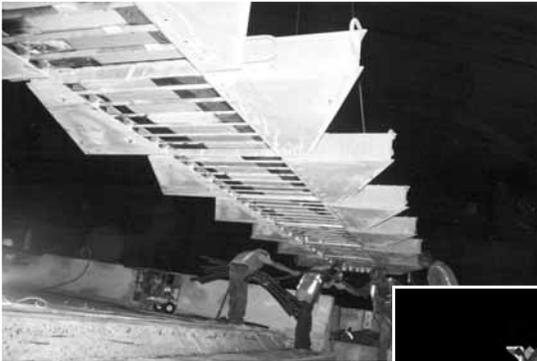
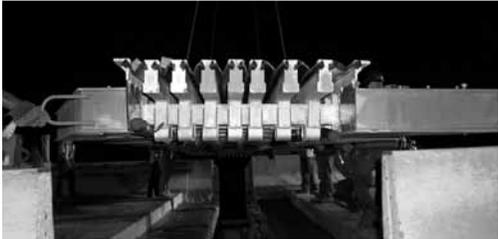
Modular Joint Replacement  
2001

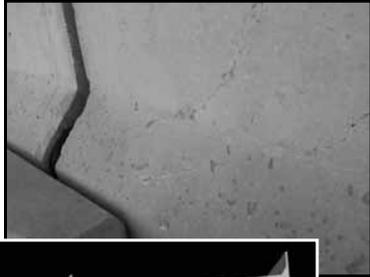
Beam Shear Cracking

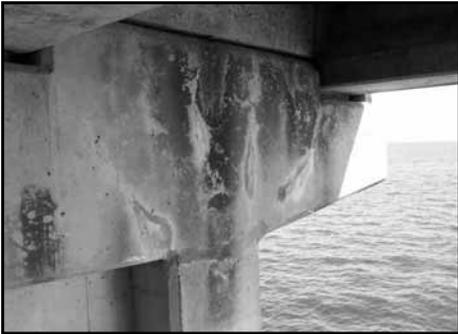
Cap Cracking

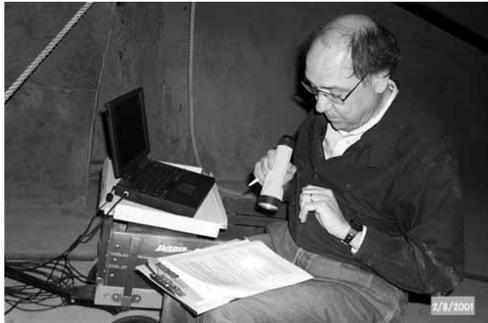
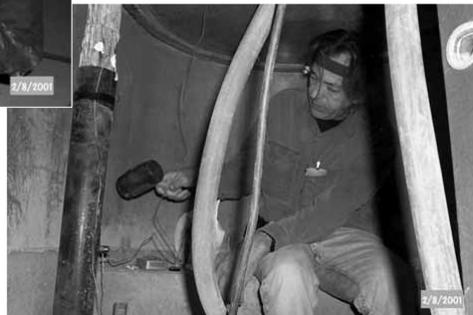
*PT Tendon Vibration Testing*

*NDT- Non-Destructive Testing*

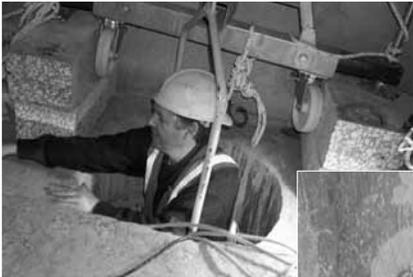
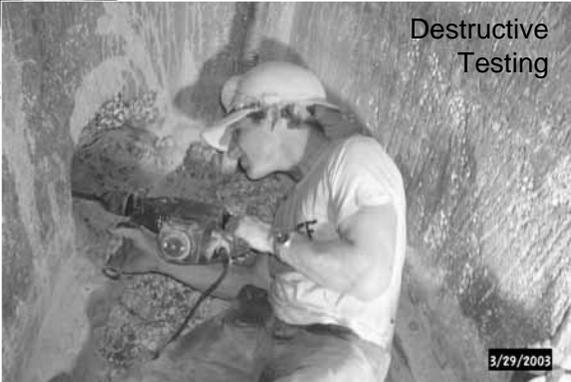
Destructive Testing

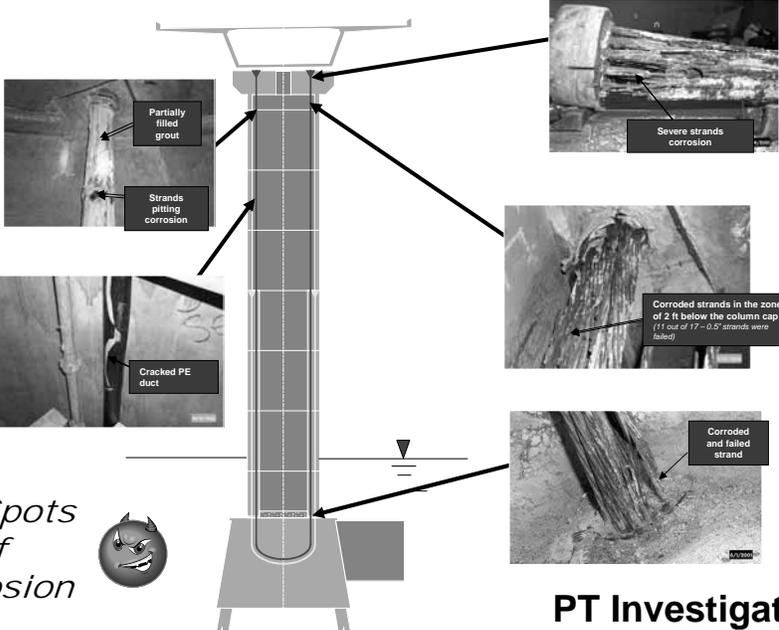
Hot Spots of Corrosion

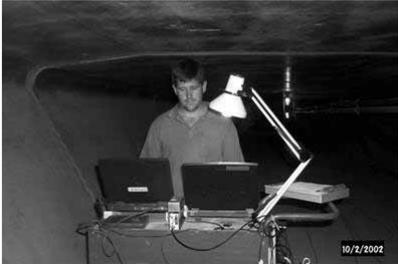
High Level Approach  
Superstructure Inspection

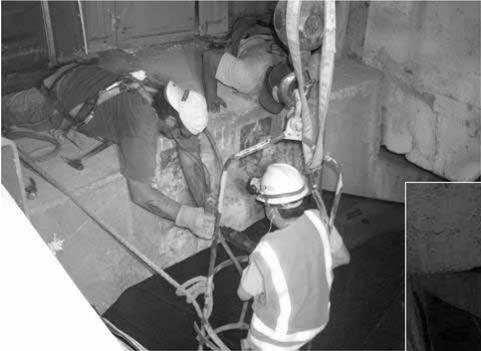
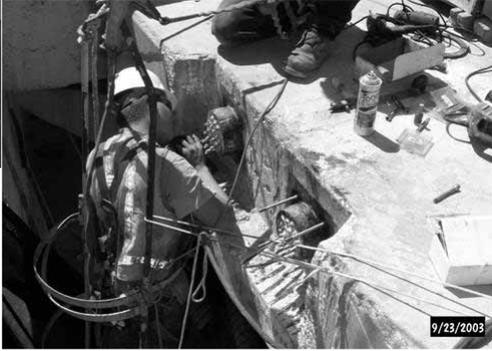
Main Span  
Superstructure  
Inspection

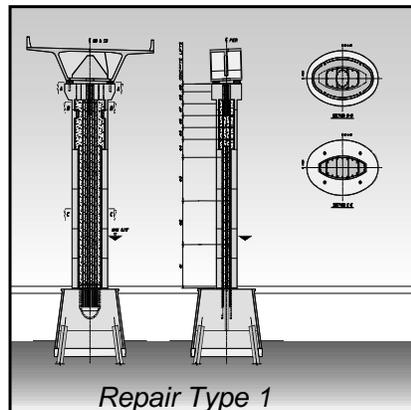
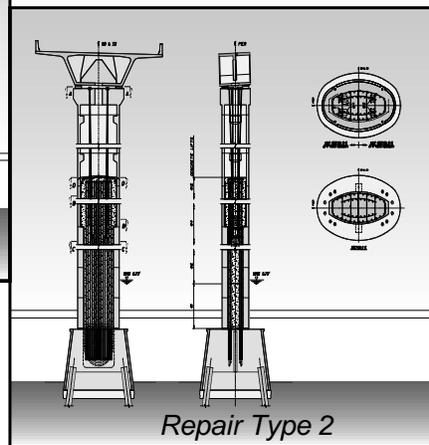
### **PT Repairs Structural Redundancy**

High Level Approaches  
Column

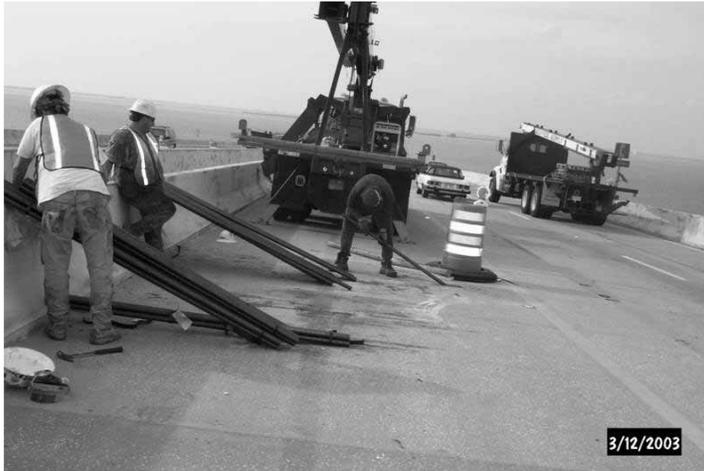
*Column Bars Through Segmental Box Girder*

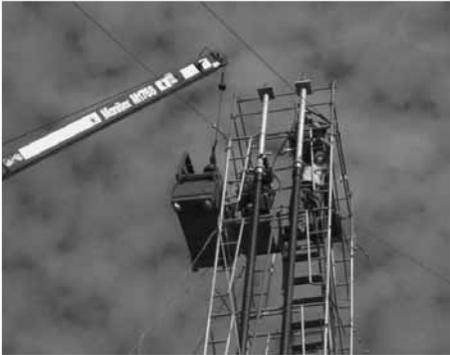
*Vertical Tendon Grouting  
Mock-Up Test Set-Up  
2003*

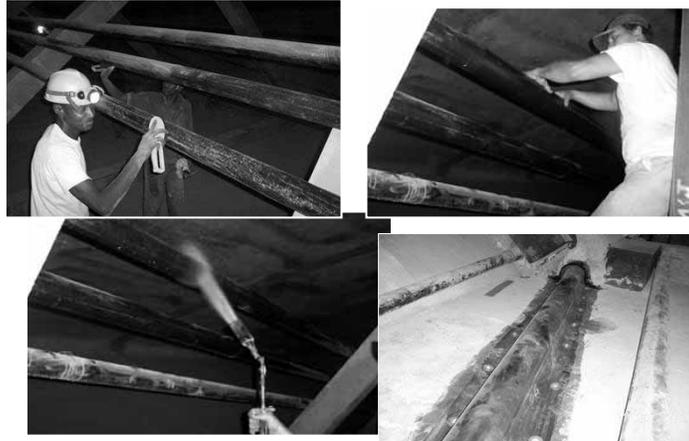
*Additional Levels of Corrosion Protection*

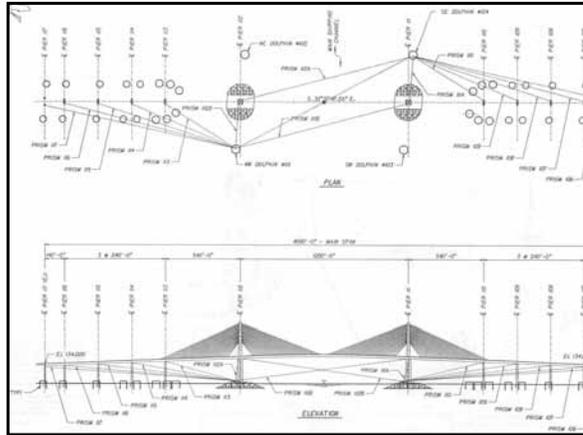
**Running Dolphin  
Control Traverse**

*Monitoring  
GPS and ATS*

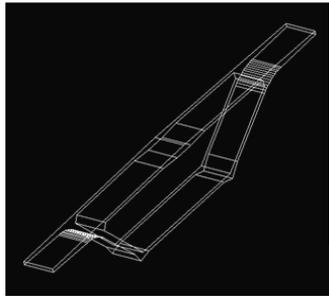
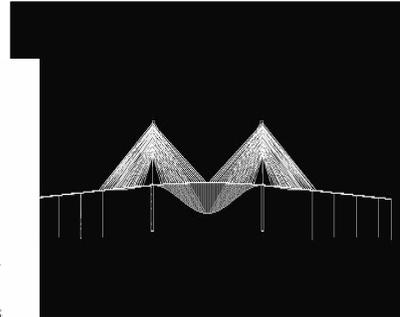
*Monitoring*  
*Structural Modeling*  
*Calibration*

- **Time-Dependent Structural Analysis**
  - High Level Approaches
  - Main Span
- **Finite Element Modeling**
- **Soil-Pile Interaction**
  - High Level Approaches
