### ***FDOT's Pursuit of Durable Post-Tensioned Bridges***

# Florida DOT efforts with AASHTO/ASBI toward improving Post Tension durability

Article by William Nickas  
Presented by Brett Pilstick

# *More Specifically FDOT POST- TENSIONING STANDARDS FOR SEGMENTAL AND GIRDER POST-TENSIONED BRIDGES*

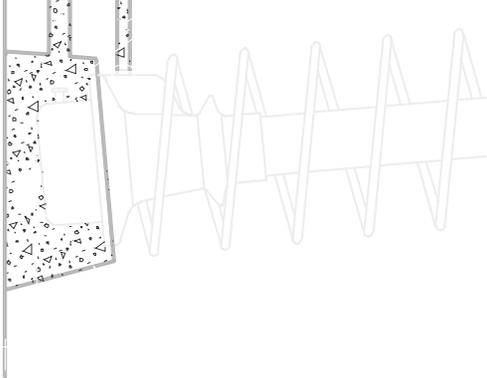
CANTILEVER TENDONS

## ANCHORAGE PROTECTION

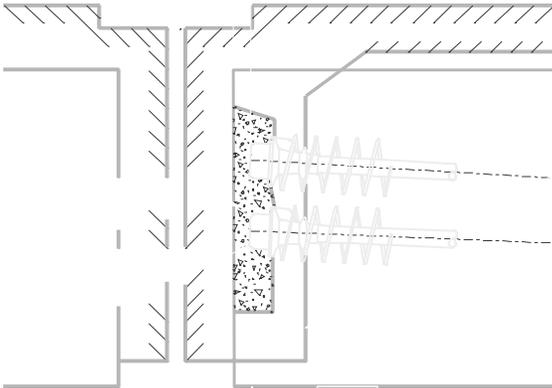
PT GIRDERS AND BULB-T'S

## ANCHORAGE PROTECTION

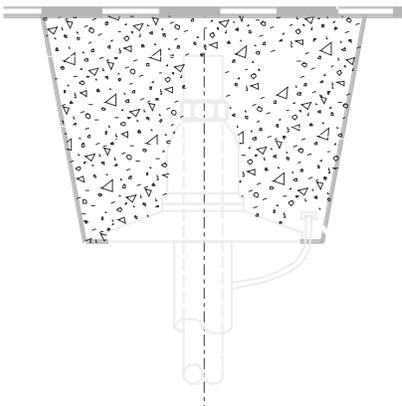
POST-TENSIONING BARS

The diagram shows a cross-section of a concrete beam. The top part of the beam is filled with a stippled pattern representing concrete, containing several small triangles. A vertical line representing a post-tensioning bar passes through the center of the beam. The bar has a hook-like shape at the bottom. A dashed vertical line passes through the center of the beam.

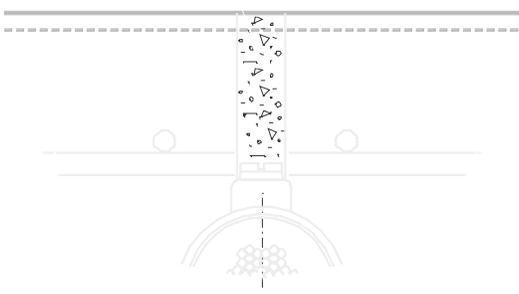
FILLING GROUT PIPE POCKETS

# HORIZONTAL SURFACES

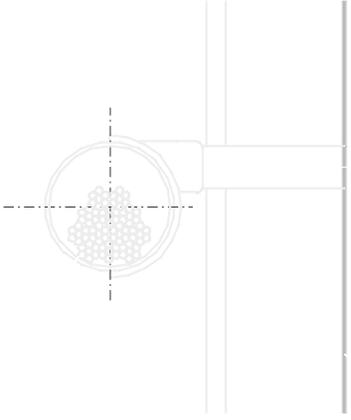
INSPECTION & POCKET PREPARATION

# VERTICAL SURFACES

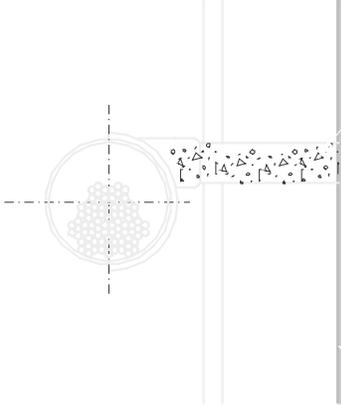
FILLING POCKET WITH EPOXY GROUT

## VERTICAL SURFACES

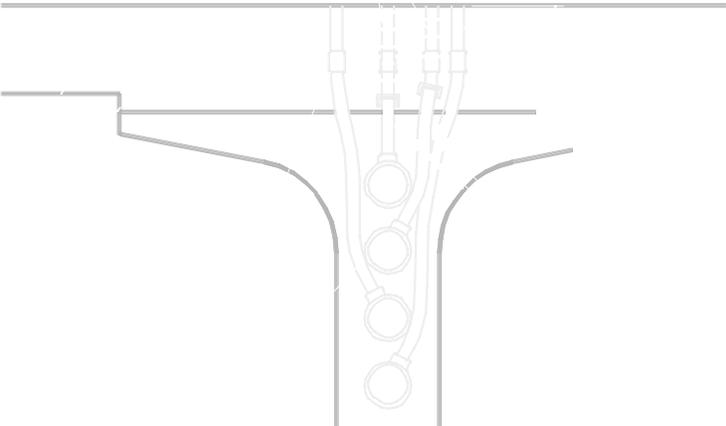
## GROUT OUTLET - 3 TO 6 FT FROM HIGH POINTS

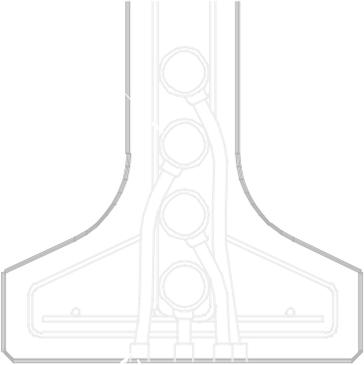
## GROUT INLET / OUTLET - AT LOW POINTS OF TENDON

A technical cross-section diagram of a tendon within a concrete member. The tendon is shown with several circular cross-sections representing individual strands. A grout inlet/outlet is depicted at a low point of the tendon, with a vertical pipe extending through the concrete. The concrete member has a wide base and tapers upwards.

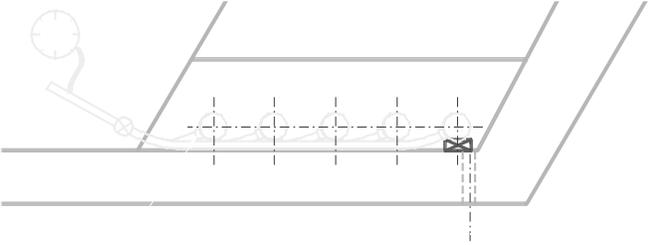
### GROUTING AT LOW POINTS SPAN X SPAN CONSTRUCTION

A technical diagram showing the anchorage and grouting details for a tendon in a span x span construction. The tendon is shown entering from the left, curving upwards, and then extending horizontally through a concrete member. The tendon is supported by a series of circular anchors. A grout inlet/outlet is shown at the end of the tendon, with a vertical pipe extending through the concrete. The concrete member is shown in a perspective view, with a horizontal line indicating the tendon's path.

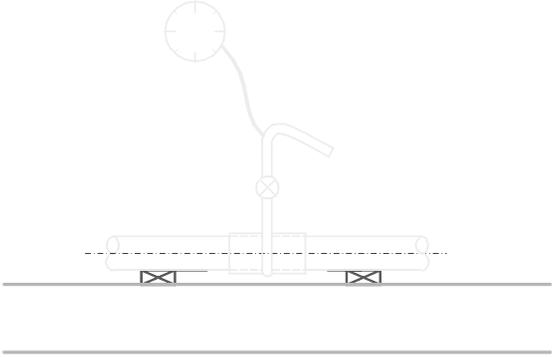
GROUTING AT LOW POINTS  
SPAN X SPAN CONSTRUCTION

## ANCHORAGE & GROUTING DETAILS

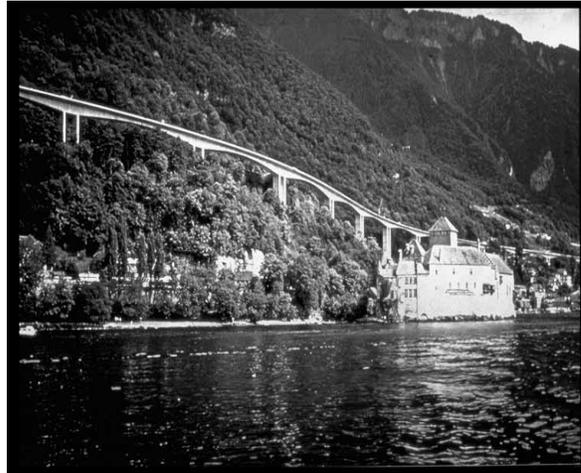
### Chillon Viaduct, Switzerland, built 1967

- Continuous
- Midspan hinges
- Deflection
- External PT added
- Waterproof deck - no corrosion of tendons

- Chillon Viaduct (Switzerland)
  - Added PT to cantilevers with mid-span hinges
  - No corrosion - good waterproofing / overlay
- Autobahn Bridges (various - Germany)
  - Cracks at 1/4 span joints with coupled tendons
  - Add external grease and sheath mono-strand
- Corbeil Bridge (France)
  - Added external longit PT to midspan - with
  - Transverse PT to bottom slab / internal frames

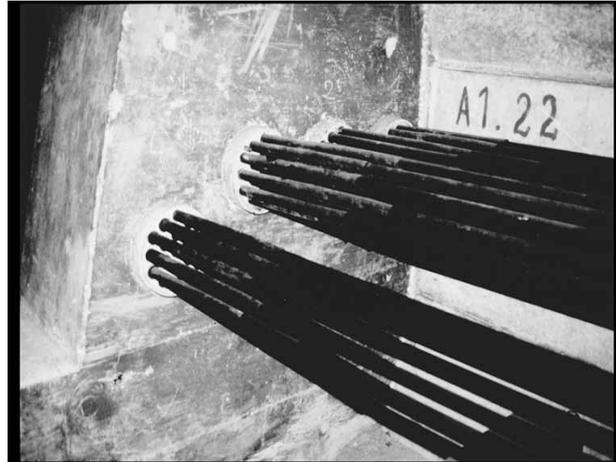
Ext. PT - Greased and sheathed strands

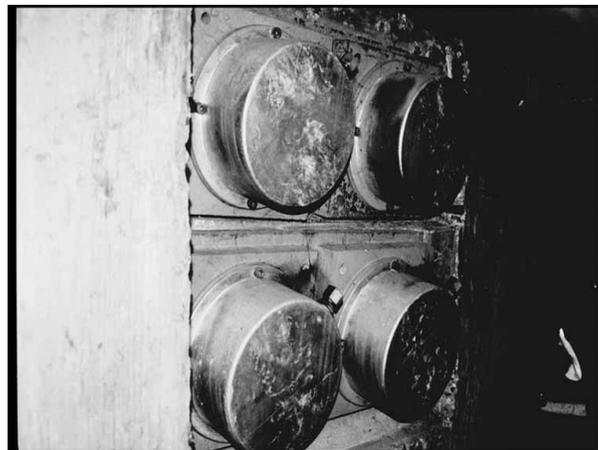
Anchors of ext. PT grouted and capped

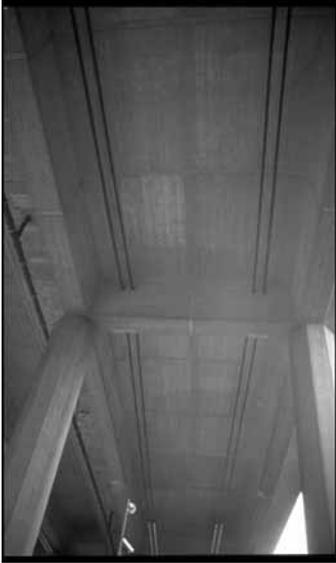
## External Strands

- Greased and Sheathed mono-strands are used for rehabilitation
- Grouted at end anchors
- Special deviator saddles used at diaphragms

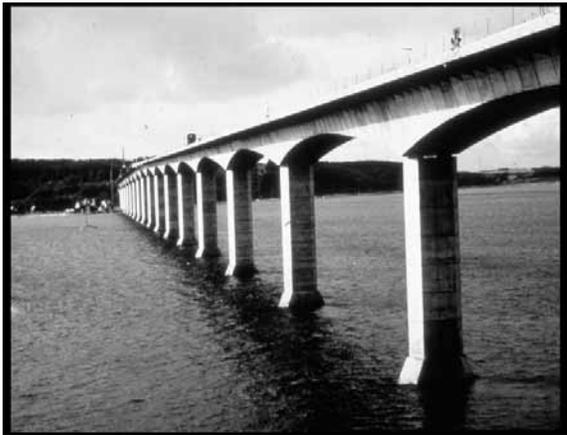
**Sallingsund, Denmark (opened 1979)**

- Epoxy sealed joints
- Deck membrane and overlay
- No corrosion

- Good (20+yr) performance with no signs of corrosion of internal PT in major cantilever bridges at;
  - Sallingsund Fjord Bridge (Denmark - 1979)
  - M180 River Trent Bridge (England - 1979)
- Both of precast match cast segments with similarly sealed epoxy joints plus,
- Waterproof membranes and asphalt overlays

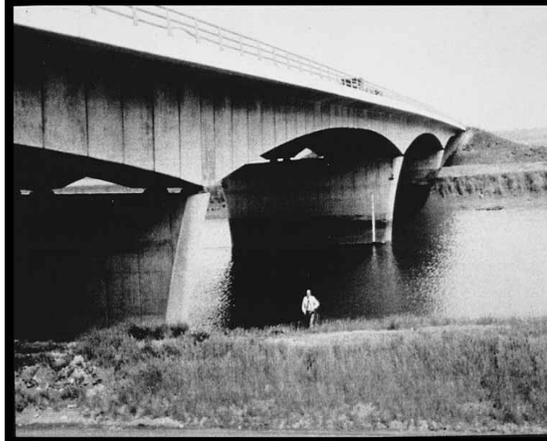
### M180, Trent Bridge, UK, (opened 1979)

- Epoxy Sealed Joints
- Deck membrane and overlay
- No corrosion

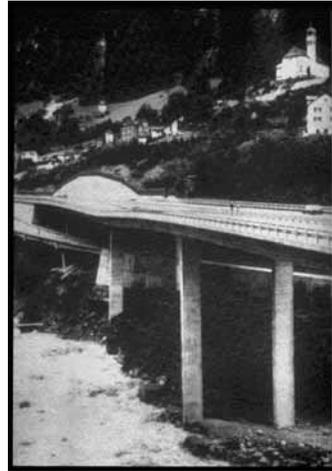
### Reussbrucke Wassen, Switzerland

- PT concrete box
- 1987 flash floods undermined pier
- Over 1m. Deflection
- Bridge remained intact

- Reusbrucke Wassen, Switzerland, 1987
- Undermined by flash floods
- Severe loss of support and deflection > 1m.
- Superstructure jacked back up, repaired and pier underpinned.
- Re-opened 1988

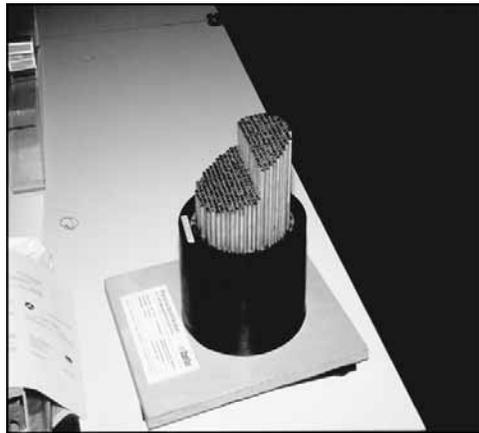
## Sunnigbergbrucke - Cable Stay

- Parallel wires
- In inert matrix
- Thick wall PE pipe
- All stays prefabricated to length at factory
