Florida Turnpike Enterprise Canal Protection Project

CRITERIA TO BE USED ON FLORIDA TURNPIKE HIGH TENSION CABLE BARRIER PROJECTS

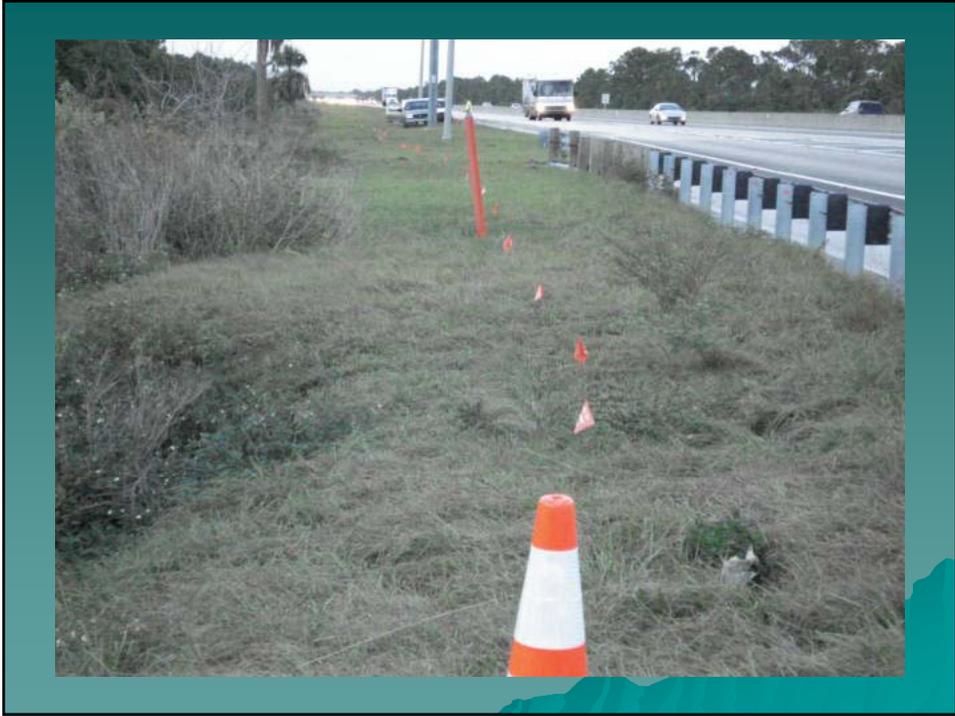
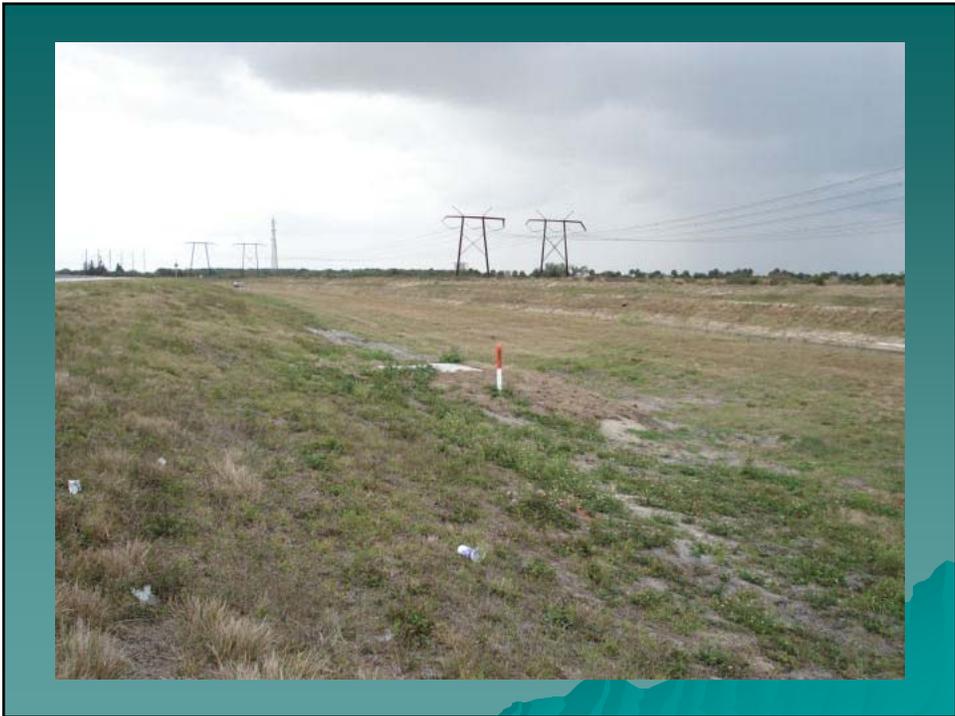
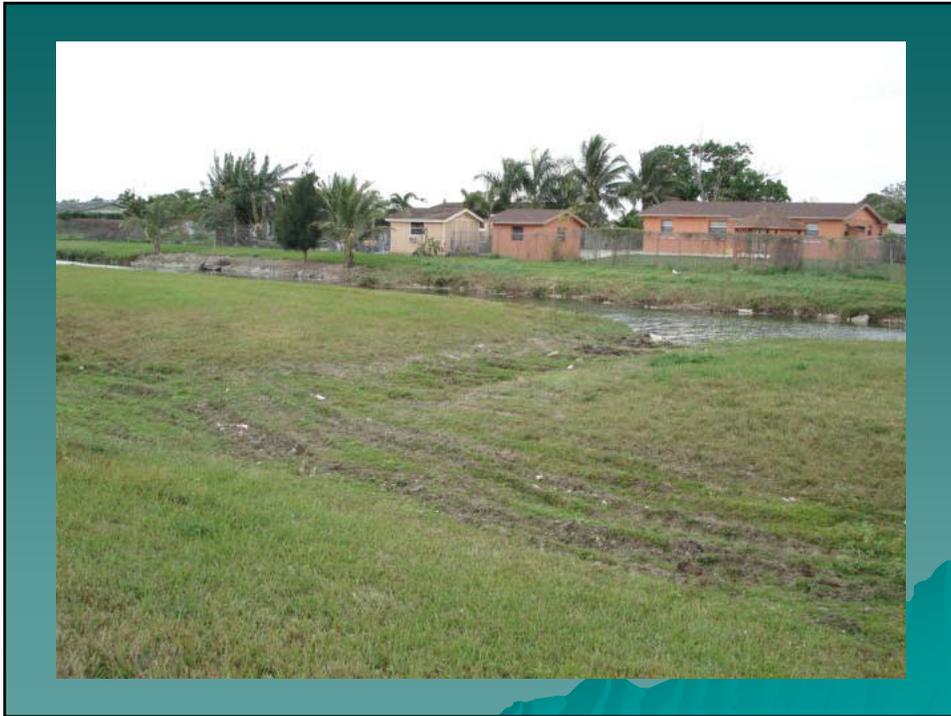
INSTALLATION OF NEW CABLE SYSTEM

It is critical that the full run be laid out and utilities are cleared before installation begins.

Installation of sockets and anchors can take 2-5 times the duration required to install and tension the cable.

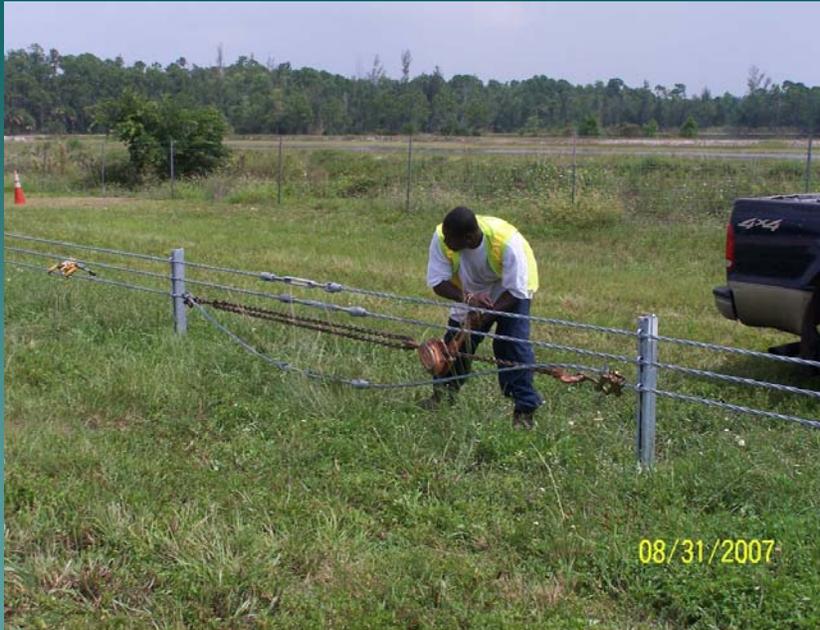
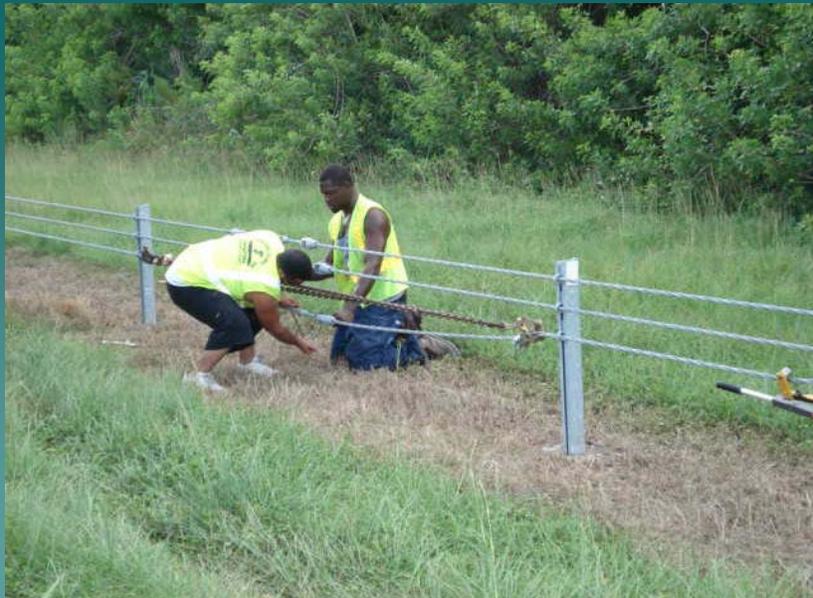
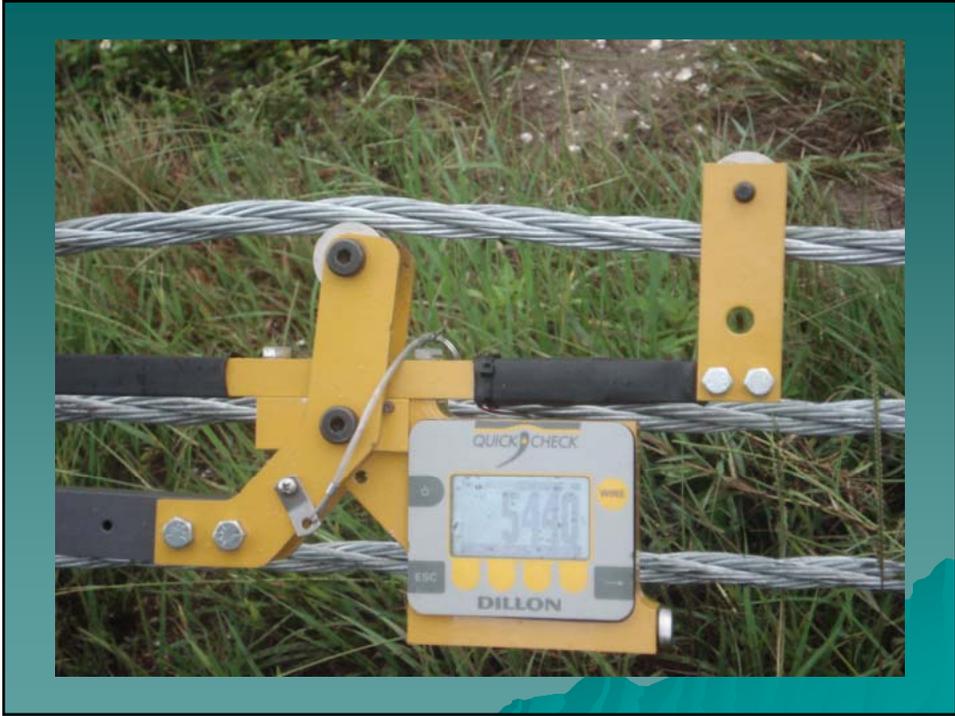
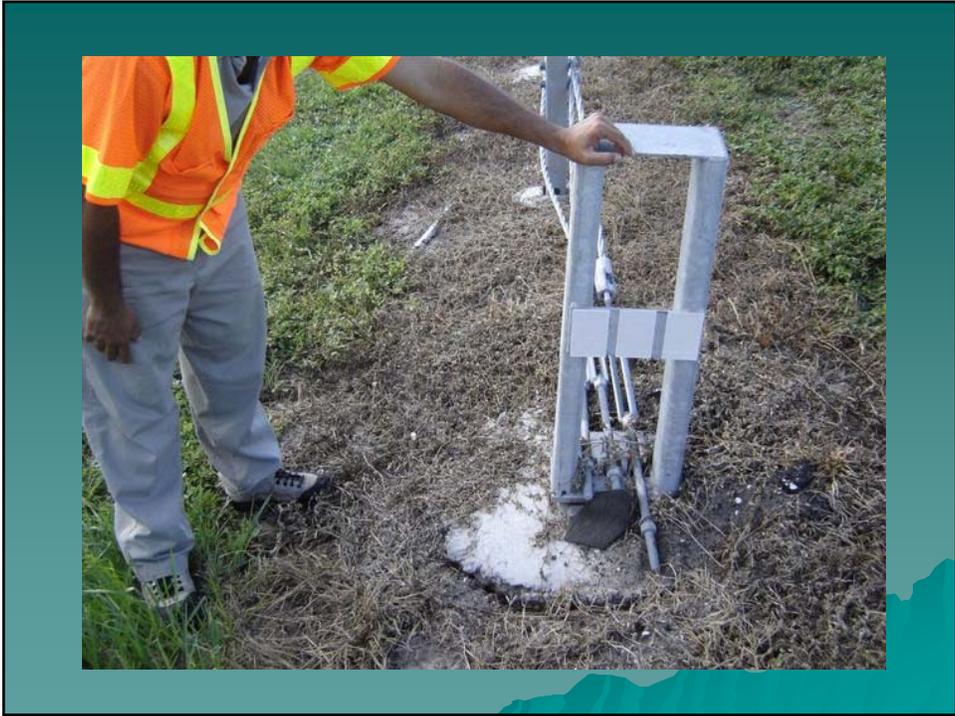
CABLE TENSIONING

- Tension Testing
- Installation Testing
 - Initial Record Test
 - Test Period

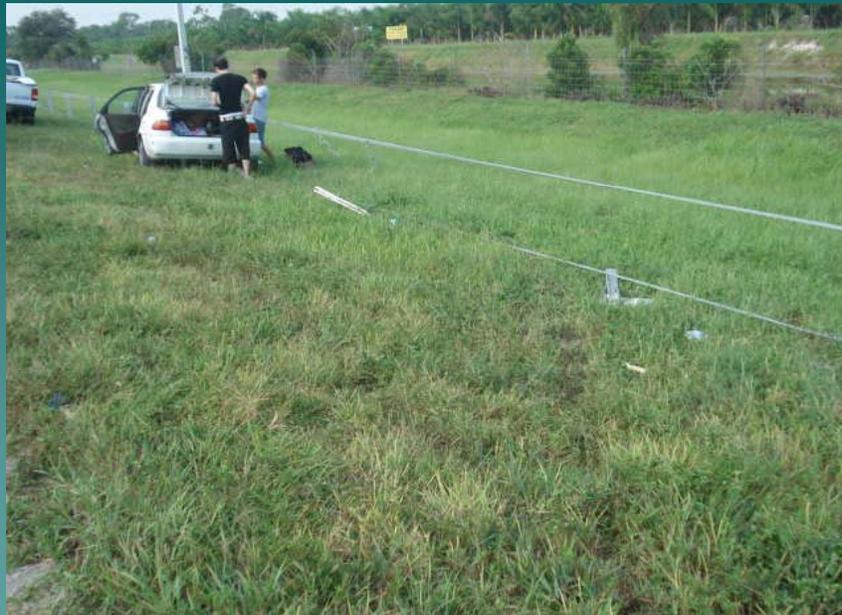
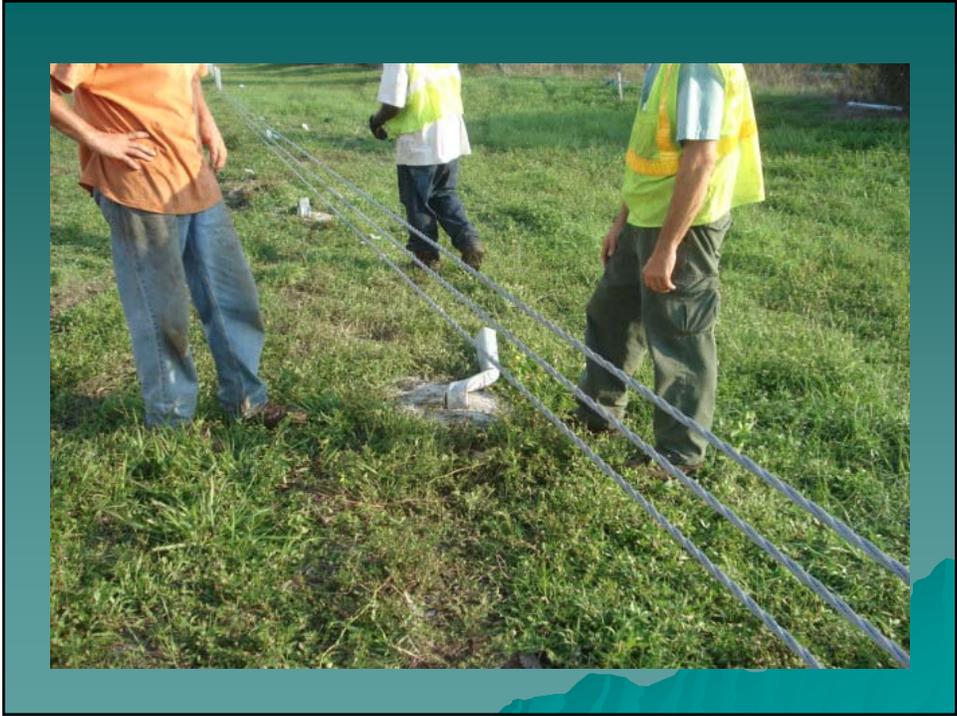
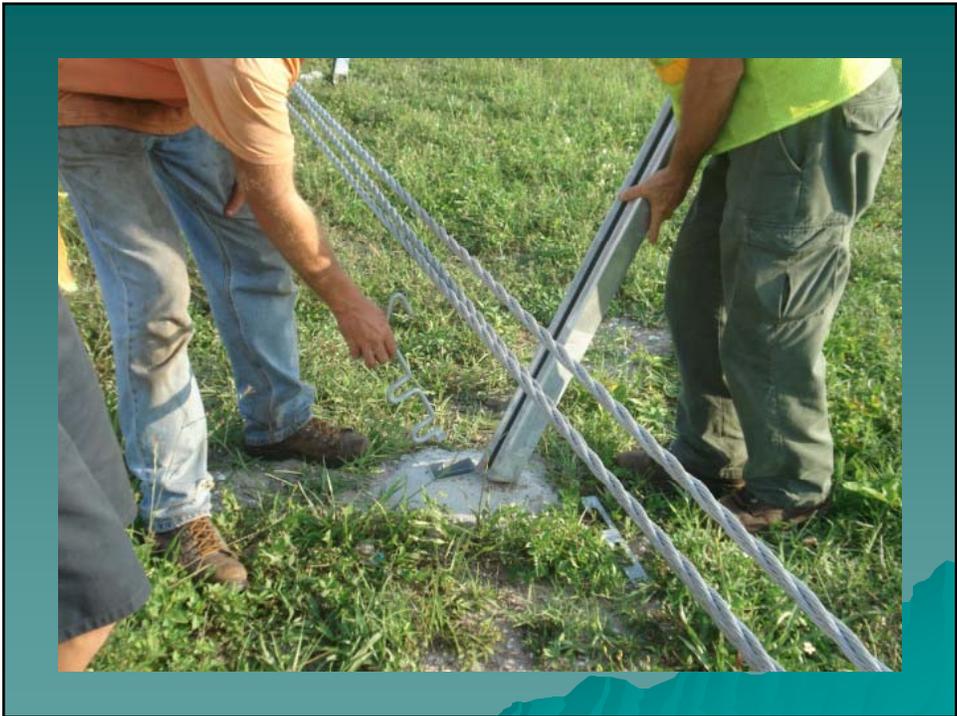
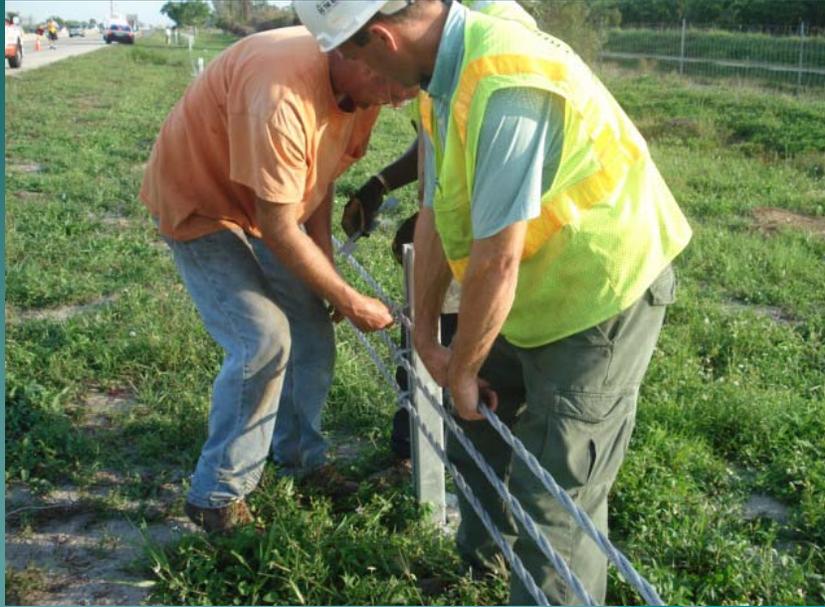
MAINTENANCE OF CABLE BARRIER

Concrete Encased Post Sockets have proven highly effective in reducing the work effort required in repairs.

A typical hit, that does not affect an Anchor, can be repaired by a 2-3 man crew and generally requires the replacement of 2-8 posts and associated hardware.

Cable tension should be tested following a hit, but re-tensioning typically is not required.

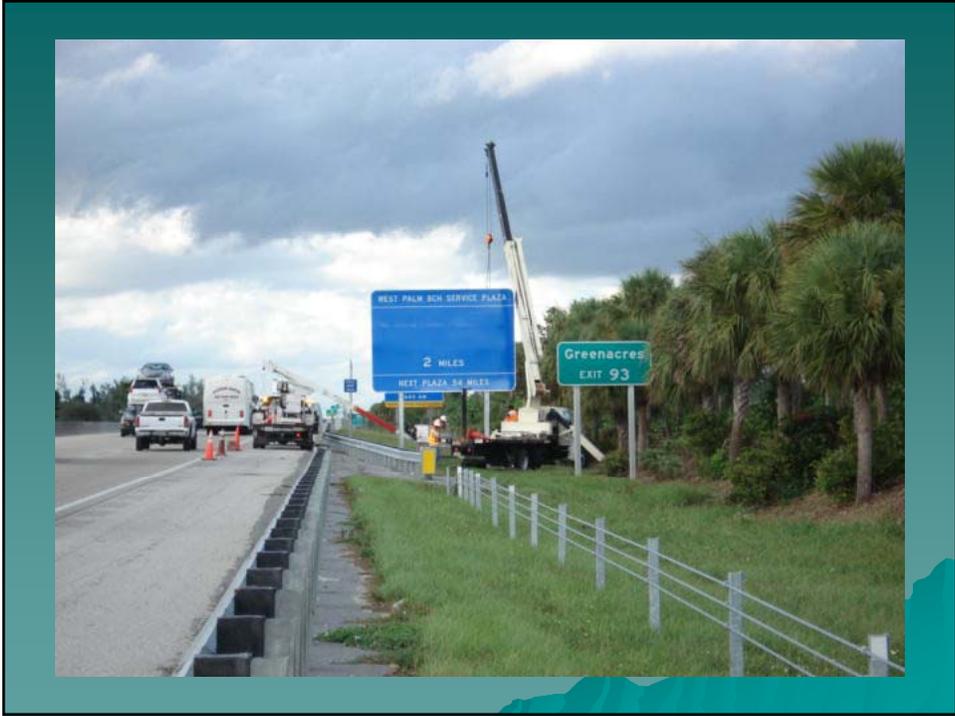
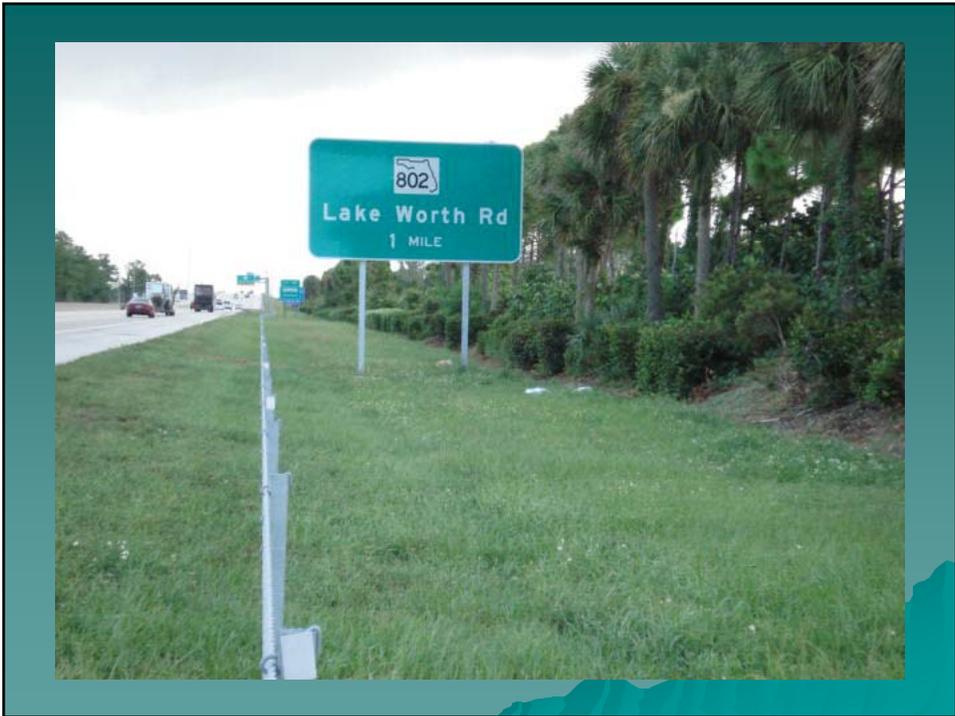
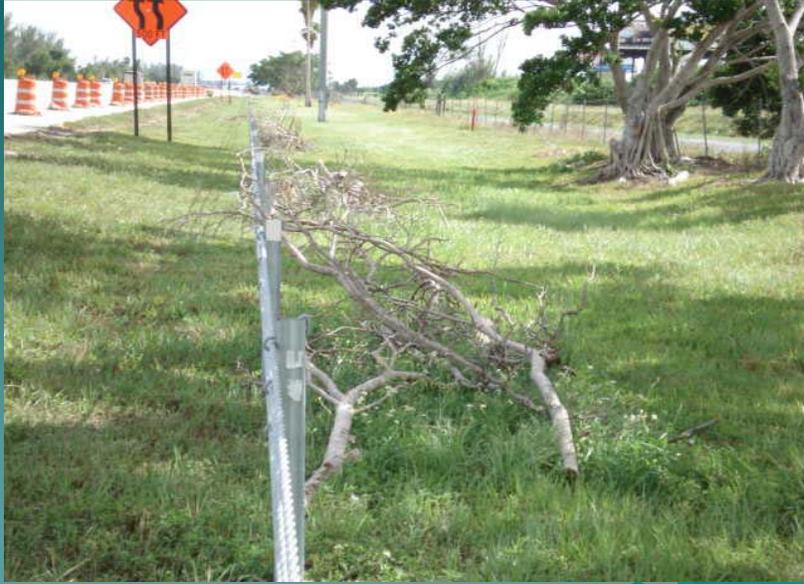
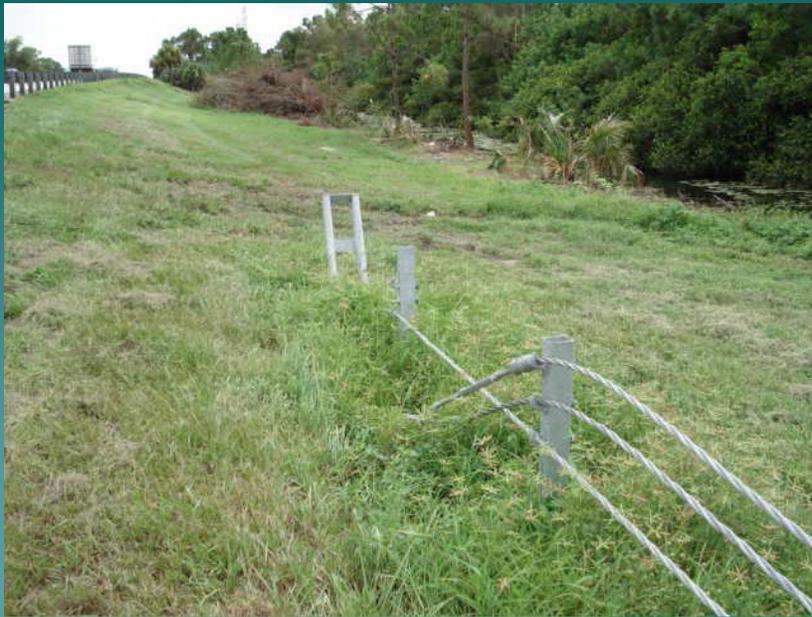
CABLE BARRIER AS IT IMPACTS MAINTENANCE

Mowing & Equipment Access

Clearing of Brush and Trees, both to provide access behind and to maintain deflection zone.

Deflection Zone and Access Requirements can have a significant impact on the location of signs.

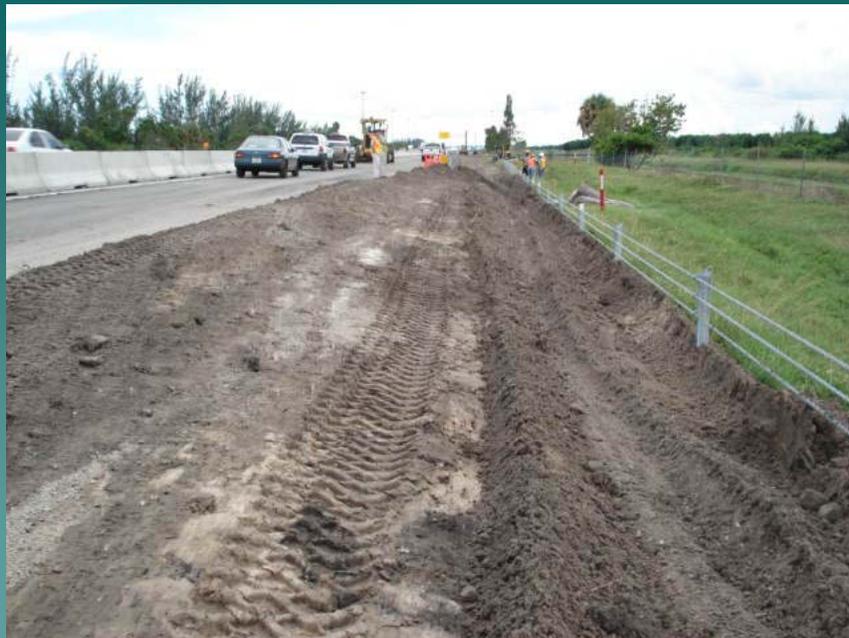
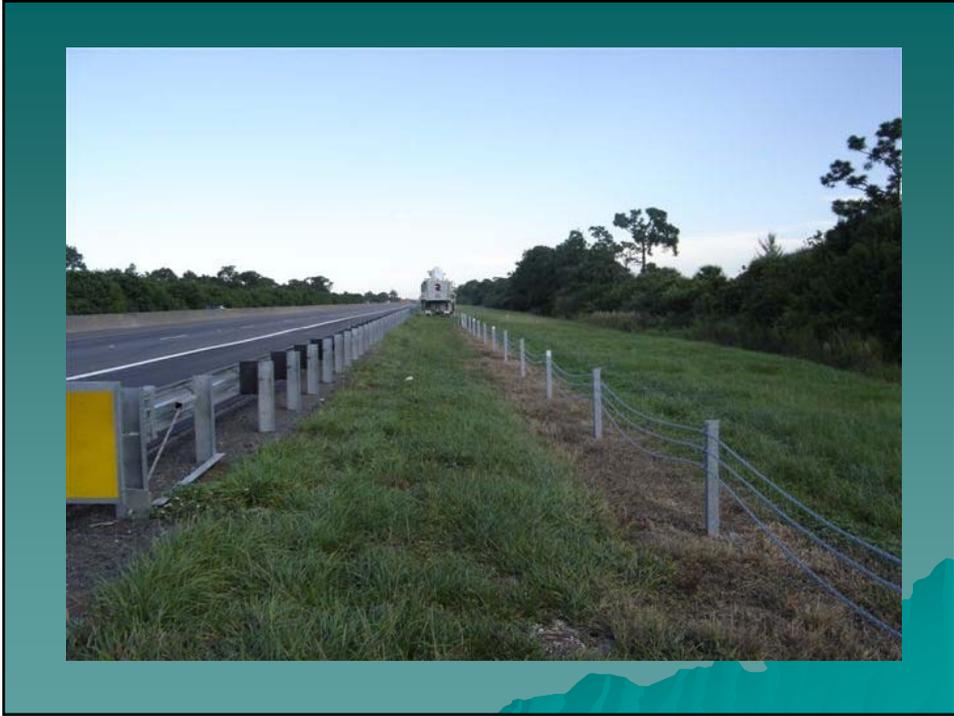
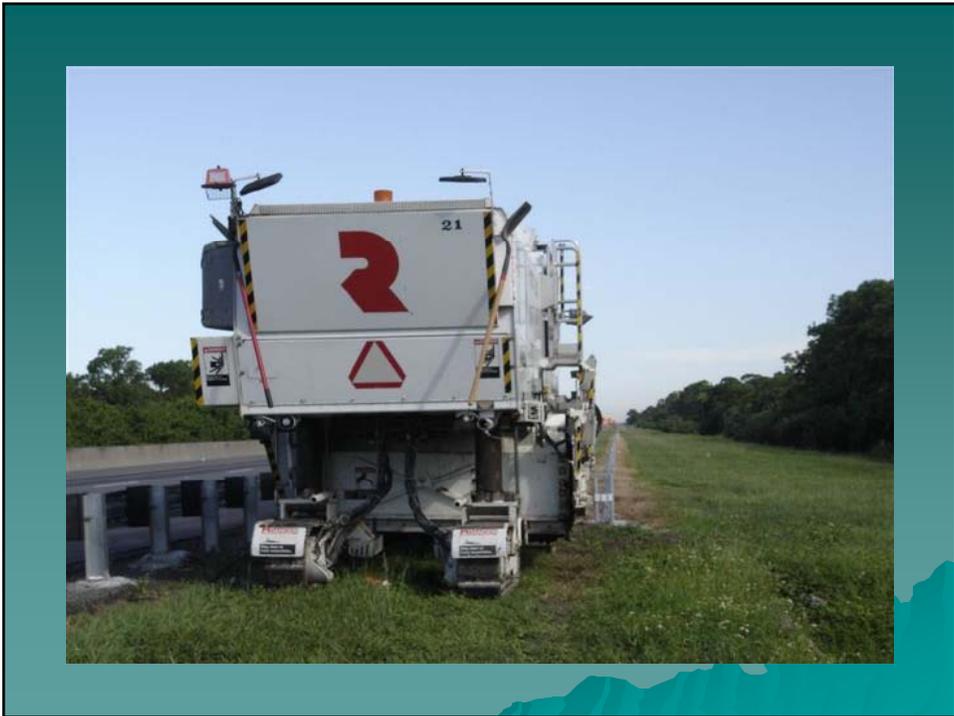
CABLE BARRIER AS IT IMPACTS FUTURE CONSTRUCTION PROJECTS

When installed along the outside shoulder, Cable and it's required deflection zone can have a significant impact on a construction ability to stage equipment and material in the immediate work area.
