Managing Florida's Fracture Critical Bridges - Phases I & II

Huy Pham
Jawad Gull, Ph.D.
Alireza Mohammadi
Atorod Azizinamini, Ph.D., P.E.

**Department of Civil and Environmental Engineering
Florida International University
Miami, Florida**

Sponsored By
Florida Department of Transportation

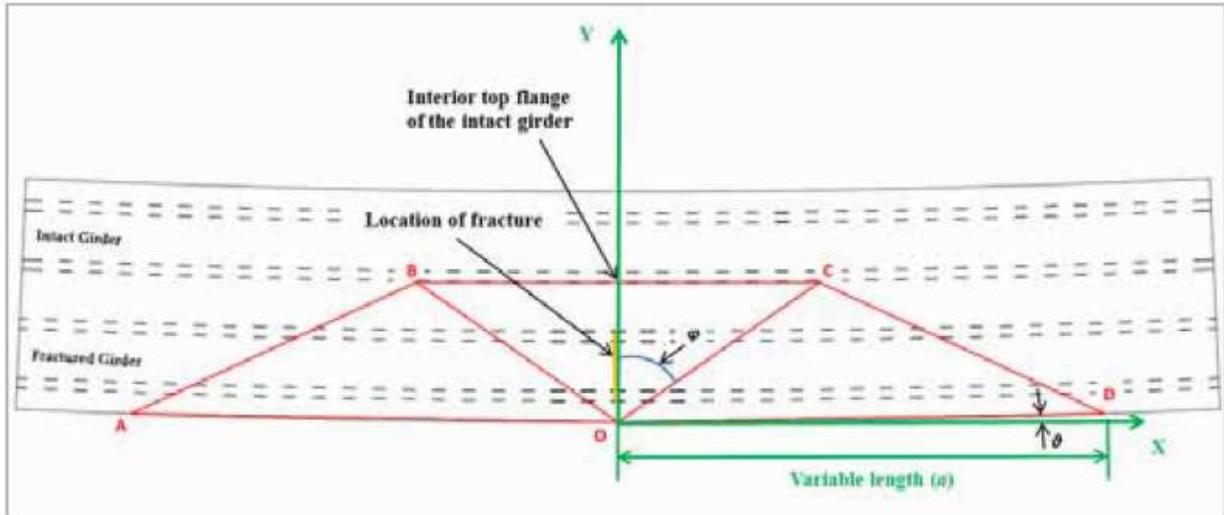
Figure 1-6 Yield line model proposed by Barnard et al. (2010).

In the yield line analysis approach, once the yield line pattern is chosen, the analysis is performed using a virtual work principle. The principle of virtual work requires that the external virtual work done by the external forces be equal to the internal virtual work done by the internal forces of each element. The yield line pattern, chosen for the bridge tested in Texas, is illustrated in Figure 1-6. In this yield line analysis approach, three parameters are required to define the yield line pattern. These parameters are angle ϕ , length a , and angle θ . The angle θ can be calculated based on the curvature of the bridge and it is zero for a straight bridge. The angle ϕ , is suggested to be constant at 55 degrees according to the results of a parametric study. The length a , is determined by finding the value that produces minimum truck load. It is important to note that length a , and magnitude of truck load are mutually dependent; therefore, one needs to be fixed to find the other. The minimum truck load is the last one that gave a physically admissible solution for the length a .

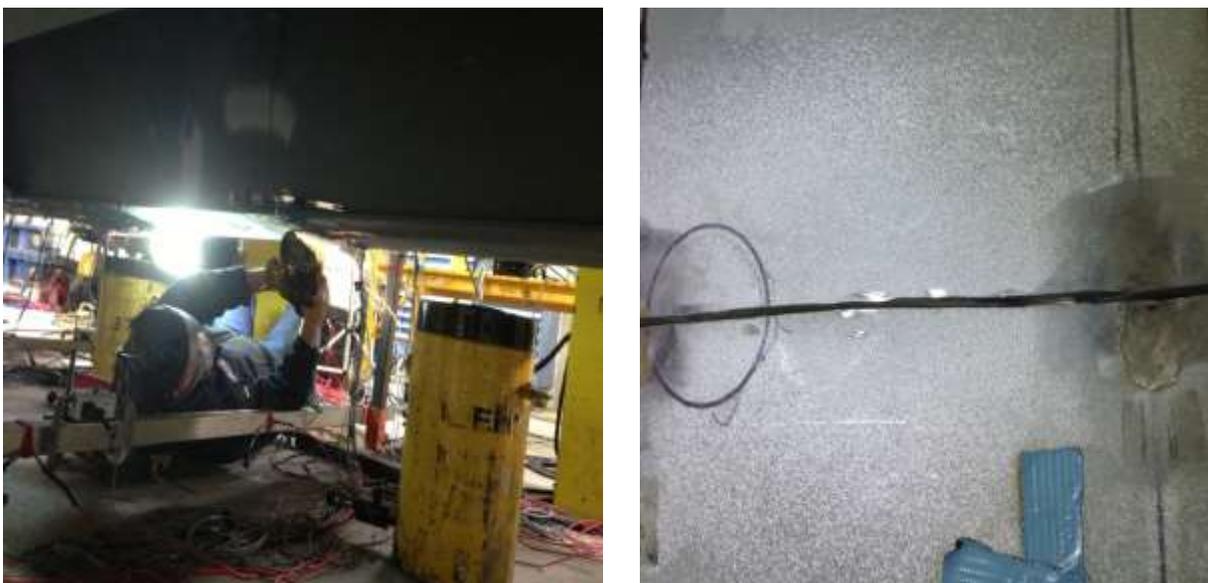
Figure 4-1 Saw cutting of bottom flange in east girder.

In this series of tests, the bottom flange in the EG was fractured at mid-span as illustrated in Figure 4-1. Due to that fracture in bottom flange, the maximum longitudinal strain in EG was now measured from its webs, while maximum longitudinal strain in WG was still measured from its bottom flange. The same six tests that had been carried out for the undamaged bridge were repeated. Again, the effects of each parameter, including rail, continuity, and loading configuration, were investigated based on the responses of the steel box-girders.

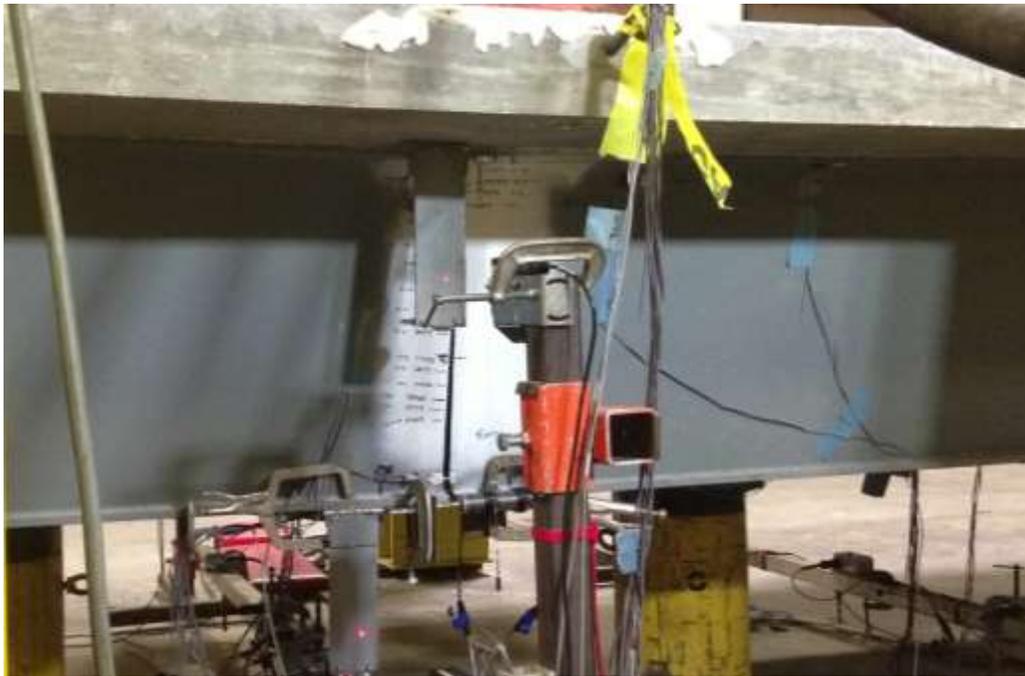
Figure 4-2 East girder with bottom flange and web fractured in one girder.

In this testing series, the damage intensity was extended by fracturing the entire webs of EG in addition to the existing fracture in the bottom flange as illustrated in Figure 4-2. It is also important to note that since the web was now fully fractured, the longitudinal strain data in EG at mid-span were lost and not reported here.

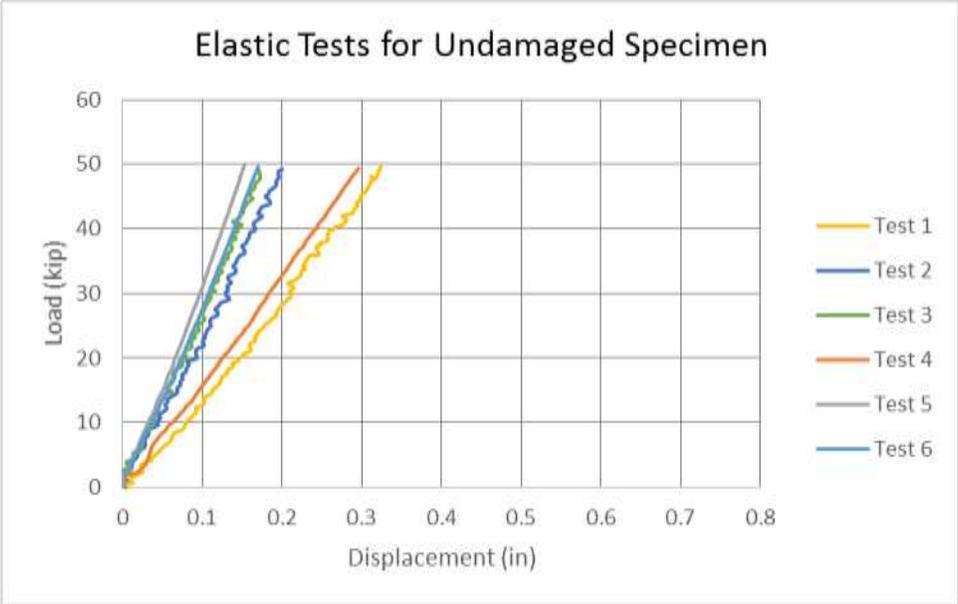
Figure 4-3 Results of elastic tests on undamaged specimen.

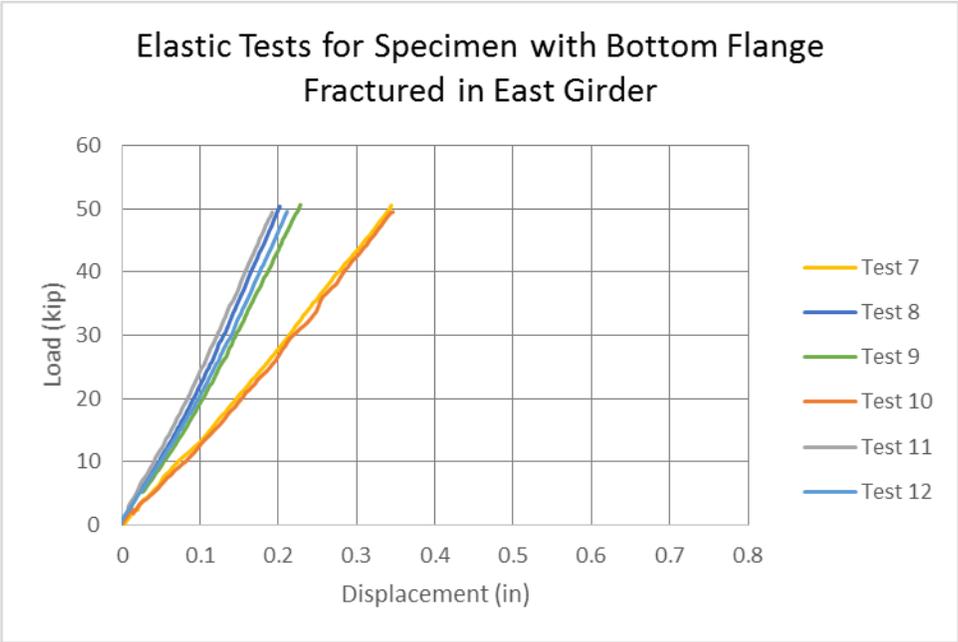
Figure 4-4 Results of elastic tests on specimen with bottom flange fractured in east girder.

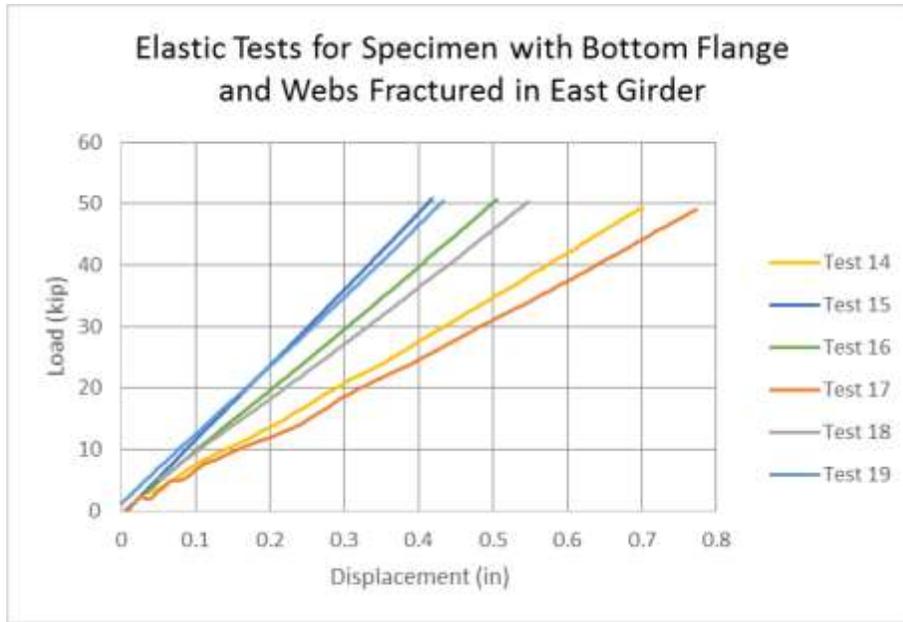
Figure 4-5 Results of elastic tests on specimen with full-depth fracture in east girder.

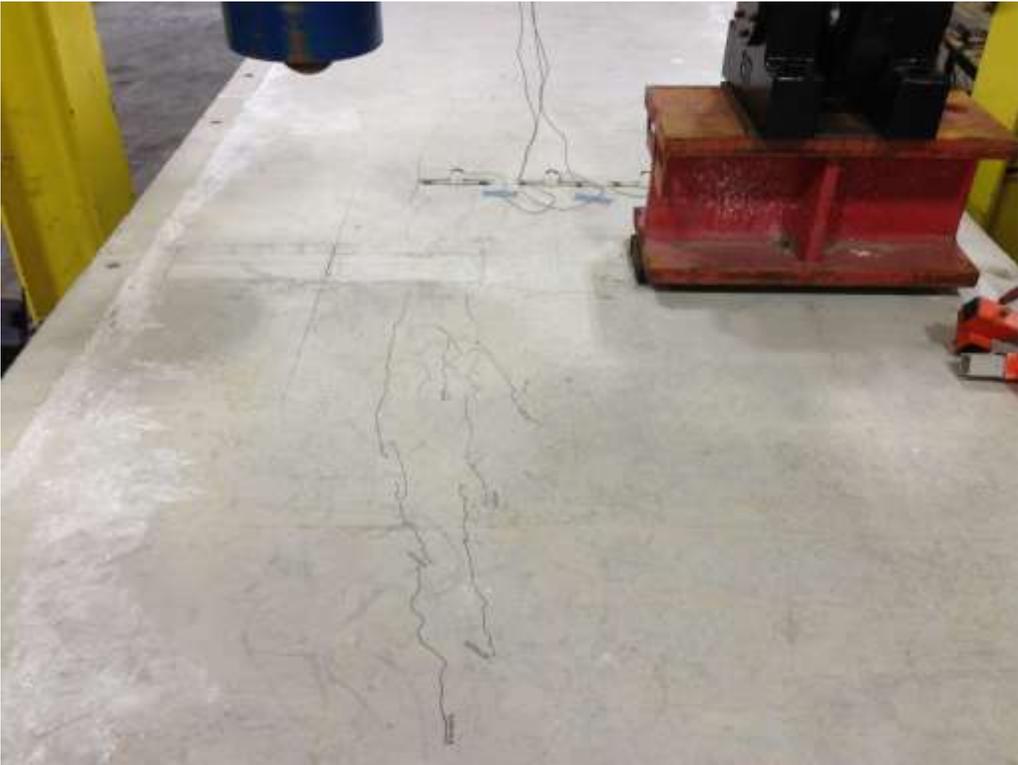
Figure 4-7 Cracks on the deck surface during cyclic test.

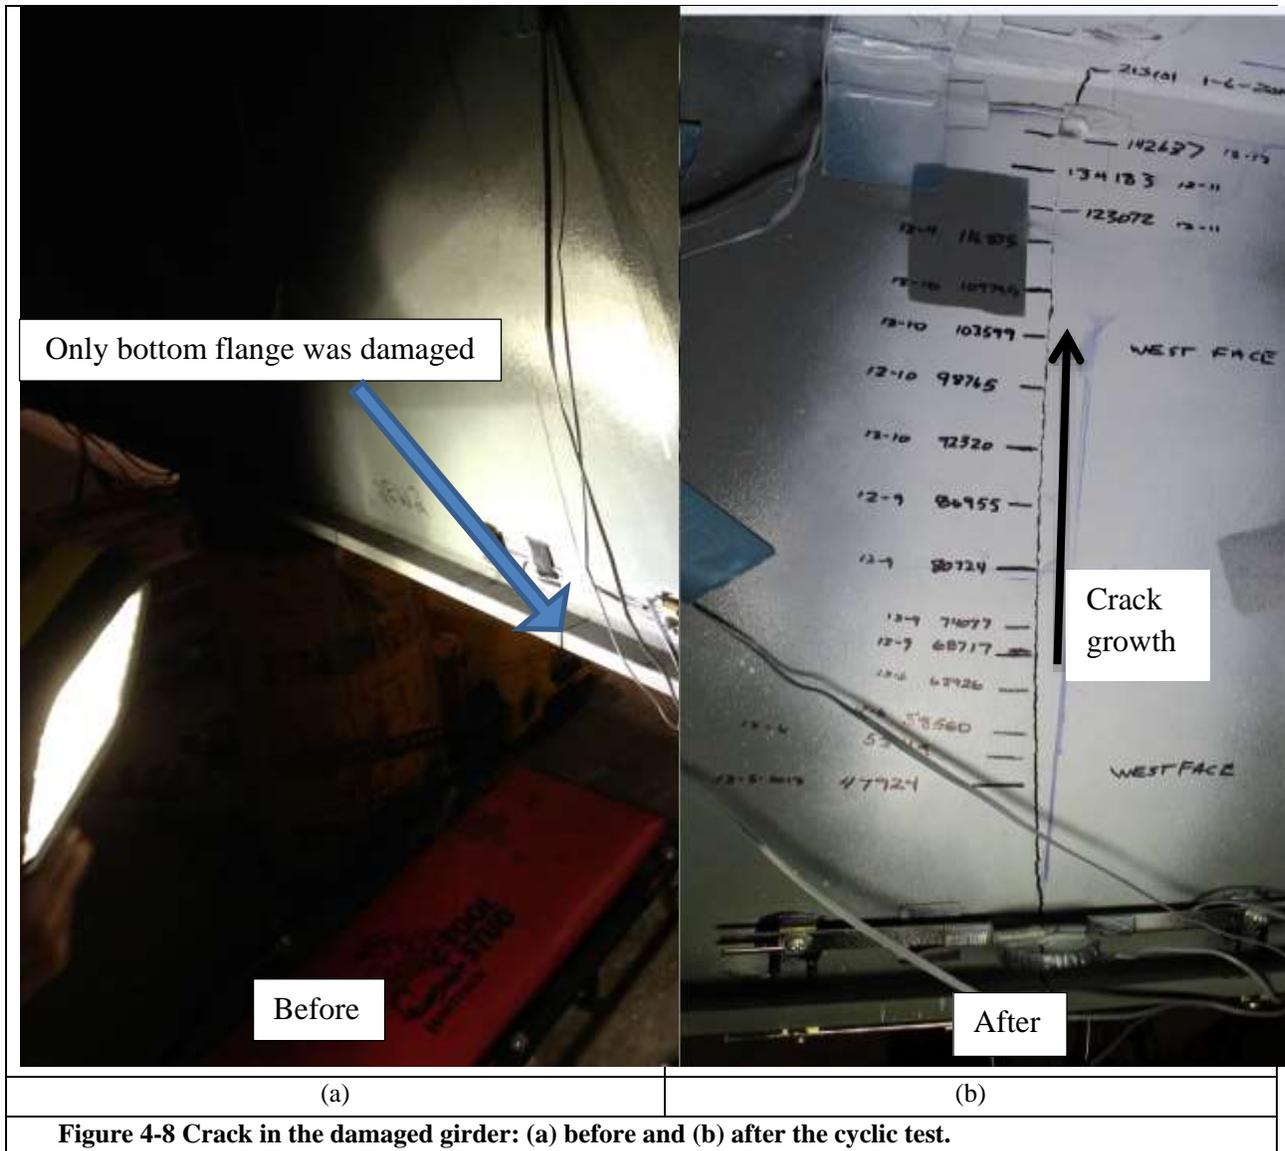
Figure 4-8 Crack in the damaged girder: (a) before and (b) after the cyclic test.

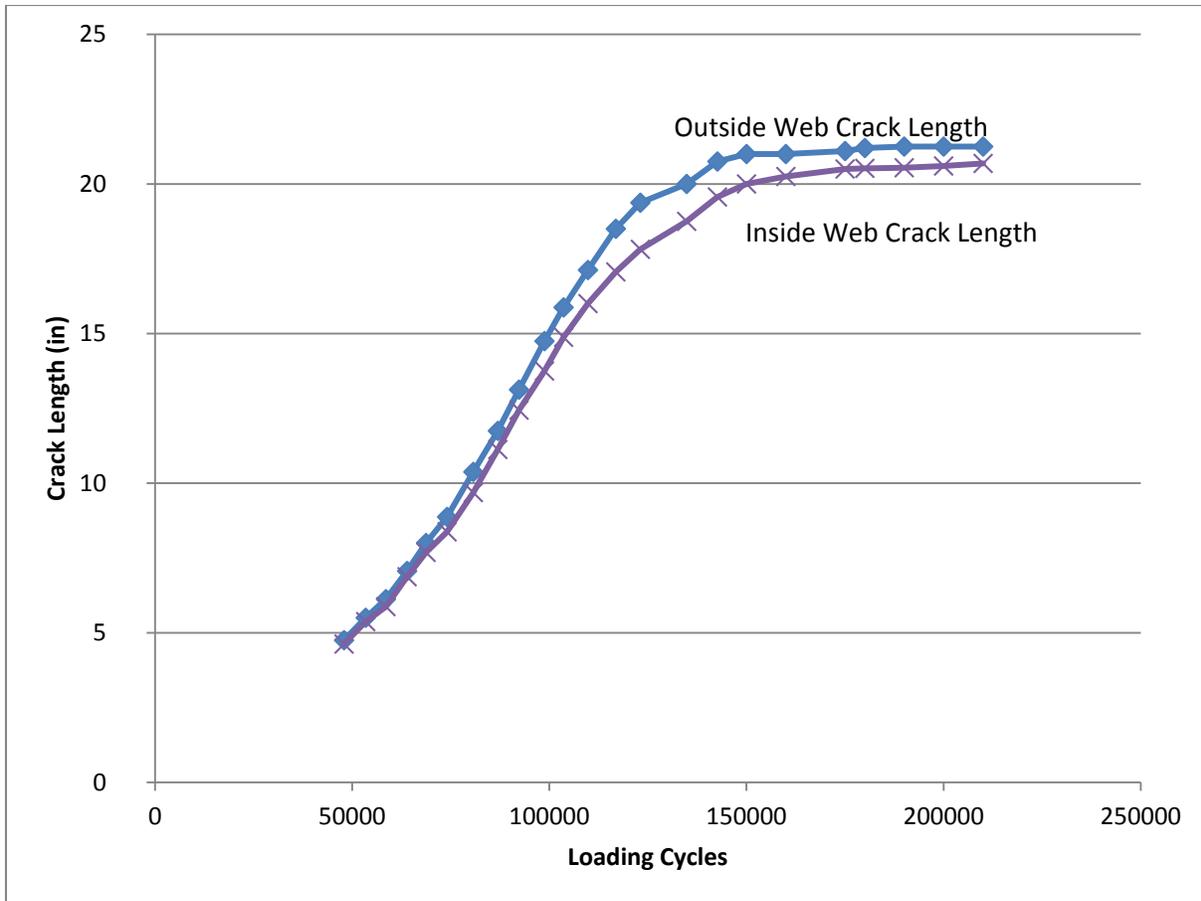
Figure 4-9 Crack growth in the damaged girder.

One of the responses observed visibly was the crack propagation from the bottom flange to the web of the damaged girder. Figure 4-9 shows growth of the crack length in the damaged girder during the cyclic test. The crack length data between the 1st and 50,000th cycle was missing because the crack propagation began overnight and was not observed until the next morning. The crack length was linearly proportional to the number of cycles until around the 160,000 cycles when the crack began to reach the webs, at which point the rate of growth slowed. The crack grew nearly evenly in both sides of the web of east girder until loading cycles of 80,000th. After that, the crack grew with a slower rate in the inside web than the outside web due to contributions of the cross-frames and the intact girder to the inside web of the damaged girder. This was consistent with experimental data from elastic tests and FEA results, which showed the outside face of the damaged girder always had higher displacement and stress than the inside face.

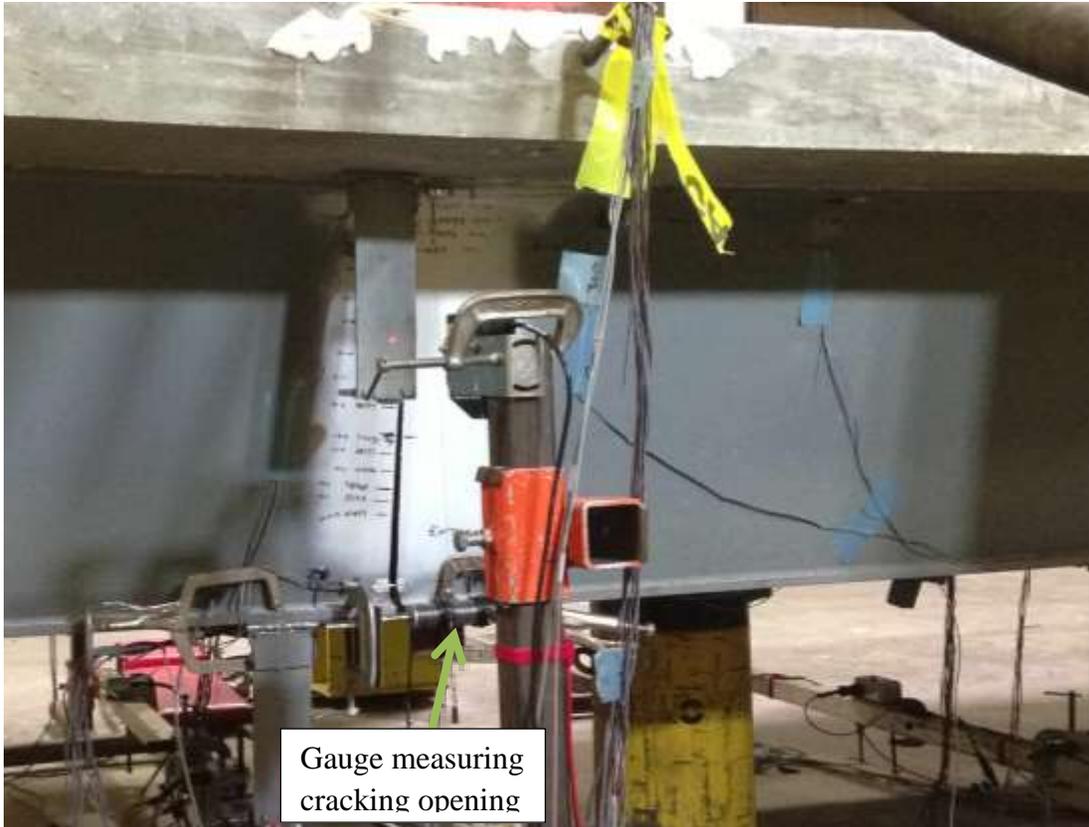
Figure 4-10 Crack opening measuring gauge on the exterior face.

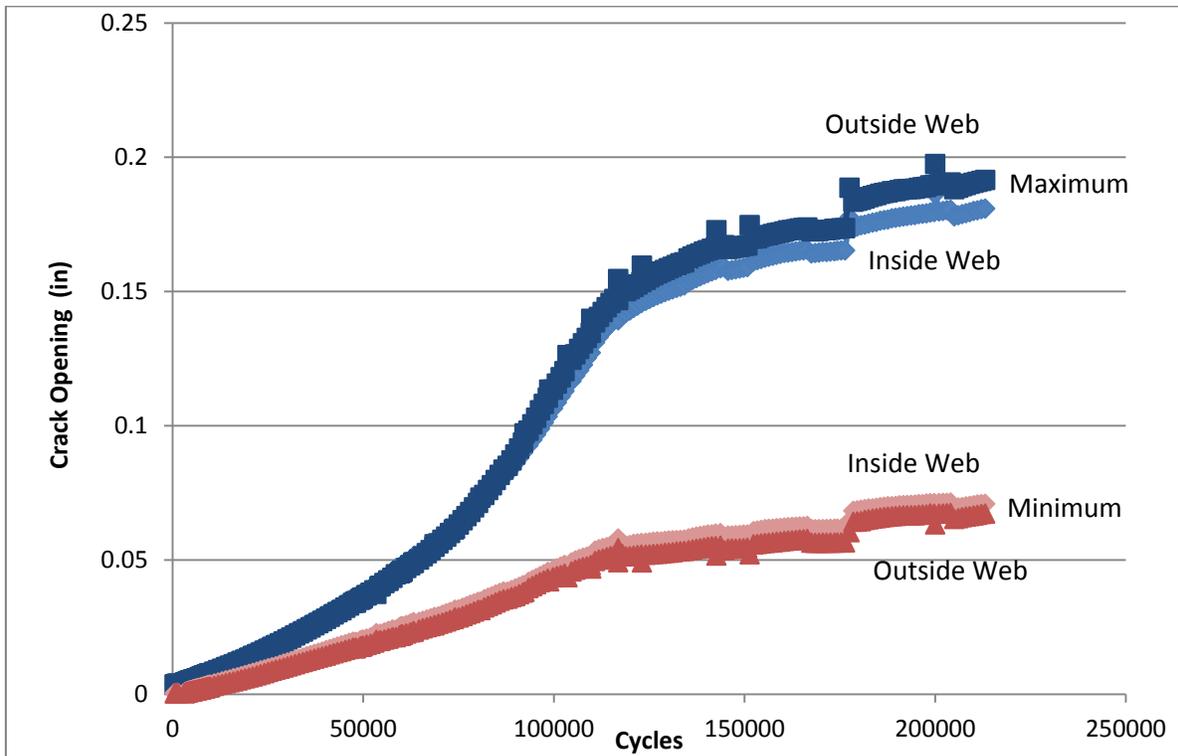
Figure 4-11 Crack base opening vs. number of loading cycles.

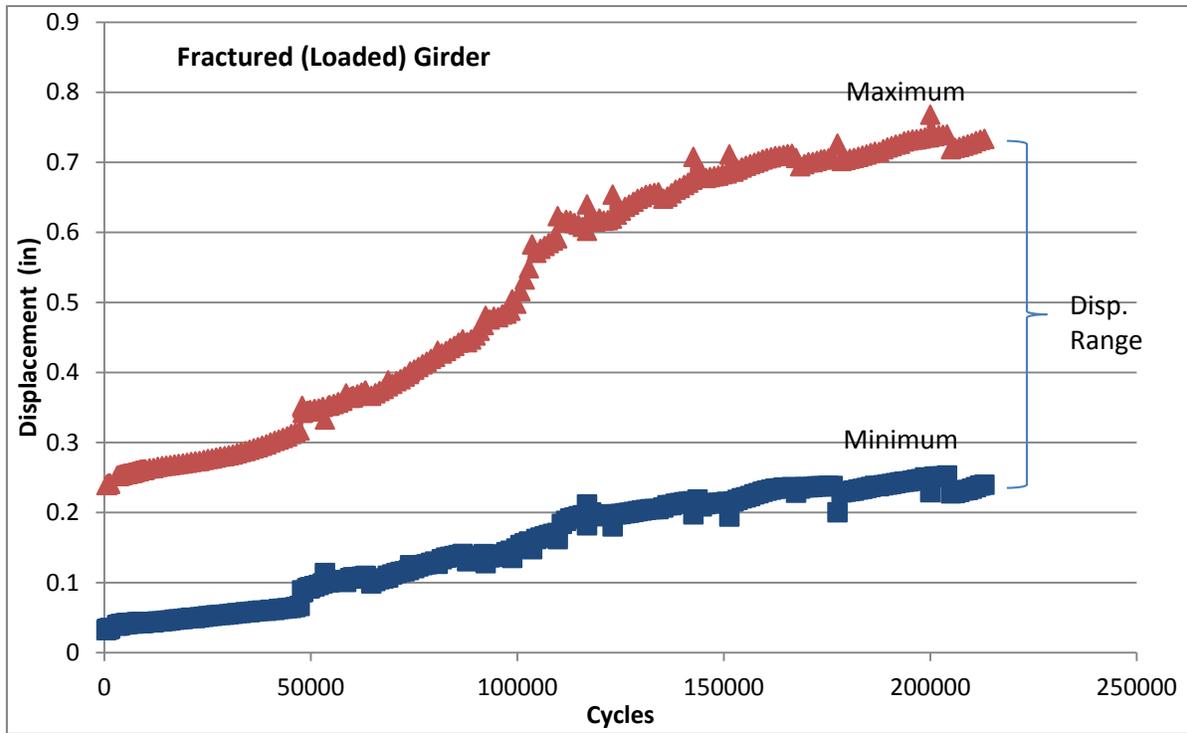
Figure 4-12 Mid-span displacement vs. number of loading cycles in the fractured girder.

The maximum displacement and minimum displacement of the girders were collected for each loading cycle. Figure 4-12 shows how the maximum and minimum displacement of the fractured girder changed over time. Figure 4-13 plots the displacement range for both girders (which is equal to maximum displacement minus minimum displacement in each girder) that shows the vertical deflection of each girder in a cycle. Both plots show similar behavior and trends to that of the crack length growth plot. The maximum displacement increased from 0.25 in. to 0.7 in. while the minimum displacement also increased from 0.03 in. to 0.24 in. during the test.

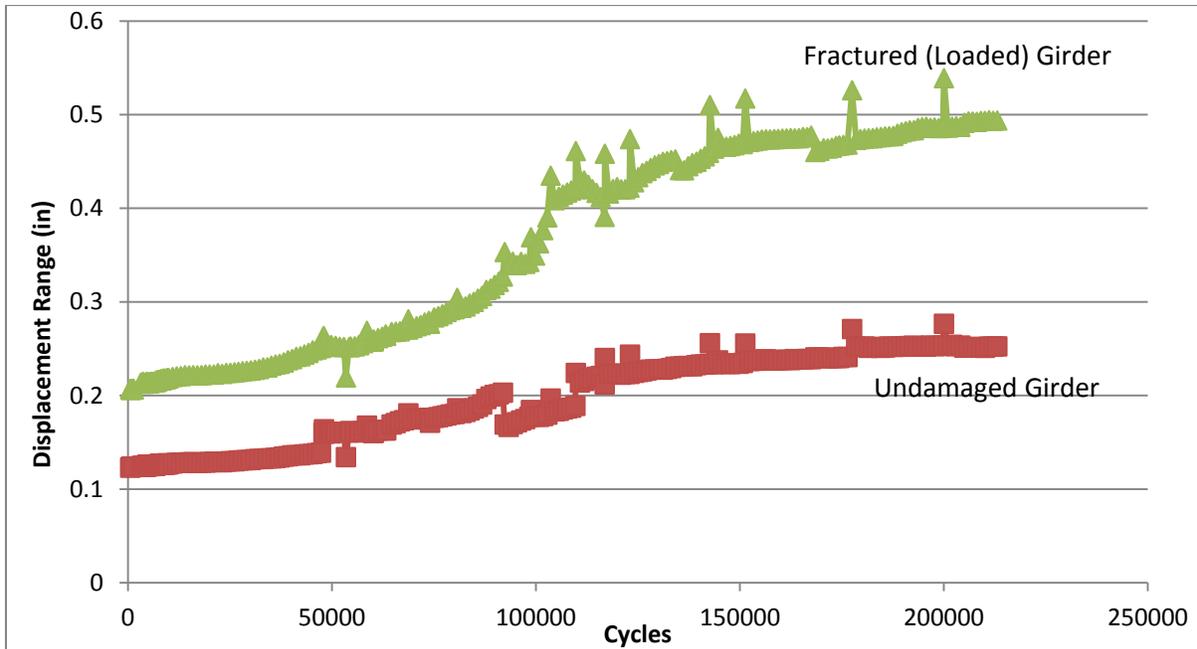
Figure 4-13 Displacement range (max – min) vs. number of loading cycles.

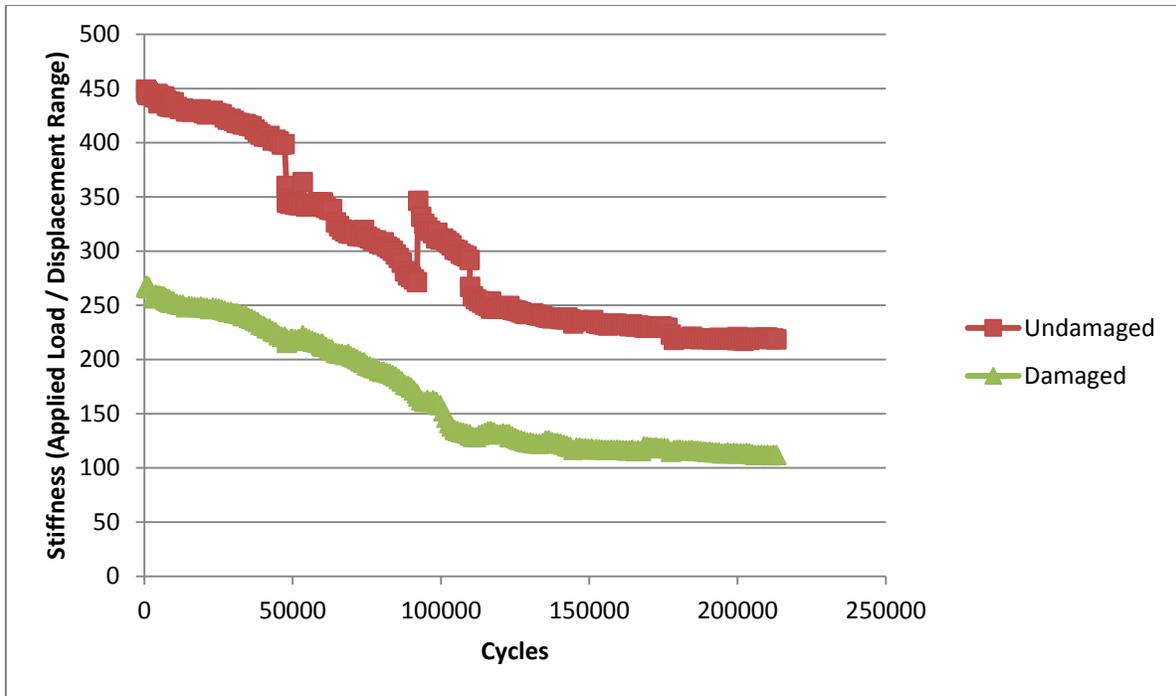
Figure 4-14 Stiffness of each girder during the cyclic test.

The stiffness of each girder over time is plotted in Figure 4-14. The stiffness of each girder is calculated by dividing the applied load by the displacement range in each cycle. Since the applied load for each cycle was constant at 60 kips, the stiffness curve was shown inversely proportional to displacement range curve. The damaged girder had a stiffness of 260 kips/in at the beginning of the cyclic test when bottom flange fractured. The stiffness reduced 60%, to 105 kips/in, at the end of the test when the web was completely fractured. Similarly, the stiffness reduction, for the undamaged girder, was around 235 kips/in, which was equivalent to 52% of its initial stiffness.

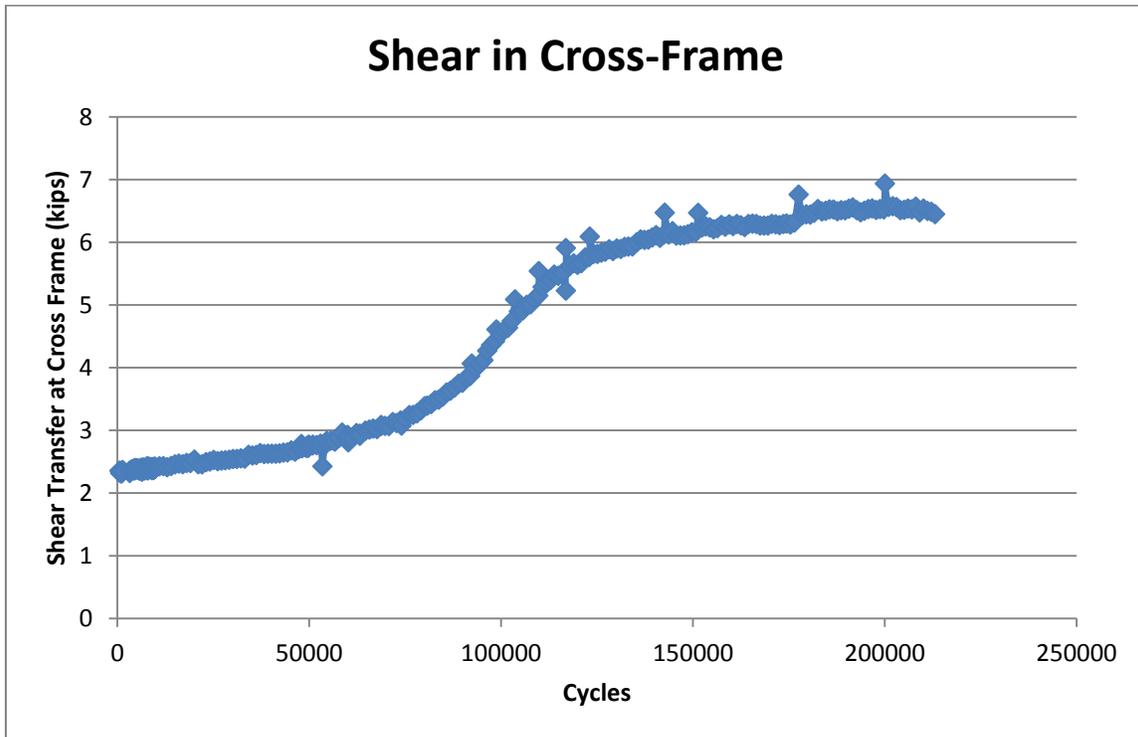
Figure 4-16 Maximum shear transfer in one cross-frame.

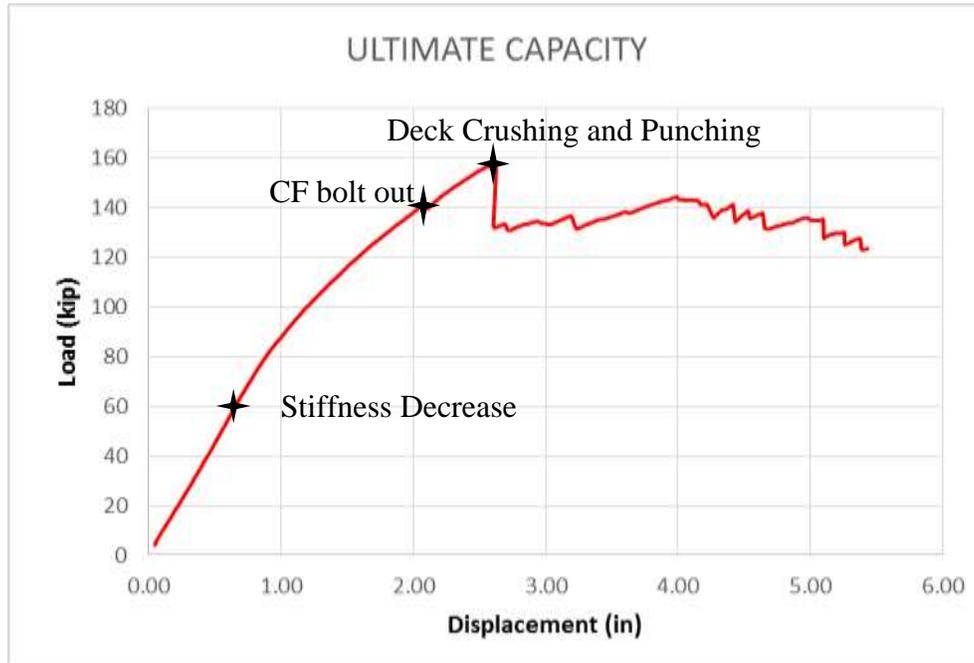
Figure 4-18 Load vs. deflection curve of the specimen during ultimate load test A.

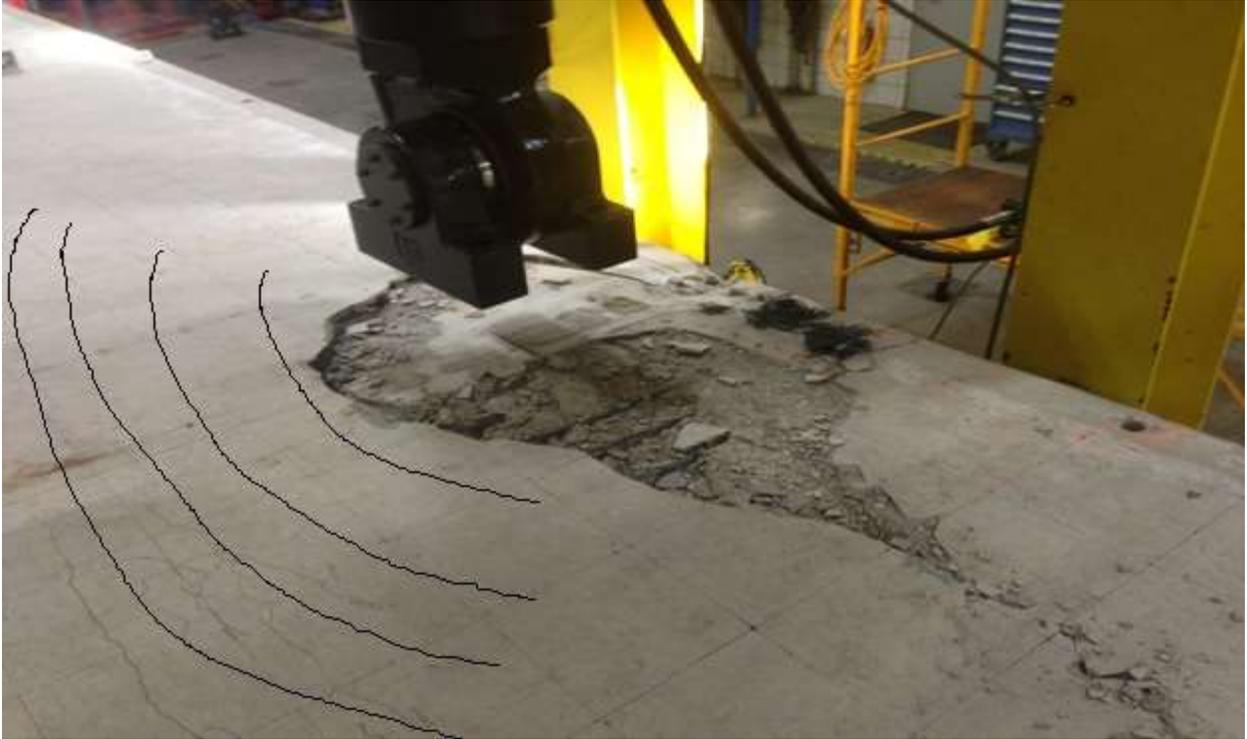
Figure 4-19 Punching in the top of the concrete surface looking to South.

A 1 ft by 1 ft grid was marked on the concrete surface to map the damage area more accurately as illustrated in Figure 4-19. In general, the major damage was observed in the deck over an area of 5 ft long by 3 ft wide at where the load was applied. Cracking started along the inside top flange of the damaged girder, then it propagated toward the intact girder. The cracking pattern was approximated by the black lines in Figure 4-19. This cracking pattern indicates that the deck failed predominantly in one-way shear failure mode. The deck damage showed that the damage propagated toward the north support more than the south support. It could be due to the presence of the cantilever portion in the south end. This cantilever made the south portion of the specimen measured from the loading point was stiffer than the north portion of the specimen. Eventually, the deck was punched by the loading pad along the inside top flange of the damaged girder when the specimen reached its maximum capacity. The spalling of concrete in the bottom of the deck is illustrated in Figure 4-20.

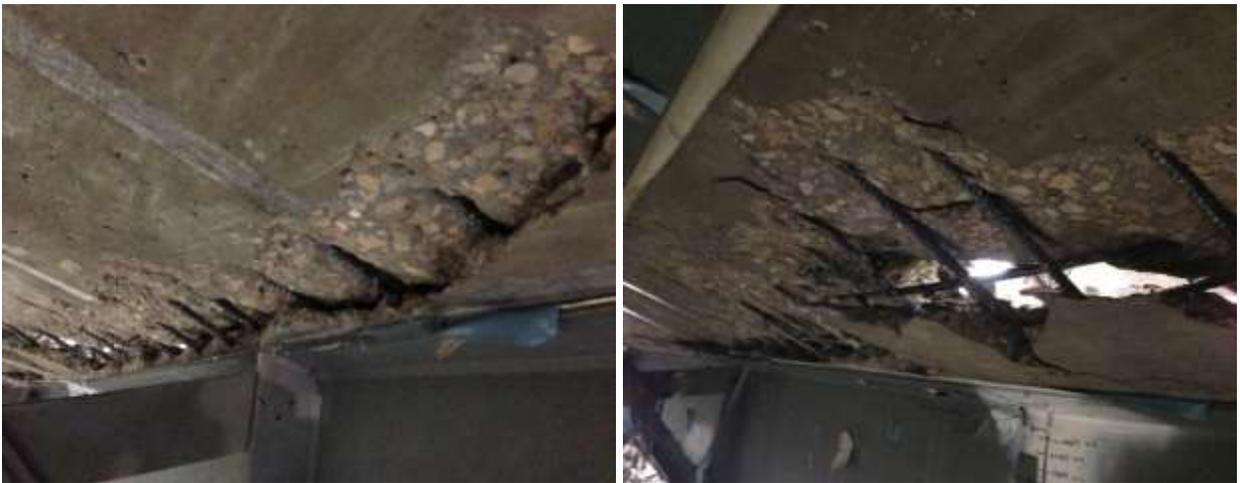
Figure 4-20 Punching in the bottom of the deck.

This same hypothetical situation can be used to examine the failure mechanism near the load point. In this region, the (hypothetical) damaged girder will be below the undamaged. Since the displacement level is being held by the loading beam, the undamaged girder will be pulled downward when the two separate structures are hypothetically re-joined. The effect of the resulting shear force can be seen in Figure 4-20.

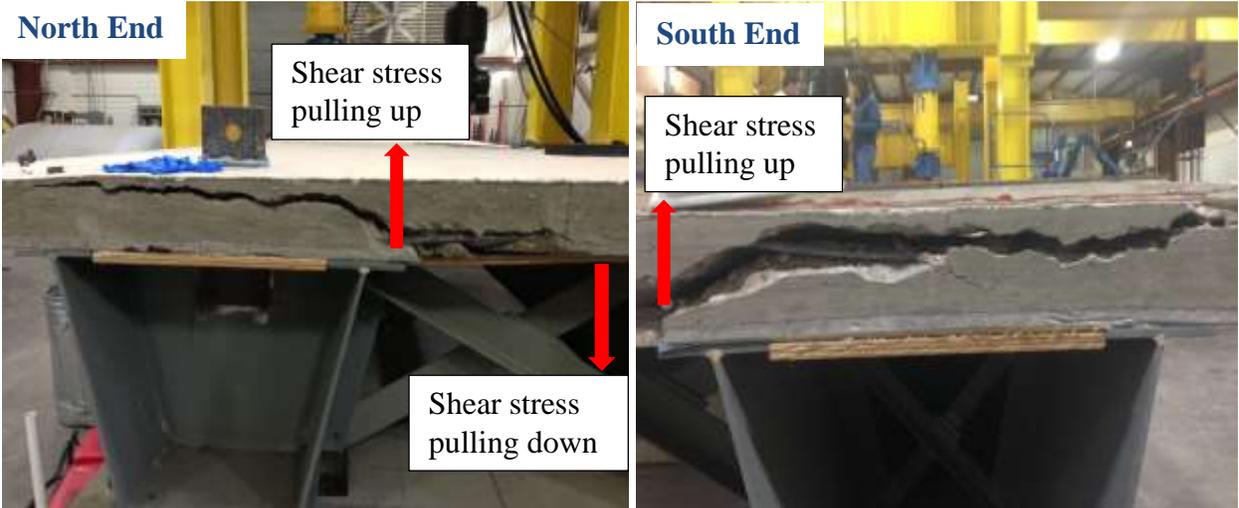
Figure 4-21 Damage at North end (left) and South end (right).

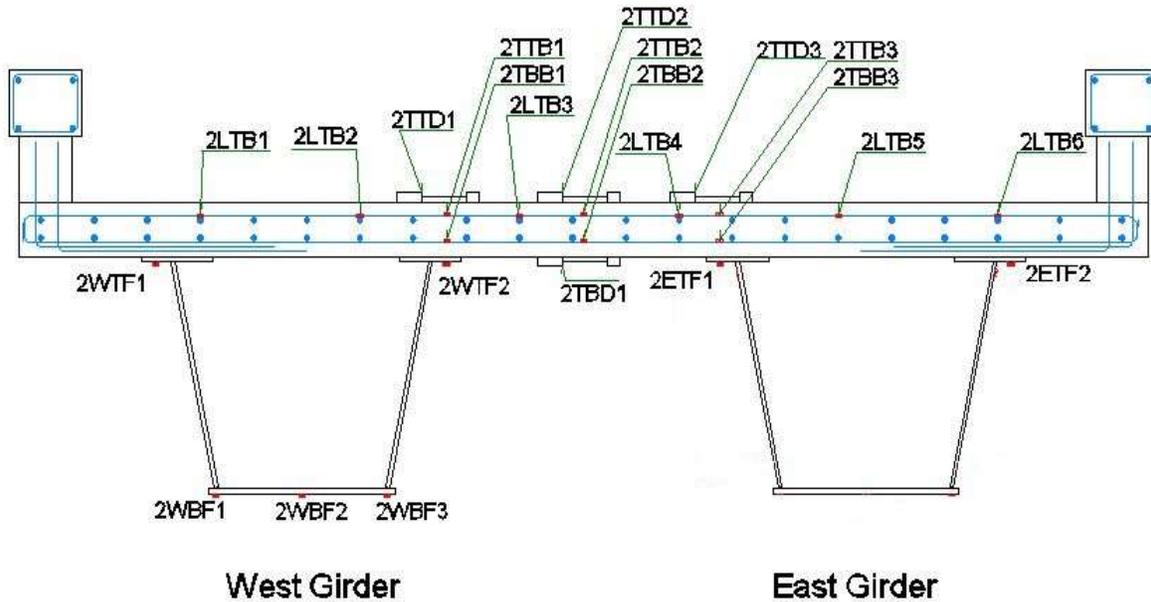
Figure 4-26 Strain gauges at the mid-span section.

It is noted that gauges 2TTD1, 2TTD2 and 2TTD3 were shifted away from the mid-span by 1 ft toward the south support to avoid contact with loading pads.

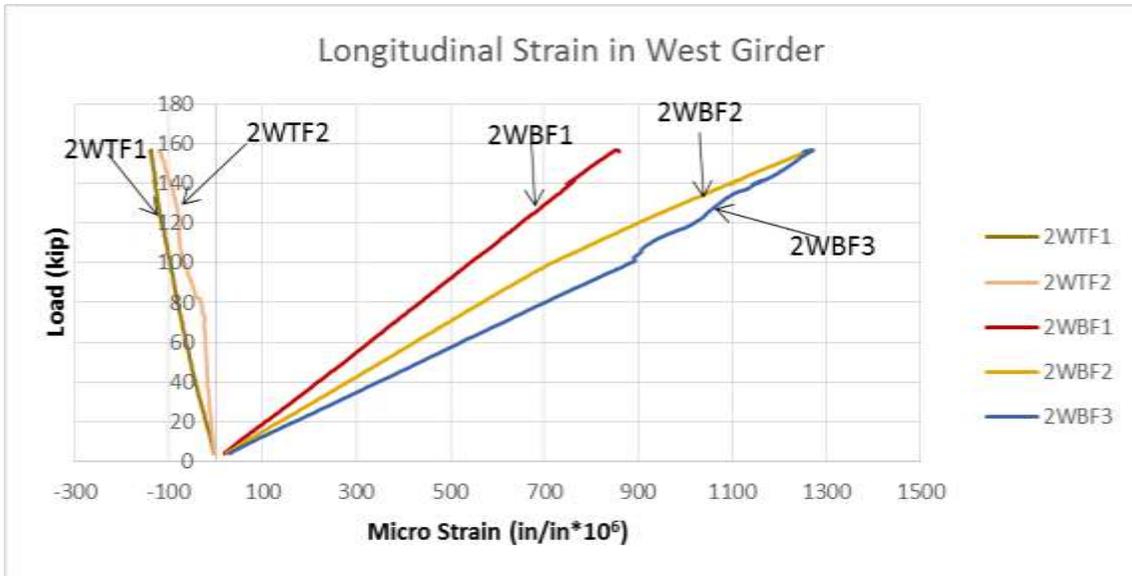
Figure 4-27 Longitudinal strain in the top and bottom flanges of west girder at mid-span.

Figure 4-27 and Figure 4-28 show longitudinal strains in both girders at the mid-span section. On the intact girder (WG), the top flanges were in compression and the bottom flange was in tension. On the damaged girder (EG), the top flanges were in tension, as expected, to balance the compressive force in the concrete deck since the fractured bottom flange and web at this location was expected to carry zero force. The linearity of the resulting curve that plots longitudinal strain in the intact girder is illustrated in Figure 4-27. The maximum strain, in the intact girder, was less than $1300 \mu\epsilon$ suggesting that the intact girder was still in the elastic range. The damaged girder experienced significant yielding at the outside top flange at approximately 80 kips.

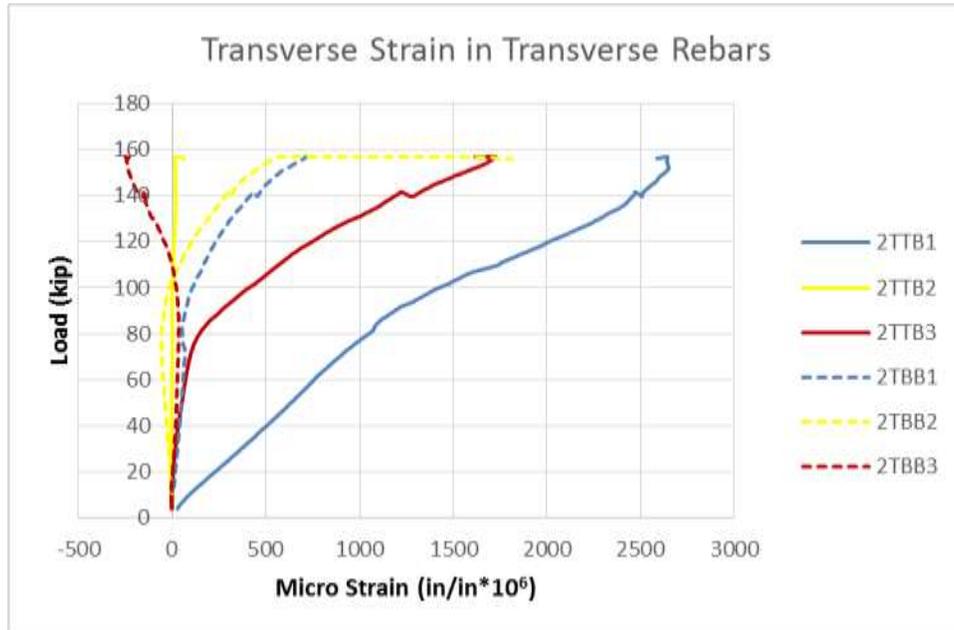
Figure 4-29 Strains of the transverse rebar at mid-span.

2TTB1 had a strain of 2600 $\mu\epsilon$ suggesting the transverse re-bar yielded at this location, which is the inside top flange of the intact girder.

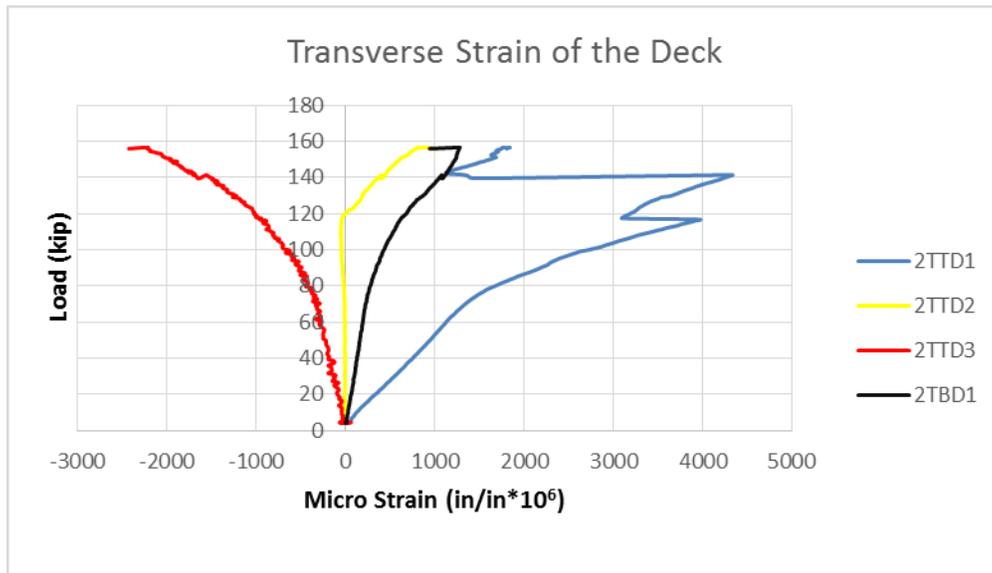
Figure 4-31 Transverse strain at the top and bottom of deck at mid-span.

Figure 4-31 showed the deck experienced positive transverse strains at location of 2TTD1, 2TTD2, and 2TBD1; and negative strain at location 2TTD3. This suggests that the top of deck was in compression at location 2TTD3, right on the top of the inside top flange of the damaged girder, while the other gauges showed the deck was in tension, which further suggests the inflection point of the deflected curve of the deck cross-section was somewhere close to the top flange of the damaged girder. This observation was consistent with data obtained from transverse and longitudinal reinforcement bars.

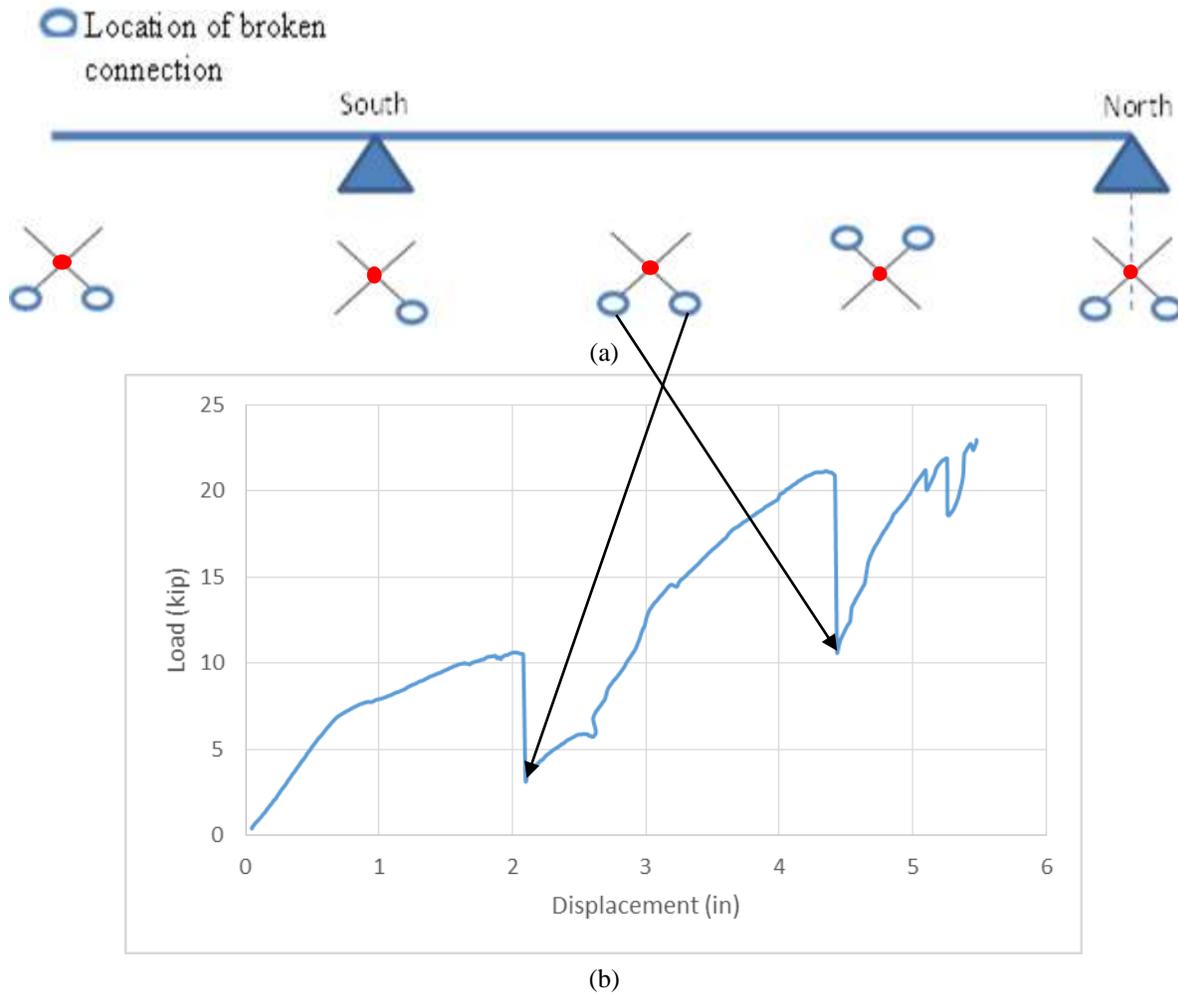
Figure 4-32 Shear transferred through one cross-frame in Test A.

After one connection failed, this cross-frame should have lost its load-resisting capability completely. However, the welded connection between two L-angle braces as shown by the red dot in Figure 4-32b enabled this tension brace to still carry forces, and this cross-frame continued to carry up to 21 kips. Then, the second failure of the bottom connection of the compression brace caused another drop of approximately 11 kips at 4.4-in. displacement. After that, the cross-frame was shown continuing to carry the load up to 23 kips until the end of the test. The reason that this cross-frame was still able to continue carrying the load after the second connection failure could be because the bottom end of the compression brace was still locked between the bottom flange and the web of the intact girder due to the way the bridge twisted and displaced. Assuming the other cross-frame carried a similar load, the total load that was transferred to the intact girder through cross-frames was approximately 46 kips, which was 29% of the applied load.

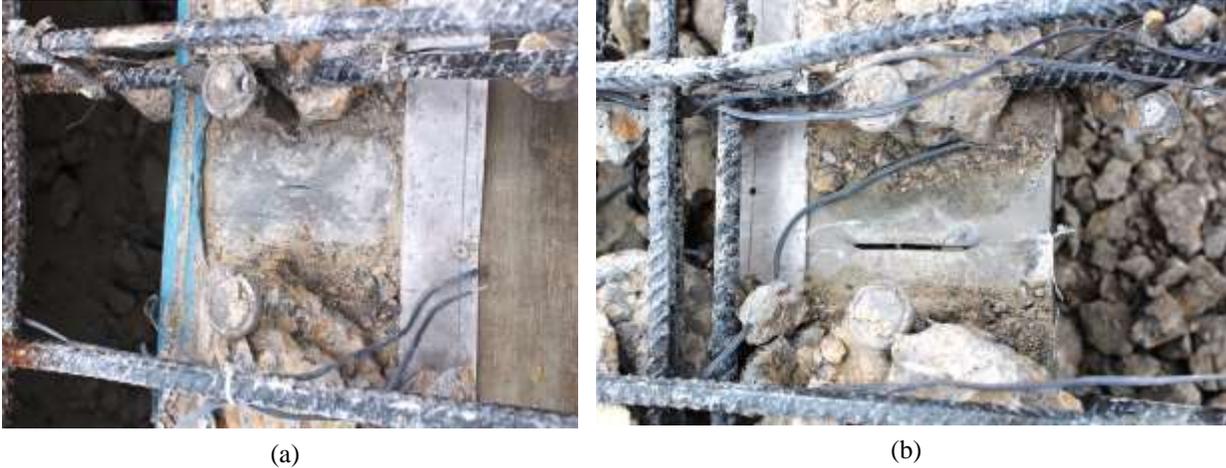
Figure 4-33 Damage in (a) the inner top flange, (b) the outer top flange of the damaged girder.

As illustrated in Test A, recorded strains in the steel box girders indicated that these girders were still in a good condition. Therefore, these girders were retained so that a new specimen can be reconstructed by casting a new deck for additional ultimate load tests. For that reason, only the deck was demolished and reinforcements were removed. After detaching the steel box girders from the deck, a thorough inspection showed only the top flanges of fractured girder at fracture location experienced severe damage which had been already expected, and this damage almost cut the damaged girder into halves as illustrated in Figure 4-33.

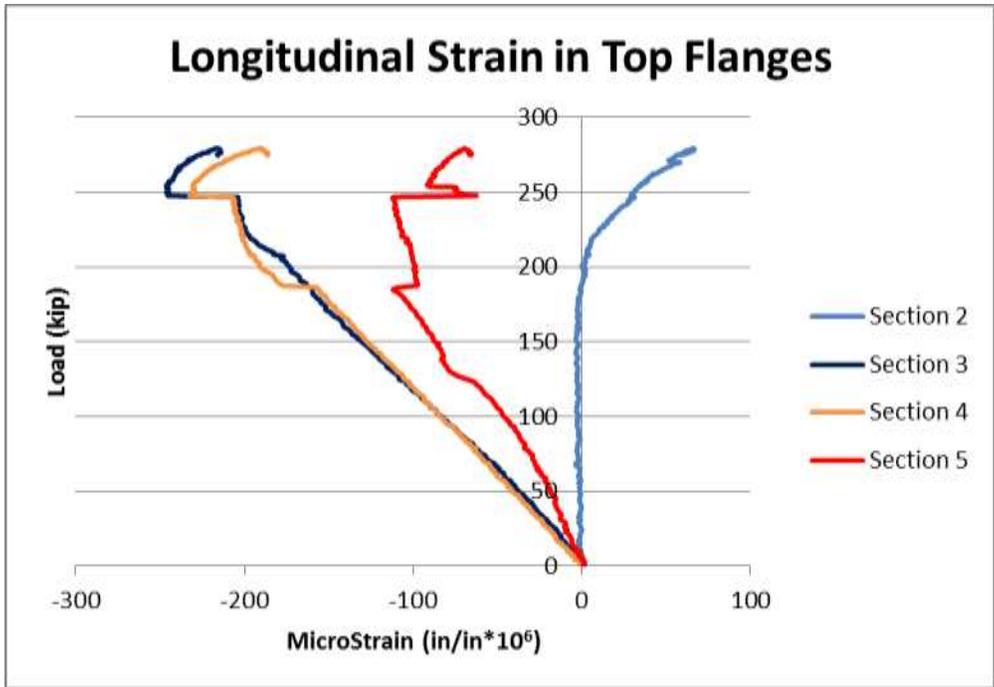
Figure 4-40 Average longitudinal strains at top flanges of the intact girder.
