Managing Florida's Fracture Critical Bridges - Phases I & II

Huy Pham
Jawad Gull, Ph.D.
Alireza Mohammadi
Atorod Azizinamini, Ph.D., P.E.

**Department of Civil and Environmental Engineering
Florida International University
Miami, Florida**

Sponsored By
Florida Department of Transportation

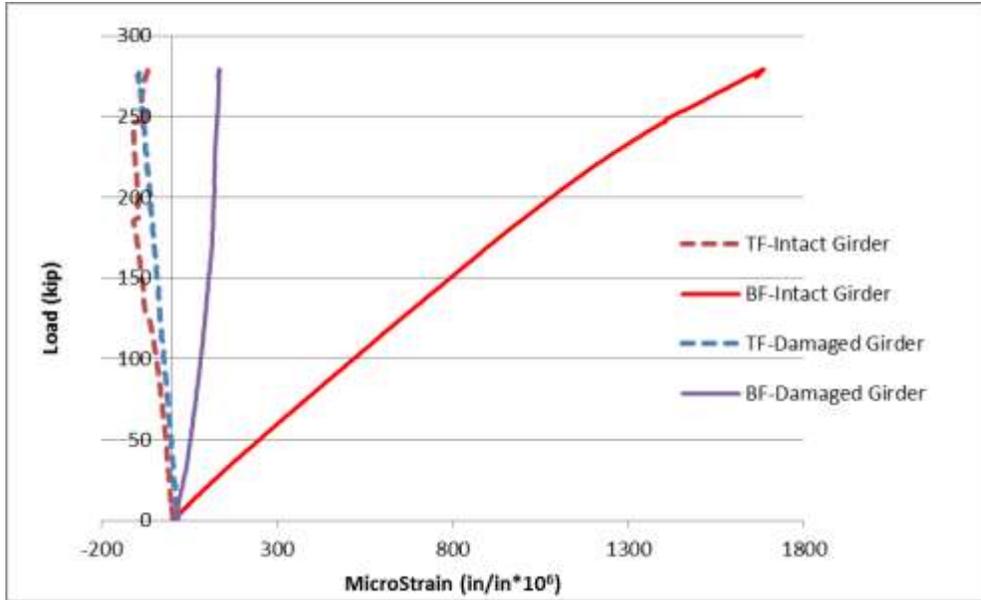
Figure 4-42 Comparison of longitudinal strains in the intact and damaged girders at Section 5.

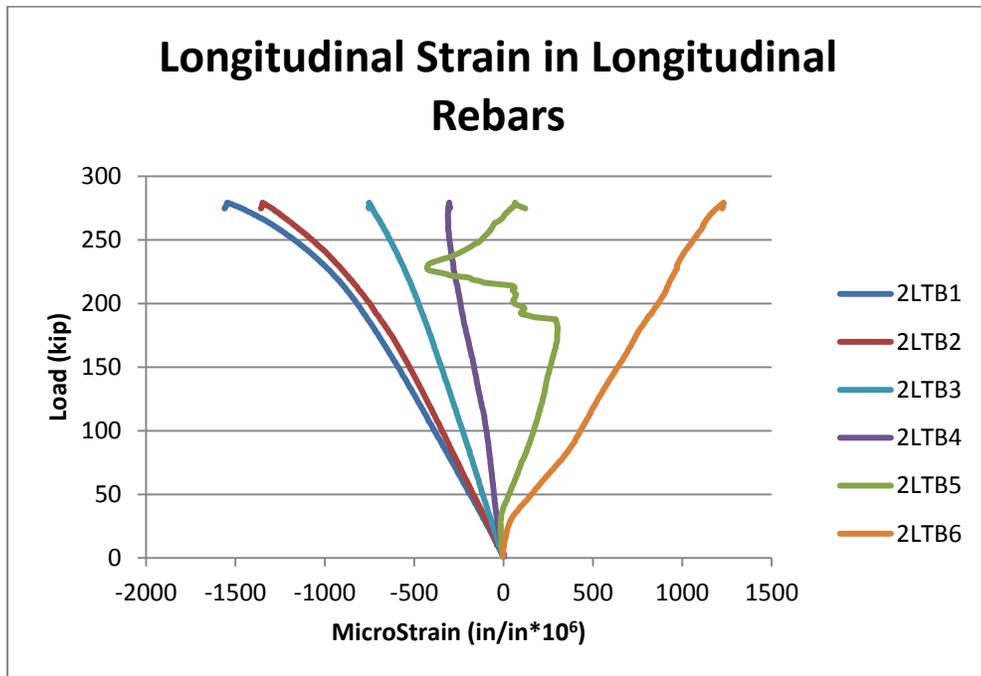
Figure 4-43 Longitudinal strain in rebars at mid-span.

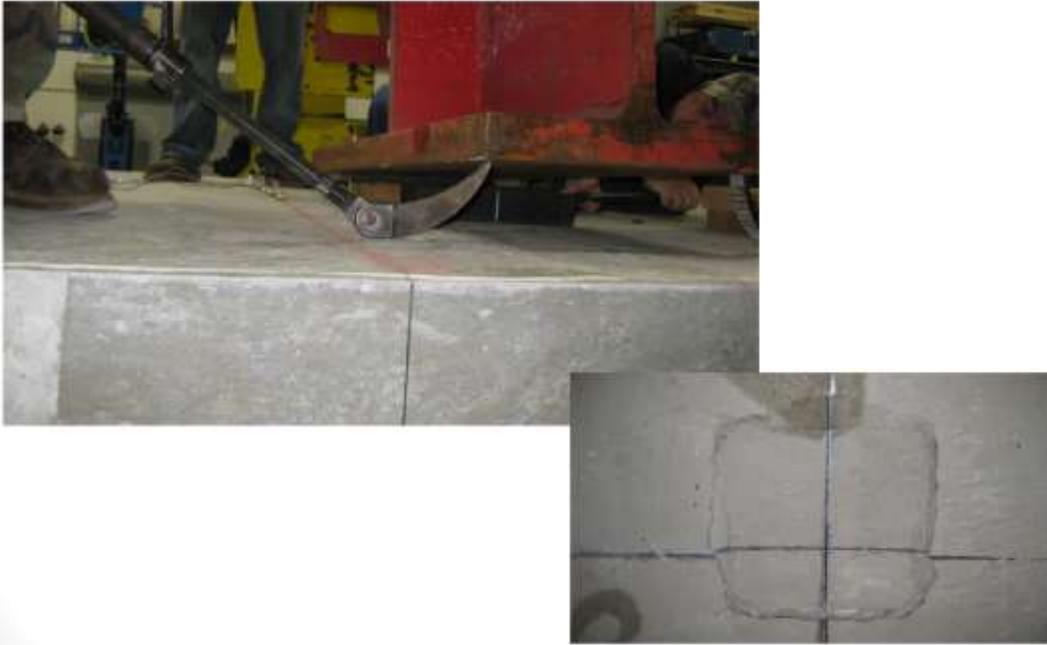
Figure 4-49 Punching damage in test C.

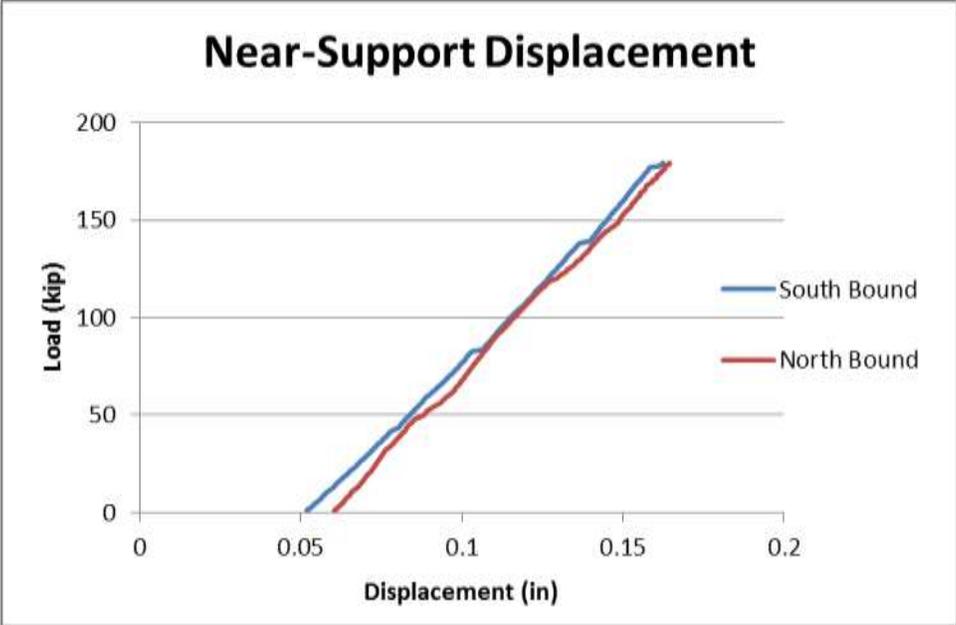
Figure 4-50 Near-support displacement.

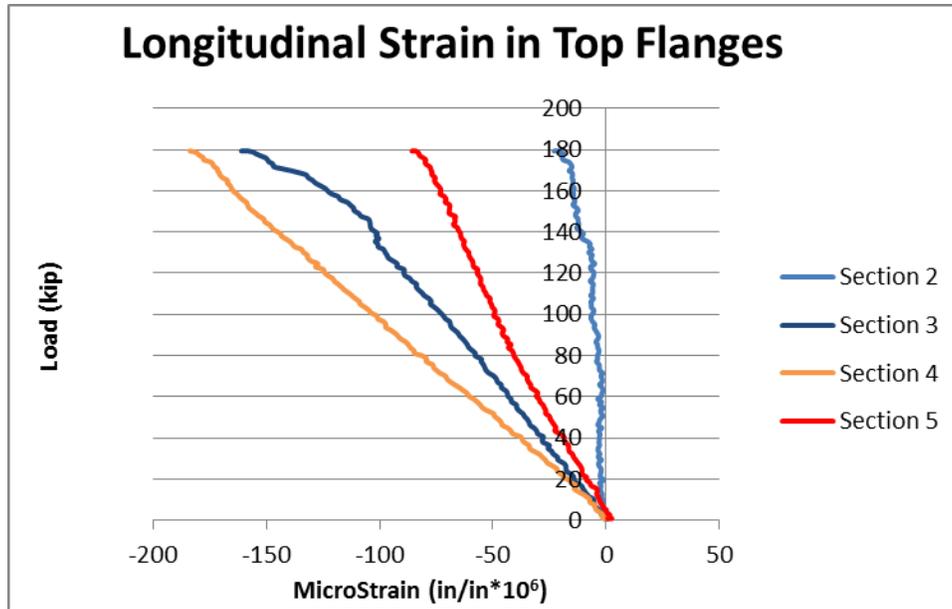
Figure 4-52 Average longitudinal strains at top flanges of the intact girder.

Overall, the recorded data were very similar to those obtained in Test B up to 180 kips of load. The data indicated that the load was mainly resisted by the intact girder. No girder uplift was observed, and cross-frame forces were negligible. However, this test had punching shear as a failure mode while Test B was likely to fail in flexural mode. The reason that this test failed much faster could be attributed to the size of the loading area. In this test, the specimen was loaded in a more concentrated manner than it was in Test B.

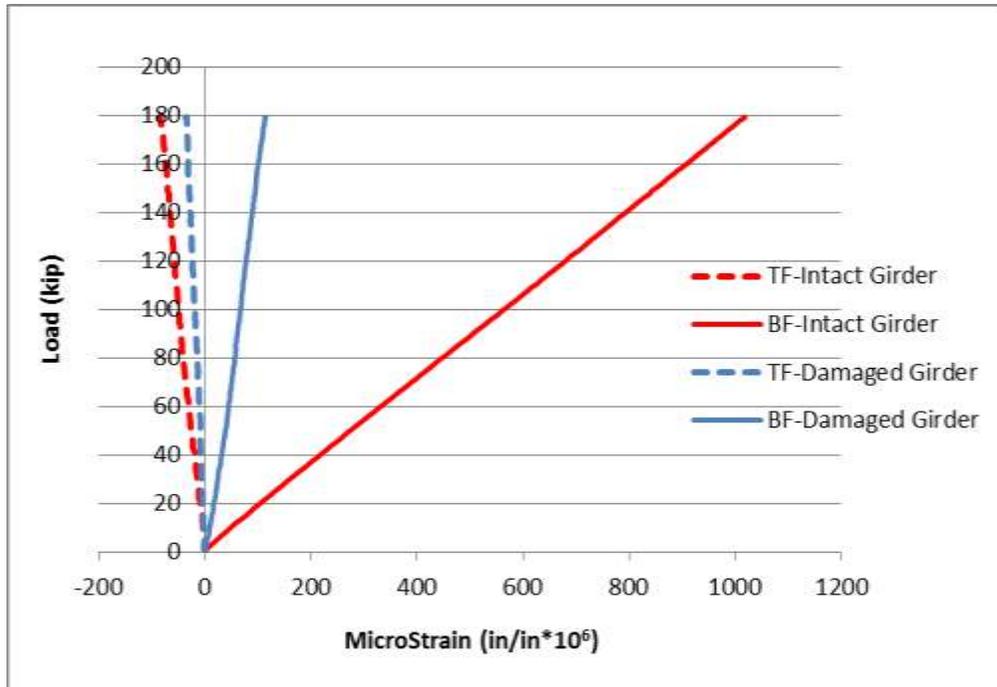
Figure 4-54 Comparison of longitudinal strains in the intact and damaged girders at Section 5.

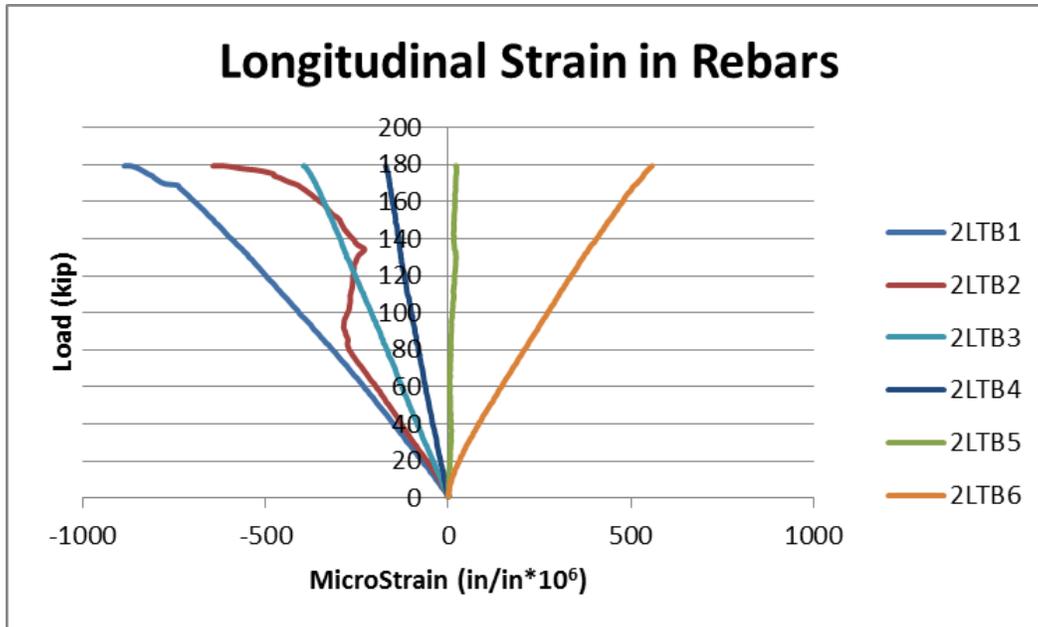
Figure 4-55 Longitudinal strain in rebars at mid-span.

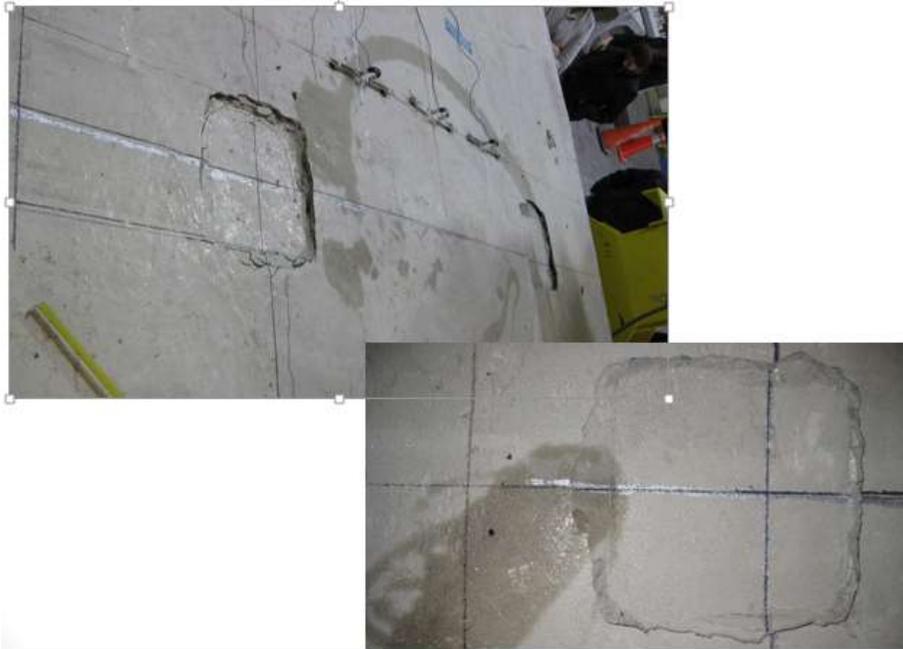
Figure 4-60 Punching damage in Test C.

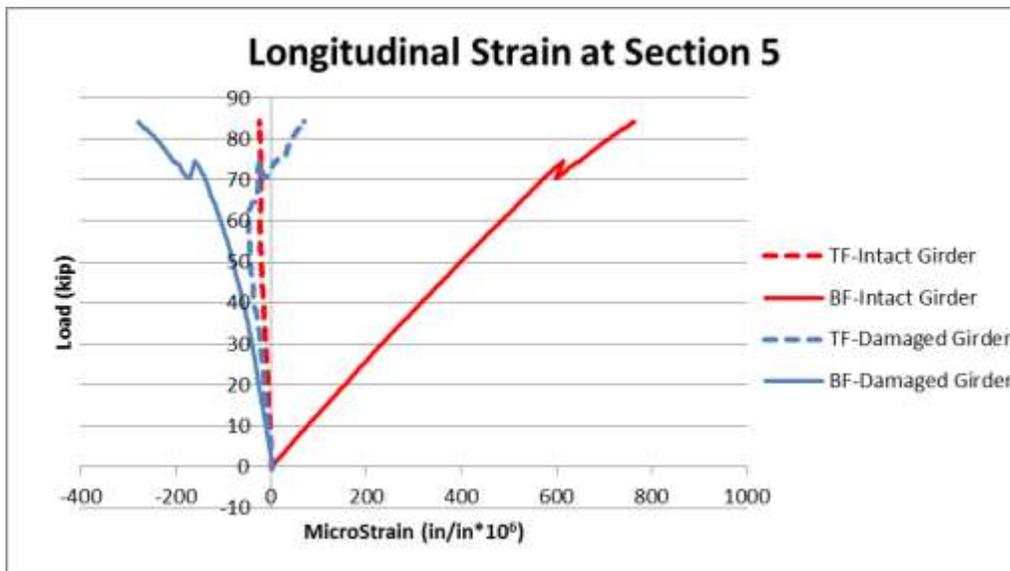
Figure 4-65 Comparison of longitudinal strains in the intact and damaged girders at Section 5.

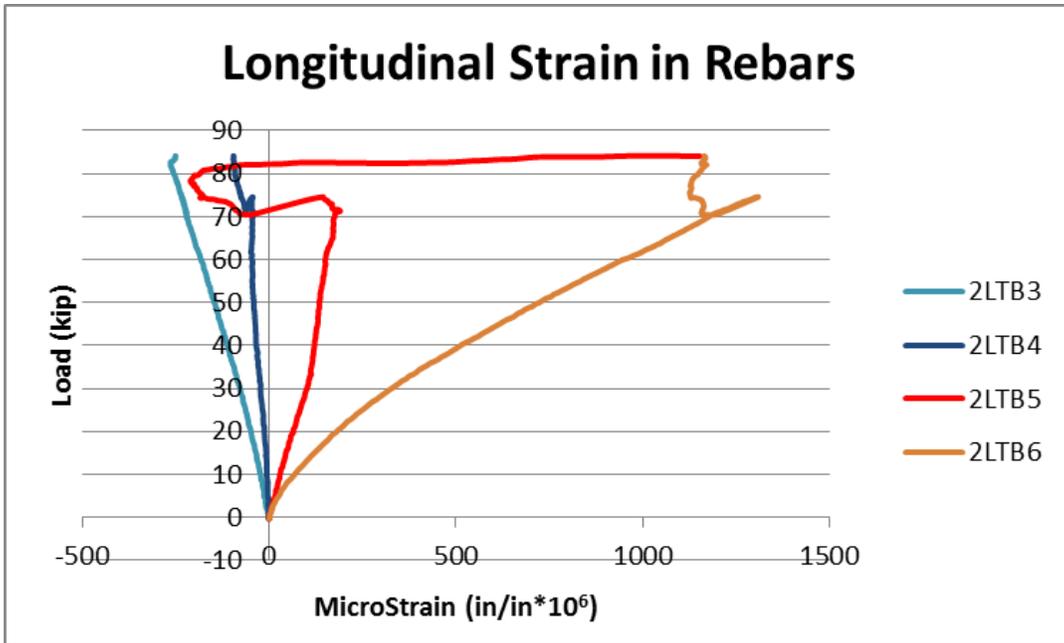
Figure 4-66 Longitudinal strain in rebars at mid-span.

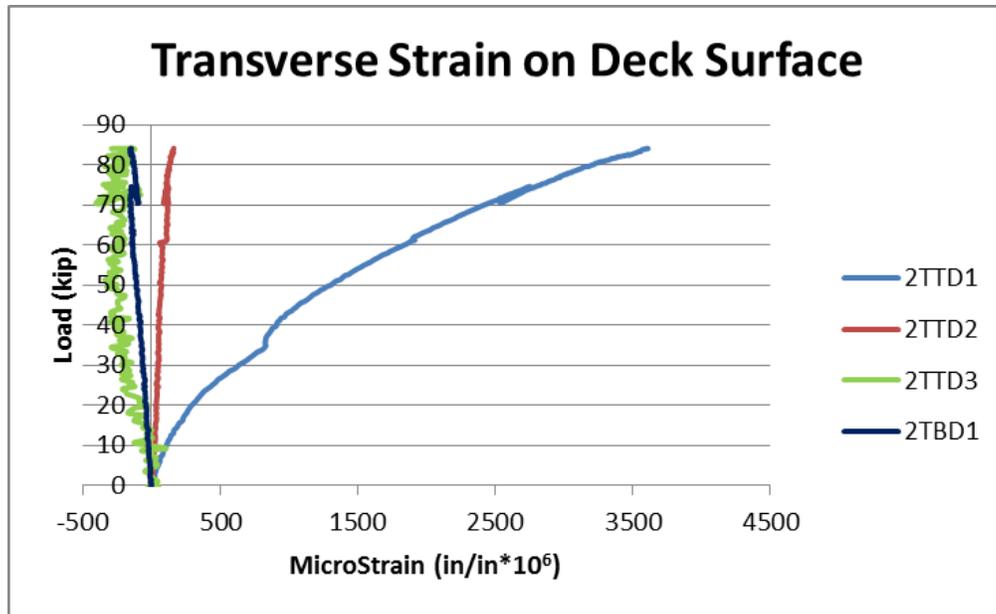
Figure 4-68 Transverse strain on the deck near mid-span.

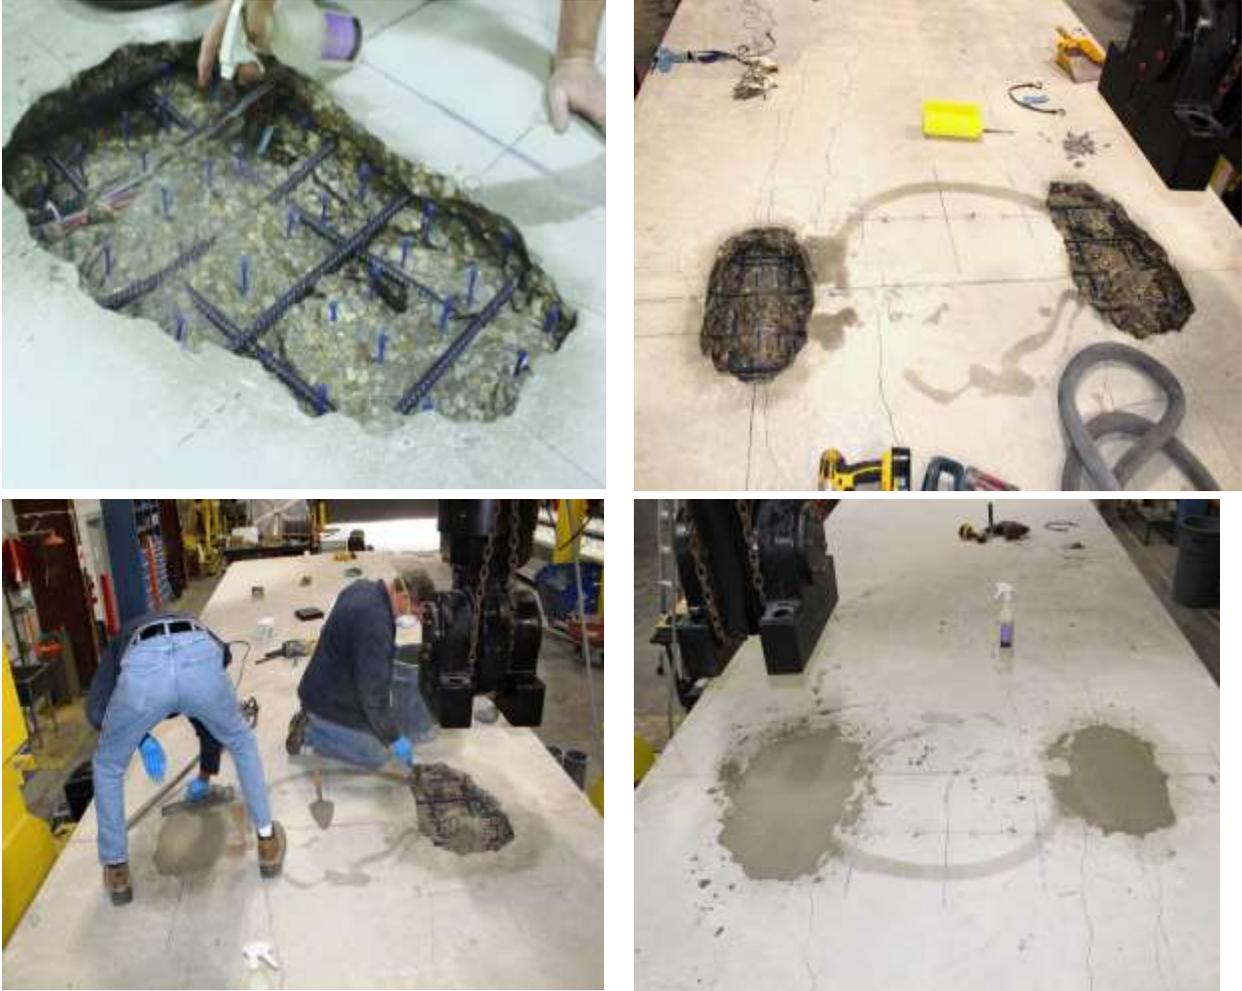
Figure 4-69 Repair of punching shear damage from Tests C and D.

After completing Tests C and D, a decision was made to repair damage due to punching in the deck before carrying out one last ultimate test in which the specimen was loaded under a truck footprint. In order to repair these damages, first of all, spalling concrete fragments were removed around punched square holes. Then tapcons were drilled into the concrete to act as shear studs. After that, an attempt was made to get a saturated surface dry (SSD) condition in the holes. The main material used for the repair was MasterEmaco T302, a two-component polymer-modified cement-based repair mortar with an integral corrosion inhibitor. The expected compressive strength for this composition is 6,000 psi. Once the mortar mix was thoroughly mixed, the moistened concrete fragments were added in, since no pea gravel was available on hand at that time. Then, the mortar mix was poured into the holes and then vibrated in order to get the best possible penetration. Once the repair patch was troweled, moist cure bags were placed over the repair areas. Some pictures taken during the repair are shown in Figure 4-69.

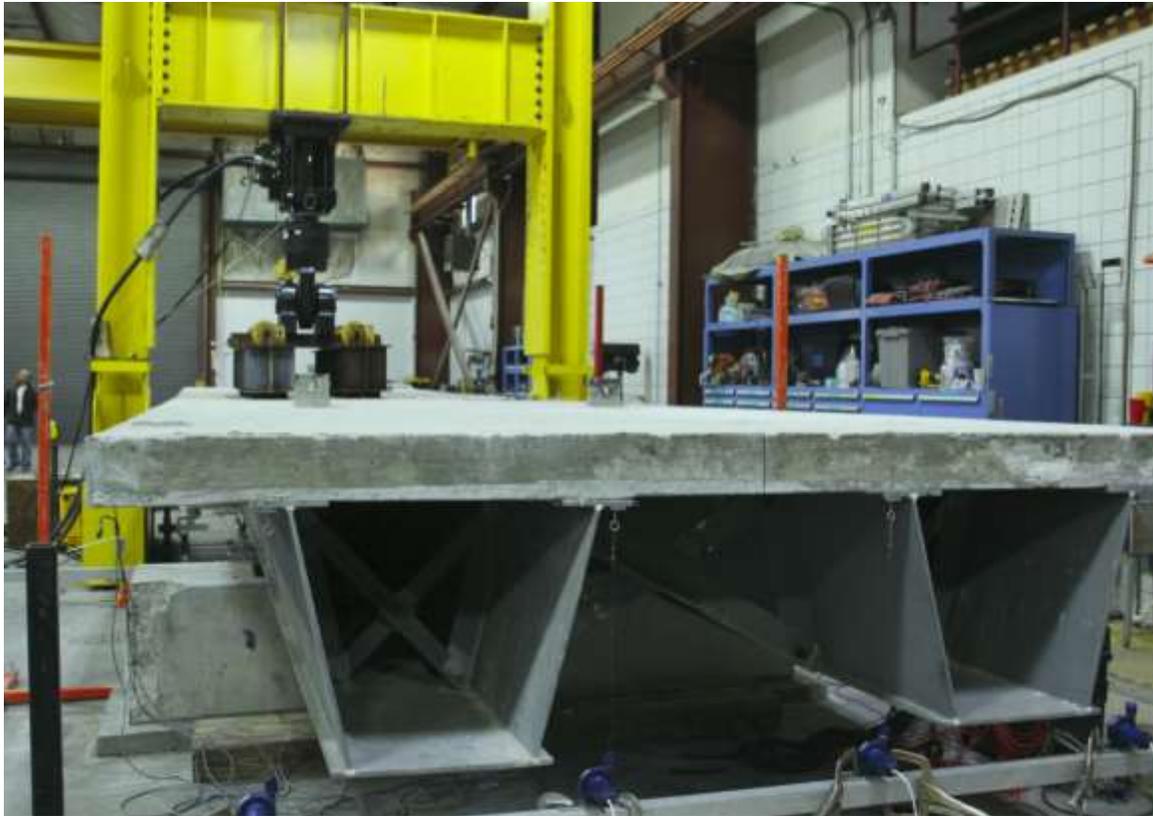
(a)

In this test, the load was applied through four loading pads in order to simulate the truck footprints. The loading pads were the same as in previous tests with a dimension of 10 in. x 10 in. The distance between north wheels and south wheels was 72 in., while the distance between west wheels and east wheels was 27 in. from center to center. The west wheels were placed at the center of cross-section while the east wheels were at the center of damaged girder. The schematic description of Test E loading set up is shown in Figure 4-70. The purpose of this test was to investigate whether the same failure mode of punching shear will be obtained, under truck-load configuration.

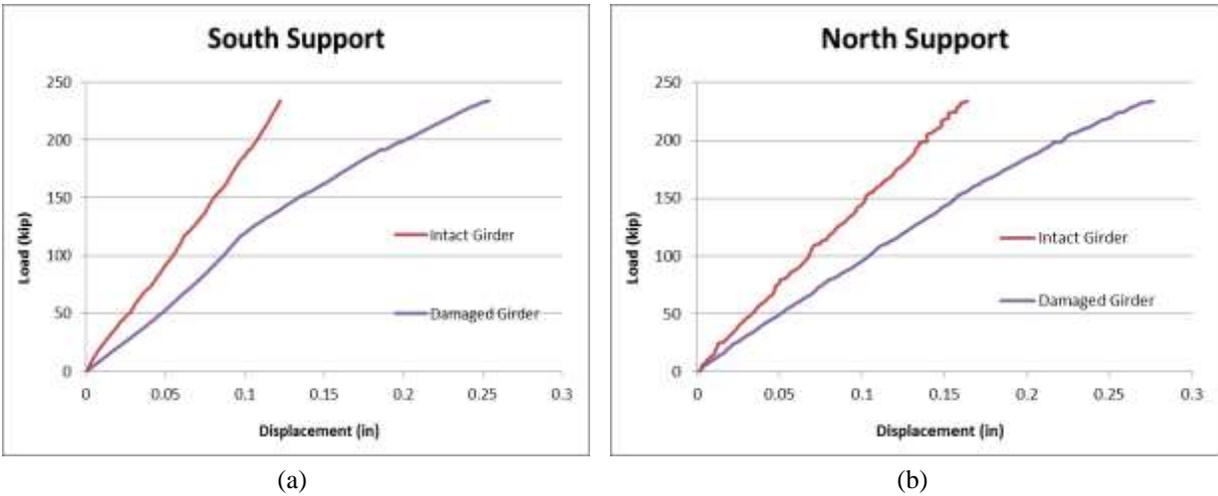
Figure 4-74 Near-support displacement.

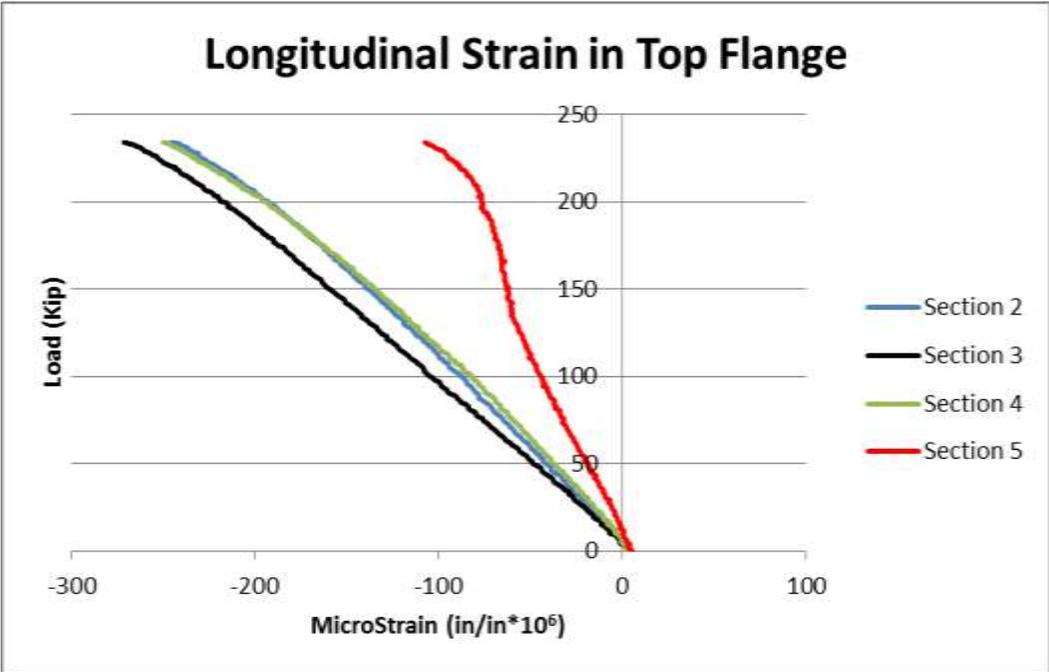
Figure 4-76 Average longitudinal strains at top flanges of the intact girder.

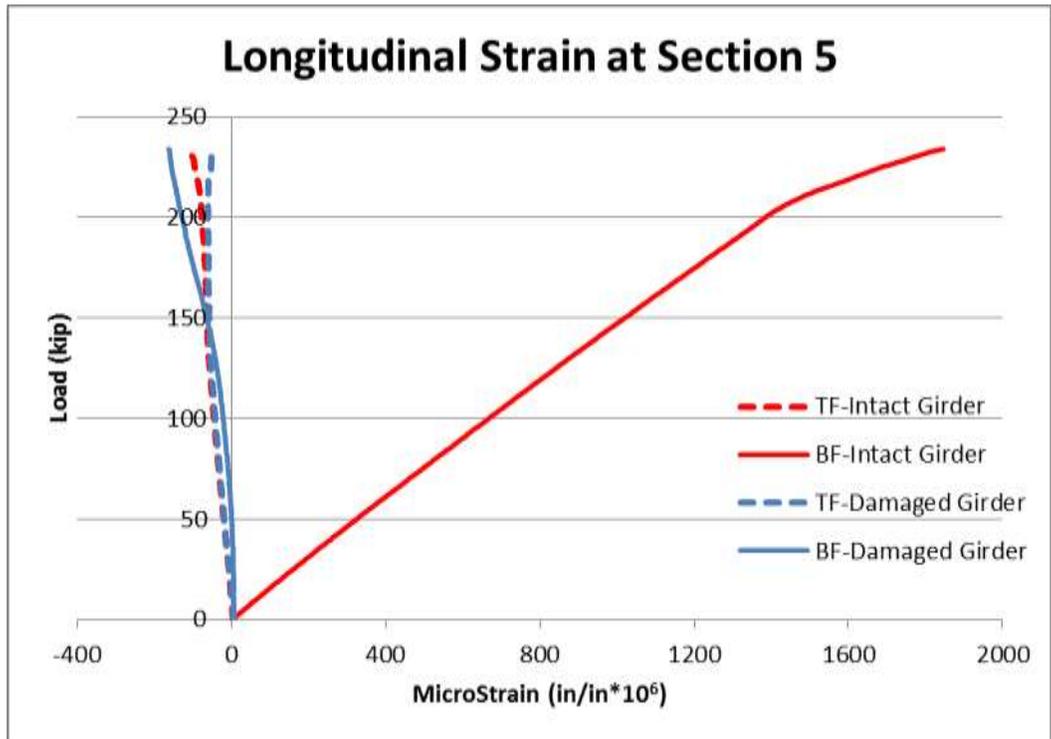
Figure 4-78 Comparison of longitudinal strains in the intact and damaged girders at Section 5.

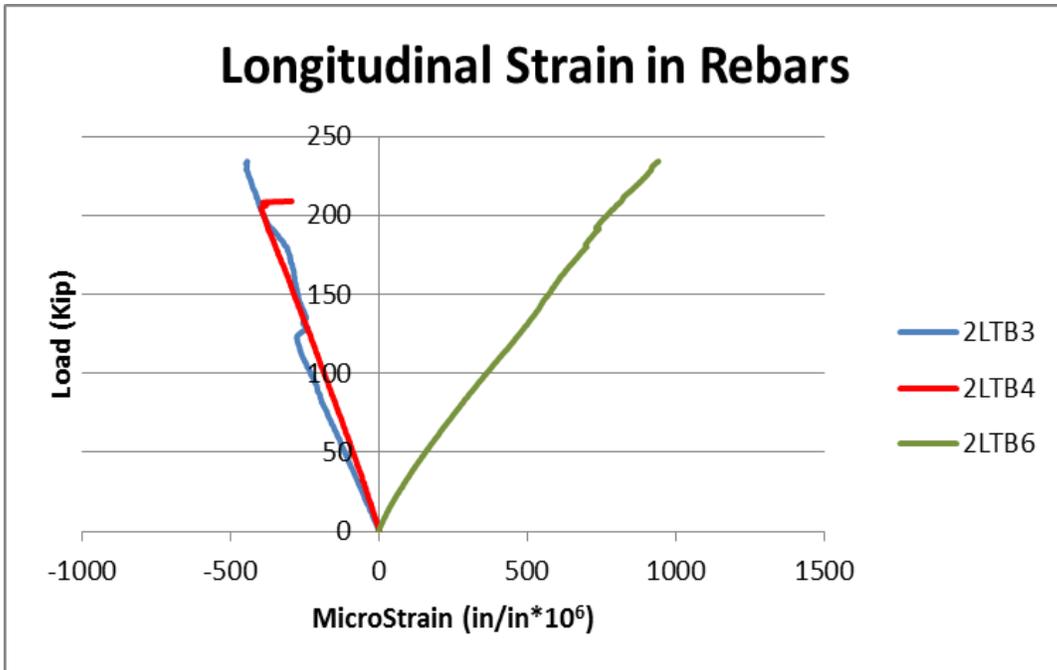
Figure 4-79 Longitudinal strain of rebar at mid-span.

The longitudinal strains in the rebars are shown in Figure 4-79. Three gauges were damaged as results of previous tests. All gauges in the transverse rebars were damaged; therefore, not reported here. The crack gauges on the top and bottom of the deck also had similar trends as they was observed in Tests A and D. Gauge 2TTD1 had significantly high tensile strain, indicating the major crack occurred over the inside top flange of the intact girder. Gauges 2TTD2 and 2TBD1 were very small. This indicates the point of inflection was at center of the bridge cross-section. While the center of gravity of the load was right at the center of the damaged girder in Test A and D, in this test with truck-load configuration, the center of gravity of the load was shifted closer to the intact girder. This was the reason why the point of inflection was also shifted toward to the intact girder.

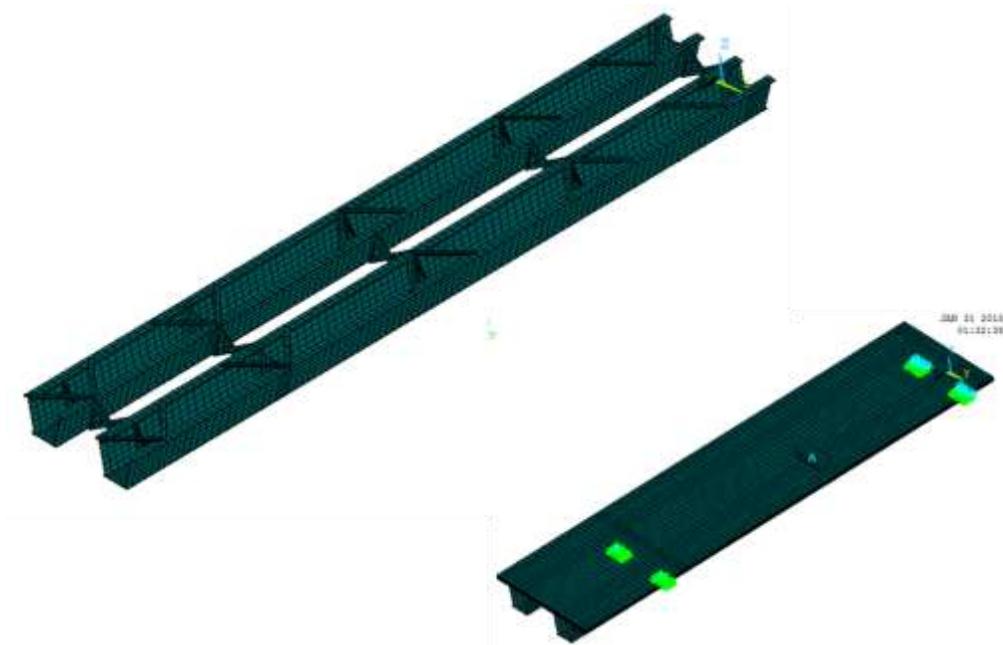
Figure 5-1 Finite element bridge model.

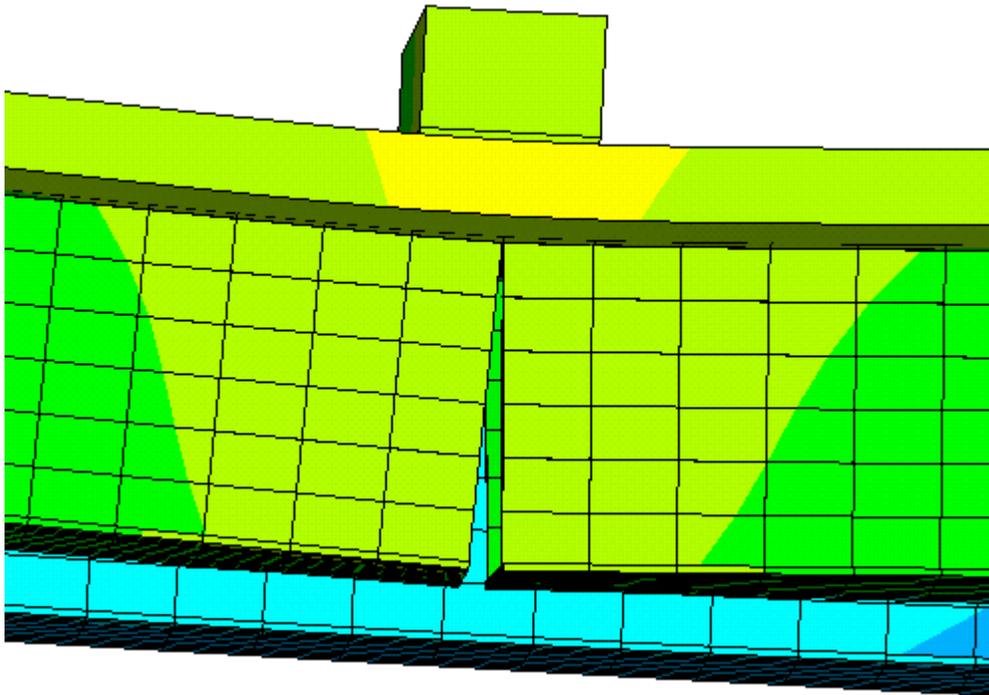
Figure 5-3 Finite element model with full-web fracture condition.

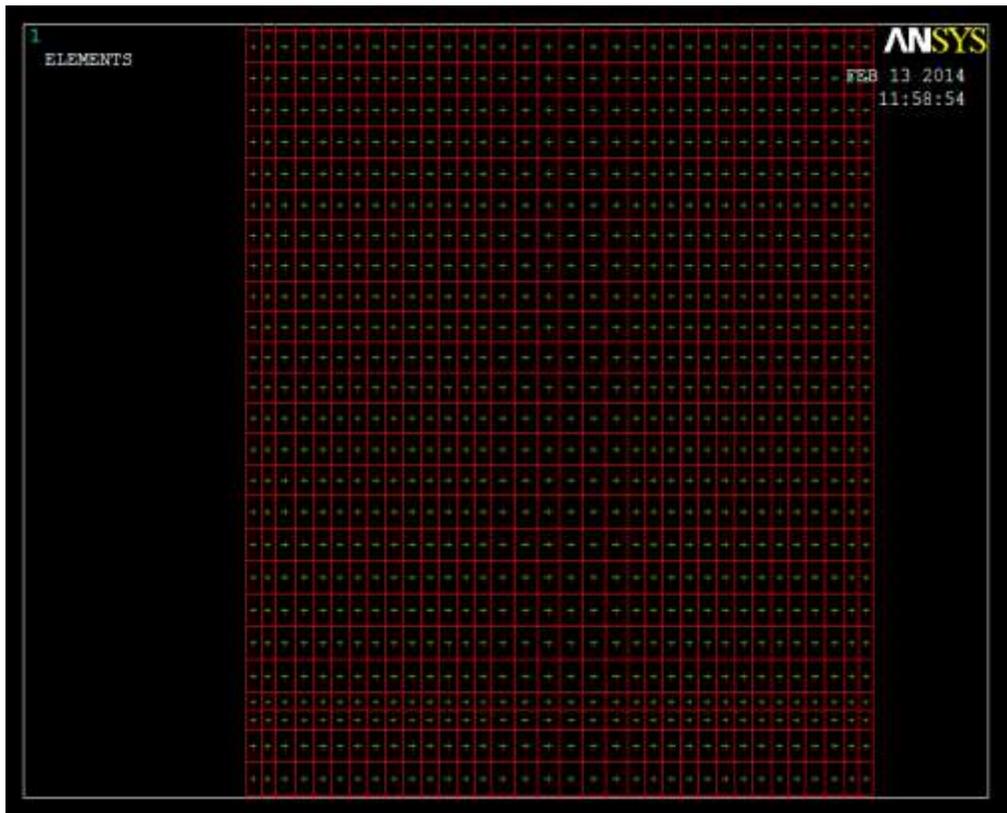
Figure 5-7 Smearred reinforcement bars.

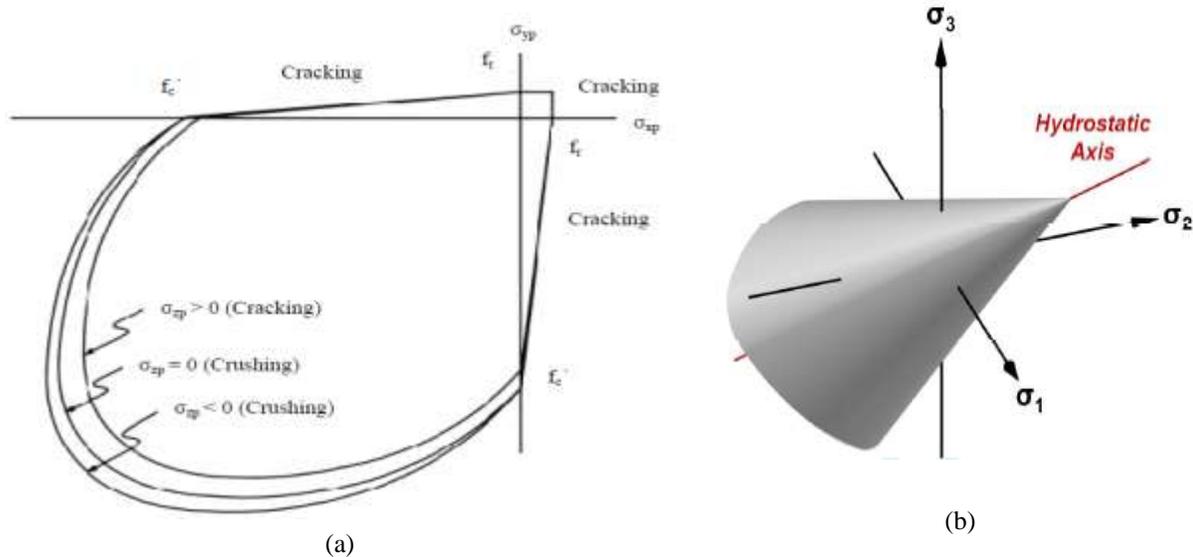
Figure 5-8 Failure surfaces of concrete under (a) biaxial and (b) triaxial loading states (Willam and Warnke, 1975).

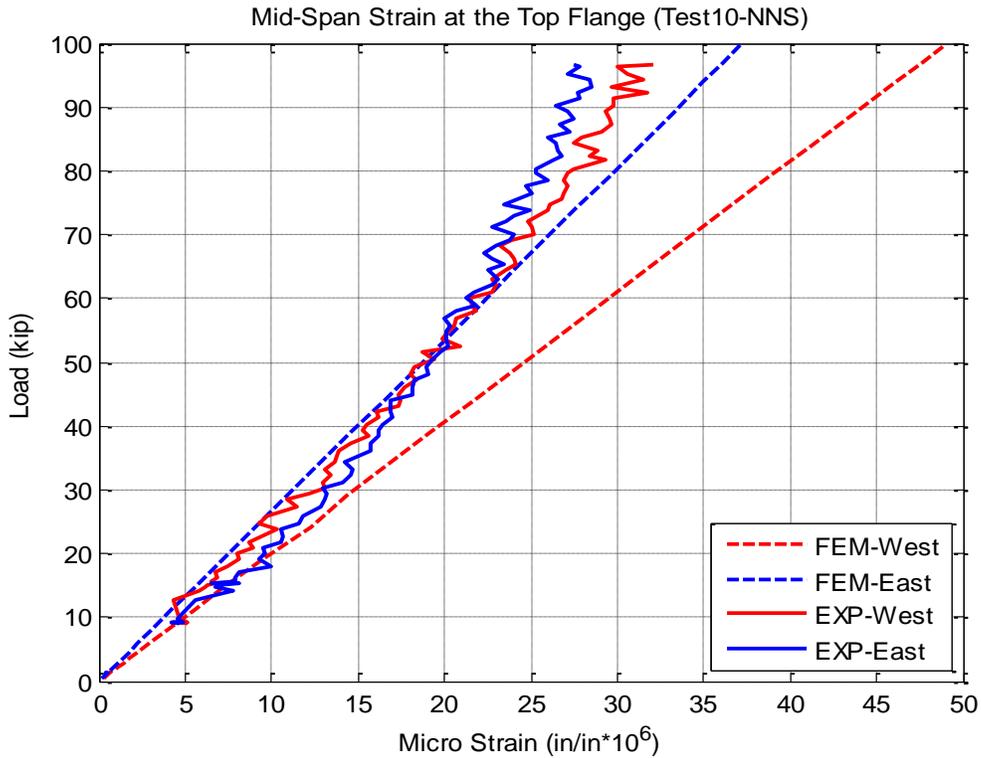
Figure 6-20 Comparison of longitudinal strain at the top flange of each girder in Test 10.

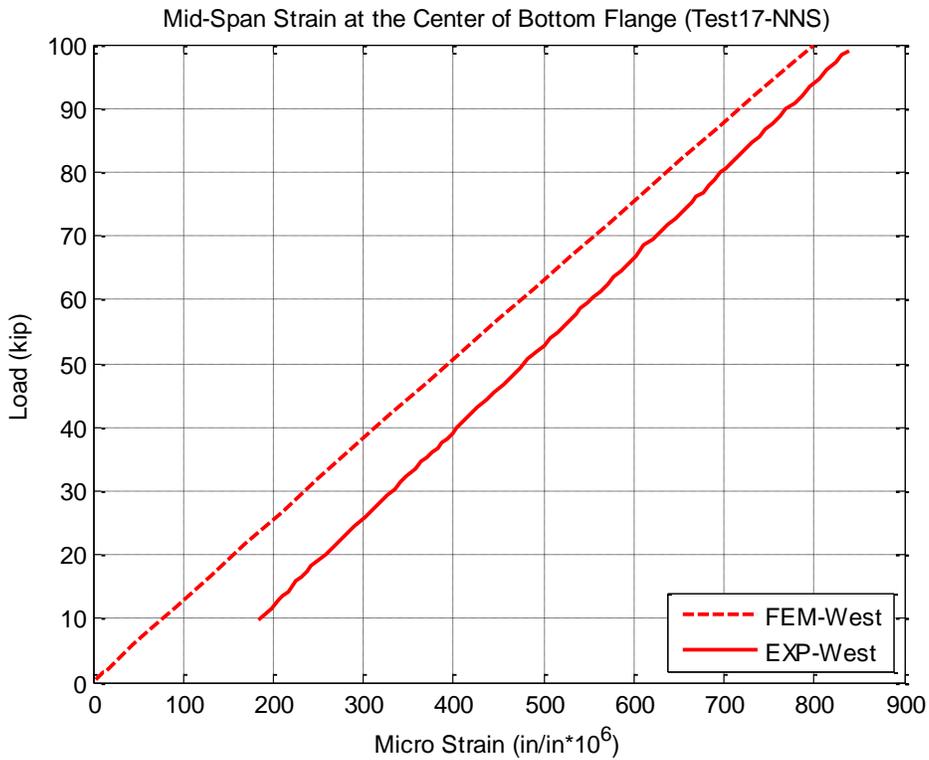
Figure 6-26 Comparison of longitudinal strain at the bottom flange of undamaged girder in Test 17.

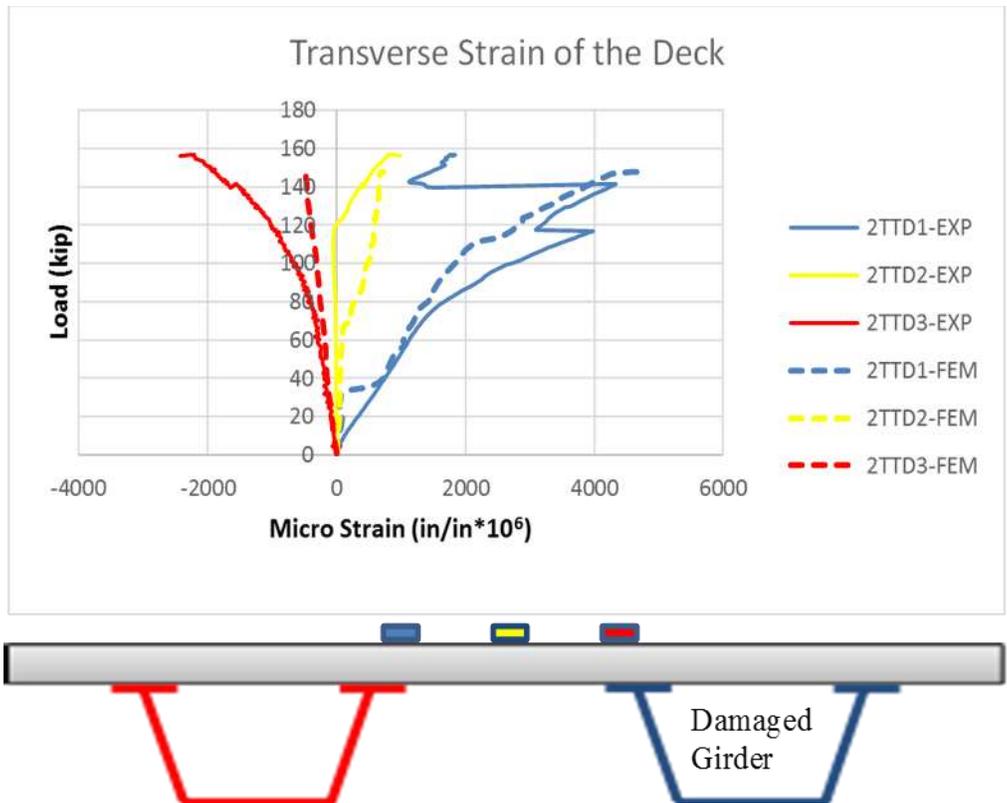
Figure 6-34 Comparison of transverse strain on the top of deck.

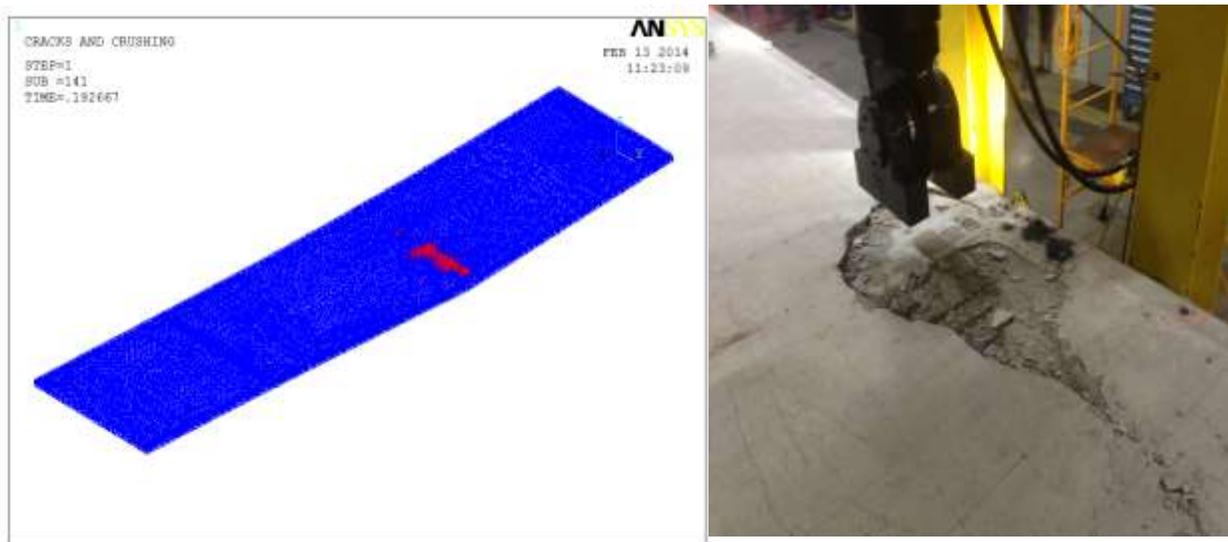
Figure 6-35 Location of concrete crushing in FEA and in experiment.

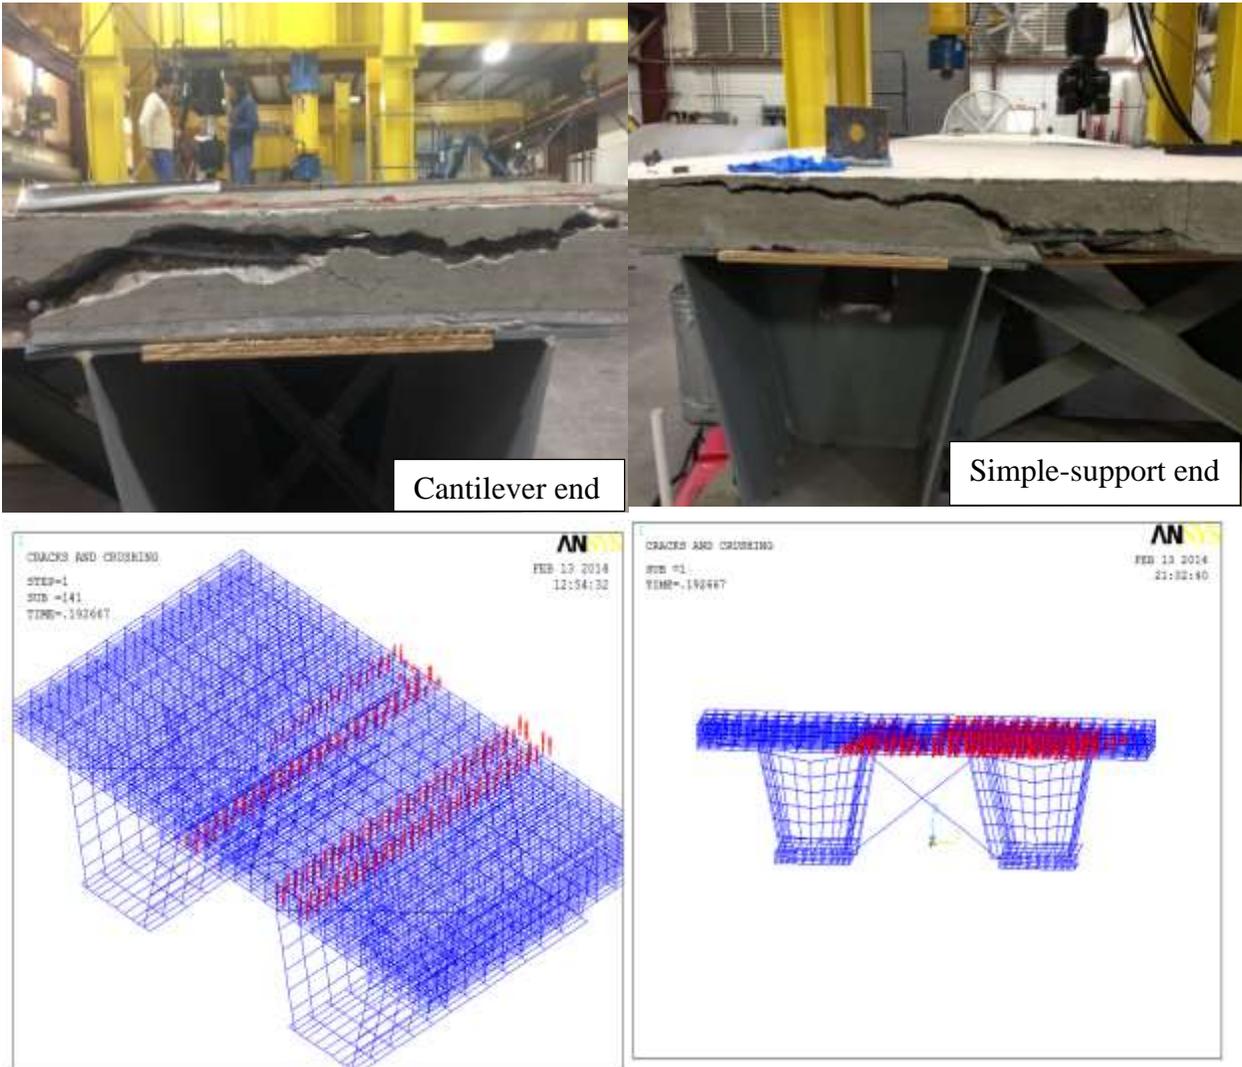
Figure 6-36 Shear cracking in south (left) and north (right) supports.

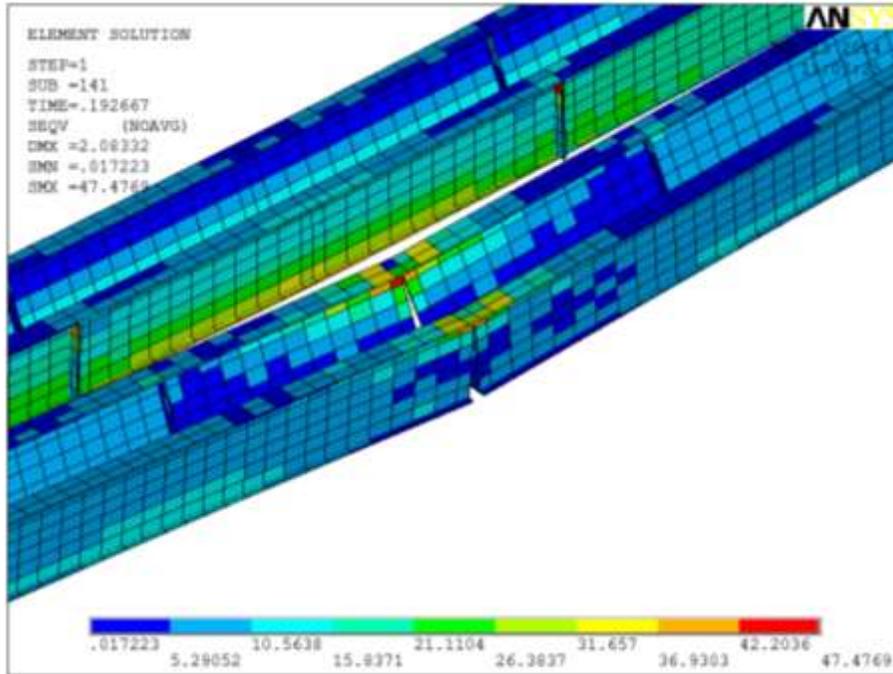
Figure 6-37 Stress contour at mid-span in the steel girders.

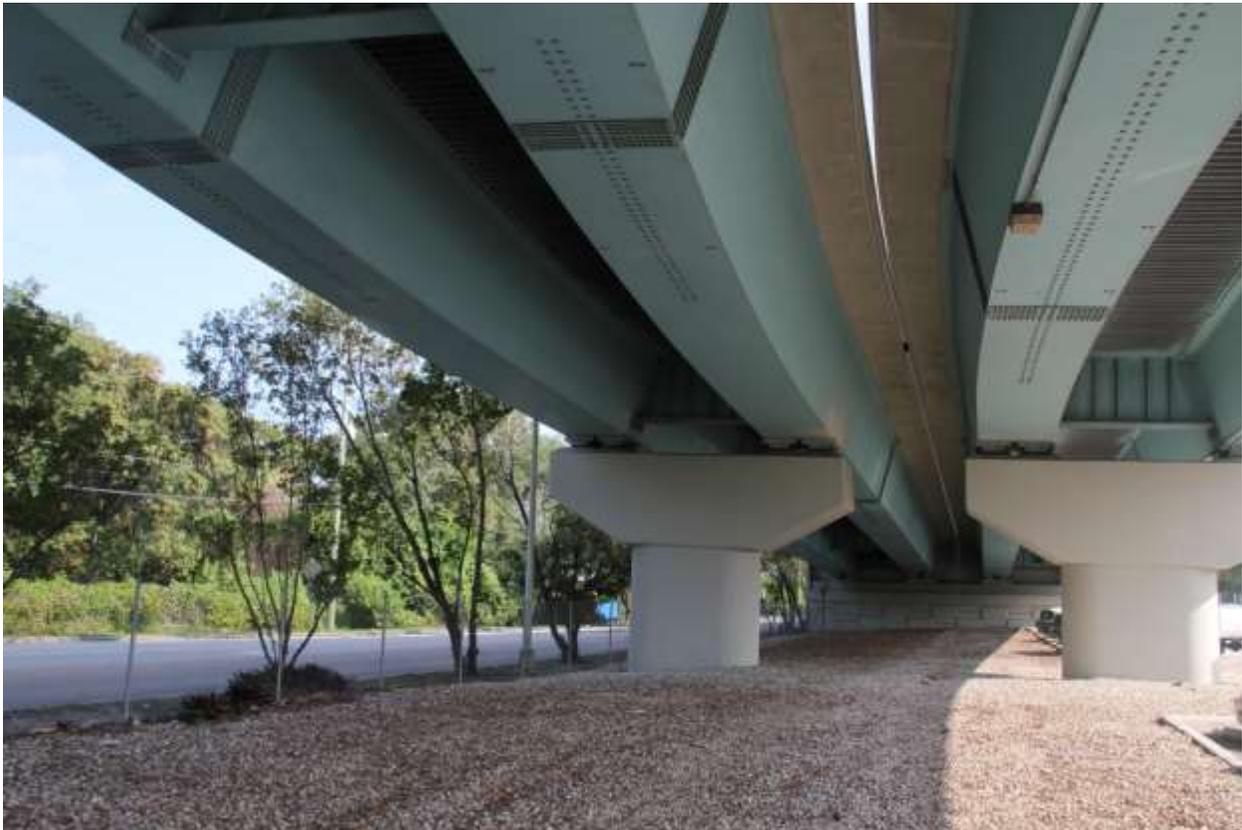
Figure 7-1 First two spans of the ramp bridge - underneath view.

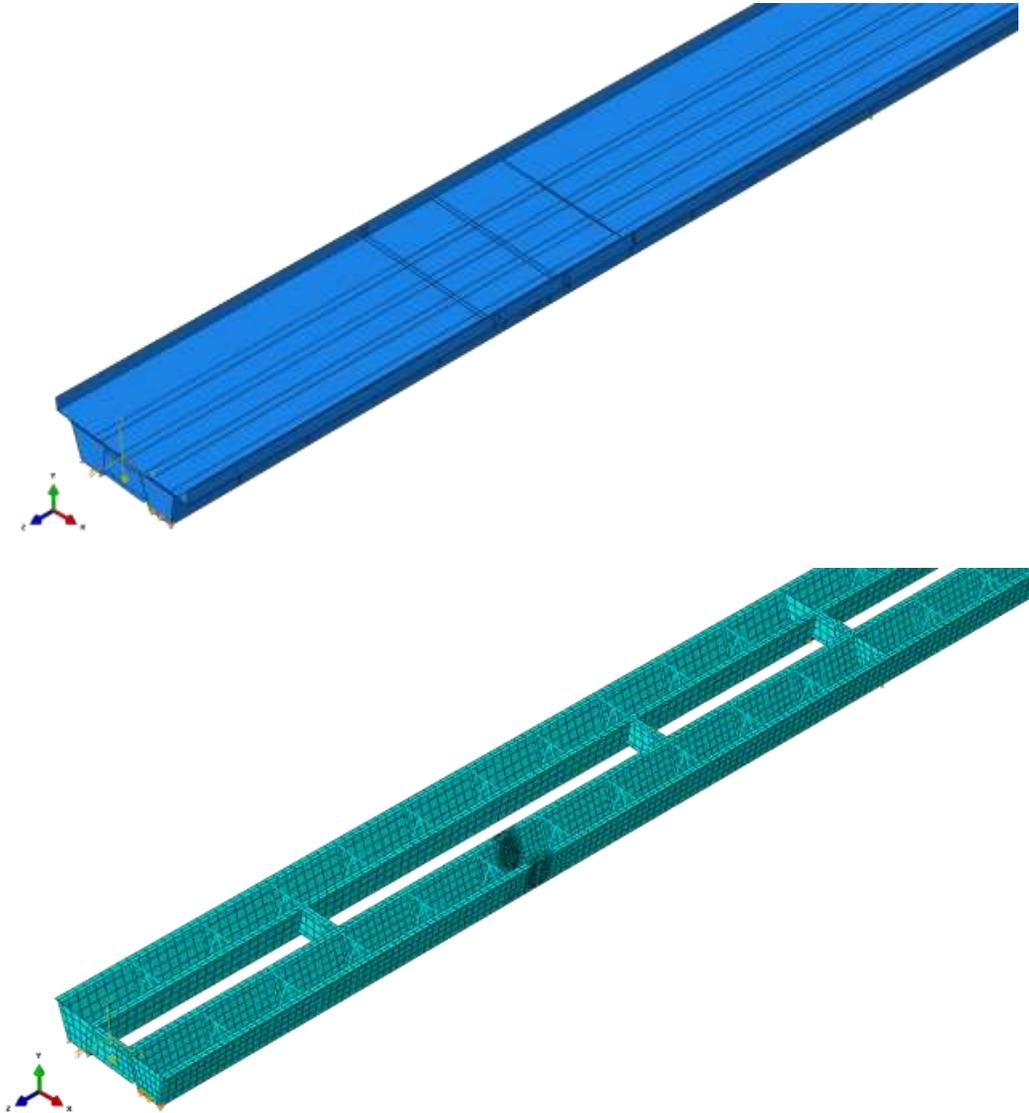
Figure 7-21 Finite element model of the first span of Ft. Lauderdale bridge 860600.
