Managing Florida's Fracture Critical Bridges - Phases I & II

Huy Pham
Jawad Gull, Ph.D.
Alireza Mohammadi
Atorod Azizinamini, Ph.D., P.E.

**Department of Civil and Environmental Engineering
Florida International University
Miami, Florida**

Sponsored By
Florida Department of Transportation

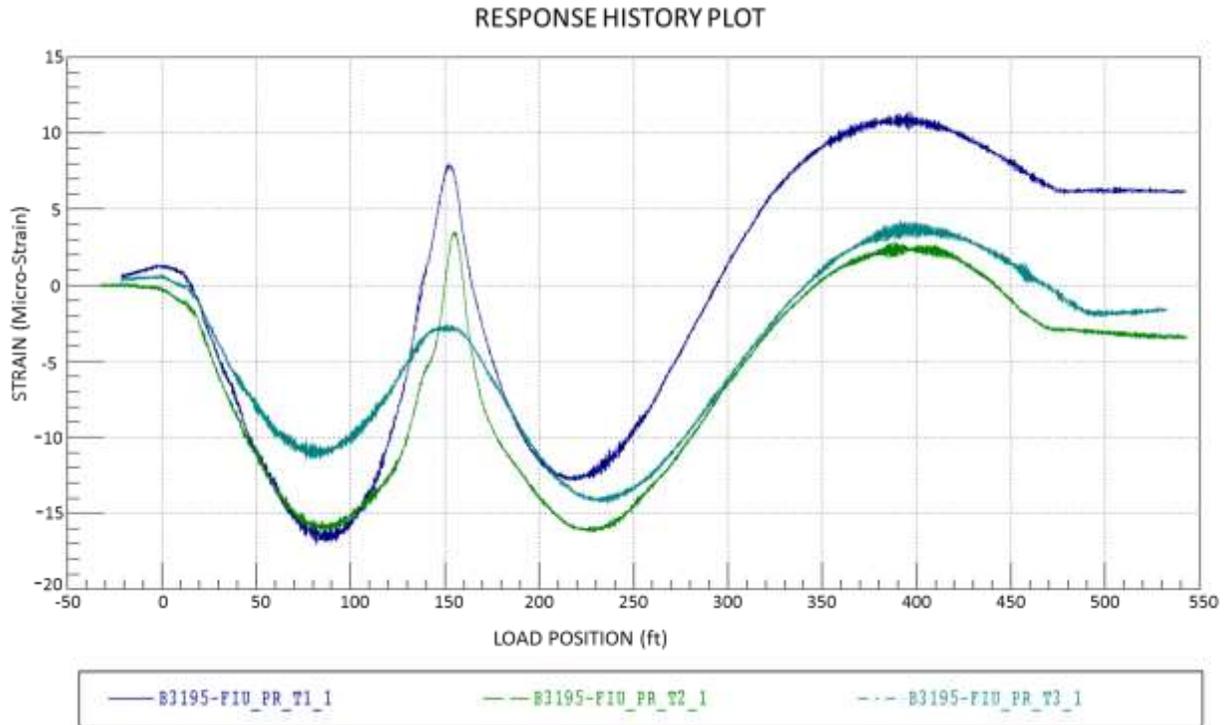
Figure 7-24 Example of variable thermal drift observed during testing.

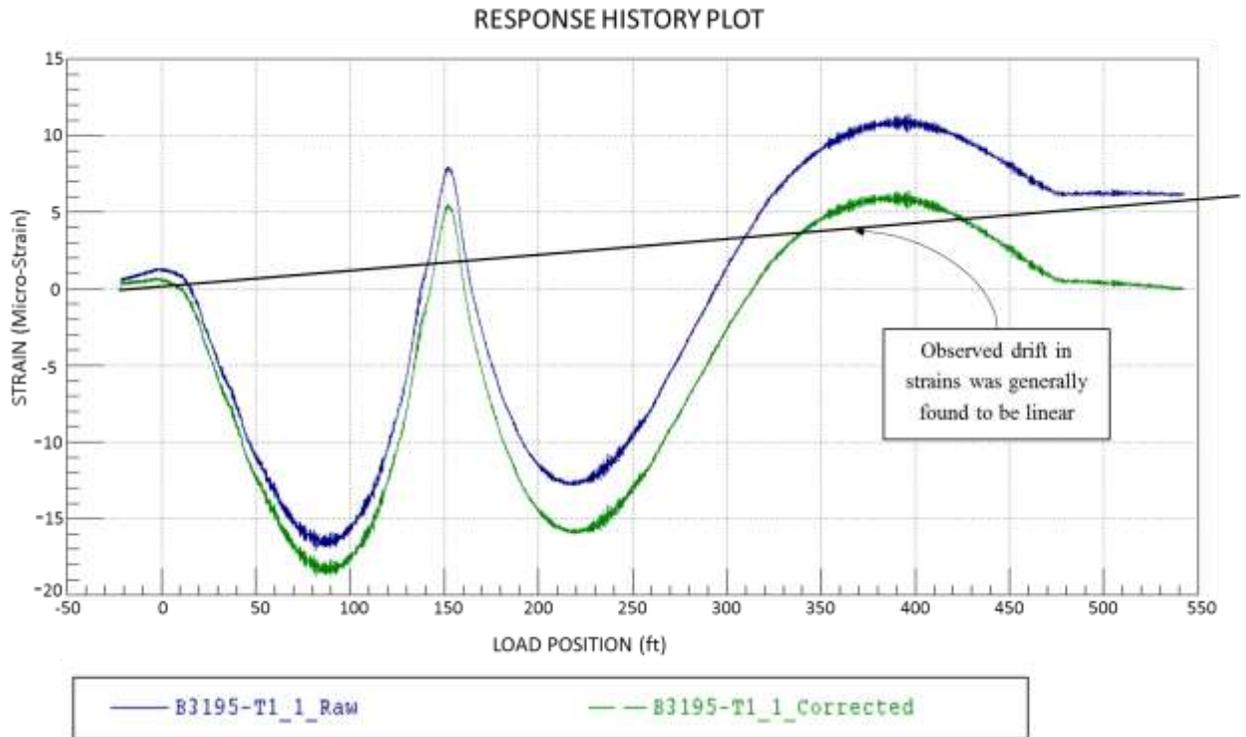
Figure 7-25 Comparison of raw and thermally corrected strain data.

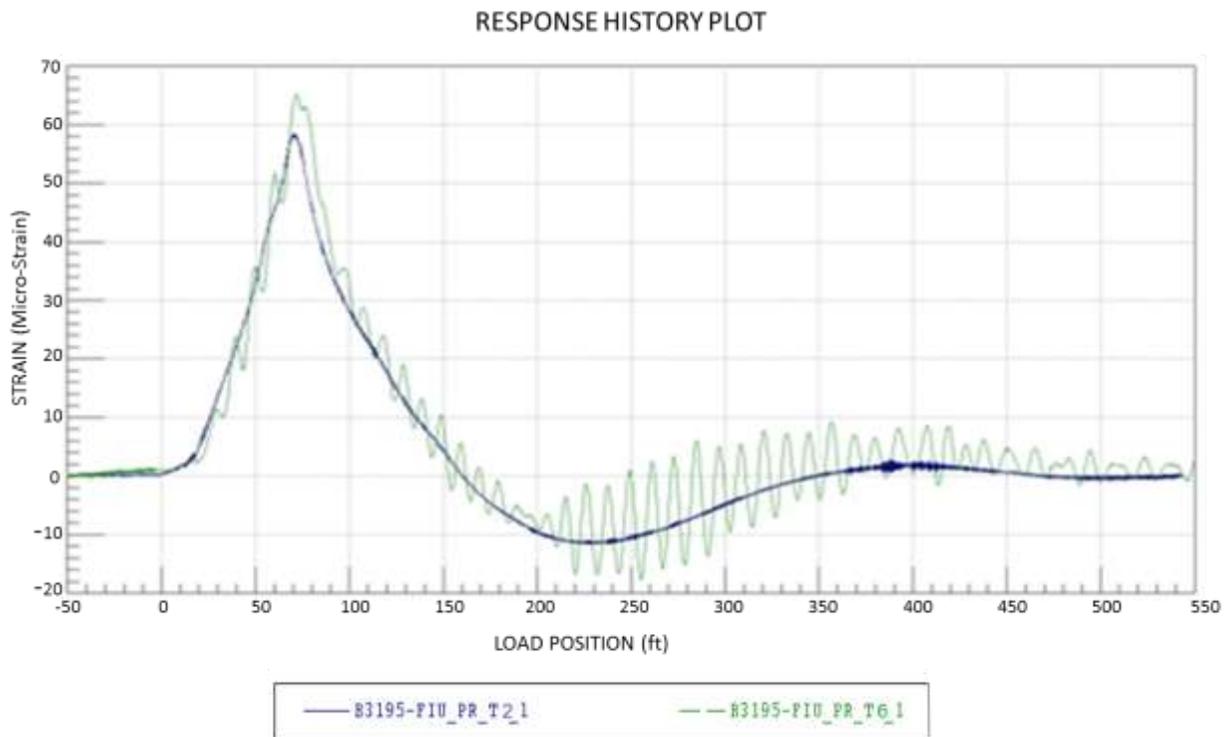
Figure 7-26 Strain history comparison – crawl speed vs. roadway speed at Section 2.

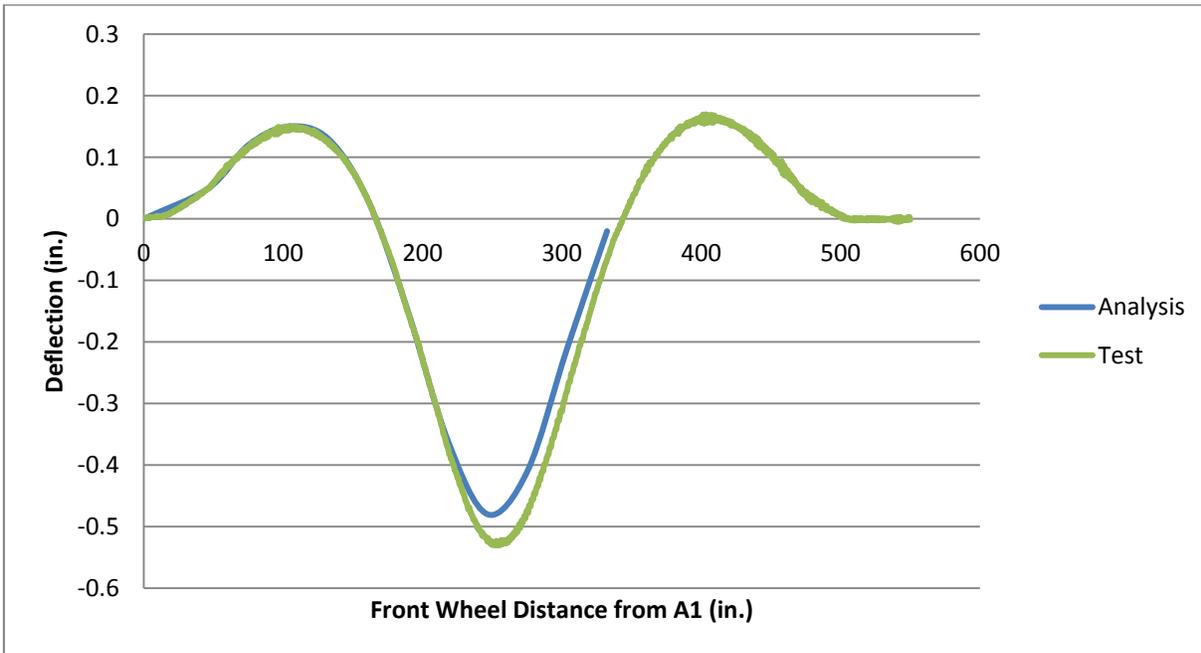
Figure 7-32 Vertical deflection of east edge of EG: 225.5 ft from north abutment, Truck-1 followed by Truck-2 on path-1.

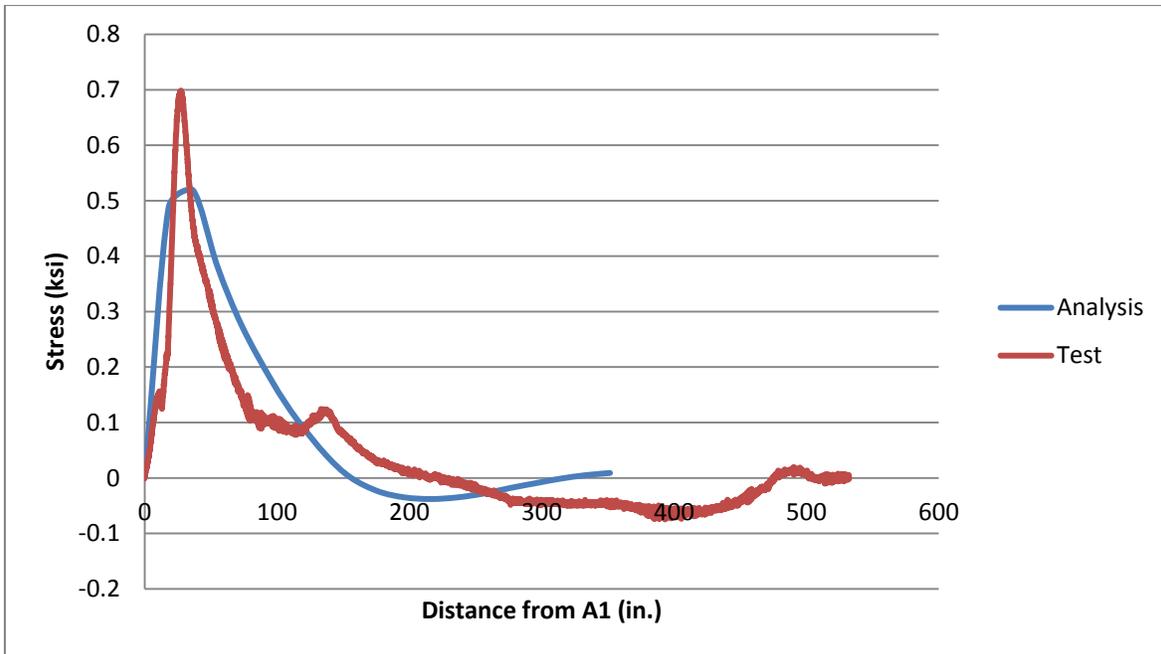
Figure 7-33 Longitudinal stress at 6 ft from north abutment in the west edge of bottom flange of WG: Truck-1 on Path-3.

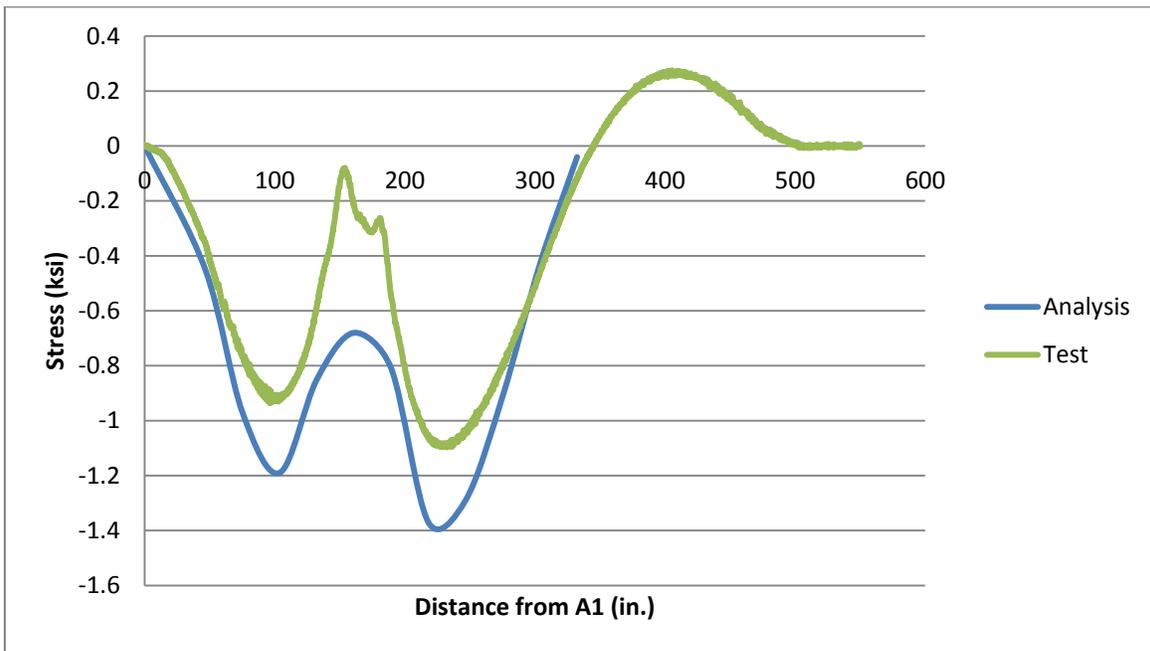
Figure 7-50 Longitudinal stress at 138 ft from north abutment in the east edge of bottom flange of EG: Truck-1 followed by Truck-2 on path-1.

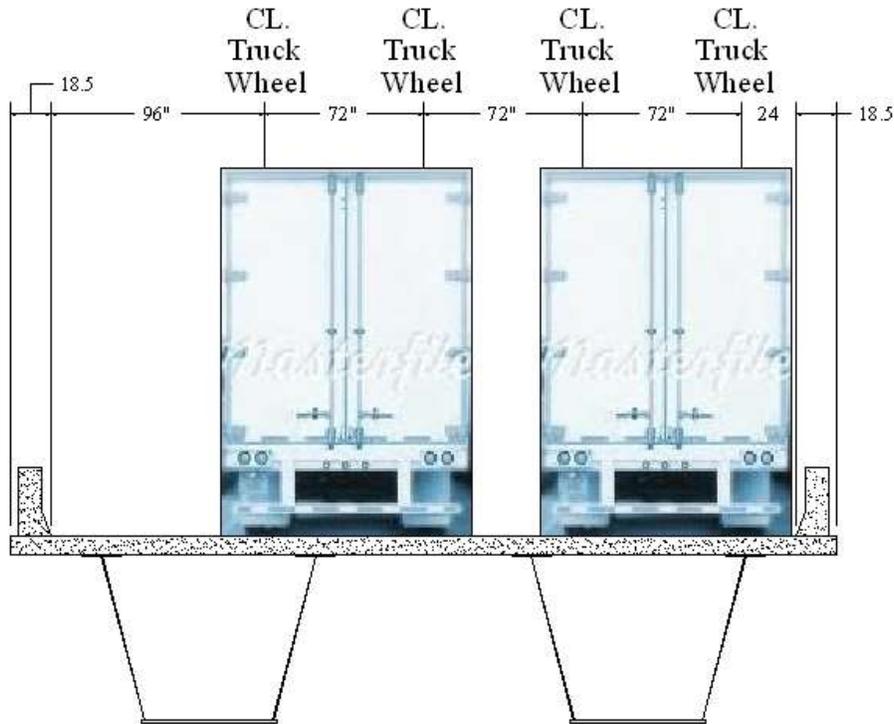
Figure 8-3 Worst case scenario for HS-20 loading of the bridge.

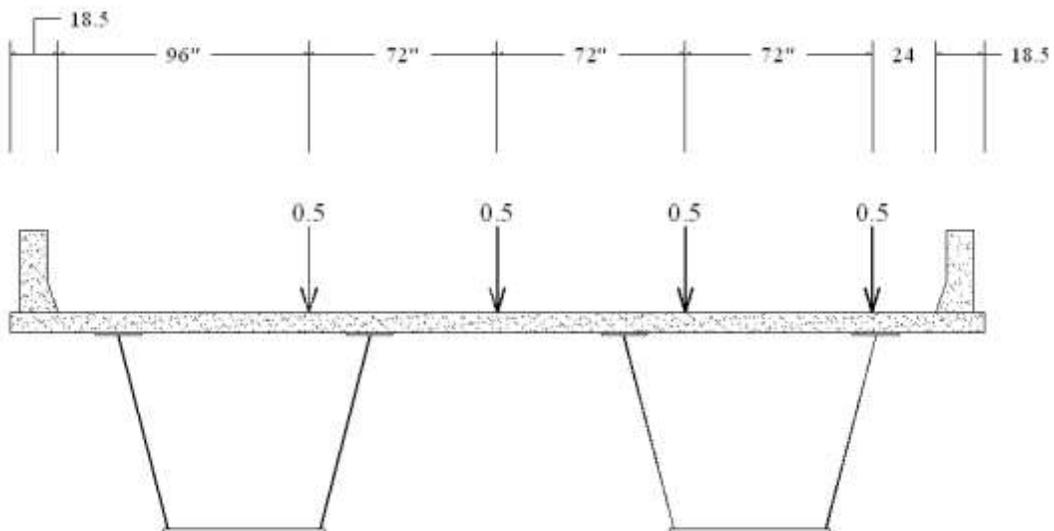
Figure 8-4 Worst case scenario of loading for two trucks with unit weight.

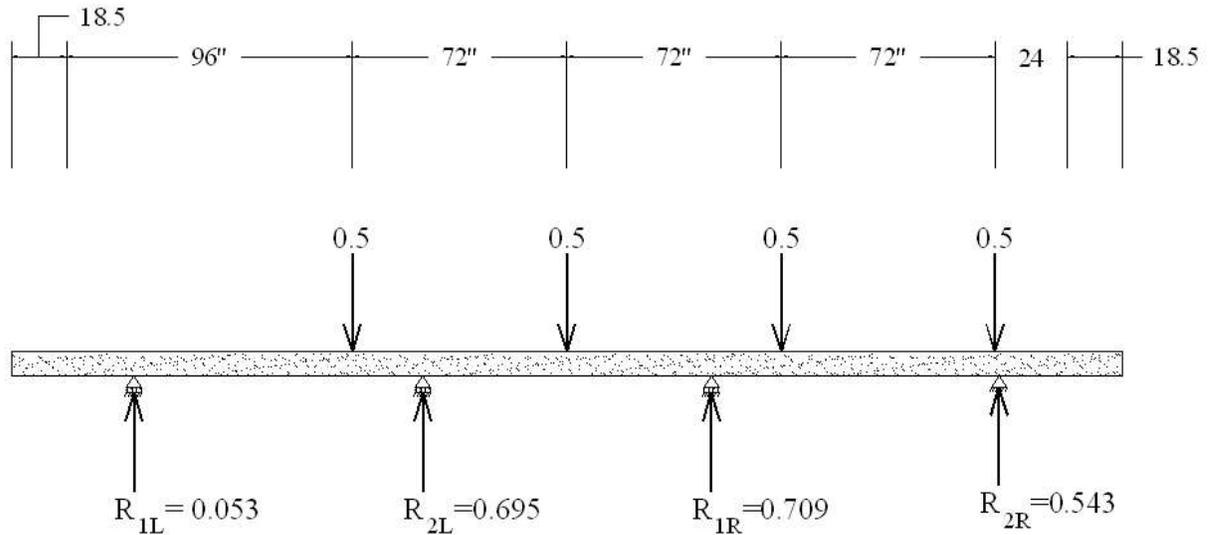
Figure 8-5 Web reactions due to application of two trucks with unit weight.

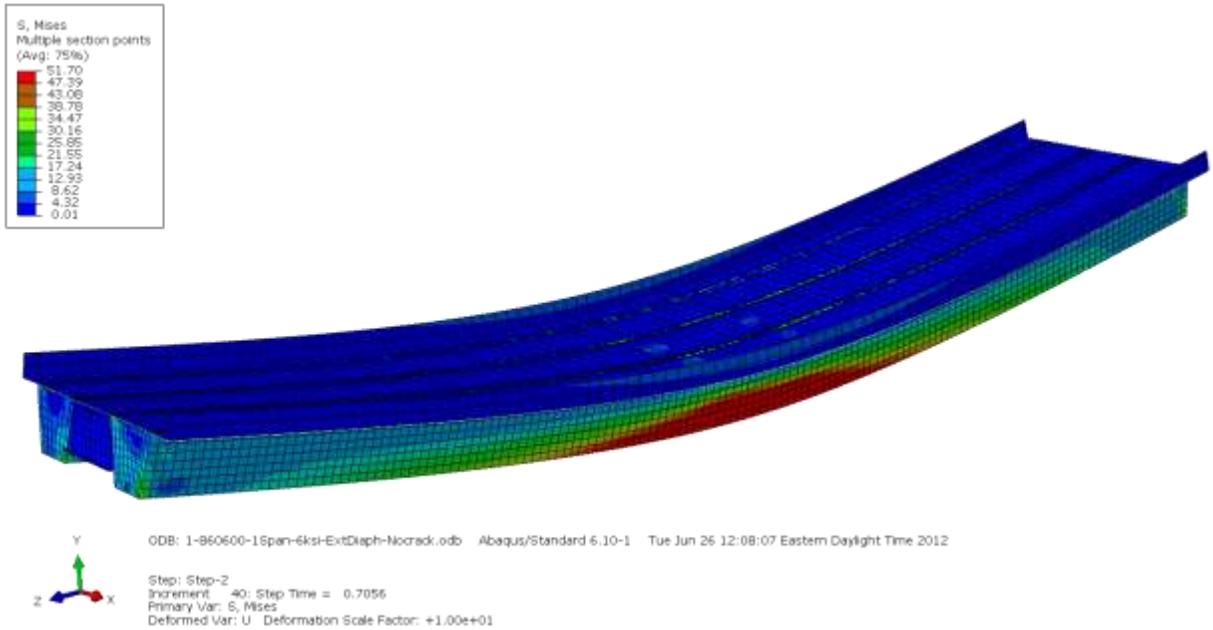
Figure 8-7 Von Mises stresses in single-span bridge under maximum moment, undamaged condition.

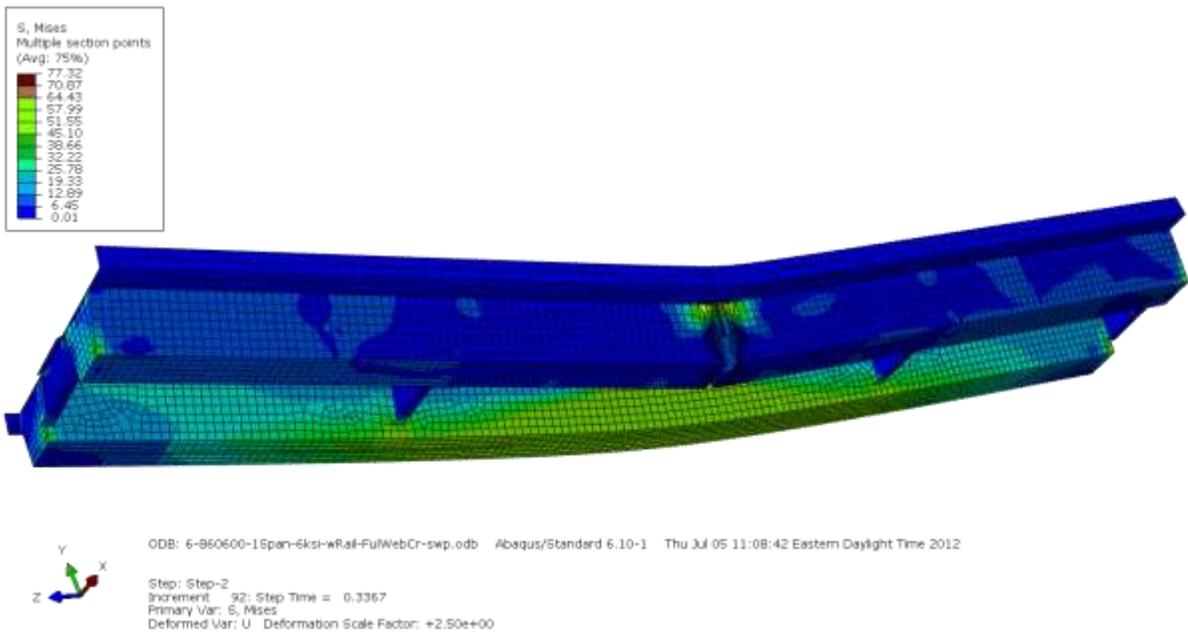
Figure 8-8 Von Mises stresses in single-span bridge under maximum moment, full-web cracked condition.

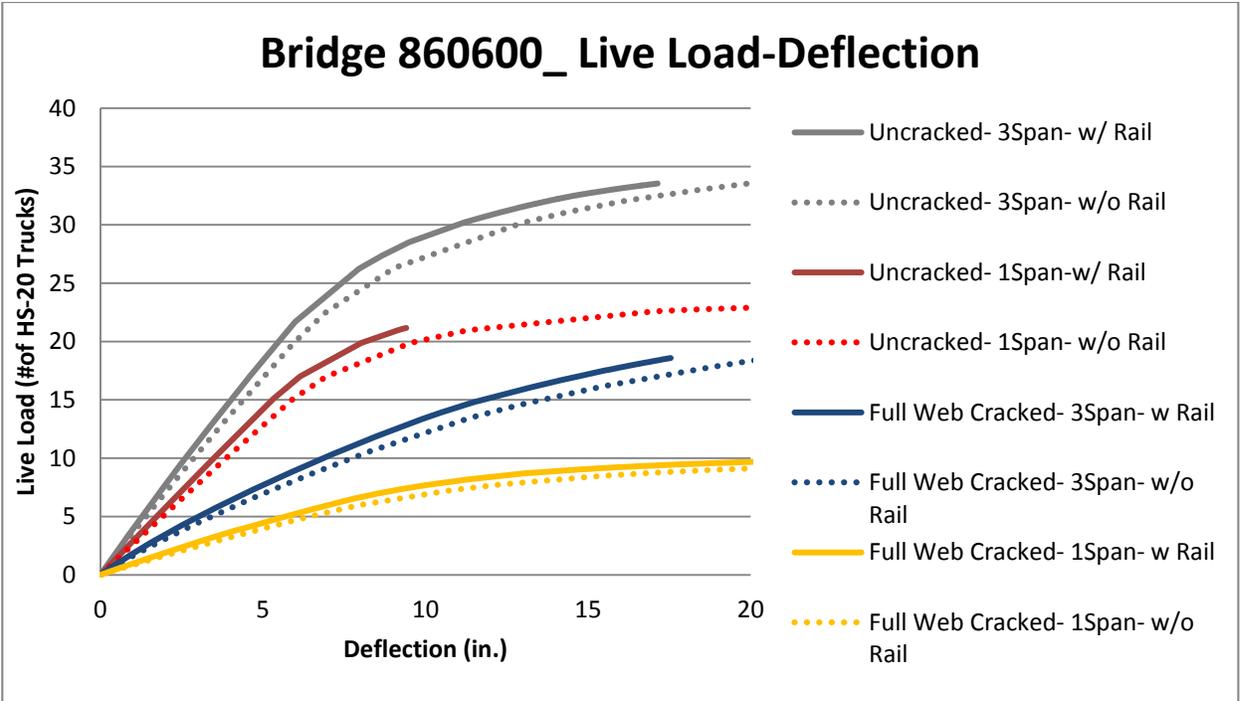
Figure 8-9 Load vs. vertical deflection of single- and three-span bridges with different conditions.

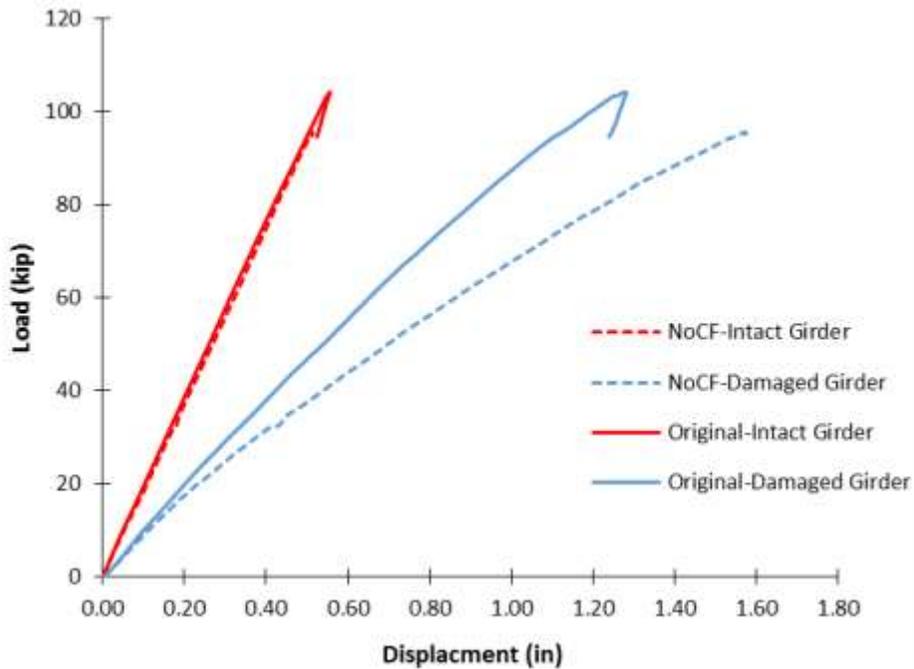
Figure 9-1 Effects of cross-frames.

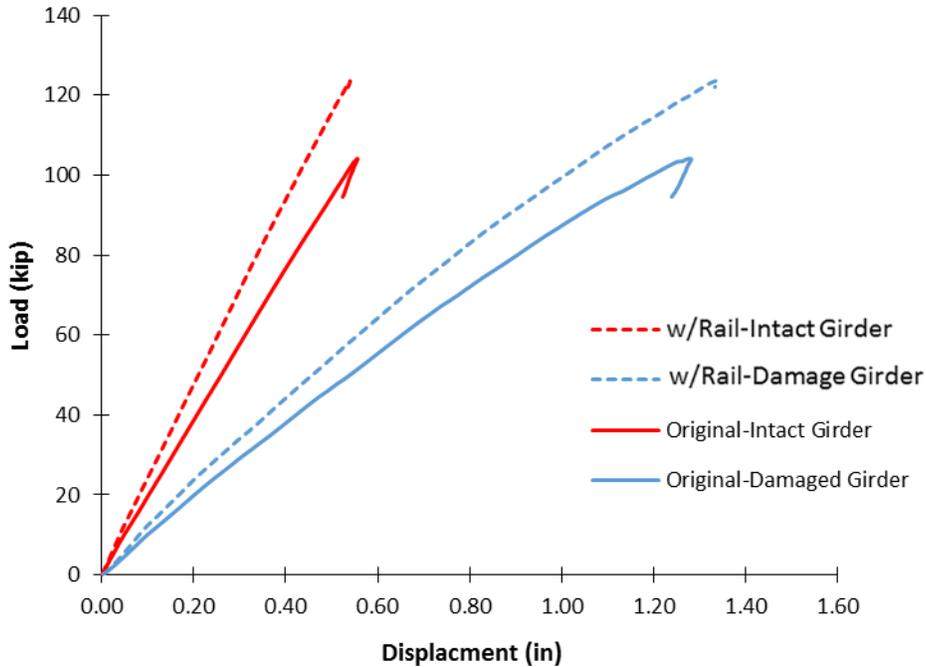
Figure 9-2 Effects of railing system.

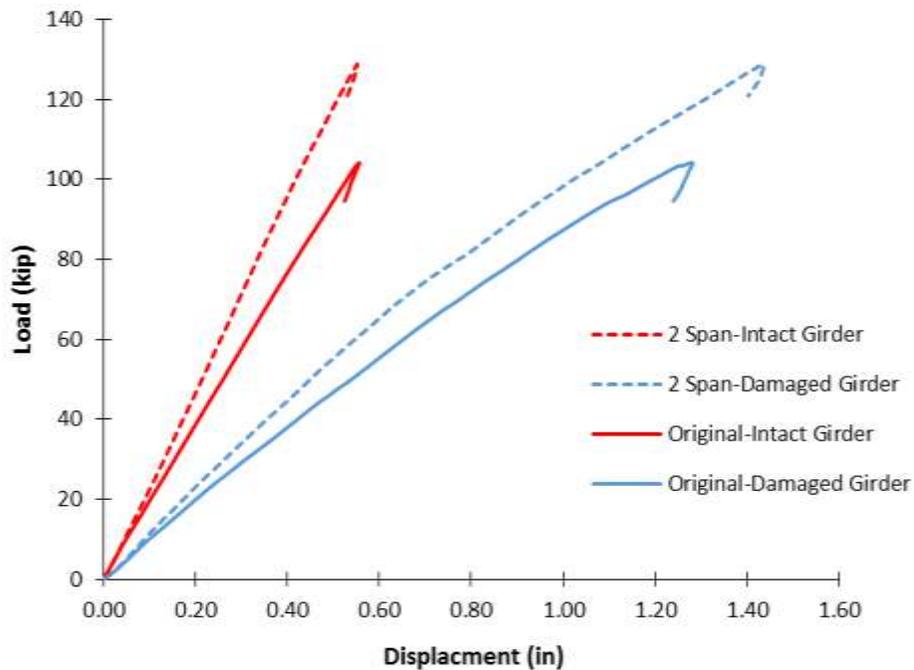
Figure 9-3 Effects of continuity.
