**UNF Project
Contract No. BDV34-977-01**

Empirical Deck for Phased Construction and Widening

Florida Department of Transportation

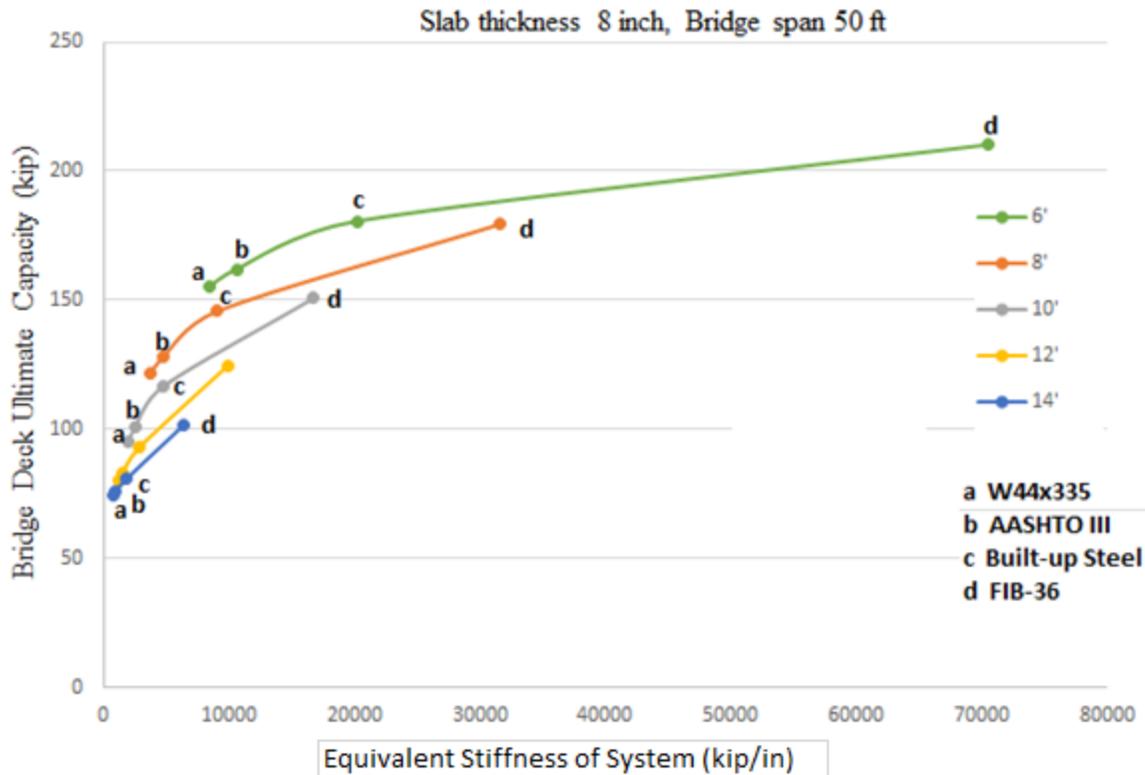
Figure 3.4: Relationship between ultimate capacity and equivalent stiffness of support system

In conclusion, the results indicated that the beam lateral stiffness has a direct effect on the ultimate capacity of the bridge deck. It was observed that the FIB-36 girder provided higher lateral stiffness compared to the other girders (AASHTO Type III, steel built-up section, and W44x335). This resulted in greater lateral restraint that enhanced the compressive membrane action, thus increasing the ultimate load capacity of the bridge deck. Varying the bridge span length had little impact on the deck's ultimate capacity. It was observed that increasing the support beam spacing decreased the deck capacity because of the reduction in lateral stiffness of the deck. However, increasing the deck thickness increased the stiffness and the ultimate strength.

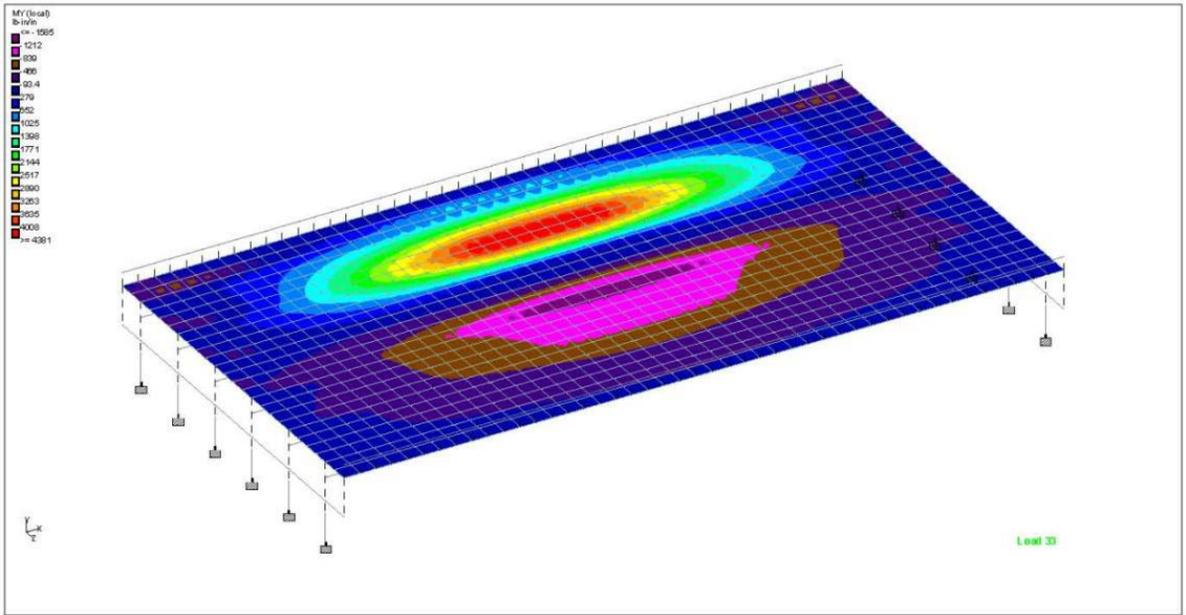
Figure 3.9: Finite element model showing maximum positive moment in the deck

The service moments due to live load, dead loads (including stay-in-place forms) and future wearing surface were extracted from the output of *STAAD.Pro V8i* and imported to a Mathcad sheet. A design of the deck flexural reinforcement was performed. Also, deck cracking and steel tensile stresses were checked.

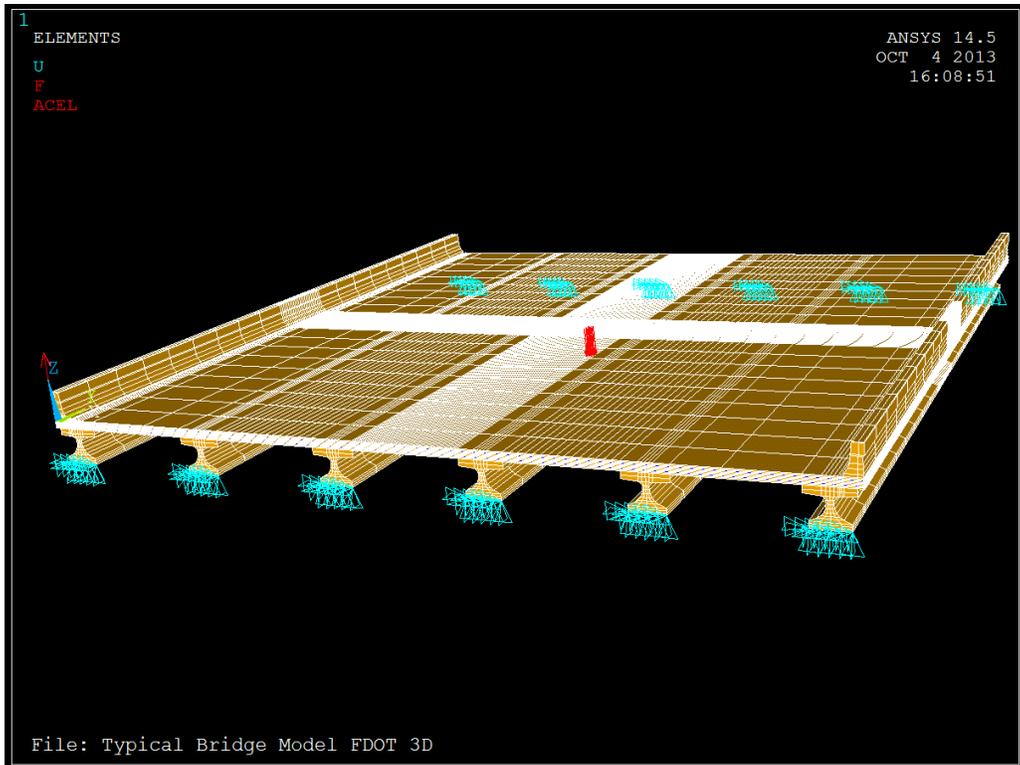
Figure 3.12: FE modeling of bridge span = 80' and beam spacing = 14'

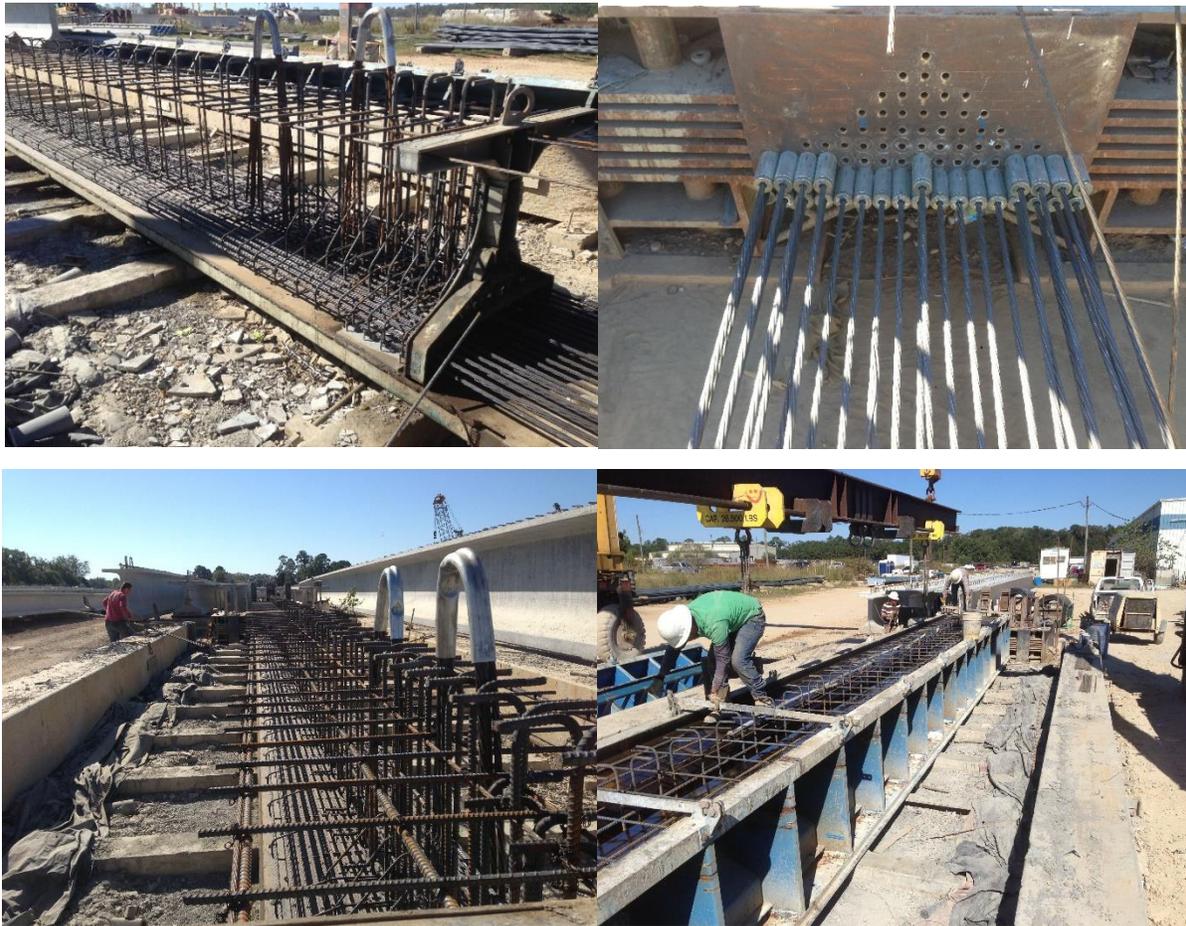
Figure 4.6: FIB-36 Fabrication showing formwork and prestressing tendons

Based on the analyses presented in Chapter 3, the two FIB-36 beams designed to support the deck were fabricated at a casting yard with twenty six 0.6-in prestressing strands stressed to 43.9 kip as can be seen in Figure 4.6. Four additional top flange dormant prestressing strands per beam were added to prevent tensile cracking. The fabricated prestressed FIB-36 followed Index 20036 of the 2014 FDOT Design Standards. Shear reinforcement was designed to avoid premature shear failure of the specimen girders as shown in Figure 3.21. All stirrups were extended above the top flange elevation to obtain composite action with the deck when cast in the lab, as shown in Figure 4.12. Figure 4.6 shows the beam fabrication along with its formwork. Figure 4.7 shows beams as delivered to the FDOT MHA-SRC. Figure 4.8 shows the stay-in-place hanger brackets that were installed in order to connect the formwork for the deck.

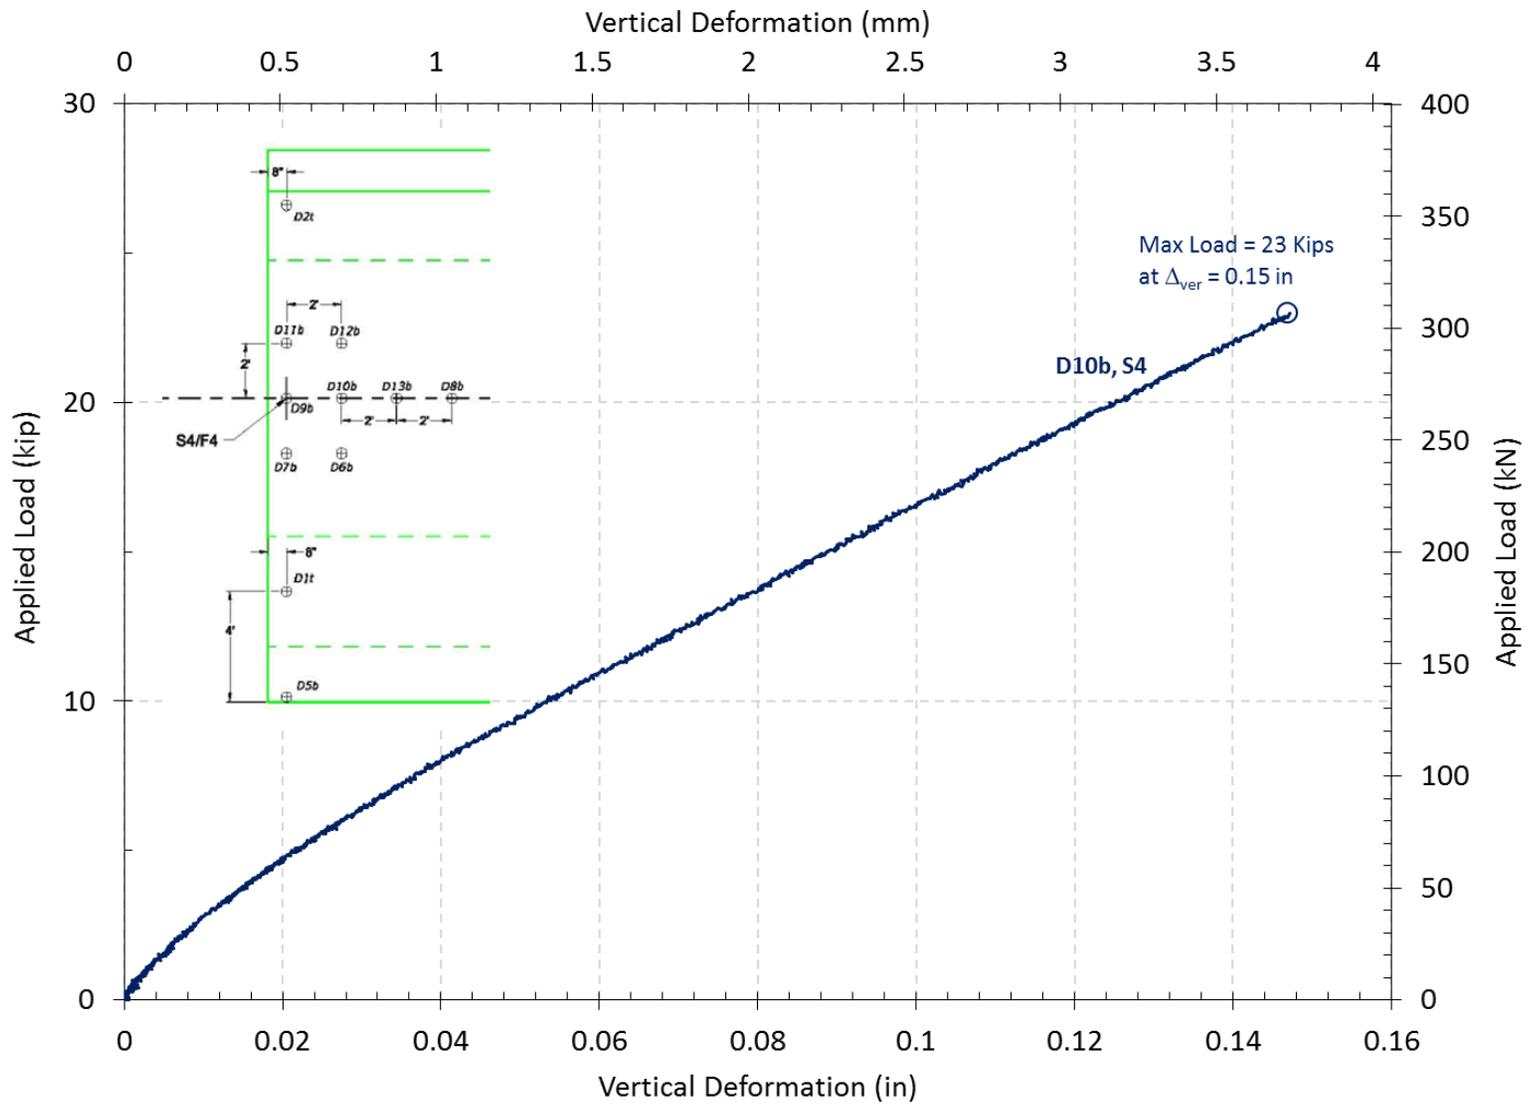
Figure 5.10: S4 Laser deflection gauge for D10b, midspan

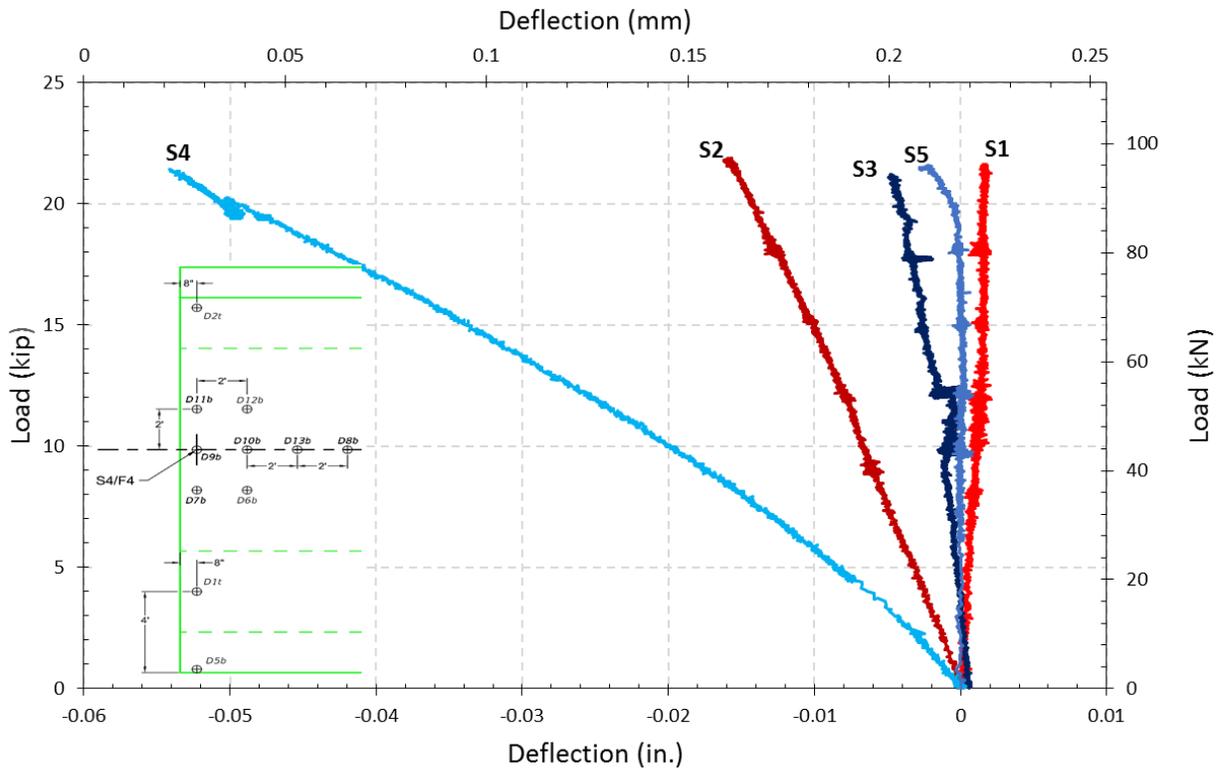
Figure 5.11: Load-deflection plots for D5b under service load levels

The overhang deflection due to the applied load under service conditions can be seen in Figure 5.11. Upward movement readings were recorded during the tests, and the negative sign of the readings in this plot should be disregarded. The magnitudes of these upward movements were minimal (maximum 0.017 in. (0.43 mm) for all interior cases). Case S4 is an exception where a higher upward movement was observed 0.54 in. (13.7 mm). The difference between the different cases can be attributed to the girder stiffness at these locations, which differs based on proximity to the girder supports (see Figure 4.48). The applied load in Case S4 is almost positioned perfectly in line with the girders supports, thus the girders provided an almost rigid support to the deck. Hence, the load distribution is lesser than at midspan in addition to being at the edge as stated before. While these deflections easily meet any deflection limits, they are an indication of negative moment development under service conditions, which may require special attention to reinforcement detailing at these critical edges.

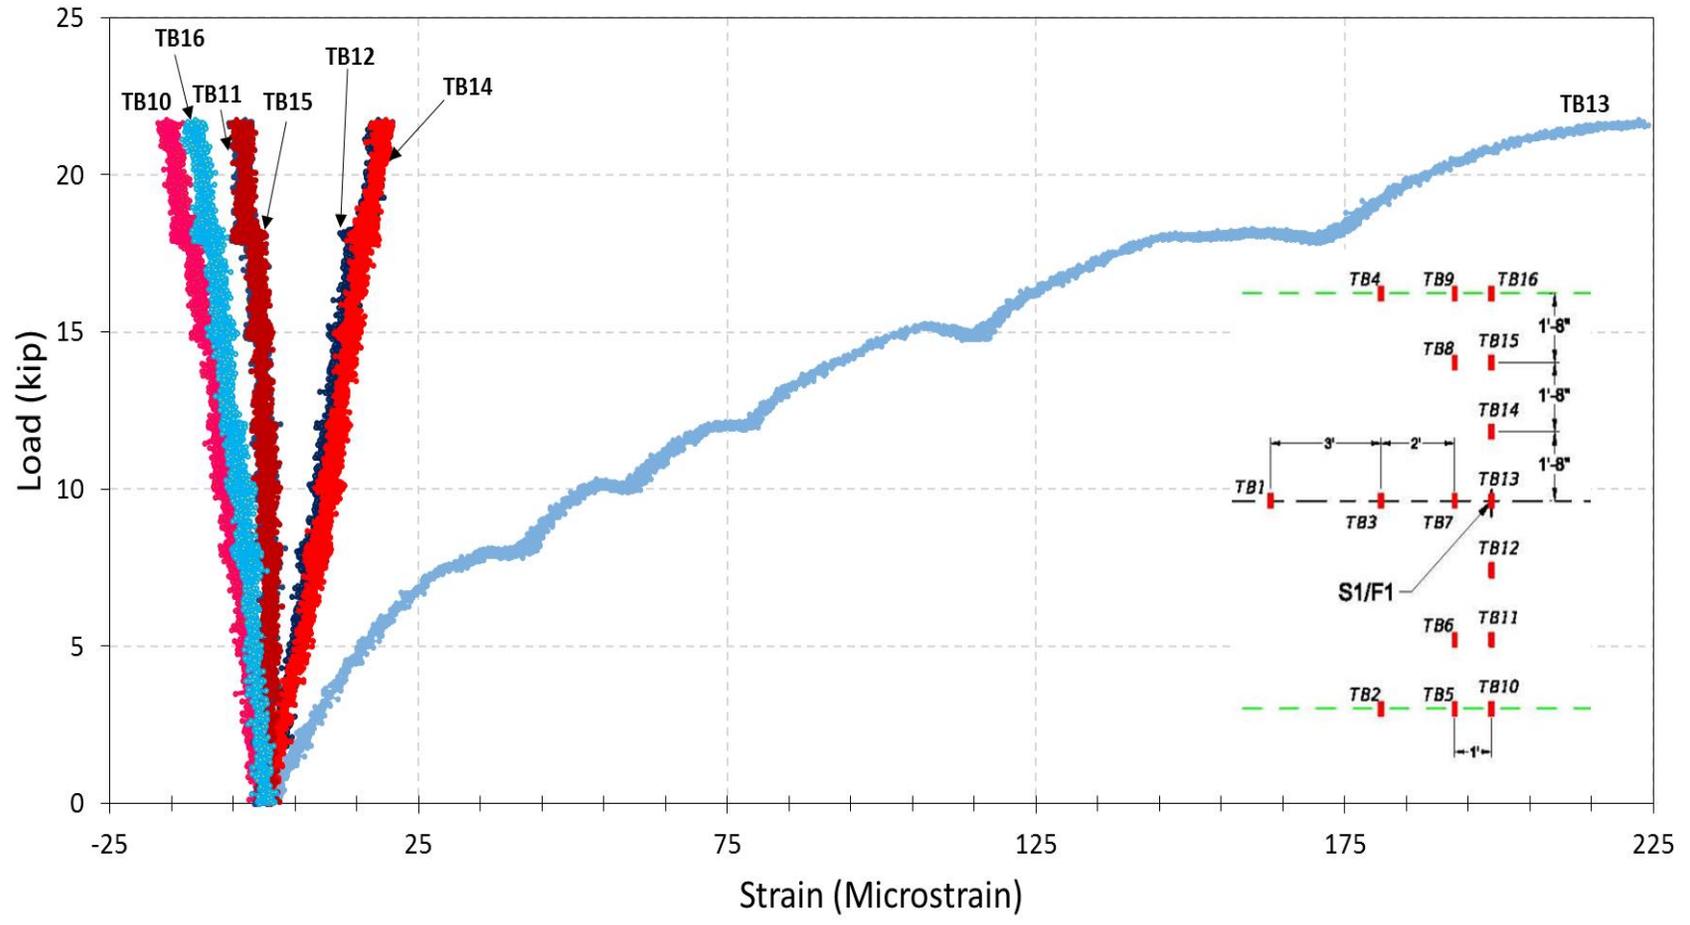
Figure 5.12: Service test S1 load strain for TB10-TB16

It should be noted that this estimate can be considered a lower limit as higher estimates of the modulus of rupture, f_r , can be found in the literature, especially for higher strength concrete mixes. With the exception of S1, all the recorded strains fall below the level that induces concrete cracking (Figure 5.30). Even though TB13 for Case S1 recorded strain readings that exceeded the concrete cracking strain, cracks were not observed during the test under this load level. Therefore, this gauge may have been faulty as the other two internal cases, S2 and S3, did not exceed the estimated concrete cracking strain. Another explanation for the high strains recorded by TB13 for Case S1 is that it is possible that a crack preexisted at this location, resulting in higher strain levels from the cracked section. These hypotheses will be revisited later when surface concrete strain readings will be discussed. It should also be noted that recorded strains (from the available gauges embedded for Case S3) for the most critical case, S4, for which the load was applied on the edge of the deck and after conducting the S3 test, were also lower than the rupture strain.

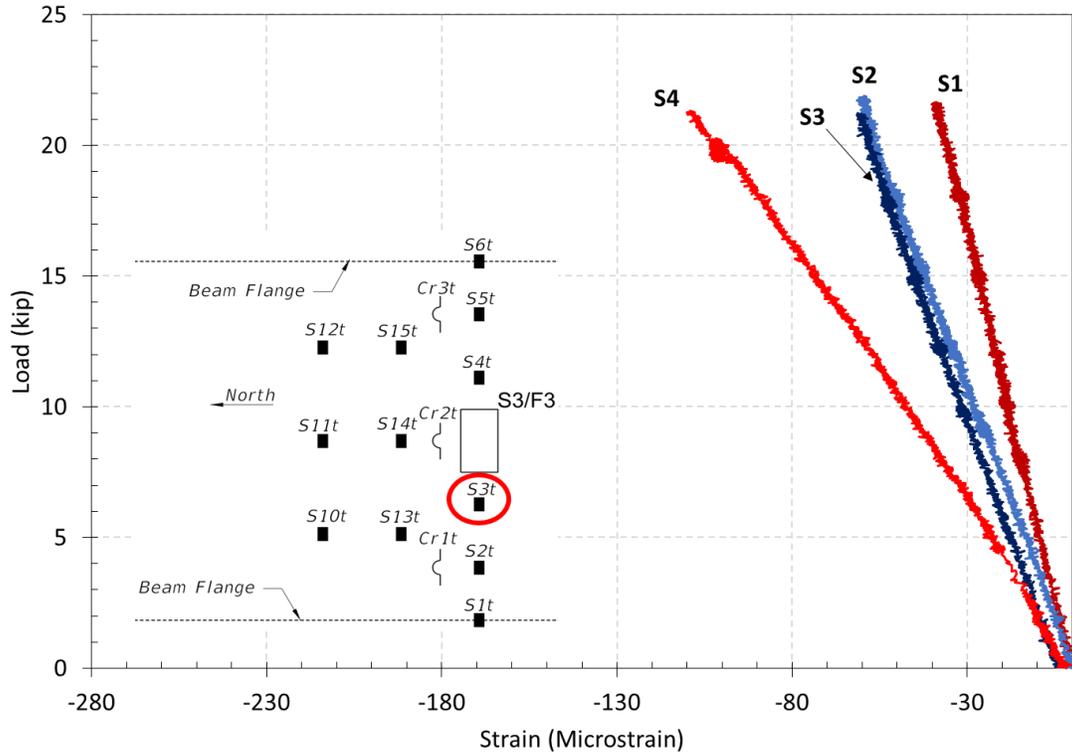
Figure 5.20: Service tests top deck strains - Gauge S3t

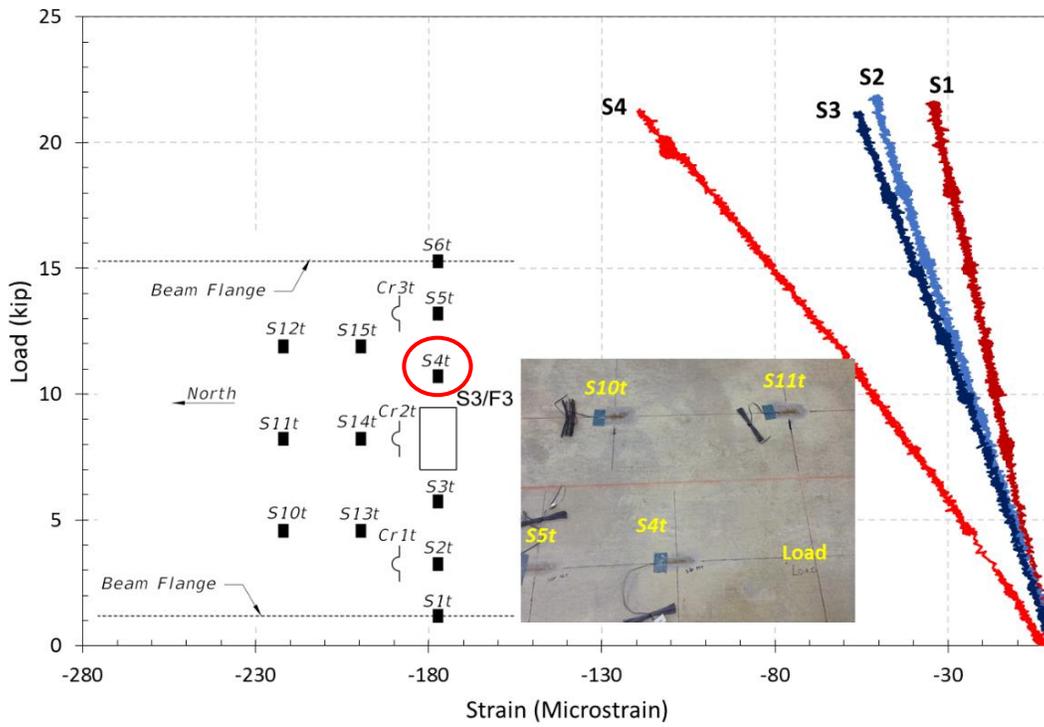
Figure 5.21: Service tests top deck strains - Gauge S4t

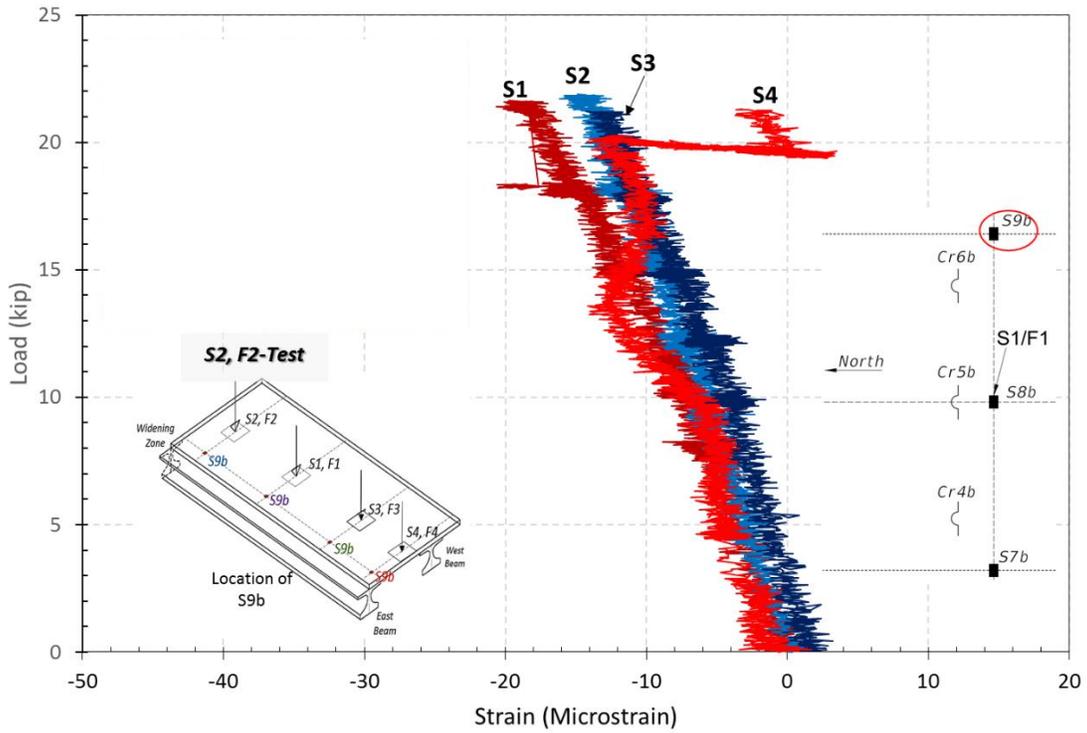
Figure 5.26: Service tests bottom strain gauge S9b

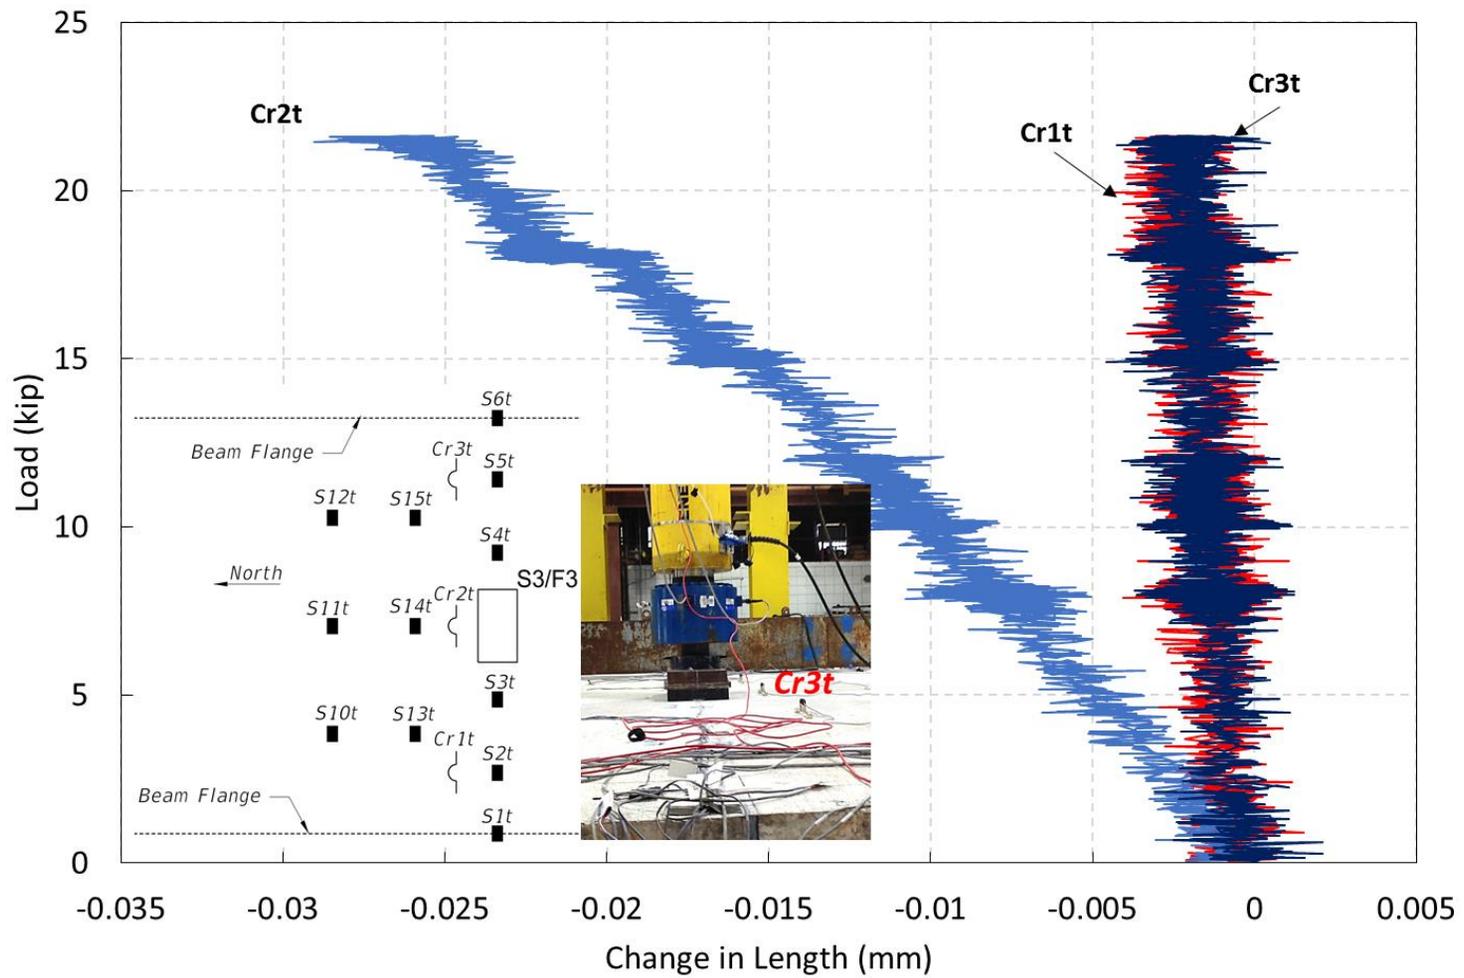
Figure 5.28: Service test S1 top crack gauges

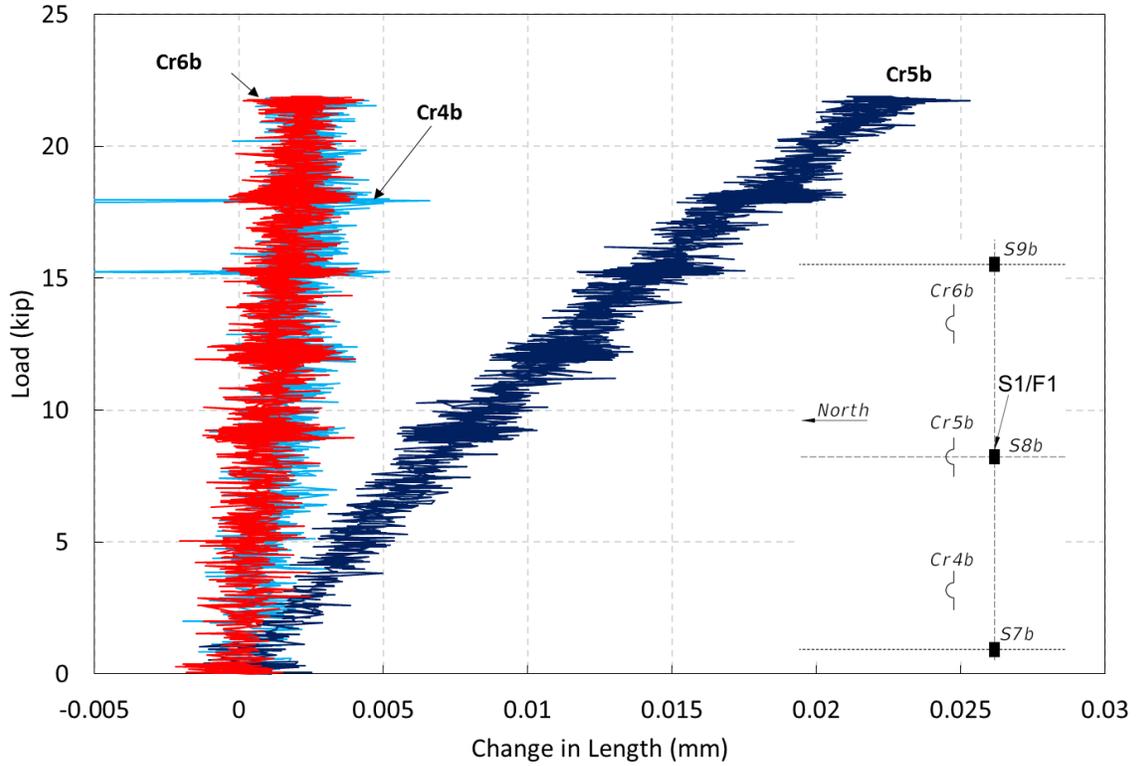
Figure 5.28: Service test S2 bottom crack gauges

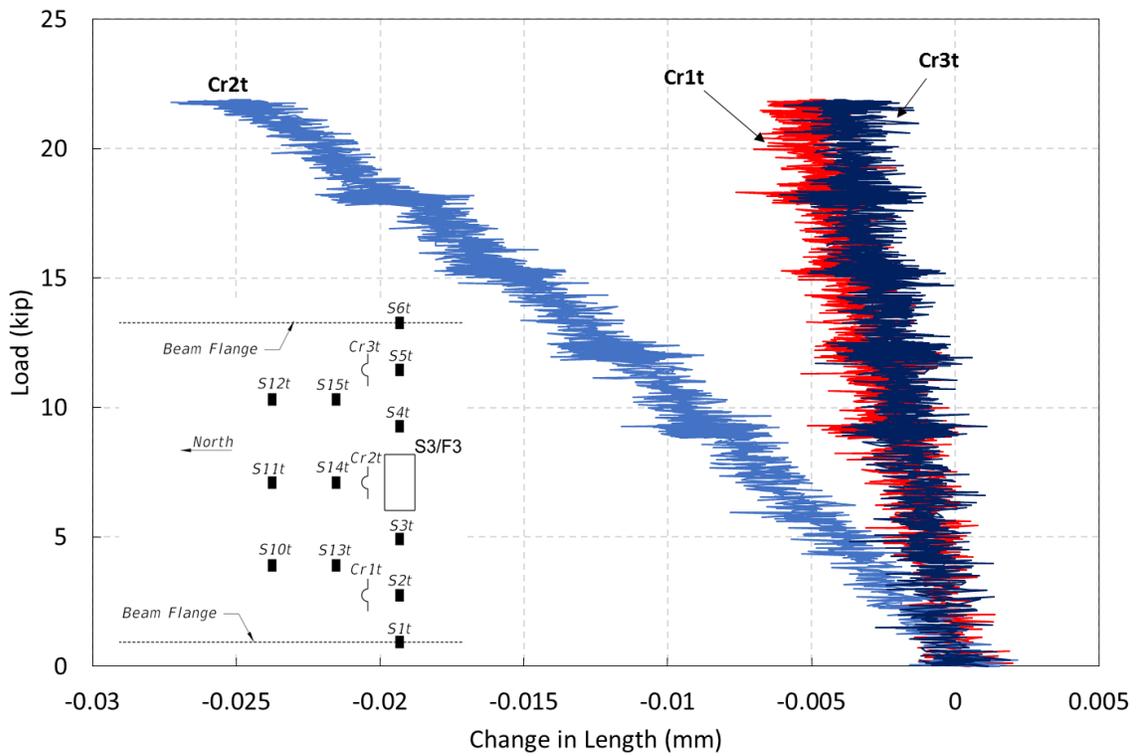
Figure 5.29: Service test S2 top crack gauges

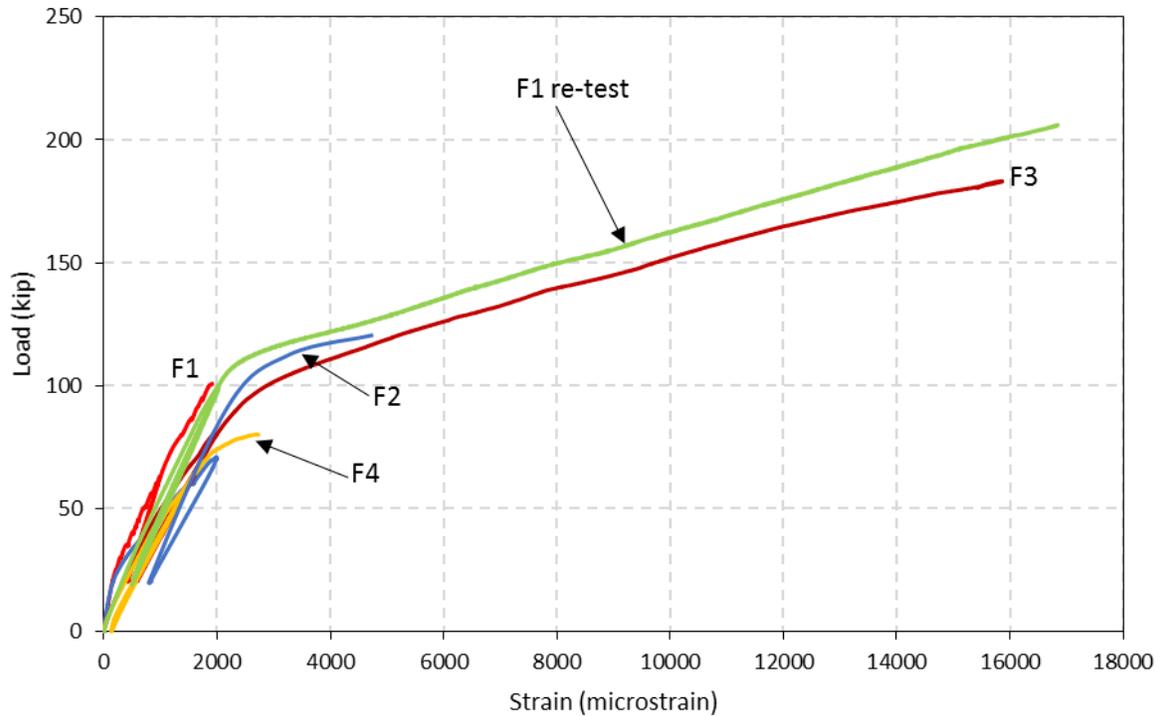
Figure 5.33: Failure tests load vs. strain, displaying TB13

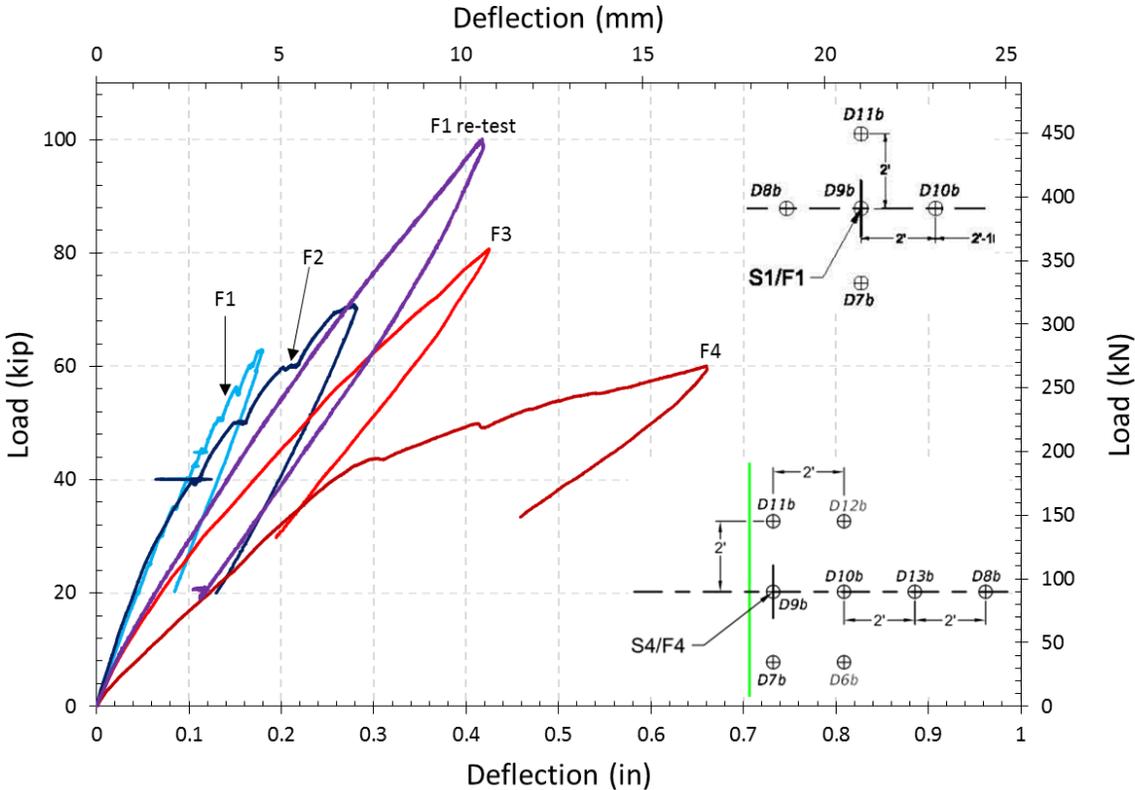
Figure 5.34: Load vs. deflection from failure tests for D7b

Figure 5.34 through Figure 5.37 show load deflection relationships for all failure load cases at select gauges up to a load level when the test was stopped to remove the laser gauges for protection. Figure 5.34 shows load vs. deflection for gauge D7b for all failure load cases. As expected, the magnitude of the recorded deflections at any given load level was highest for load case F4 as a result of the limited load distribution at the deck’s edge.

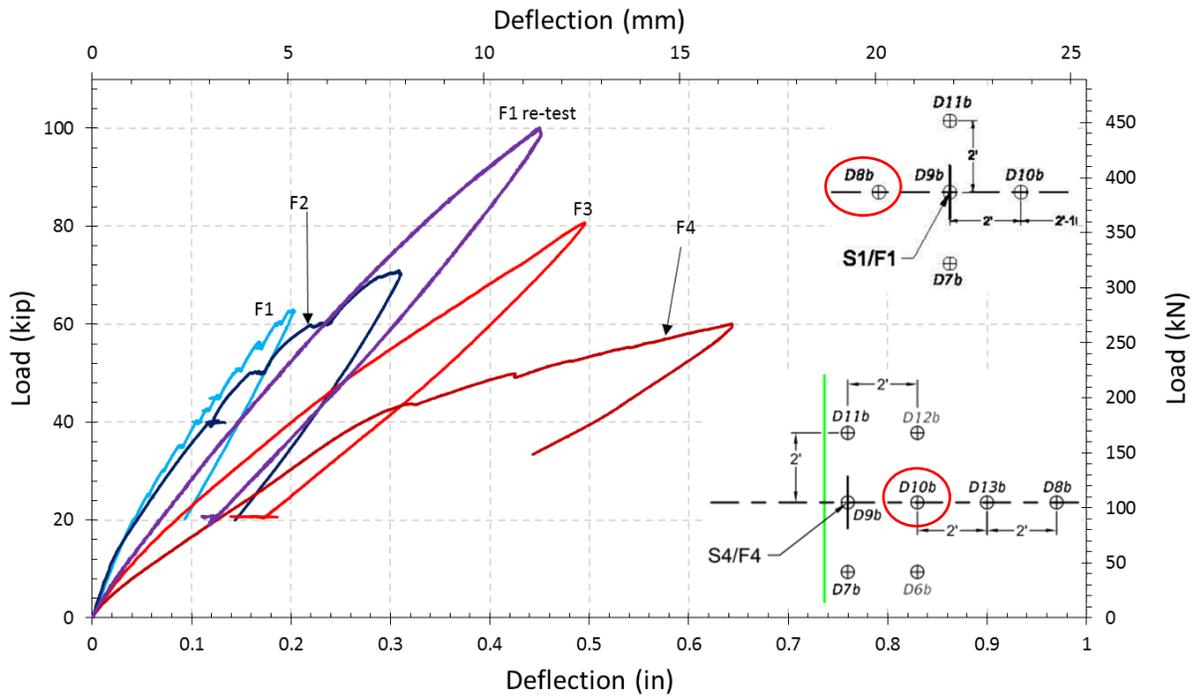
Figure 5.35: Load vs. deflection from failure tests for D8b (load cases F1, F2, and F3) & D10b (load case F4)

It can be seen in Figure 5.35 that deflections from load case F4 were less than deflections recorded during load case F3, which is due to D8b being moved 6 feet away from the center of the load as shown in the lower right corner of Figure 5.35. Figure 5.36 shows deflections for D9b are higher with the F4 case as that load case was at the edge of the slab which has less resistance due to the decreased amount of surrounding concrete slab. Figure 5.38 shows the load deflection relationships up to failure for all load cases. The plotted curves in Figure 5.38 were obtained using the actuator gauge, and later by the extrapolation method depicted in Figure 5.1. Just like Table 5.6, these deflection measurements also include girder deflection.

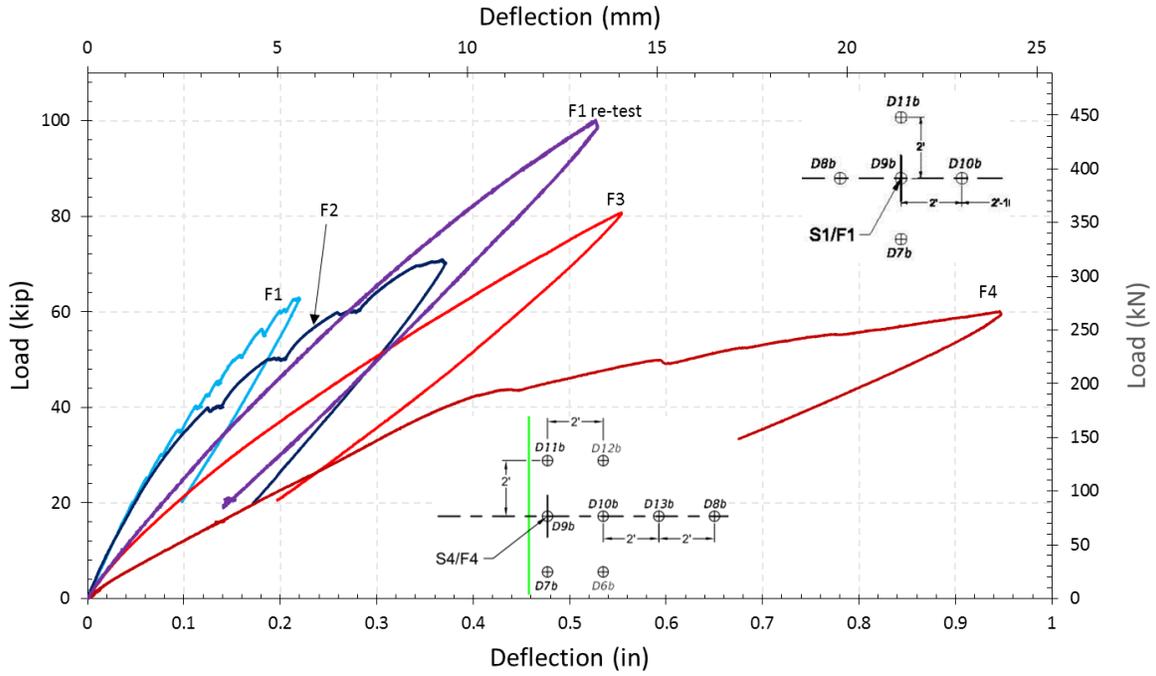
Figure 5.36: Load vs. deflection from failure tests for D9b

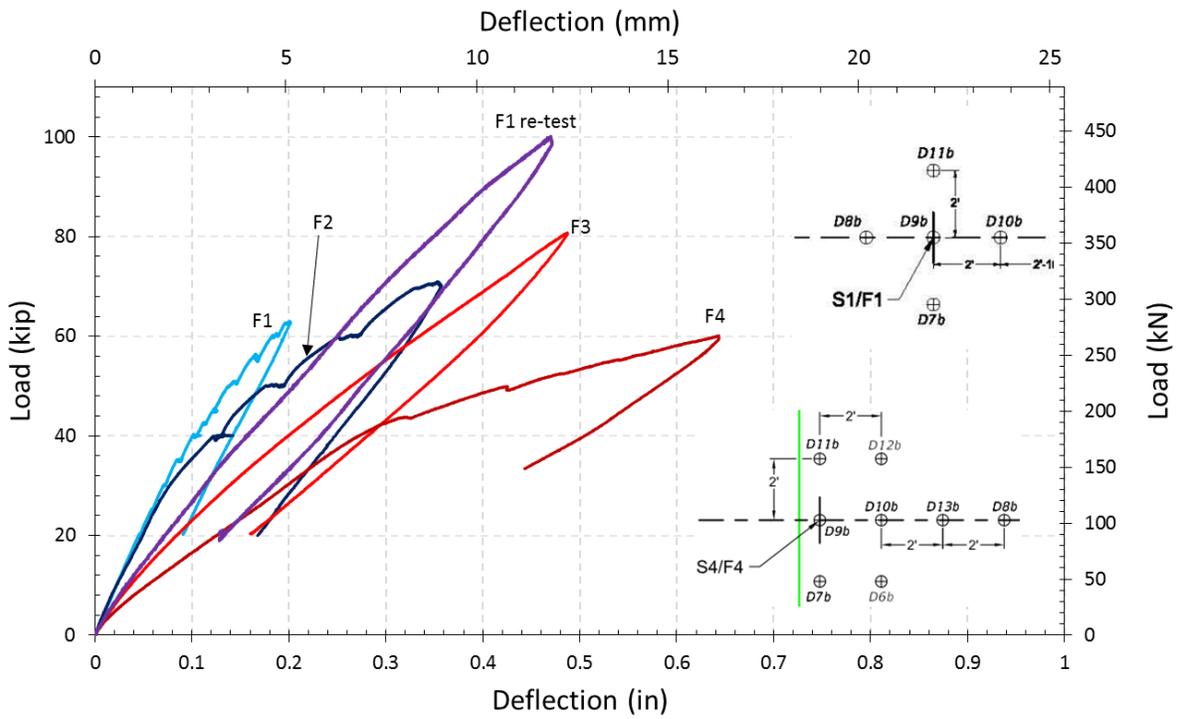
Figure 5.37: Load vs. deflection from failure tests for D10b

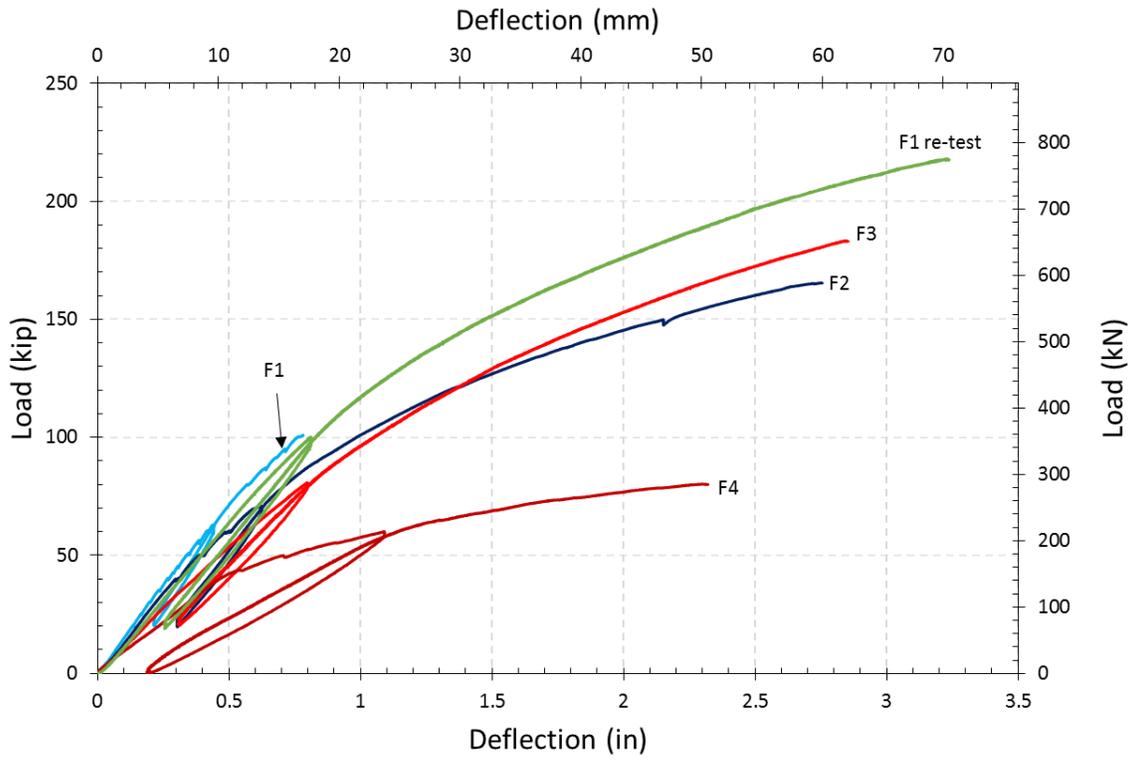
Figure 5.38: Load vs. deflection relations up to failure (raw readings from actuator displacement gauge before corrections)

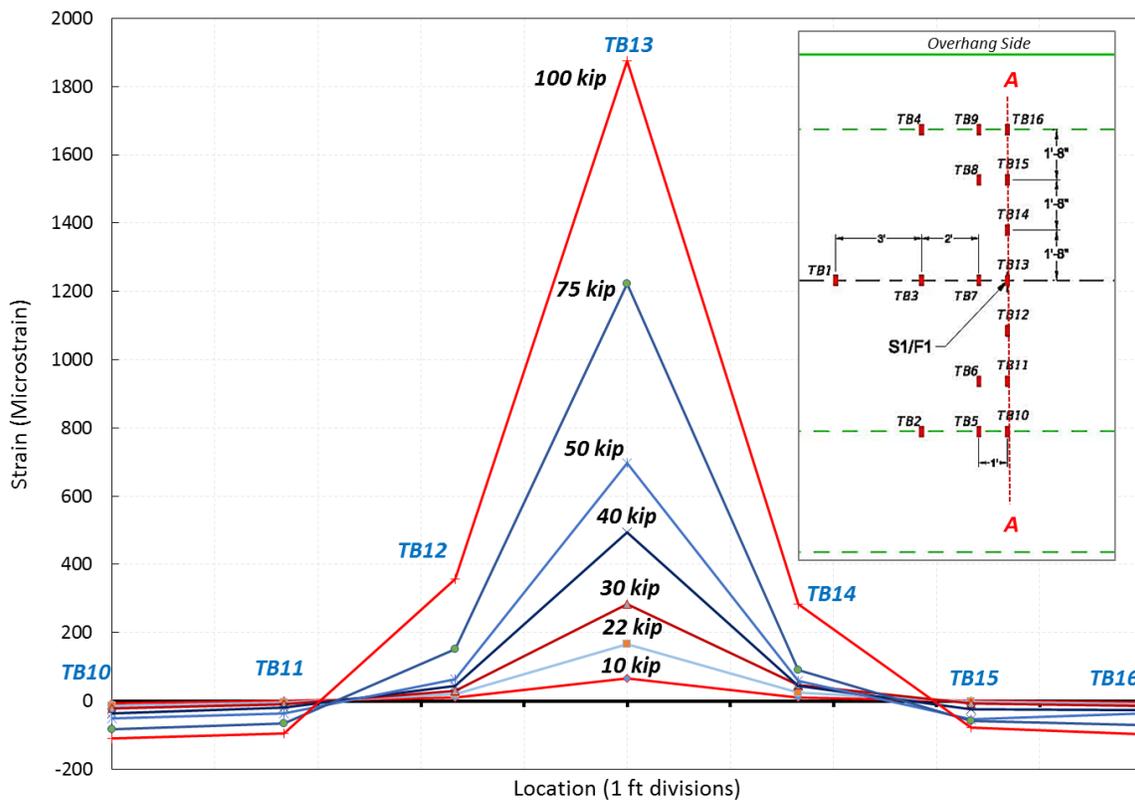
Figure 5.39: F1 Transverse cross-section of bottom transverse strain TB10-TB16

The plotted results show that the maximum recorded strain for the first failure test was about 1900 microstrain for a 100 kip load. This strain level is still below the yield strain of the steel reinforcement (about 0.00207 for Grade 60).

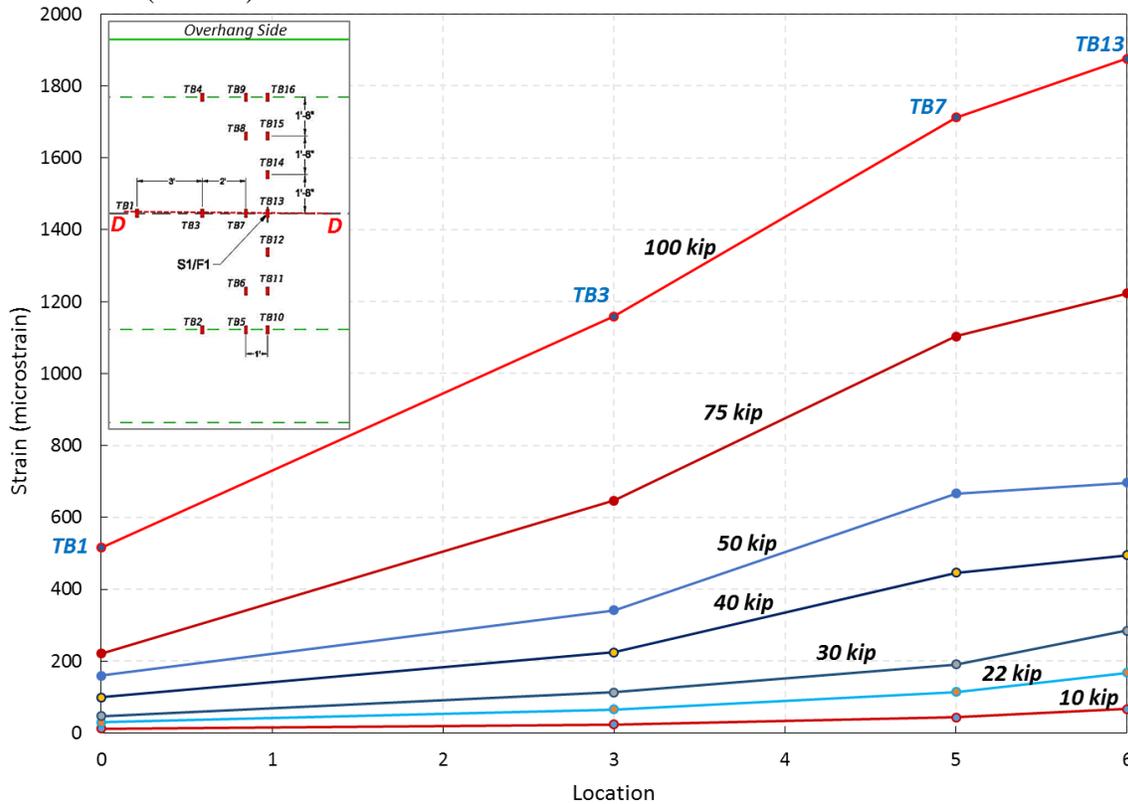
Figure 5.42: F1 Longitudinal cross-section view of bottom transverse strains (TB1, TB3, TB7, and TB13)

Figure 5.42 is a plot of the same strain data in a longitudinal section of the deck showing that the maximum recorded strains took place under the applied load. Transverse strains away from the applied load drop as the distance from the load increased. However, it can be seen that even the farthest gauge (TB1), which is installed 6 ft away from the applied load still recorded positive strains, which is an indication that the area or distance influenced by the applied load is at least equal to 12 ft (2 x 6 ft).
