**UNF Project
Contract No. BDV34-977-01**

Empirical Deck for Phased Construction and Widening

Florida Department of Transportation

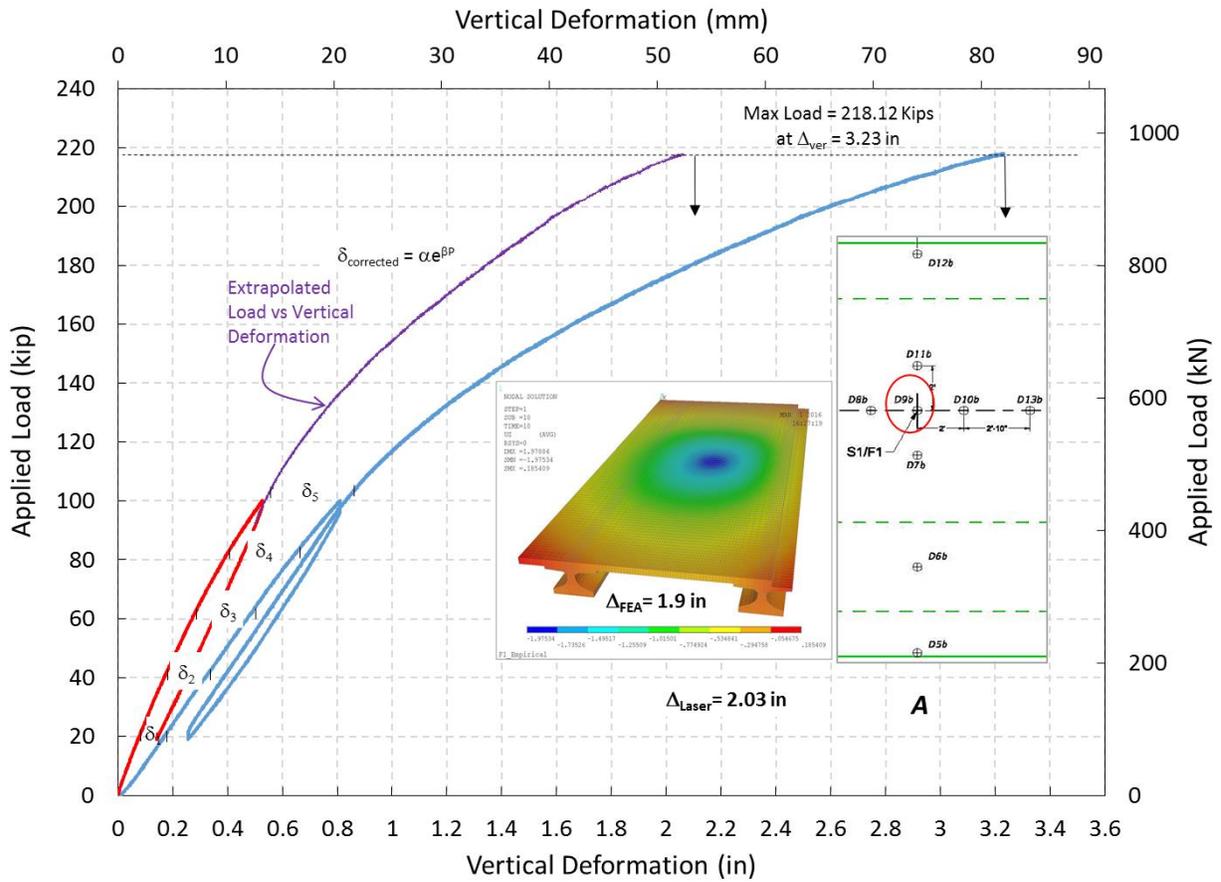
Figure 5.47: F1 Load vs. deflection with extrapolated curve

Figure 5.47 is a plot of the load deflection relationship for F1. Two curves are provided in the figure. The one on the right represents the uncorrected reading from the gauge installed on the load actuator, while the other curve is for the same relationship after deducting system flexibility using an extrapolated relationship. At failure, the maximum adjusted deflection was 2 in. compared to the raw deflection including system flexibility of 3.23 in. Even though punching shear is typically considered to be a brittle failure, the recorded deflections at failure are substantial and would be noticed during a field inspection. Figure 5.48 represents the deflection profile at 100 kip for case F1.

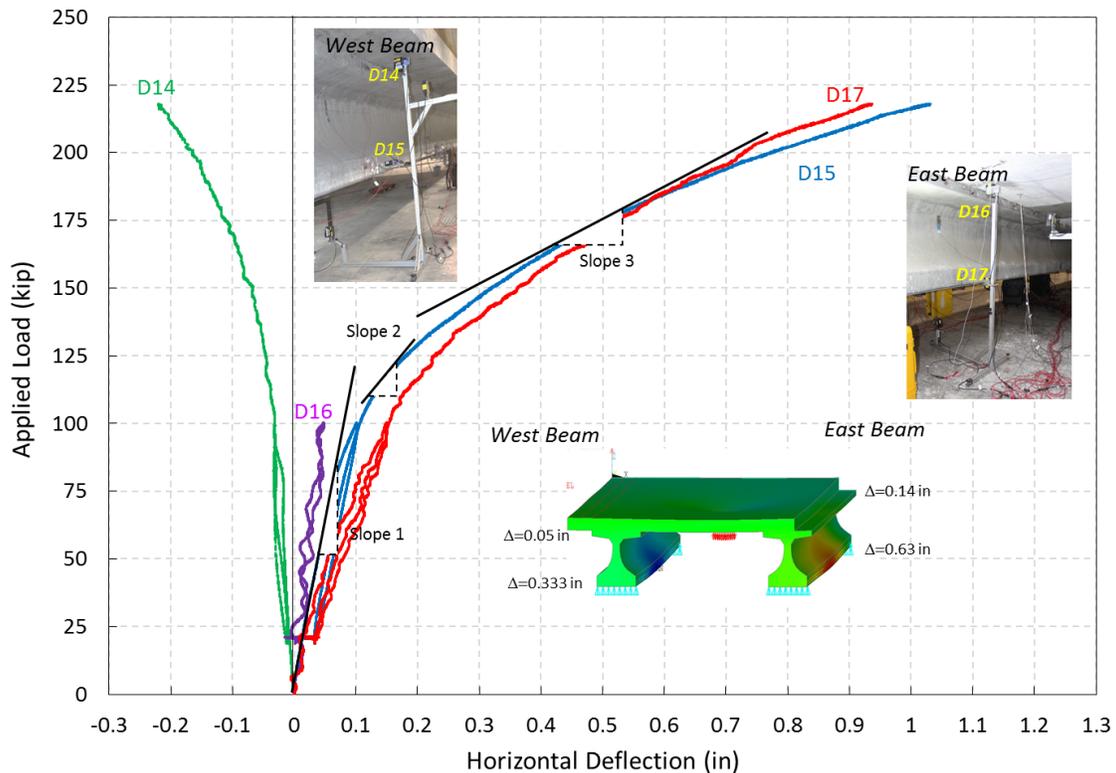
Figure 5.49: F1 Load vs. horizontal displacement of girder flanges

It can be seen in Figure 5.49 that laser gauge D16 readings were not recorded after the second cycle of loading up to failure as it started acting erratically.

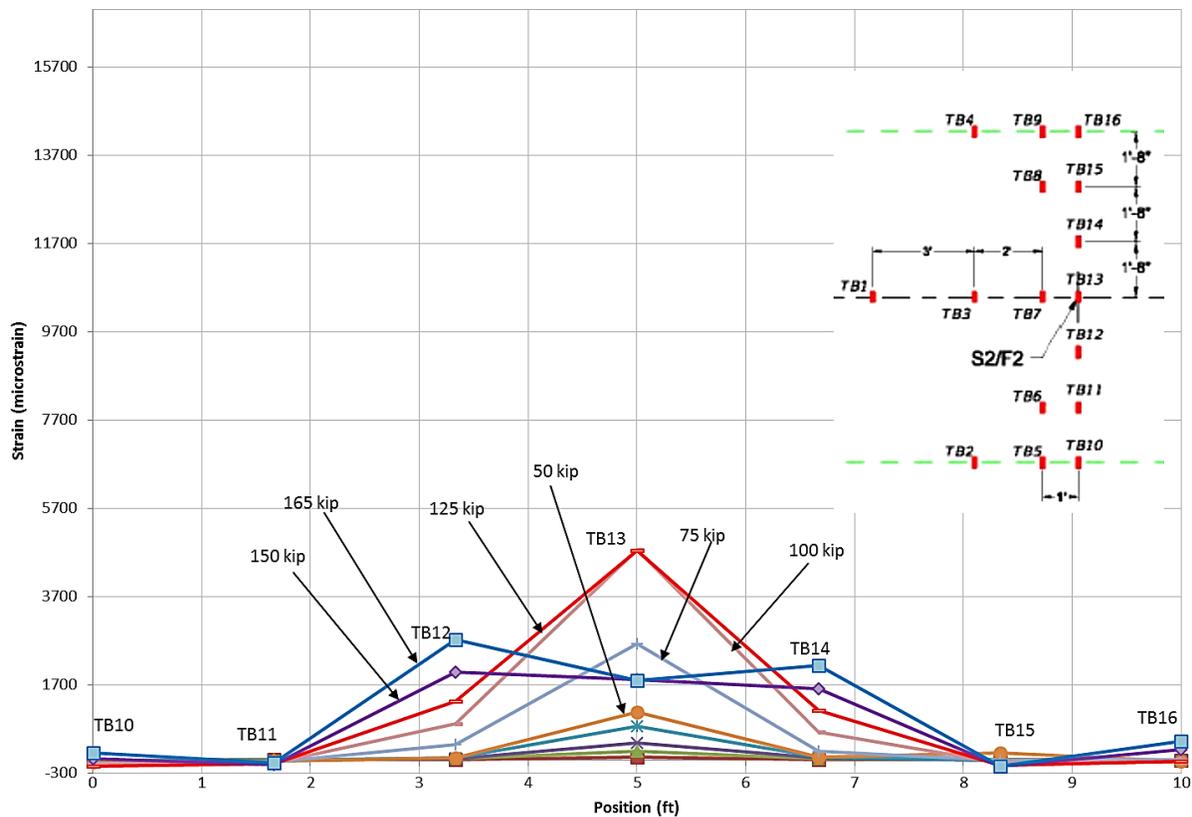
Figure 5.50: F2 Transverse cross-section view of bottom transverse strains (TB10-TB16)

Figure 5.50 through Figure 5.52 show strain cross-sections for various load levels, note the yield strain at TB13 being reached between 75 and 100 kip. Figure 5.53 confirms what has been observed for load case F1 with respect to the area influenced by the applied load. It can be seen that at failure, gauge TB1 recorded strains in excess of the yield strain; i.e. the area or distance influenced by the applied load is at least equal to 12 ft (2 x 6 ft). As expected, the recorded strains under the applied load were higher than at other locations with TB13 dropping after reaching 5000 microstrain indicating a malfunction such as failure of the strain gauge / steel bar interface. Figure 5.53 to Figure 5.56 show strain across the transverse and longitudinal bars for both top and bottom mats. Figure 5.57 shows load deflection relationships for load case F2.

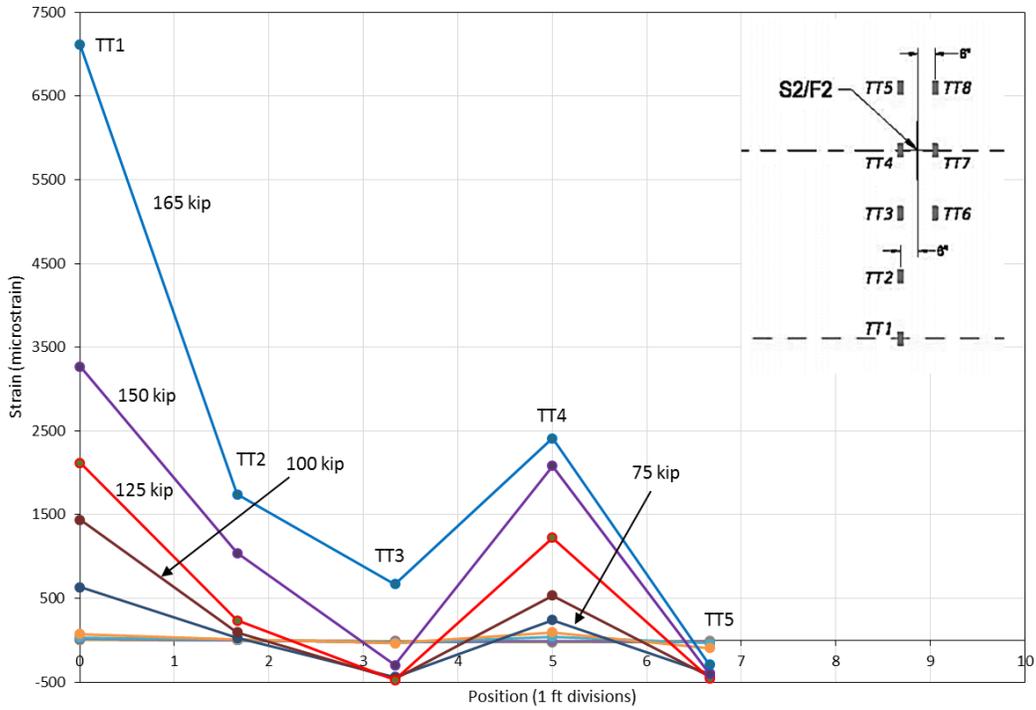
Figure 5.54: F2 Transverse cross-section view of top transverse strains (TT1-TT5)

At the girder's top flange edge, readings from gauges TT1 and TT2 show that positive strains take place in this area. This is due to the aforementioned negative moments that develop as a result of slab continuity over the girders. The magnitude of the strains recorded by TT1 exceed cracking strain levels, which explains the cause of the cracks observed in this area as will discussed later in Section 5.3.

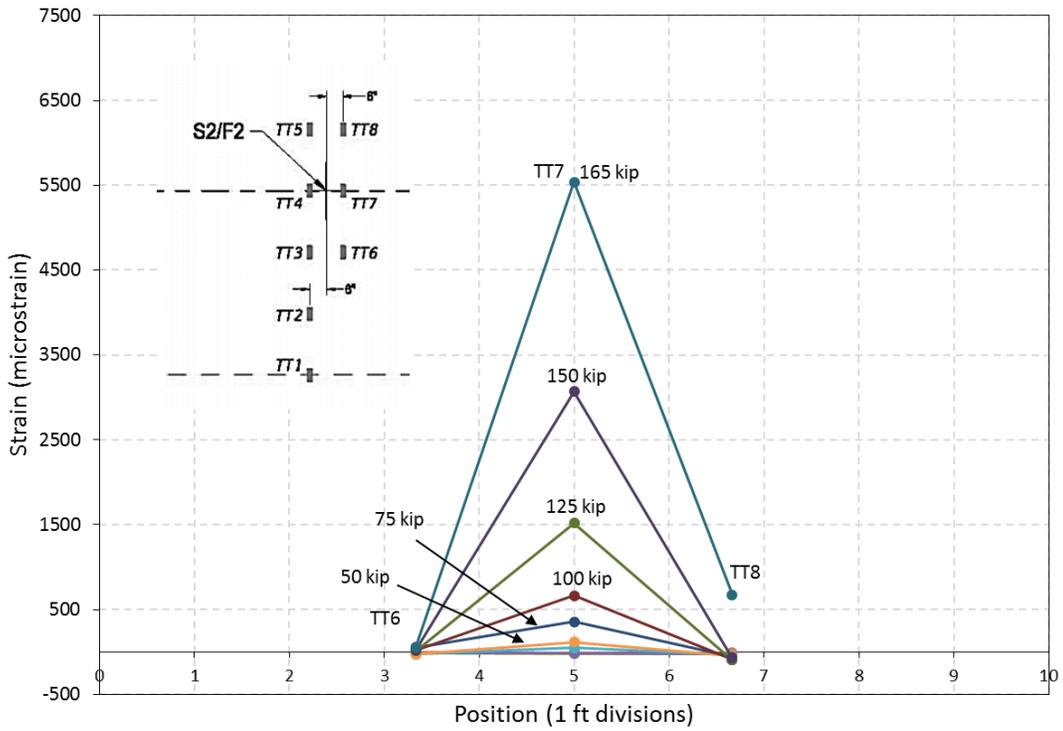
Figure 5.55: F2 Transverse cross-section view of top transverse strains (TT6-TT8)

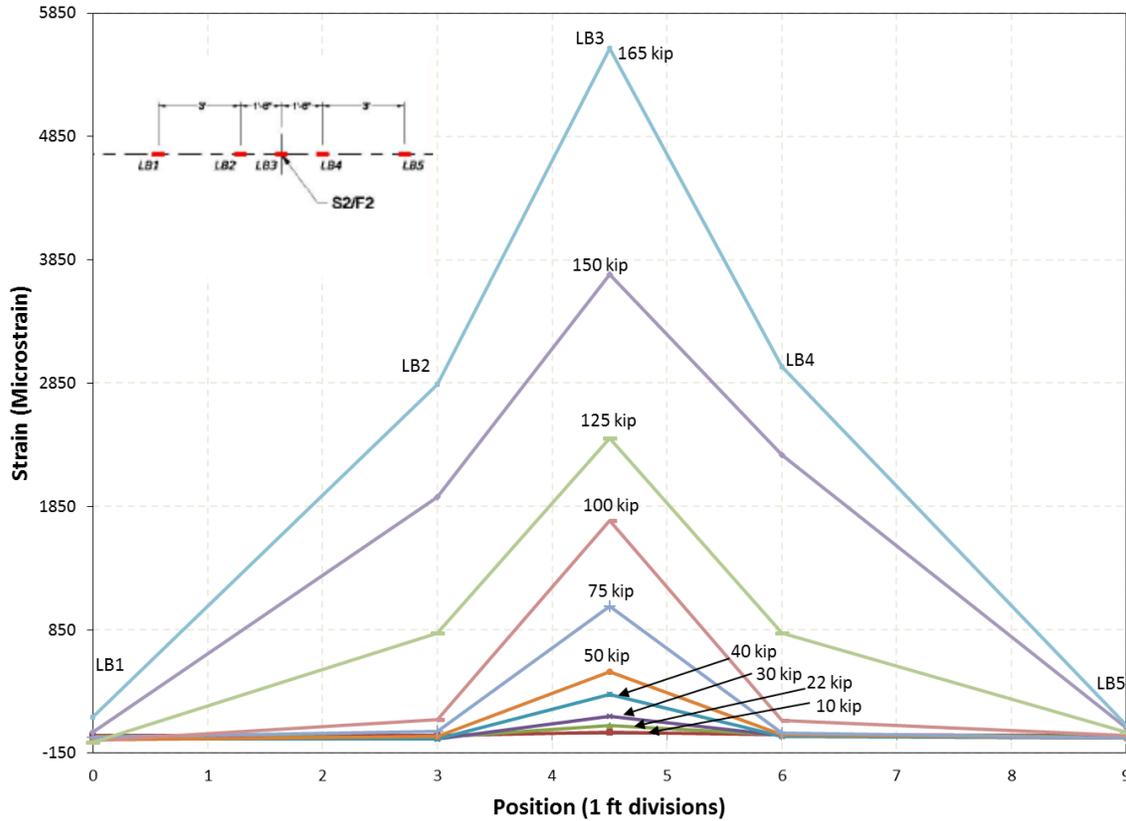
Figure 5.56: F2 Longitudinal cross-section view of bottom longitudinal strains

Figure 5.56 is a plot of strain levels in the distribution reinforcement (longitudinal bottom bar). As the test progressed and the applied load exceeded 100 kip, gauges LB2 and LB4 indicated that the load started getting distributed over a wider influence area with gauges LB1 and LB5 also being strained, however, at a smaller level of strain. It is possible that this behavior is an indication of the size of the arching action dome (see Figure 2.1), which appears to increase in size as the load increases. It can be said that the influence area of the applied load at failure does not extend beyond the locations of gauges LB1 and LB5 by much. The failure pattern for F2 load case showed crack propagation at the bottom surface of the deck with diameters of 98-in x 105-in in the transverse and longitudinal directions.

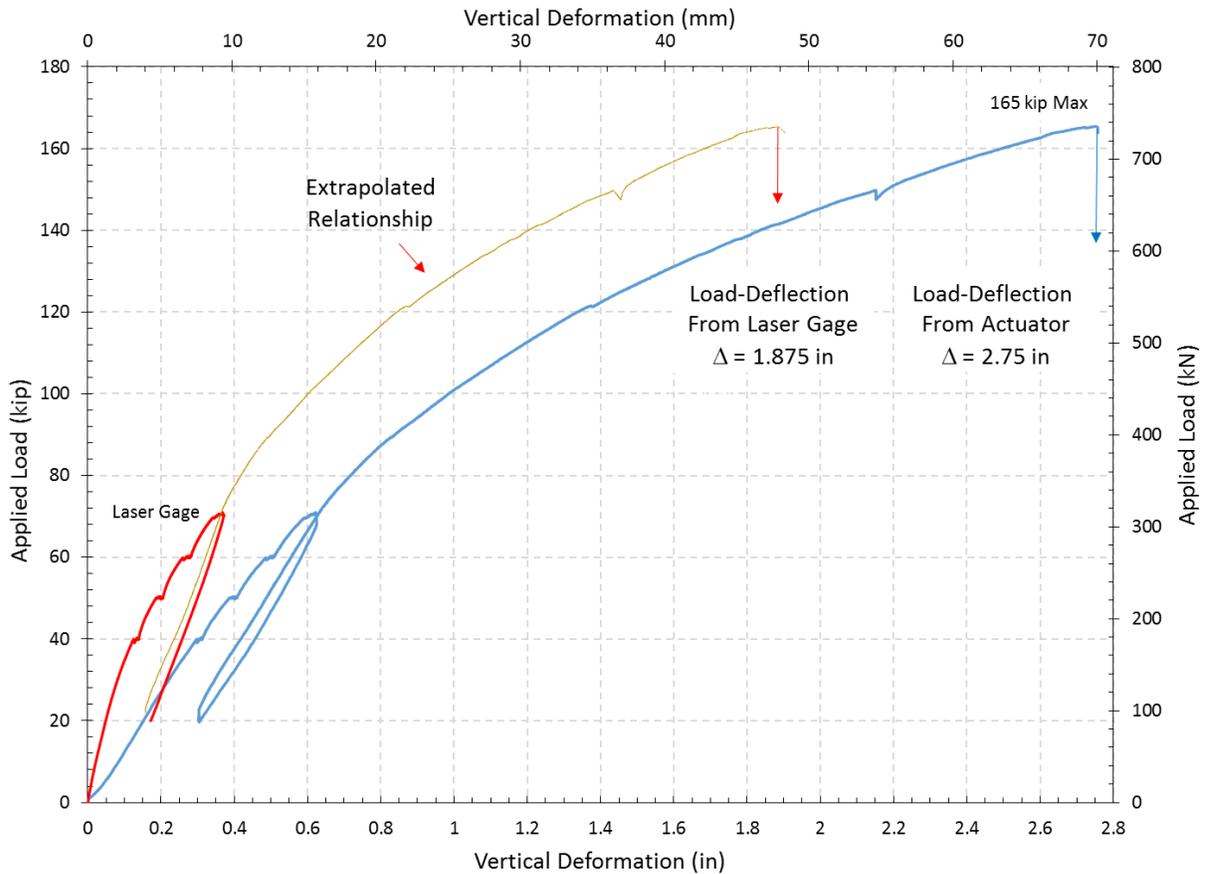
Figure 5.57: F2 Load-deflection

In Figure 5.57, the two curves representing the deflection of the specimen for load case F2 are plotted. It can be seen that the raw recorded deflection at failure was 2.75 in., which translated into 1.875 in after taking the loading system flexibility out of the reading based on the initial laser gauge readings. Again, this level of deflection would be noticeable during field inspection despite the fact that the mode failure is relatively brittle. Despite including girder deflections in the presented results, under service load levels, the observed deflections were minimal and fall below the allowable limits.

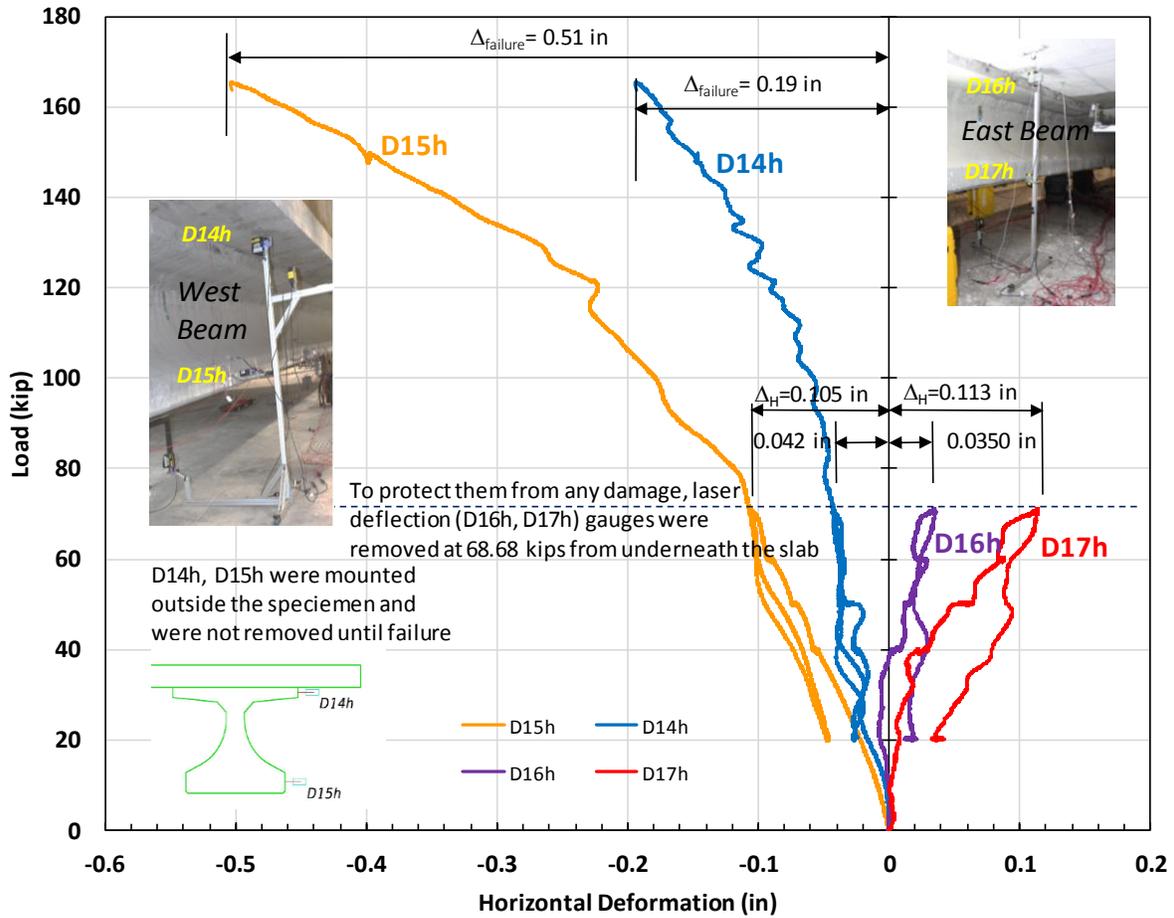
Figure 5.58: F2 Load vs. horizontal displacement of girders flanges

Reading from the laser displacement gauges measuring the girders' horizontal movement are shown in Figure 5.58. As is indicated on the figure, the gauges measuring the east girder's horizontal movement were removed for protection at a load equal to about 68 kip since they were positioned under the slab between the girders, whereas the west girder's gauges were positioned on the outside; i.e., not vulnerable to damage due to slab failure. The behavior was linear up to this load level and indicated that the bottom flanges moved to the outside more than the top flanges did, which is expected because of the restraining action the deck imposes on the top movement of the girder. The behavior started deviating from the linear trend up to failure, which happened at an applied load equal to 165.4 kip.

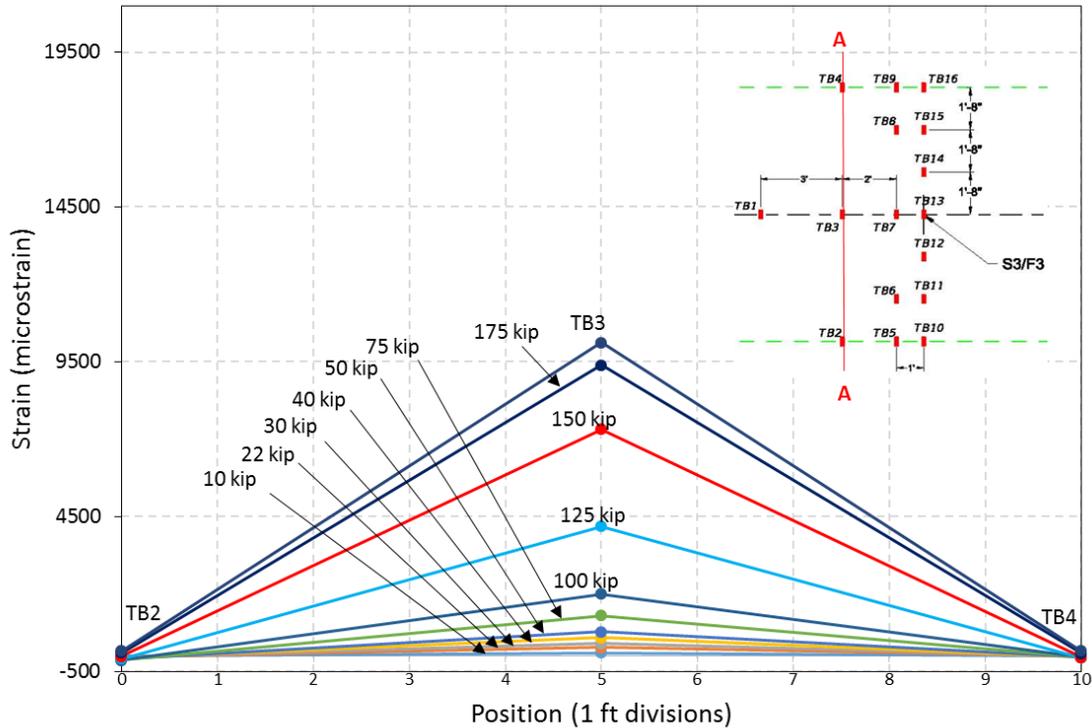
Figure 5.61: F3 Transverse cross-section view of bottom transverse strains TB2-TB4

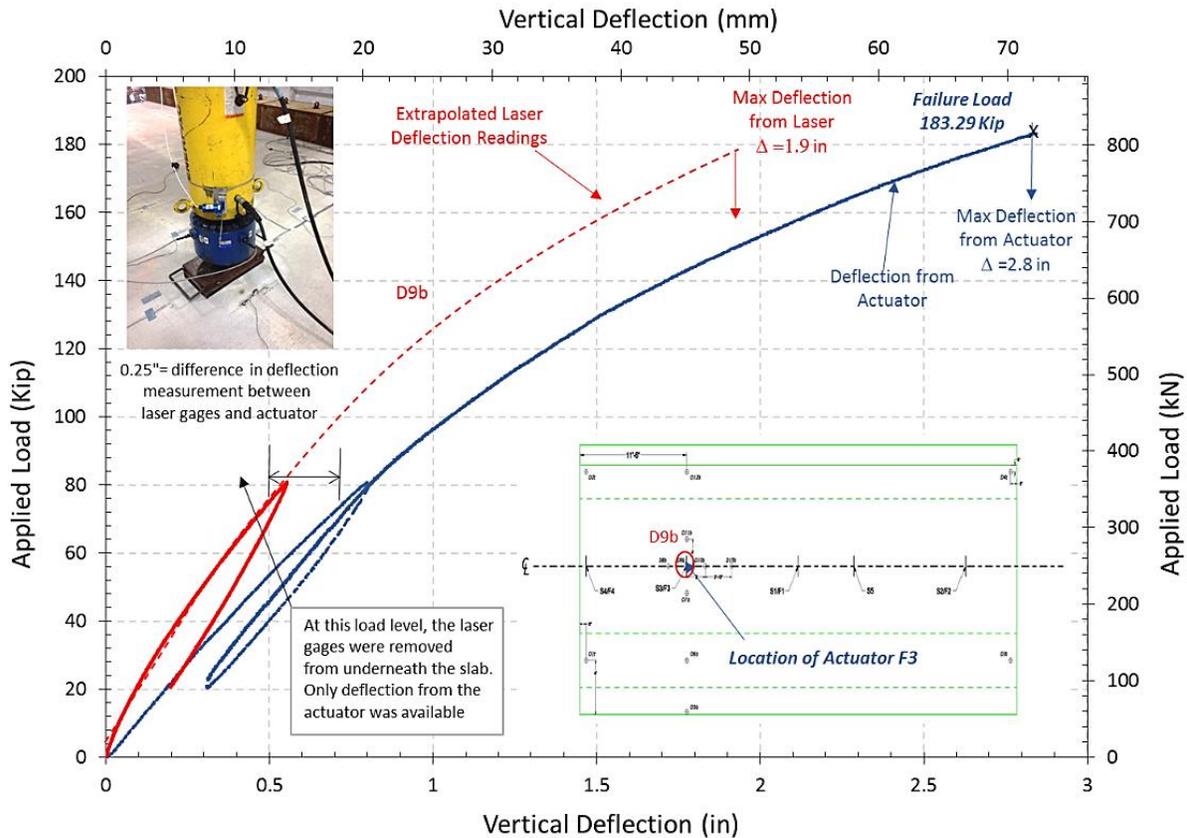
Figure 5.66: F3 Load-deflection

The recorded deflections for load case F3 at failure were 2.8 in. and 1.9 in. based on the raw and extrapolated data, respectively. These values are very similar to the recorded values from the previous two cases (F1 and F2). Under service load levels, the deflections are minimal and fall below the allowable limits.

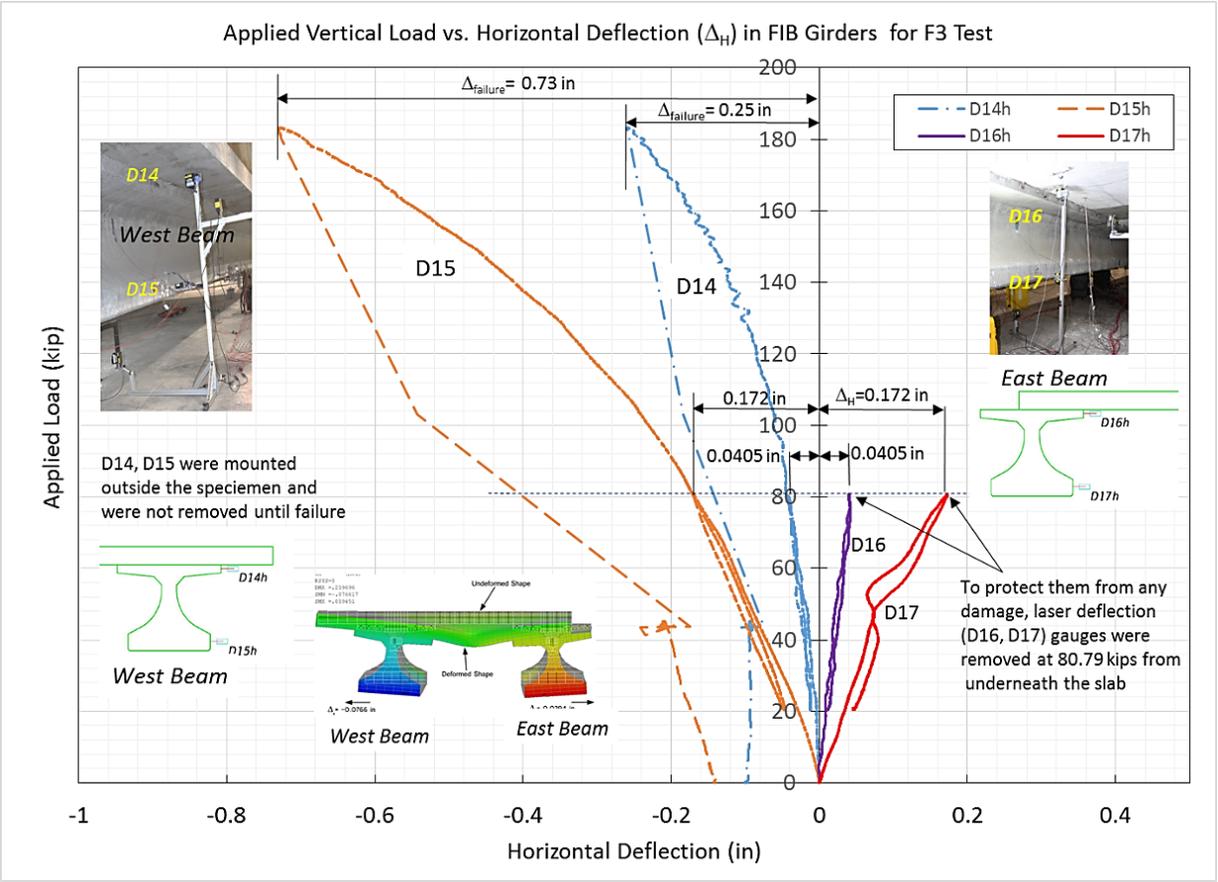
Figure 5.67: F3 Load vs. horizontal displacement of girders flanges

Reading from the laser displacement gauges measuring the girders' horizontal movement are shown in Figure 5.67. As is indicated on the figure, the gauges measuring the east girder's horizontal movement were removed for protection since they were positioned under the slab between the girders, whereas the west girder's gauges were position on the outside; i.e., not vulnerable to damage due to slab failure. Up to the point when the gauges on both sides were recording deformations (80 kip), there was minimal difference between the girders' behavior. The behavior was linear up to this level. The behavior started deviating from the linear trend up to failure, which happened at an applied load equal to 183.3 kip.

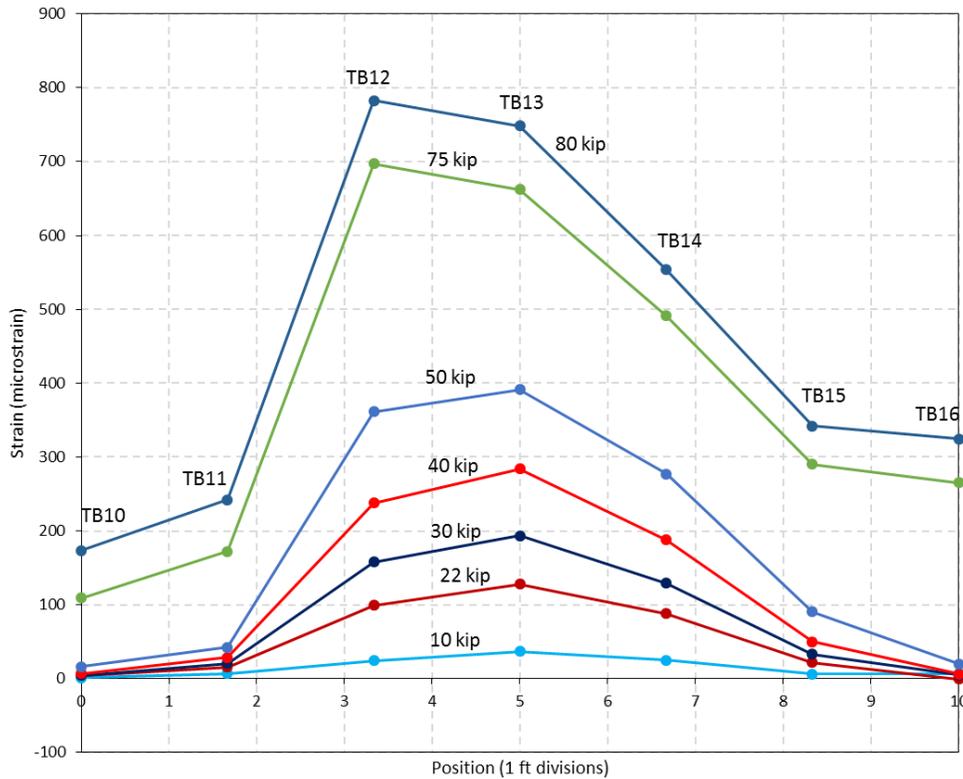
Figure 5.70: F4 Transverse cross-section view of bottom transverse strains (TB10-TB16)

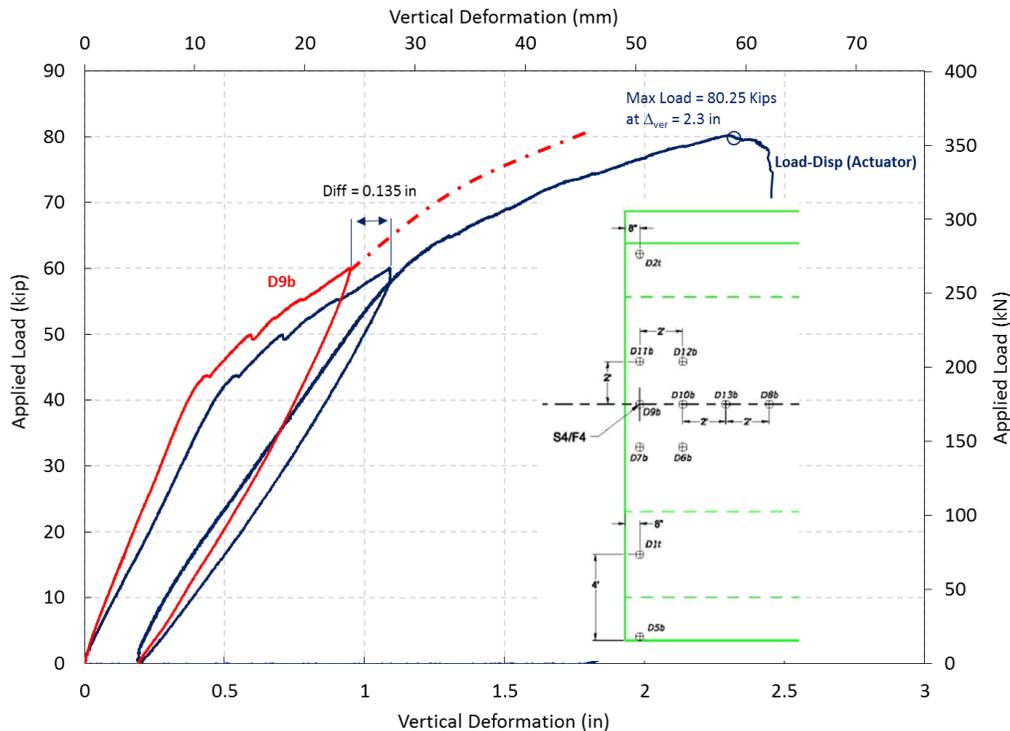
Figure 5.73: F4 Load vs. deflection (D9b)

The load deflection relationship from the laser displacement gauge positioned exactly under the applied load is plotted in Figure 5.73. The figure shows the relationship starts with a linear behavior up to a load level of about 42 kip. Despite being the weakest part of the slab for resisting wheel loads; i.e., the edge of the slab, this load level is about twice the service load level for one wheel load (21 kip) and more than the factored design load (37.2 kip). A hardening nonlinear behavior followed this initial linear trend all the way up to failure at 80.3 kip. There was no softening behavior observed, and the failure was a sudden drop in load resistance as a result of punching.

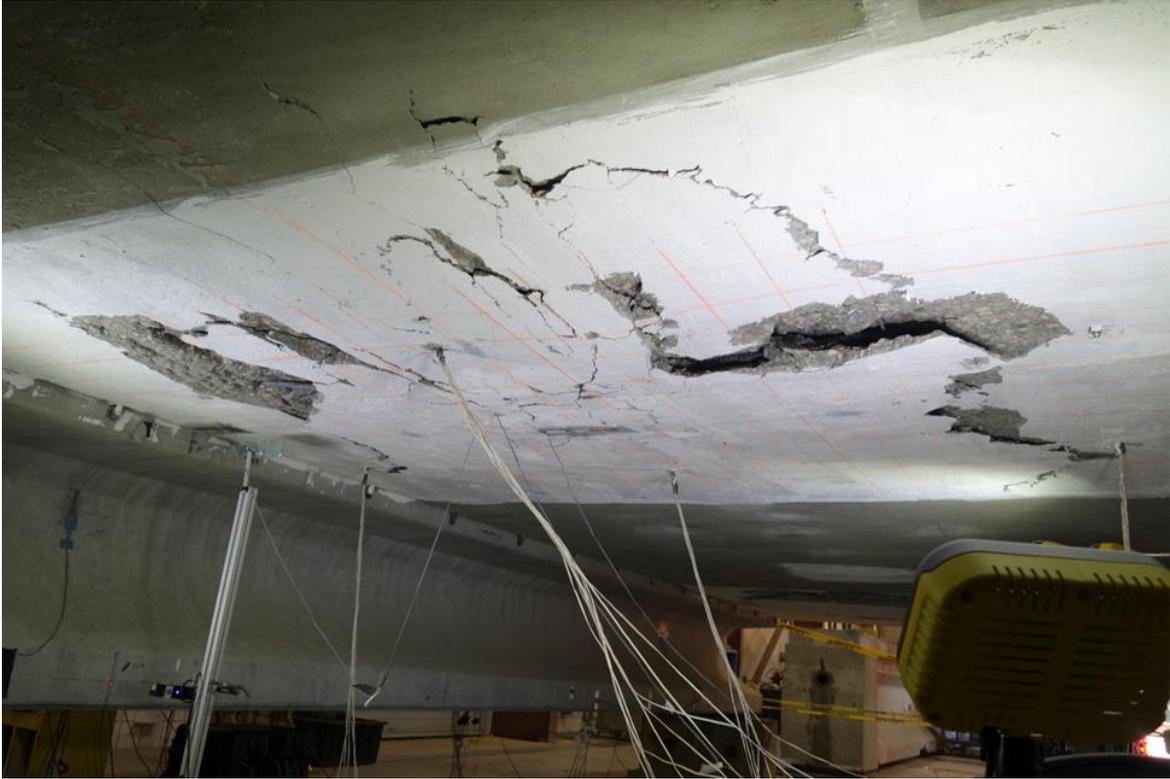
Figure 5.77: Load Case F1 – Failure ellipse area from bottom slab: 87 in. (7.25 ft) x 96 in. (8 ft)

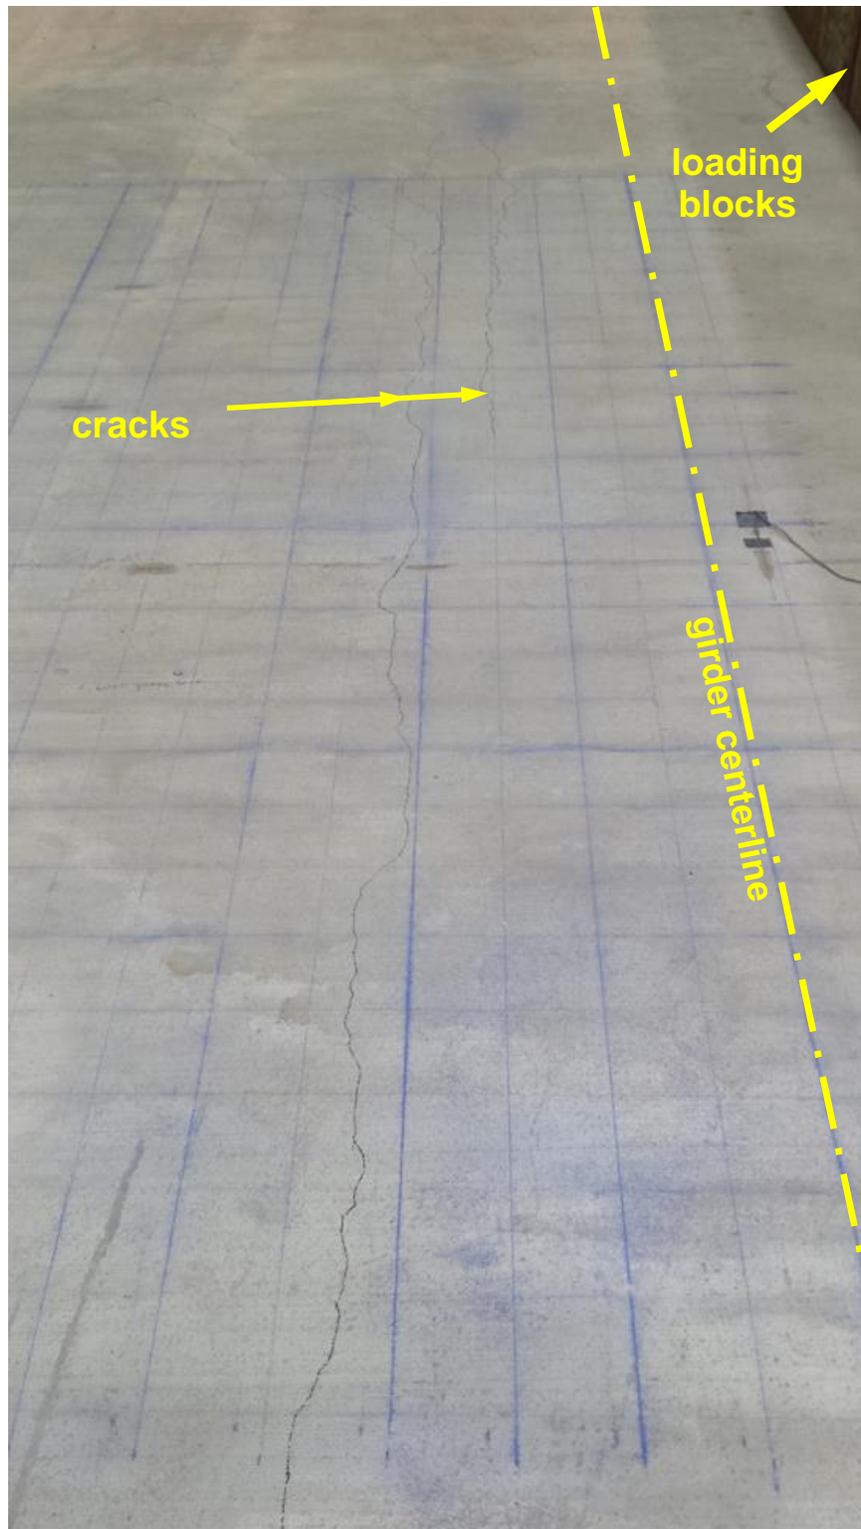
Figure 5.79: Load Case F1 – Longitudinal cracking on top of slab near overhang

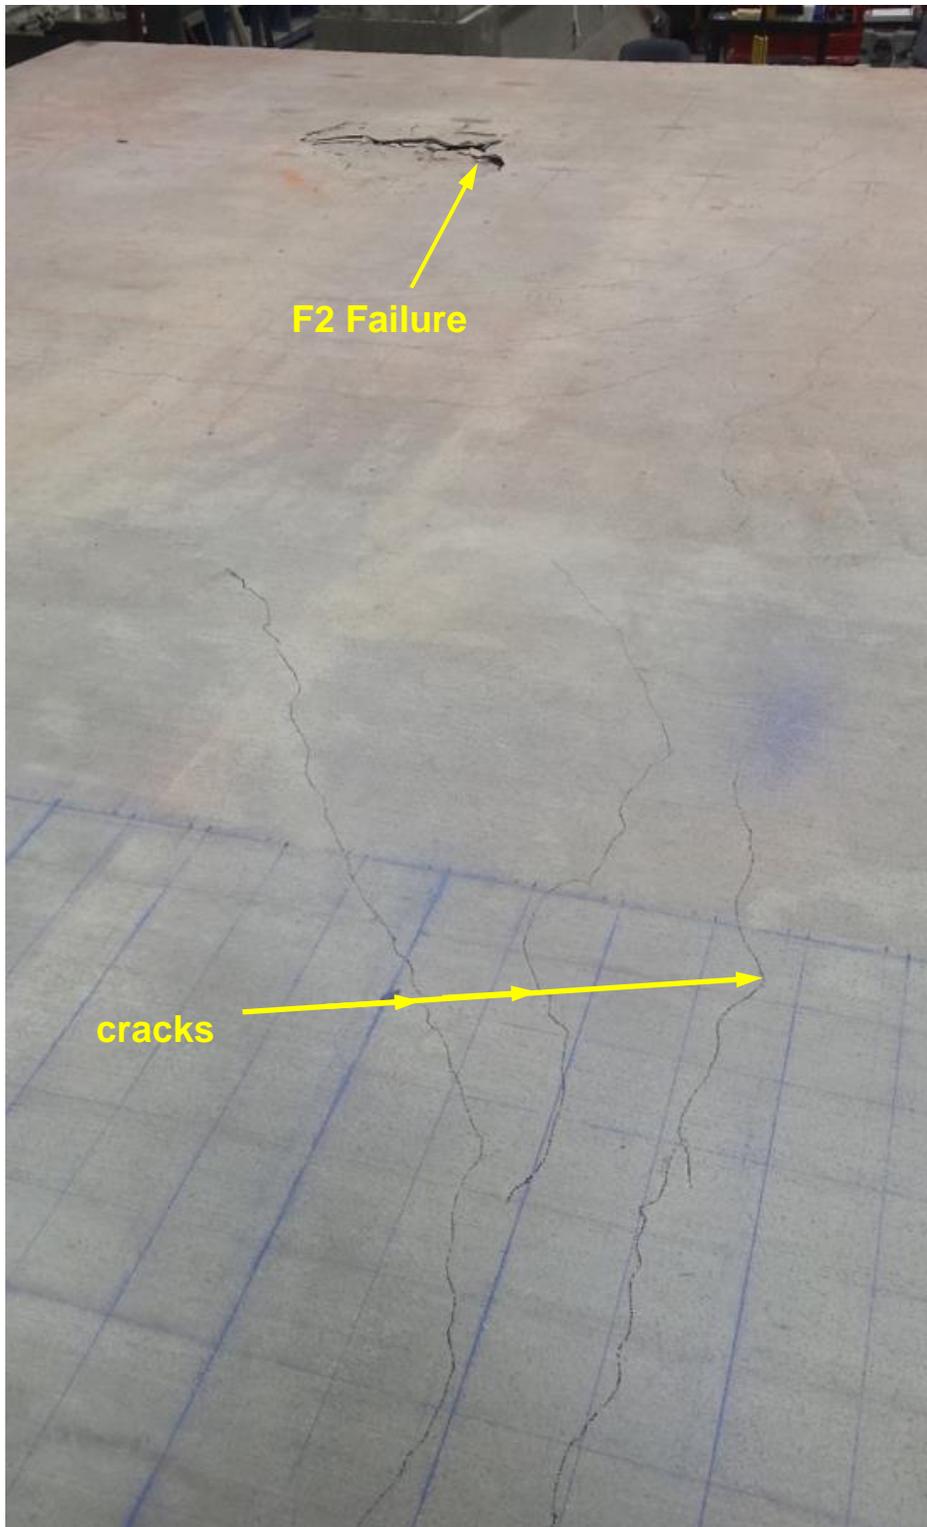
Figure 5.80: Load Case F1 – Longitudinal crack extending roughly 80 inches from center line of load to farthest visible crack towards F2 location

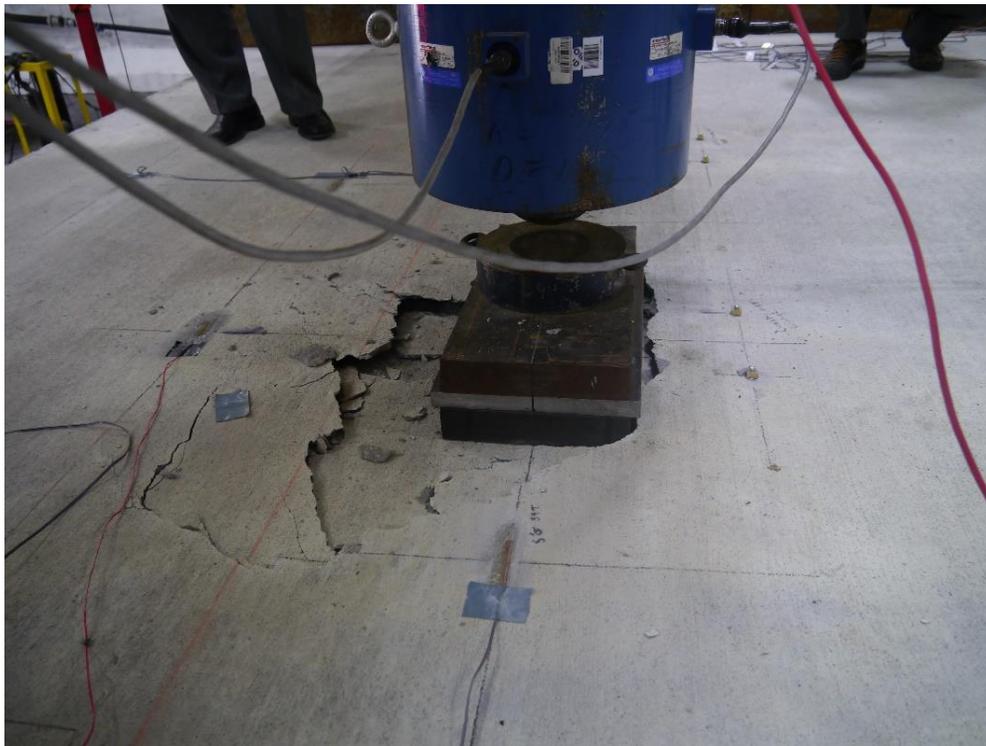
Figure 5.83: Load Case F2 – Failure at the top of slab

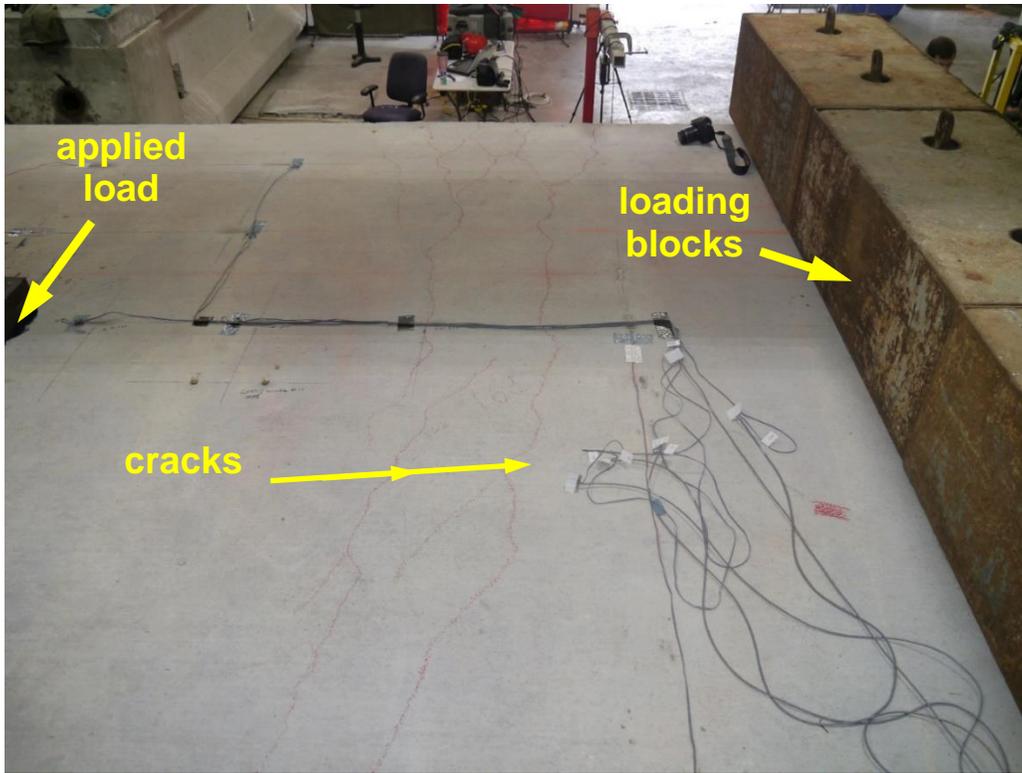
Figure 5.86: Load Case F2 – Longitudinal cracking near overhang

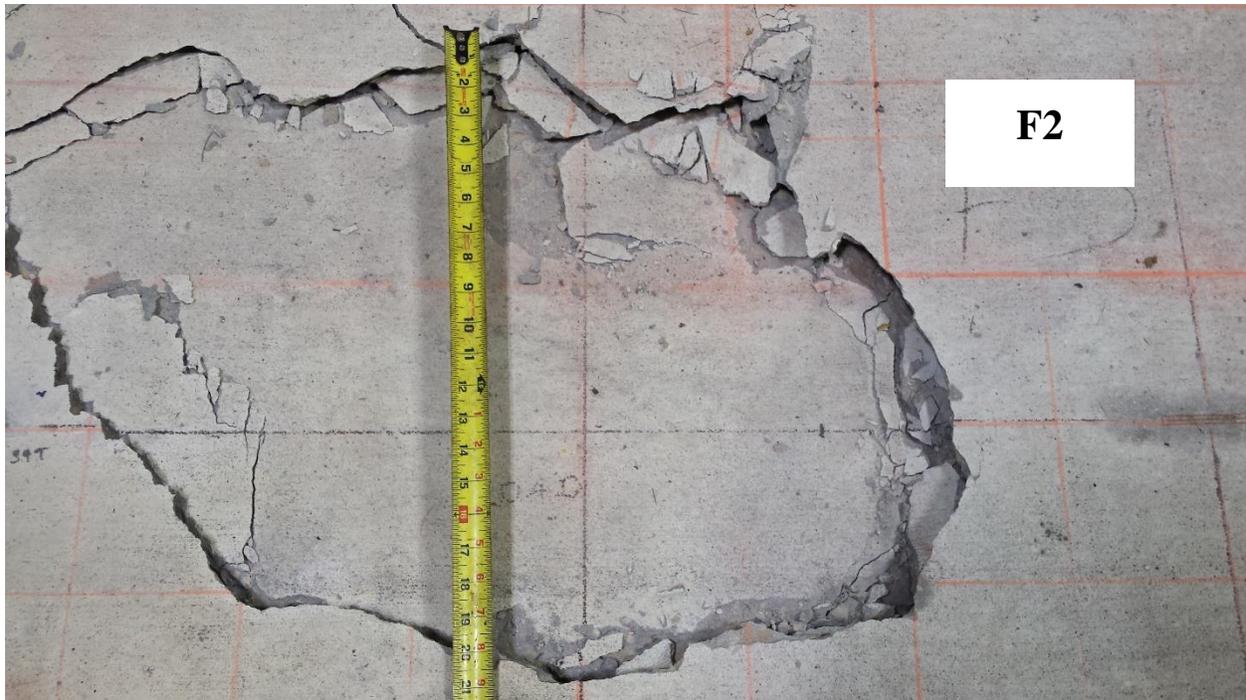
Figure 5.87: Load Case F2 – Close-up of failure at top of slab under load point

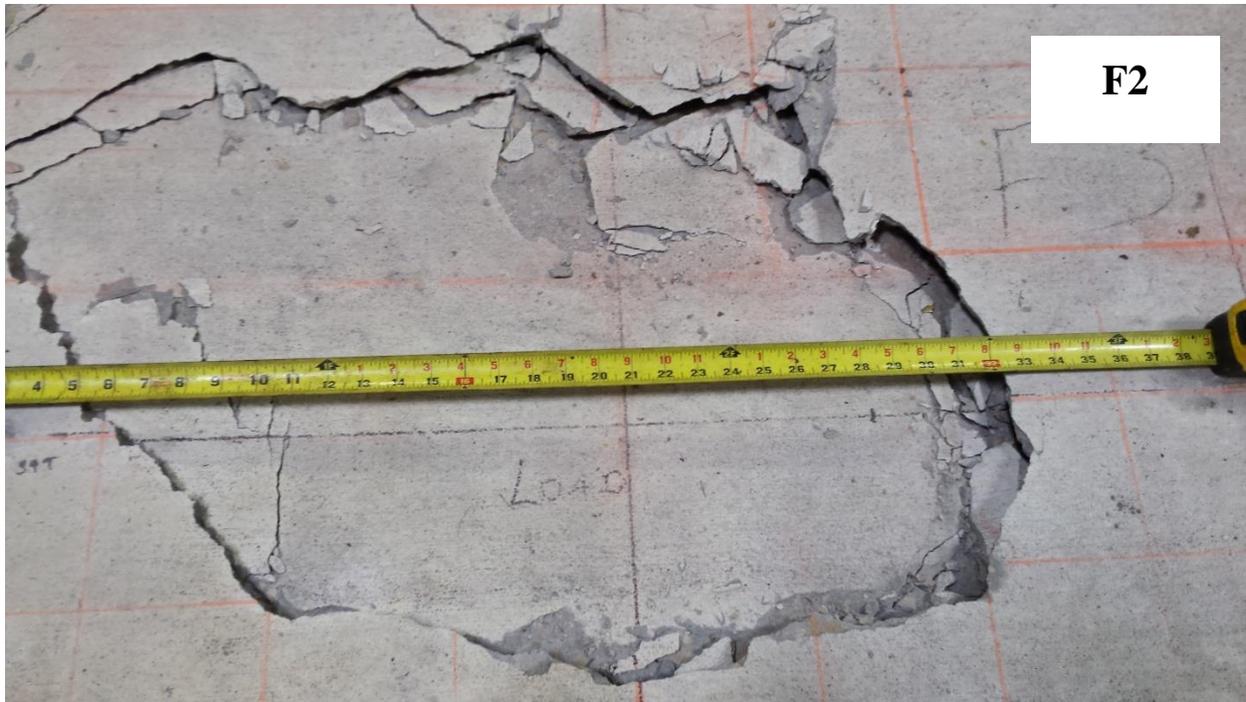
Figure 5.88: Load Case F2 – Close-up of failure at top of slab under load point

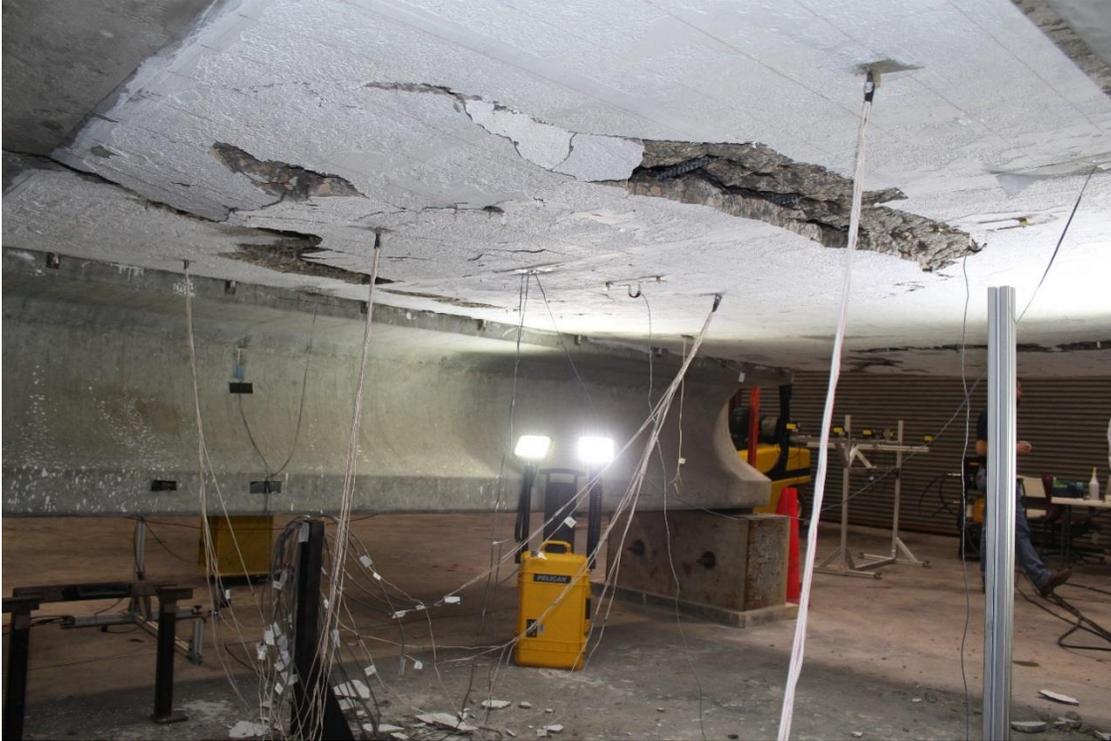
Figure 5.92: Load Case F3 – Extent of failure surface at bottom of slab

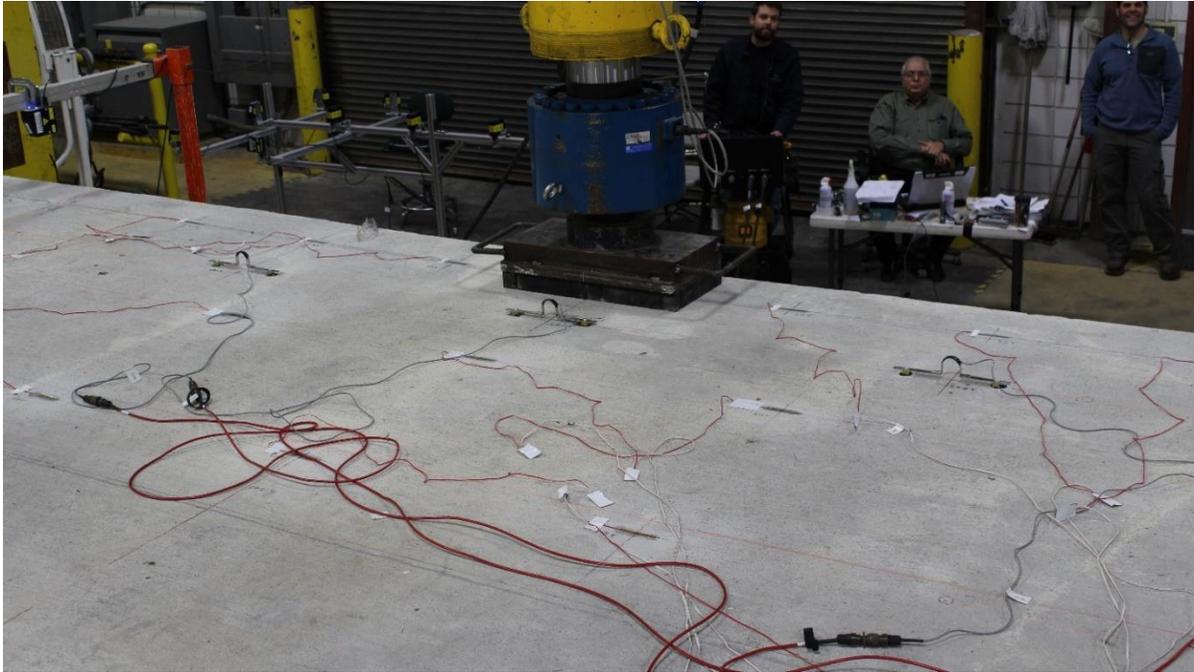
Figure 5.93: Load Case F4 – Test location
