**UNF Project
Contract No. BDV34-977-01**

Empirical Deck for Phased Construction and Widening

Florida Department of Transportation

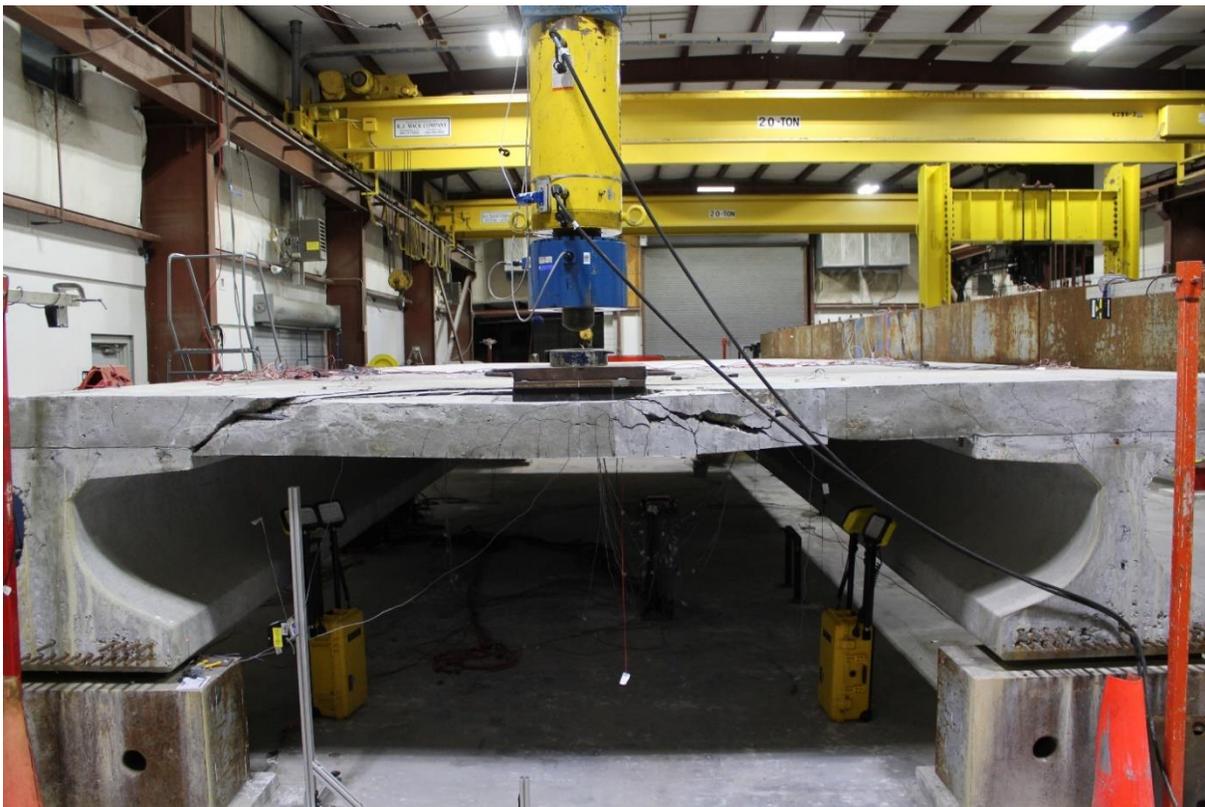
Figure 5.94: Load Case F4 – Failure

As with all other test locations, Load Case F4 also failed by punching shear, albeit at a lower load level due to being at the edge of the deck. As with the other cases, the main failure surface at the top of the slab was close to the footprint of the applied load, as can be seen in Figure 5.95. At the bottom of the slab, the failure surface extended beyond the extents observed at the top of the slab (see Figure 5.96). The unique location for this case allowed a better view of the failure mode from a side view in addition to the top and bottom views. Figure 5.94 shows a side view of the slab at failure. It can be seen that the failure surface is cone-shaped, which is consistent with a punching shear failure mode rather than flexure, for which the main crack would have been vertical and concrete crushing would have been evident. It is noted that the cone was not exactly symmetrical about the point of load application. This may be attributed to the effect of the overhang and the loads applied on it that, unlike on the widening side, restrains deck rotation. Figure 5.97 shows that in addition to the main failure surface, elliptically-shaped top slab cracks extended in an increasing spacing away from the applied load.

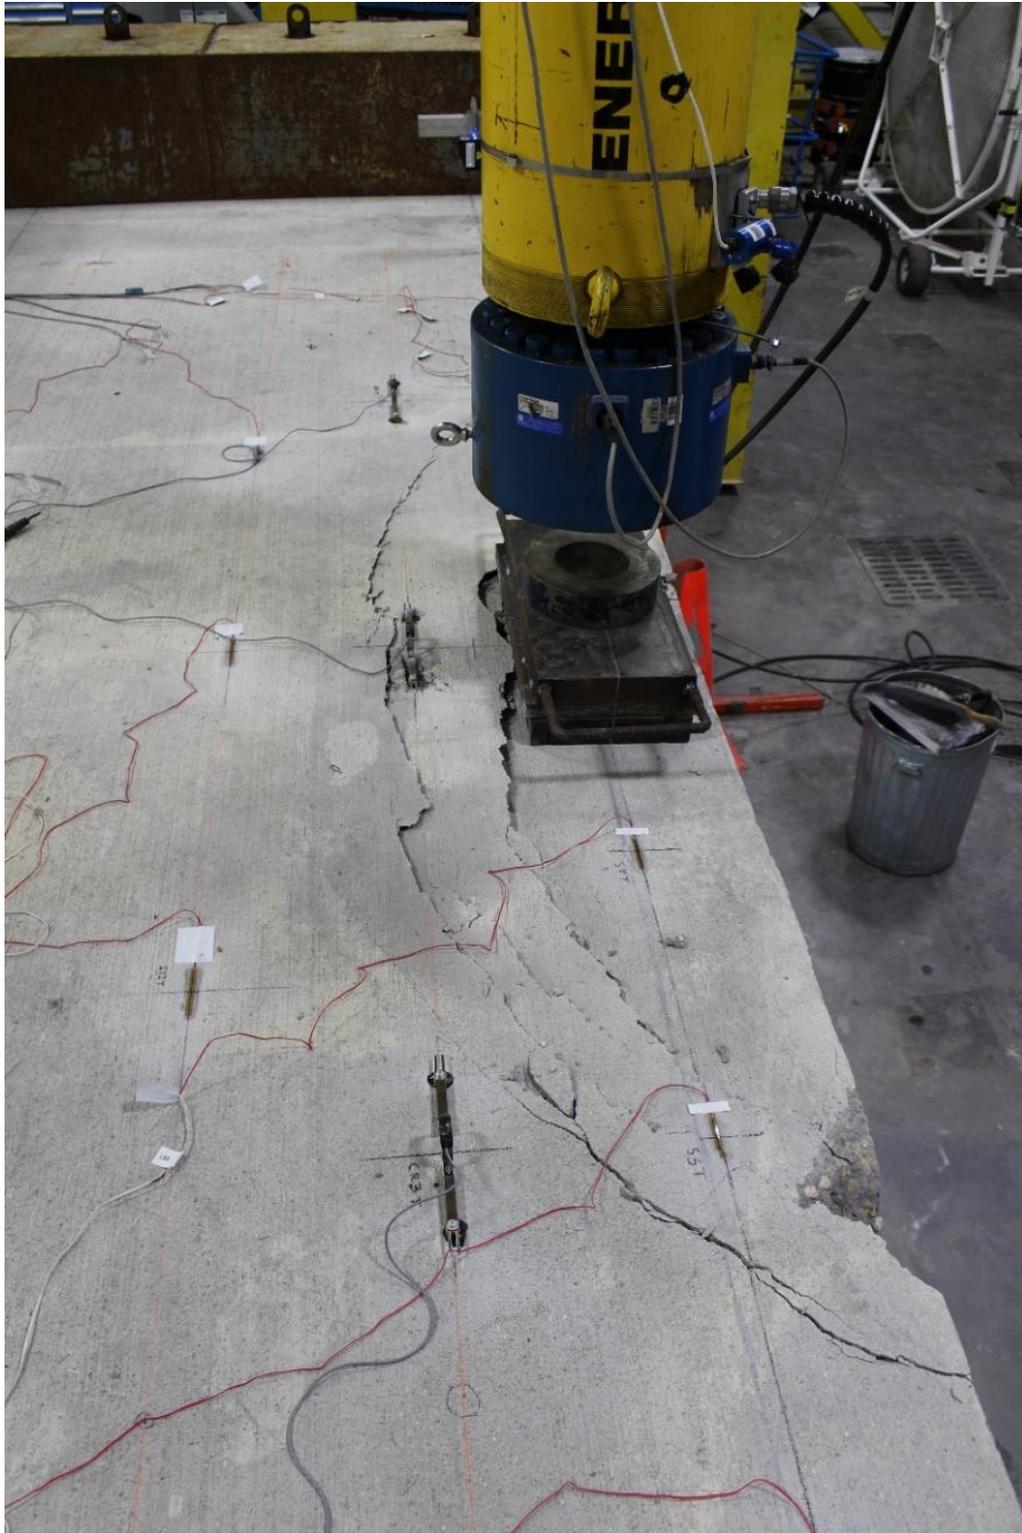
Figure 5.95: Load Case F4 – Failure at top of slab

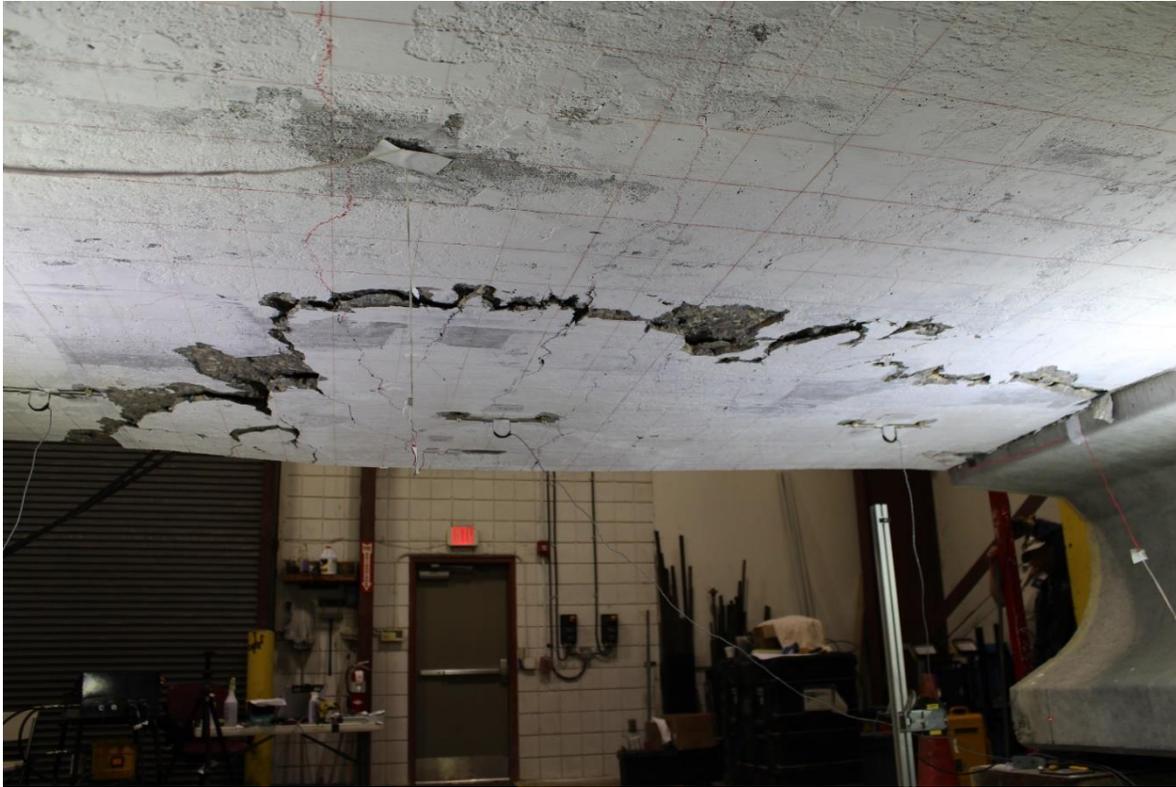
Figure 5.96: Load Case F4 – Extent of failure surface at bottom of slab

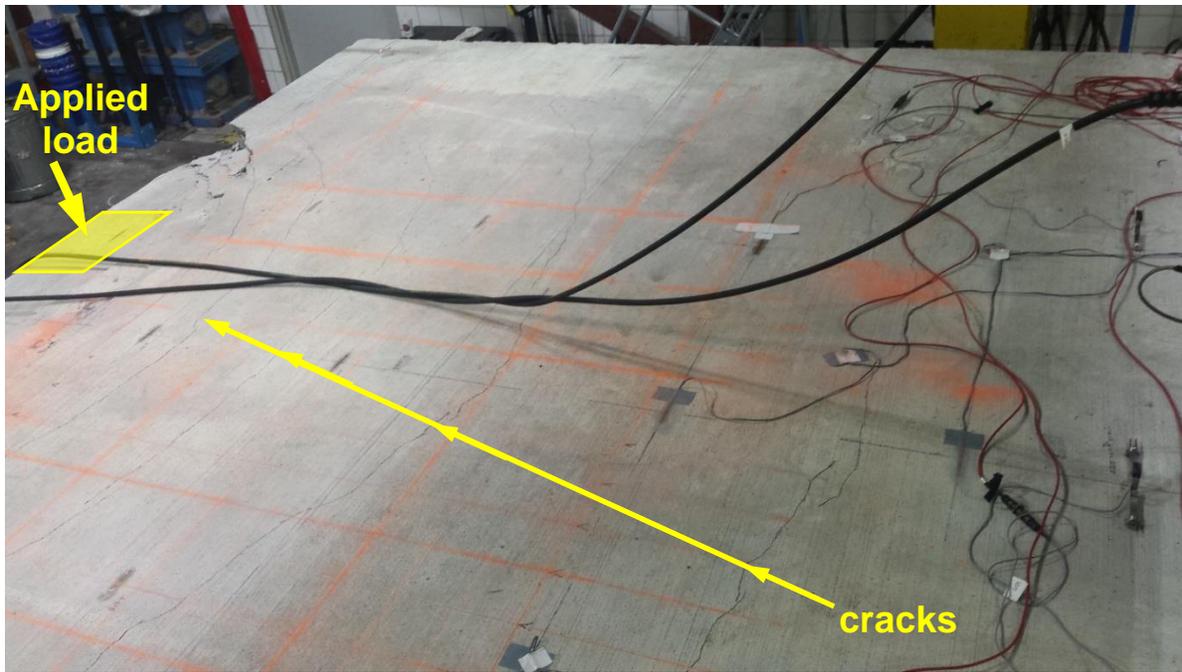
Figure 5.97: Load Case F4 – Extent of top deck cracking

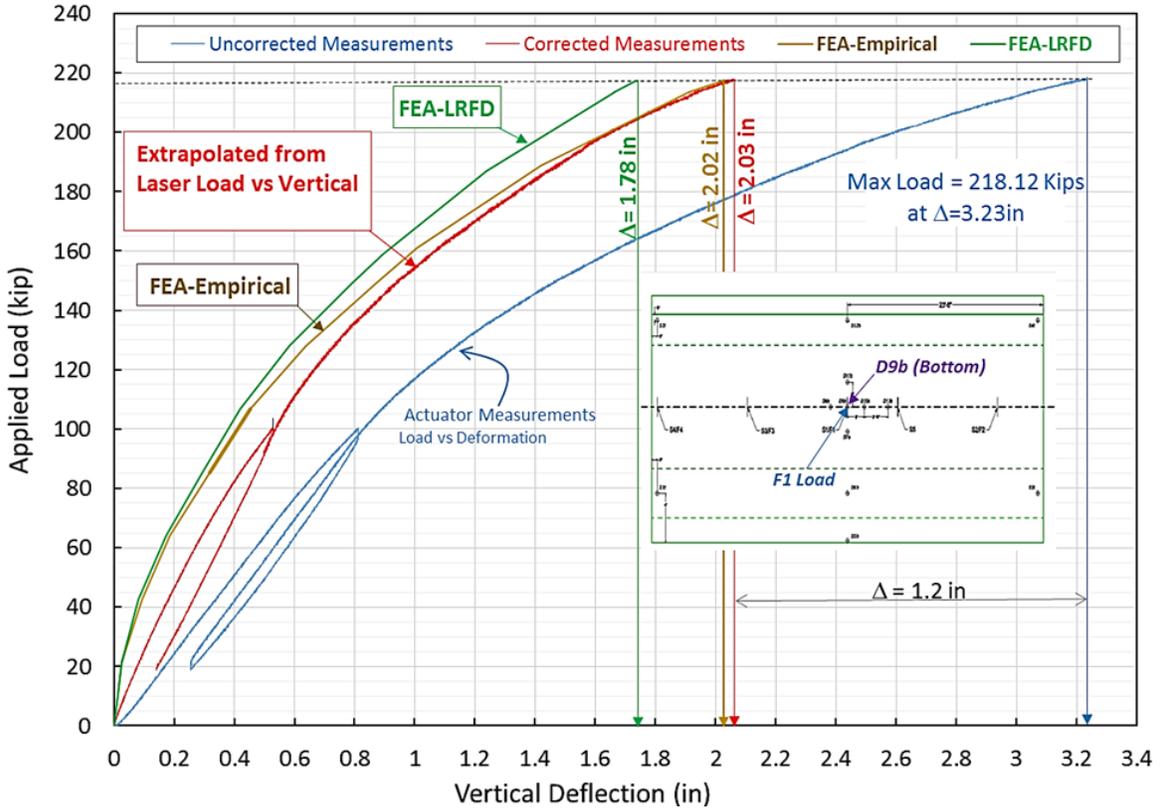
Figure 6.5: Laboratory test results and FEA results of F1-Test

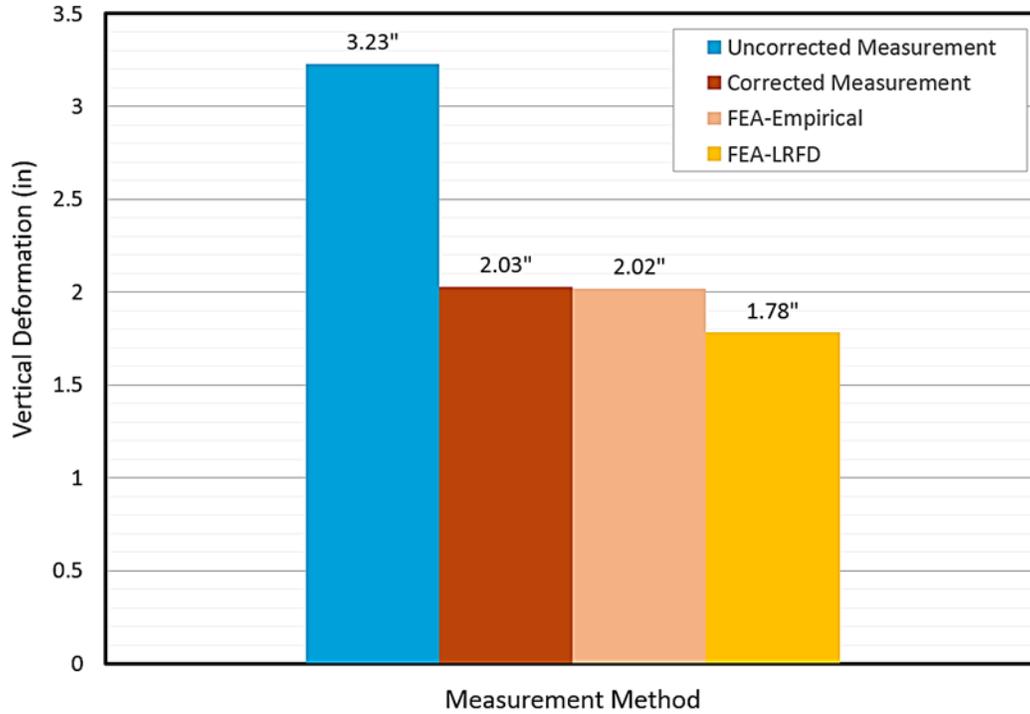
Figure 6.6: Vertical deformations from laboratory and FEA models for F1-Test

2.02 inch. Figure 6.6 shows a comparison of the deformations from laboratory and FEA models for the F1 case.

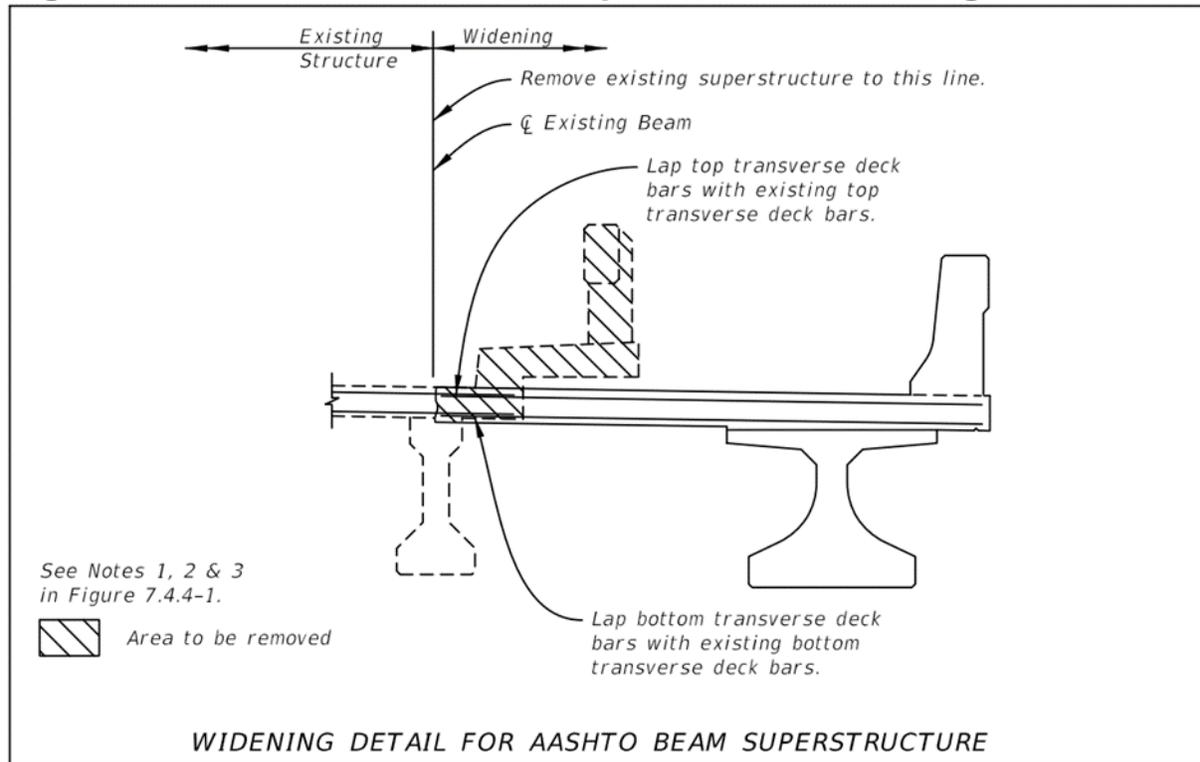
Figure 7.1: Typical widening taken from FDOT SDG

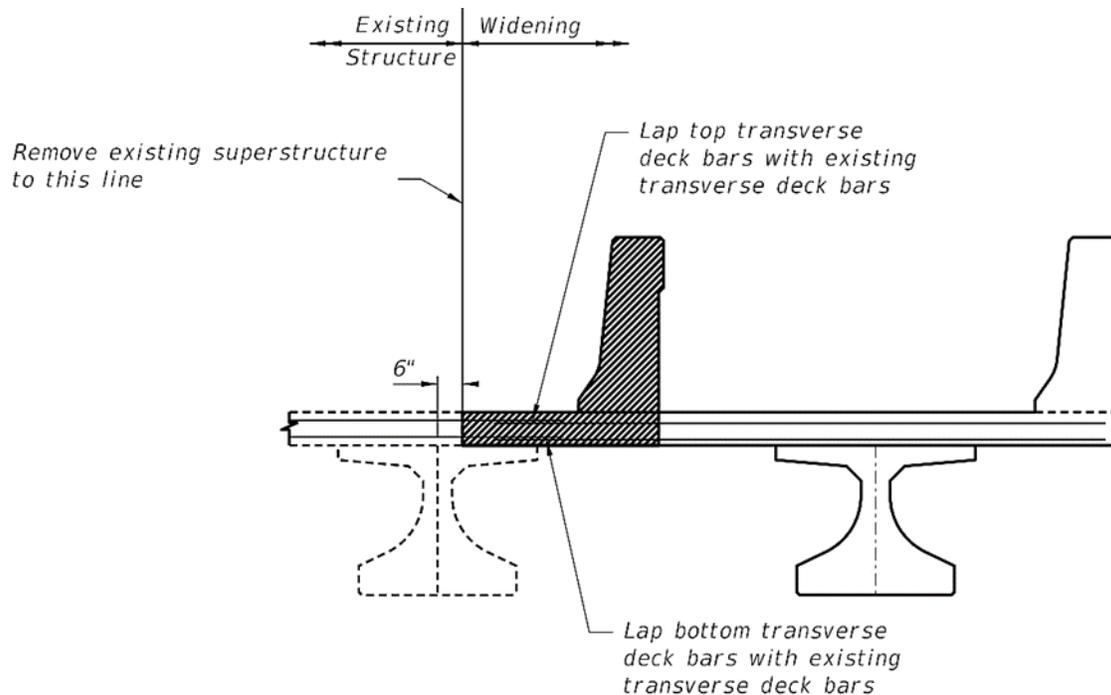
Figure 7.2: Proposed widening detail

1. In comparison to AASHTO beams, the wider top flanges of FIB precast prestressed concrete sections (4 ft) allow extending the distance at which existing deck concrete removal starts beyond the centerline of the beam, thus keeping both legs of girder stirrups embedded in old deck concrete. It is recommended that the extent of existing deck demolition (for widening projects) or cold joint location (for phased construction projects) be set at a distance equal to 6 in. beyond the centerline of the exterior girder as shown below in Figure 7.2.

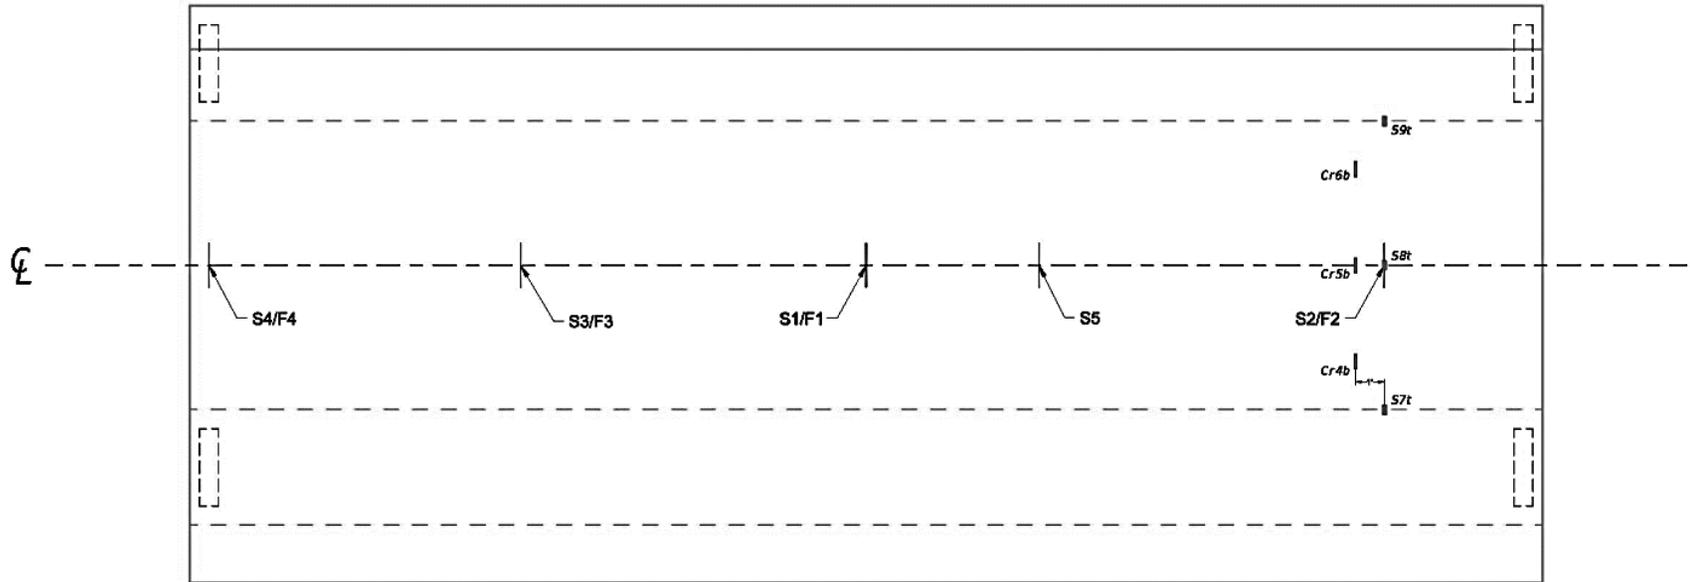
Bottom deck surface crack and foil Gauges for S2/F2

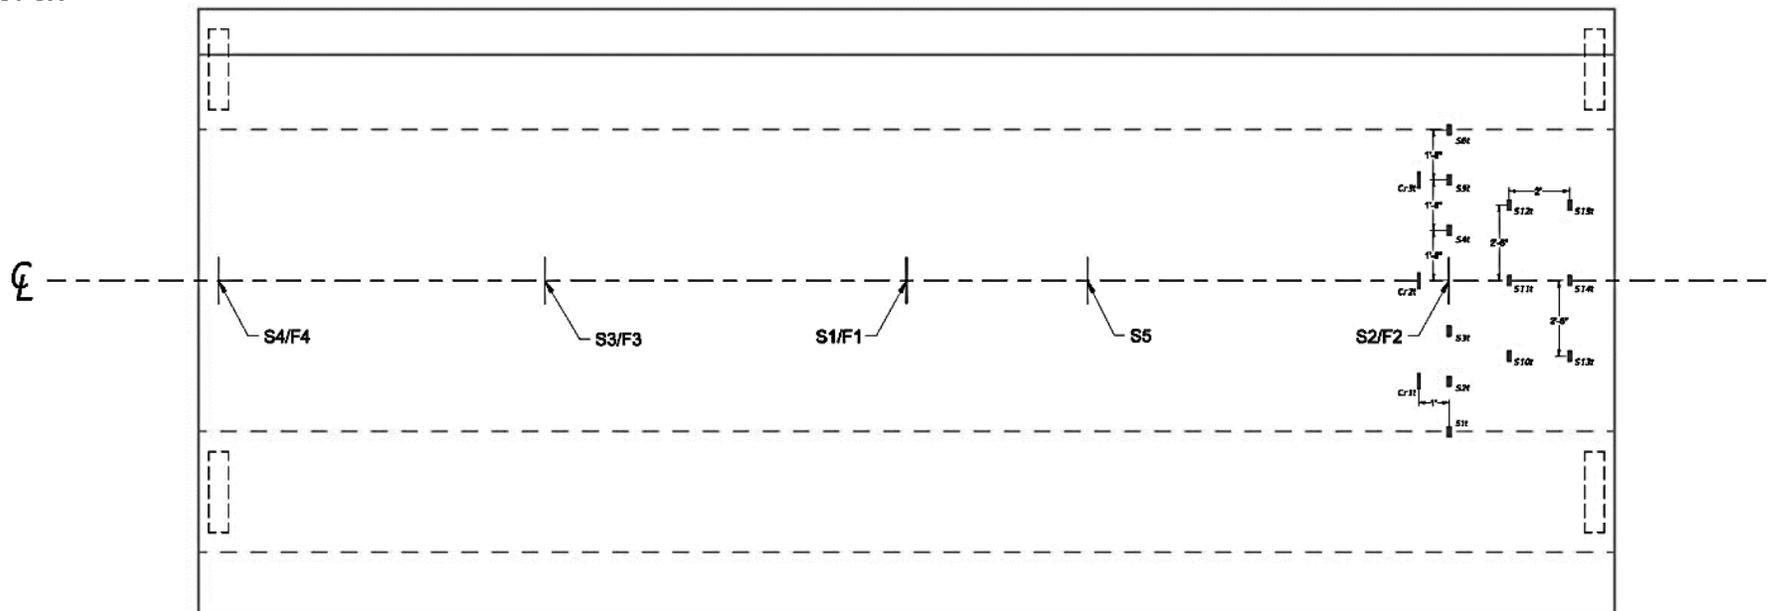
Top Deck Surface Crack and Foil Gauges for S2/F2

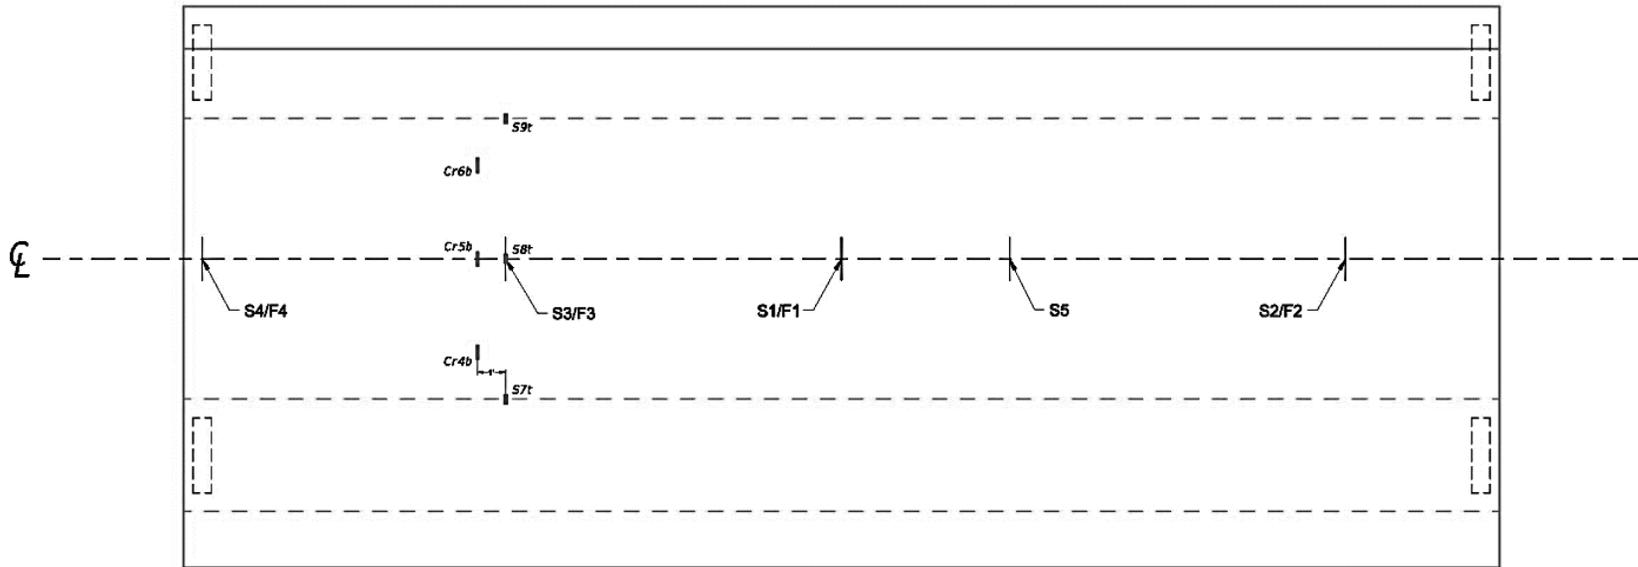
Bottom Deck Surface Crack and Foil Gauges for S3/F3

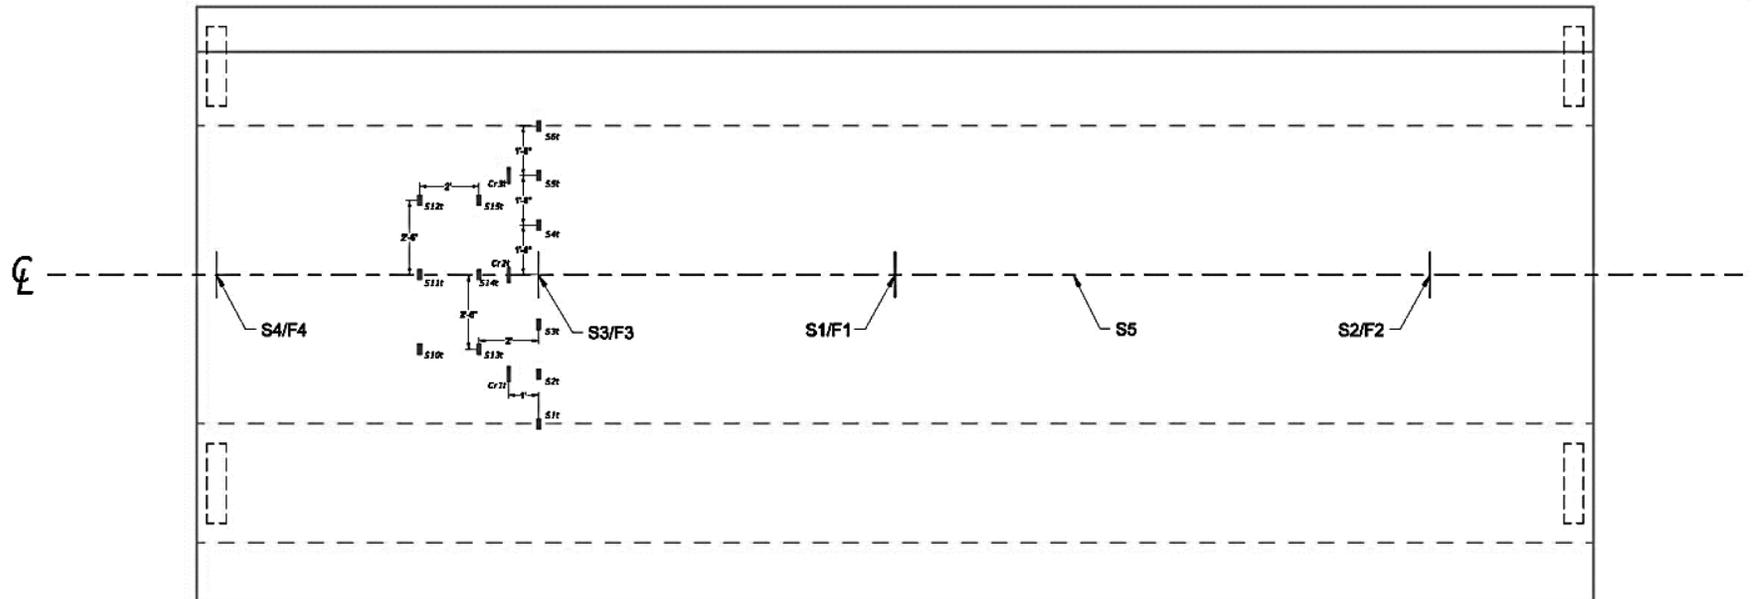
Top Deck Surface Crack and Foil Gauges for S3/F3

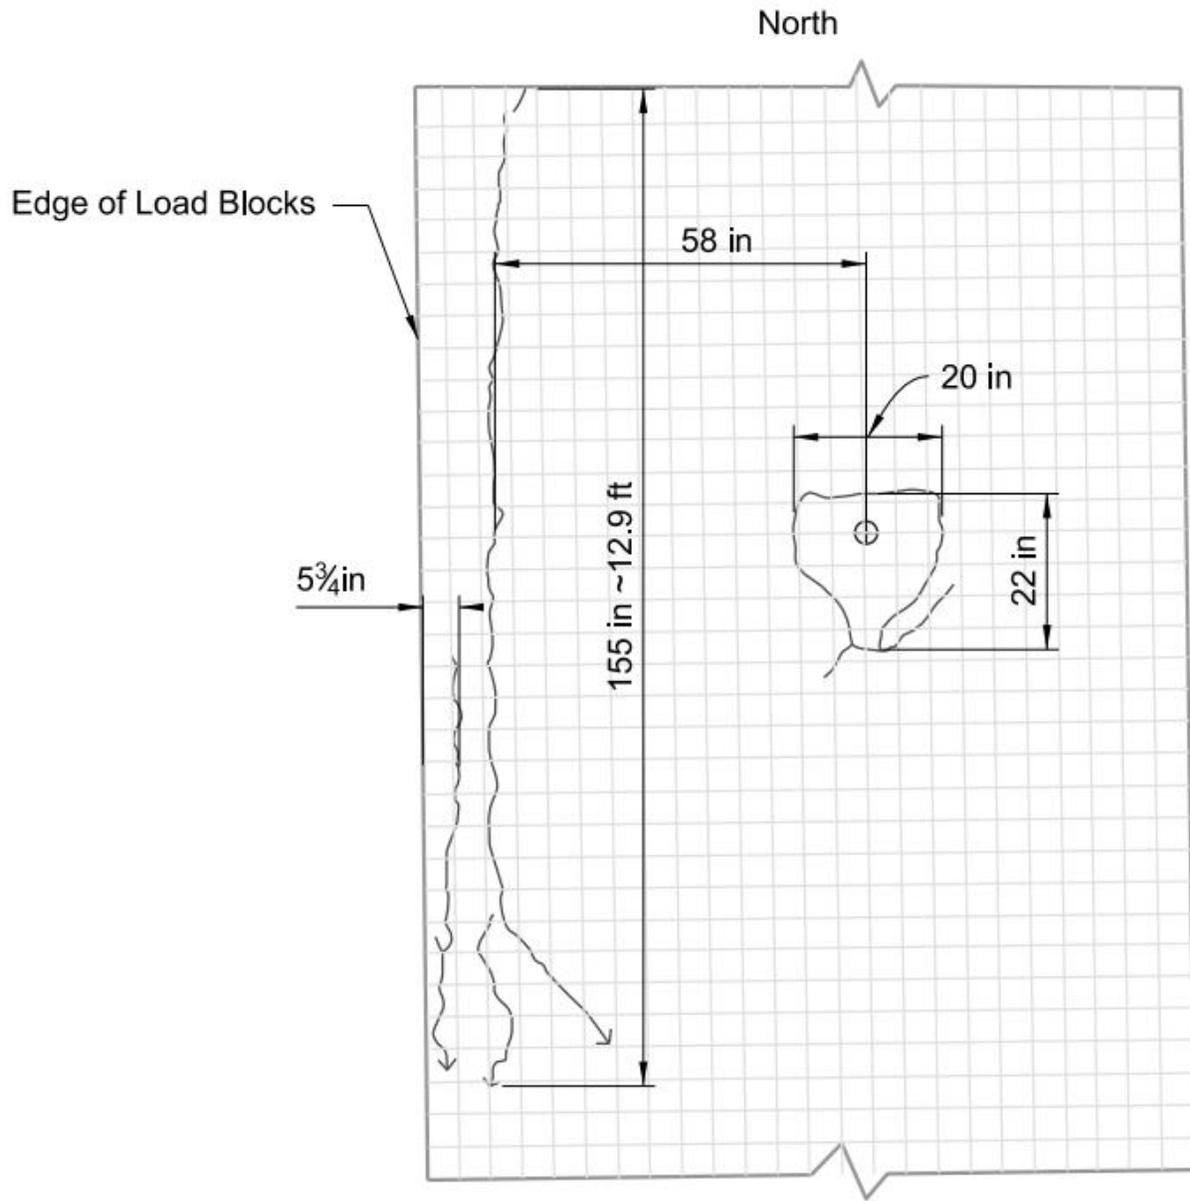
Crack Mapping for F1 Top of Slab (5 inch grid)

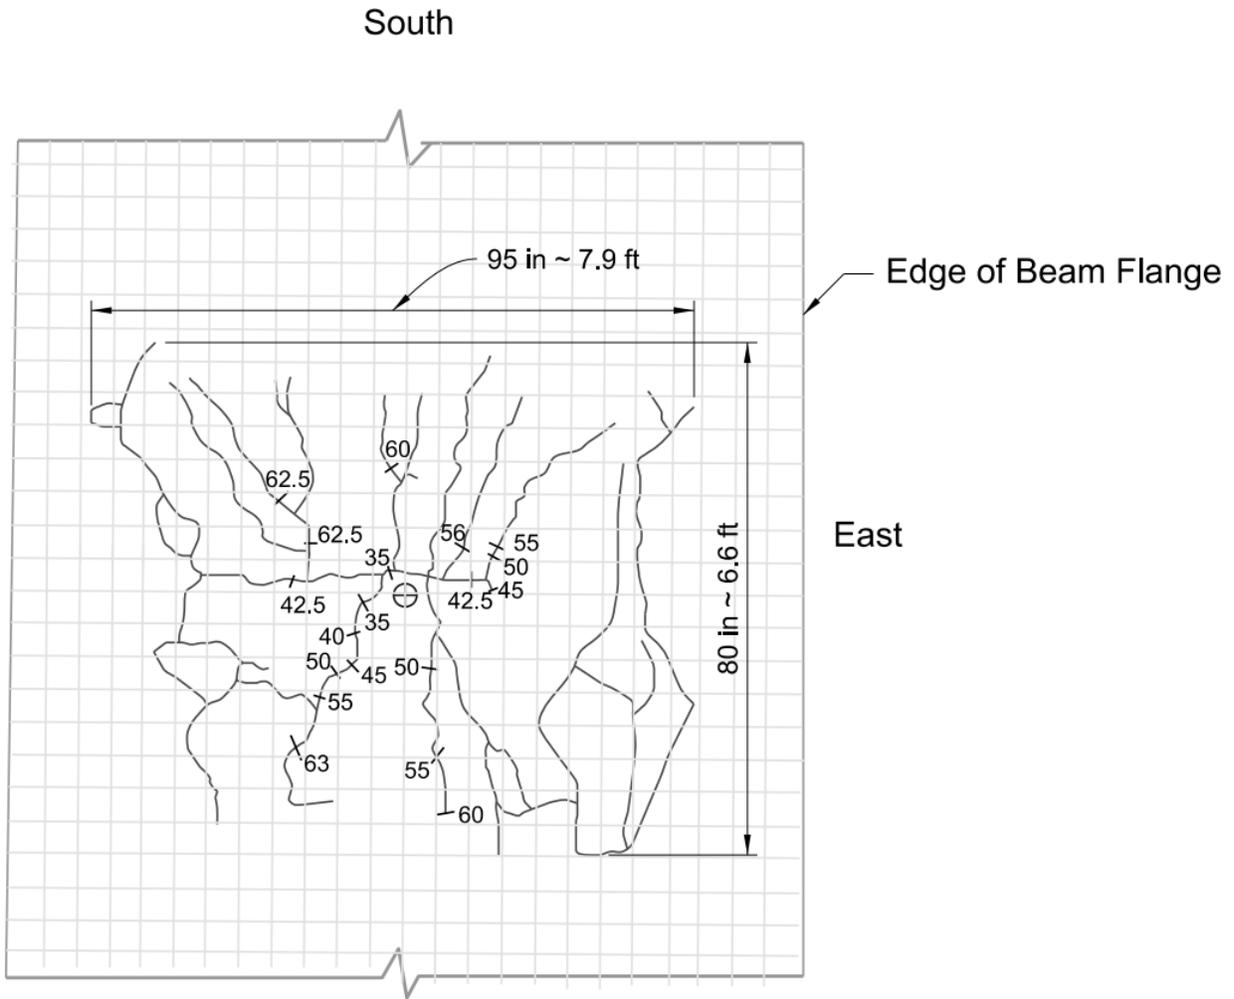
Cracking Mapping for F1 Bottom of Slab (5 inch grid)

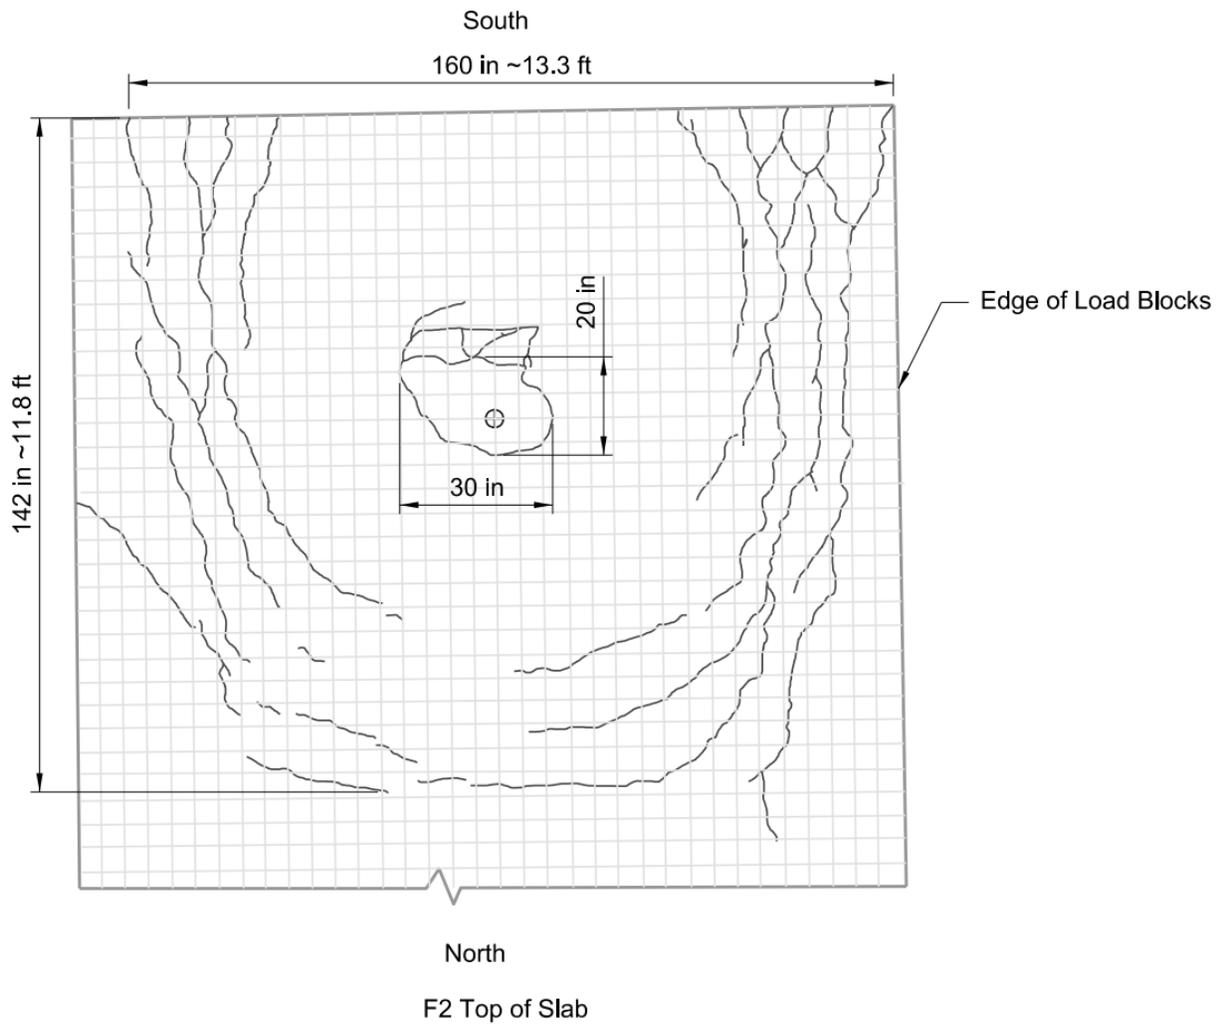
Crack Mapping for F2 Top of Slab (5 inch grid)

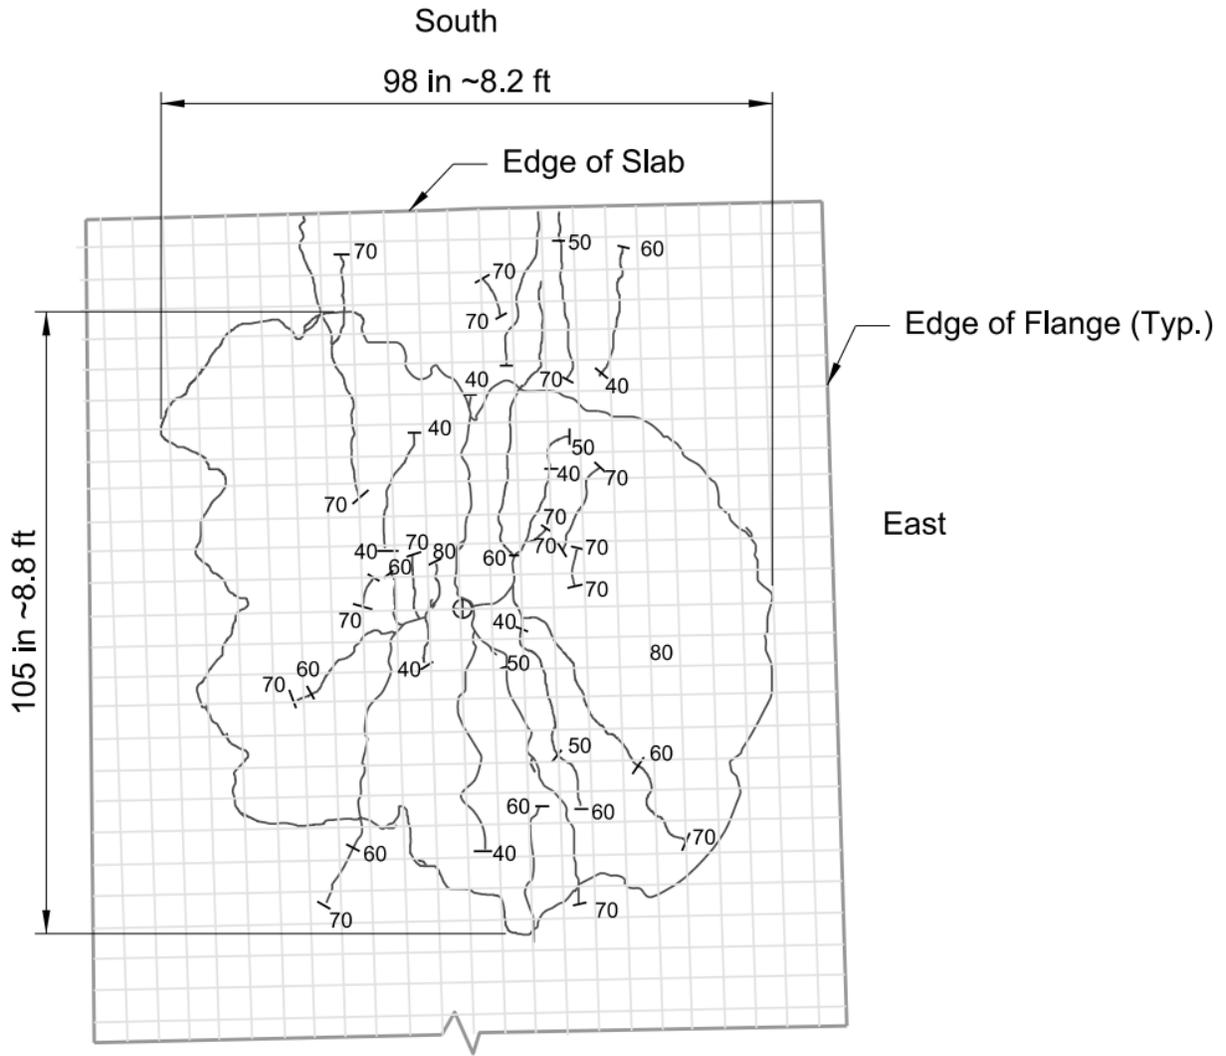
Cracking Mapping for F2 Bottom of Slab (5 inch grid)

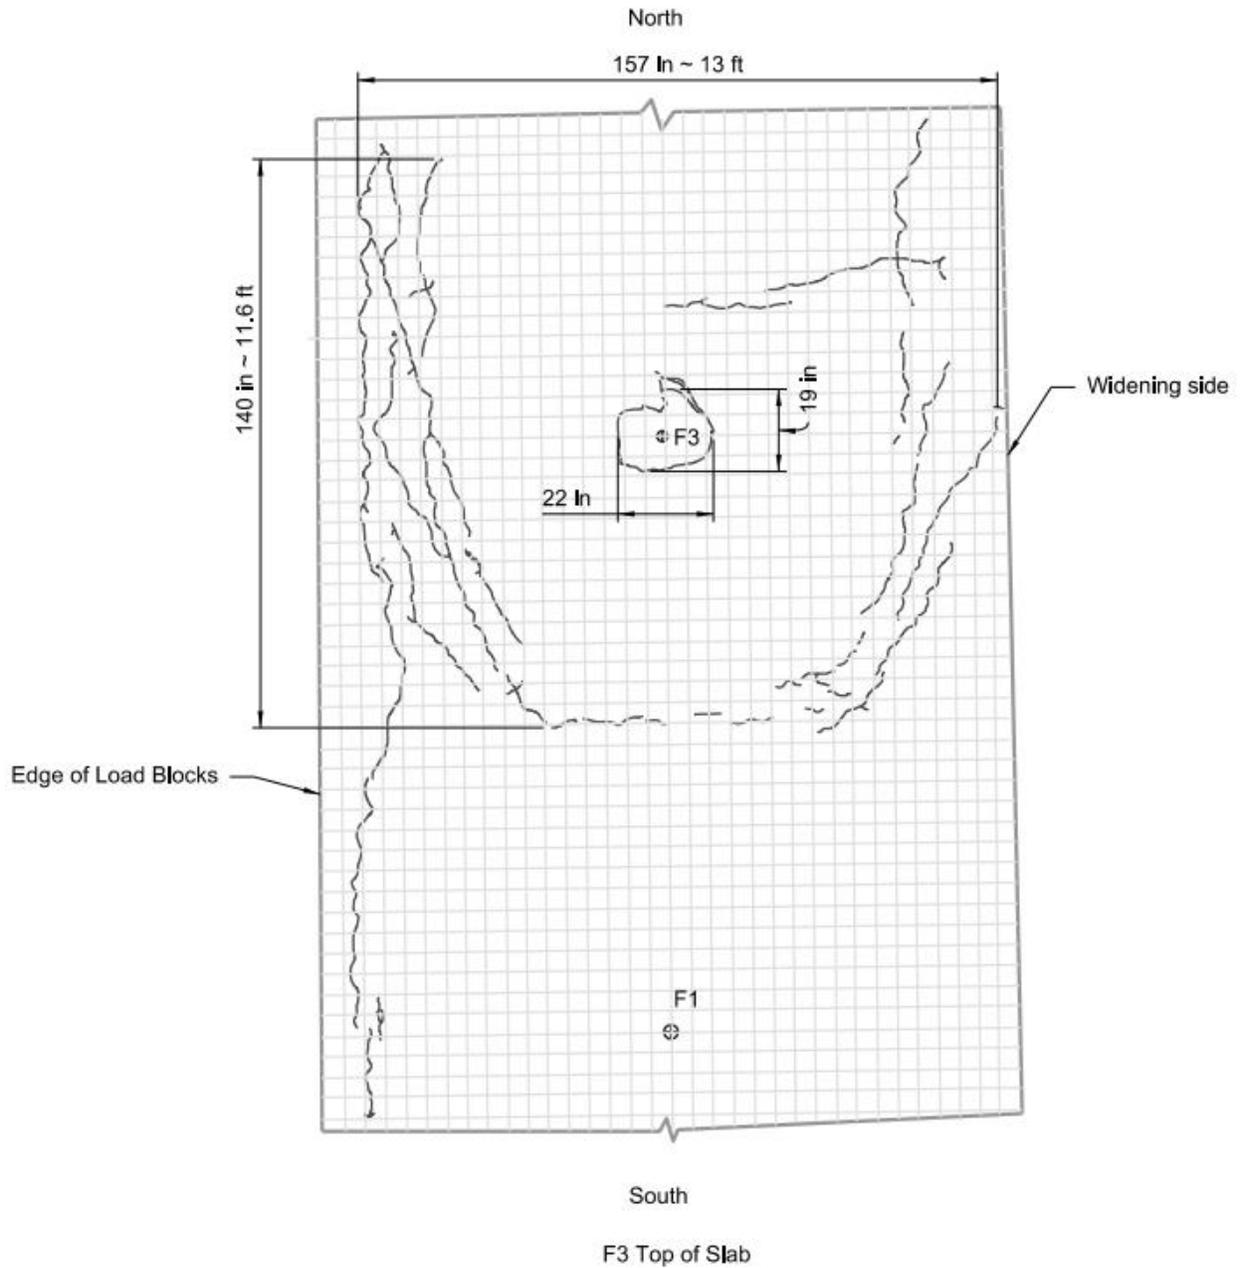
Crack Mapping F3 Top of Slab (5 inch grid)

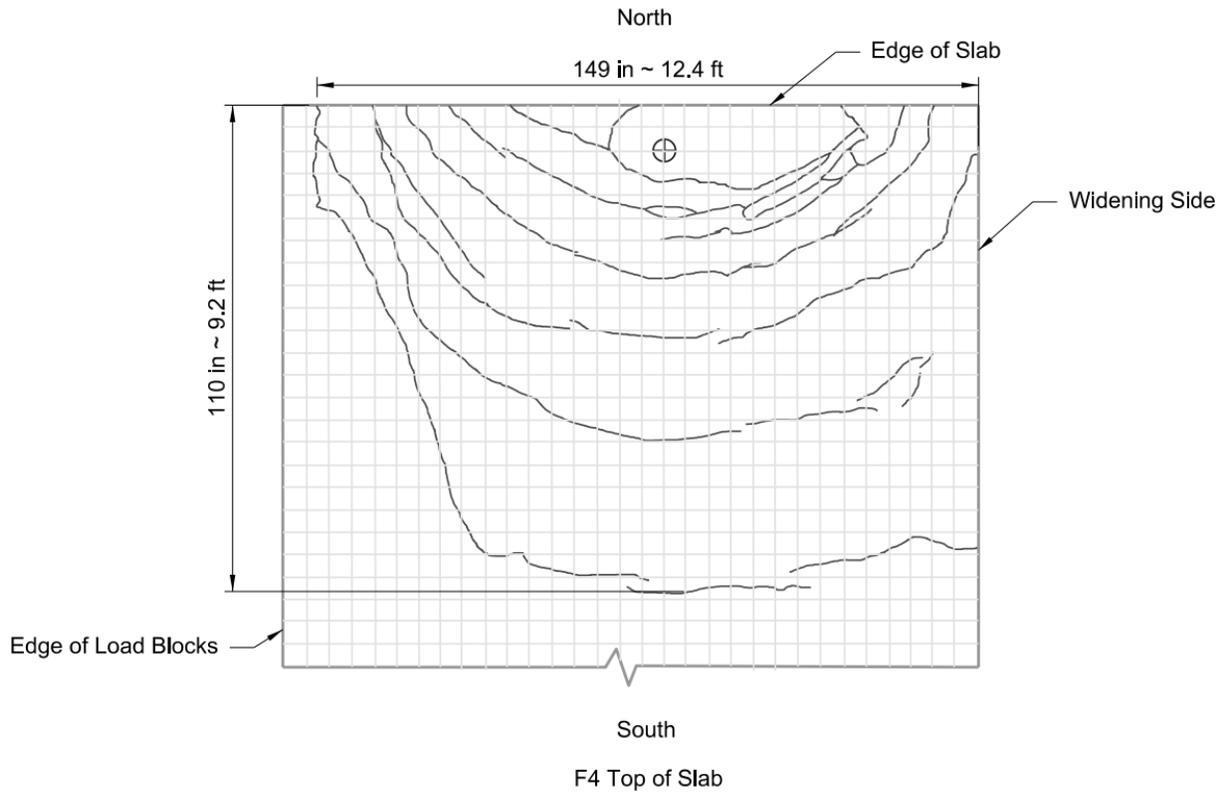
Crack Mapping for F4 Top of Slab (5 inch grid)

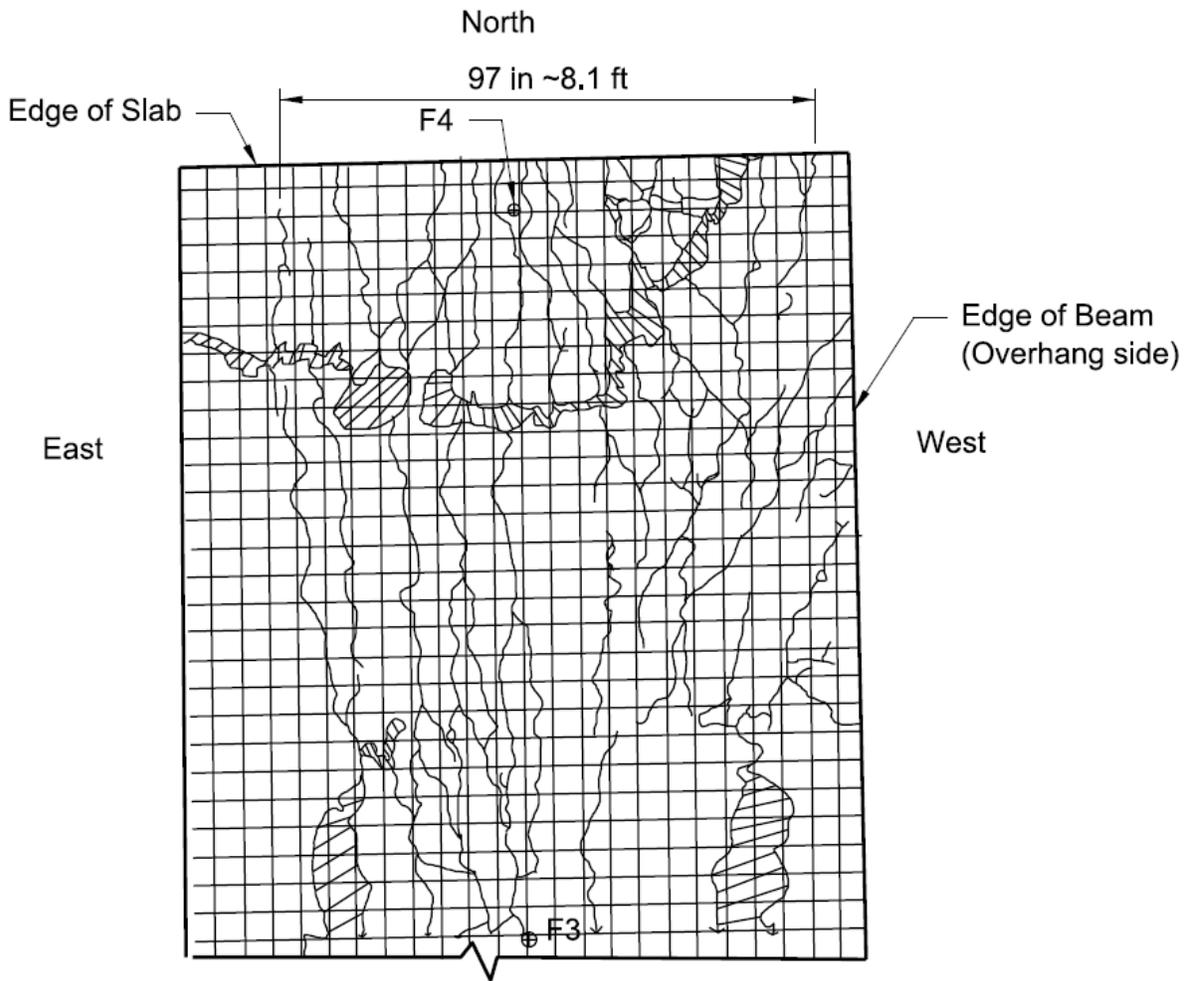
F4 Bottom of Slab
 Striped areas denote exposed aggregate
