Two Steel Box Girder Bridges Evaluating Redundancy

**Lead Graduate Student: Huy Pham
P.I. Atorod Aziznamini, Ph.D., P.E.**

**Department of Civil and Environmental Engineering
Florida International University
Miami, Florida**

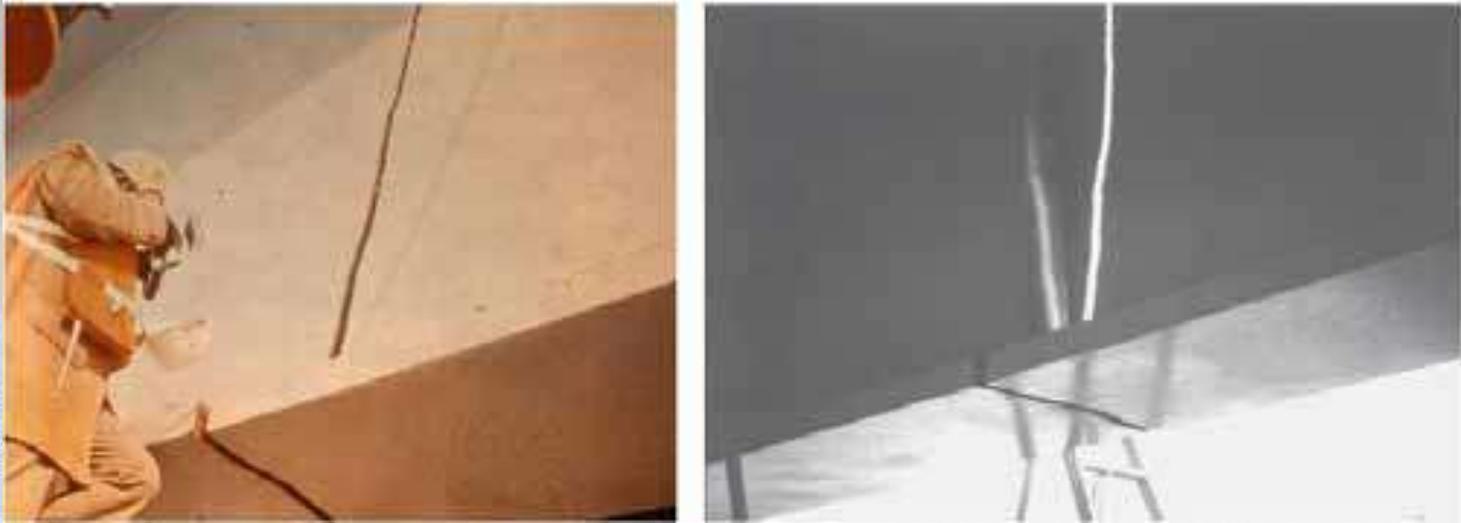
Full-depth fracture of one of the two girders on the Neville Island Bridge on I 79 in Pittsburg, Pennsylvania-1977

A number of incidents involving the full-depth fracture of in-service, two-girder bridges provide evidence that, in certain cases, a redundant load path does exist in these structures even though they have not been given credit for such.

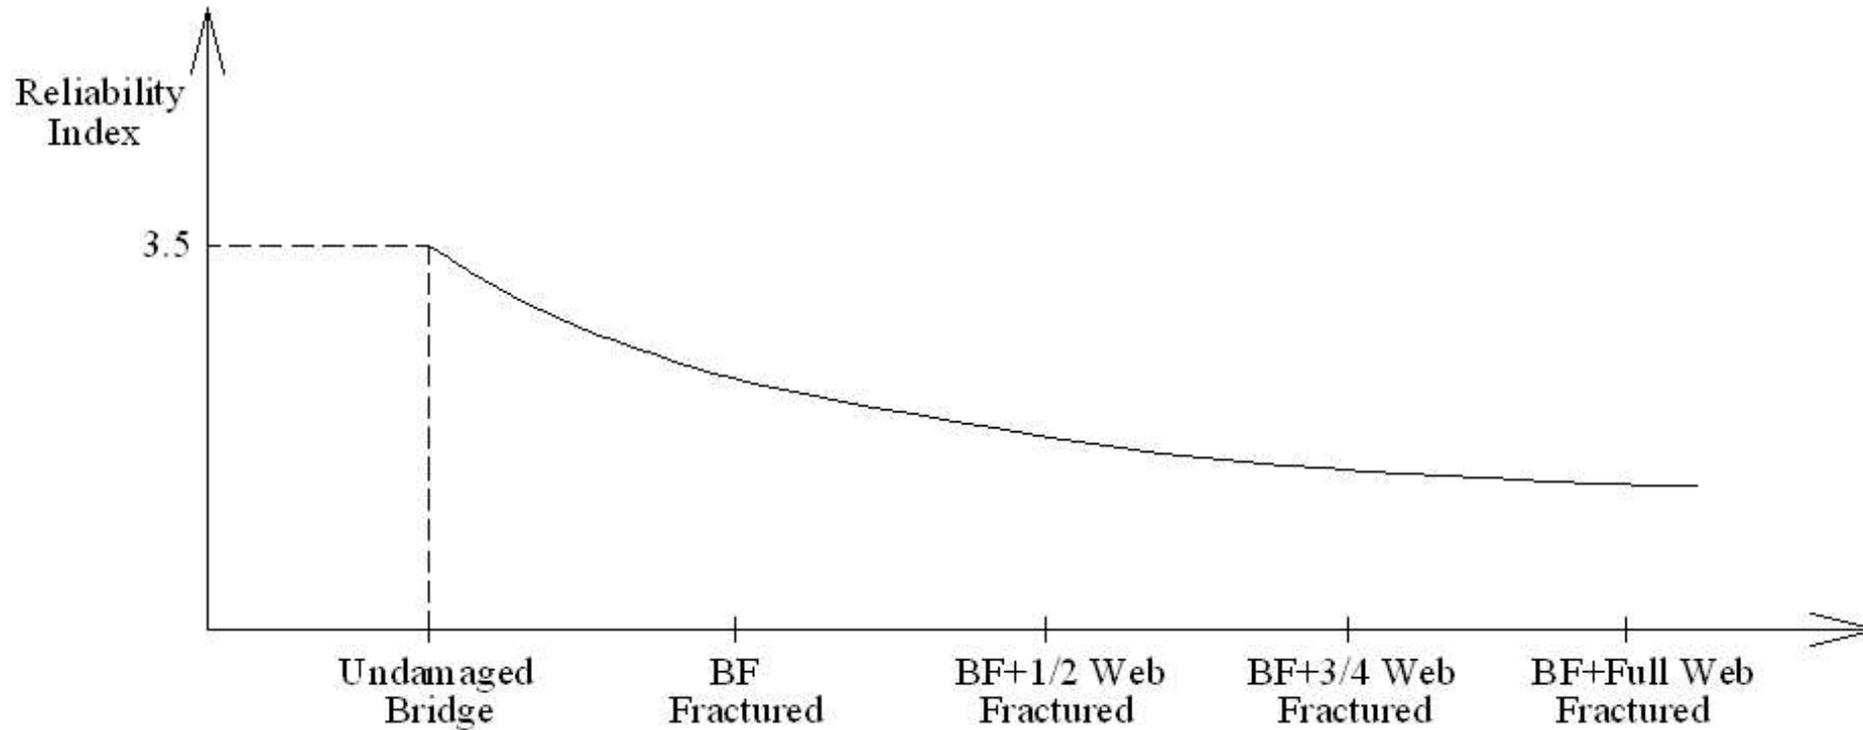
Reliability index of new and damaged bridge

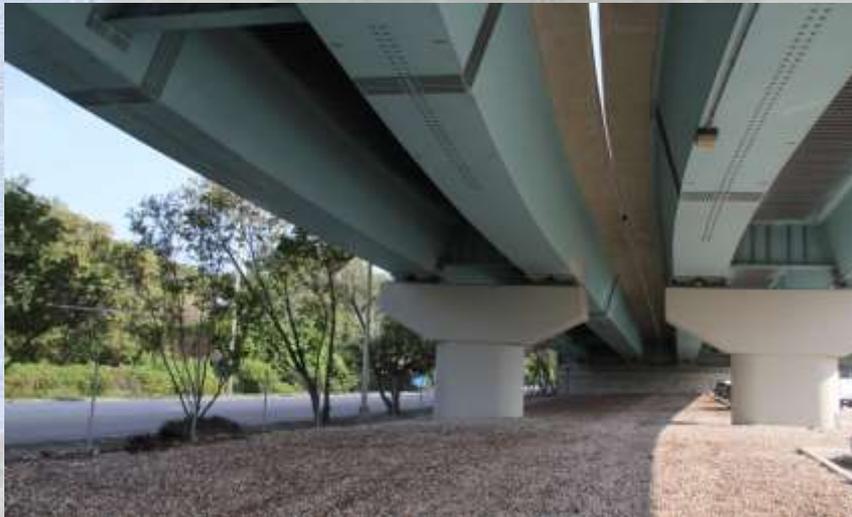
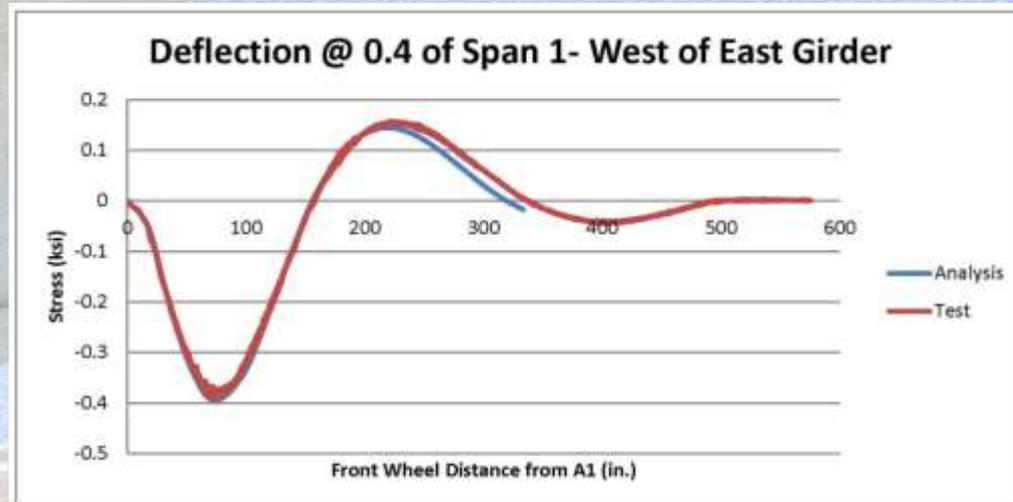
Have field tested two steel box girder bridge under elastic load

Modeling elastic response was simple and verified using field test

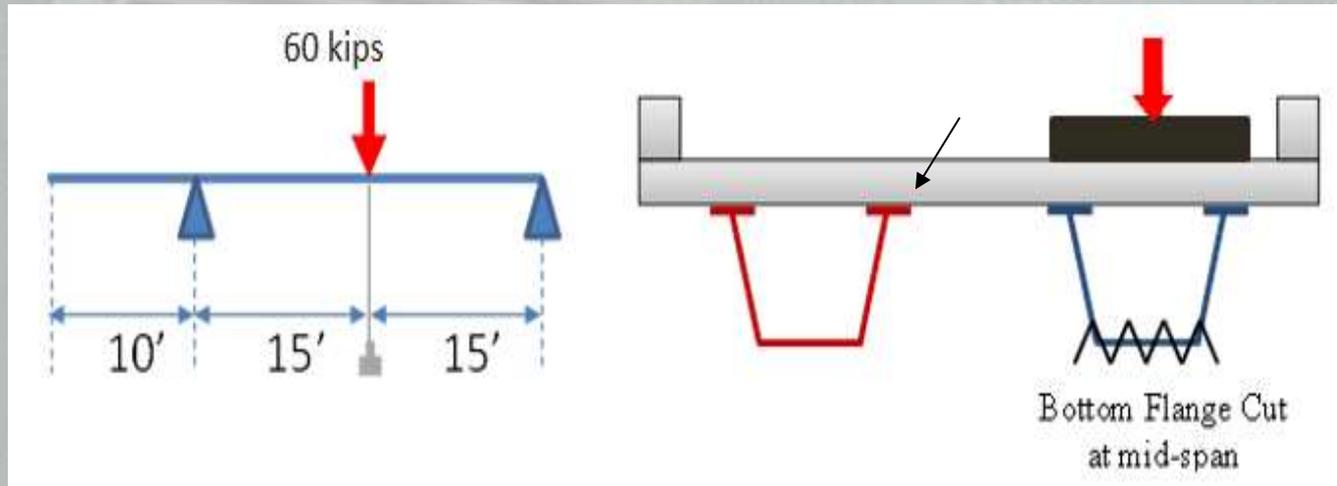
Cyclic Loading

Type "C" Fatigue Category

Threshold Stress: 10 ksi

Estimated trucks for two years of traffic: 940,000 cycles

Crack propagated to top flange after about 210,000 cycles- Equivalent to about 5.5 months of traffic

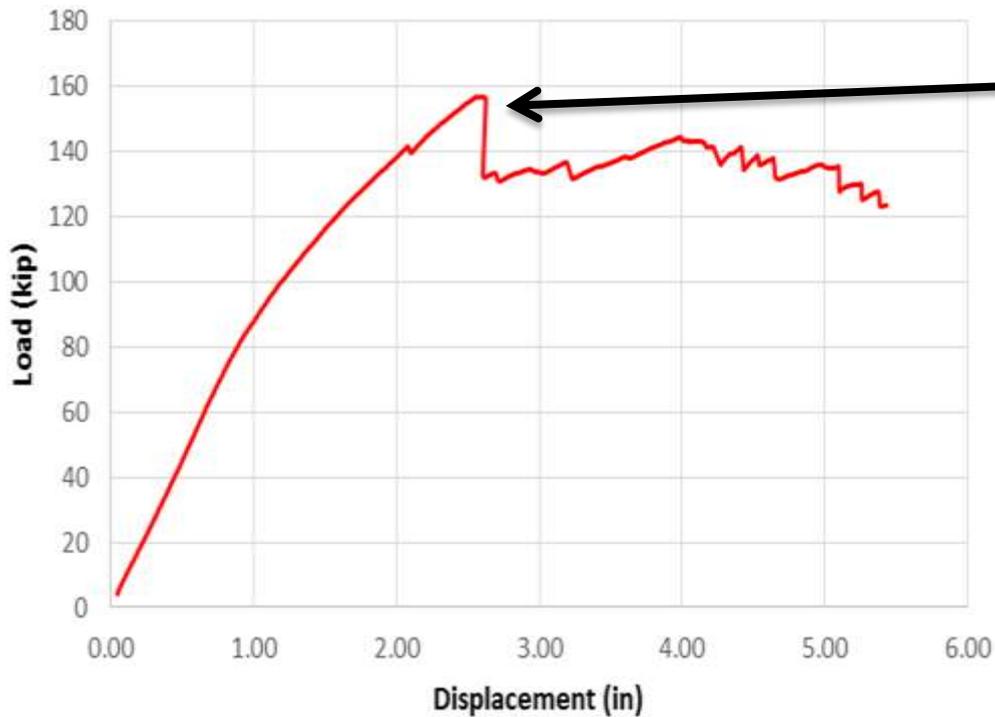
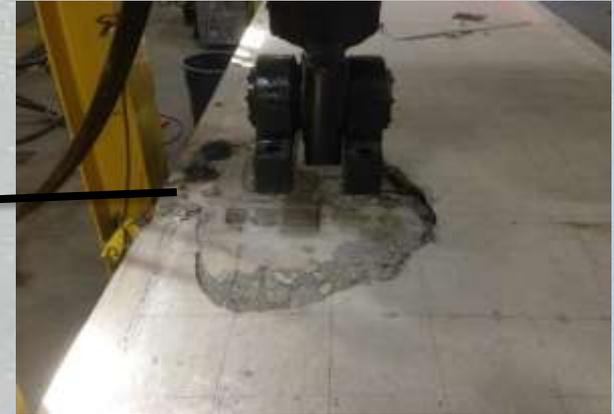
Ultimate Test Results

ULTIMATE CAPACITY

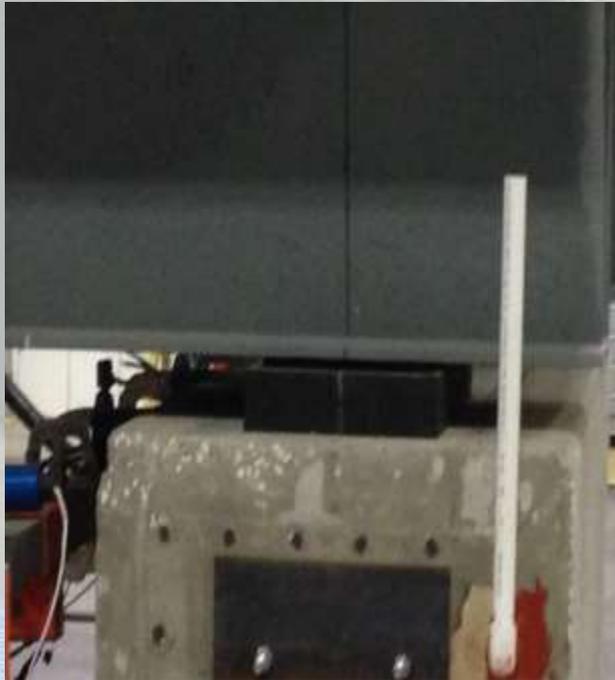
North
Support

Uplift in Undamaged Girder

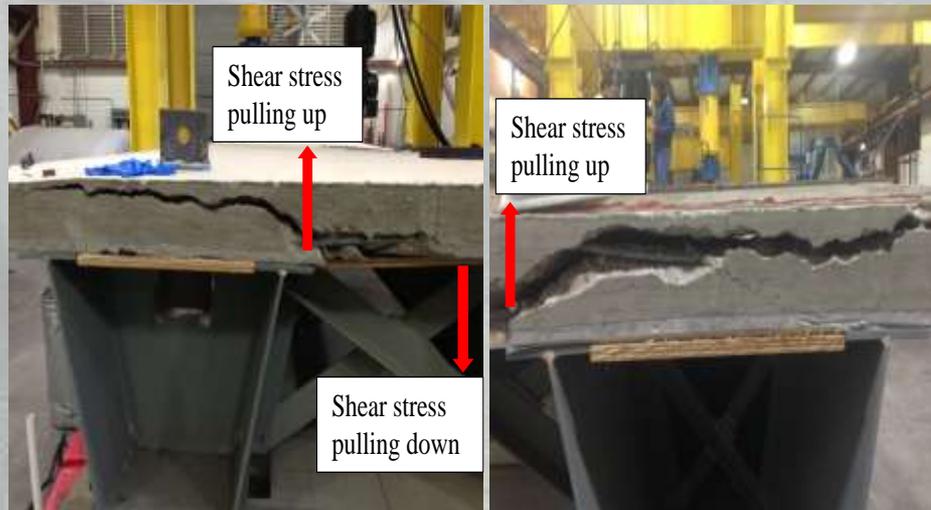
Damage at ends

This splitting was attributed to the internal transverse shear forces that was produced to balance the unequal displacements of two girders.

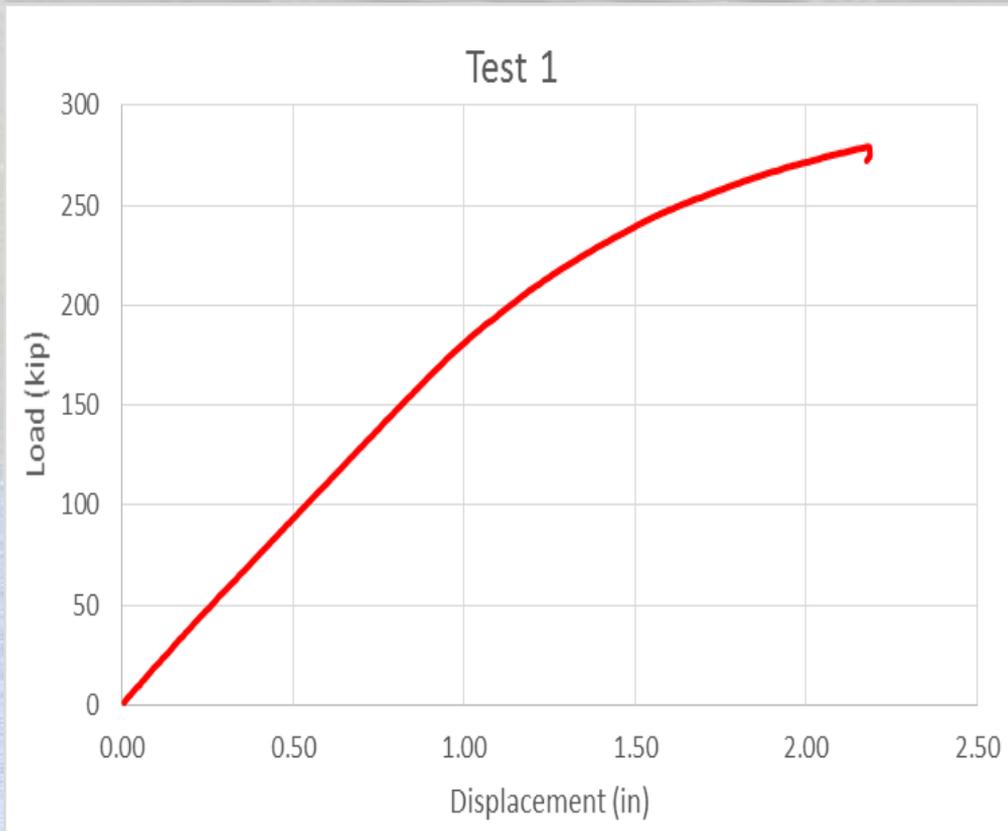
Phase II- Test I

- No major damage in the deck were observed
- The good girder experienced a significant yielding in bottom flange.

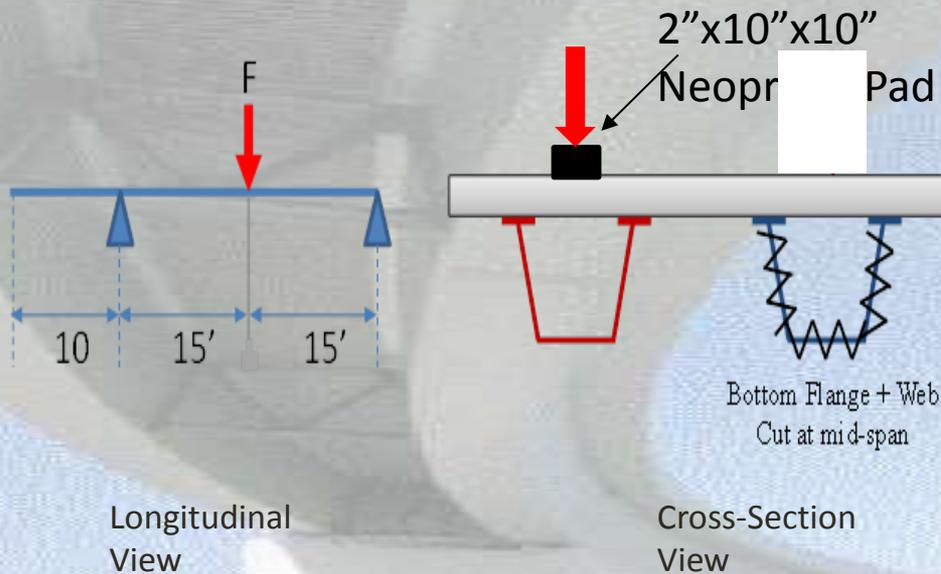
Phase II- Test 2

- This test is similar to test 1; however, with a smaller loading pad (2"x10"x10")

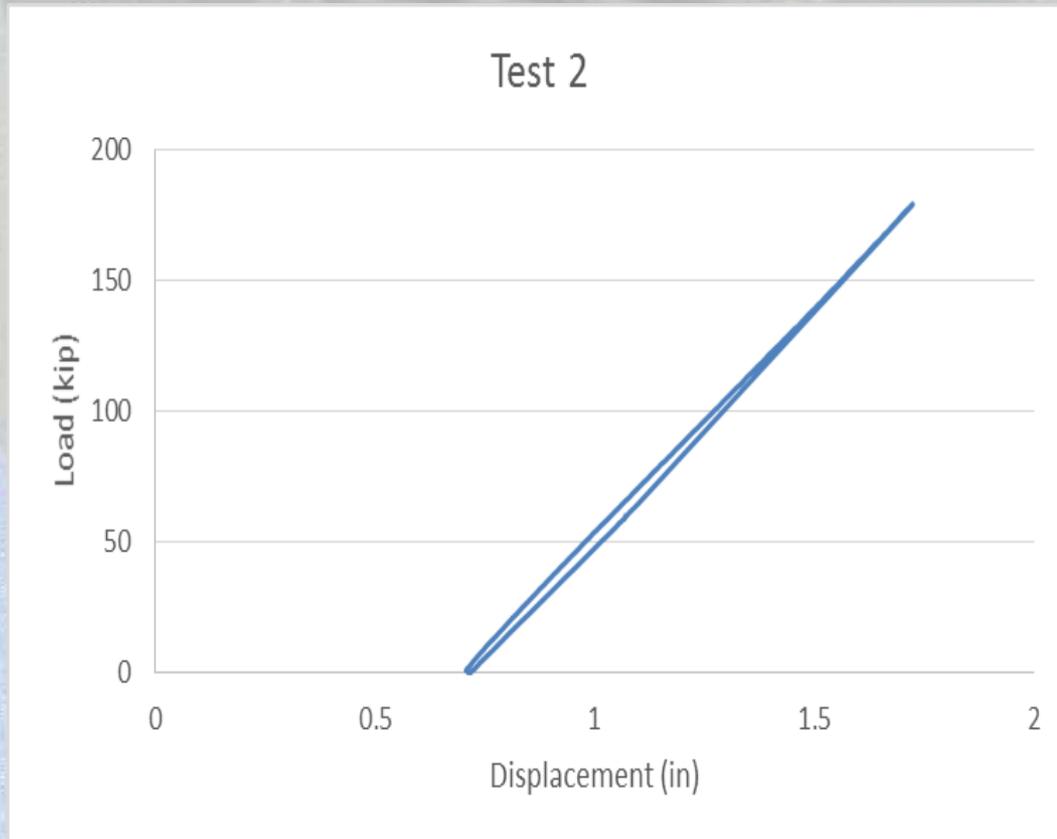
Phase II – Test 2

A permanent displacement was observed as a result of Test 1

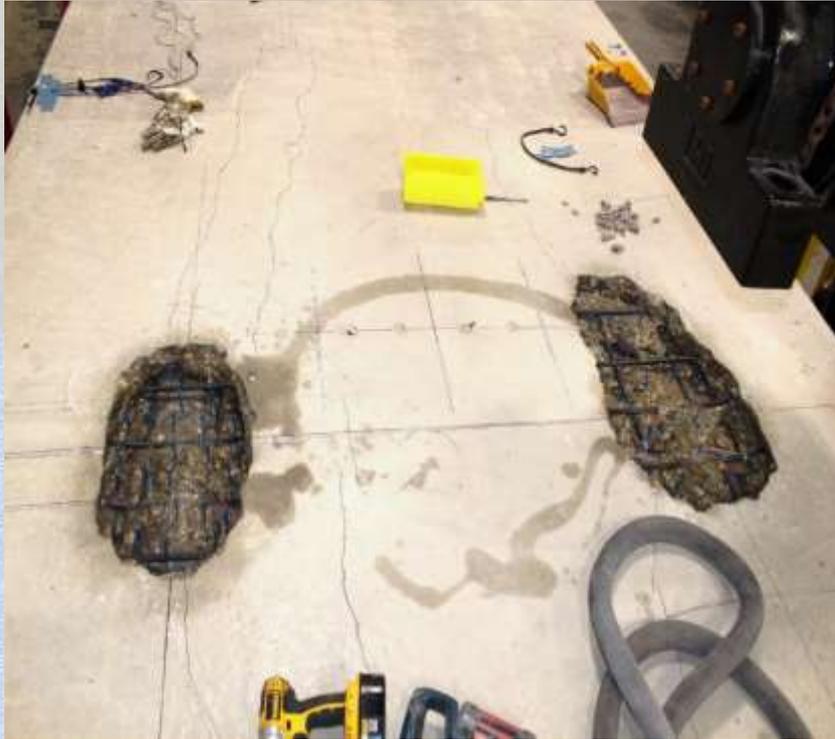
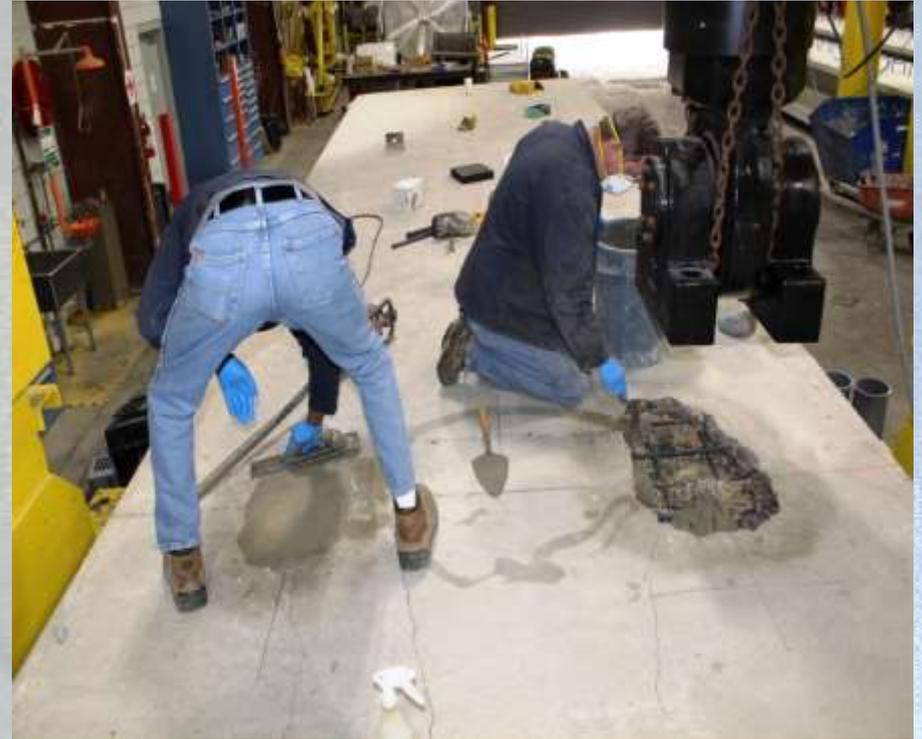
After Completion of Test 3 Deck was Repaired
