BDV30-977-16

Florida Department of Transportation Research

Rheology Limits for Grout Materials Used for Precast Bent Cap Pile Pockets in Hot Weather

March 2017

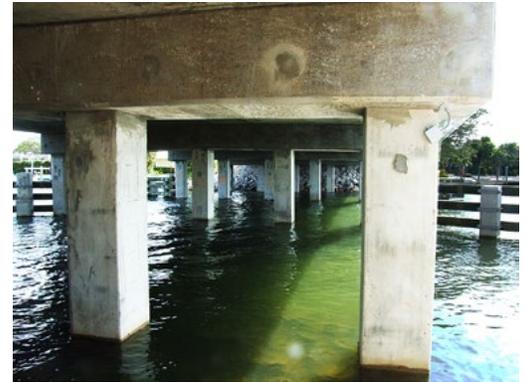
Precast piles fit into grouted sockets in the horizontal precast bent cap which supports the bridge deck.
