# Evaluation of Fog Seal Preservation Technique On US 17 and US 27

State Materials Office

FL/DOT/SMO/14-568

December, 2014

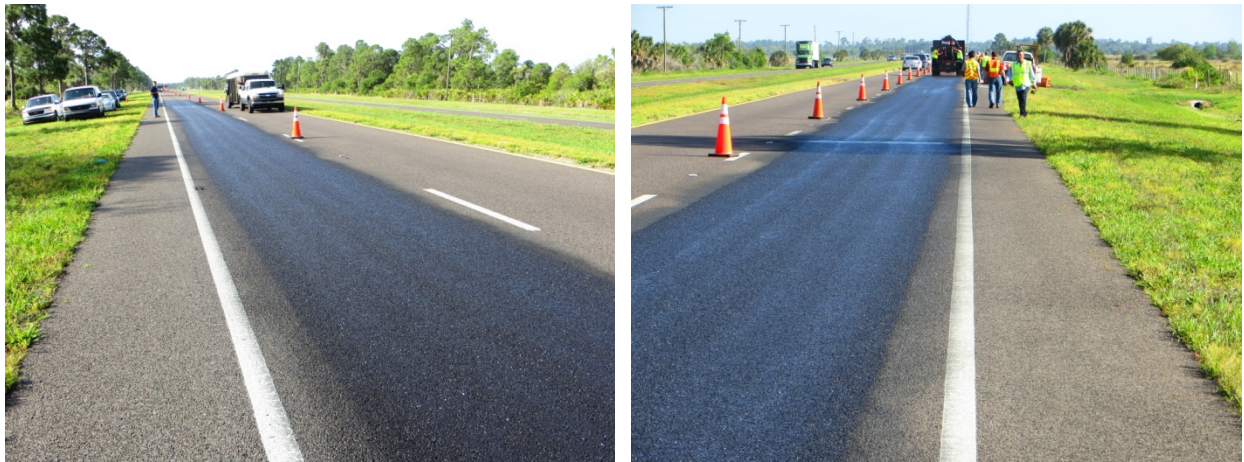
**FIGURE 4. Application for AsPen**

Each product was applied with a different distributor. The distributor used to apply the AsPen material had difficulty spraying the material within the lane lines due to the spray nozzles being physically located higher than the other distributor trucks' nozzles. After the US-27 project, AsPen product representatives lowered the nozzle height and used a plate to prevent the end nozzle from spraying over the lane line. The E-Fog material was applied without any problems. The Reclamite product did not have any problems due to the nature of the product, which had a light pink color and didn't mask the lane lines even when spraying on them. Figures 4-6 show the application of each product.

after they applied the same rate for both US 17 and 27. For Reclamite, the product representatives decided to apply a lower rate for US-17. For AsPen, the product representatives initially applied too much fog seal on US-27 since they had minimal experience with OGFC. After discussions with AsPen product representatives about US-27, AsPen product representatives decided to apply a much lower rate on US-17.

For the AsPen product, due to the higher application rate on US-27, the curing time was longer than for the other two products, therefore taking longer to open to traffic. For the Reclamite product, a water truck followed the distributor truck and sprayed a small amount of water to help the Reclamite penetrate into the pavement easier. This caused the pavement surface to remain relatively slick for approximately two hours until the residue disappeared.

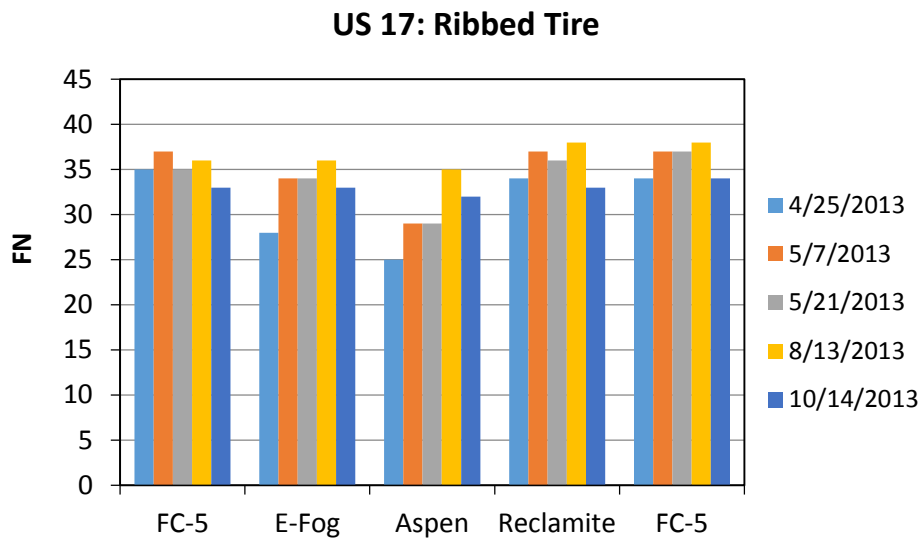
**FIGURE 7. Friction Test Results (Ribbed Tire) for US 17**

Based on the PCS survey completed six months after application, there were no distresses in any of the sections. The results from the friction tests are summarized in Tables 4 and 5, and Figures 7 and 8.

Although having slightly lower pavement friction immediately after application, the Reclamite sections have shown good friction numbers (FN) for all five tests; after one day, two weeks, one month, three months, and six months. The E-Fog FNs dropped slightly at the first evaluation and quickly recovered to be slightly lower than the control sections after a month. After three months,

the FN on the E-Fog section was the same as the control section. The Aspen sections had the largest FN drop initially and recovered somewhat. After three months, the FN is still much lower than the control section on US-27, but similar to the FN for the control section on US-17. In general, for all products as a whole, the FN decreased immediately after application and recovered through the first two weeks to three months, depending on the application rate.

- Pavement friction values dropped on all of the products immediately after application, but recovered after two weeks to three months. The recovery time varied by the product and application rate.
- The products with a rejuvenating agent (Reclamite and E-Fog) reduced the absolute viscosity by approximately 40 to 50% as compared to the control sections. Although the product without a rejuvenating agent also showed a viscosity reduction, the values are more varied than those from the other products. It is difficult to determine whether the softening is from rejuvenation or simply from dilution due to the addition of new materials.
- With the exception of the Reclamite, the fog seal applications all reduced the permeability. The reductions appear to be dependent upon the application rate.

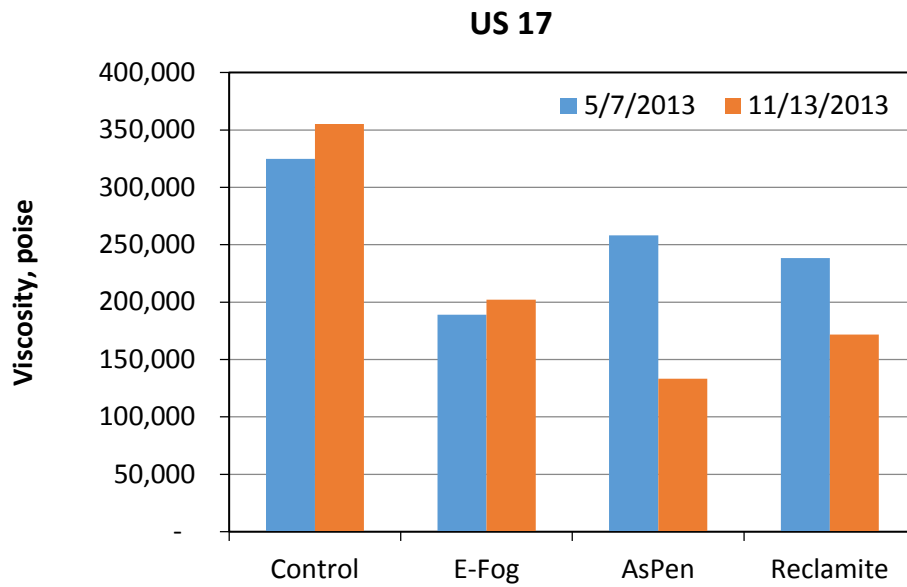
**FIGURE 9. Viscosity Test Results for US 17**

In an effort to determine how much rejuvenation had occurred in the FC-5 mixture, roadway cores were obtained from the sections and the binder was extracted in accordance with FM 5-524, recovered in accordance with FM 3-D5404, and then tested. Four cores were taken from the first 500 ft. and the last 500 ft. of each section. Figures 9 and 10 show the recovered viscosity results from US-17 and 27. The viscosity values from the cores taken on May 7 were from the absolute viscosity test (AASHTO T 202). The viscosity values from the cores taken on November 13 were from the Dynamic Shear Rheometer (DSR) test (AASHTO T 315). The reason why the viscosity was measured by the DSR after the first evaluation done by the absolute viscosity test, is that the PG grade was measured by using the DSR after cores taken on November 13 to determine the binder rejuvenation instead of the absolute viscosity. The control section represents an average of two sections for each site. All of the test sections with the fog seal application showed lower viscosities than the control section.

Tables 6 and 7 show the rate of viscosity reduction for the test sections with the fog seal application compared to the control section. Since the AsPen showed much lower viscosity for US-17 and higher for US-27 from the cores taken November 13, it is difficult to estimate how much softening effect is expected. However, the Reclamite and the E-Fog seem to be more consistent than AsPen in terms of the viscosity reduction. Based upon monitoring for six months, the Reclamite and the E-Fog reduced the viscosity approximately 40 - 50% as compared to the control section.

Since the asphalt rubber binder for US-17 cannot be fully extracted through the extraction process, the viscosities and high temperature PGs from US-27 resulted in much higher values than the ones from US-17.

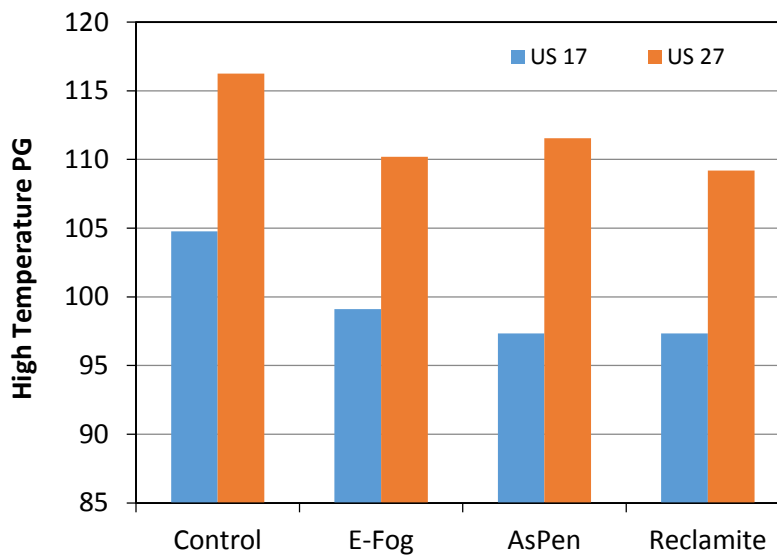
**FIGURE 11. Continuous PG Grade Test Results**

The continuous Performance Grade (PG) was determined on the recovered binders from the cores taken on November 13. These results are shown in Figure 11. All of the fog seal sections had high temperature PG grades that were 5 - 7°C lower than the control section.

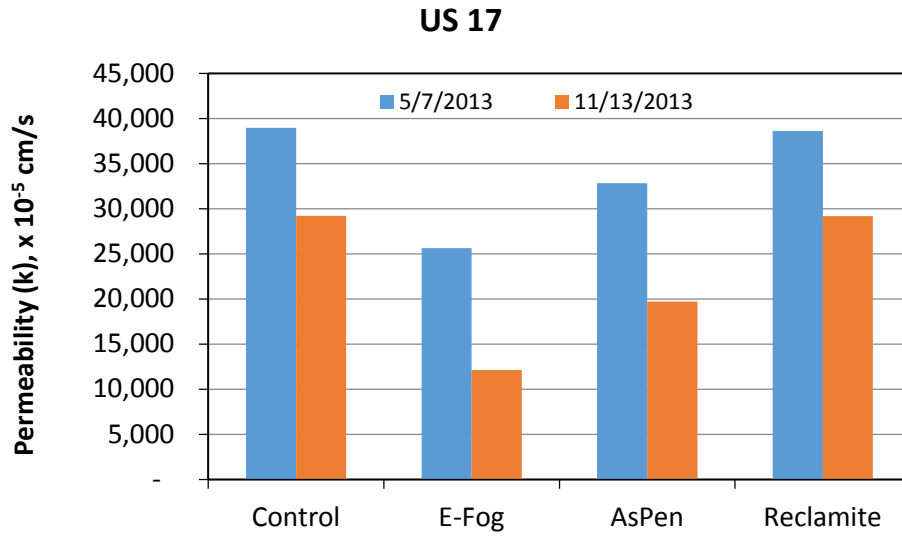
**FIGURE 12. Permeability Test Results for US 17**

The field permeability tests were also performed at locations near where cores were taken. For each location, three tests were performed and averaged. Figures 12 and 13 show the permeability test results from US-17 and 27, respectively. In general, US-17 has lower permeability than US-27, possibly due to the tighter aggregate structure. The E-Fog section showed the lowest permeability among the three products for US-17, since they used the same application rate as was used on US-27, while the other producers decided to reduce the application rate for US-17 due to the tighter aggregate structure than US-27. The AsPen product had the higher application rate than the others

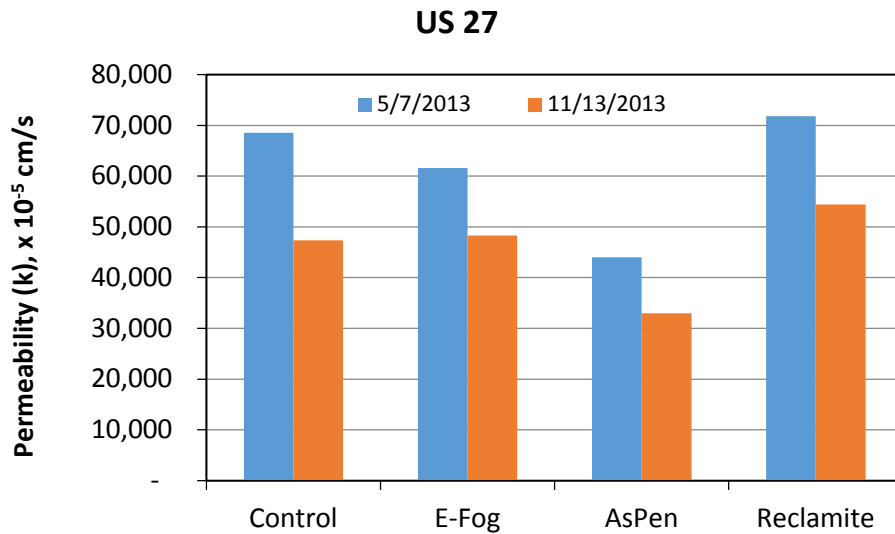
**FIGURE 13. Permeability Test Results for US 27**

on US-27 and it also had the lowest permeability. The Reclamite had minimal effect on permeability.
