Performance Evaluation of Graded Aggregate as a Base Material

FDOT Office
State Materials Office

Research Report Number
FL/DOT/SMO/13-562

Date of Publication
12/2013

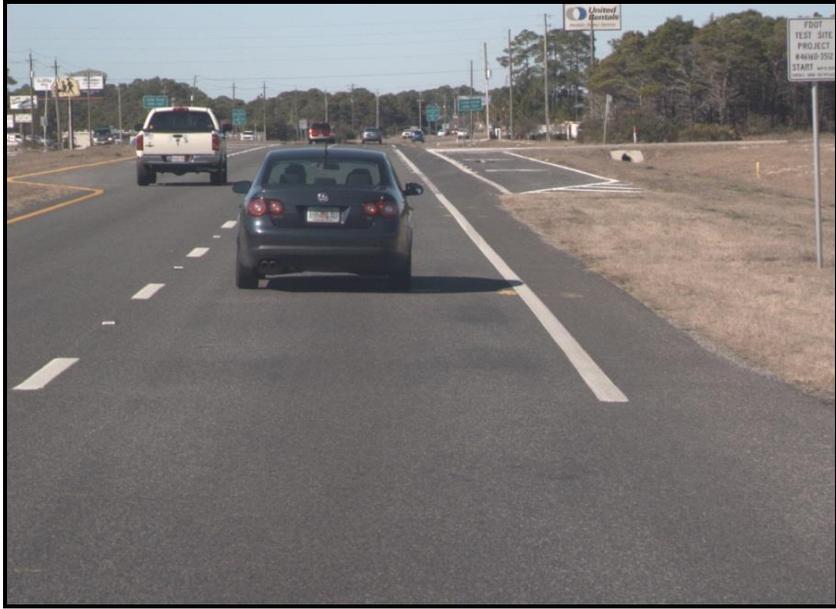
FIGURE 1. SR-30A at milepost 4.577

The experimental project was constructed in 1994 along the westbound travel lane of SR-30A, between Panama City Beach and the Walton County line. This four-lane divided highway consists of 12 foot lanes separated by a grassy median and four foot asphalt shoulders. The two test sections are 1500 feet long. The test sections were resurfaced in May of 2005. TABLE 2 describes the limits of the test sections, base material sources and the installed price for the GAB and limerock base. A photograph of the beginning of section 1 is shown in FIGURE 1. Also, FIGURE 2 summarizes the traffic loading that has been applied to the test sections.

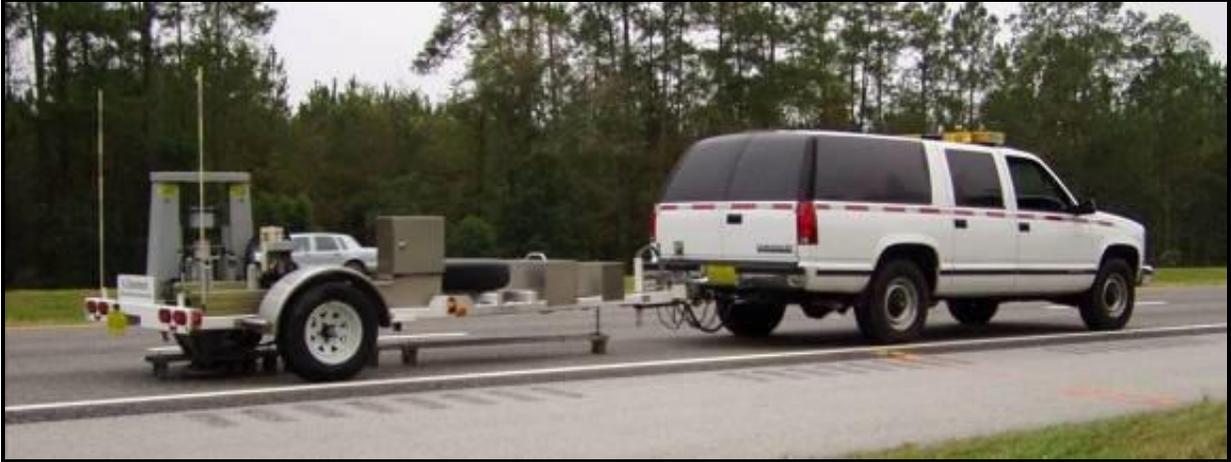
FIGURE 3. Falling Weight Deflectometer

Annual deflection measurements were conducted in the outside of wheel path for each lane. A photograph of a FWD is shown in FIGURE 3. A typical testing configuration includes the following:

- A 12 inch load plate
- A 9 kip applied load
- Deflection sensors placed at 0, 8, 12, 18, 24, 36, and 60 inches from the load plate
