SEAROBOTICS
CORPORATION

AWARE NovaRoam Radio Field Test Results

On Tri-Rail Train

October 12, 2001

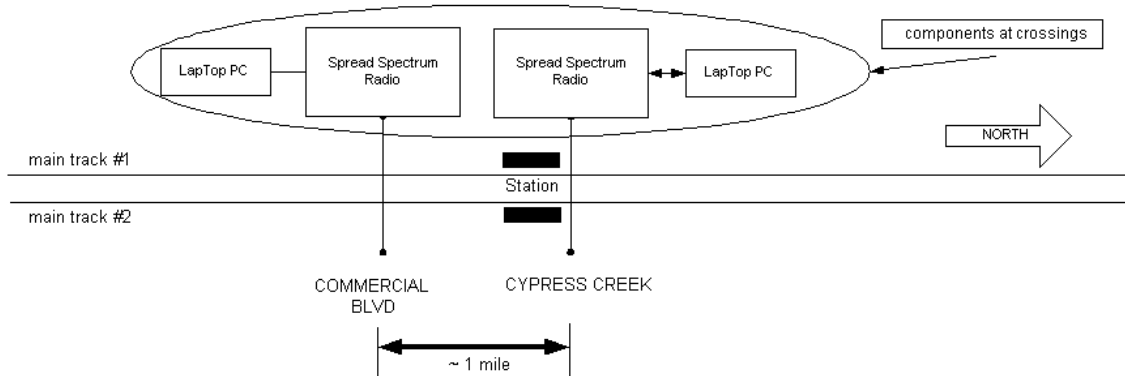
SYSTEM CONFIGURATION FOR AWARE PROJECT RADIO TEST ON TRI-RAIL TRAIN

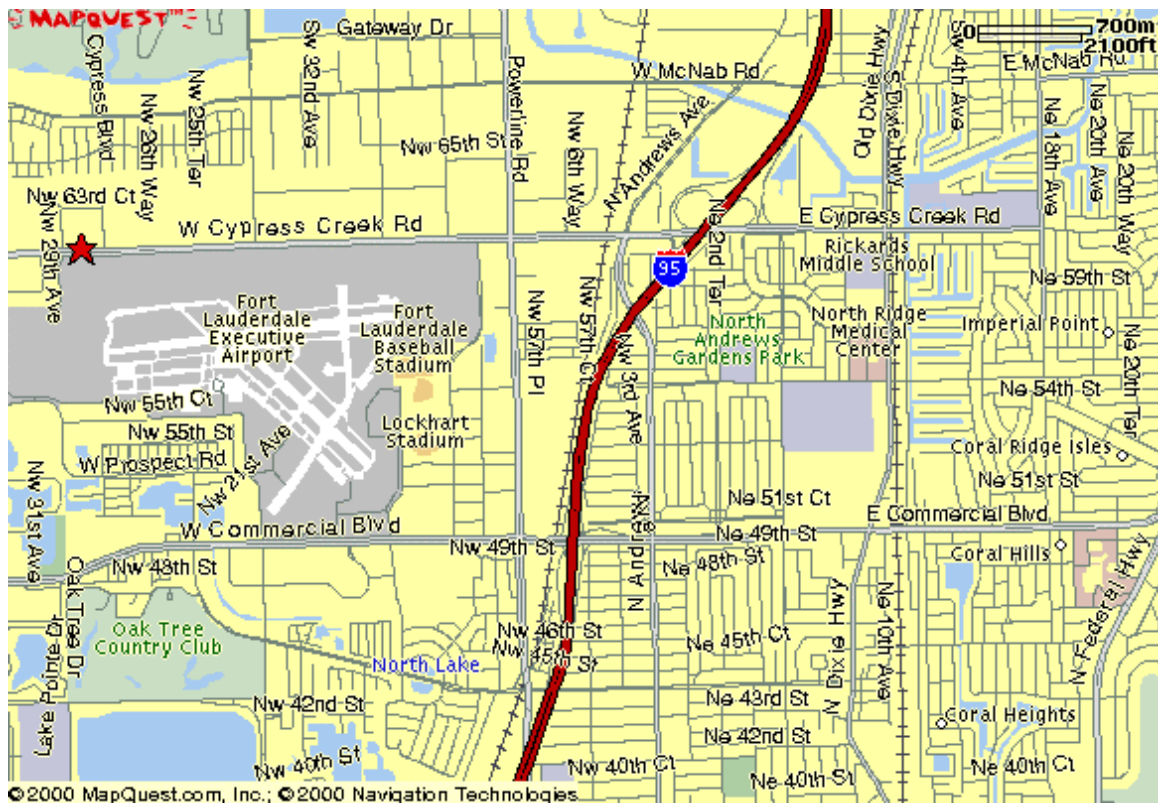
Figure 1: Railroad Crossing Sites

The MMIT and SMIT radios and laptop setups were installed in an automobile. The ACC setups were installed at the Commercial Blvd. and Cypress Creek railroad crossings and were connected to the pre-installed road crossing antenna on a 30 foot tower.

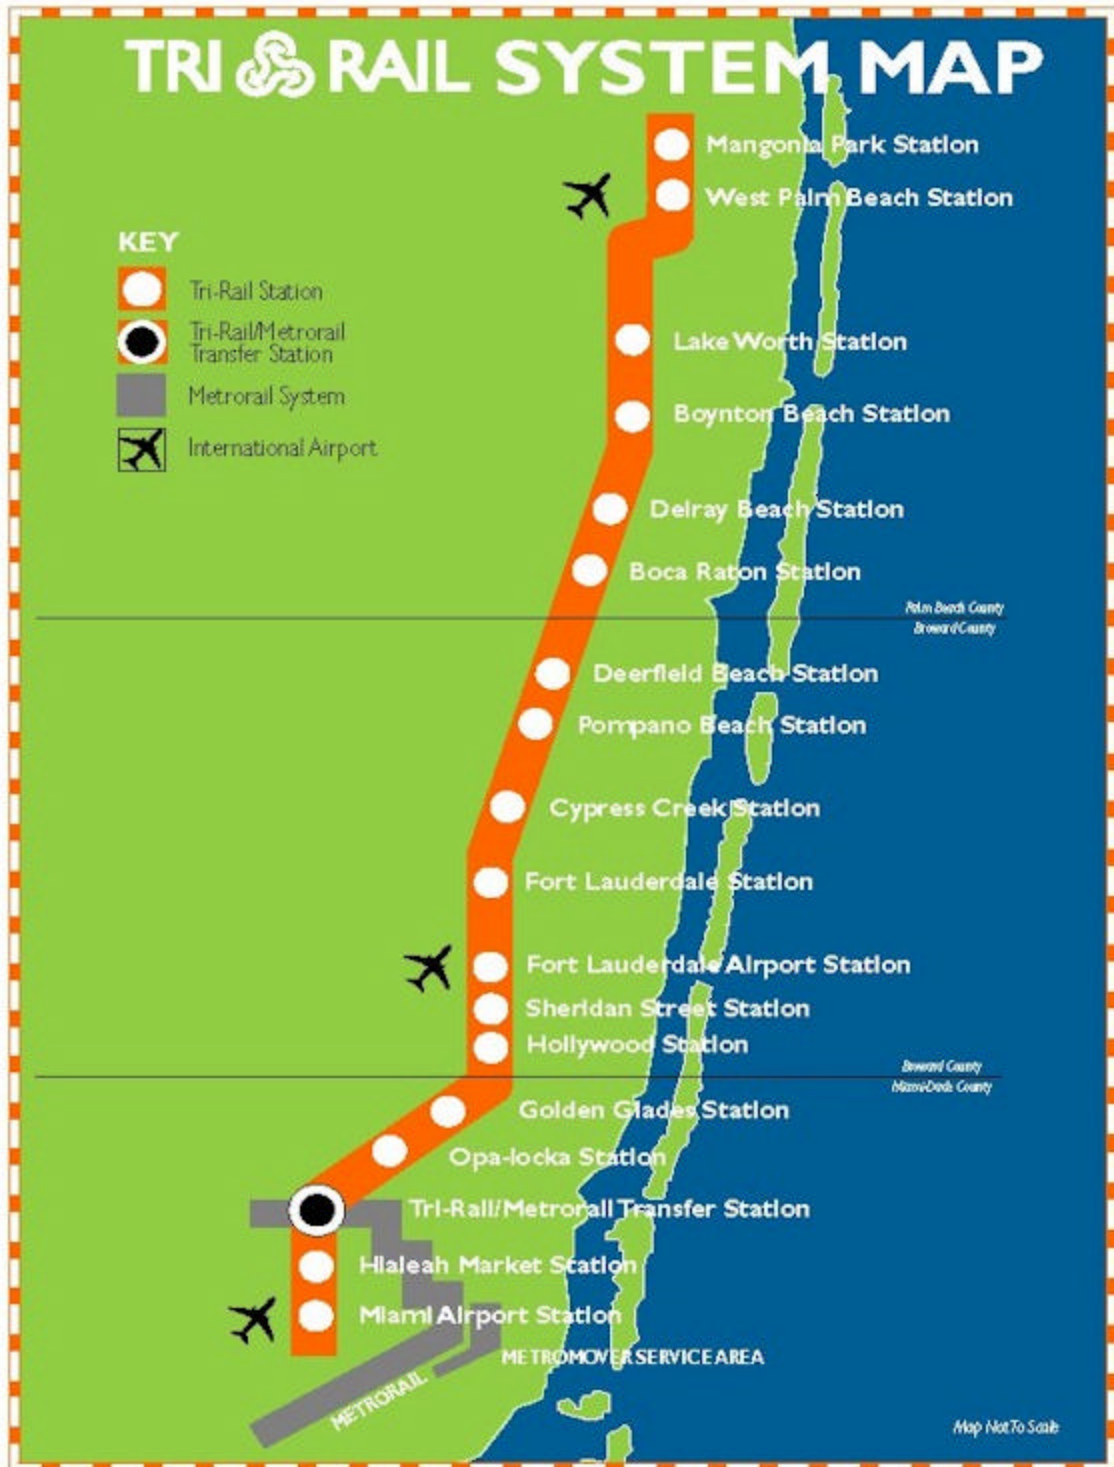
Figure 4: Tri-Rail System Map

The MMIT radio, laptop and a GPS receiver were installed in the locomotive of the Train. The SMIT radio, laptop and a GPS receiver were installed in the cab car of the train. The ACC setups were installed at the Commercial Blvd. and Cypress Creek railroad crossings connected to the pre-installed railroad crossing antenna.

The MMIT system repetitively pinged the ACCs and SMIT systems logging GPS and IP connectivity data. The train containing the MMIT and SMIT traversed the South Florida Tri-Rail tracks and data was logged from Mangonia Park to Miami Airport in a southerly trip and then from Miami Airport to Deerfield Beach in a northerly trip.

Figure 8 graphically shows the entire run from Mangonia Park south to Miami Airport. The two clear circles indicate where the two railroad crossing radios were installed. This data reflects the actual coordinates of the railroad tracks, similar to Figure 4: Tri-Rail System Map.

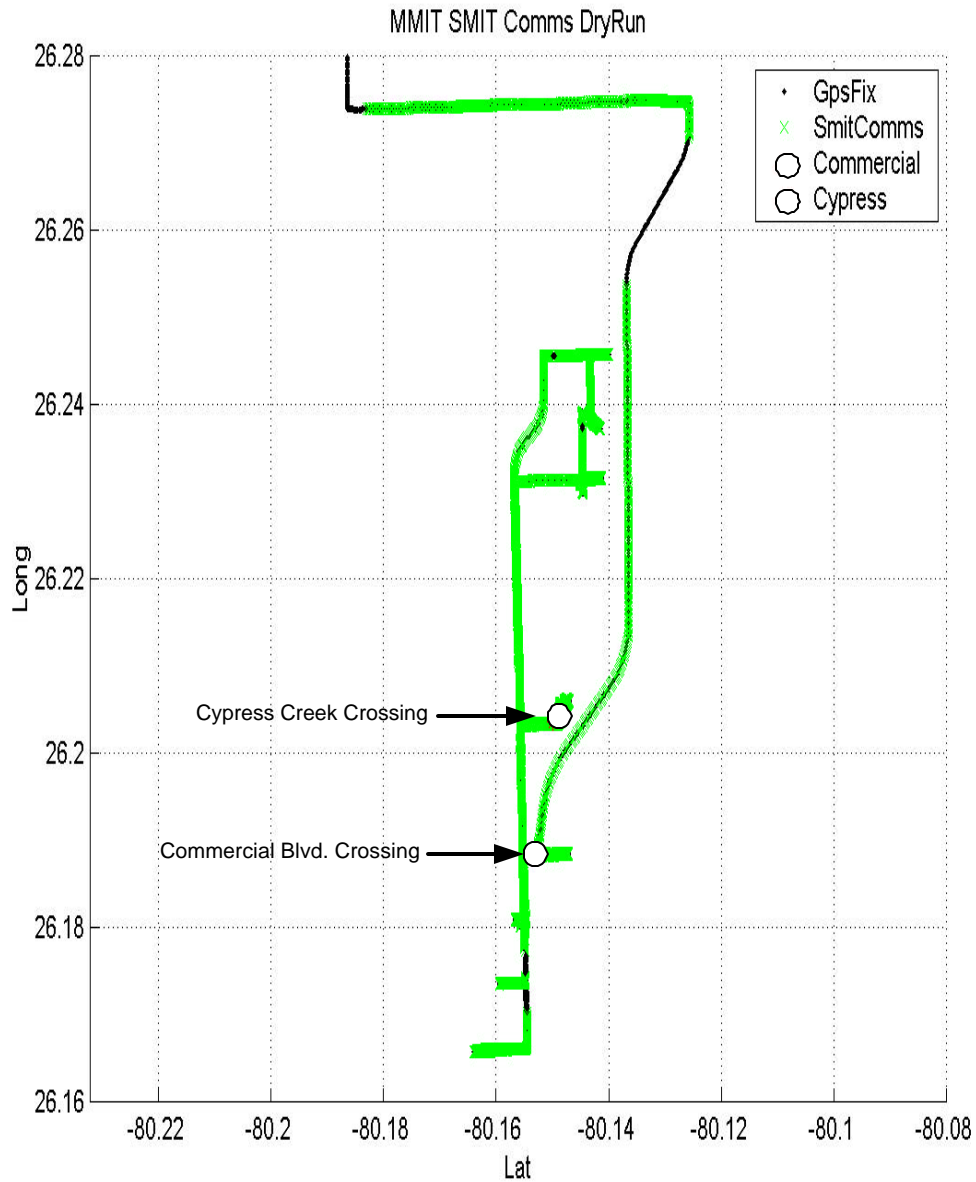
Figure 5: MMIT SMIT Comms Dry-Run

The following Figure 5. depicts the connectivity between the MMIT and the SMIT during the dry-run test. Green indicates successful pings and black indicates that communications were not successful.

The graph displays the route the vehicle with the MMIT and SMIT took during the dry-run test. See Section 4.2.3

During the transit in the automobile from SeaRobotics on Lyons Road in Coconut Creek to the first crossing at Commercial Blvd., there was a period where communications

between the MMIT and SMIT failed (the black line in the upper-right portion of the graph). Also, when traveling south of Commercial Blvd., there were two other brief stretches where communications were interrupted. It was at this location that a test was performed in order to determine the point at which the communications path was interrupted. The test involved having the MMIT laptop ping the SMIT radio, which was successful, indicating that there was a problem between the SMIT radio and the SMIT laptop. After checking the cabling between the two units, successful communications resumed. Although this may have been a coincidence, manipulating the wires between the SMIT radio and the SMIT laptop seemed to fix the problem during later testing.

The data in **Figure 5: MMIT SMIT Comms Dry-Run** indicated that communication to the north of the Cypress Creek crossing was relatively good, due to a clear line of sight. Communication to the south was relatively poor due to an abrupt turn in the tracks about 0.5 miles south of the Commercial Blvd. crossing.

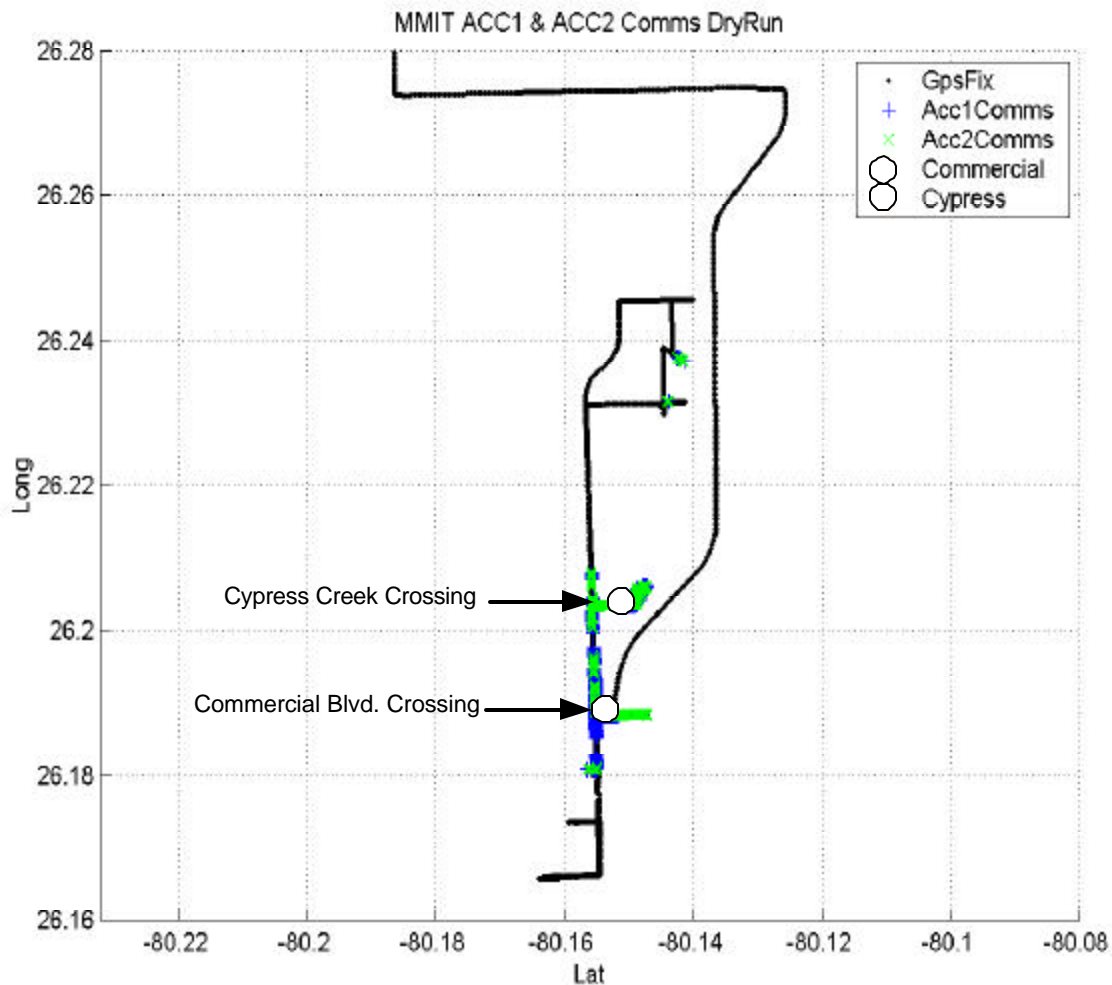
Figure 6: MMIT-ACC Comms Dry-Run

This graph displays the route the vehicle with the MMIT and SMIT took during the dry-run test. The first data points in the upper-left of the graph indicate the route taken from SeaRobotics east down Sample Road to I-95 and then to the first crossing at Commercial Blvd. where the first ACC (ACC1) was installed. The vehicle then traveled north up Powerline Road to the Cypress Creek crossing where the second ACC (ACC2) was installed. Tests were then conducted by traveling north and then east to a point where the road crossed the train tracks. Two other data points were taken further north until communications between the MMIT and the ACCs failed, indicating a relative range of the radios from a vehicle based MMIT. The vehicle then traveled south past Commercial Blvd to railroad crossings on intersecting roads.

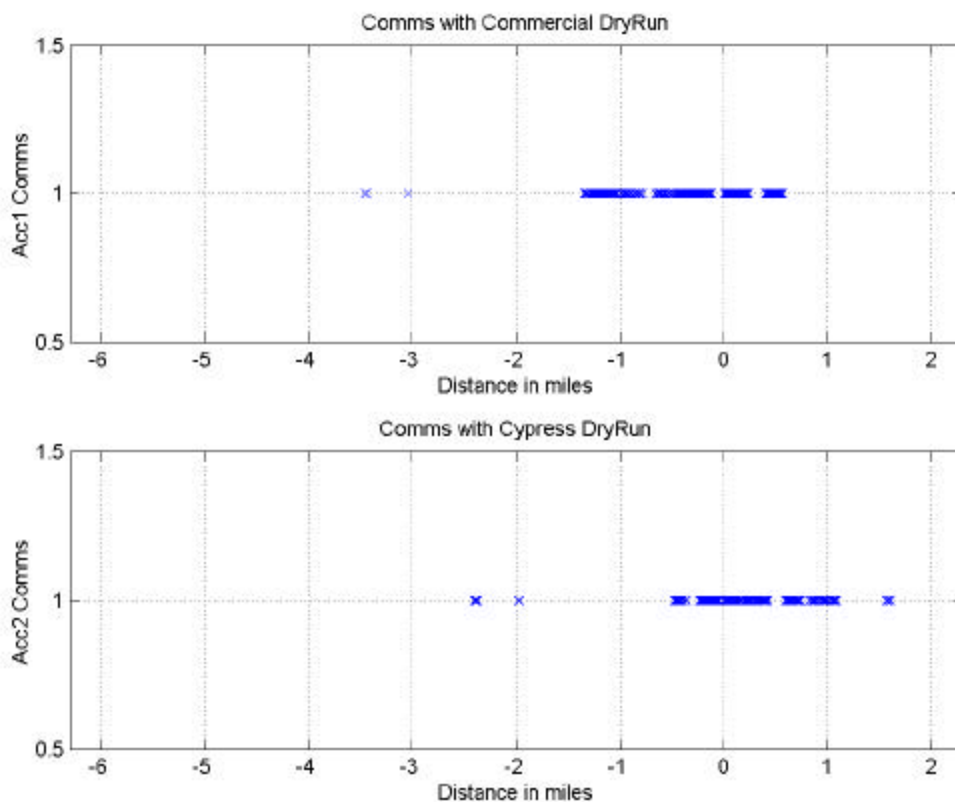
The above graphs indicate the relative range of the MMIT radio from the ACCs where successful communications were possible. The negative distances indicate range from the crossings to the north, the positive distances indicate range to the south of the crossings. ACC1 is Commercial Blvd., ACC2 is Cypress Creek. The blue data points indicate where a ping successfully reached its destination. If there was true line-of-sight between the MMIT and the ACCs throughout the test, then there would be a solid blue line indicating successful communication at all distances until a maximum range was achieved. Because the vehicle traveled on roads (and not along the tracks), the radios'

communication paths were blocked by buildings and foliage until the vehicle got to a railroad crossing where line-of-sight was re-established.

Specifically, the data in the lower graph of **Figure 7: MMIT-ACC Distance Dry-Run** indicates a communications range of approximately 2.5 miles to the north from the MMIT to the Cypress Creek (ACC2) crossing. The range of 3.5 miles to the north from the MMIT to the Commercial Blvd (ACC1) crossing indicates that the Cypress Creek radio was forwarding packets received from the MMIT to the Commercial Blvd. Radio at this point. This was then verified by tracing the route of the IP data. A range of approximately 0.5 miles was determined to be the maximum distance that the MMIT could communicate with the Commercial Blvd. crossing when going south because of loss of line of sight at the curve in the tracks.

Specifically, the data in the lower graph of Figure 7: MMIT-ACC Distance Dry-Run indicates a range of approximately 5 miles to the north from the MMIT to the Cypress Creek (ACC2) crossing. The range of 5 miles to the north from the MMIT to the Commercial Blvd (ACC1) crossing indicated that the Cypress Creek radio was forwarding packets received from the MMIT to the Commercial Blvd. radio. A range of approximately 0.5 miles was determined to be the maximum distance that the MMIT could communicate directly with the Commercial Blvd. crossing when south of that crossing.

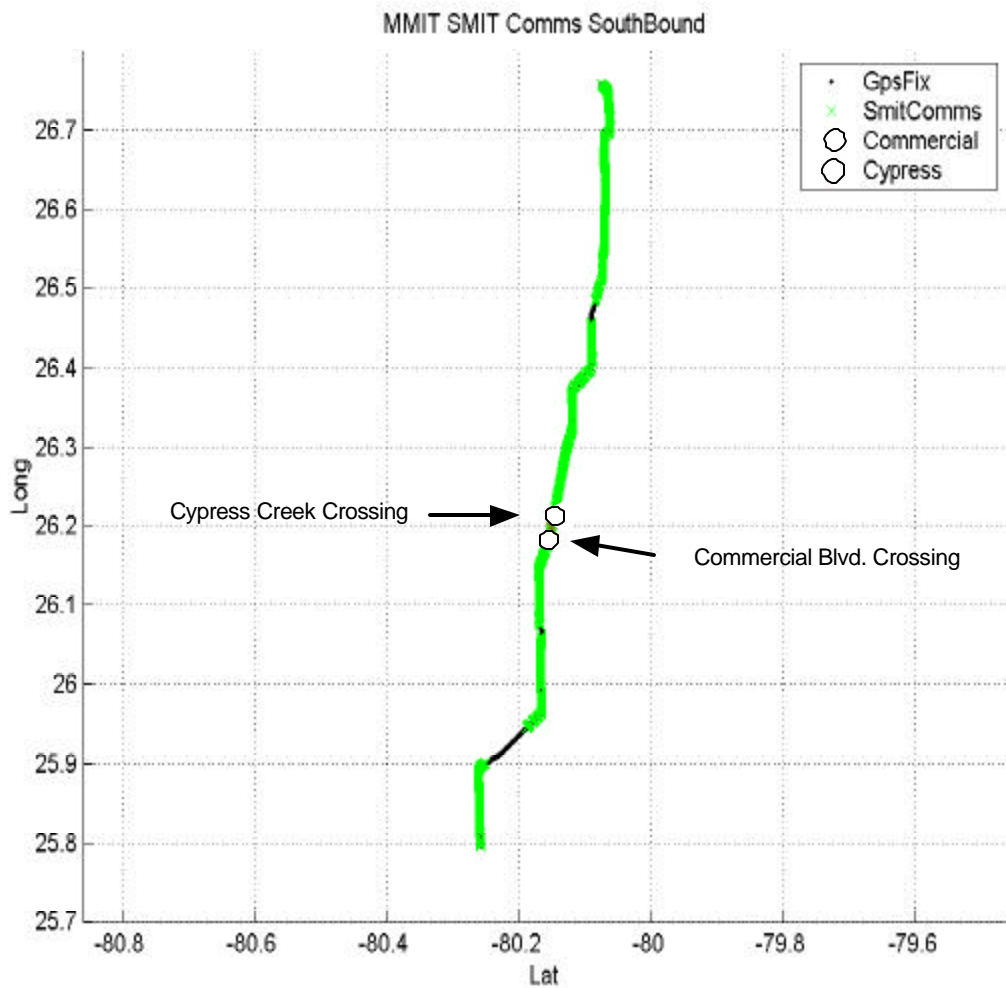
Figure 8: MMIT SMIT Comms Southbound

The following two figures indicate the connectivity between the MMIT and the SMIT on the train throughout the southbound leg. Green indicates successful pings and black indicates that communications were not successful.

From the data one can conclude that communications between the MMIT and the SMIT were in general very good. During the southbound and northbound run there were occasions where the MMIT laptop was unable to ping the SMIT laptop. During those times, a manual ping of the SMIT radio was conducted from the MMIT. All manual ping attempts of the SMIT radio were successful, indicating that radio communications were intact, yet that the communications path between the SMIT radio and the SMIT laptop was broken. It is currently believed that there was a physical connection problem between the SMIT radio (Serial Number 13174) and the Ethernet cable that connected to the

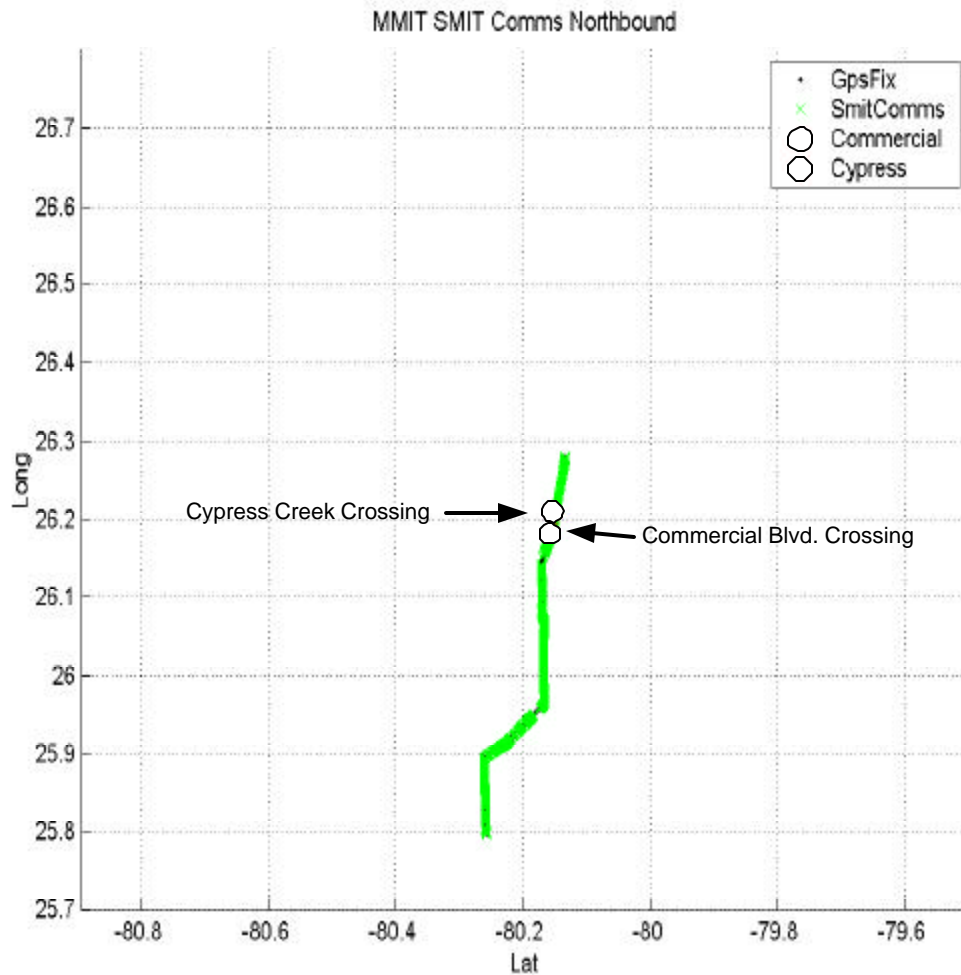
Figure 9: MMIT SMIT Comms Northbound graphically shows the shortened run from Miami Airport to Deerfield Beach, where data logging was stopped. The two clear circles indicate again where the two railroad crossing radios were installed.

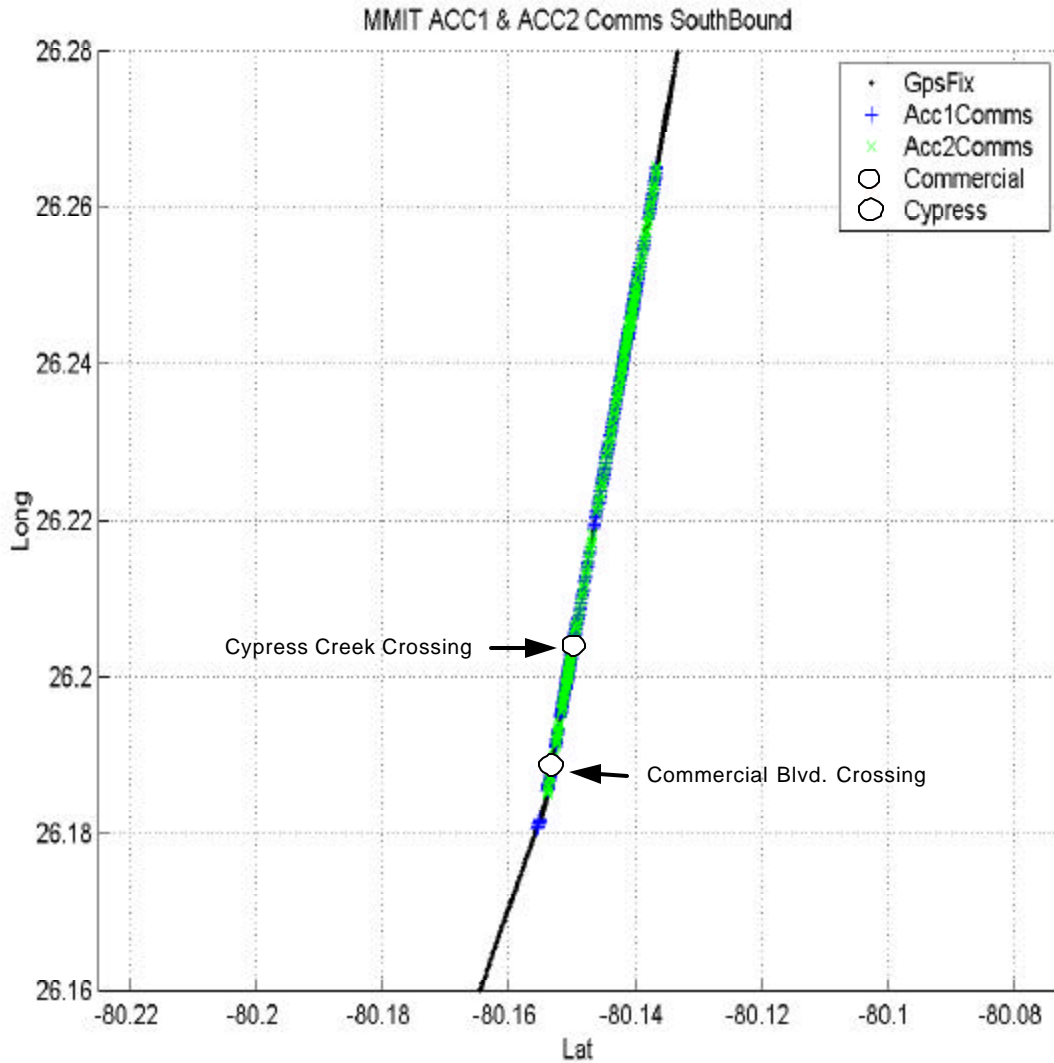
The following two figures indicate the connectivity between the MMIT and the SMIT on the train throughout the southbound leg. Green and Blue marks indicate successful pings with the Cypress and Commercial crossings and black indicates that communications were not successful.

Figure 10: MMIT-ACC Comms Southbound and Figure 11: MMIT-ACC Comms Northbound graphically show a zoomed-in portion of the track in the area of the Cypress and Commercial crossings (approximately 8 by 8 miles). The two clear circles indicate where the two railroad crossing radios were installed (distance between the two crossings is 1.06 miles).

The data in Figure 10: MMIT-ACC Comms Southbound and Figure 11: MMIT-ACC Comms Northbound indicates that communication to the north of the Cypress Creek crossing was very good, due to a clear line of sight and the increased height of the antenna on the locomotive. Communication to the south of Cypress Creek was relatively poor due to the abrupt turn in the tracks about 0.5 miles south of the Commercial Blvd. crossing. This data matches the data taken during the dry-run in the automobile but with increased range to the north.

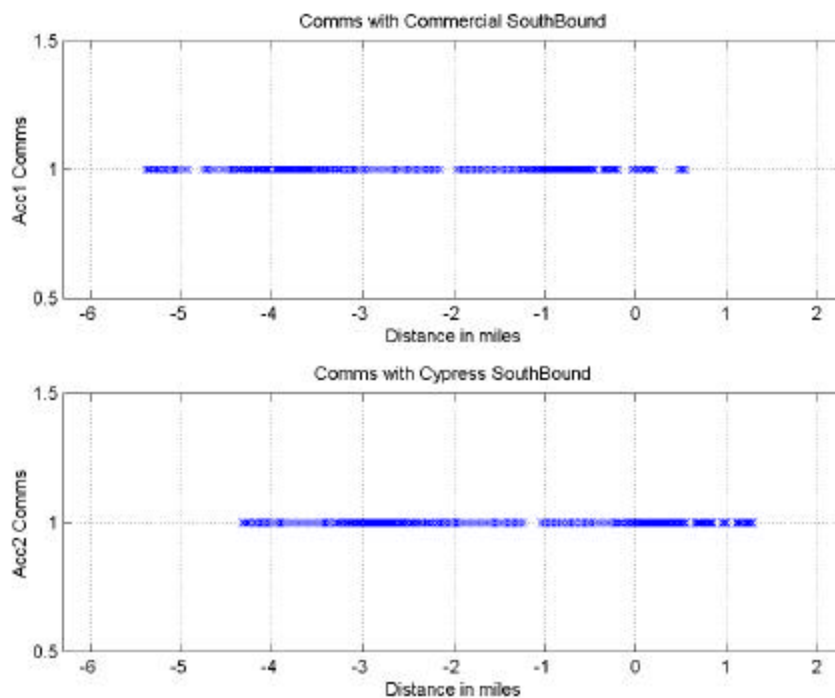
Figure 12: SMIT-ACC Distance Southbound and Figure 13: MMIT-ACC Distance Northbound graphically show the distance in miles when communications were established between the MMIT and the crossings. The negative distances indicate range from the crossings to the north, the positive distances indicate range to the south of the crossings. ACC1 is Commercial Blvd., ACC2 is Cypress Creek.

It is unclear why there are larger gaps in the range graphs (Figure 12: SMIT-ACC Distance Southbound and Figure 13: MMIT-ACC Distance Northbound). By comparing the Northbound with the Southbound runs, it can be concluded that the gaps do not appear to be related to a particular location. Small gaps could be attributed to interference.
