Research Showcase

florida department of transportation
Research Showcase

Research in Action: IMPROVING PEDESTRIAN SAFETY

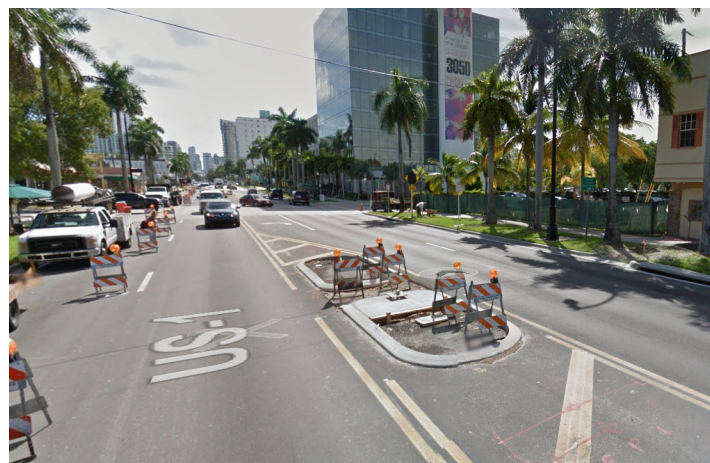
The Biscayne Boulevard corridor in Miami, specifically the intersection with NE 33rd St, was ranked the number one intersection for pedestrian crashes. Efforts to improve the safety of this location included new signage, high emphasis crosswalks, and mid-block pedestrian refuge medians. Source: Google Street View

at NE 33rd St in Miami, where 14 pedestrian crashes occurred between 2008 and 2012. At this location, Biscayne Blvd sees an average annual daily traffic (AADT) between 29,500 and 30,000 vehicles with a high concentration of pedestrian activity in the surrounding areas. Following a safety study, FDOT staff identified a number of improvements – including short-term, long-term, and non-infrastructure enhancements – that could be implemented to mitigate these crashes.

In the short-term, high-emphasis crosswalks were added to each leg of the intersection. Additional signage was installed, including “Turning Vehicles Yield to Pedestrians” and “Use Crosswalk” signs to alert both drivers and pedestrians. Similar enhancements are planned for other cross streets in this corridor.

Long-term solutions are either in progress or planned as part of a corridor improvement project. Medians on Biscayne Blvd are being added or reworked, including mid-block pedestrian refuge medians, and rapid rectangular flashing beacons are being installed to alert drivers to the presence of pedestrians. Permissive/protected left-turn facilities will also be added at the intersection with NE 33rd St.

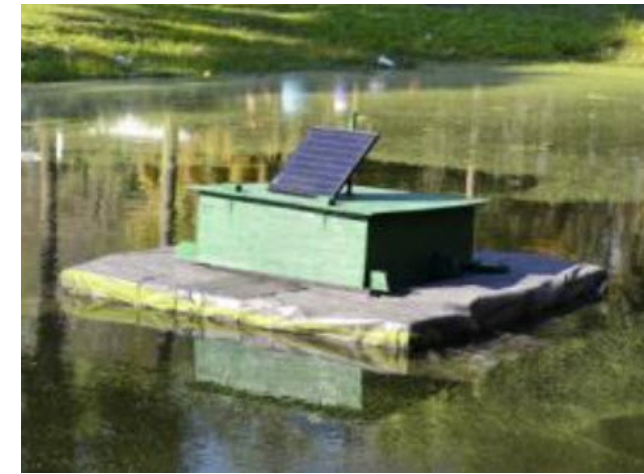
The solar panel on top of the floating media bed reactor installed in the East Palatka pond powers a pump that moves water through the filtration media and back into the pond.

In District 5, two ponds, one in East Palatka and one in Orlando, were chosen for study. The East Palatka pond was small, 0.11 acres, and experiencing high sediment loads, algae growth, and nuisance vegetation. A floating media bed reactor (FMBR) was installed approximately two thirds of the distance from the inlet to the outlet. The media mix in this reactor was made up of 50% sand, 20% tire crumb, 20% fine expanded clay, and 10% limestone. Like the Zolfo Springs reactor, the FMBR uses a solar pump to move water through the reactor. After six readings, soluble phosphorus was reduced by 37.1% and total phosphorus reduced at a rate of 52%.

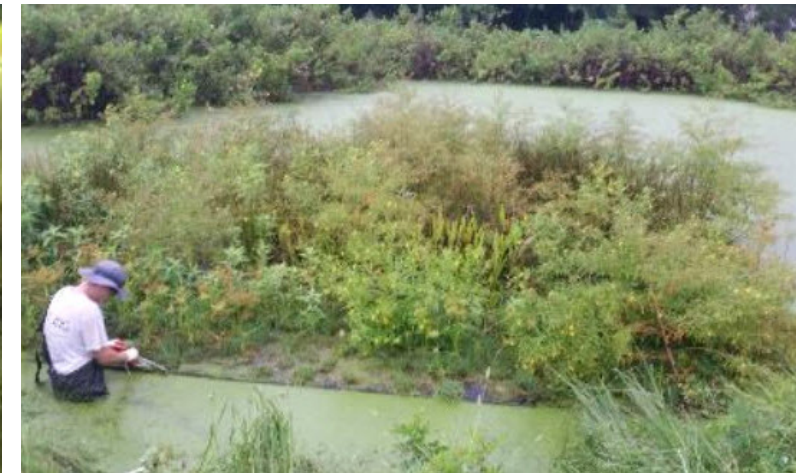
At the Ruskin pond, a researcher catalogs the health of the various plant species on the floating treatment wetlands installation. At this pond, invasive species were discovered, removed, and the filtration plants were replaced with seedlings.

The Ruskin pond studied is unique as it is bordered on the western and southern edges by active tomato fields. As such, this pond is exposed to very high nutrient concentrations as fertilizers are washed from the field into the pond, typically resulting in severe algae growth and a heavily overgrown littoral zone.

The researchers installed a floating treatment wetland in the Ruskin pond in January 2014. Over a seven-month period that included an even mix of

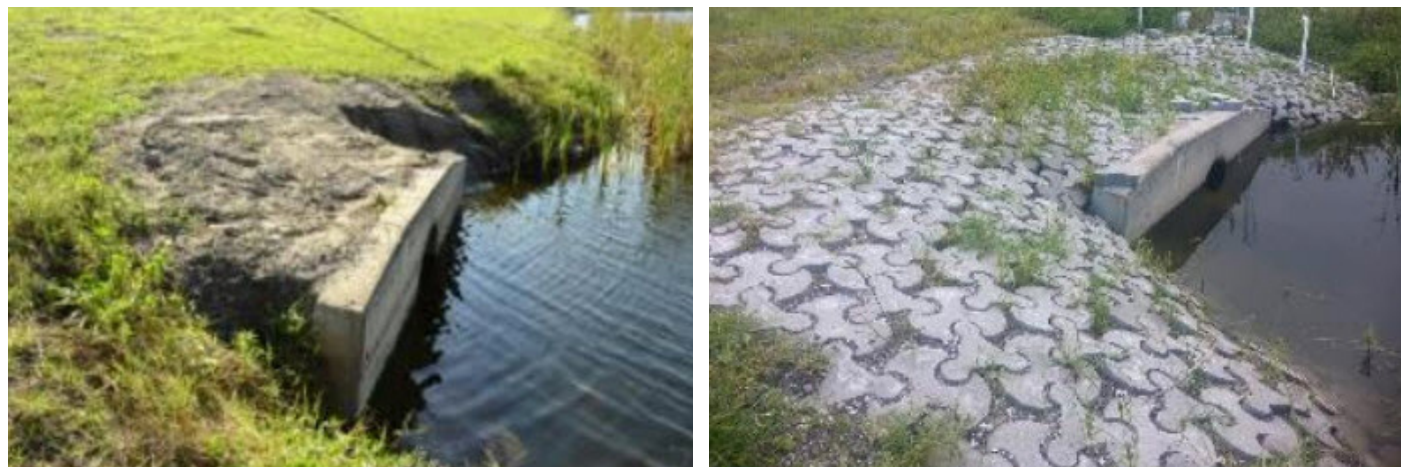
The Royal Palm Estates pond was experiencing severe erosion, as evidenced in the photograph on the left. After being graded, Tri-Lock, a concrete bank stabilization product was installed and vegetation allowed to grow in the cracks. In the months following installation, no evidence of erosion was found.

A larger pond, 1.69 acres, located immediately north of State Road 80 in Palm Beach County, was experiencing erosion problems, specifically erosion of the banks and at the inlet structure. Researchers chose to install Tri-Lock once water levels in the pond dropped enough to allow for construction. Tri-Lock is an interlocking concrete block system that forms a continuous, flexible retaining wall. Pre-cast blocks are installed over a geotextile base and provide reinforcement for an eroding bank.

The pond was monitored over the next year. No clear signs of erosion were noted, and vegetation was growing in and around the blocks, further improving the erosion control. Though Tri-Lock seemed to have a negligible effect on removing sediment levels in the water, construction in the area and seasonal fluctuations in the water level of the pond may have skewed the readings.

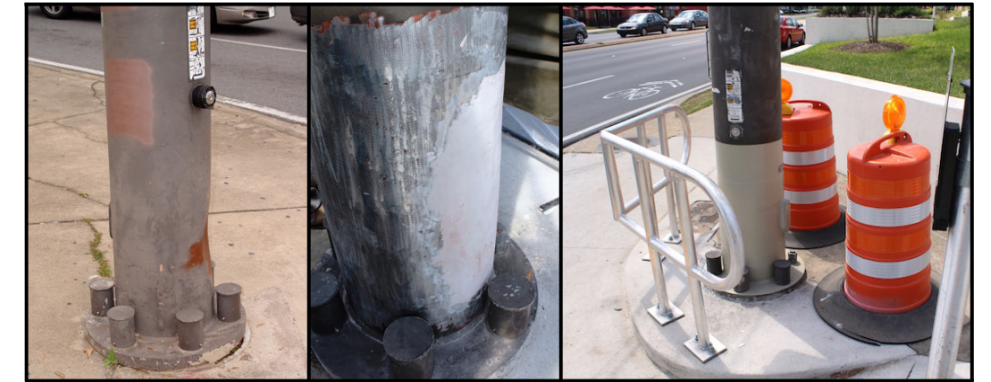
A dented utility pole in Tallahassee was chosen as a field test of the FRP pole repair system. Left: The pole was dented but still usable. Middle: After sanding, the dent is filled with epoxy. Right: After FRP application and painting, the pole is back in service without major maintenance of traffic operations.

filler material to restore the circular cross-section of the pole, a primer or adhesive layer, an impregnated FRP laminate, and a final coating to restore the pole's appearance.
