FY 2017-18
DESIGN STANDARDS

TEMPORARY DETOUR BRIDGE DETAILS
TIMBER PILE FOUNDATIONS

INDEX NO. 21610	SHEET NO. 1 of 3
---------------------------	----------------------------

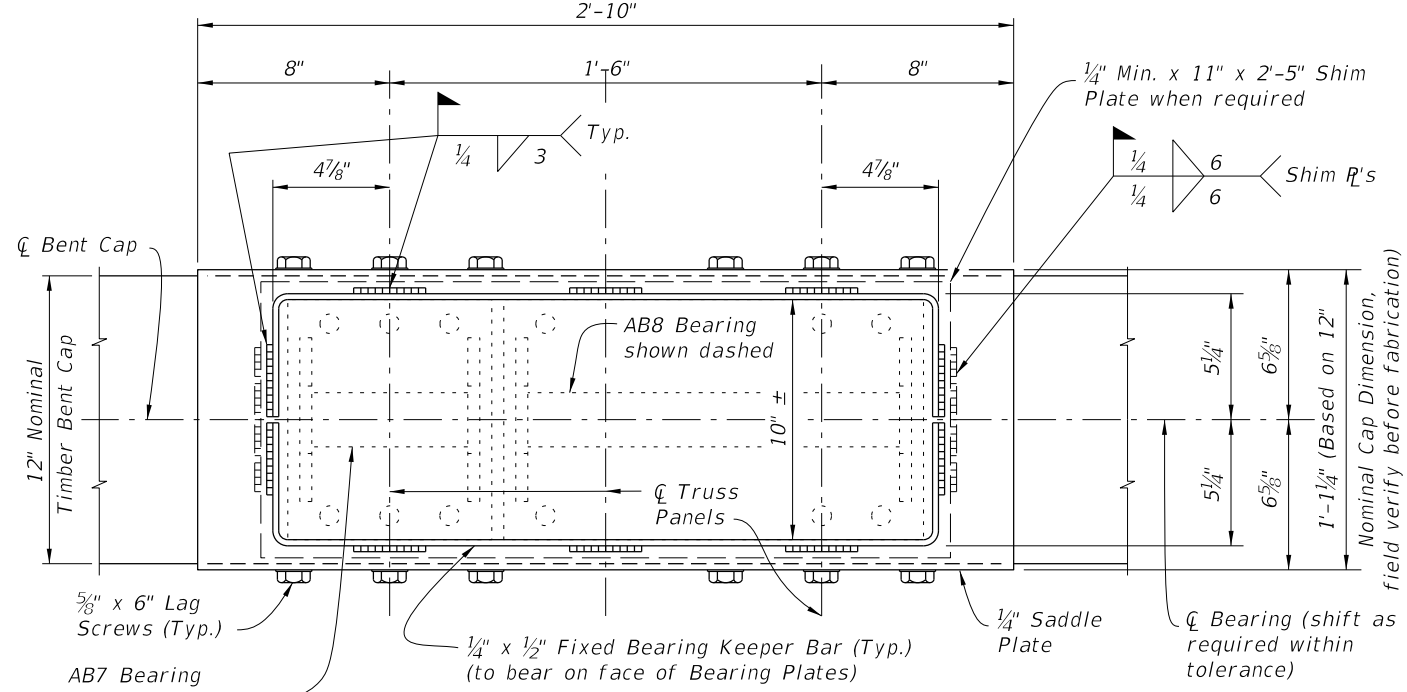
FIXED BEARING DETAILS

PLAN VIEW

ELEVATION VIEW OF SADDLE PLATE

END VIEW
