# An Evaluation of Flashing Crosswalks in Gainesville and Lakeland

**Herman Huang**  
University of North Carolina at Chapel Hill  
Highway Safety Research Center

*Florida Department of Transportation*  
November 2000

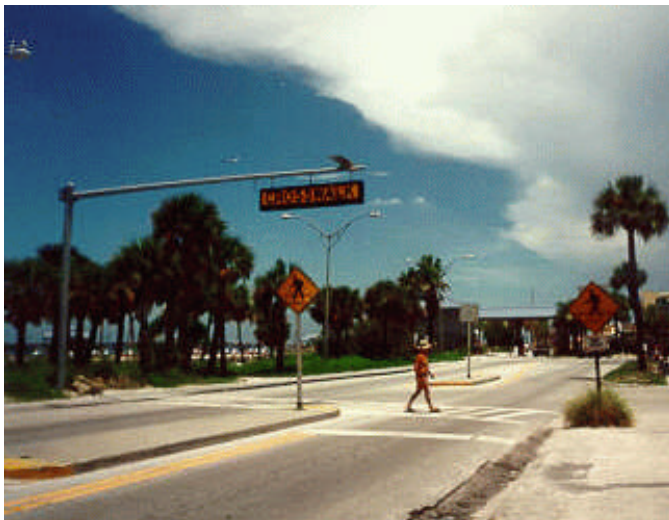
To enhance visibility at midblock crosswalks, cities may use high-visibility (continental) crosswalk markings, or they may install supplementary signs and devices. For example, Clearwater, Florida, uses an internally-illuminated overhead sign (Figure 1). Portland, Oregon, and several cities in New York State are experimenting with a YIELD TO PEDESTRIANS@ sign that is mounted on a traffic cone placed at the crosswalk, on the centerline of the roadway (Figure 2).

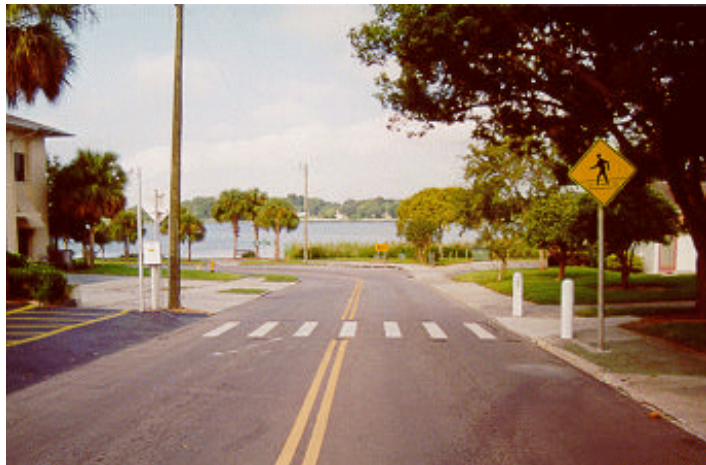
The crosswalk connects single-family houses to the north with Florida Presbyterian Homes (a senior citizens=home) to the south (Figure 6). Many senior citizens live in the houses and go to the seniors=home for meals and social activities. In-pavement flashers were added to the existing crosswalk at this location in July 1999 (Figure 7). Pedestrians activate the flashers by stepping in between bollards on the north side and by entering the microwave detection zone on the south side (Figures 8 and 9). Pedestrian activity is very light except when meals and social events are scheduled in the seniors=home.

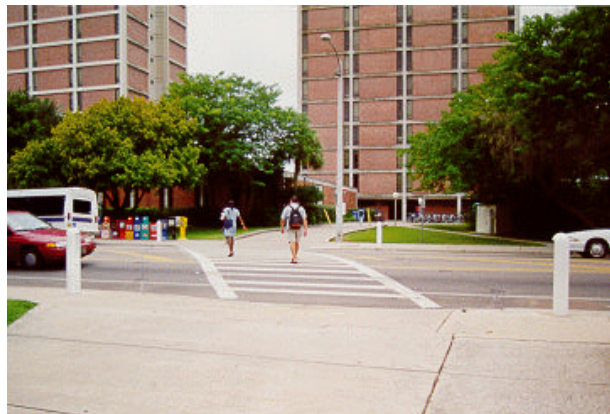
Museum Road is an east-west road with two through lanes, a painted median, and bike lanes on both sides. It is one of the main thoroughfares on the University of Florida campus. The speed limit is 20 mi/h (32 km/h) and the ADT is 14,500 vehicles per day. The in-pavement flashers were added to the existing crosswalk in August 1999. Pedestrians activate the flashers by walking in between bollards. There are also speed humps about 40 feet (12 m) upstream of the crosswalk in each direction. Pedestrian activity is steady and sometimes heavy during weekdays, when classes are in session.

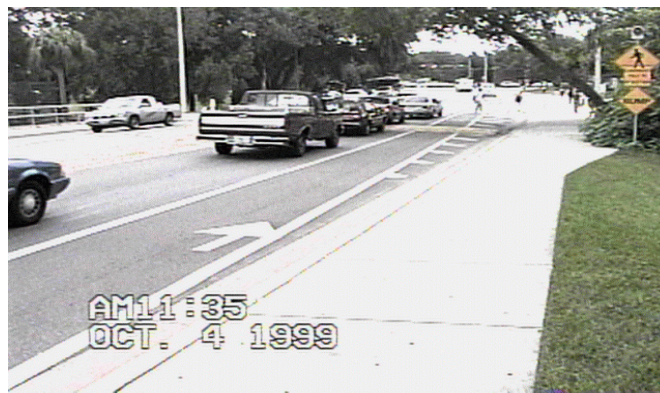
In Gainesville, most motorists yielded to pedestrians in the crosswalk (Figure 12 and Table A-1). However, the percentage was unexpectedly higher before the flashing crosswalk was installed than after (80.6 percent *Abefore@* vs. 74.6 percent *Aafter@*). Although this decline was statistically significant (chi-square statistic = 3.61, p-value = 0.057). It is not clear whether it is of *practical* significance. It is likely that the percentage of motorists who yield varies somewhat from one day to another. More important, the flashing crosswalk was installed immediately before the start of a new academic year. Therefore, the *Aafter@* data were collected soon after a new academic year had started, at a time when many newcomers were present. As motorists, these newcomers may not have been familiar with driving in a university setting and how to react when they saw pedestrians in the flashing crosswalk. As pedestrians, these newcomers may not have been familiar with the location of the flashing crosswalk and when it was appropriate to cross the street.

Only a minority of motorists yielded to pedestrians in the crosswalk in Lakeland (Figure 12 and Table A-2). Although the percentage of motorists yielding to pedestrians was higher after the flashing crosswalk had been installed (18.2 percent *before* vs. 29.7 percent *after*), this increase was not statistically significant (chi-square statistic = 1.51, p-value = 0.220). The lack of statistical significance is most likely the result of smaller sample sizes in Lakeland, compared to Gainesville. As sample sizes increase, the chi-square statistic becomes more sensitive to relatively small percentage differences.

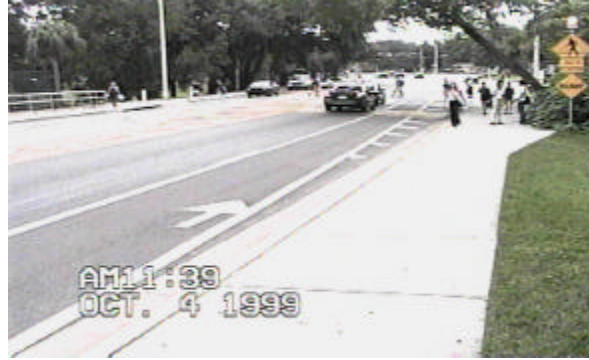
In Gainesville, fewer pedestrians had the benefit of motorists yielding to them after the flashing crosswalk was installed (85.1 percent **Abefore** vs. 55.4 percent **Aafter**) (Figure 14 and Table A-3). This decrease was significant (p-value = 0.000).

The flashing crosswalk in Lakeland resulted in more pedestrians who benefitted from motorists yielding to them (15.8 percent **Abefore** vs. 41.0 percent **Aafter**) (Figure 14 and Table A-4). This increase was significant (chi-square statistic = 6.01, p-value = 0.014).

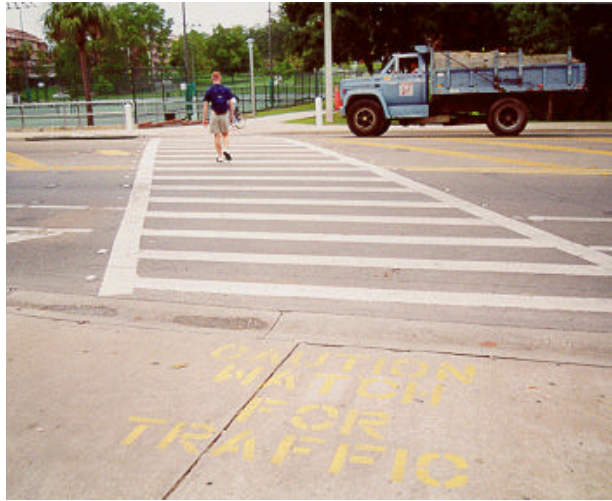
pedestrians using the crosswalk, so that they would benefit from motorists yielding to them (Figure 16).

The chi-square statistic was used to compare the percentages of pedestrians who crossed in the crosswalk. The vast majority of pedestrians at both locations crossed within the crosswalk (Figure 17 and Tables A-7 and A-8). The slight decrease in Gainesville was statistically significant (chi-square statistic = 3.23, p-value = 0.072) but is probably not of *practical* significance for two reasons. First, even with the decline, 95.0 percent of pedestrians still used the crosswalk. At such high levels of crosswalk usage, there is not much room for improvement. Second, the chi-square statistic becomes more sensitive to small percentage differences when the sample sizes increase. The improvement in Lakeland was also significant (chi-square statistic = 11.050, p-value < 0.001).
