Florida Department of Transportation

New Directions for Florida Post-Tensioned Bridges

Volume 1 of 10: Post-Tensioning In Florida Bridges

February 15, 2002

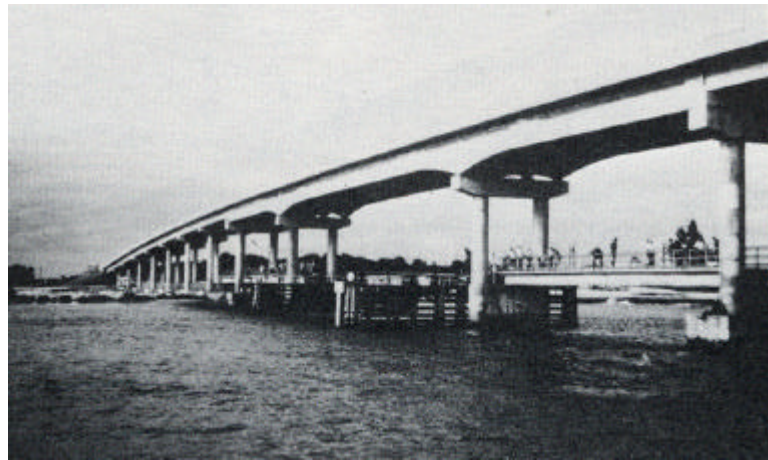
Figure 1.1 - Sebastian Inlet Bridge

Though eventually built as a totally pretensioned bridge, the Sebastian Inlet Bridge (Figure 1.1) represented a significant early Florida post-tensioned bridge design. The bridge is a statically determinate, cantilever and suspended span structure with side spans of 100 feet and a main span of 180 feet.

The superstructure of the three-span main unit is made of variable depth I-girders. Each line of variable depth I-girders is made of 5 precast beam elements. The end beams reach from the side piers to splice locations 35 feet from the main piers. The 65-foot long cantilever beams located over the channel piers vary from 6 feet to 9 feet in depth are spliced with the end beams, and cantilever 30 feet into the main span. The fifth beam is a 120-foot pretensioned drop-in beam supported by cantilever beams resting on the main piers. During construction, temporary bents supported the elements in the side-span prior to pouring the closure joints (Figure 1.2).

The end beams of the side spans and the drop-in span were designed to be entirely pre-tensioned with 0.5-inch diameter straight and deflected (depressed) strands. The variable depth portion that cantilevers over each pier was designed to be post-tensioned using 15 tendons each comprising 18 wires of 0.196-inch diameter high strength steel. The tendons draped over the top at the pier and anchor at the ends of the variable depth cantilever portion. Two of these tendons were to be post-tensioned after casting for shipping and erection - the rest were post-tensioned in phases as the construction of the deck proceeded.

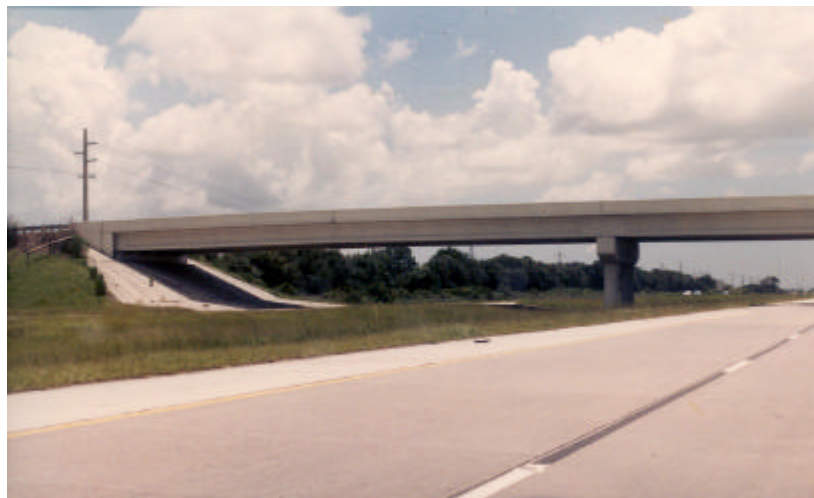
Figure 1.3 – Chipola Nursery Road Bridge over I-10

Chipola Nursery Road Bridge over I-10 near Marianna (Figure 1.3) represents Florida's first use of draped post-tensioning tendons installed in the webs of precast pre-tensioned AASHTO girders. This bridge, designed by the FDOT Central Office, is a two span continuous girder bridge superstructure. Tendons run from one end of the bridge to the other through four AASHTO Type IV precast girder sections. The four girder sections are connected by three cast-in-place concrete connections, two at the mid-spans and one over the median pier. Temporary piers were used to support the girder elements during construction. All tendons are internal and grouted after post-tensioning.

The continuity achieved through the addition of the post-tensioning allowed longer span lengths and eliminated permanent piers adjacent to the outer shoulders of I-10. As a result of the success of this project, the two span continuous girder concept was successfully adopted for subsequent structures in Florida.

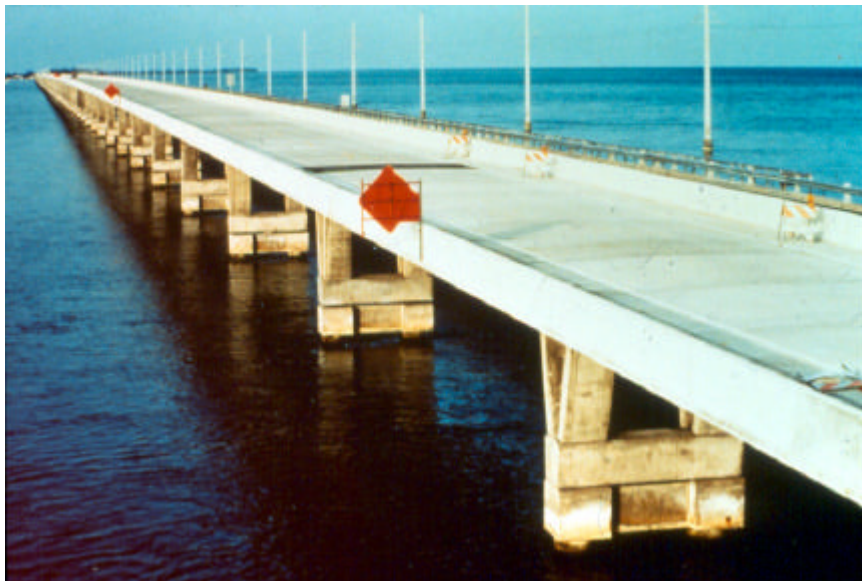
Figure 1.4 – Long Key Bridge

The first application of span-by-span construction in Florida, as well as the United States, was in 1979 for the Long Key Bridge (Figure 1.4). Three other bridges in the Florida Keys, the Seven Mile, Channel Five, and Niles Channel Bridges were subsequently built using the span-by-span method. Spans of 118 feet were selected at Long Key to match the span of two arches of the adjacent existing highway (and previously rail) bridge that was to remain a local recreational amenity. The same superstructure cross section used for the Long Key Bridge was used for the Seven Mile Bridge; however, longer spans of 135 feet were selected for the Seven Mile Bridge. During construction, the anticipated rapid rate for span-by-span erection was achieved in these bridges. Additional cost savings for these bridges were made possible by using smaller piers and foundations. Wide pier caps and multiple columns that are normally required for beam and slab construction are not needed in segmental construction using trapezoidal box girders.

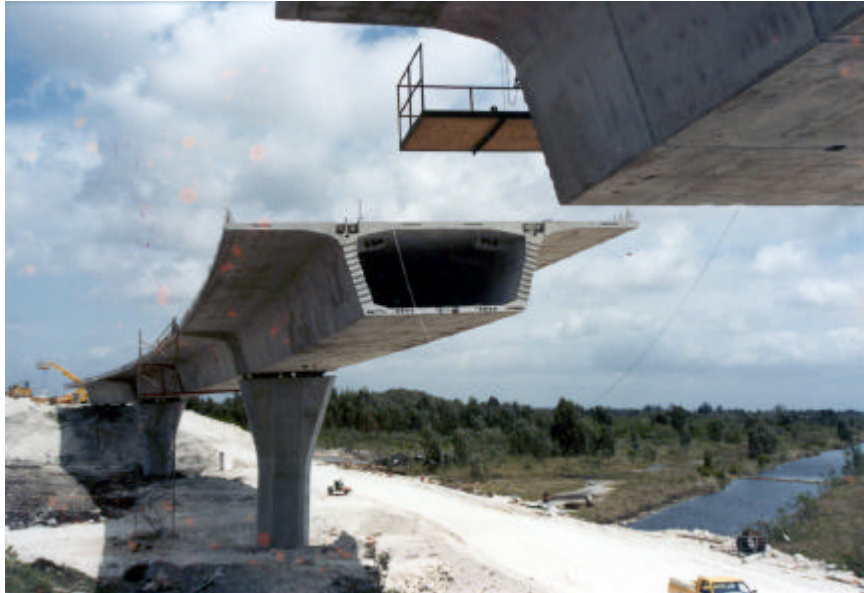
Figure 1.5 – Ramp I Bridge

As work progressed in the Florida Keys, the first precast segmental balanced cantilever bridge in Florida, carrying Ramp I over the I-75 (1984) was constructed. The Ramp I Bridge (Figure 1.5) is a 9-foot 4-inch deep, trapezoidal box girder with continuous spans up to 224 feet. The

balanced cantilever method of construction begins with the placement of the pier table, the precast elements directly over the supporting pier. Matching pairs of segments, one on either side of the pier table, are erected and post-tensioned to the pier table with cantilever tendons. Temporary support frames adjacent to the pier provide stability to the growing cantilever. When cantilevers from adjacent piers reach mid-span, a concrete closure joint is poured and continuity tendons stressed, completing the span.

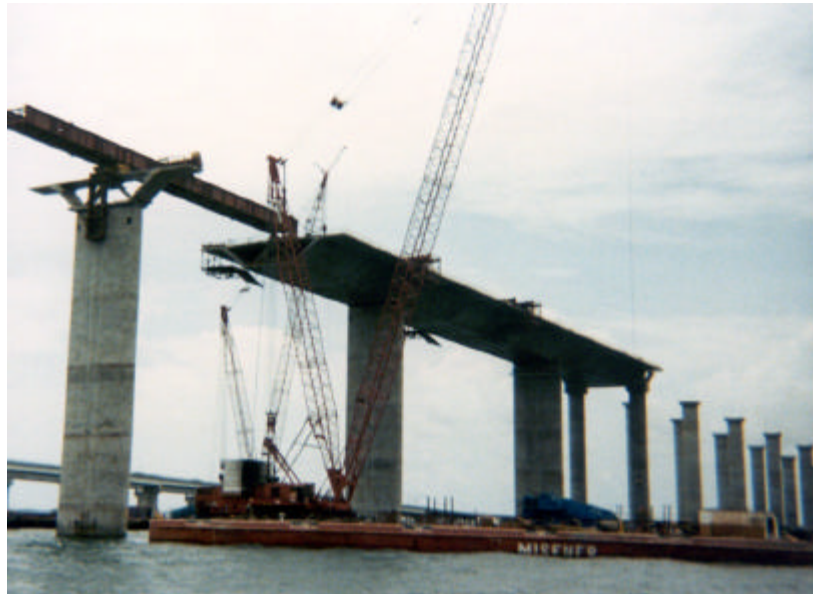
Figure 1.6 – Balanced Cantilever Side Spans of the Sunshine Skyway Bridge

Contemporary with the above projects in south Florida, the side-spans adjacent to the cable-stayed spans of the New Sunshine Skyway Bridge (1987) (Figure 1.6) were erected in precast balanced cantilever. A beam and winch system fabricated specifically for the project lifted precast segments weighing up to 300 tons while stabilizing beams spanned from one pier to the next, carrying temporary out-of-balance effects during construction.

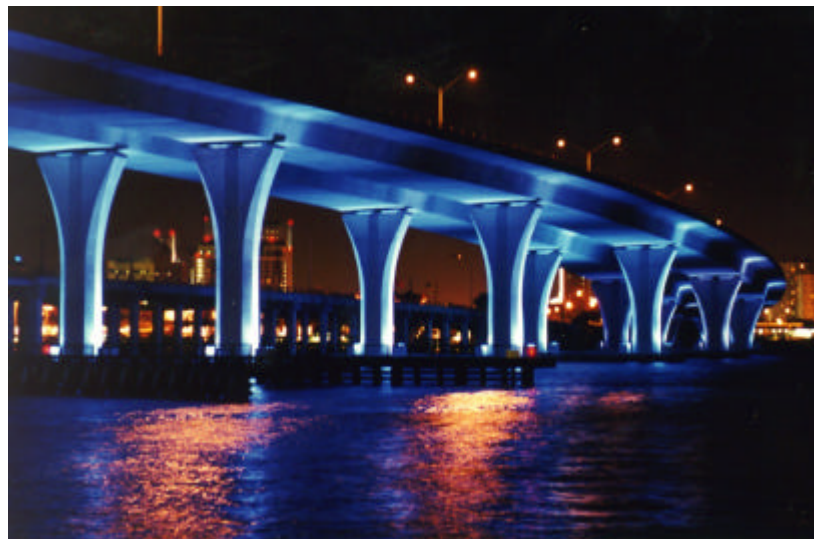
Figure 1.7 – Dodge Island Bridge at the Port of Miami

The Dodge Island, Bridge (1991), shown in Figure 1.7, was the first bridge built in Florida having precast segments with three webs. Two parallel structures carry the eastbound and westbound roadways of this important connection to the Port of Miami. The 3-web box was chosen to carry the 58-foot wide bridge deck of each structure. Span lengths range up to 220 feet using a constant depth box of 9 feet 3 inches. Each bridge is approximately 2,500 feet long and is divided into two continuous units with an expansion joint centered at an interior pier rather than at a quarter point. Segments were precast off-site and erected using a barge mounted crane.

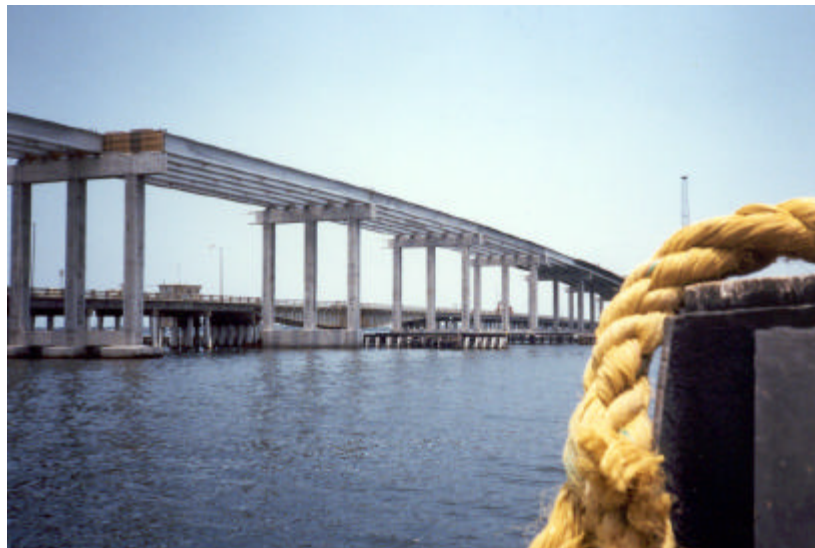
Figure 1.8 – Eau Gallie Bridge

The concept of using post-tensioning in I-girders, originally used in the late 1970's (Section 1.2.1), was applied by FDOT to develop Florida Bulb-Tee girder bridges. Eau Gallie Bridge (Figure 1.8), completed in 1988, was the first Florida bridge built with continuous bulb-tee girders. These precast girders combine straight pre-tensioning strands in the bottom flange and post-tensioning tendons of multiple strands draped in the webs. Each girder was pre-tensioned sufficiently at the precast plant to carry its own weight for transport and erection. When erected, it was made continuous with the beam in the next span through a cast-in-place joint that was a part of the transverse diaphragms connecting the ends of the beams over each interior pier. Longitudinal post-tensioning tendons extend and drape through four continuous spans in ducts cast into the webs and spliced over the piers. The post-tensioning tendons were stressed in phases; one half of the tendons were stressed before the deck slab was cast and the other half afterward. All tendons are internal and were grouted after stressing.

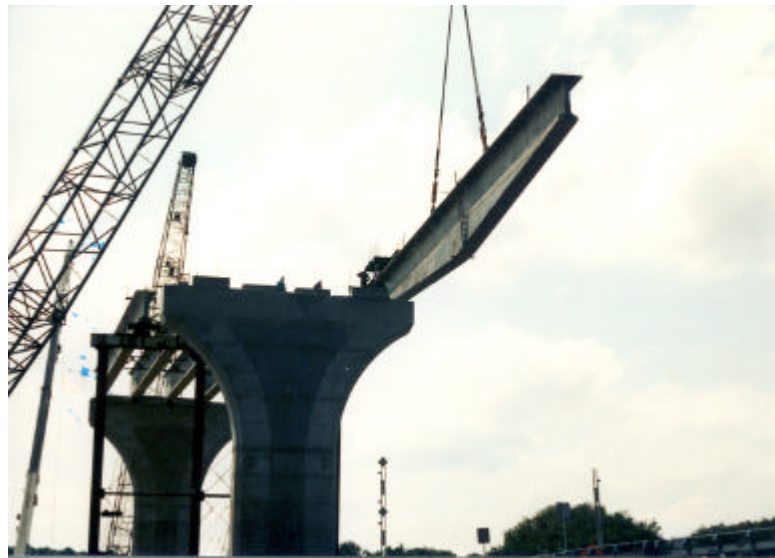
Figure 1.9 – Flagler Beach Bridge, Flagler County

The method of making bulb-tee girders continuous through the use of post-tensioning has been extended from constant depth bridge units of repetitive span length to variable depth precast cantilever girders made continuous by post-tensioning through cast-in-place splices. The approach to construction is very similar to the early Sebastian Inlet Bridge and the Dupont Bridge, except that the central precast element is made integral with the remainder of the precast girders using post-tensioning tendons that run the full length of the three-span unit. Figure 1.9 shows the placement of one of the variable depth precast girders for the Flagler Beach Bridge in Flagler County. This method has allowed the construction of three span units with central spans up to 320 feet.

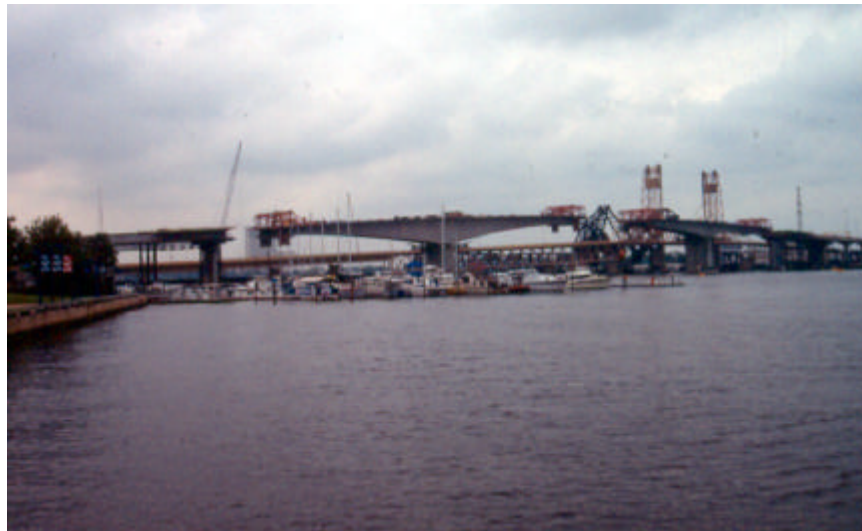
Figure 1.10 – Acosta Bridge in Jacksonville, Florida

Currently, the Acosta Bridge in Jacksonville (1992) (Figure 1.10) is the only cast-in-place segmental balanced cantilever bridge in Florida. Each of the parallel structures utilizes a three-web box girder up to 35 feet deep and 75 feet wide. The central five-span continuous structure has a main span of 630 feet. Superstructure cantilever segments were cast in lengths up to 16 feet using form travelers. All spans are post-tensioned with internal grouted, multi-strand, cantilever and continuity tendons. Parts of the superstructure webs near the piers are post-tensioned with vertical bars. In addition to longitudinal post tensioning, the top slab is also transversely post-tensioned as with precast segmental construction.

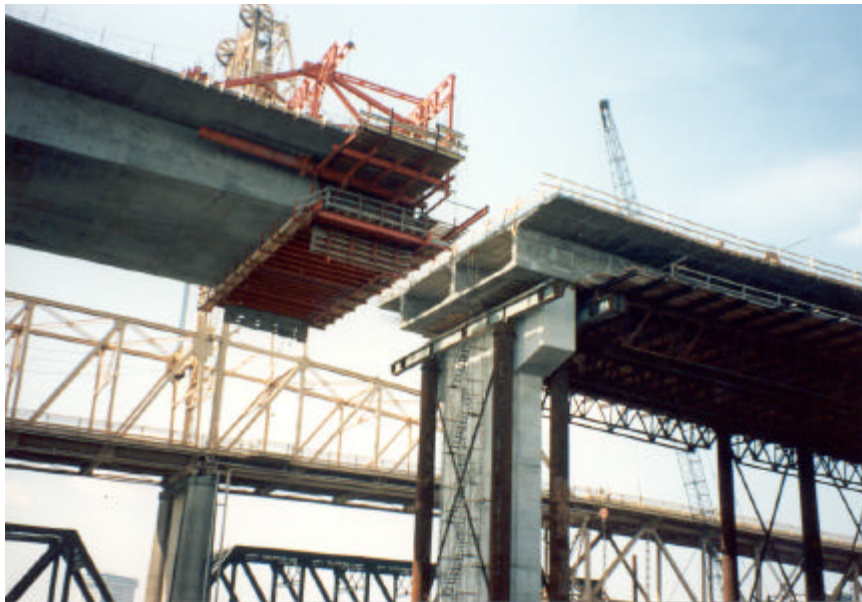
Figure 1.11 – Cast-in-place on Falsework Spans of the Acosta Bridge

The cycle time for the construction of one segment at each end of the cantilever was about one week. Segments were constructed on each end of a cantilever in an arrangement laid out to be no more than one half of a segment out-of-balance at any time. Temporary stability towers carried out-of-balance construction effects to the main foundations. The end spans of the five span unit of the Acosta Bridge (Figure 1.11) were cast-in-place on falsework.

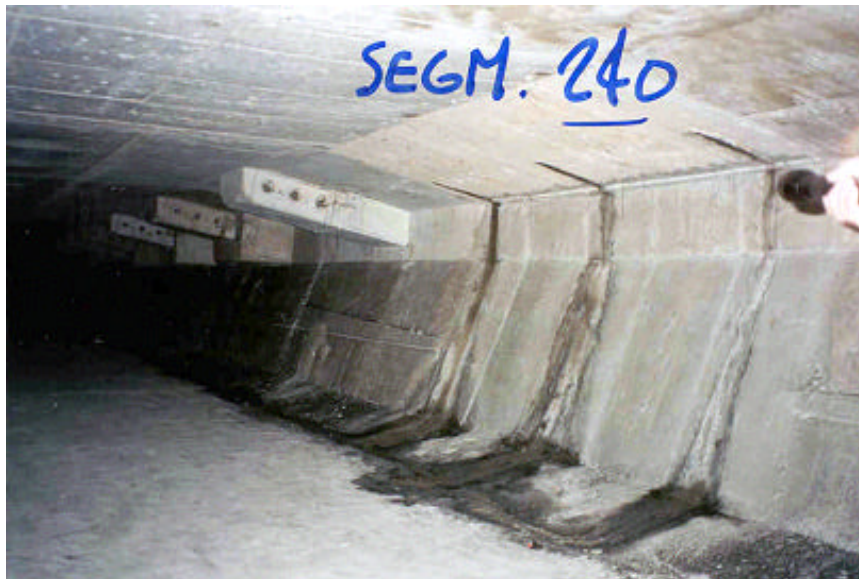
Figure 1.12 – Epoxy Joint Leaking in the I-595/I-75 Interchange

District 4 in Broward County did have an ongoing maintenance effort in some of the balanced cantilever post-tensioned bridges at the I-595/I-75 Interchange built between 1986 and 1989. Inspections of these bridges, beginning in 1992, routinely reported water leaking through the epoxied joints (Figure 1.12) and efflorescence coming from the top slab continuity tendons. Efforts were taken to locate the source of the leaks, and in doing so prevent further leakage of water, cracking of protective pour backs and some additional efflorescence. Additional investigations found one top continuity tendon in excess of 300 feet to be substantially without grout. The result was to drill multiple holes through the deck into the duct and FDOT crews injected the duct with grout in 1996. At this point in time the FDOT believed that these circumstances were isolated incidences that could be attributed to a poor construction and inspection practices.

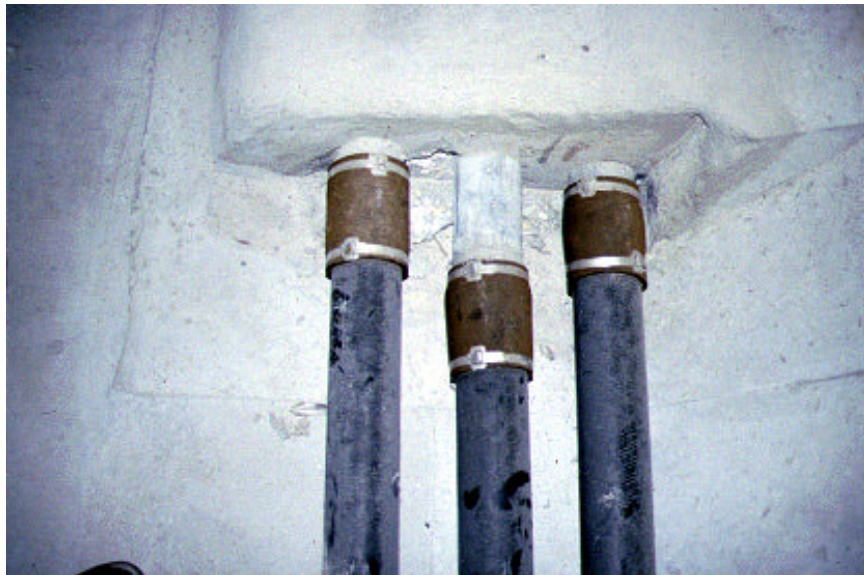
Figure 1.13 – Plan View of Slipped Tendon at Deviation Saddle

In the summer of 1999 a routine inspection of the Niles Channel Bridge revealed that a longitudinal post-tensioning tendon, one of 6 in each span, had failed. A 9-inch movement of the tendon through one of the deviation saddles was noticed first (Figure 1.13). The boot connecting the polyethylene duct to the steel pipe at the expansion joint diaphragm was opened and active corrosion was found on the prestressing strands in this tendon.

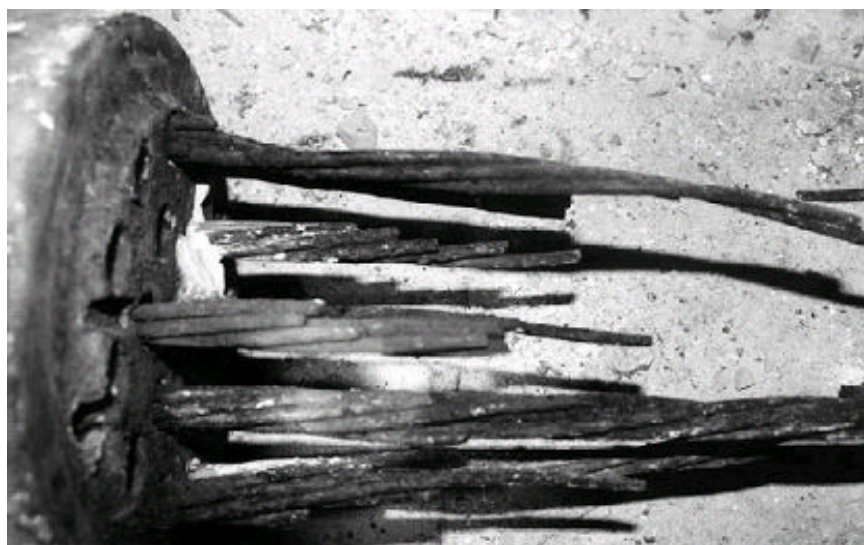
Figure 1.14 – Advanced Corrosion of Strands within Niles Channel Anchorage

Considering the impact of losing one tendon of the six in each span, and that these bridges provide the only access to the Florida Keys, the failed tendon was immediately replaced. Examination of the removed tendon indicated a void in the grout and heavy pitting of the prestressing strands inside the anchor head (Figure 1.14). Initially, the corrosion was attributed to excessive bleed water at grout/void interface. Further investigation indicated that cyclical recharge of the void in the anchor head by water contaminated by wind-born ocean salt spray was a primary cause of tendon corrosion. The contaminated water leaked through the expansion joints and ran down the inside faces of the segment diaphragms onto the anchorages. Evidence of this recharge is seen in water staining on the concrete surrounding the anchor face (Figure 1.15). The circumstances found were very important, but by and large the problem was believed to be an isolated case

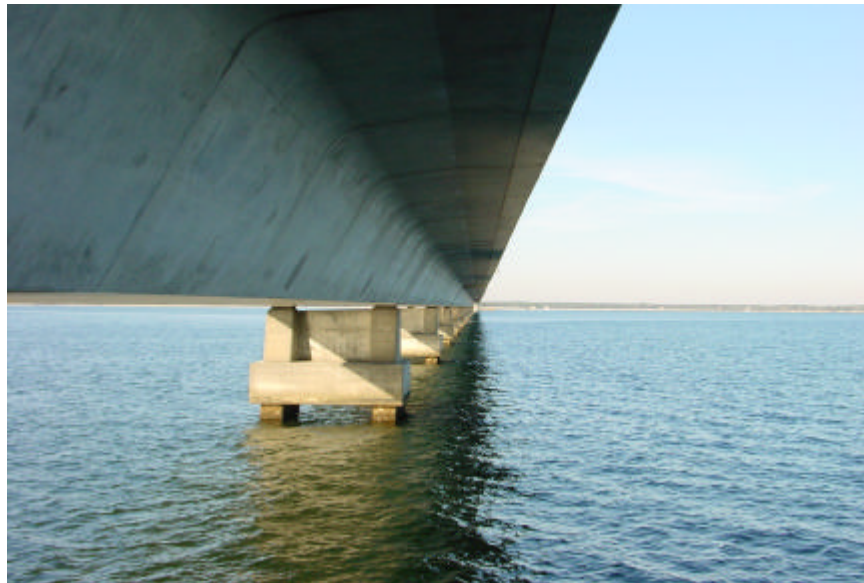
Figure 1.16 – The Mid-Bay Bridge

The next incidence of post-tensioning corrosion discovered was on the Mid-Bay Bridge, opened to traffic in 1993 (Figure 1.16). The 19,265-foot long bridge, opened to traffic in 1993, was

undergoing an annual inspection on August 28, 2000 when two failed tendons, one in Span 28 and one in Span 57, were discovered.

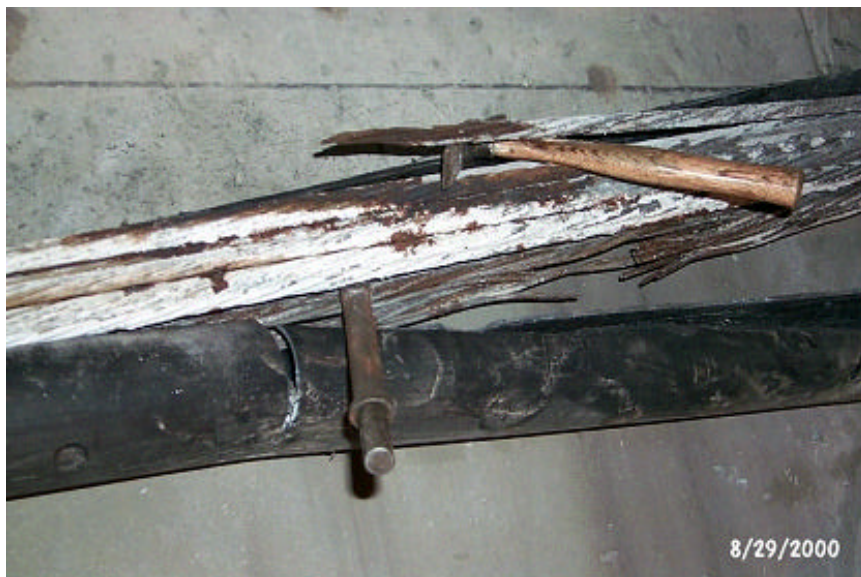
Figure 1.17 – Failure of Tendon 28-6 on the Mid-Bay Bridge

The failed tendon of Span 28 was different in its nature than that previously observed at the Niles Channel Bridge. The failure had come at a corrosion cell that had grown in the free length of the tendon away from anchorages (Figure 1.17). This failure could not be traced to the corrosion of strands in the void of an anchor head; rather, a breach in the duct itself resulted in access of moisture and development of isolated corrosion.

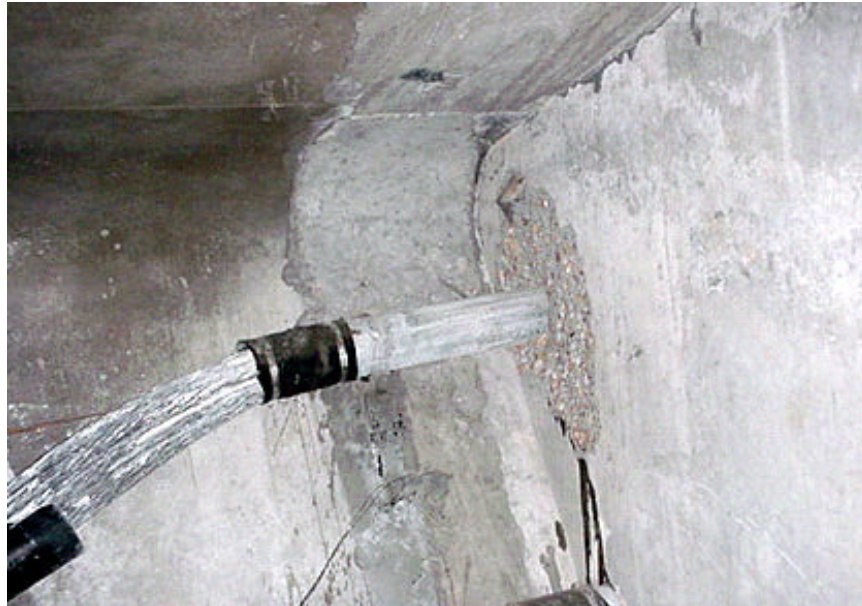
Figure 1.18 – Failure of Tendon 57-1 on the Mid-Bay Bridge (At Expansion Joint Diaphragm)

The failure of the tendon in Span 57 (Figure 1.19) was similar to the failure at the Niles channel Bridge. Corrosion of strands in the anchor head progressed to the point that strands in the tendon fractured. The bond between the grouted portion of the duct and the failed tendon was sufficient to pull the tendon and steel pipe from the expansion joint segment diaphragm.

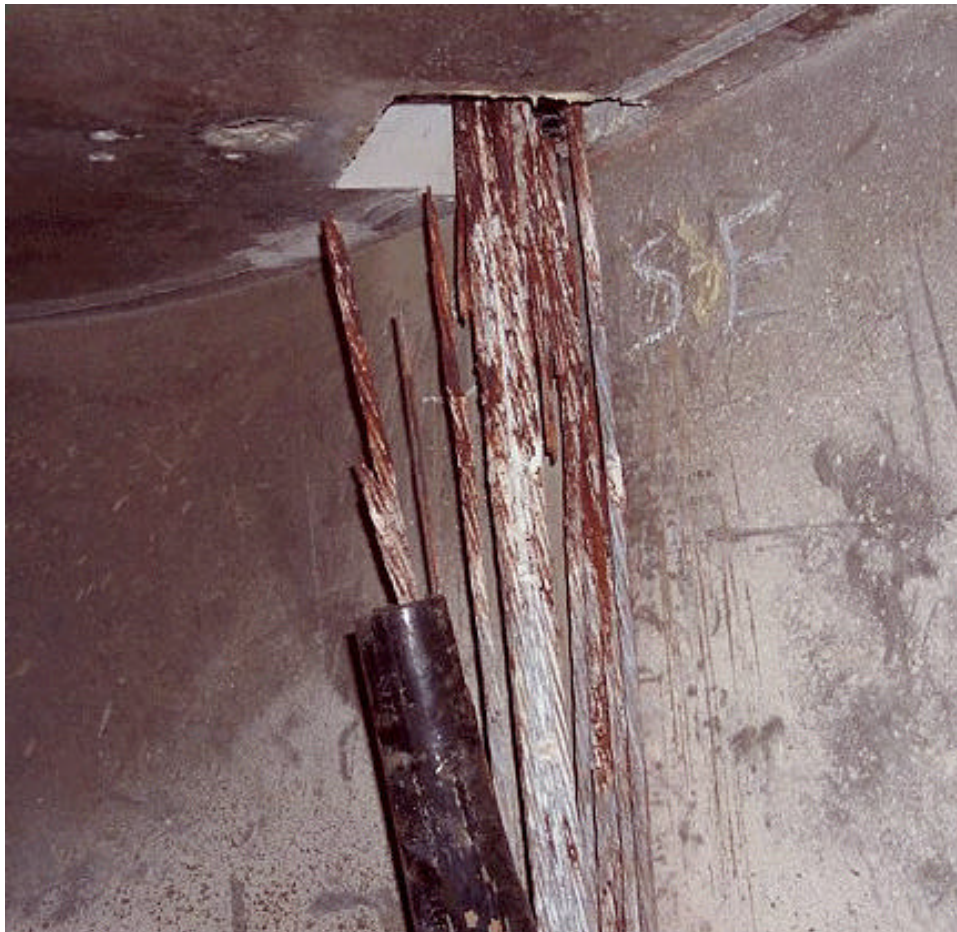
Figure 1.19 – Tendon Corrosion in the Sunshine Skyway Bridge Piers

of the high level approaches of the Sunshine Skyway Bridge in Tampa, Florida, opened to traffic in 1987. The precast segments of these hollow piers are nearly elliptical in shape but vary in dimension as a function of column height. The vertical post-tensioning is a mix of both internal and external tendons. On September 21, 2000 the FDOT found a failed tendon in Pier 133 North (Figure 1.20). The FDOT retained a consultant team to perform extensive inspection and testing of the post-tensioning of the Sunshine Skyway piers. Pier 133 North has been rehabilitated by the addition of mild reinforcing doweled into the support footings and the core of the hollow pier filled with concrete. The final report of the evaluation of the post-tensioned piers of the Sunshine Skyway Bridge is under final review and will soon be available through the Department.

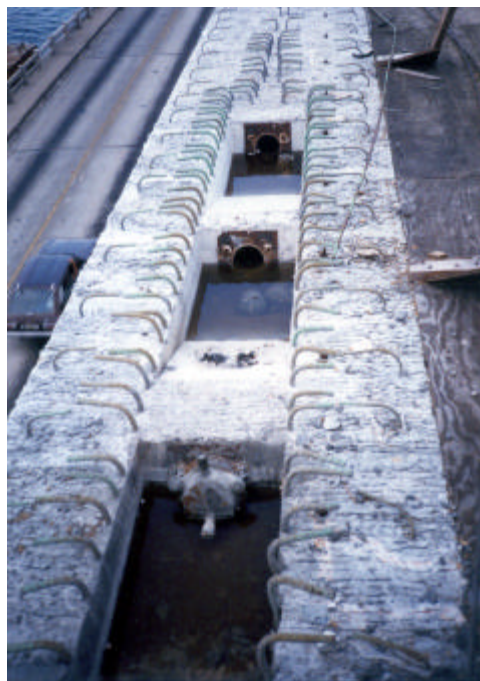
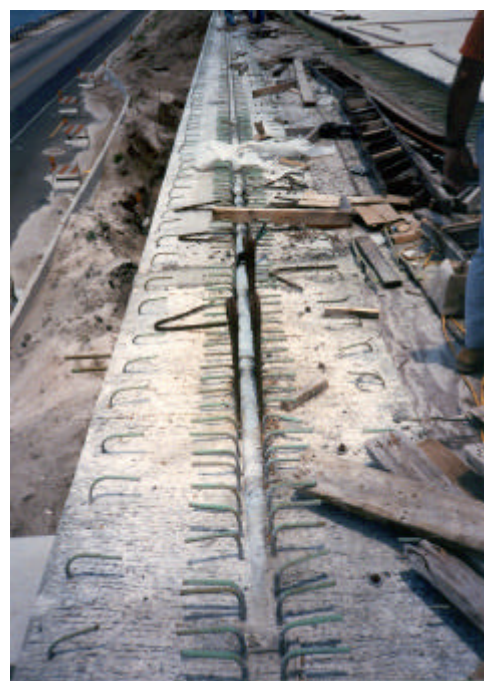
Details of the longitudinal tendons at end of the girders and over the piers for the Eau Gallie Bridge are shown in Figure 2.13. For this project the tendons actually rose out of the beams and into the top slab over the piers. In a construction change proposed by the Contractor, the originally designed four tendons of 9, 0.6-inch diameter strands per beam were changed to three tendons of 12, 0.6 inch diameter strands. Since the original bulb-T had a web only 6 inches thick, it was difficult to accommodate the ducts, rebar and cover. Similar difficulties arose after a few similar applications using oval ducts with a 7-inch web width and increased side cover. Currently, most designs increase the web thickness to 8 inches. The Florida bulb-T, with minor modifications and improvements, has been used successfully on many long and major bridges.

Anchors at Beam End

Rising Ducts at Piers

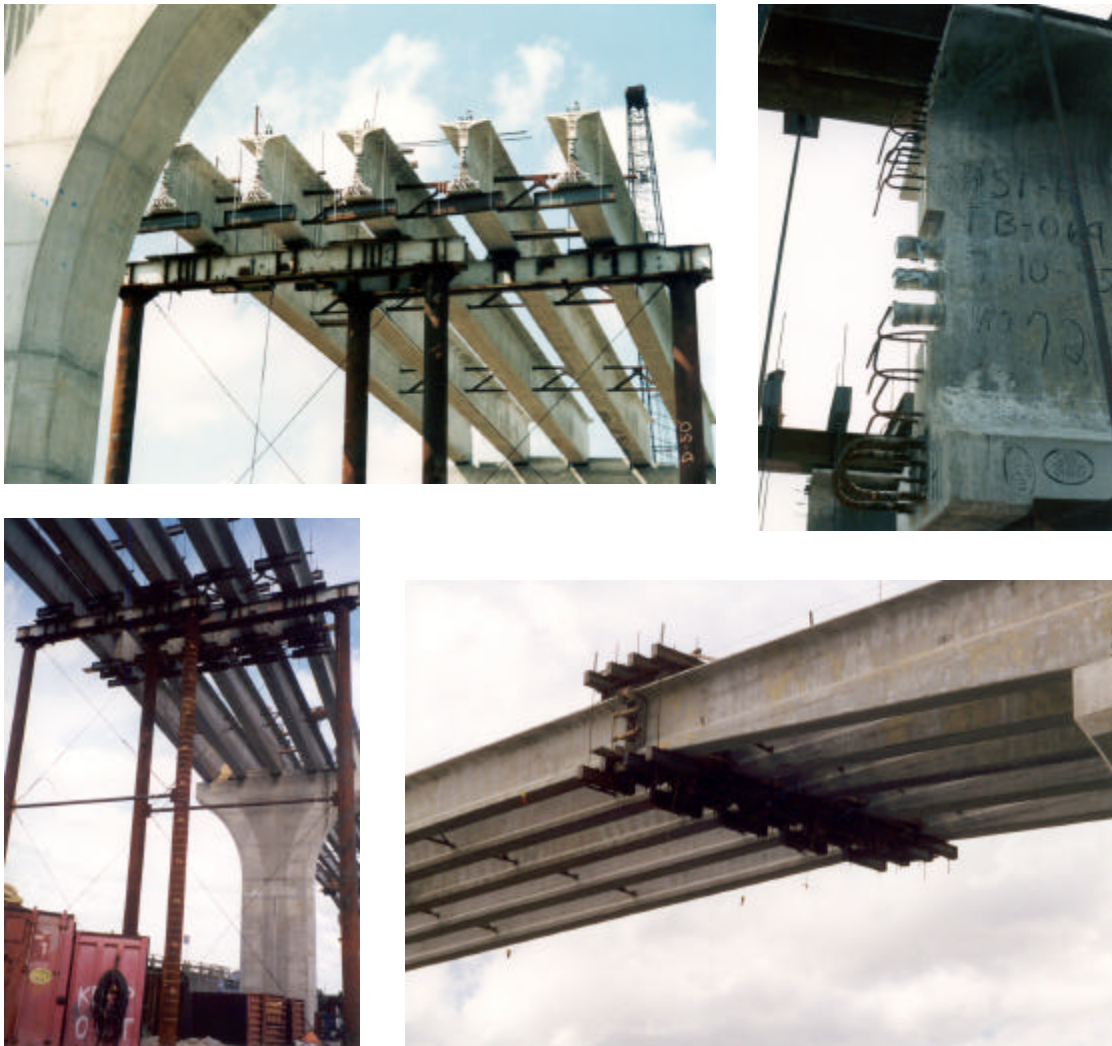
Figure 2.14 – Spliced Girder Main Unit of the Flagler Beach Boulevard Bridge

Figure 2.14 shows four photographs of the construction of a three span main unit for the Flagler Beach Boulevard Bridge. Temporary supports are erected at the splice location in the side spans (upper left). The end of the girders have protruding mild reinforcing bars that will help secure the girder to the closure and ducts that splice with those of other girder sections allowing for placement of tendons over the full length of the main unit (upper right). The variable depth girder sections are placed over the piers, aligned with the girders of the side spans, and closures cast (lower left). Temporary strongback beams support the drop-in girder of the main span while closures are cast (lower right). When all closures have reached sufficient strength, the longitudinal post-tensioning tendons are placed and stressed. Phased stressing on the non-composite and composite sections may be used to maximize the efficiency of the post-tensioning.

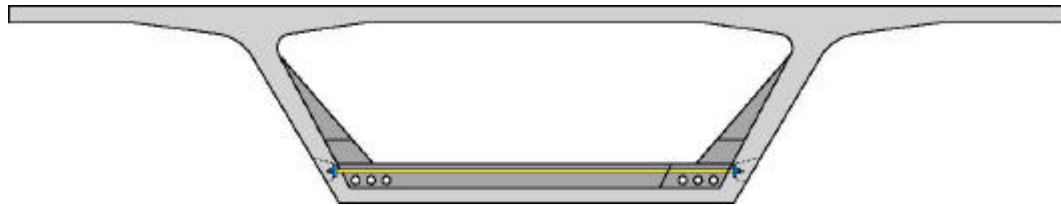
Figure 2.18 – Transverse Post-Tensioning in Deviation Ribs

Transverse deviator ribs of span-by-span bridges may contain tendons (usually straight bars) in the top of the ribs across the bottom slab anchored in the web faces (e.g. Mid-Bay and Garcon Point and the side spans of the Sunshine Skyway Main Structure). Figure 2.18 shows a typical layout for these transverse post-tensioning bars. The bars are stressed and grouted in the casting yard.
