Testing of Trelleborg Structural Plastics

Written by: David Wagner
Reviewed by: Jerry Hocking, P.E.

Introduction:

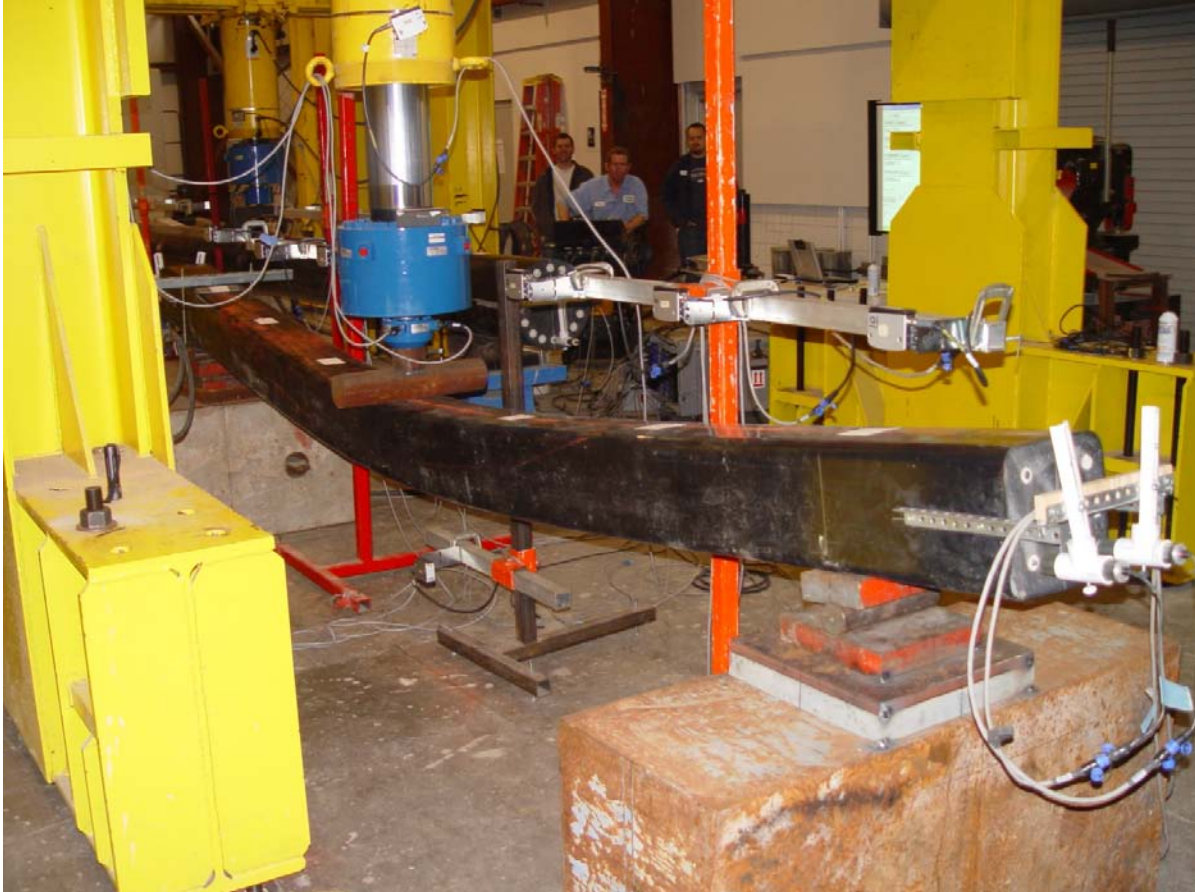
Figure 1: 3-Point Loading Test of a SCL Wale

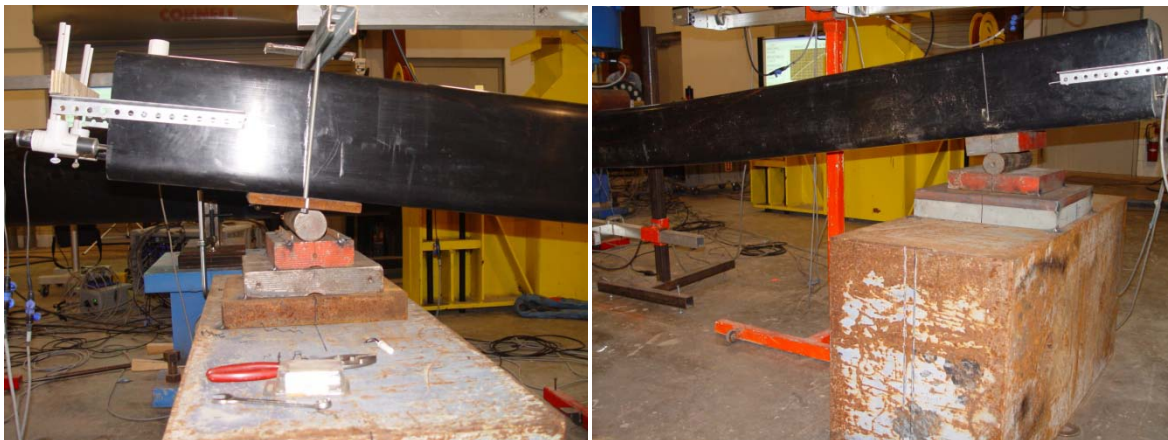
Figure 7: North Roller Support and South Rocker Support during Testing

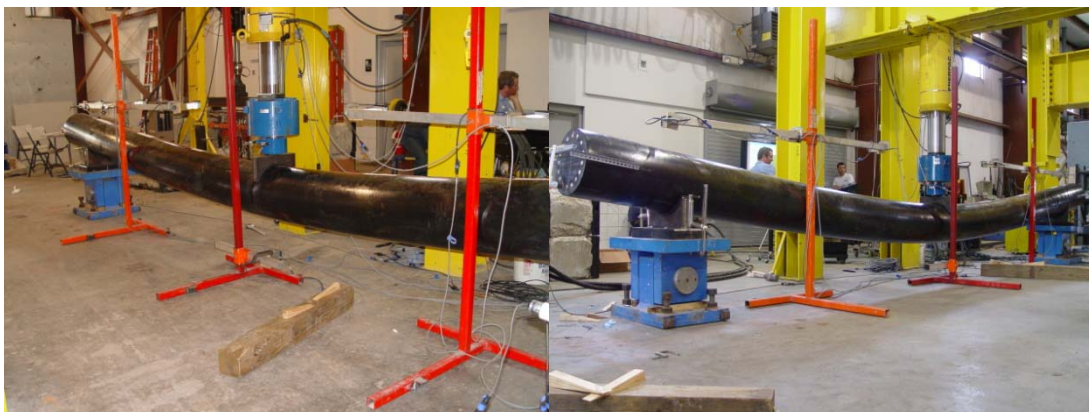
Figure 16: Testing a CP Specimen

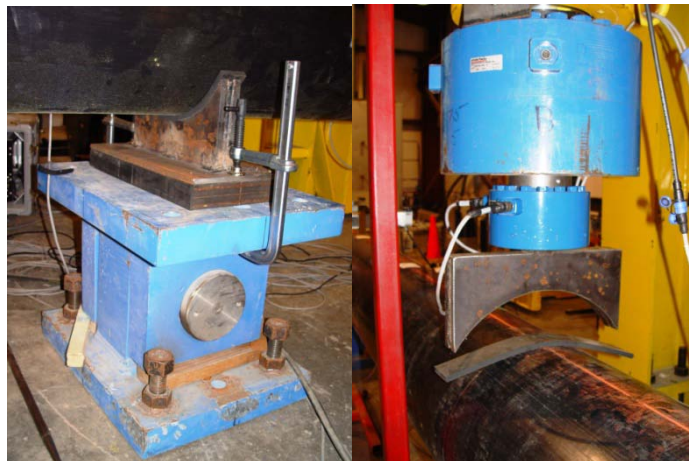
Figure 18: End Support for CP Specimens (Left) and Load Point (Right)

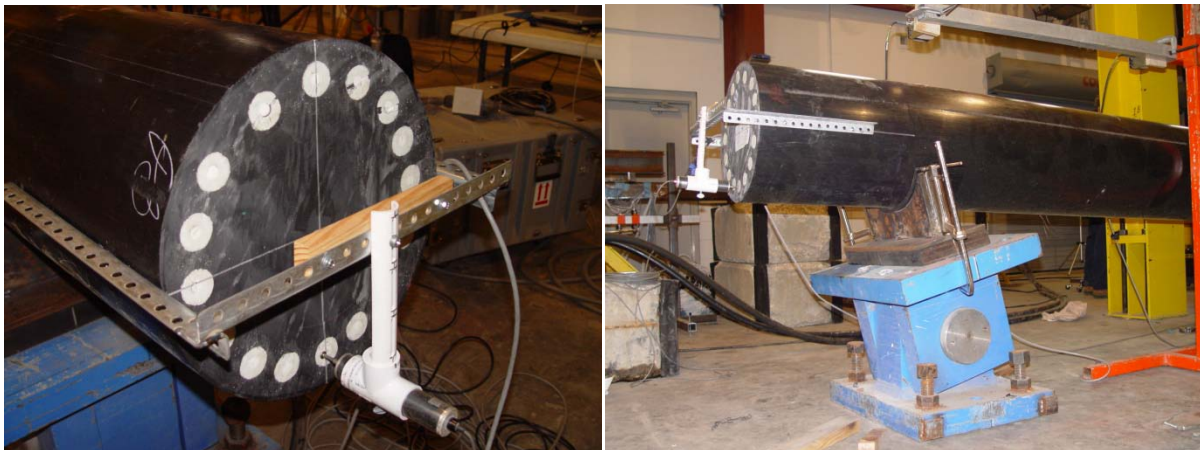
Figure 20: Deflection Gauge Setup for Detecting Slip of Reinforcement for CP Specimens
