Final Report

Movable Bridge Maintenance Monitoring

A Report on a Research Project Sponsored by
Florida Department of Transportation
Contract No. BDK78-977-10
Alberto Sardinias, Project Manager, FDOT

October 2013

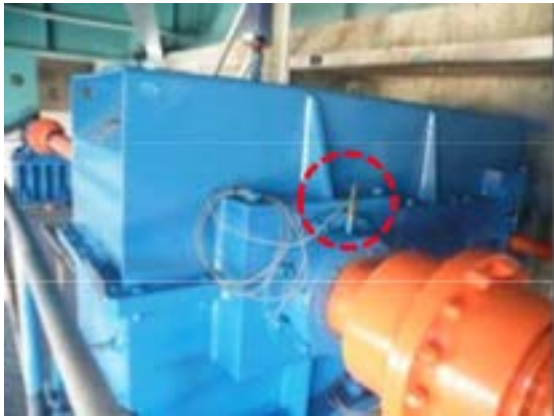
Figure 3-Gearbox acceleration and sample data

The gearboxes contain the assembly that transmits the torque generated by the motor to the shafts (Figure 3). When the gearboxes experience deterioration or lack of lubrication, some change in the vibration and sound characteristics during the bridge operation should be noted. Abnormal vibration is an indicator of wear in the gears. Oil viscosity is also an important parameter for proper functioning of the gearbox. Considering these issues, the monitoring system included accelerometers to measure the vibration of the gearbox during bridge opening/closing events. Furthermore, microphones were also installed in the vicinity of the gearbox to determine its acoustic signature for opening/closing events. The vibration and acoustic signatures associated with a bridge opening/closing event are shown in Figure 3 and Figure 4, respectively.

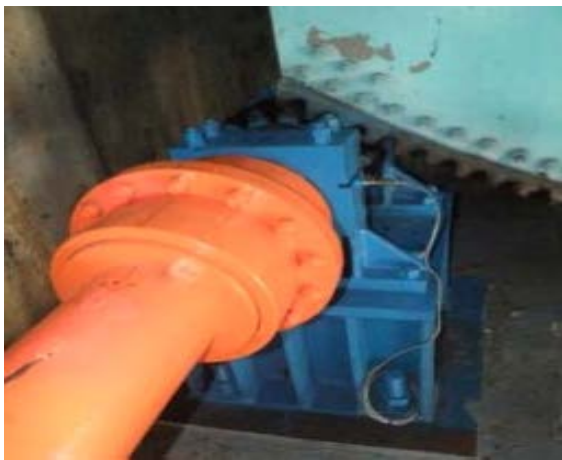
Figure 11- Rack and Pinion accelerometer and sample data

To monitor the condition and maintenance needs of the open gears and rack and pinions, accelerometers were installed at the base of the rack and pinion to monitor its vibrations (Figure 11). A video camera was also installed facing the open gear (Figure 12) to allow the use of computer vision algorithms for detecting corroded and/or non-lubricated areas as discussed in the previous report.

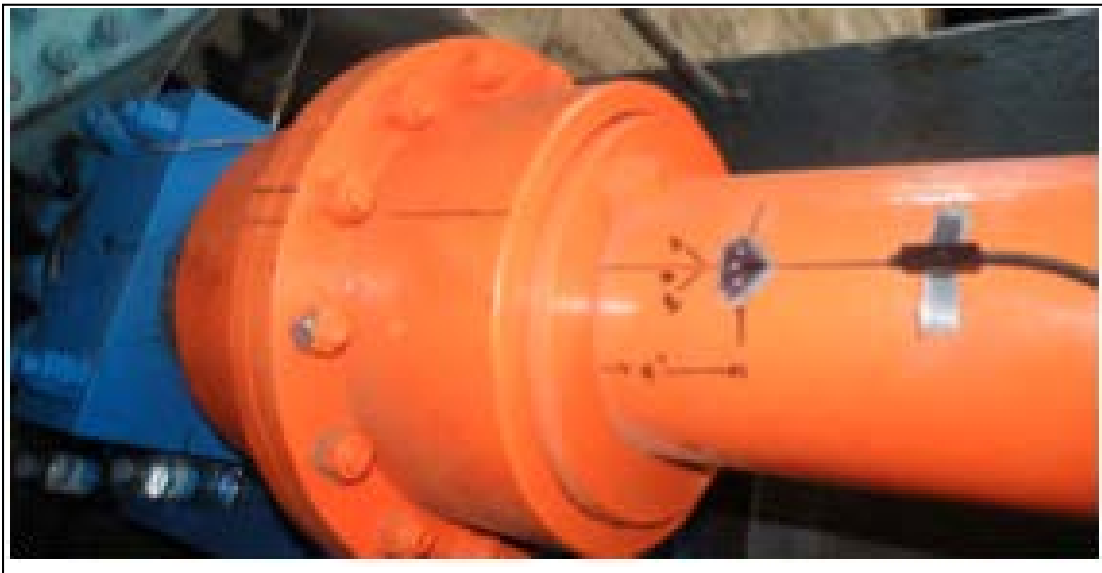
Figure 15-Strain rosette on the drive shaft

The drive shafts can be monitored for the total torque, friction of the system, as well as for the center of weight, by means of a balance test, which is a common method for detecting changes in the opening/closing operational characteristics. During the test, torsional strain measurements are collected using strain gage rosettes mounted on the shaft (Figure 15).

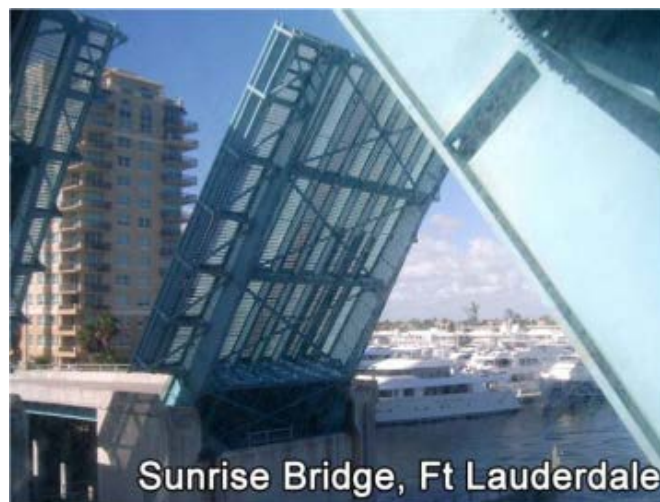
Figure 22-Structural components of Sunrise Boulevard Bridge

The structural framing system for the bridge includes the main girders, the floor beams and the stringers. These components are constructed from both rolled and built-up steel sections with welded plates. Corrosion is one of the main concerns for the bridge girders, floor beams, and stringers, especially at exposed surfaces. Corrosion leads to section loss and reduced capacity. Any misalignment, bending, or deformation in these components can also cause increased strain on the structure. Deformation or thermal effects can cause misalignment of the girders, leading to a malfunction in the bridge operation. The selected sensor layout provides the distribution of stresses on the girders and is expected to provide information regarding damage and deterioration for preventive maintenance purposes. Figure 22 shows the main structural components of the Sunrise Boulevard Bridge.

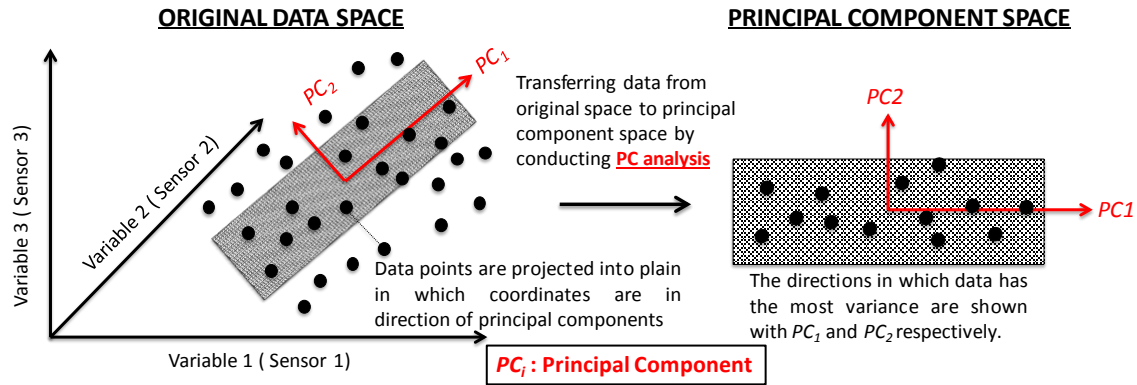
Figure 23-Schematic demonstration of Principal Component Analysis

explained in more detail in the following sections. The concept of principal component analysis and the projection procedure are exhibited in Figure 23.

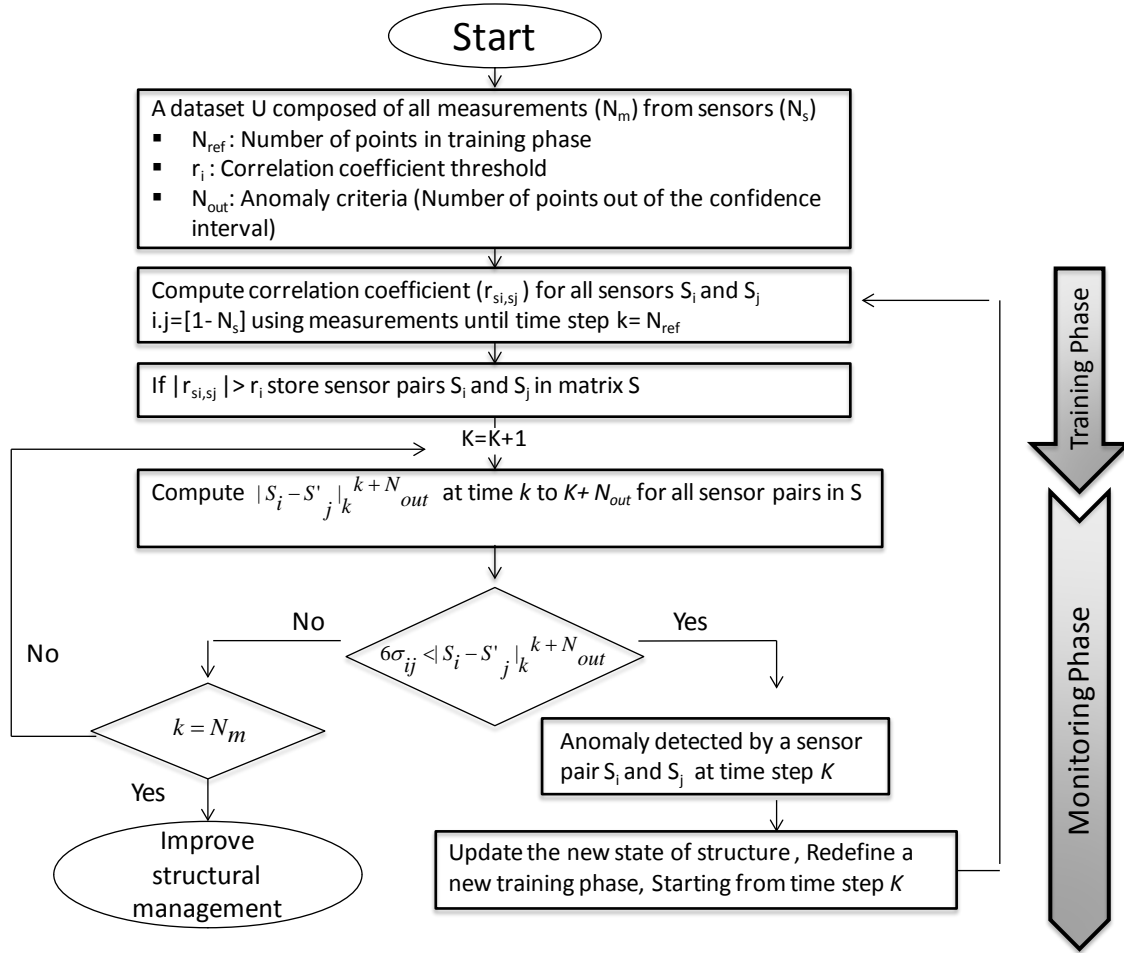
Figure 25-Application of RRA algorithm to long term monitoring of structures

A damage detection algorithm was designed based on robust regression analysis (Posenato et al. 2010). Like the other two algorithms, RRA is also started by dividing data into two categories referred as training and monitoring phase. In the training phase, all pairs of sensors with a correlation that exceeds a predefined threshold are selected. In the following step, regression lines are established between individual pair of sensors. Afterward, confidence intervals are developed for each individual pair of sensors based on the error between real value of the sensor and the estimation of regression line. During the final monitoring phase, this error (difference between real value and estimation from regression line) is computed and considered as a damage index. A change/damage is reported once the error in any of the pairs exceeds the confidence interval. A summary of the above-mentioned procedures is presented in Figure 25.

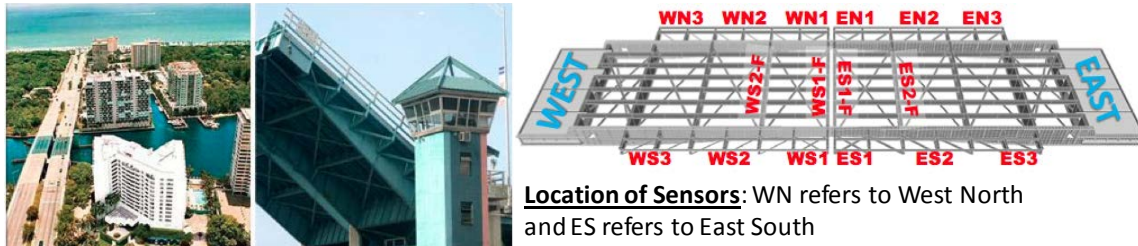
Figure 30-Sensor locations for structural components of Sunrise Boulevard Bridge

The measurement data recorded during three prescheduled time slots (morning and early and late afternoons), corresponding to the peak hours of operation in a 24-h period, were selected for the analysis. The data were collected continuously for 5 minutes during each time slot. Field tests were also conducted to establish thresholds for conditions that are critical for the maintenance and operation of the bridge. These conditions will be referred to as “damage”. In collaboration with FDOT engineers, some of the most common structural maintenance problems were identified and subsequently implemented on the movable bridge to simulate damaged conditions. These damage scenarios are further discussed in the following.

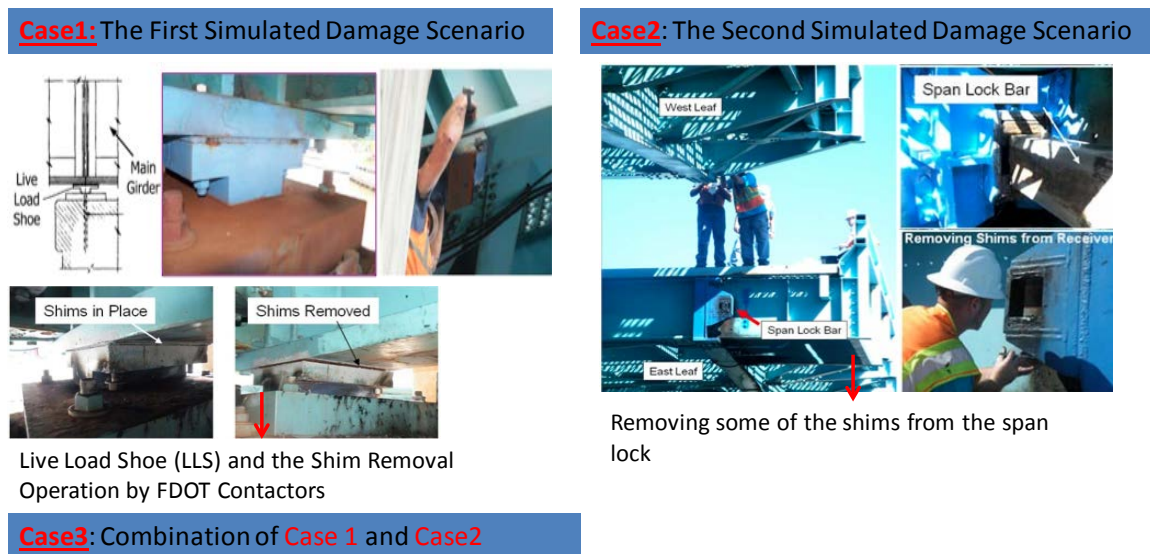
Figure 31 -Implemented damage scenarios on the Sunrise Bridge

In double leaf bascule bridges, Span Locks (SL) are used to connect the tip ends of two cantilever bascule leaves; therefore, both leaves are forced to deflect equally (Figure 31). This ensures compatibility of the deck deflections from the opposing span leaves under traffic loads. The span locks typically consist of two main components: the receiver and the rectangular lock bar.

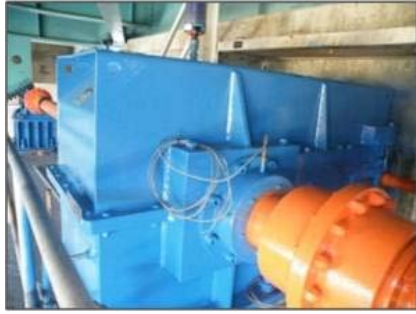
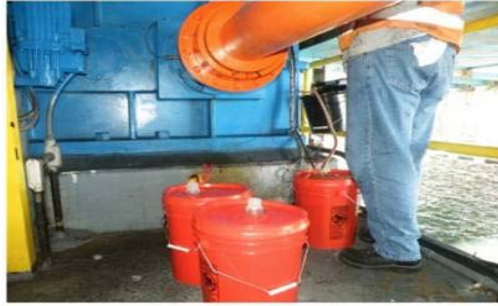
Figure 37-Results of MPCA application for gearbox malfunction detection

Removal of Oil From Gearbox
