Final Report to
FDOT Structures Research Center
UF Project No. 00065162

August 2007

TESTING BRIDGE DECKS WITH NEAR-SURFACE MOUNTED FRP BARS EMBEDDED IN CEMENT BASED GROUT

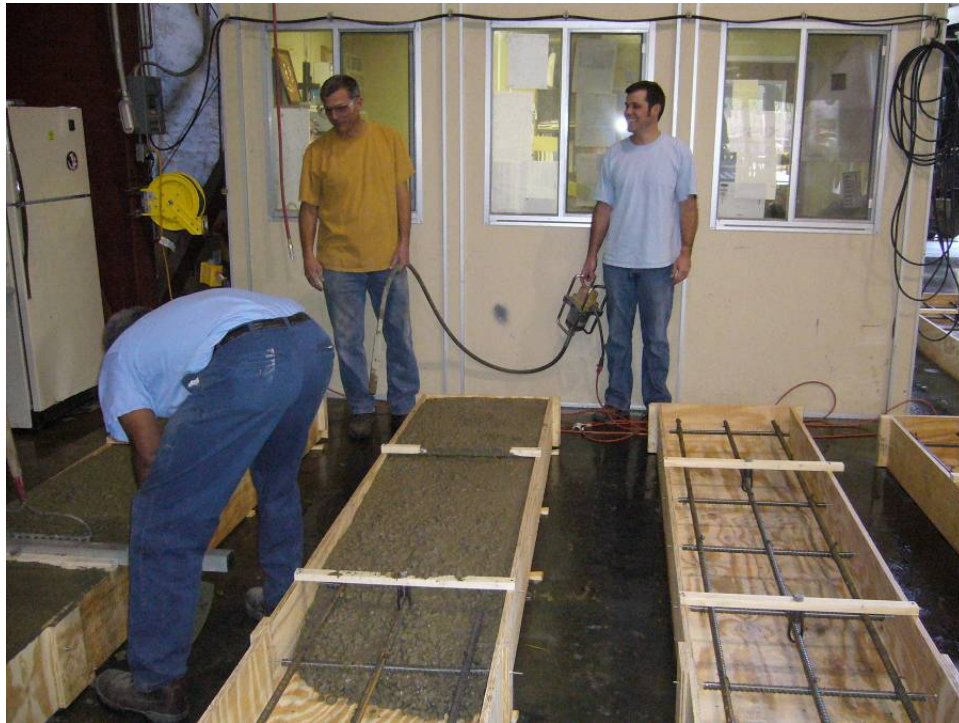
Figure 3 – Casting of Bridge Deck Segments.

Seven bridge deck segment specimens were constructed with the dimensions and mild steel reinforcement shown in Figure 2. Each segment was 10-ft long, 2-ft wide and 8-in. thick and reinforced with three ASTM A615, Grade 60, #6 mild steel bars. The segments were cast on the same day (see Figure 3) using a ready mixed concrete mixture with a specified 28-day strength of 4000 psi. The aggregate type was Florida limestone. Standard cylinders (6 x 12 in.) were cast to determine the concrete strength on test day.

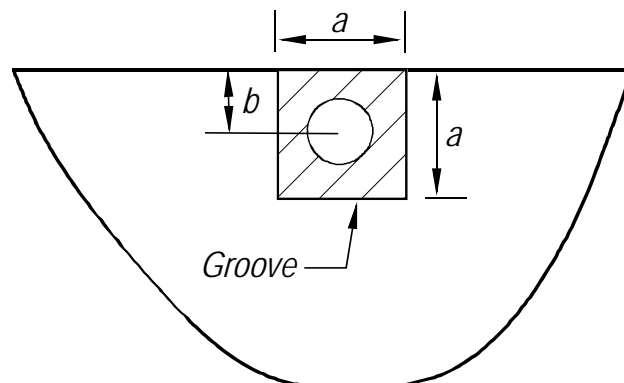
Figure 4 – Groove Detail.

The two different materials used to embed the NSM bars were an epoxy adhesive and a Portland cement based grout. The grooves had a square cross-section as seen in Figure 4. All the details about the materials used and the sizes of reinforcement and grooves are listed in Table 1. Three different types of reinforcing bars were used: (a) glass FRP, (b) carbon FRP, and (c) MMFX steel.

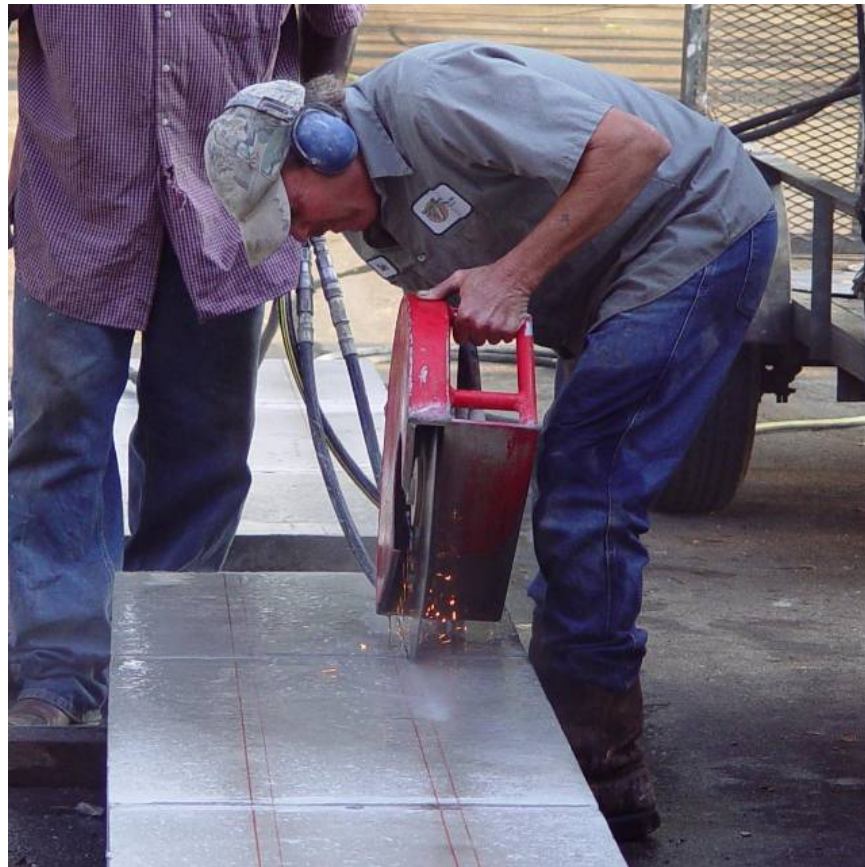
Figure 5 - Groove Cutting.

Two grooves were cut in each specimen (centered lengthwise) with the exception of the control specimen (see Figure 5). Figure 2 shows the size and location of the grooves, which were 8 ft long and cut to 1.5 times the diameter of the NSM bar (Hassan and Rizkalla 2004; De Lorenzis and Nanni 2001(b)).

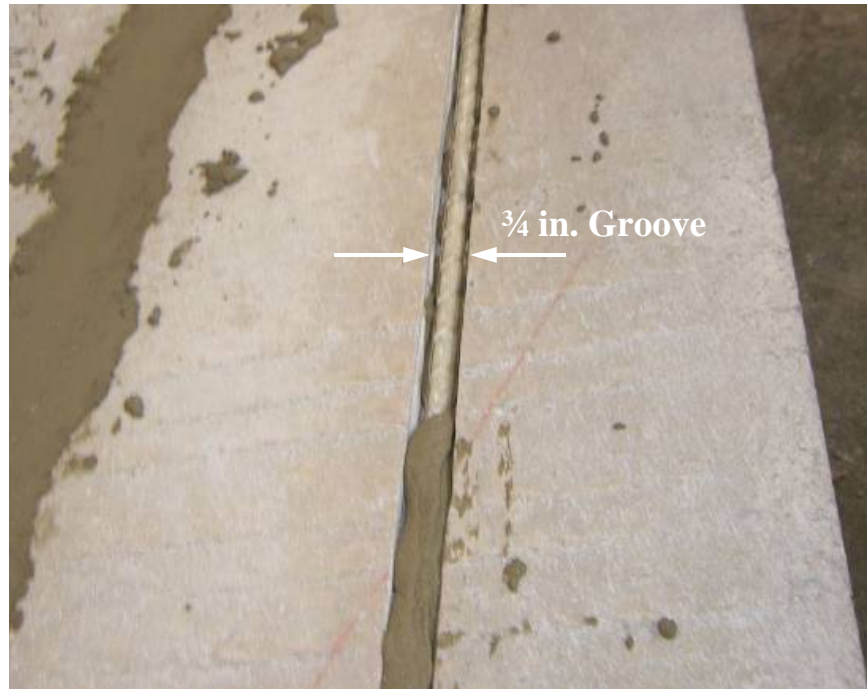
Figure 6 – NSM Bar Installation Using Cement Grout.

After the grooves were cut they were pressure washed to remove dust left from the saw cuts. Once dry, shots of compressed air eliminated any loose particles still present. The Portland cement grout was mixed and poured into the groove to approximately half the depth of the groove. The reinforcing bars were then placed into the groove, gently pressed into place and the groove was completely filled with grout (see Figure 6). The grout surface was then finished with a small trowel. The cement grout used was a non-shrink grout produced by Sika Inc. known with the trade name of SikaGrout 212. The same procedure was followed for the epoxy. The epoxy was dispensed into the groove using a grout bag (see Figure 7). The epoxy used was also a Sika Inc. product known as SikaDur 30. SikaDur 30 is a two part epoxy with 100% solids that has a paste consistency.

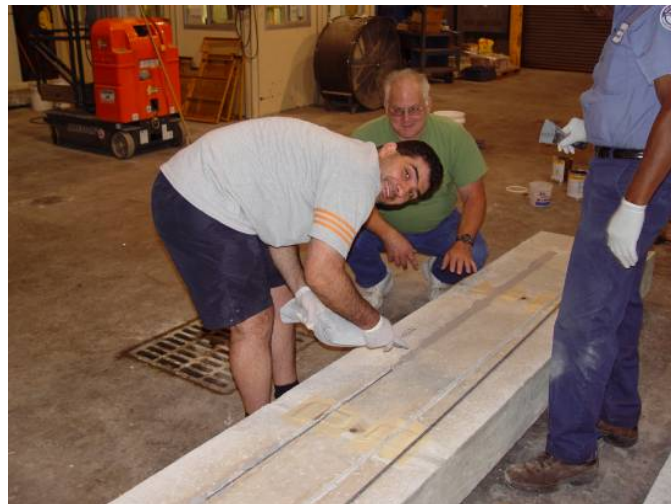
Figure 7 – NSM Bar Installation Using Epoxy.

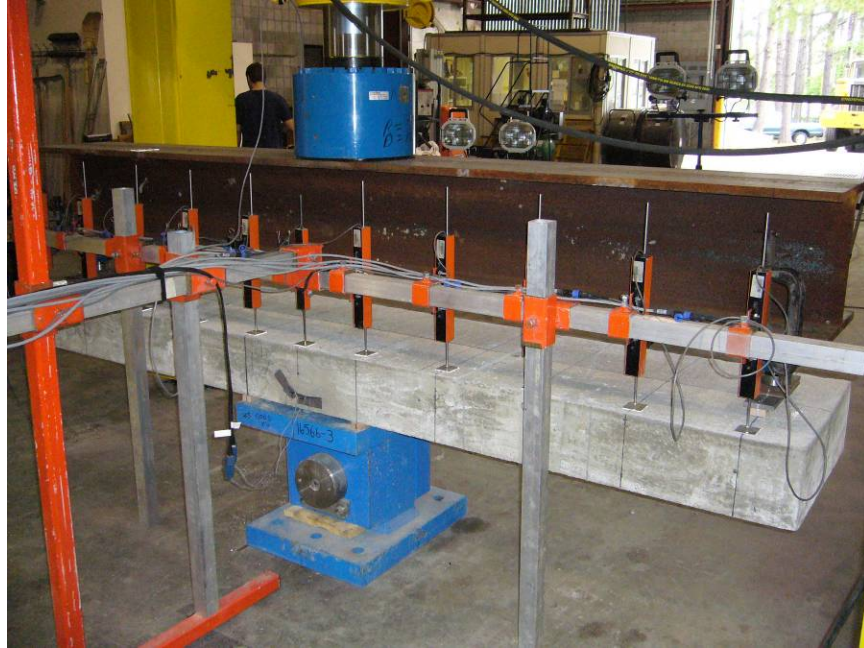
Figure 10 – Test Set-Up for Control Specimen.

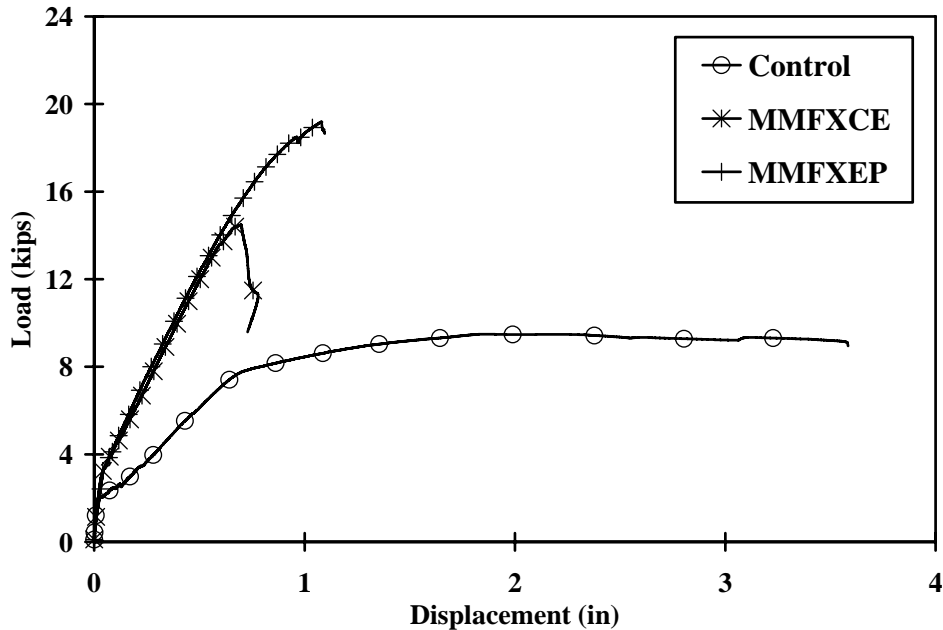
Figure 13 – Load-Displacement Curves for Control, MMFXCE and MMFXEP Specimens.

The load-displacement curves of the bridge deck specimen are shown in Figures 11 through 13. The load and displacement values are the average values of the cantilever ends of the bridge deck specimens. The control specimen failed due to concrete crushing after the mild steel reinforcement yielded. All specimens reinforced with NSM bars had a significant increase in stiffness and strength. The specimens with the epoxy adhesive had higher strength increases than the specimens with the cement based grout. Specimen CAEP had a strength increase of 55%, specimen GLEP 40% and specimen MMFXEP 82% compared to the control specimen. Specimen CACE had strength 25% higher than the control specimen while specimens GLCE and MMFXCE had a strength increase of 27% and 37% respectively. The type of adhesive material had a significant effect on the strength increase with the epoxy providing a higher increase than the Portland cement grout.

The ductility of the NSM reinforced specimens was lower than the ductility of the control specimen as seen in the load-displacement curves (Figures 11 through 13). However, the bridge deck specimens with flexural failure modes demonstrated significant ductility compared to the specimens with bond or shear failure modes. The displacement ductility factor ($\mu_{\Delta} = \Delta_u / \Delta_y$) for the control specimen was approximately 4.8. The ductility factors for specimens CAEP and GLEP were 2.7 and 3.2, respectively. Specimen GLCE had a ductility factor of 2.8 and specimen CACE value was 1.6. This indicates that even though specimen GLCE failed due to bond the glass FRP bar developed a better bond with the cement grout than the carbon bar. The specimens with the microcomposite steel had low ductility factors because the bar was not fully developed due to slip. Specimen MMFXEP failed in shear resulting in a ductility factor of 1.4. Specimen MMFXCE had a ductility factor of 1.1. The highest ductility from the NSM reinforced specimens was exhibited by specimen GLEP, which demonstrated 67% of the ductility of the

As it was mentioned in a previous section of the report, the NSM reinforcement ratio for the MMFX reinforcement was same as the reinforcement ratio for the Bow Channel Bridge proposed repair method using the MMFX steel as NSM reinforcement. This reinforcement ratio, if selected, is likely to result in similar behavior in the actual bridge. Although specimen MMFXEP had the highest capacity of all specimens it also had the lowest ductility. Therefore, it is reasonable to assume that if the specific repair option is adapted the actual bridge deck will lose much of its ductility much like specimen MMFXEP (see Figure 13). It could also lead to a change in the failure mode of the deck similar to the case of specimen MMFXEP where the mode changed from a flexural mode (control specimen) to a shear mode (MMFXEP). The shear mode is a non-ductile failure mode and it should be avoided if possible.
