Final Report

March 2006

UF Project No. 00030907
Contract No. BD545, RPWO# 9

CRACK CONTROL IN TOPPINGS FOR PRECAST FLAT SLAB BRIDGE DECK CONSTRUCTION

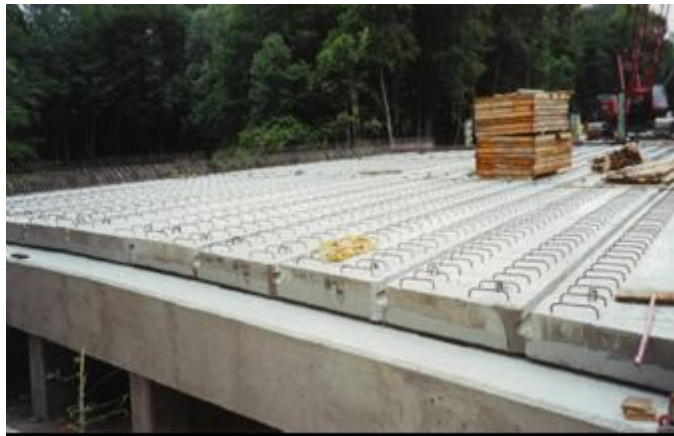
Flat slab bridges consist of prestressed, precast concrete deck panels that span from bent to bent. The panels act as permanent forms for a cast-in-place deck. The top surface of the flat slab is roughened to transfer horizontal shear. In some cases, transverse reinforcement is placed to ensure horizontal shear transfer. A topping is then placed over the precast flat slab, which allows the composite to act as a single unit. Some panels incorporate a shear key to transfer transverse shear. The keys usually contain welded wire mesh, reinforcing bars or both as well as non-shrink grout. The topping contains transverse and longitudinal reinforcement intended to provide crack control and lateral transfer of shear between the panels. Figure 1 shows recently erected prestressed slabs before topping placement. These panels have horizontal shear reinforcement and shear keys.

Figure 1. Typical prestressed slab panels

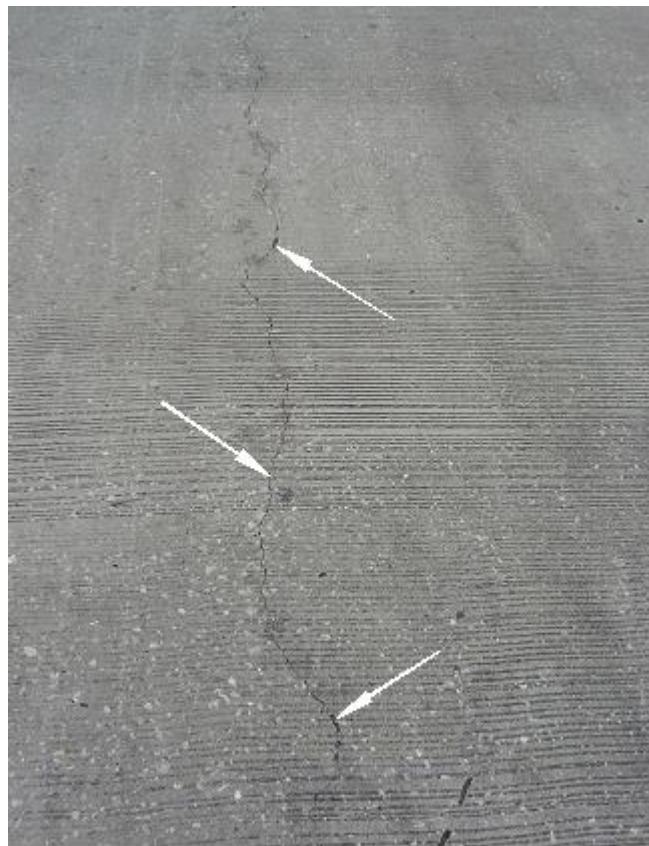
The Mill Creek Bridge is located on CR318 north of Ft. McCoy. It is a simply supported, two-span bridge composed of 15 in. deep precast flat slabs. The topping has a reflective crack over each flat slab joint (Figure 2) that measures an average of 0.016 in. Cracks were also noted over the middle bent where the flat slabs meet end to end. The control joint is located at the center and runs with the span of the bridge. All of these cracks are relatively small and have not affected the performance of the bridge. No construction drawings were available for this bridge.

Figure 2. Reflective crack on topping of Mill Creek Bridge

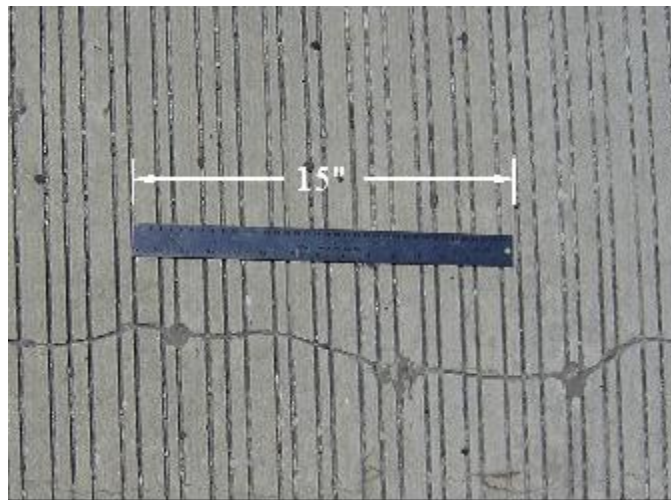
The Turkey Creek Bridge is located on US1 south of Melbourne. It is a simply supported, six-span bridge with 12 in. deep precast flat slabs with shear keys and an 8 in. topping. The topping is reinforced with No. 5 bars at 12 in. on center in each direction. The topping has extensive longitudinal cracks that vary in size. Reflective cracks are located over each flat slab joint. Many of the cracks have been repaired with epoxy (Figure 3) and show no signs of continued cracking. A large number of vehicles were using the bridge on the day of the visit. In addition to showing the most cracking, it also carries the largest traffic volume of the three bridges.

Figure 3. Repairs to cracks on Turkey Creek Bridge

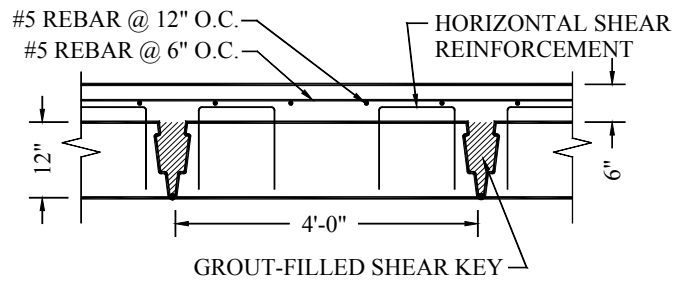
Cow Creek Bridge is located on CR 340 just west of High Springs. It is a five-span bridge with 12 in. deep flat slabs with shear keys and a 6 in. topping (Figure 4). The flat slabs have horizontal shear reinforcement and the topping has No. 5 reinforcing bars at 6 in. on center in the transverse direction and at 12 in. on center in the longitudinal direction. Previous assessment by the FDOT showed that the longitudinal cracks formed before the bridge was opened to traffic, and the reinforcement bars in the topping were incorrectly installed at 4 to 5 in. below the topping. The topping has a reflective longitudinal crack over each joint in the flat slab. These cracks measured an average of 0.028 in. It also has cracks along most of the saw-cut joints located over the bents. Figure 5 shows the typical saw cut and bearing located over every bent. Concrete has spalled in some areas adjacent to the cuts (Figure 6). This type of cracking occurs when the control joints are cut after the concrete has set. The longitudinal cracks do not appear to have affected the performance of the bridge.

Figure 4. Cow Creek Bridge cross-section

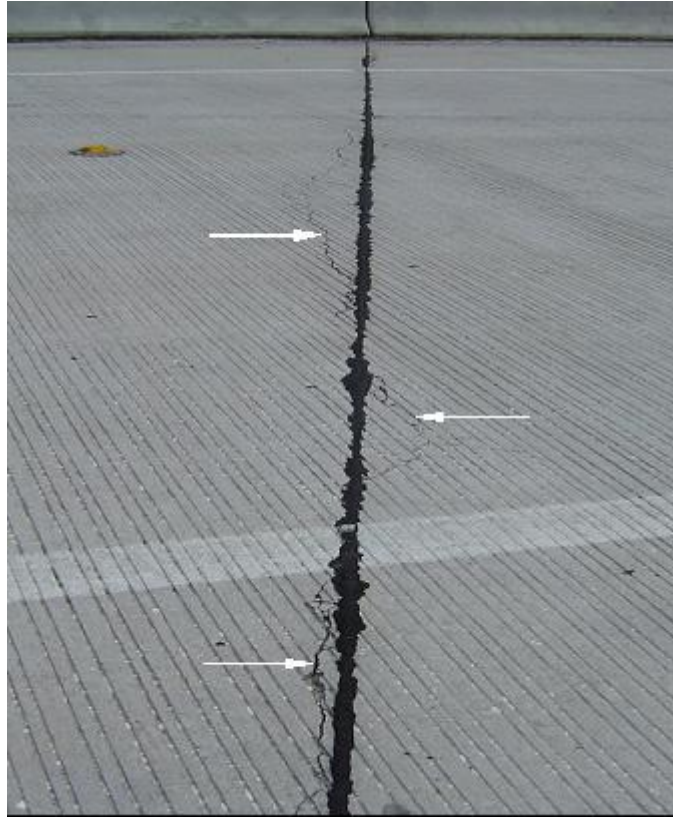
Figure 6. Transverse cracks at a control joint on the Cow Creek Bridge

Three precast flat slab bridges with reinforced concrete toppings were visually inspected. The Cow Creek and Turkey Creek bridges had shear keys built into the prestressed slabs. Slab depth varied from bridge to bridge. All of the bridges had a reflective longitudinal crack over each flat slab joint and multiple transverse cracks over the bents where the topping goes into negative moment. The topping on the Cow Creek Bridge was spalling at these locations. The Turkey Creek Bridge showed the most cracking and is the only one to have been repaired.

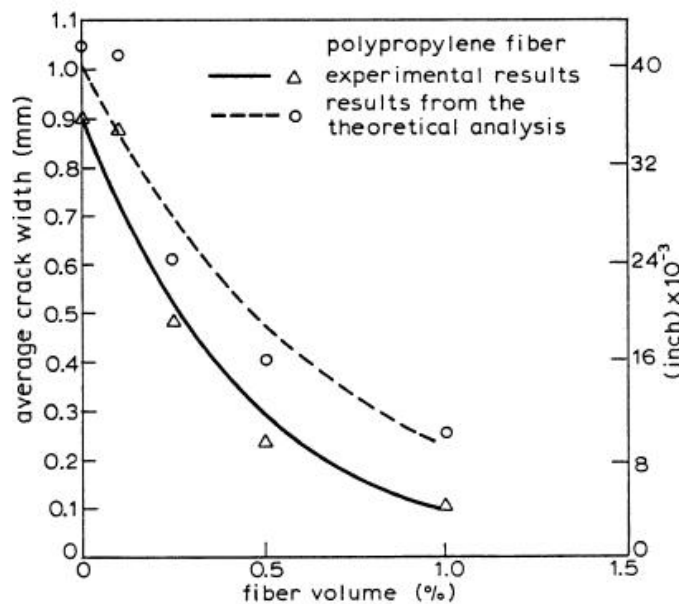
Figure 7. Average crack width vs. fiber volume for polypropylene fibers (Grzybowski and Shah 1990)

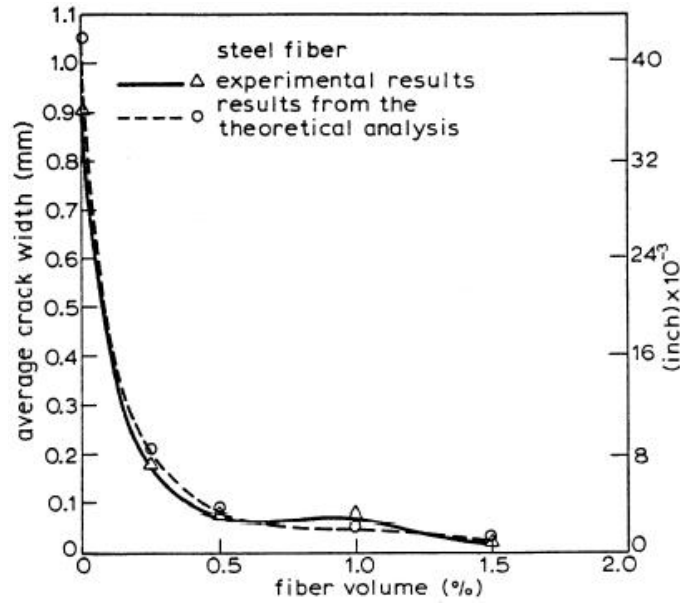
Figure 8. Average crack width vs. fiber volume for steel fibers (Grzybowski and Shah)

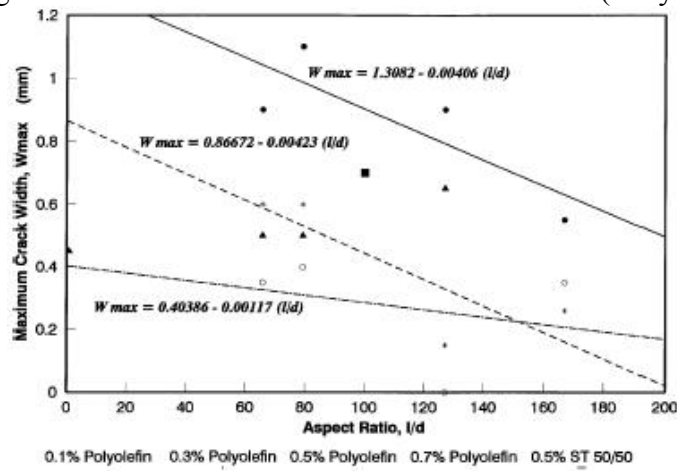
Figure 9. Maximum crack width vs. aspect ratio (Grzybowski and Shah 1990)

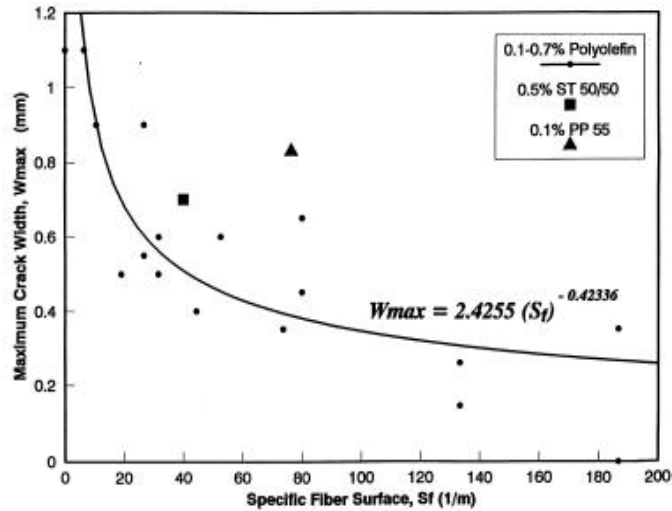
Figure 10. Maximum crack width vs. specific fiber surface (Grzybowski and Shah 1990)

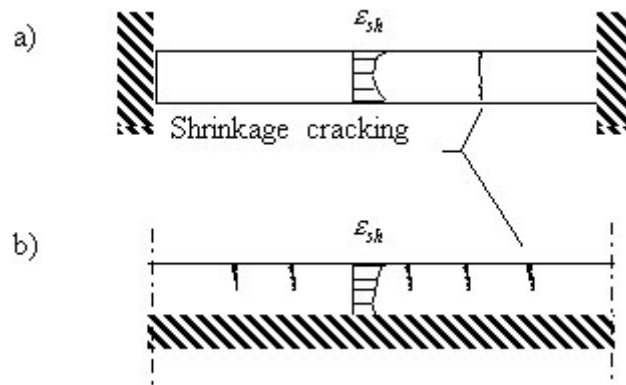
Figure 11 shows two idealized restrained concrete slabs. Figure 11a shows a slab restrained at the ends. If the slab is unreinforced, then a single crack will form whose size is equal to the total shrinkage strain. In Figure 11b the base provides frictional restraint to the slab, generating cracks at the free surface that are equally distributed. The cracks that form under these conditions are referred to as primary cracks. Secondary cracks can also form between the primary cracks as a result of combined shrinkage strains and externally applied tensile stress. Furthermore, when the axial stresses increase and no more primary cracks form, the secondary cracks begin to widen. The contribution of drying shrinkage to concrete cracking can be controlled by preparing a proper mix design, proportioning the concrete member to minimize differential shrinking stresses, optimizing curing procedures, and proper use and application of joints.

Figure 11. Typical cases of internally loaded and time dependent strains caused by shrinkage

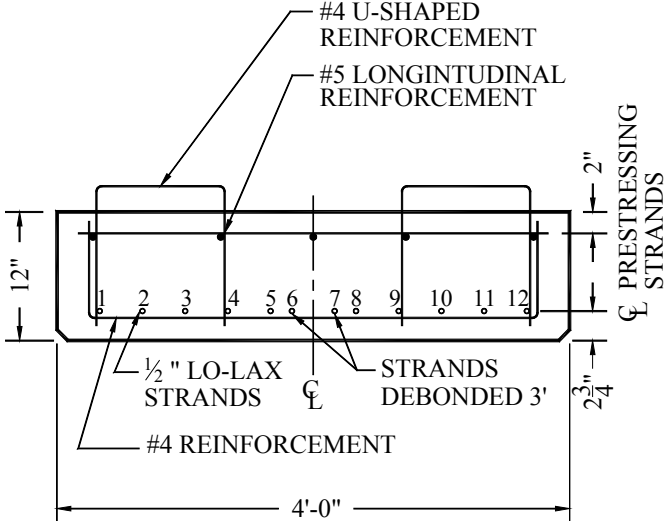
Twelve full-scale precast slabs were constructed by Dura-Stress Inc., a Precast/Prestressed Concrete Institute (PCI) certified plant, in Leesburg, Florida. The slabs were similar in size and design to the Cow Creek slabs with a length of 30-ft. Unlike the Cow Creek Bridge, the flat slabs used to construct the test specimens did not have shear keys. The Texas DOT has had success with flat slab bridges without shear keys (Cook and Leinwohl 1997) and eliminating them would help reduce labor and construction costs. Each slab had twelve 1/2 in. diameter lo-lax prestressing strands tensioned to 31 kips each. The two center strands were debonded 3 ft. from each end of the slab. The slabs were also reinforced with mild steel. Vertical shear reinforcement was provided every 12 in. U-shaped reinforcing bars, spaced at 12 in., provided horizontal shear reinforcement. Mild steel was also provided at each end of the slabs for confinement. All of the steel had a minimum concrete cover of 2 in. Reinforcement details are shown in Figure 12 and Figure 13. Complete reinforcement details are found in Appendix F. Figure 14 and Figure 15 show the constructed reinforcement system.

Figure 12. Typical cross-section through precast slab specimen

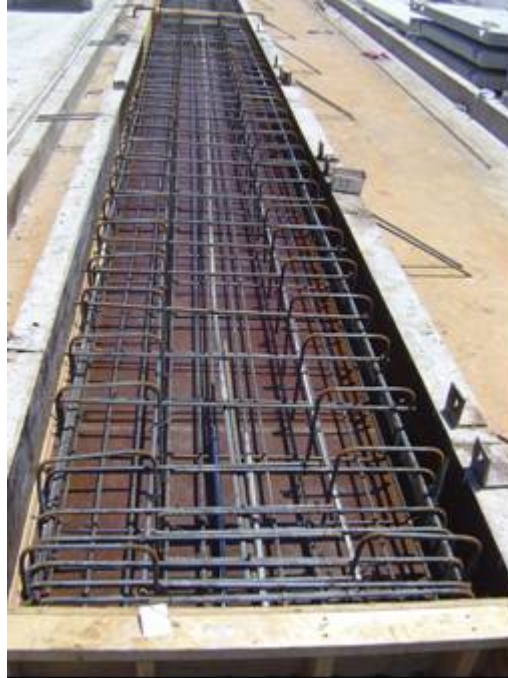
Figure 15. Flat slab reinforcement layout

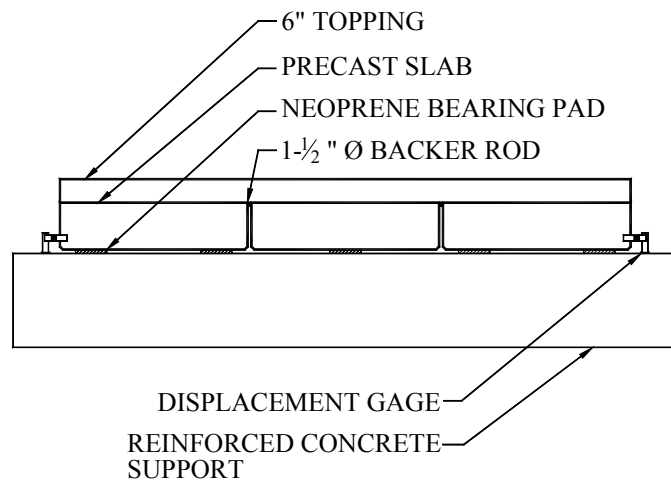
Figure 22. Typical superstructure end elevation view

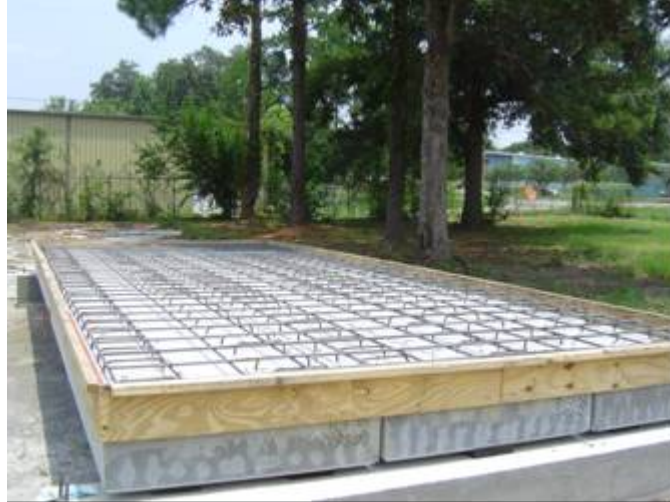
Formwork was erected on the edges of each deck for the placement of the topping. It was composed of $\frac{3}{4}$ in. plywood that had one side sealed to prevent moisture absorption from the concrete mixture (Figure 23). Once the formwork was erected the topping reinforcement was installed. The formwork was removed seven days after casting the toppings.

Figure 23. Reinforcement and formwork on precast slabs before topping placement

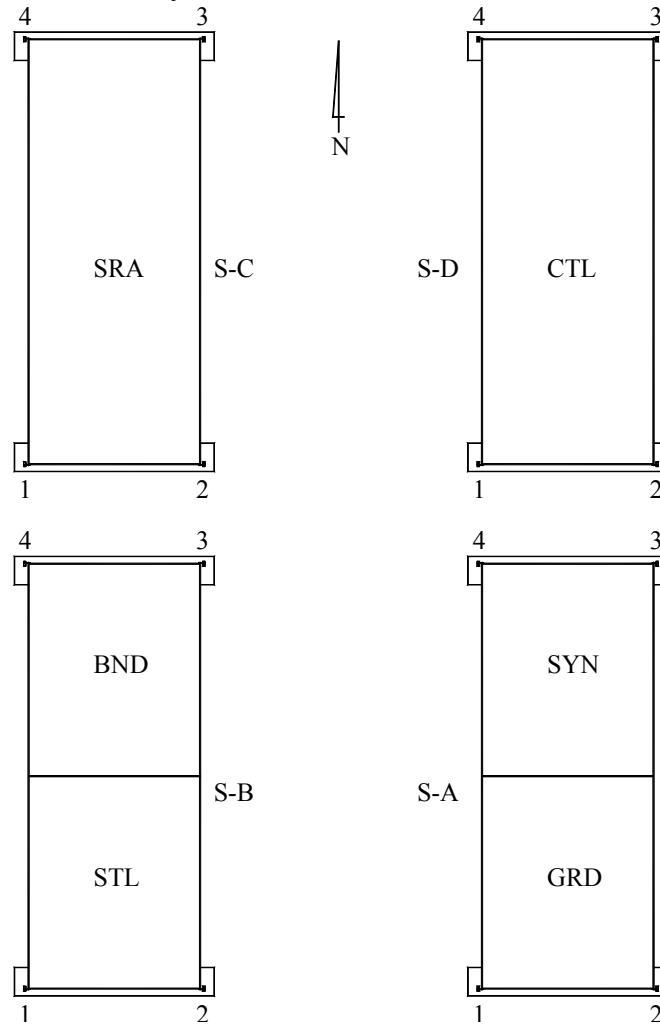
The toppings were cast daily during the week of July 26, 2004. Figure 25 shows the layout of the toppings with their respective designations shown in Table 12. Toppings that had a similar mixture were paired to minimize shrinkage cross-over effects over a span. The STL and BND toppings were combined because each had steel fibers incorporated into their concrete mixtures. To ensure that the CTL topping was not affected by cross-over effects and that it remained valid as a basis for comparison it was cast on a single span. The SRA topping was also cast on a single span because of the lower overall shrinkage expected of this type of concrete. The remaining two toppings, GRD and SYN, were cast on a single span. Any toppings that shared a span were cast within 2 days of each other.

Figure 25. Displacement gage locations and superstructure and topping designation

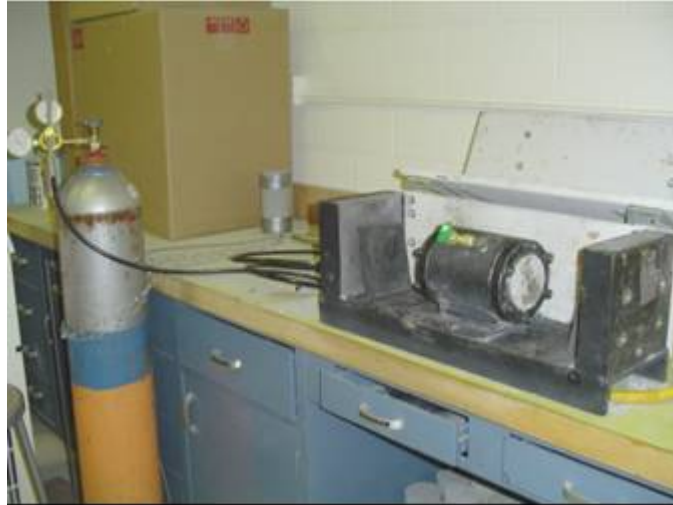
Figure 26. Pressure tension testing equipment (Li 2004)

Tensile strength was measured using the pressure tension test (Figure 26). The equipment consisted of a cylindrical chamber for pressurizing the specimen, nitrogen filled tank, collars for the ends of the specimen, and a computer that records data supplied by a pressure transducer. This procedure required the operator to open a valve by hand to apply pressure to a 4 in. by 8 in. concrete cylinder for each test. The load rate was determined by watching a monitor that plotted a load versus time line, which should be in the range of 35 psi/sec. Li (2004) details the test equipment and procedure.

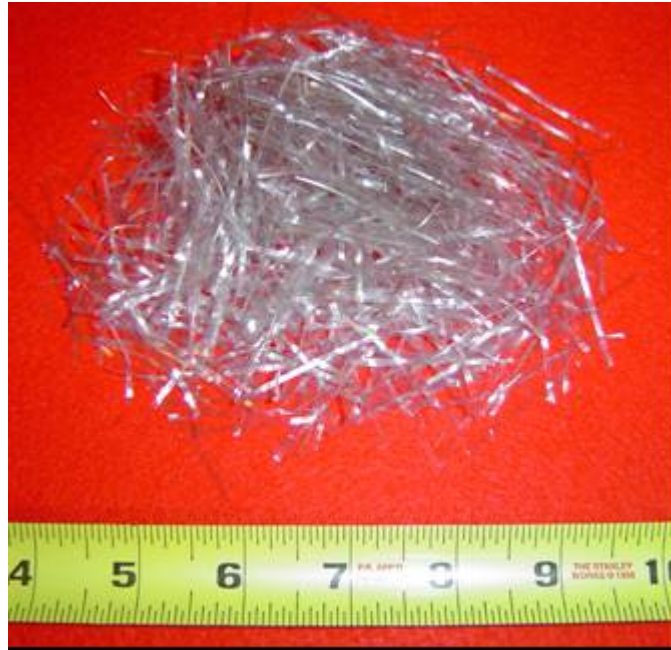
Figure 27. Synthetic fibers used in SYN topping

Polypropylene/polyethylene monofilament fibers (Figure 27) were used in the SYN topping at a dosage rate of 6 lbs/CY. The material properties provided by the fiber's

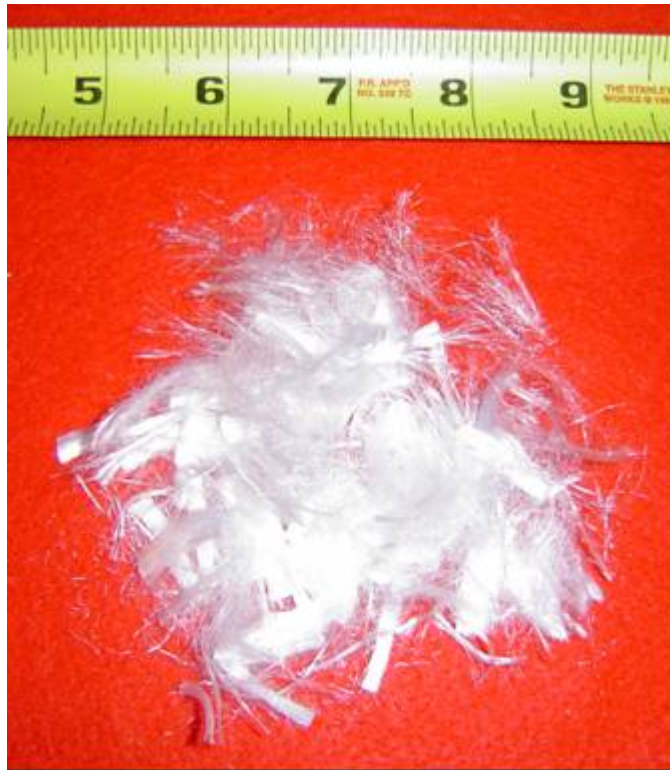
Figure 28. Synthetic fibers used in BND topping

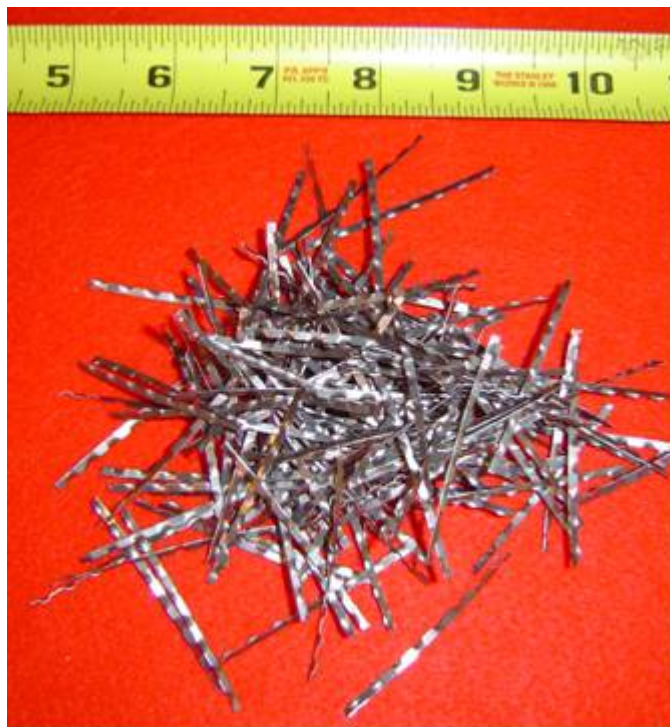
Figure 29. Steel fibers used in BND and STL toppings

The BND topping was a blended fiber concrete mixture composed of synthetic (Figure 28) and steel fibers (Figure 29). The synthetic fibers were ¾-in. long multifilament nylon fibers while the steel fibers were 2-in. long with a crimped profile. Table 17 and Table 18 outline the material properties of the synthetic and steel fibers provided by the manufacturer. Synthetic and steel fibers were used at a dosage rate of 1 lb/CY and 25 lbs/CY respectively. Table 19 shows the batched quantities of the ingredients in the BND mixture.

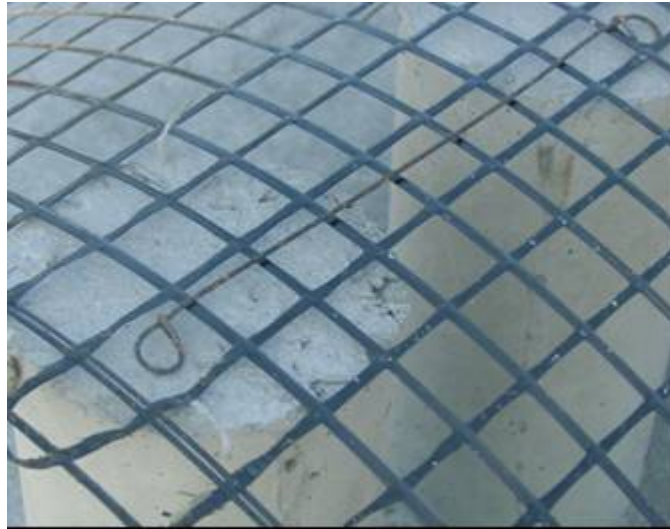
A 1.6 in. by 1.8 in. carbon-fiber grid (Figure 30) was embedded in the GRD topping (Figure 31) to provide crack control near the surface of the topping. Results from tensile tests performed on grid specimens are shown in Table 20. The material properties supplied by the manufacturer are listed in Table 21. The grid was placed one inch below the surface of the topping to prevent spalling or delamination. This positioned it below the minimum $\frac{1}{2}$ in. wearing surface required by the FDOT Structures Manual (2004b). The concrete was screeded at the embedment depth to provide a level surface for the placement of the grid. A float was used to fully coat the grid with concrete paste. The topping placement was then completed with a 1 in. layer of concrete placed over the grid. Bleed water was clearly visible on the surface of the topping as it cured.

Figure 30. Carbon-fiber grid used in GRD topping

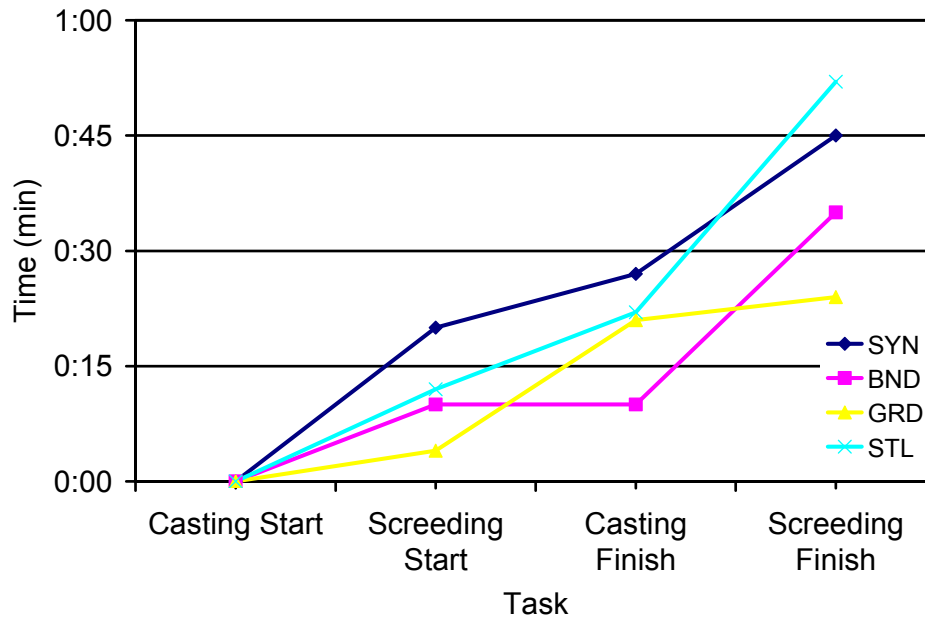
As Figure 32 shows, workability issues with the STL and SYN mixtures affected the finishing time of the toppings. Toppings with fiber treatments took the longest to complete. Screeding of the toppings commenced once casting was approximately half completed except on the BND topping which started immediately after it was cast. More time was spent screeding the GRD topping because it was performed twice, once to level the surface for placement of the grid, and a second time to level off the concrete. The time it took to install the grid includes the screeding time yet it was completed faster than the others because of good workability of the mixture. Timeline data for the SRA and CTL toppings were not listed for comparison because they were twice the size of the documented toppings.

Figure 32. Normalized timeline for construction of the half-span toppings

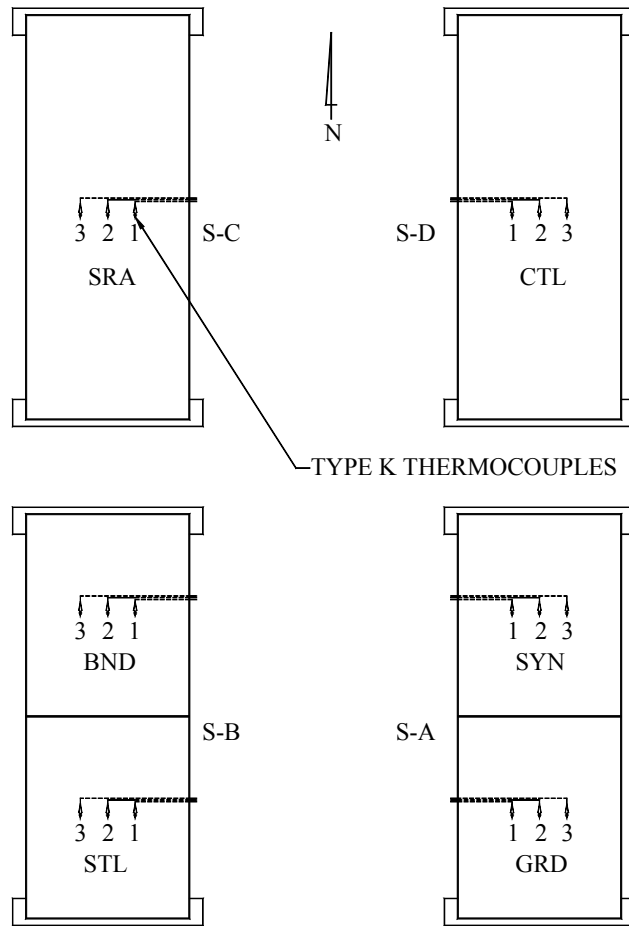
Nine locations were monitored for each topping (Figure 35). Two four-channel data loggers (eight total channels) were used to record the temperature data. One of the channels was used to monitor the temperature at two locations. The plugs were alternated on this channel approximately every half hour. The time and wire label was documented every time they were alternated. The data loggers were not left on-site overnight due to security concerns therefore temperature data were collected for approximately 8 to 10 hours on the days of the topping placement. Since the CTL and GRD toppings are the same FDOT approved mixture, temperature data were only collected for the CTL topping.

Figure 35. Monitored locations for each topping

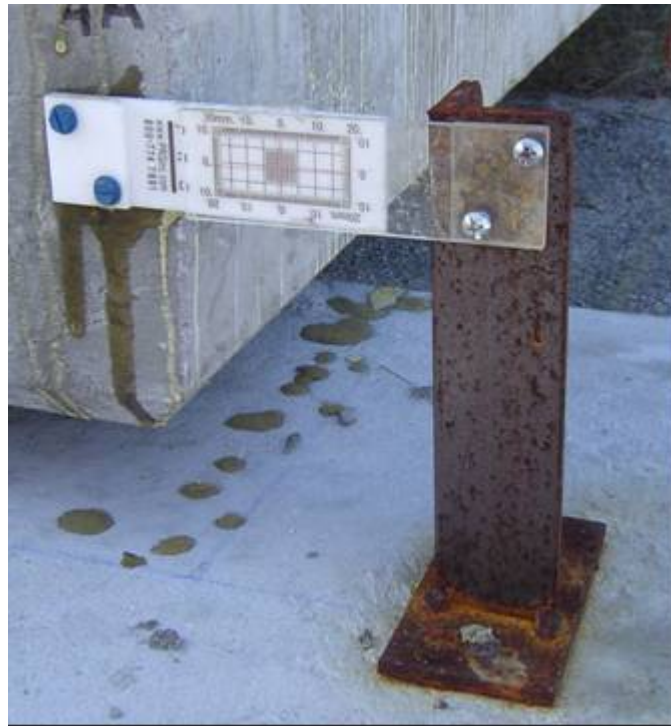
Figure 36. Displacement gage attachment bracket

Displacement gages were installed at the corners of the bridge decks to monitor vertical or in-plane movement (Figure 25). They were manufactured by Preservation Resource Group, Inc. and had a measurement range of 0.79 in. in the vertical direction and 1.57 in. in-plane. As shown in Figure 36, steel brackets were used to mount the gages to the superstructure support. The opposite end of the gage was attached to the flat slab with screws (Figure 37).

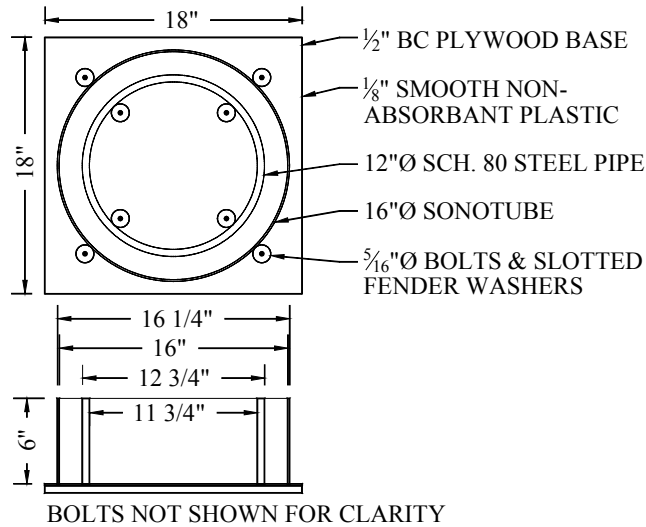
The ring with the GRD mixture was the only one that did not incorporate its respective crack control treatment. Hence, the results do not take into account the performance of the carbon-fiber grid.

Figure 38. Restrained shrinkage ring

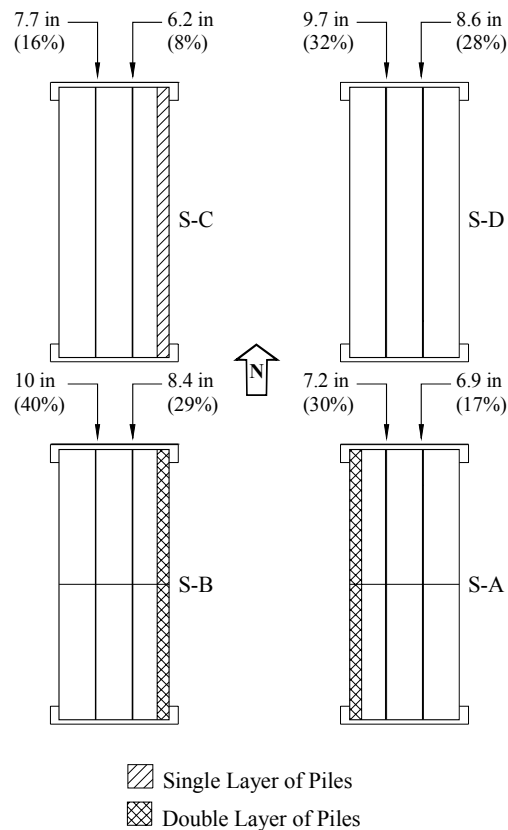
Measurements of the topping thickness were taken every 1-ft. along the length of the joint (Appendix G). The average thicknesses along with the coefficient of variation (COV) are shown in Figure 41

Figure 41. Average and COV of measured topping thickness at joint. Position and number of piles to add load.

The control specimen has one of the largest average joint thicknesses with the exception of one in BND and STL specimen. This indicates that the additives were better able to control the cracking under self weight than the control. This will be discussed further in the following section.

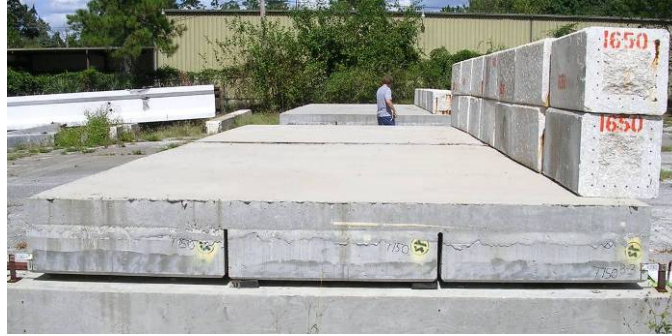
Figure 42. Pile sections stacked on slab S-B in the foreground and S-C in the background.

Additional load was necessary to induce cracking in the remaining specimens. Figure 42 shows the 20-in. square concrete pile sections that were used to add load. The sections were cut from precast prestressed bridge piles to a length of approximately 48-in. that ranged in weight from 1600 lbs to 1700 lbs. As shown in the figure, the piles were stacked along one edge of the specimen to increase the transverse flexural tensile stresses in the topping over one of the joints while leaving the flexural stresses from the self weight in the opposite joint.

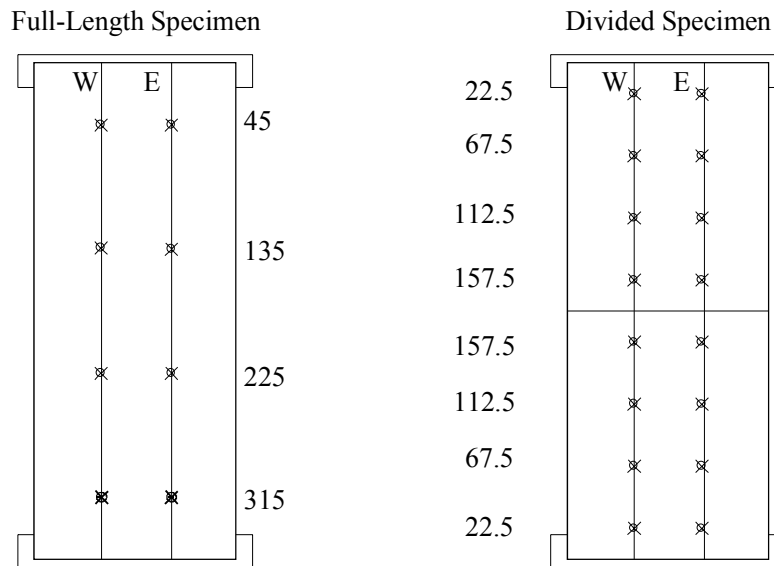
Figure 43 shows the locations of each measurement point. Eight locations were monitored for each additive with four locations equally spaced along each joint. The W and E designation indicate west and east joints, respectively.

Figure 43. Location of Crack Measurements

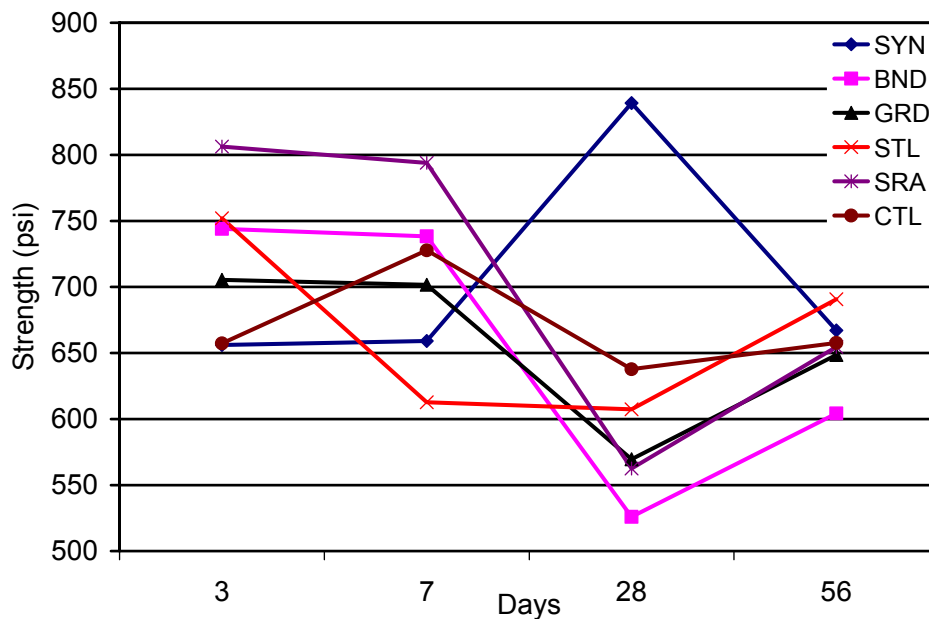
Figure 44. Tensile strength using pressure tension test

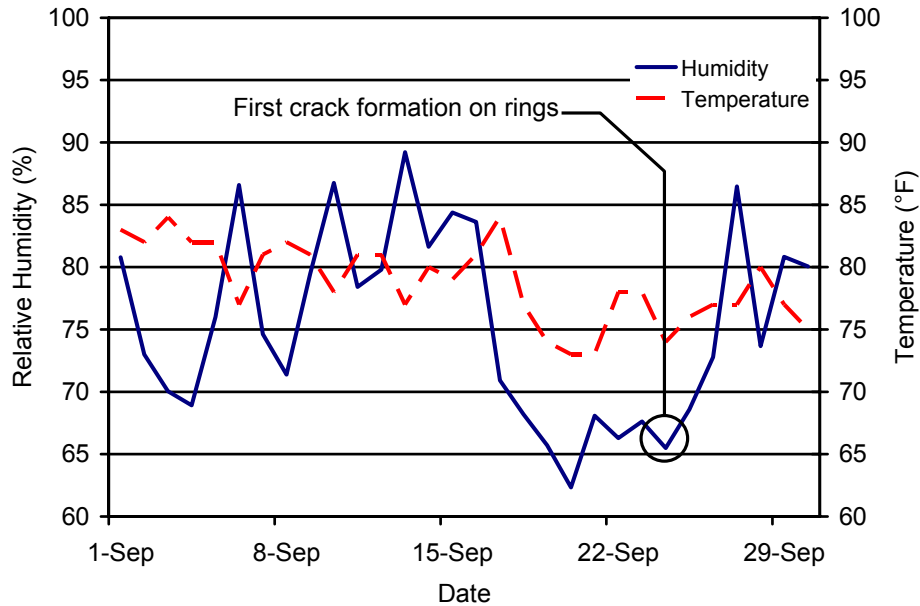
were observed on the toppings. The variability in the humidity and temperature at the site contributed to the long time to cracking of the rings when compared to research that shows cracking at much earlier ages when the rings are kept in a controlled environment (Grzybowski and Shah 1990; Shah, Karaguler, Sarigaphuti 1992).

Figure 47. Humidity and temperature for Sept. 2004

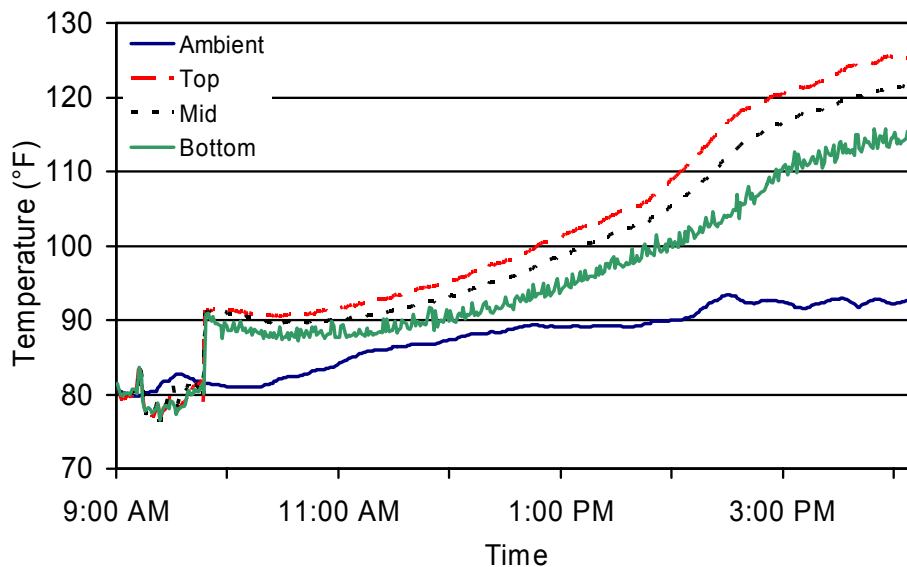
Temperature data measured through each topping's depth at the time of casting is presented in Appendix F. While most of the toppings had a temperature difference of approximately 5°F, a 13.2°F temperature gradient was measured approximately five hours after casting in the SRA topping (Figure 48) at location 3. This may promote the formation of internal micro cracks in hot weather concreting.

Figure 48. Temperature data through depth of topping for SRA-3

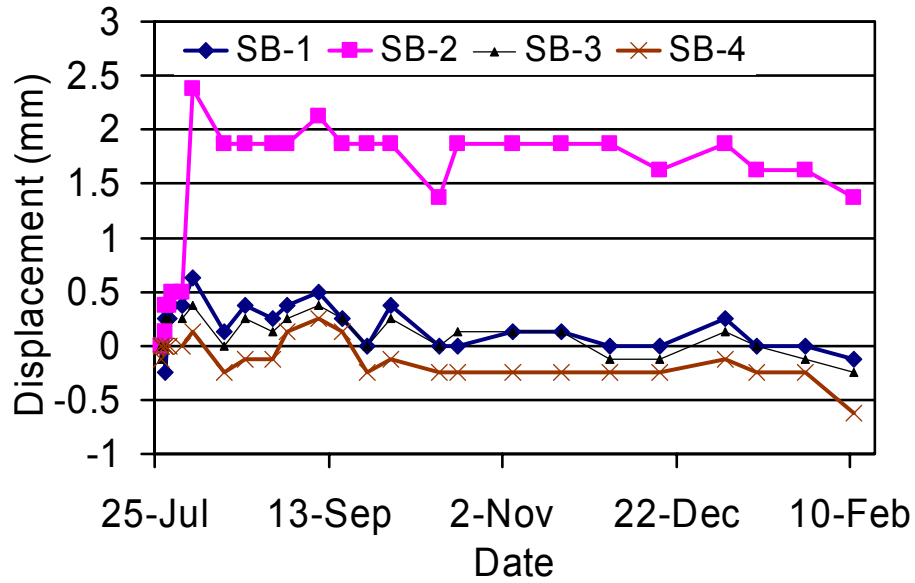
Figure 50. Displacement of superstructure S-B. Gage SB-2 was bumped on August 5, 2004

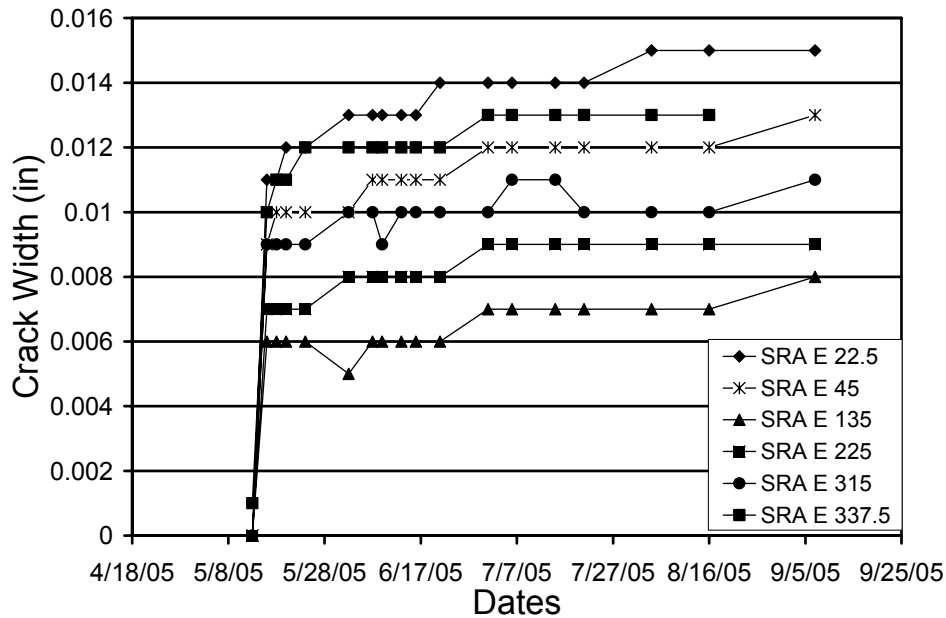
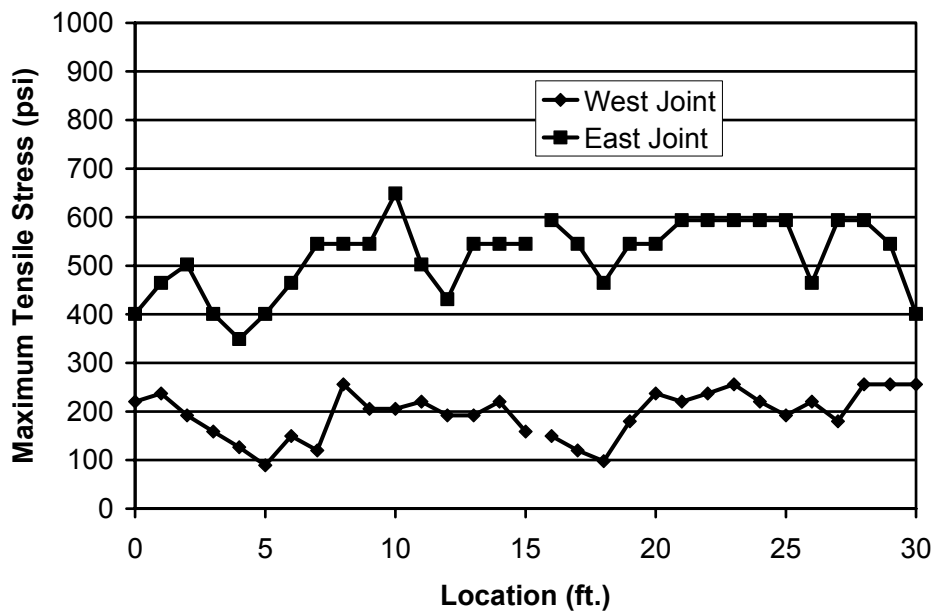
remainder of the monitoring period. Calculated flexural tensile stresses are shown in Figure 54b. Stresses in the east joint were in the range of 500-600 psi, which is comparable to the predicted tensile strength of the topping concretes.

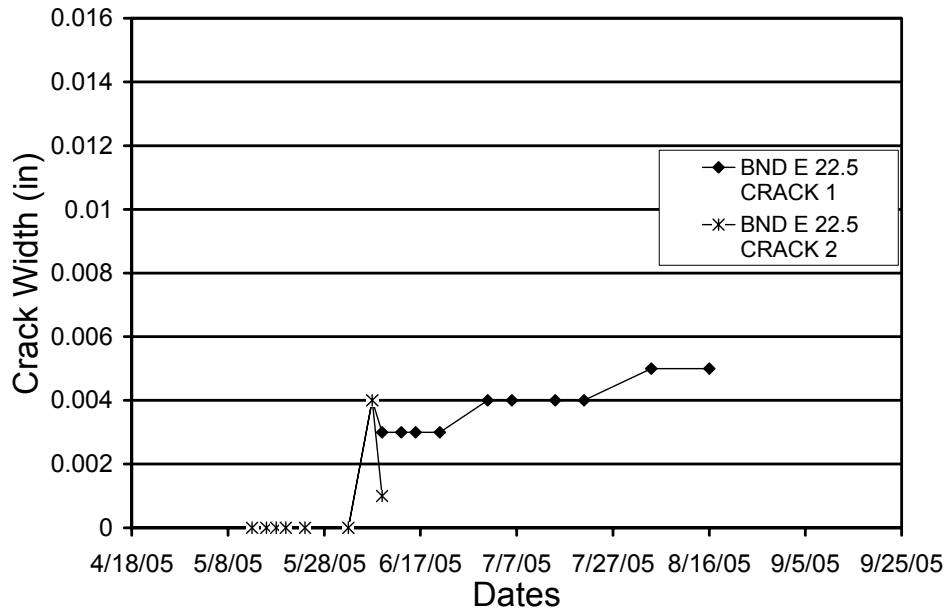
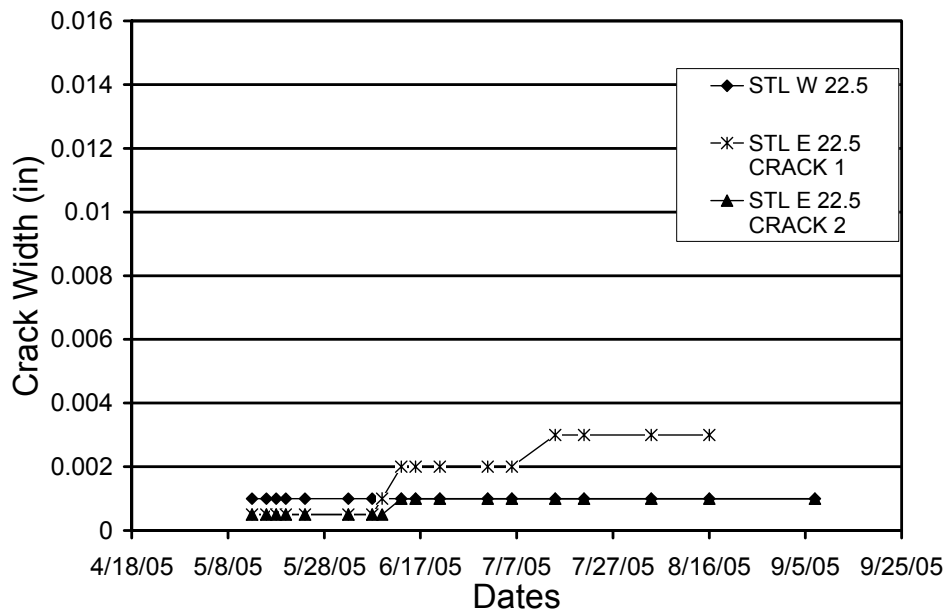
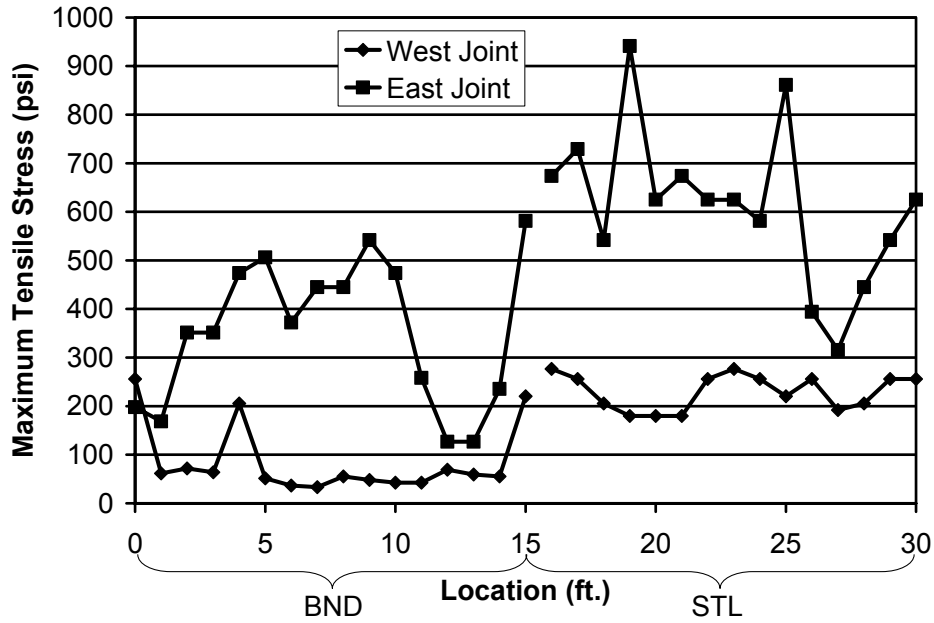
specimen. Maximum crack widths for BND were small at no more than 0.005 in. Figure 55c shows that the calculated stresses for BND were in the range of 400-500 psi. STL performed better yet than that of the BND with two cracks forming at a single location, but with widths no more than 0.003 in. Calculated stresses, however, were much higher (600-700 psi) than that of the BND due to the reduced thickness of the topping.

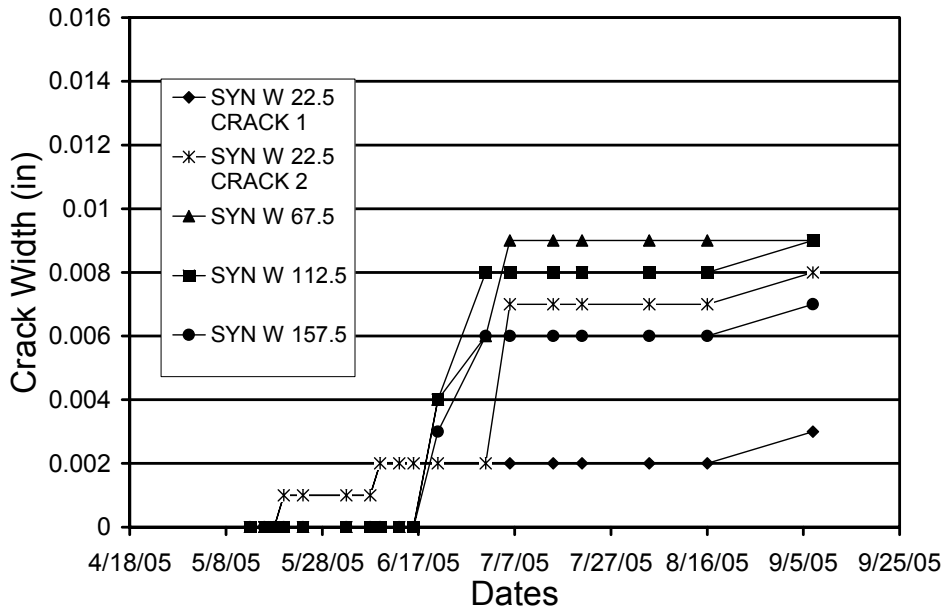
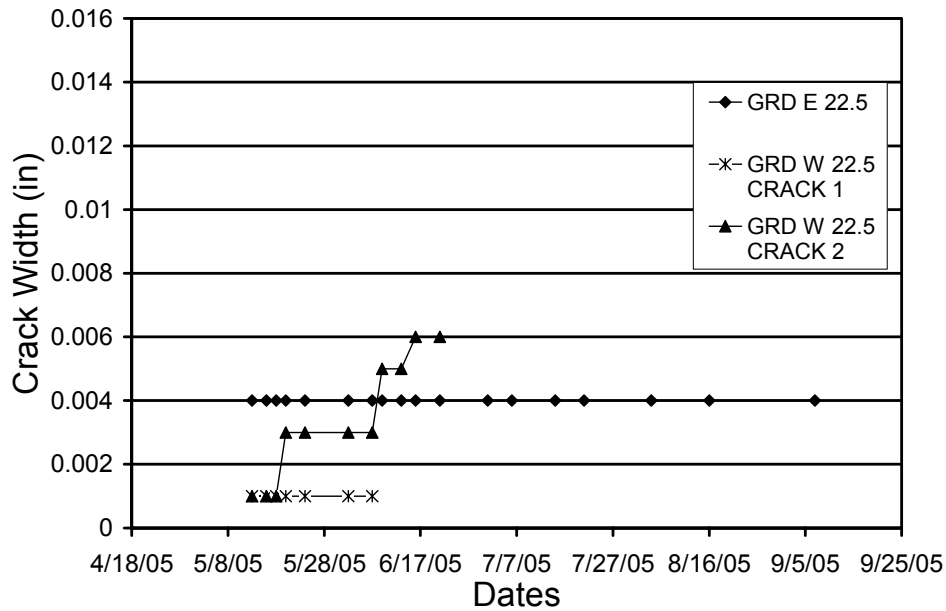
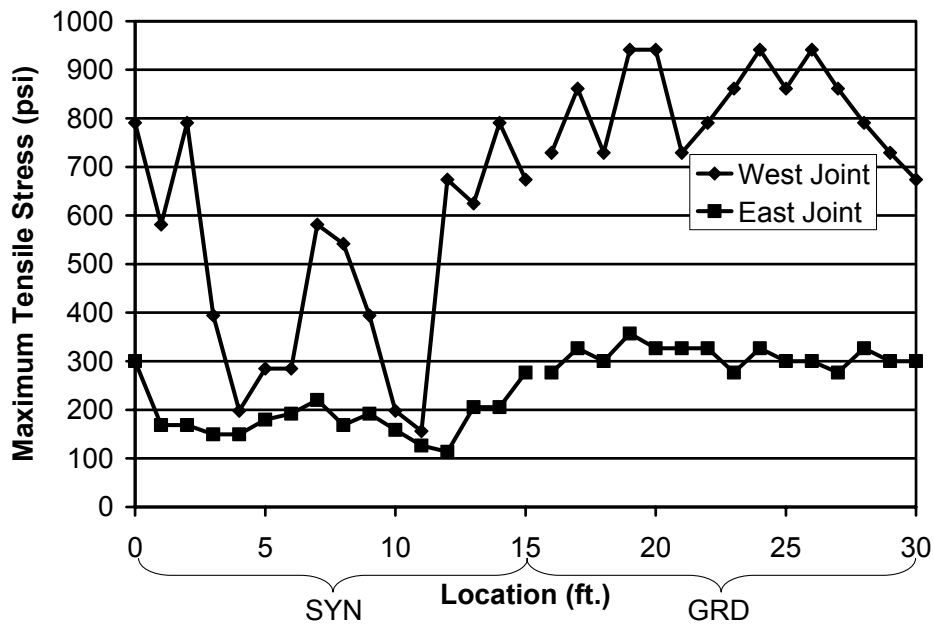
Two layers of piles were also needed to form cracks in specimen SYN and GRD. Figure 56a shows that 0.006 to 0.009-in. wide cracks formed in the west joint of SYN while Figure 56b shows that 0.004 to 0.006-in. wide cracks formed in the west joint of GRD. Crack growth was similar to the other slabs with rapid initial growth followed by stabilization. Comparing the calculated stresses (Figure 56c), however, indicates that the stresses were in the 700 to 900 psi range for the GRD compared to the SYN, which varied widely between 200 and 700 psi.

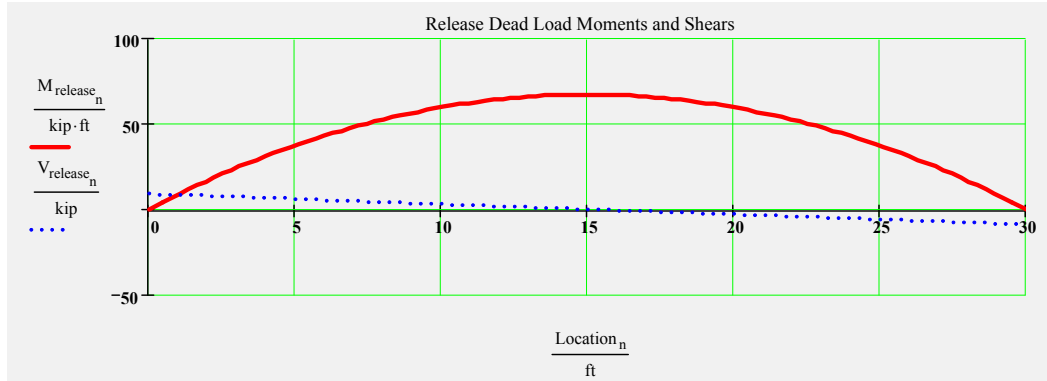
Loads - Release, Non composite, Composite, and Live Load (truck and lane)

$w_{\text{beam}} = 0.599 \frac{\text{kip}}{\text{ft}}$ $\max(M_{\text{release}}) = 67.4 \text{ kip}\cdot\text{ft}$ *note: at release, span length is the full length of the beam*
