Final Report

March 2006

UF Project No. 00030907
Contract No. BD545, RPWO# 9

CRACK CONTROL IN TOPPINGS FOR PRECAST FLAT SLAB BRIDGE DECK CONSTRUCTION

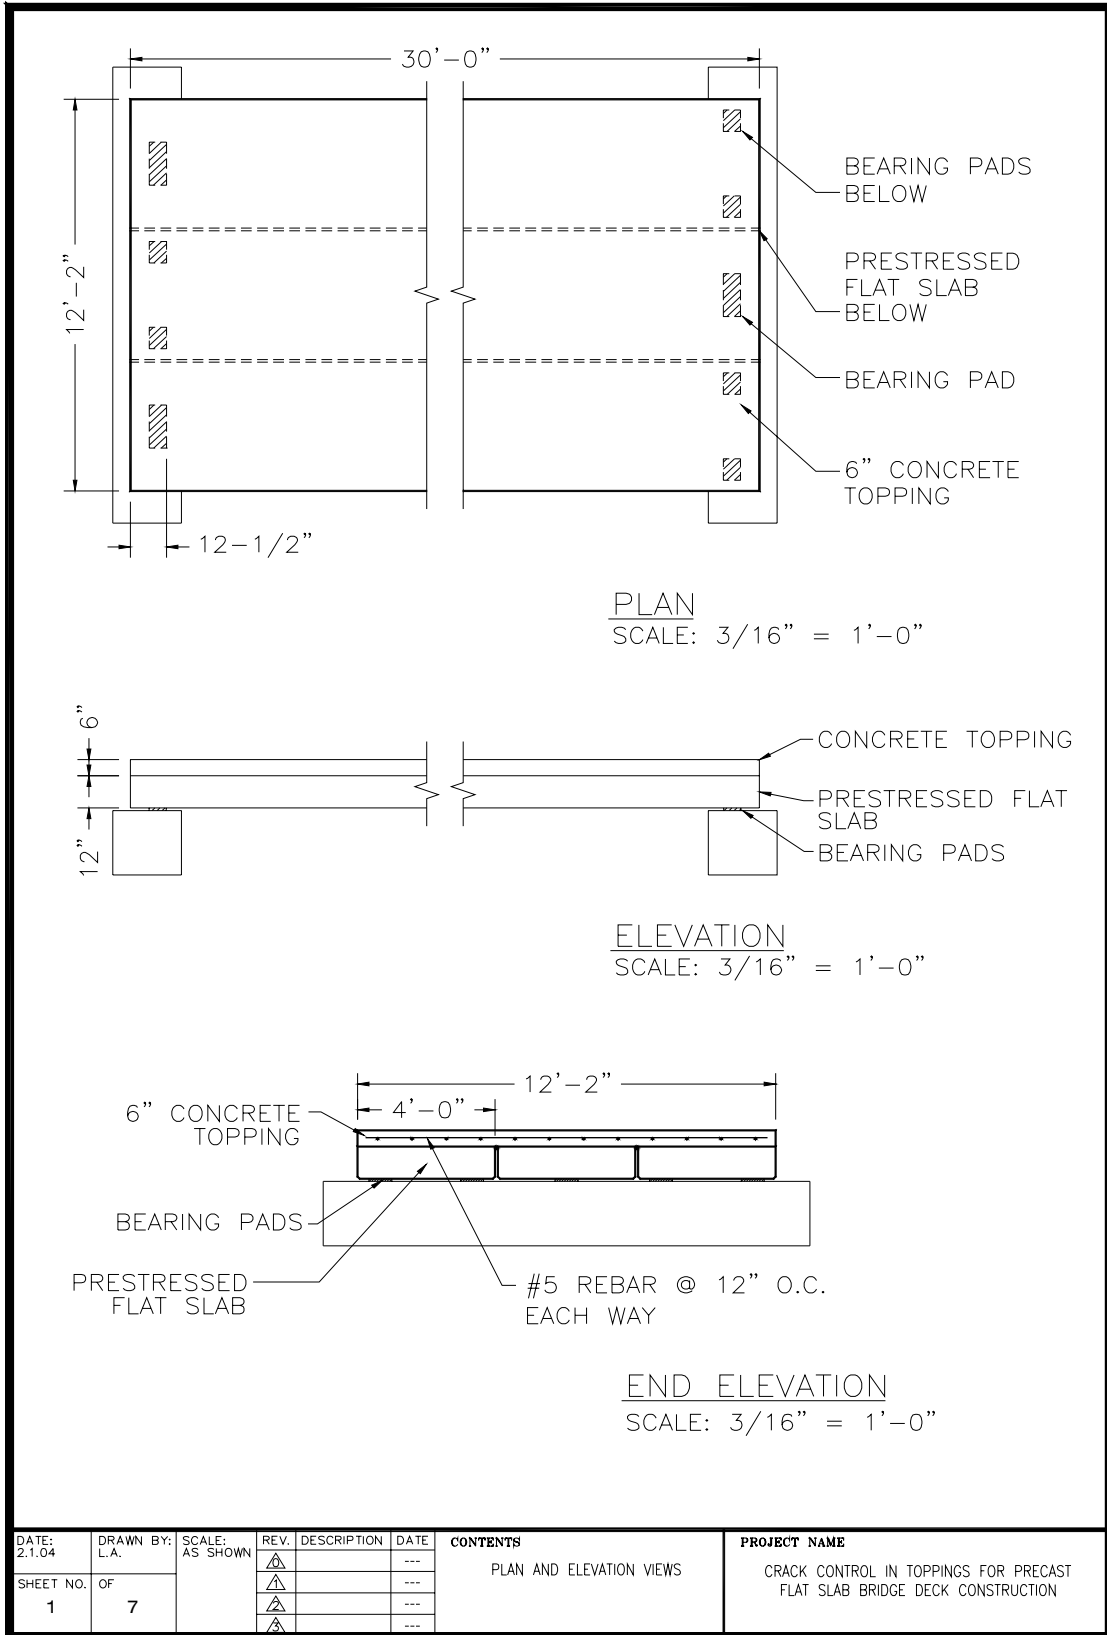
Figure 104. Plan and elevation view of specimen

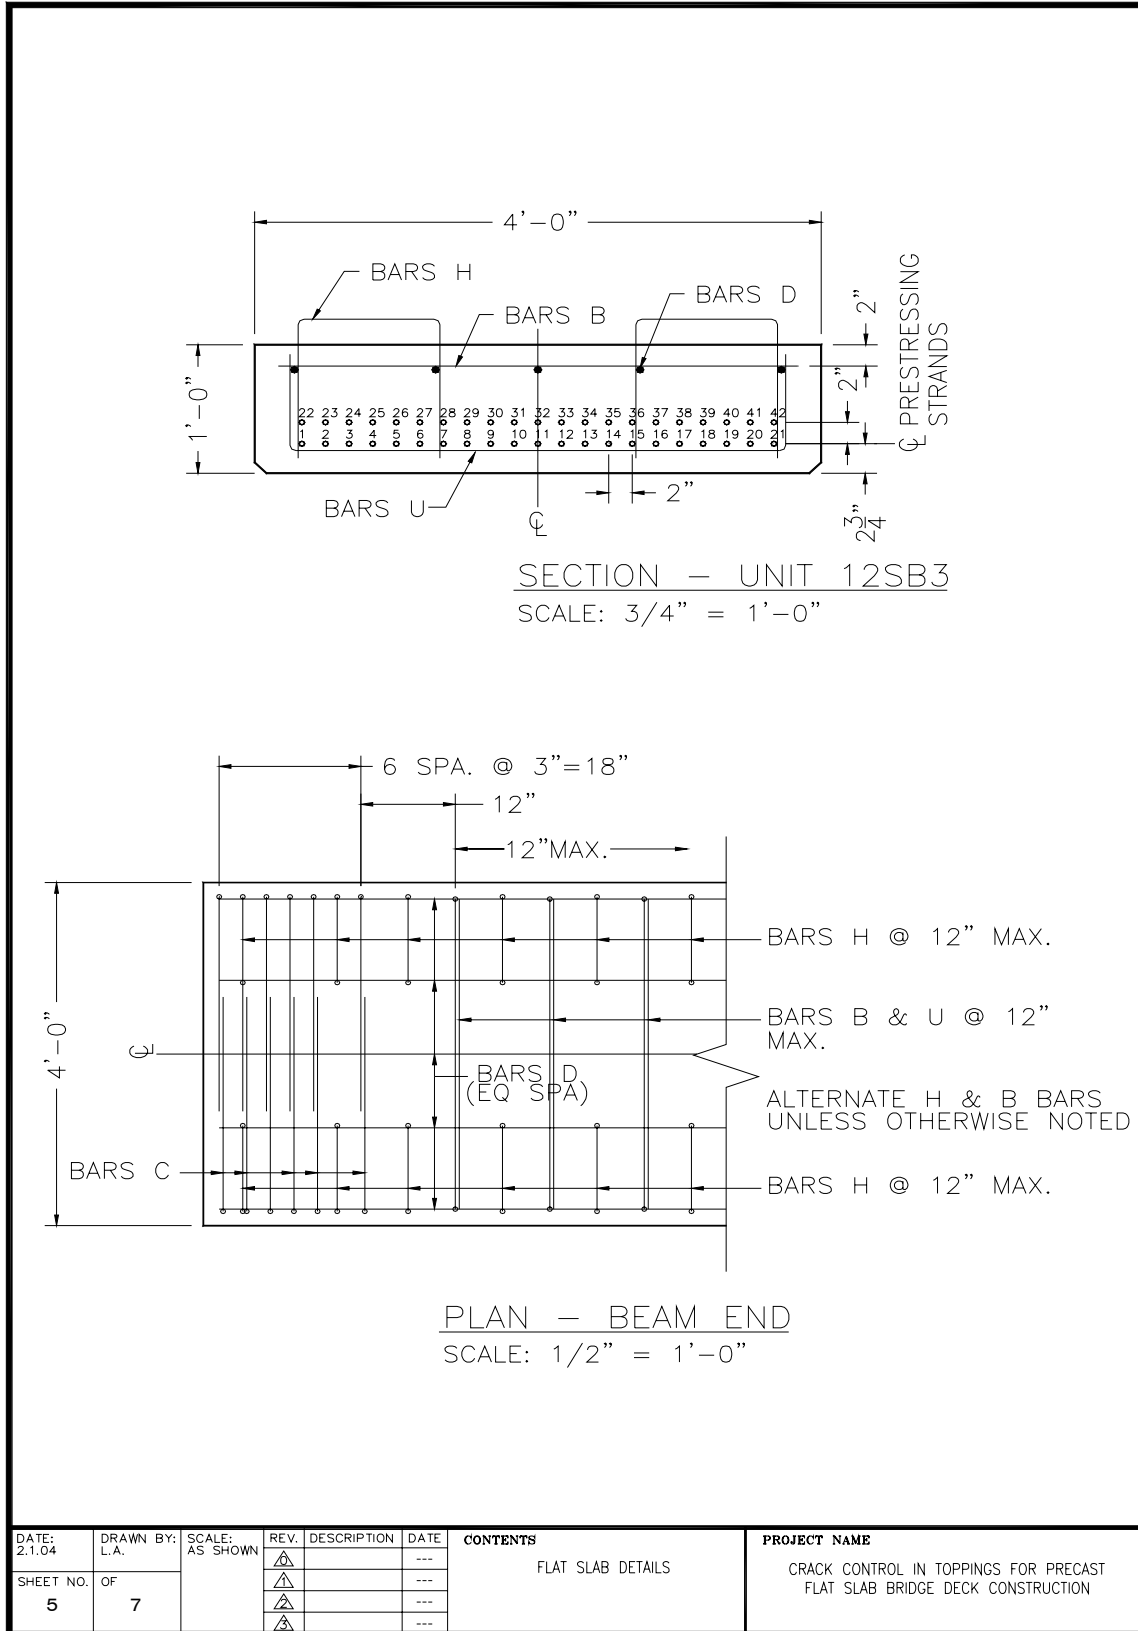
Figure 108. Flat slab detail drawings

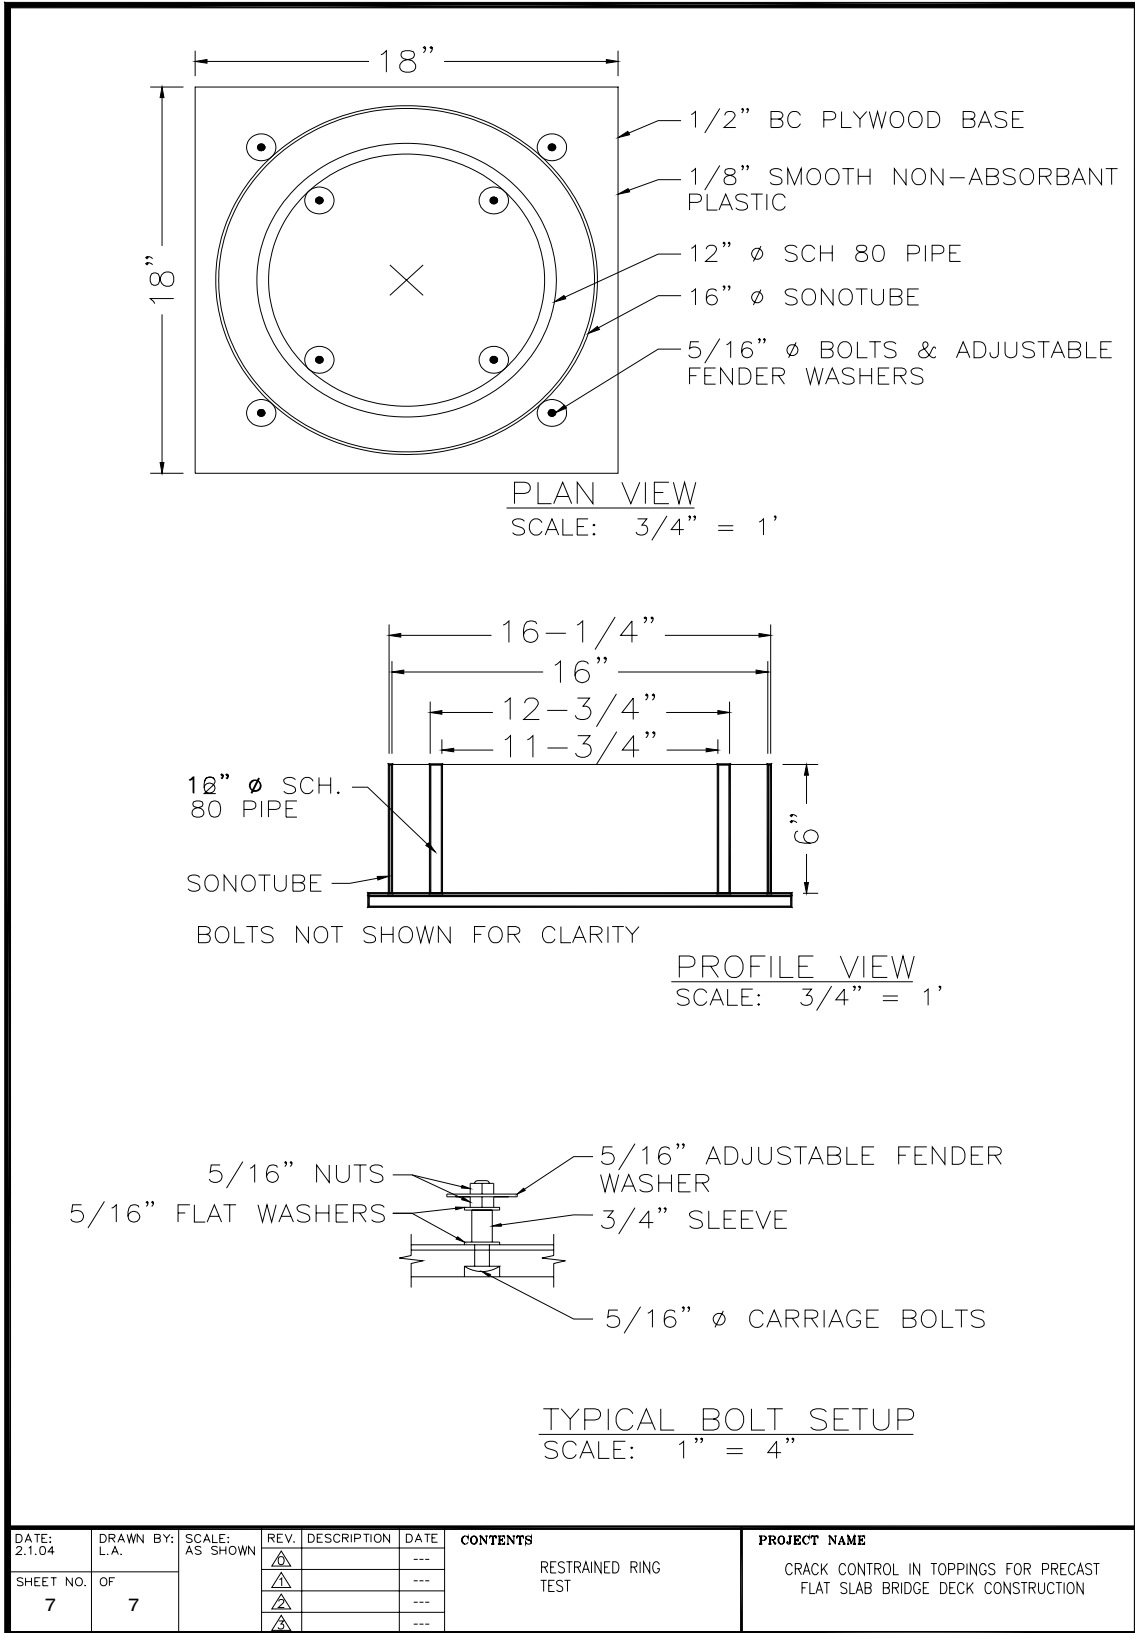
Figure 110. Restrained ring test fabrication drawing
