# The Effects of Pedestrian Countdown Signals in Lake Buena Vista

Herman Huang and Charles Zegeer  
University of North Carolina at Chapel Hill  
Highway Safety Research Center

**Florida Department of Transportation**

November 2000

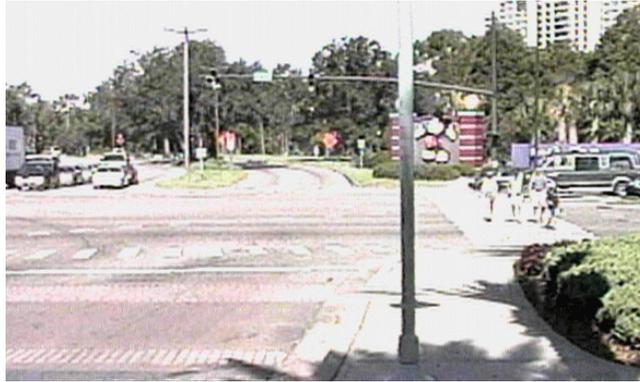
**Figure 3.** State Route 535 at Hotel Plaza Boulevard (countdown signal site).

**Figure 4.** SR 535 at Hotel Plaza Boulevard.

State Route 535 is a bustling north-south commercial strip with many hotels, restaurants, and souvenir shops (Figures 3 and 4). The east leg of Hotel Plaza Boulevard is the entrance to a shopping plaza. The west leg of Hotel Plaza Boulevard is one of the entrances to Walt Disney World™. State Route 535 has three lanes of through traffic and a right-turn lane in each direction. There is one left-turn lane for southbound traffic and two left-turn lanes for northbound traffic. Northbound and southbound traffic are separated by a raised grass median. The ADT is 68,300 vehicles per day and the speed limit is 64 km / h (40 mi / h).

The northside crosswalk is equipped with a countdown signal. It starts at 37 seconds, when the Walk first appears. At 25 seconds, the flashing Don't Walk appears. At 0 seconds, the steady Don't Walk appears and the timer display disappears.

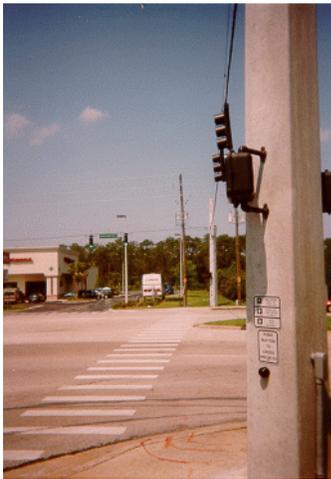
**Figure 5.** County Route 535 at Vinings Way (control site #1).

This T-intersection is two traffic lights, about 0.8 km (0.5 mile) north of its matching treatment site (State Route 535 at Hotel Plaza Boulevard) (Figure 5). The east leg is the entrance to a shopping plaza. County Route 535 has two lanes of through traffic and a left-turn lane in each direction, and a raised grass median. The ADT is 47,200 vehicles per day and the speed limit is 64 km / h (40 mi / h). Compared to State Route 535 at Hotel Plaza Blvd., pedestrian

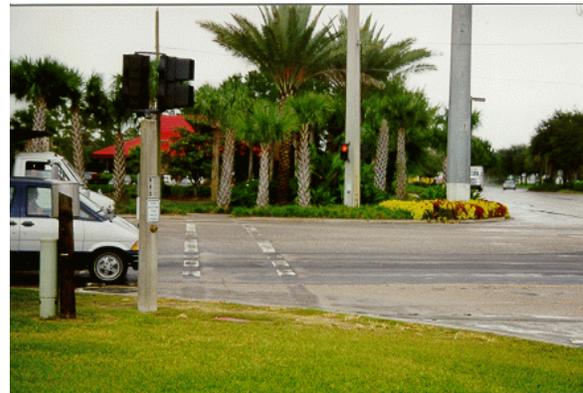
**Figure 6.** State Route 535 at Palm Parkway (control site #2).

Because of low pedestrian activity at Vinings Way Drive, a second control site for Hotel Plaza Boulevard was added to the study. This site is about halfway in-between Hotel Plaza Boulevard and Vinings Way Drive. State Route 535 approaches this intersection from the south and turns to the west. It has two lanes of through traffic and a left-turn lane in each direction, and a raised grass median (Figure 6). The ADT is 47,200 vehicles per day and the speed limit is 64 km / h (40 mi / h). To the north of the intersection, the road is known as County Route 535 and has a similar cross-section as State Route 535 to the south. Palm Parkway approaches from the east. It has two lanes of through traffic in each direction, left- and right-turn lanes for westbound traffic, and a raised median. There are hotels, restaurants, and souvenir shops here. More pedestrian activity was observed here than at County Route 535 and Vinings Way Drive.

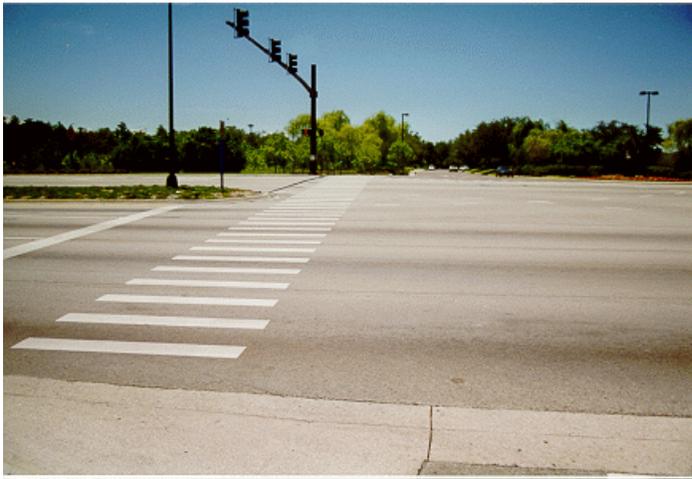
**Figure 7.** Buena Vista Drive at Team Disney (countdown signal site).

**Figure 8.** Buena Vista Drive at entrance to Team Disney.

Buena Vista Drive is an east-west roadway with a raised grass median (Figures 7 and 8). There are three through lanes and a left-turn lane in each direction. The ADT is 30,500 vehicles per day and the speed limit is 56 km / h (35 mi / h). The north side of Buena Vista Drive is occupied by Downtown Disney, which is a shopping, restaurant, and entertainment complex. Team Disney, which houses Walt Disney Company offices, is on the south side.

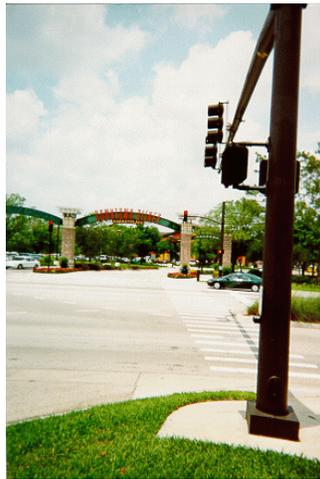
**Figure 9.** Buena Vista Drive at Disney Casting Center (control site).

This location is one traffic light (about 1/4 mile) east of its corresponding treatment site (Buena Vista Drive at entrance to Team Disney). Buena Vista Drive is an east-west roadway with a raised grass median (Figure 9). There are three through lanes and a left-turn lane in each direction. The ADT is 30,500 vehicles per day and the speed limit is 56 km / h (35 mi / h). Downtown Disney is on the north side of Buena Vista Drive. The Disney Casting Center serves as the Walt Disney World™ employment office, and is on the south side.

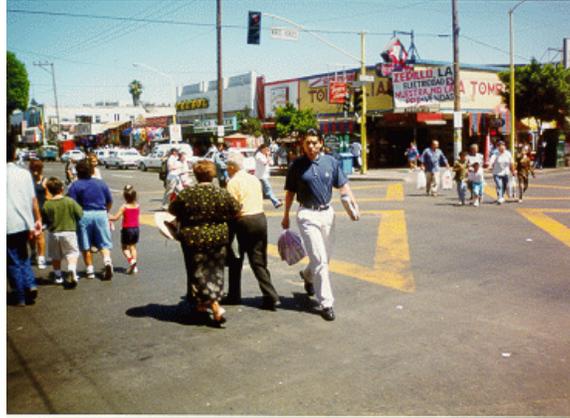
**Figure 13.** With scramble timing, pedestrians are allowed to cross in any direction, including diagonally.

Two alternatives are exclusive timing and scramble (or Barnes dance) timing. With exclusive timing, all vehicular traffic is stopped and pedestrians are allowed to cross in any crosswalk: the Walk interval is displayed for all crosswalks at the same time, while all motorists have a red traffic signal. Exclusive timing has been associated with approximately a fifty percent reduction in motor vehicle - pedestrian crashes as compared to standard timing (Zegeer *et al.*, 1985). With scramble timing, all vehicular traffic is stopped and pedestrians are allowed to cross in any crosswalk or diagonally across the intersection (Figure 13). These exclusive timing schemes are most appropriate in downtown signalized intersections with high pedestrian volumes (1,200 or more per day), and relatively low vehicle speeds and volumes. Such timing schemes will typically increase vehicle and pedestrian delay, since longer signal cycles are required, and it may

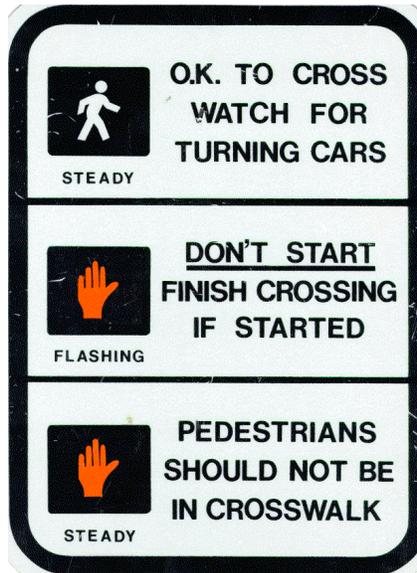
**Figure 15.** A sign that explains the meaning of the pedestrian signal displays.

Education and enforcement can help improve conditions for pedestrians. Table 2 and Figure 10 show that 47 percent of pedestrians at the countdown sites, and 58 percent of those at the control sites, complied with the Walk phase. In other words, 53 and 42 percent, respectively, did not comply. Some of those who started crossing on a flashing Don't Walk were still in the street when the countdown timer reached zero. This finding highlights the need to educate pedestrians as to what the signals mean and when it is appropriate to cross the street. For instance, an informational sign could explain what pedestrians should do during the Walk, flashing Don't Walk, and steady Don't Walk signal intervals (Figure 15).
