Agency of Transportation

**Report on
Spring 2006 Evaluation of
Detectable Warning products
installed 2003- 2005**

July 12, 2006

**Produced by the Bicycle and Pedestrian
Program, Local Transportation Facilities
section of the Program Development Division**

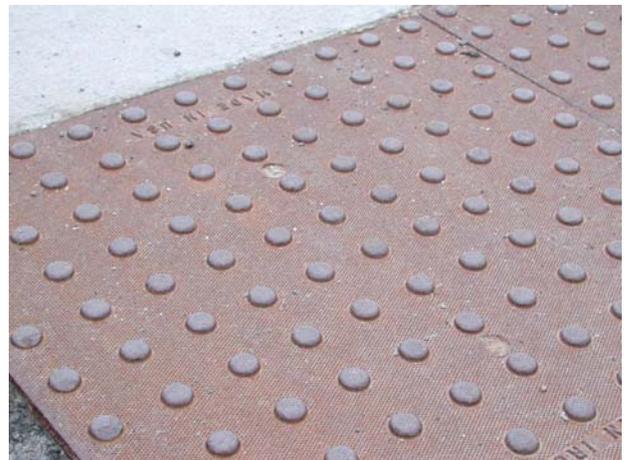
These panels showed virtually no damage and all domes were intact. There was good color contrast to the surrounding concrete. Some minor bleeding of rust onto the adjacent concrete was observed.

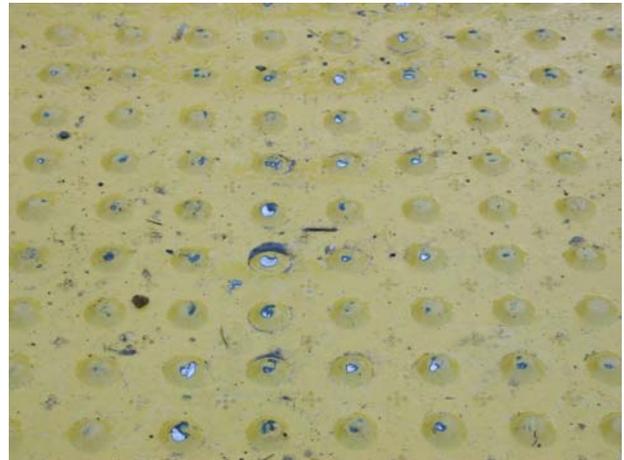
The removal of surface coating was noted on some internal domes, not just the leading edge.
