Maintenance Practices for Stormwater Runoff - Phase 2

Phase 2 Final Report
Submitted May 2015

Stormwater Management Academy
University of Central Florida
4000 Central Florida Blvd. P.O. Box 162450
Orlando, Florida 32816-2450

Agency Number: BDV24-977-02

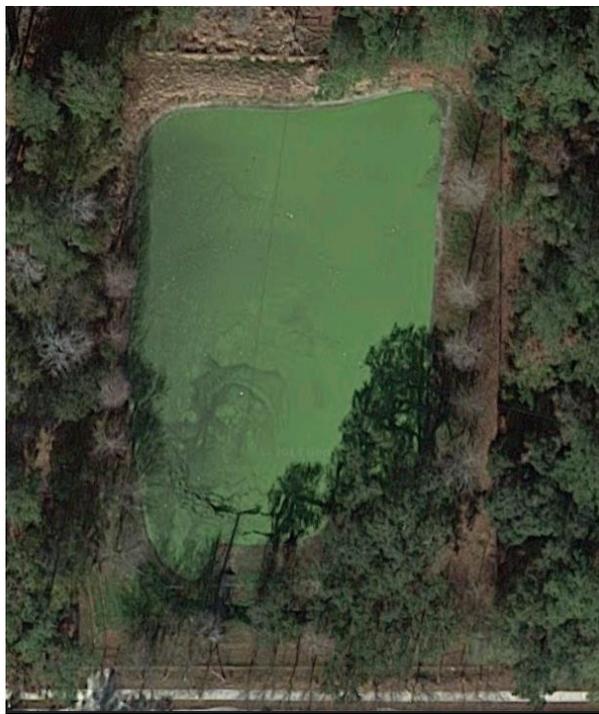
Figure 9: Gainesville pond

This 0.58-acre pond lies at the low point between two hills to the east and west. Runoff pooling at the low point of State Road 26 to the south is discharged into the pond through stormwater piping. District 2 reported major algae growth within the pond, in addition to significant amounts of floating debris. During the initial site visit, the entire surface of the pond was covered in a layer of algae. Since the pond is surrounded by forest that is at higher elevation, the nutrients from the forest floor are collected during storm events and carried downhill into the pond. Bottles and miscellaneous floating debris were also observed on the surface on the pond. The chain-link fence around the pond should prevent debris from entering, which leads one to conclude that the majority of the floatables are being transported in through the stormwater inlet to the pond. An image of the Gainesville pond is presented in Figure 9.

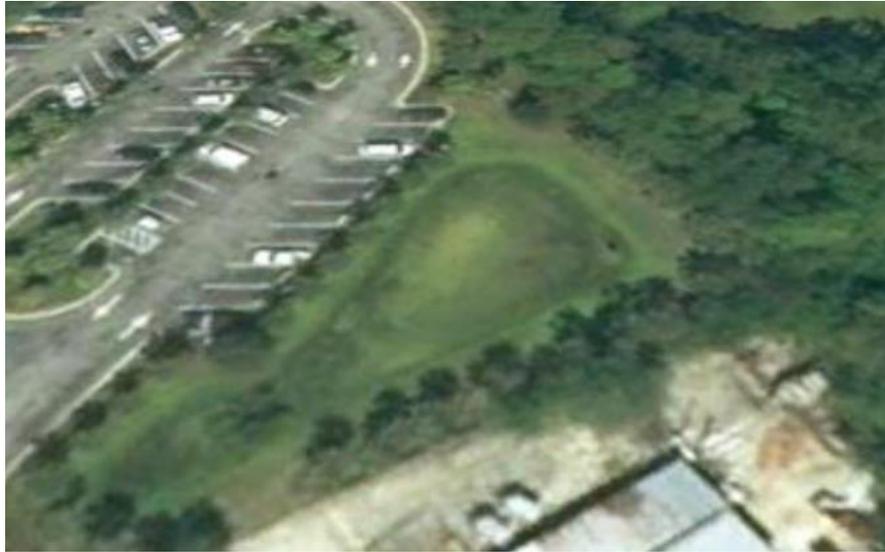
Figure 16: East Palatka pond

This 0.11 acre pond has parking lots to the north and south of it. US 17 runs along the western side of the pond and is directly connected to the parking lot to the south. A forested area and stream are downhill from the pond to the east. Sediment loadings, algal growth, and nuisance vegetation were the primary maintenance issues reported for this pond. The algal growth was quite apparent during the initial site visit. There is a mature forest area located across from US 17; this is one possible nutrient source that is contributing to the algae problem. A minor amount of nuisance vegetation was seen in the eastern portion of the pond, yet nuisance vegetation and sediment loading were visible near the pond inlet. An image of the East Palatka pond is presented in Figure 16.

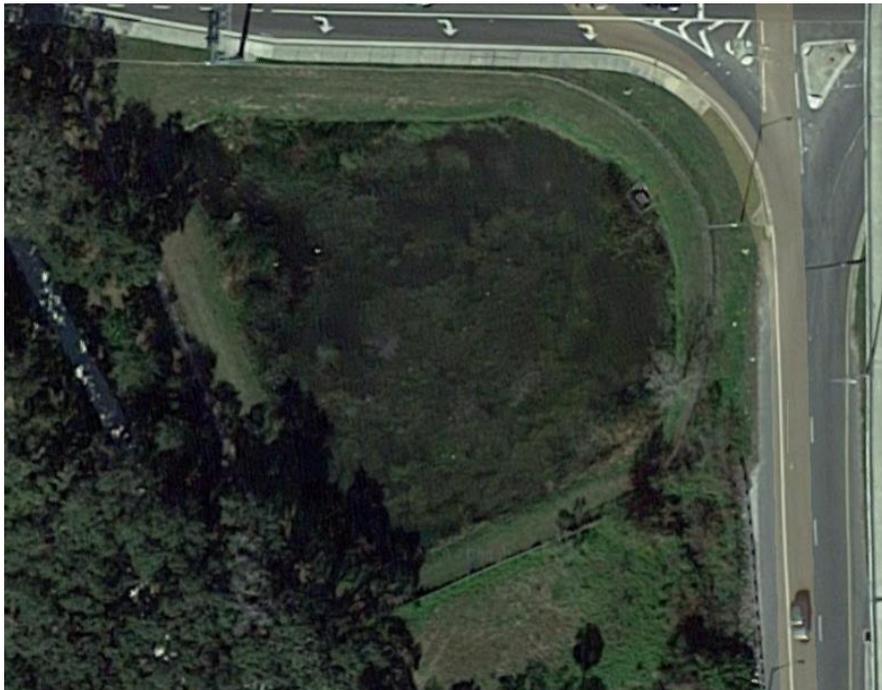
Figure 30: Clearwater pond

This 0.53-acre pond is located adjacent to a highway intersection and a residential park. The area to the west of the pond is a residential park, and a forest borders the southern end of the pond. Hidden beneath the trees in the southwest corner of the pond is a small parking lot. To the north is Gulf-to-Bay Boulevard, and County Road is to the east. With regard to the pond, it has a lengthy grass swale that runs along its perimeter. The inlet to the pond is located on the northwest corner, which is connected to the stormwater drain on Gulf-to-Bay Boulevard. Thick recurrent cattail growth was the major problem reported for this pond. During the initial site visit, it was seen that the entirety of the lake was clogged with cattail. It would appear that the cattail had not been cleared from the pond in recent years. As a result, the pond is covered from inlet to outlet, which has severely reduced the storage volume of the pond. Routine removal of the cattail should occur in order to prevent the nuisance vegetation from taking over the pond. An image of the Clearwater pond is presented in Figure 30.

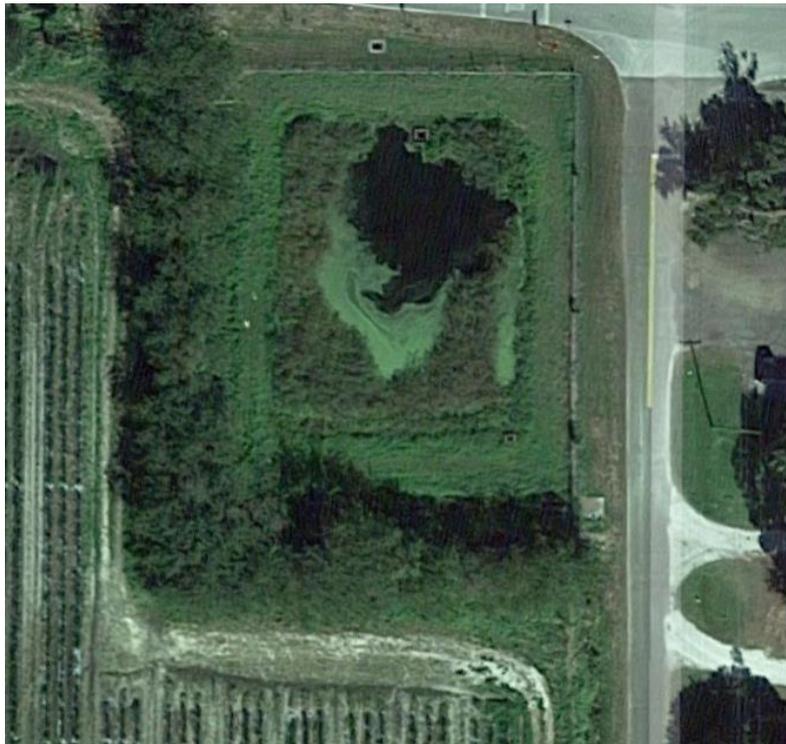
Figure 37: Ruskin pond

This 0.31 acre pond has a commercial shopping center to the east of it and a residential neighborhood to the north. The western and southern edges of the pond border a tomato field. This made the pond a prime candidate for selection, because the pond is exposed to very high nutrient concentrations as fertilizers are washed from the tomato field into the pond. A thicket of trees and shrubs are between the agricultural field and the pond, yet algal blooms still appear to be a problem. The brush bordering the pond exhibited significant growth and the littoral zone needed to have excess vegetation removed. Severe algal growth and an overgrown littoral zone were the primary maintenance issues with this pond. An image of the Ruskin pond is presented in Figure 37.

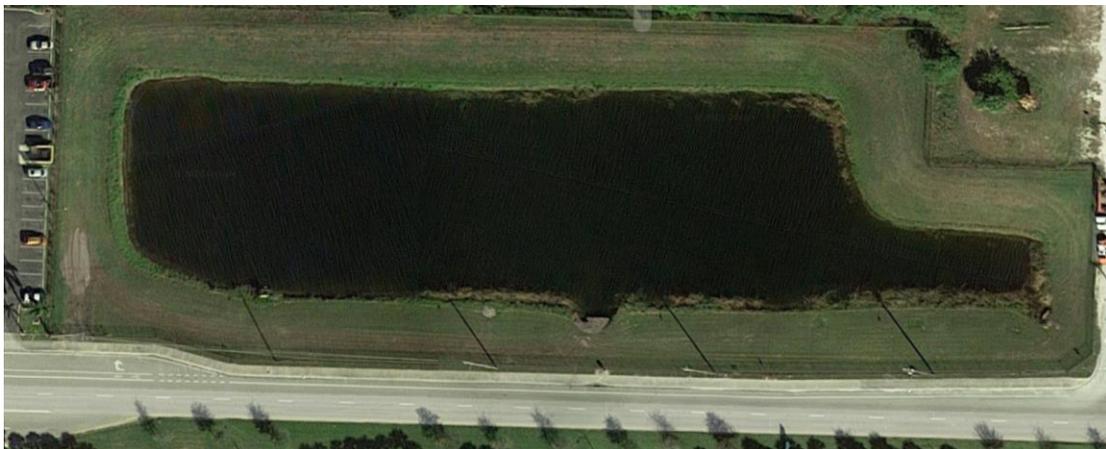
Figure 43: Royal Palm Estates pond

This 1.69 acre pond is located immediately north of State Road 80. An apartment complex lies to the west of the pond, and a commercial building is to the east. North of the pond is an undeveloped field. Erosion at the inlet structure was the reported problem for this pond. The initial site visit confirmed this. It appeared that the overland flow from State Road 80 was eroding the dirt from around the structure. The primary maintenance issue with this pond was bank erosion which can result in high levels of total suspended solids in the water and lead to unstable slopes surrounding the pond. This pond was selected in order to showcase erosion control BMPs that can be employed when the banks around pond structures are being washed away. An image of the Royal Palm Estates pond is presented in Figure 43.

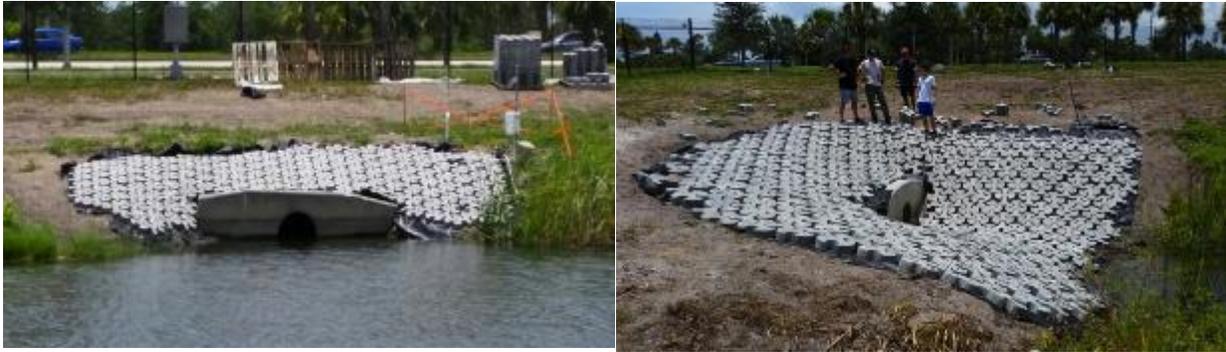
Figure 46: Tri-Lock installation at S-139 and S-145 at the conclusion of the second day of work

Work resumed on June 26, with a crew of 4 UCF students and 6 FDOT workers in addition to the 2 representatives from Midwest Construction. After 6 hours of work, the block-laying had been completed and backfilling commenced around structure S-145 as shown in Figure 46. At this point, work concluded for the week, with the remaining work consisting of digging a trench for the anchor rows, laying the block for the anchor rows, backfilling, and placement of rip-rap at the toe of the block in structure S-139.

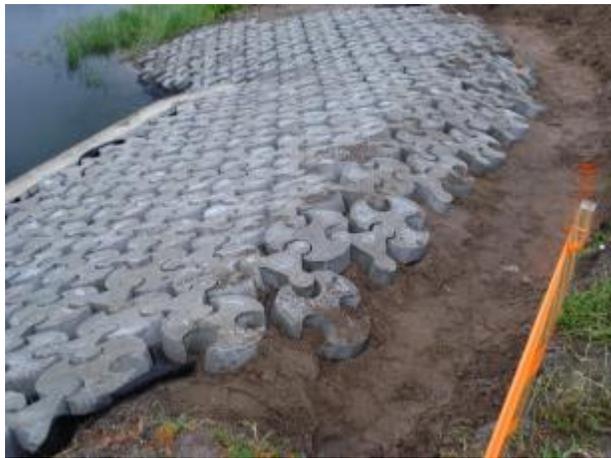
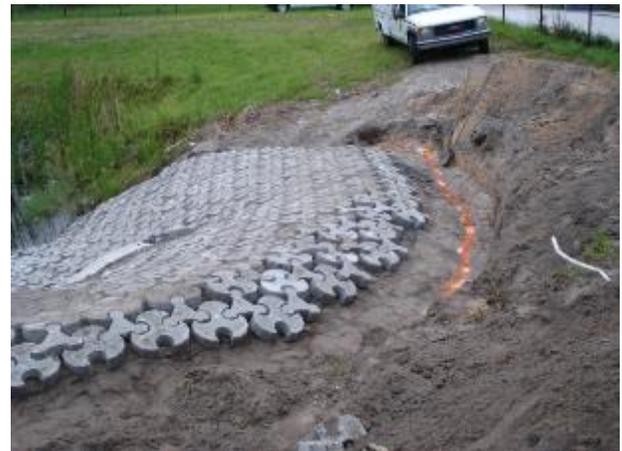
Figure 47: Anchor trench along top of S-139 and S-145

On June 30, FDOT staff excavated the anchor trench around the top of the revetment at both structures and laid down 1-2 rows of block to serve as the anchor row, as directed by the vendor's specifications. The configuration of the anchor trench at both structures is provided in Figure 47. On July 3, FDOT staff completed the backfilling of the trench, backfilling of the block, and grading of the slopes in the area, as shown in Figure 48. The only remaining site work consisted of sodding the disturbed areas, seeding the backfill in the block area, and placement of rip-rap around the toe of the block in structure S-139.

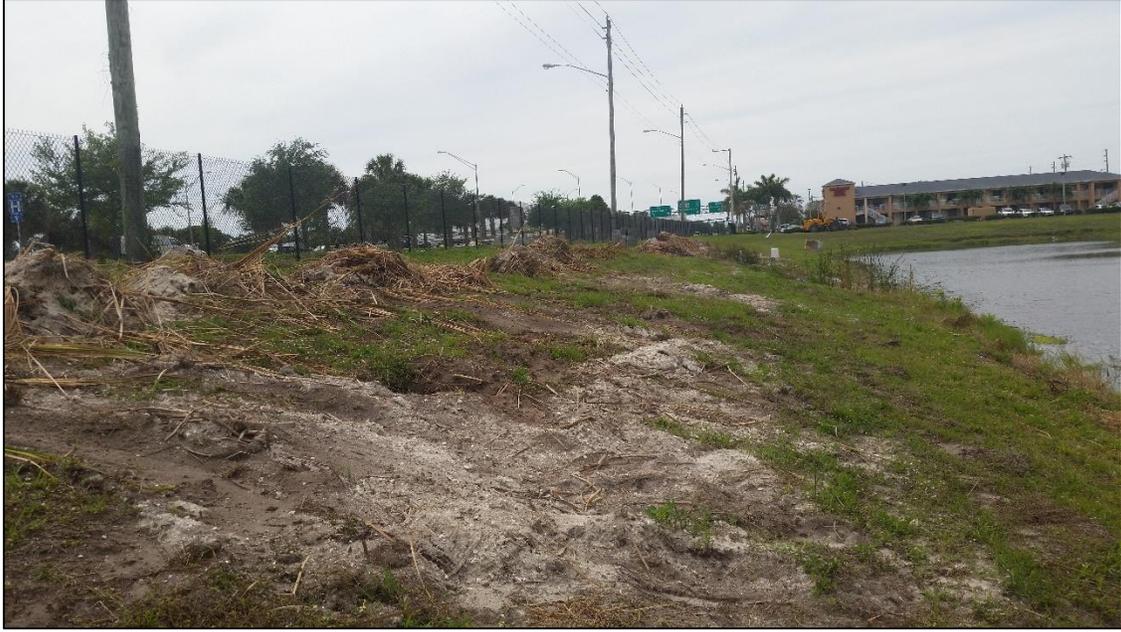
Figure 54: Construction activities at the Royal Palm pond

resulted in higher concentration readings even though there was the same or even less suspended solids present in the pond. Another interesting note is the large spike in TSS concentration at inlet 1 for the March 28, 2015 sampling date. During the site visit there appeared to be construction activities ongoing at the pond, as seen in Figure 54. It appeared the vegetation along the banks of the pond was being removed, which resulted in the destabilization of surrounding soil and left large quantities of loose soil on the pond banks. These destabilized and loose soils were likely carried into the pond by stormwater runoff, resulting in elevated TSS concentrations for the final two storm events. Due to this, the TSS readings on March 28 and April 2 of 2015 may have been elevated due to construction activities and not representative of normal conditions at the pond following a storm event.
