**REPLACEMENT PRIORITIZATION OF PRECAST
DECK PANEL BRIDGES**

Final Report for:

MARCH 2005

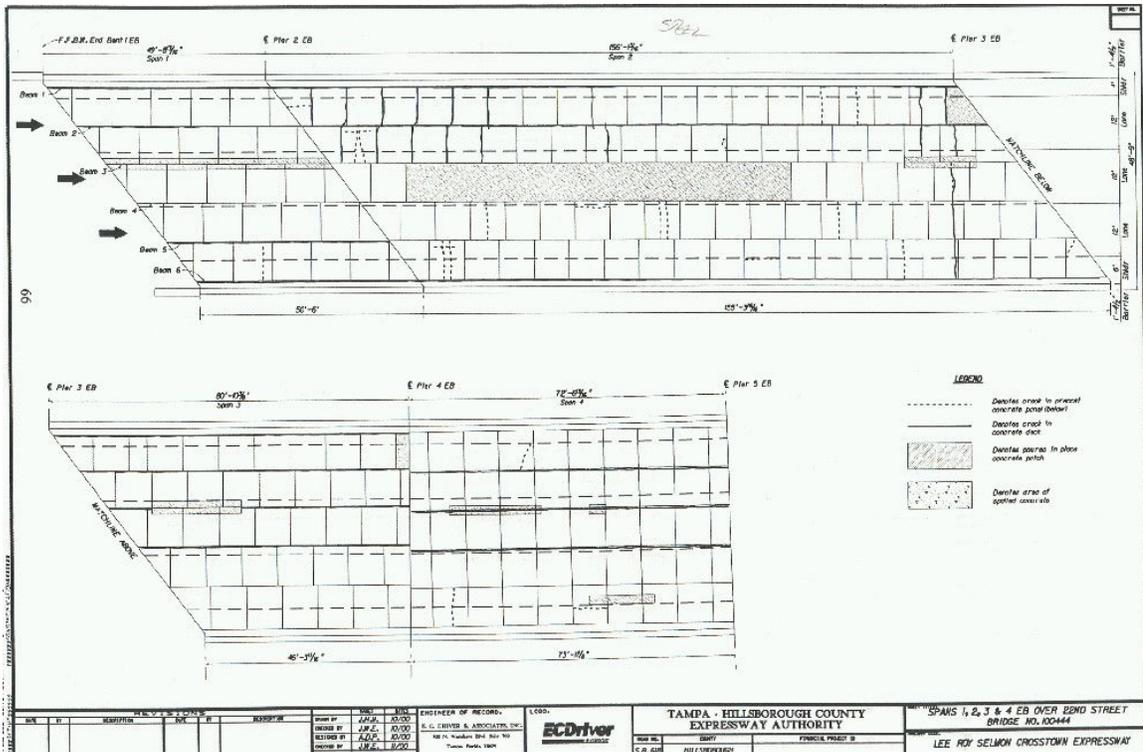
Figure 2.10 Deck Deficiency Survey in Crosstown Expressways [2.4].

The bridge deck assessment revealed that this type of construction has inherent design flaws that in some cases can lead to systematic deterioration of bridge decks ultimately resulting in localized deck failures.

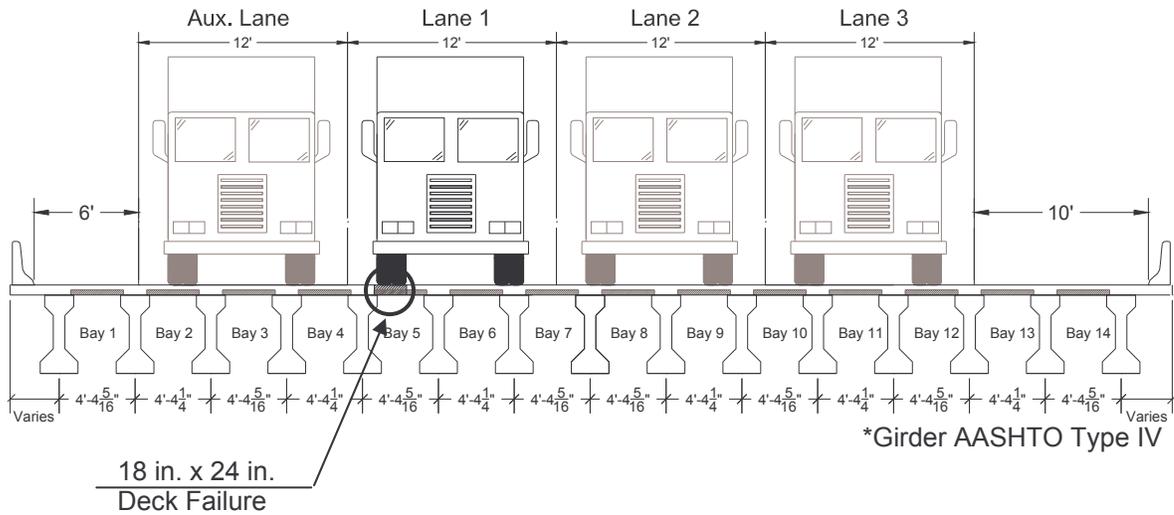
Figure 3.1 Cross Section View of Bridge #170146 – Main Span

This 3-span bridge located in Sarasota, FL was built in 1981 and was 19 years old when it failed in February 2000. It has two 36 ft secondary spans (*span 1*, *span 3*) and a 118 ft 8 in. main span (*span 2*) to make the total bridge length 190 ft 8 in. The shorter spans were built using two AASHTO Type IV girders on the outside and five AASHTO Type II girders on the inside all spaced 8 ft 10 in. apart. In the main span, fifteen AASHTO Type IV girders are spaced at 4 ft 4 1/4 in. or 4 ft 4 5/16 in. on centers as shown in Fig. 3.1.

The bridge has four 12 ft wide lanes, and 6 ft or 10 ft wide shoulders as shown in Fig. 3.1. There is an auxiliary lane that merges with traffic entering the interstate from Bee Ridge Road. The average daily traffic (ADT) in the bridge during the year 2000 was 34,000 [3.1]. Thirty percent of the ADT was truck traffic (ADTT). Details are summarized in Table 3.2.

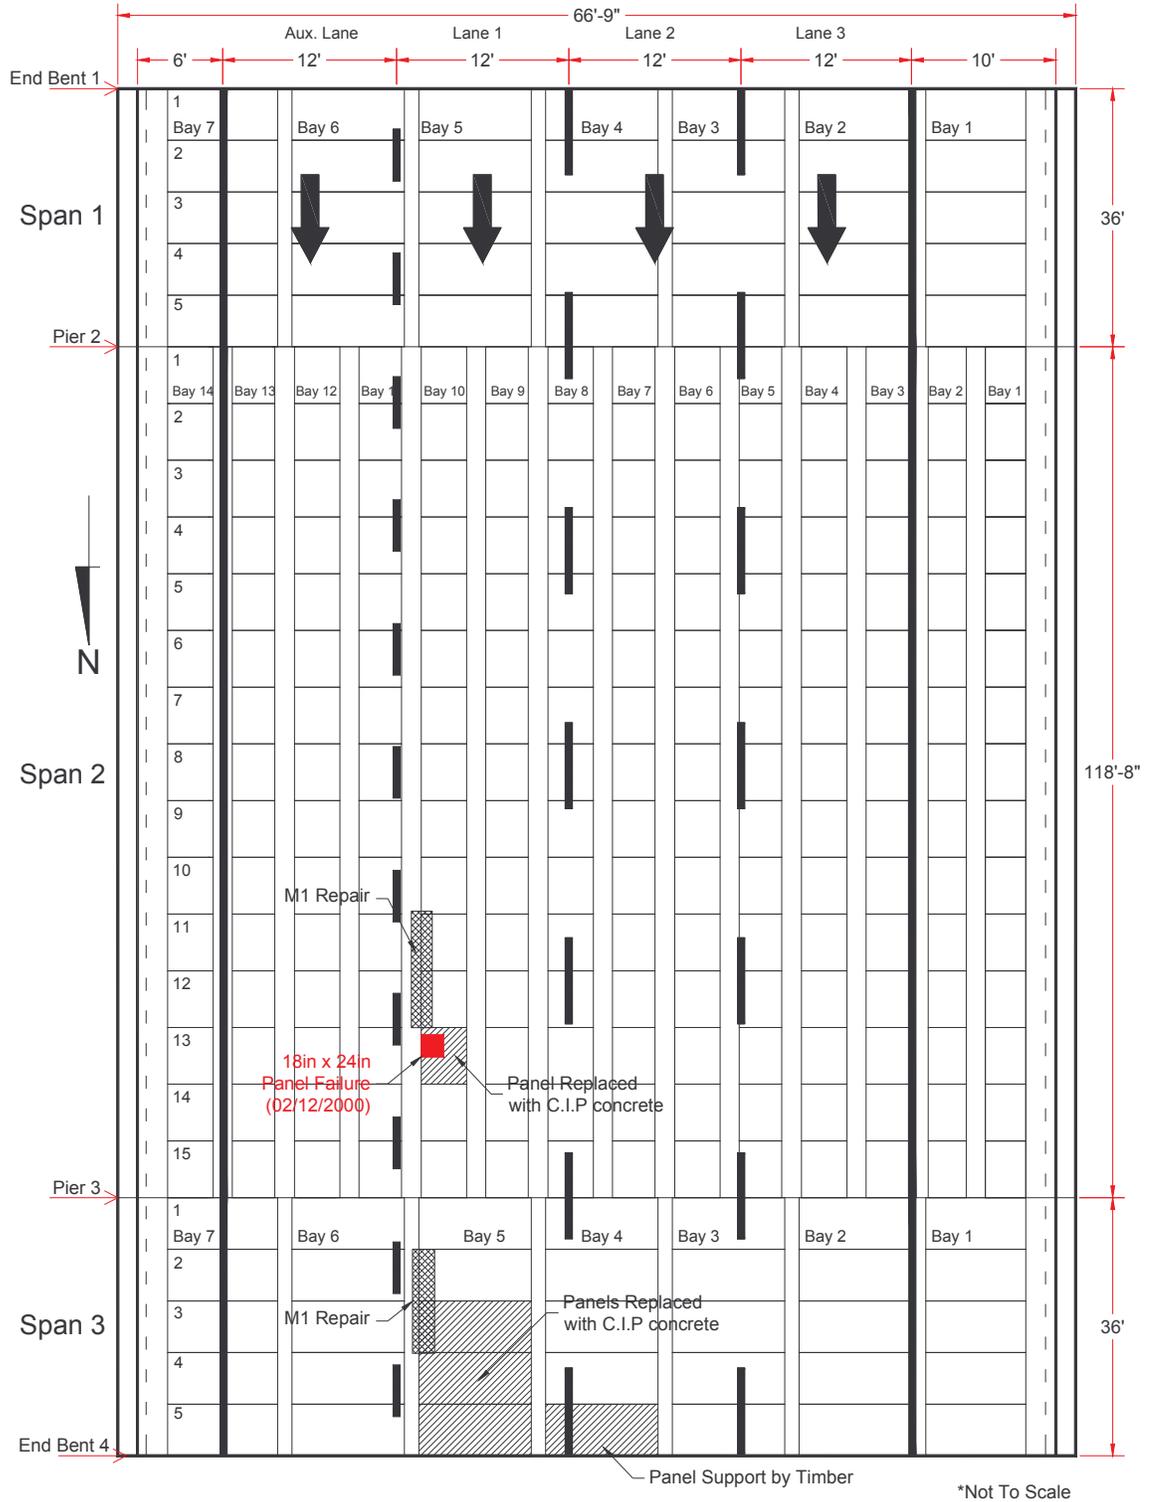
Figure 3.3 Location of Failed Panel, Bridge 170146 (I-75 NB) [3.4]

Fig. 3.3 shows the location of the failed panel taken from reference [3.4]. It was re-drawn to clarify details. Failure occurred in “Span 2, Bay 10 at the edge of panel 13” [3.2]. This location is also identified in Fig.3.1 as coinciding with the placement of the right truck wheel in the slow lane (lane 1) close to the face of a girder.

An estimate of the punching shear resistance can be obtained using code specified formula [3.6]. The analysis is approximate since available information is limited, e.g. the exact location of the punching failure in the deck is unknown. Only the panel where failure occurred was shown in the sketch (Fig. 3.3) included in the consultant's emergency report [3.4].

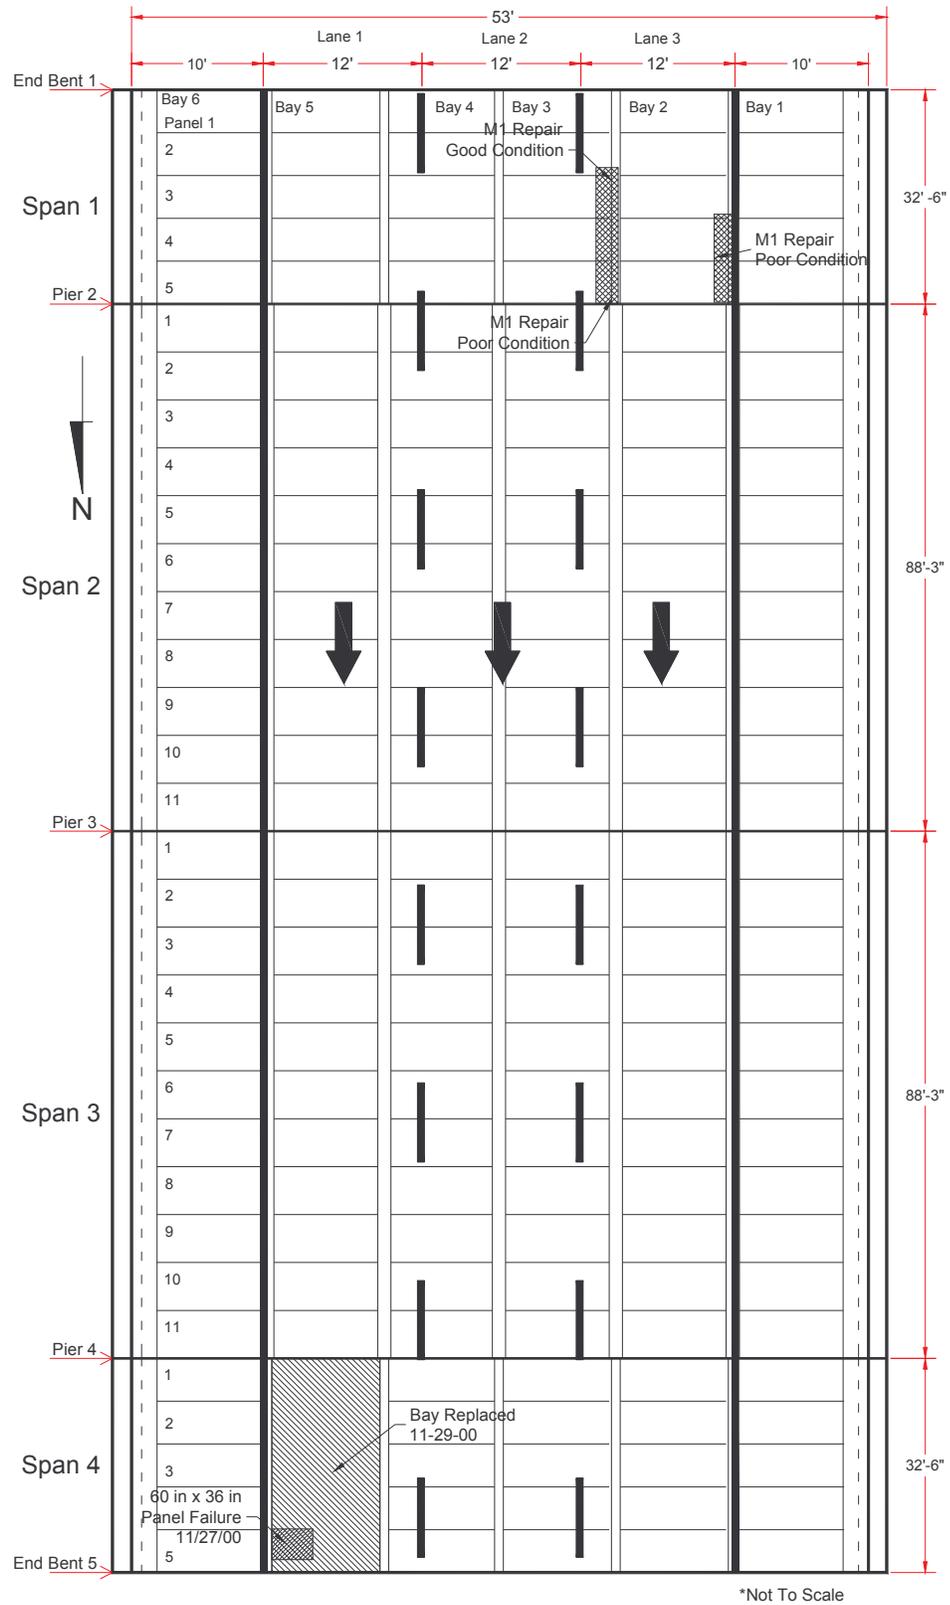
Figure 3.6 Location of Failed Panel, Bridge 170086 [3.4]

Localized punching shear occurred late morning, Monday November 27, 2000. According to the consultant's emergency response report [3.4], failure occurred in span 4 (secondary span), bay 6, on the right lane where a 60 in. by 36 in. gaping hole developed near end bent 5 (Fig. 3.6). The report stated "Half of the end panel adjacent to the expansion joint had been replaced at some previous time. This hole was the result of the failure of the remaining half of that panel".

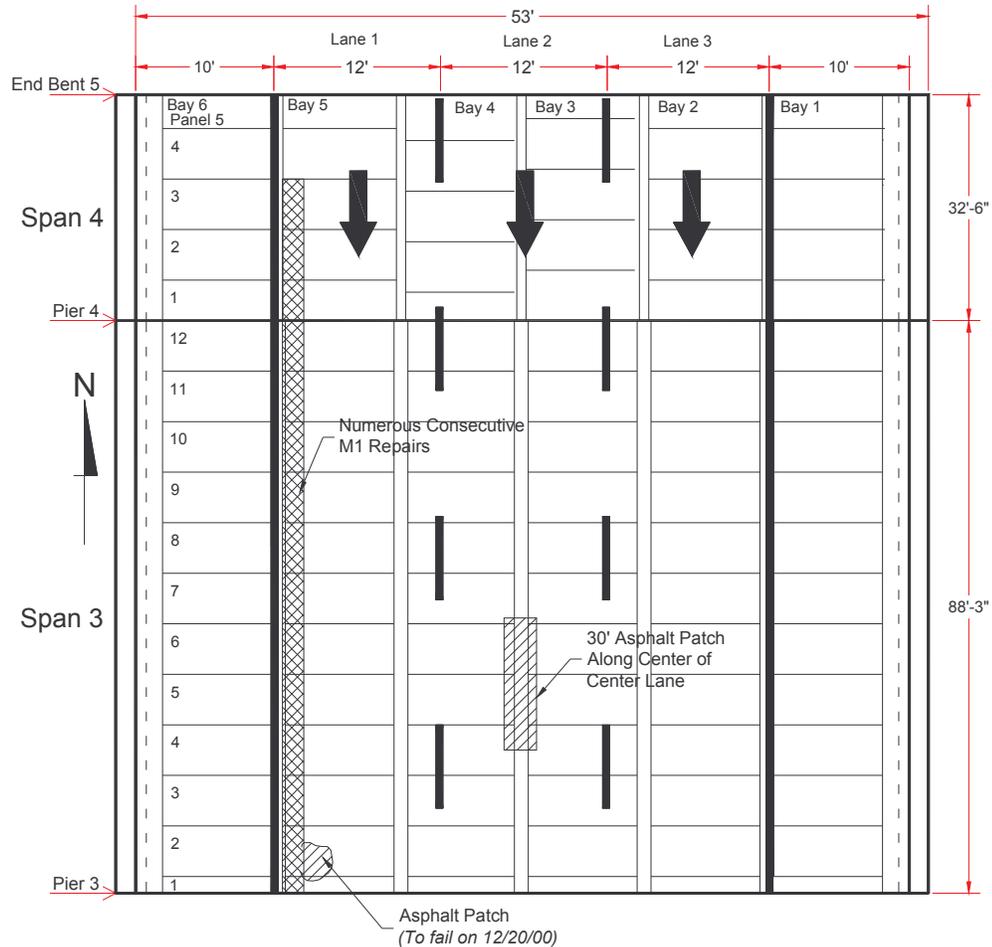
Figure 3.10 Location of Failed Panel Bridge [3.4]

The first article published on December 21, 2000 [3.22] stated that the hole was discovered at 7 am and that no one was injured. The reported size of the hole is 3 ft x 5 ft – same as in the previous bridge – possibly a mistake. The reporter quotes FDOT spokesman Gene O’Dell who said “*We just had our consultant inspect the Clark Road bridge two weeks ago and they said it was fine*”. The last article published on December 23, 2000 [3.24] stated that the damage had been repaired and the bridge was opened to traffic. Mention was also made that a consultant was inspecting the bridge decks every 45 days and FDOT employees check them out once a month to “*see if there are any bad cracks, anything that will create a hole*” (O’Dell’s quote).

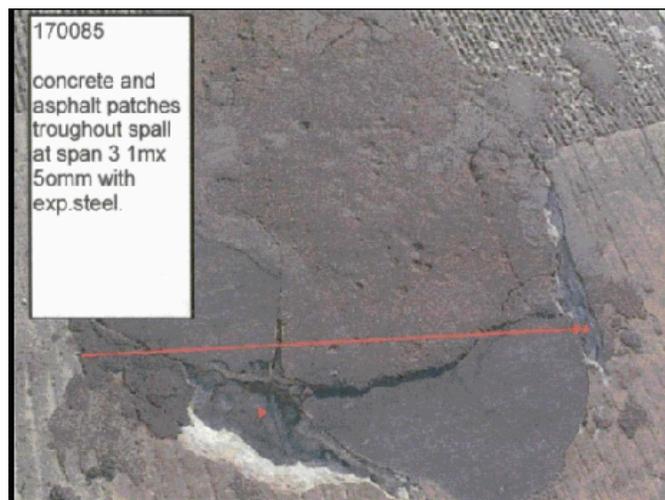
Figure 3.11 Deck Deficiency Six Months Before Failure, Bridge #170085

In the final report (May '00) [3.29], top decking cracking is described as “minor”. The delamination in the middle of span 4 reported in the previous report had not grown in size. Fig. 3.11, scanned from the photo addendum of this inspection report, shows “*concrete and asphalt patches throughout spall span 3 1m x 50mm with exposed steel*”. The deficiency shown here happens to be at the exact location where failure occurred six months later. The deck condition rating of was given as 7, and the condition state of the bridge was reported as 2. None of the reports describe the underside of the deck. This suggests there was no cracking or efflorescence.

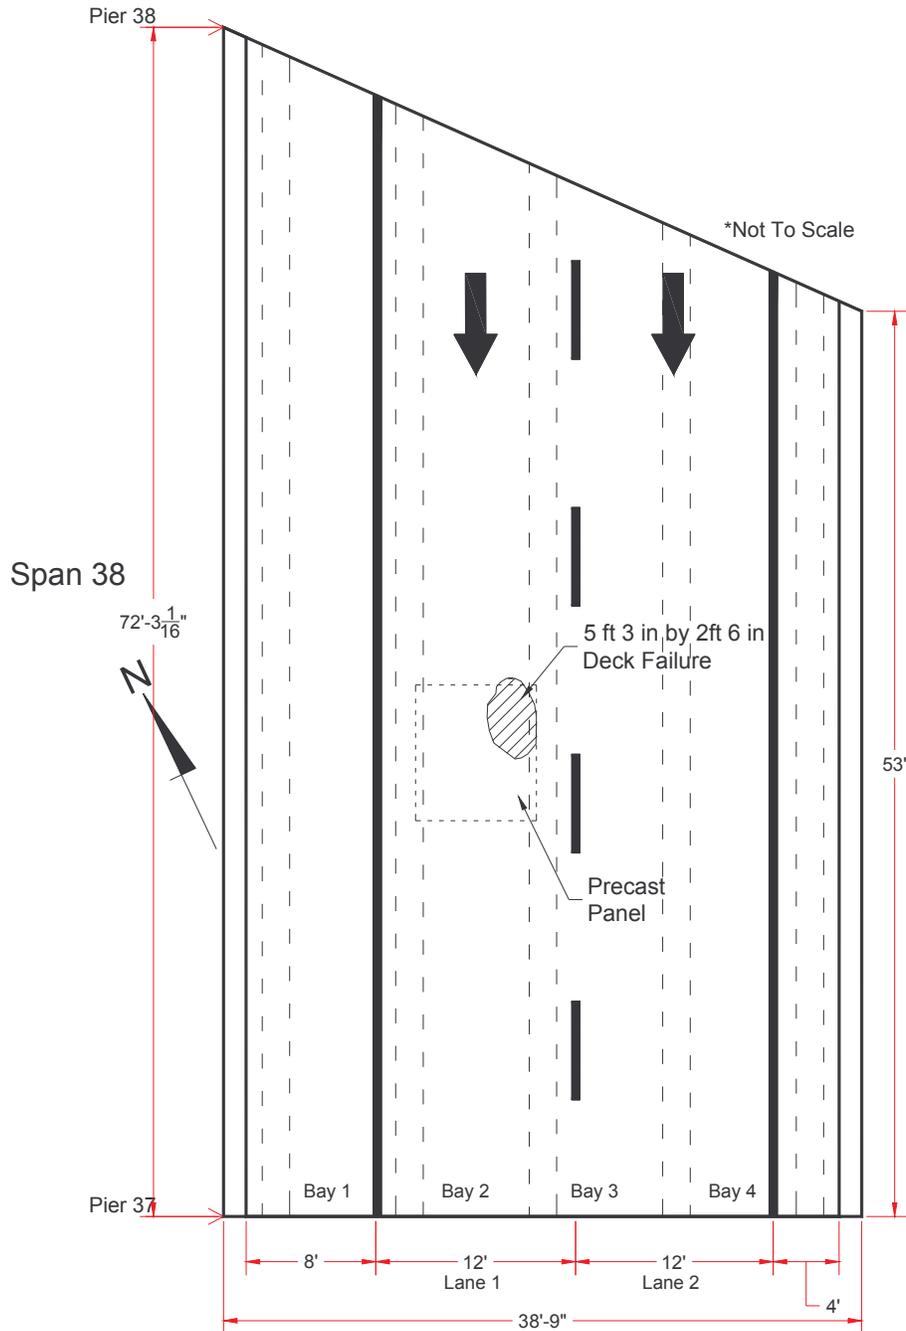
Figure 3.15 Location of Failed Panel, Bridge 100332 Span

This failure was first noticed early morning on Wednesday, October 2 2002. It was located on the right lane close to mid-span. A gaping 5 ft 3 in. by 2 ft 6 in. hole formed (see Fig. 3.14). The same figure shows photos of the failed region and its underside two days prior to failure. Staining of the underside is visible. The concrete and repair material separated from the reinforcement which did not rupture. Fig. 3.15 provides a sketch showing the failure location on the deck.

This damage was repaired by demolishing the whole bay where the failure occurred and placing a new deck using full depth cast in place concrete.

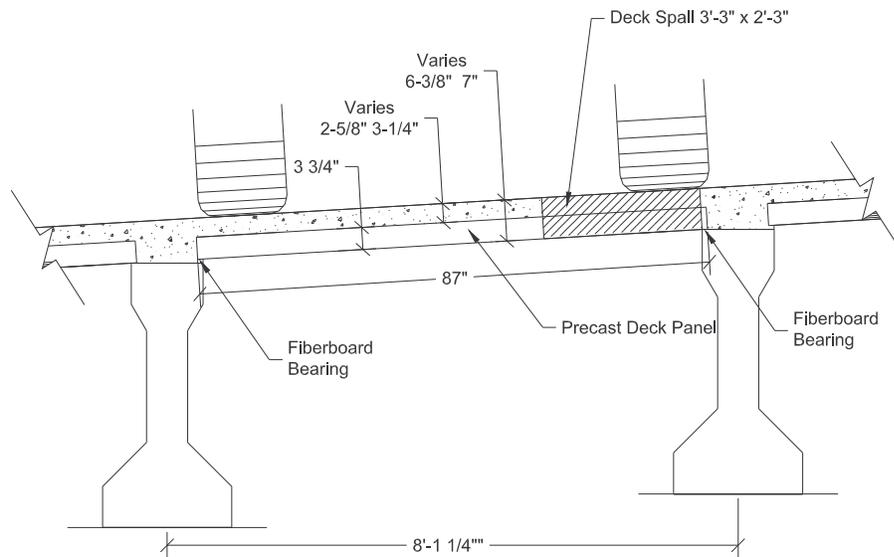
Figure 3.16 Deck Thickness Measurements and Details of Failed Section. Bridge # 100332, Span 38

A USF research team visited the bridge one day after failure. Measurements taken at the site and from retrieved debris indicated that the deck was thinner than its nominal thickness. It was found to be 6- $\frac{3}{8}$ in. not 7 in. as specified in the plans stamped "as built" (see Fig. 3.16).

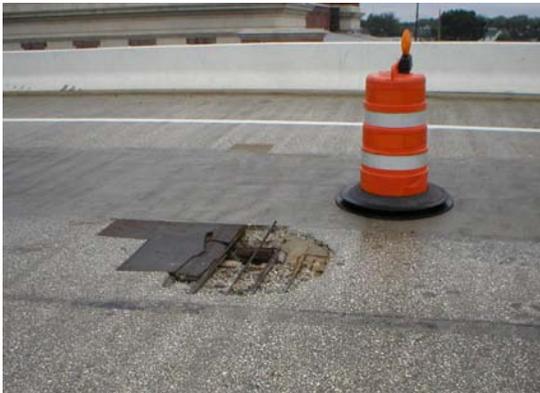
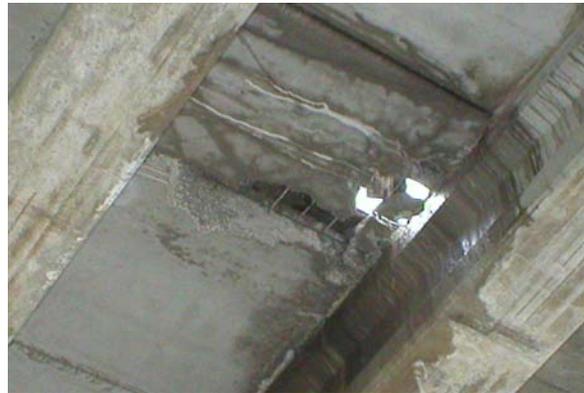
Figure 3.19 Localized Deck Failure, Bridge # 100332, Span 70

Photos of the failed section are shown in Fig. 3.19. A sketch showing the location of the failure in the deck is shown in Fig. 3.20. Initial spalling ahead of an M1 repair extended into the repair itself. Under subsequent loading, rebar were exposed in the spalled region. The concrete ultimately separated from the steel due to the impact of repeated wheel loads and a void formed.

Fig. 3.19 has three photos. The main photo is a close-up plan view of the damage from the top of the deck. Note that the rebar are not broken nor plastically deformed. Small sections of concrete just separated from the reinforcement. One of the prestressing strands can be seen to be intact. A second photo provides an overview of the deck. The third photo shows the extent of the opening in the deck from the underside. Water staining is clearly visible. This failure was repaired by demolishing the whole bay where the failure occurred, and the one adjacent in the left lane, and placing a new deck using full depth cast in place concrete.

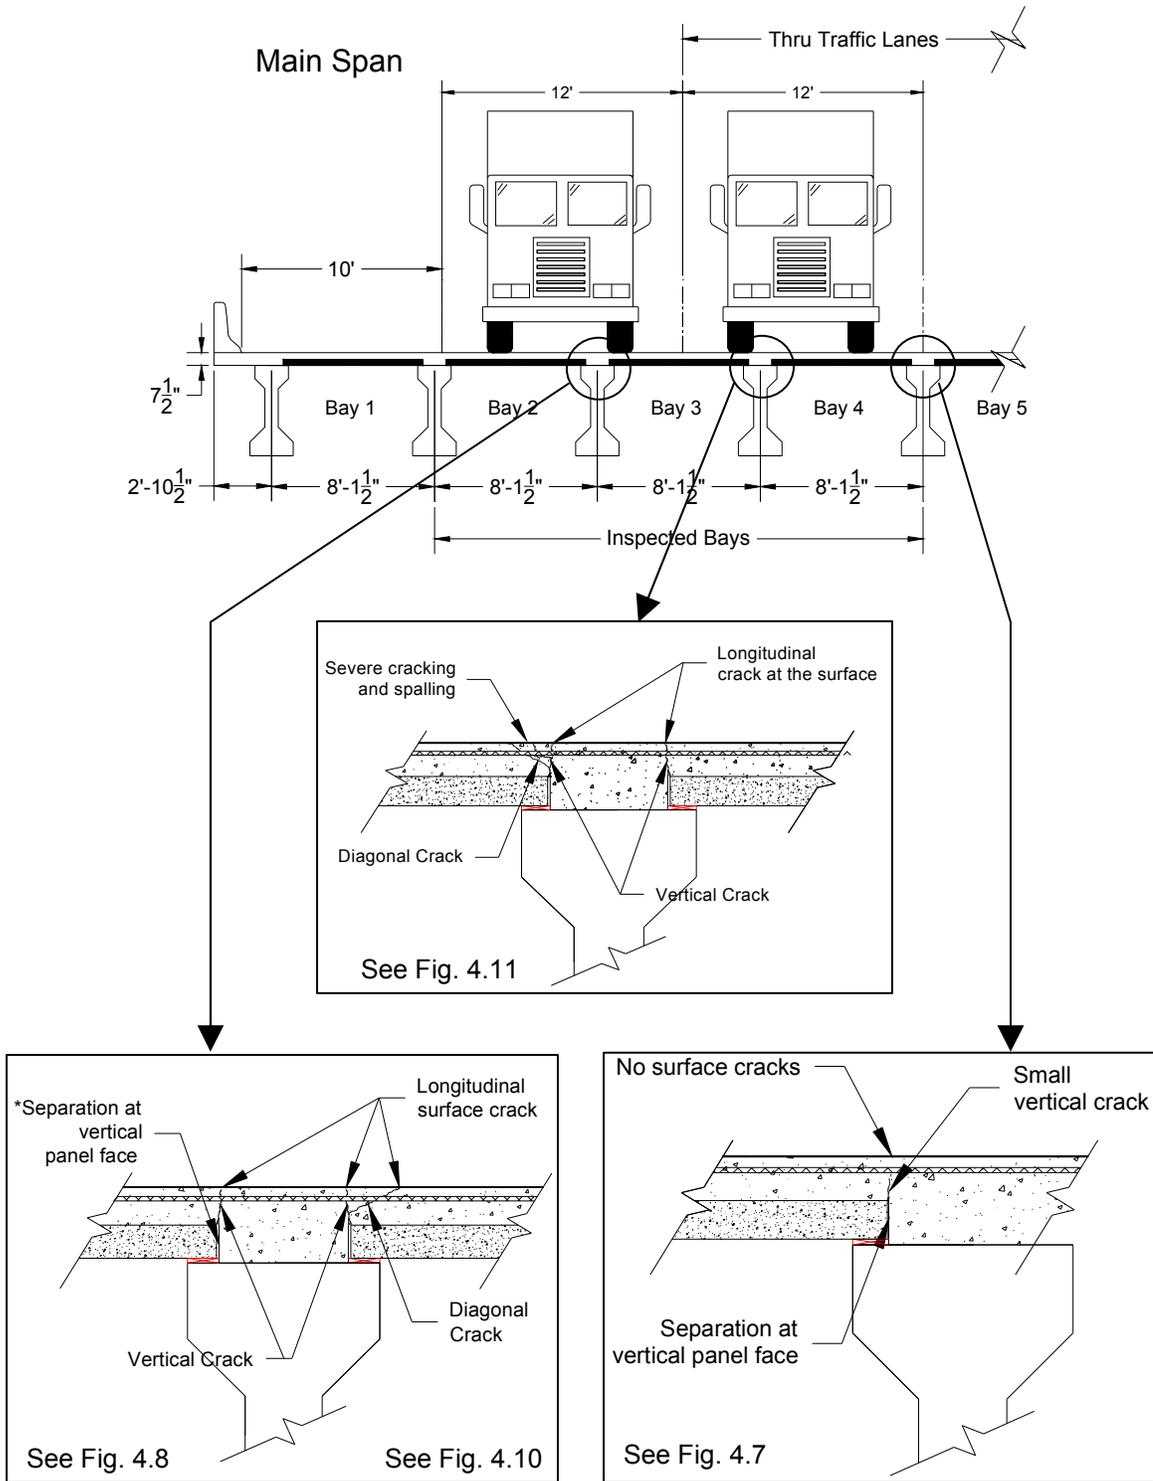
Figure 4.6 Overview of Findings from Bridge # 130079

Fig. 4.6 is a schematic drawing highlighting some of the findings. It provides details of their location in the deck cross section and also cross-refers to figure numbers where photographs of the particular deficiencies are provided.

This type of crack is not as common as the typical longitudinal crack; it is only found in localized regions of the deck whereas other cracks tend to occur along the entire span. Also it was found that this additional cracking only occurs when a wheel load is located close to the panel support (see Fig. 4.6).

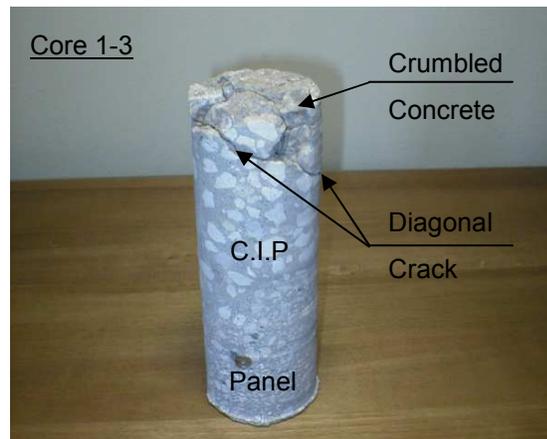
Most of the cracks found on the cores showed signs of water and dust infiltration (Cores 1-3 [Fig. 4.12], 1-4, 5-4, 5-6, 5-7 in Appendix C). In the case of vertical cracks, some of them showed these signs only over half the depth indicating that the prestressed slab was uncracked. But when the section deteriorated, infiltration occurred over the entire deck depth (Cores 5-6, 5-7).

In most cases (Cores 1-3, 1-4), concrete at the top of diagonal crack was crumbled and showed signs of water infiltration.

Figure 4.12 Crumbled concrete in top of a diagonal crack. (Core 1-3)

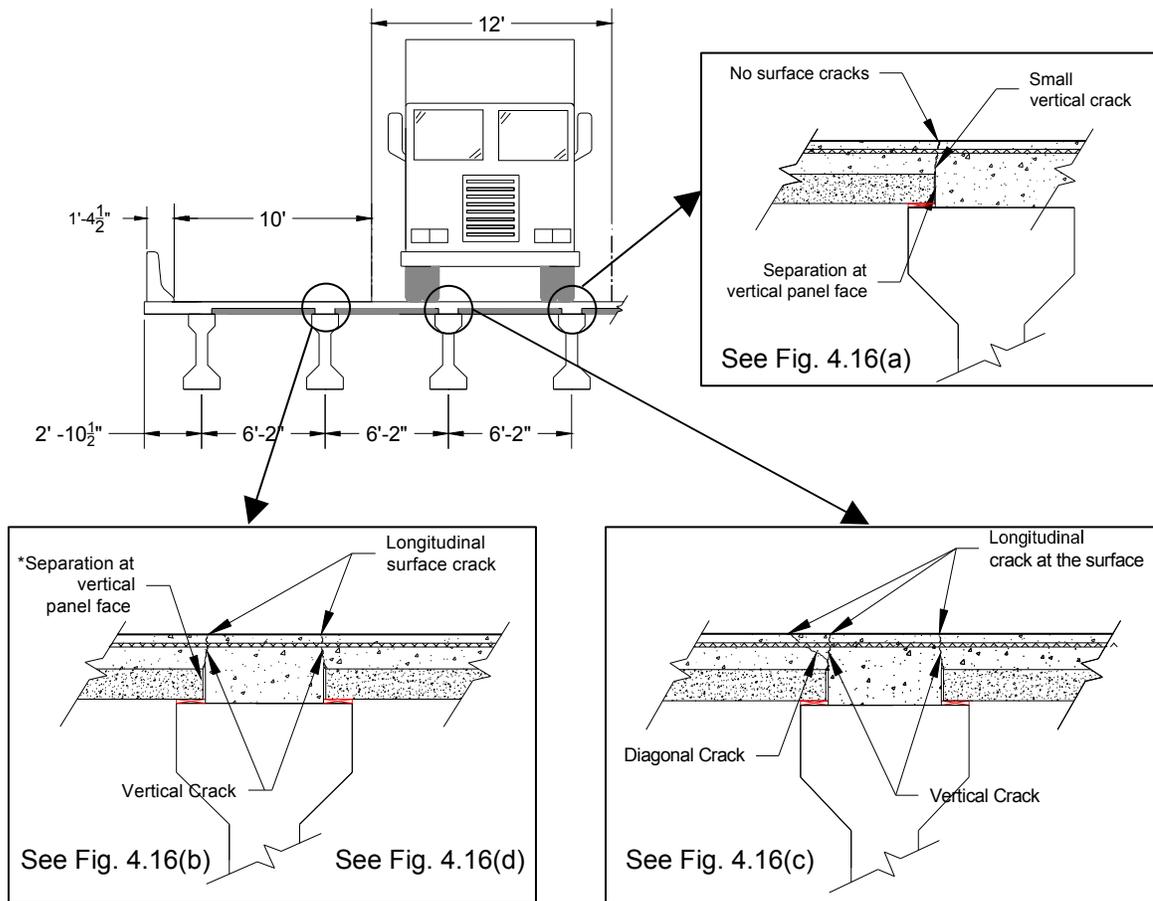
Figure 4.15 Findings Overview, Bridge # 170140

An examination of the retrieved panels confirmed the findings from the previous bridge (Fig. 4.15). Longitudinal cracks emanated from the corner of the prestressed panel and propagated through the slab thickness to emerge as visible cracks (Fig. 4.16a, 4.16b). Additional parallel cracking due to divergence of the crack emanating from the panel corner was also observed. However, the parallel cracking on the deck surface only appeared intermittently as shown in Fig. 4.16c.

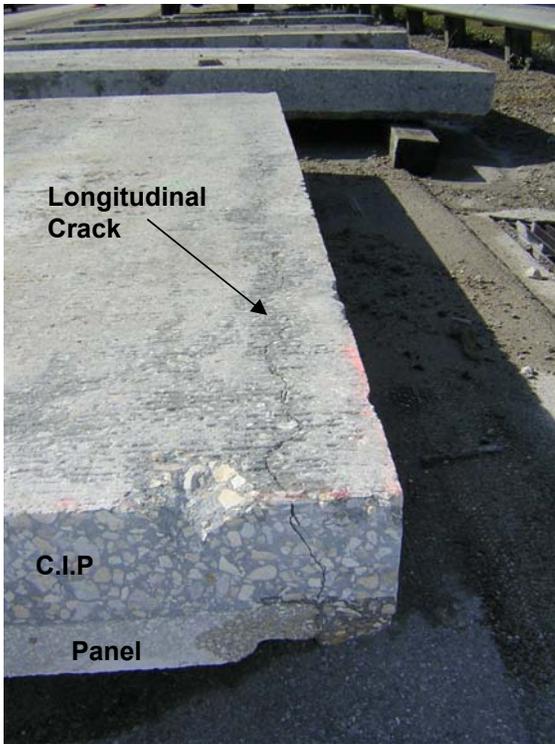
(a) Longitudinal Cracking

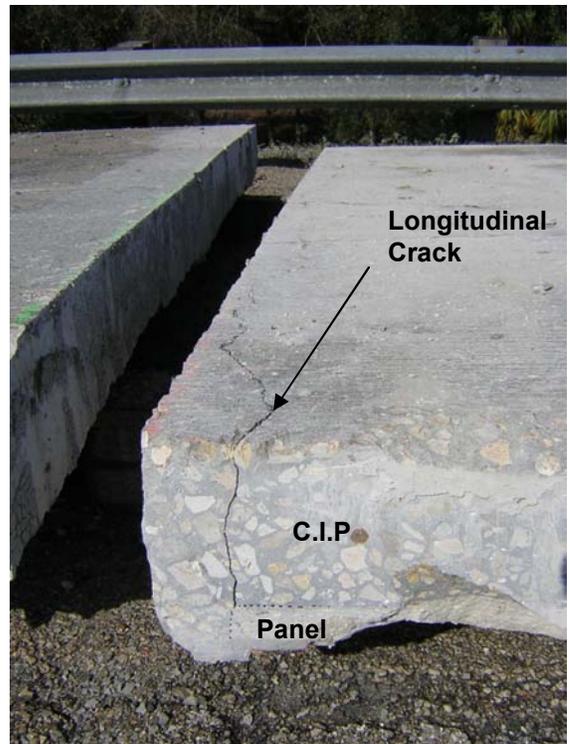
(b) Longitudinal Cracking

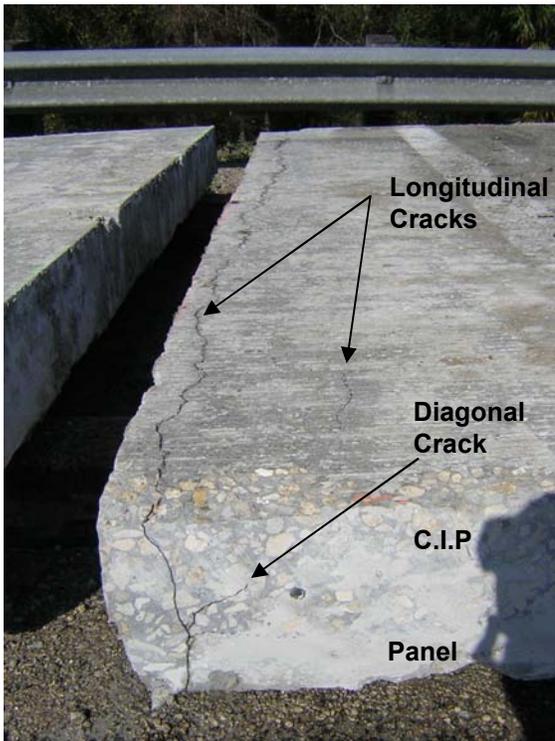
(c) Additional Longitudinal Cracking

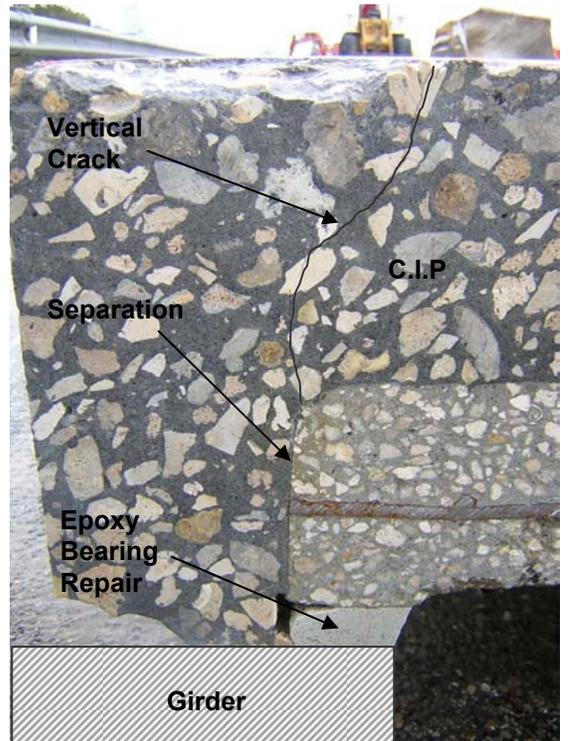
As before, there was separation between the precast panel and the cast-in-place slab at its vertical interface. This was suspected to be due to long term creep and shrinkage as stated earlier. An example was also found of the deck panel being supported by epoxy instead of fiberboard. In this instance, the extent of the longitudinal cracking was reduced (Fig. 4.16d). Overall, there were no dramatic new findings, simply confirmation of what was found earlier.

(d) Epoxy Support

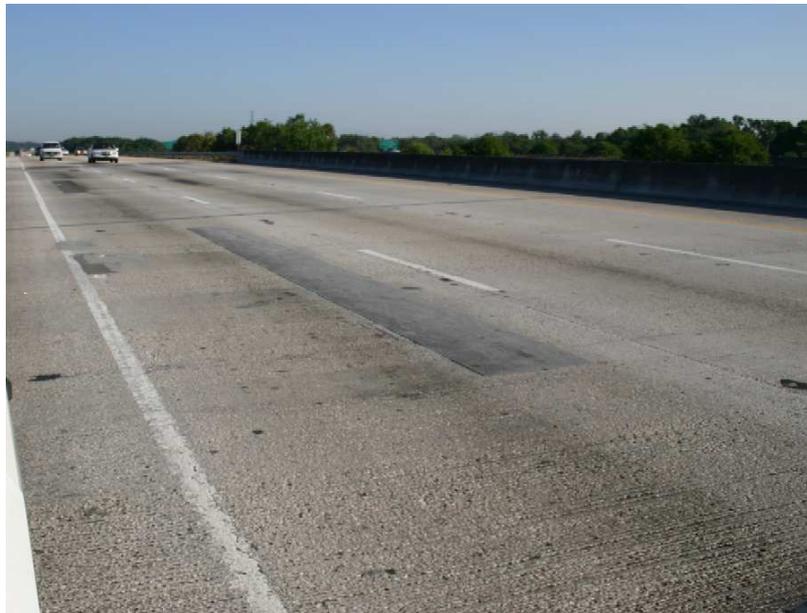
Figure 4.18 Deck Overview of Bridge #130075

From the inspection performed before the deck removal, typical longitudinal and transverse cracking plus various M1 repairs, some of them stable and some unstable (Fig 4.18) were found.

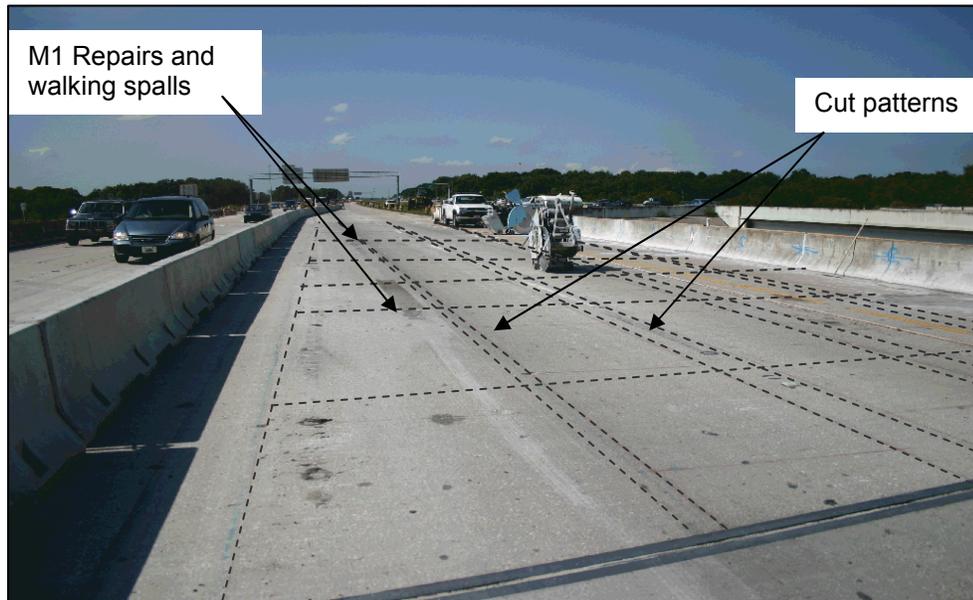
Figure 4.23 Bridge # 100415 Span 2, Prior to Deck Removal

The forensic study was conducted on span 2, bays 1 to 5. This section of the bridge exhibited longitudinal and some transverse cracking typical of deck panel construction. Also along bay 5, there were two deteriorated M1 repairs and several walking spall patches as shown in Fig. 4.23. This figure also identifies the cut patterns used by the contractor.

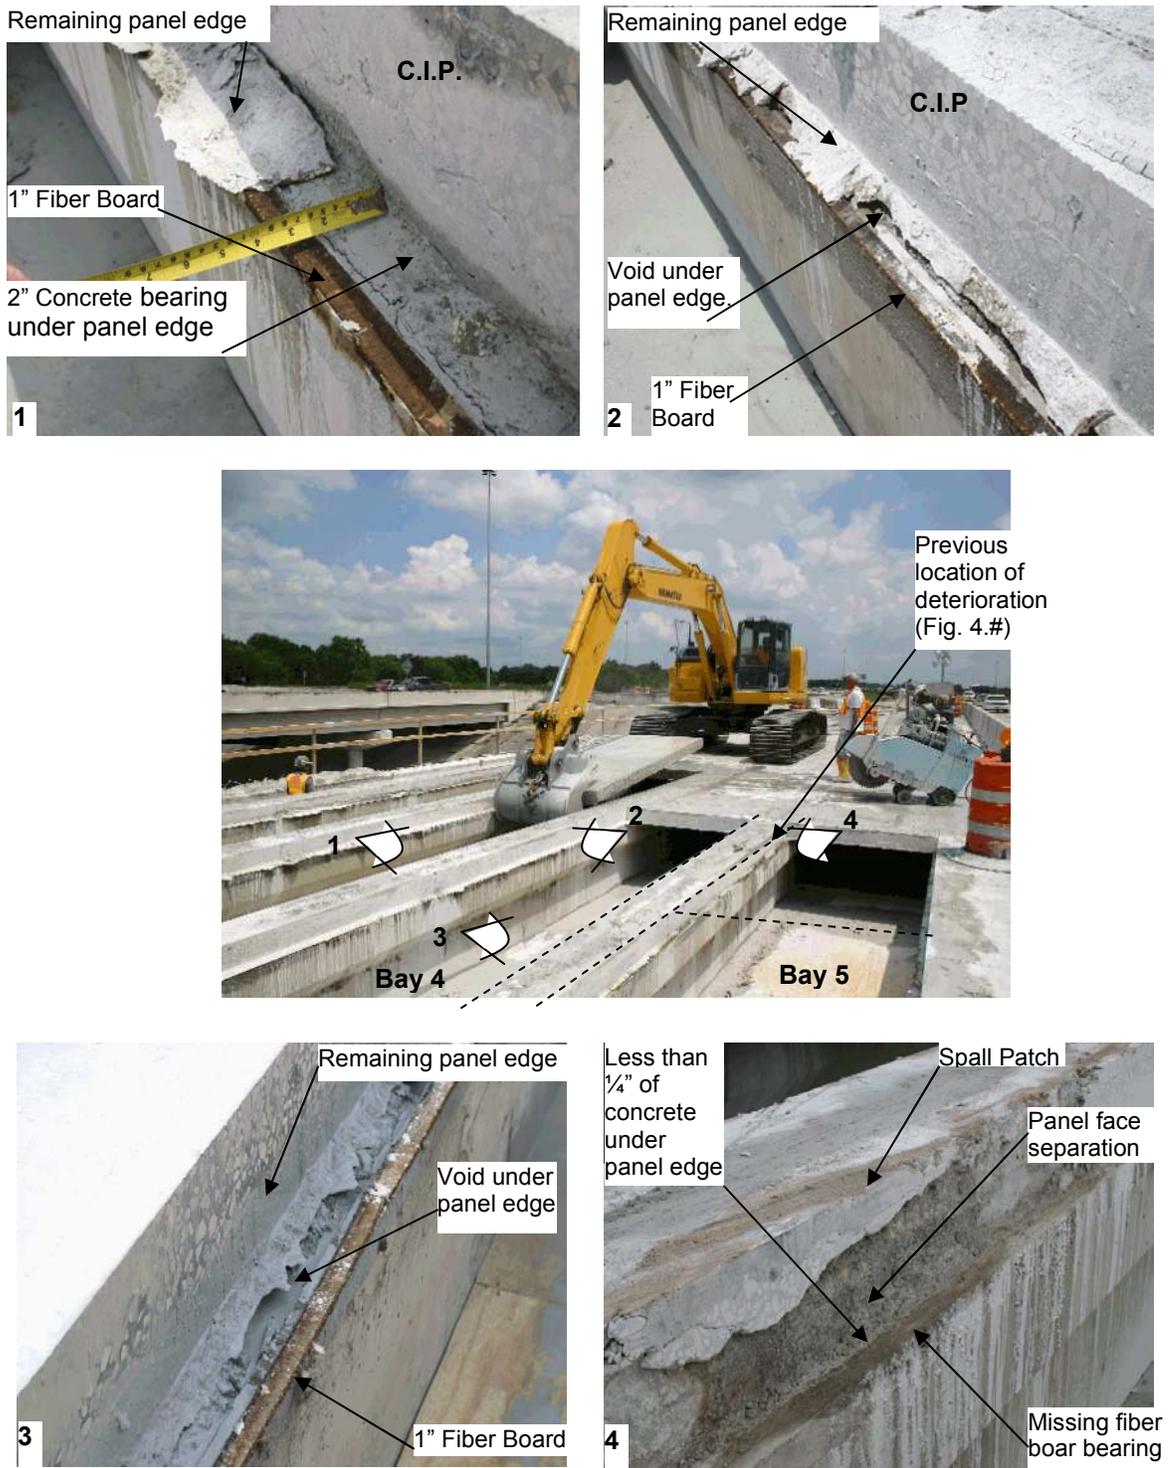
Figure 4.26 Panel Bearing Examination on Bridge #100415

Fig. 4.26 shows support for the panels at various locations along the bridge. Four pictures reflecting bearing locations marked 1-4 in the plan view are shown. The figure marked 1 shows a region where the slab was supported by 1 in. of fiberboard and 2 in. of concrete. This was unexpected from the Crosstown construction drawings and from previous research that indicated that the fiberboard was placed at the ends leaving no room for concrete to penetrate under the panel. Only vertical cracking was present in the panel with no delamination. Unfortunately, it cannot be seen because it was saw cut. The figures marked 2 and 3 show alternate locations where the concrete was unable to penetrate below the panel. The last figure, marked 4, also appearing in Fig. 4.25, shows lack of support that led to cracking and spalling of the deck. Thus, this figure provides evidence on the role of the bearing support on the performance of the deck.

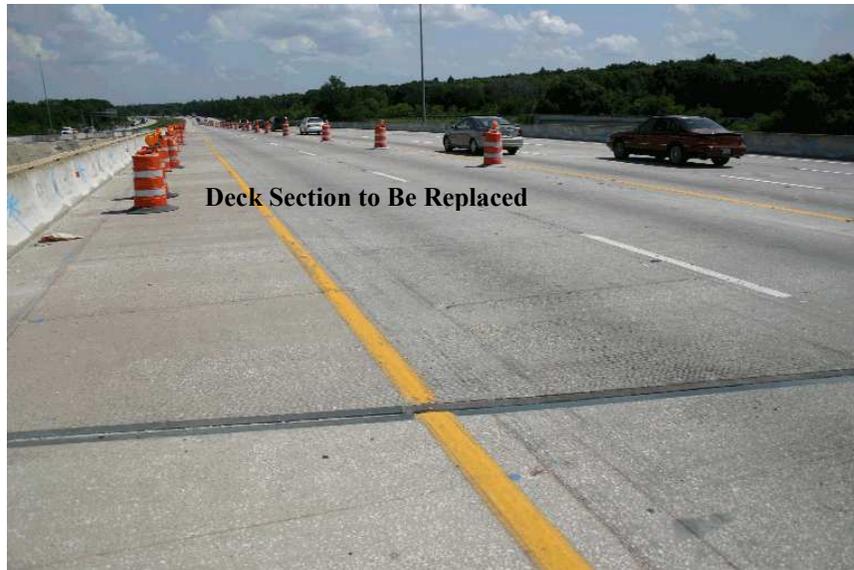
Figure 4.28 Deck Overview of Bridge #100398

After the half of the bridge to be replaced was closed, a detailed inspection of the bridge deck was conducted. During this inspection, no major deterioration was found, only typical longitudinal and some transverse cracks typical of deck panel bridges. Also no signs of previous repairs were found (Fig. 4.28).

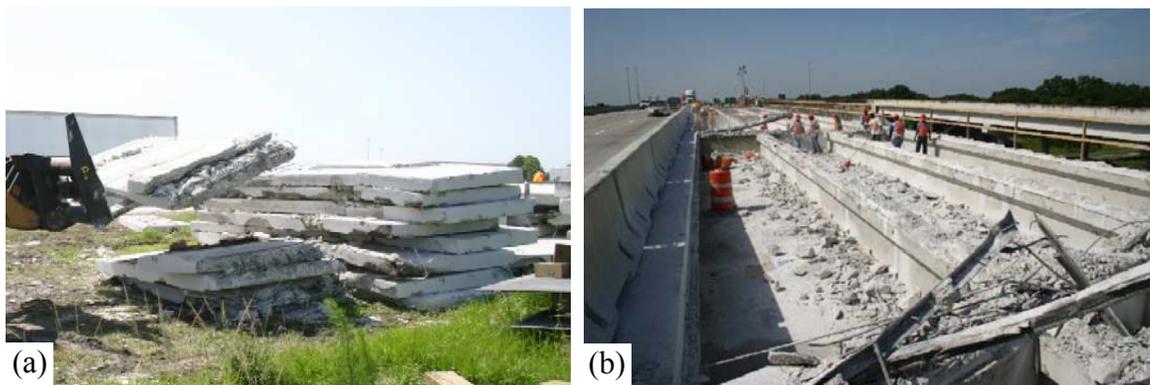
Figure 4.29 Inspection Methods Bridge #100398

First, random sections previously removed were inspected to identify panel face separation, vertical cracking or other type of typical internal deterioration (Fig. 4.29a). Then a detailed inspection of the panel bearing over the edges of the girders was conducted (Fig. 4.29b).

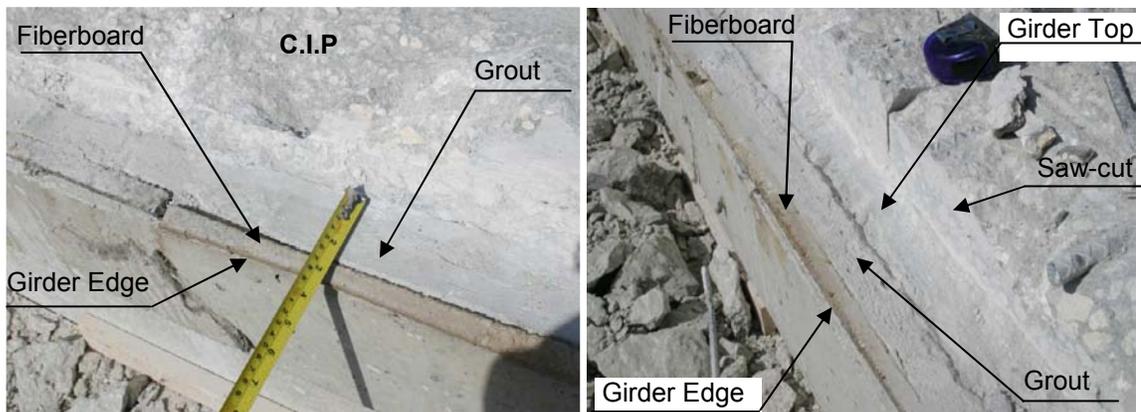
Figure 4.30 Panel Bearing Examination Bridge #100398

The most important finding was related to panel bearing support. It was found that the type of panel bearing used in this bridge was completely different, to the ones believed to be used in all deck panel bridges in Florida. Here a positive bearing was provided by a layer of grout placed next to a 1 in. fiberboard strip (Fig. 4.30). This system provided a stiff support for the panel. Soft fiberboard bearing is known to be responsible for premature deterioration of Florida's deck panel bridges [4.2].

Keeping in mind that this bridge was built on 1984, it is likely that in this bridge the panel bearing detail was changed to a positive bearing to prevent deterioration that had been observed in deck panel bridges built earlier in this area. This is the main reason why this bridge deck did not exhibit major deterioration after 20 years of service.

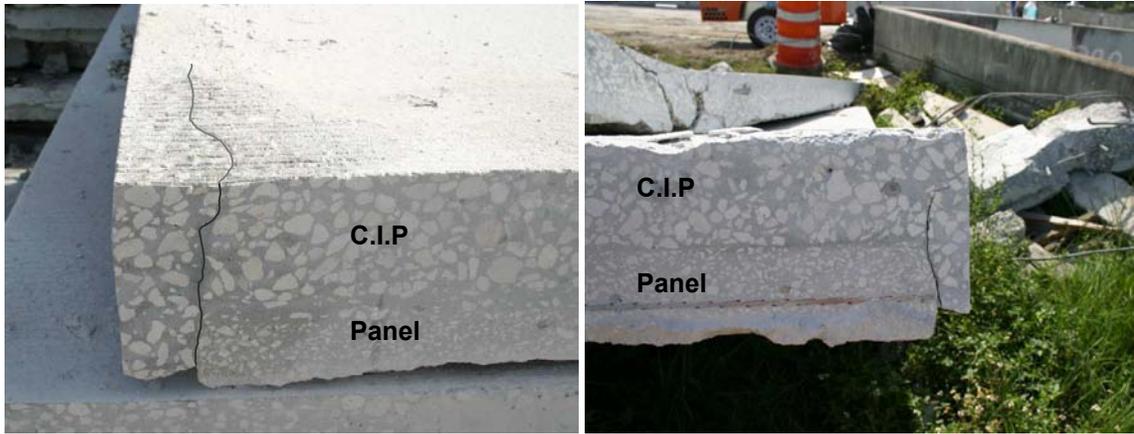
Figure 4.31 Vertical and Longitudinal Cracks Bridge #100398

Despite the use of positive panel bearing in this bridge, typical deterioration such as panel face separation and vertical cracking was observed (Fig. 4.31). This proves that this kind of cracking is not related to the type of bearing used to support the panel. Positive bearing only prevents the occurrence of additional shear cracking that causes spalling in the deck surface, and may lead to sudden failures.

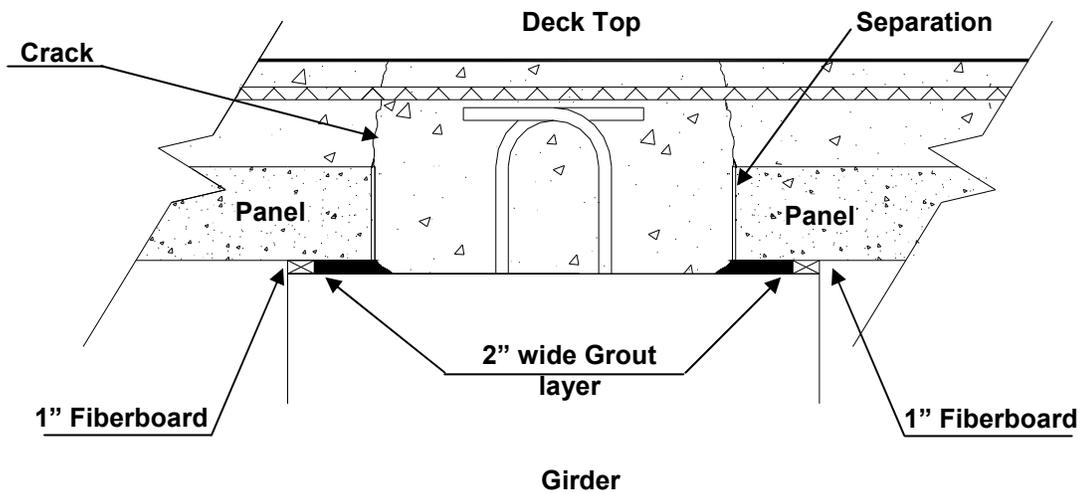
Figure 4.32 Findings Overview Bridge #100398

Fig. 4.32 provides a summary of all the findings of the forensic investigation of bridge #100398. It shows the panel bearing detail used, and the typical panel face separation and vertical cracking found in all the deck sections inspected on this bridge.

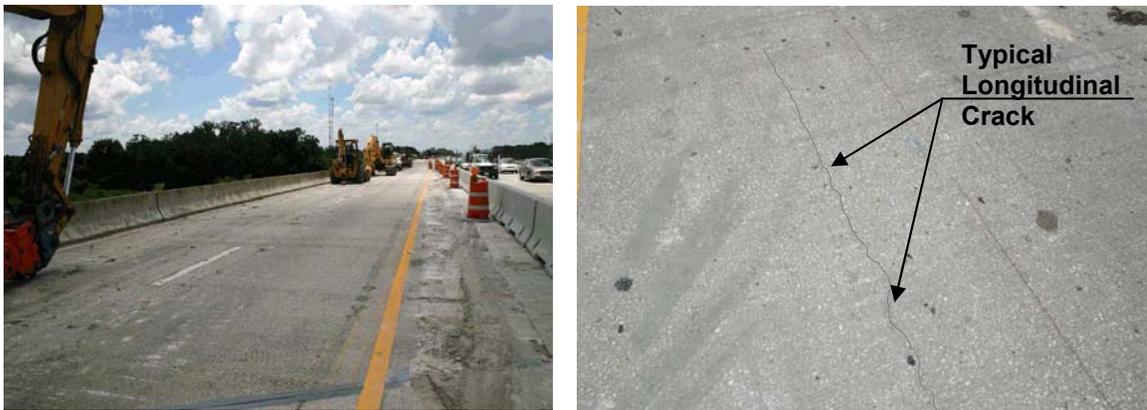
Figure 4.34 Deck Before Removal Bridge # 100417 (Bays 4-6)

After the half of the bridge to be replaced was closed, a detailed inspection of the bridge deck was conducted. During this inspection only typical longitudinal cracks along the entire deck and some transverse cracks were found. Both are typical of deck panel construction. Also no signs of previous repairs were found (Fig. 4.34).

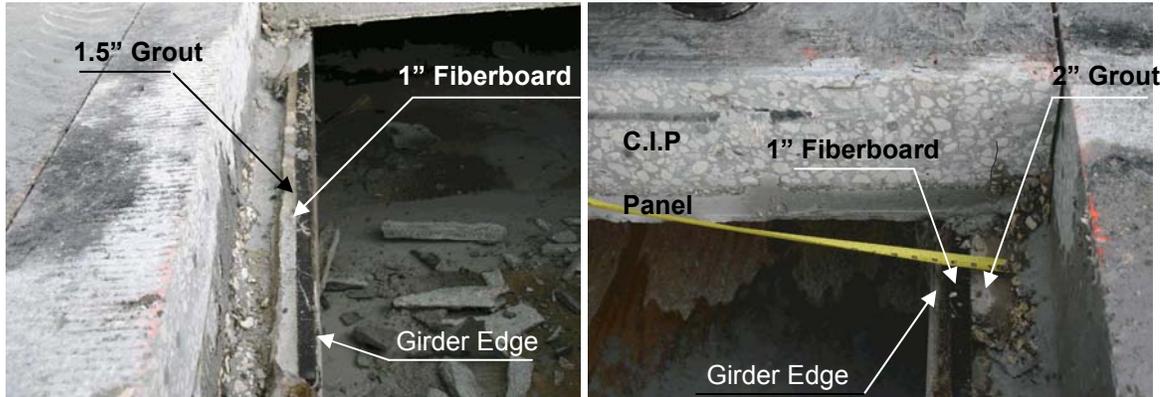
Figure 4.35 Panel Bearing Examination Bridge #100417

This bridge had exactly the same type of panel bearing detail as in the previous bridge (Section 4.7). Here a positive bearing was provided by a layer of grout placed next to a 1 in. fiberboard strip (Fig. 4.35). This system provided a stiff support for the panel. Soft fiberboard bearing is known to be responsible for premature deterioration of Florida’s deck panel bridges [4.2].

The use of positive panel bearing in this bridge is believed to be the reason why it did not exhibit major deterioration after 20 years of service.
