**REPLACEMENT PRIORITIZATION OF PRECAST
DECK PANEL BRIDGES**

Final Report for:

MARCH 2005

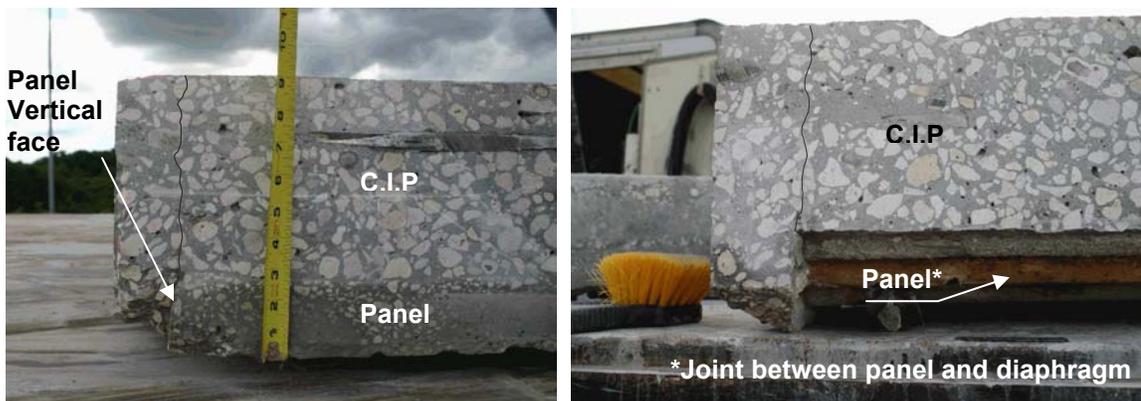
Figure 4.36 Panel Bearing Examination Bridge #100417

The inspection confirmed that longitudinal cracks were caused due to separation of the vertical face of the panel (Fig. 4.36). It also proved that the presence of deck surface longitudinal cracking is related only to the use of precast panels regardless the type of panel bearing used, whereas the occurrence of spalls or additional cracking was directly linked to the type of bearing used (“negative bearing”).

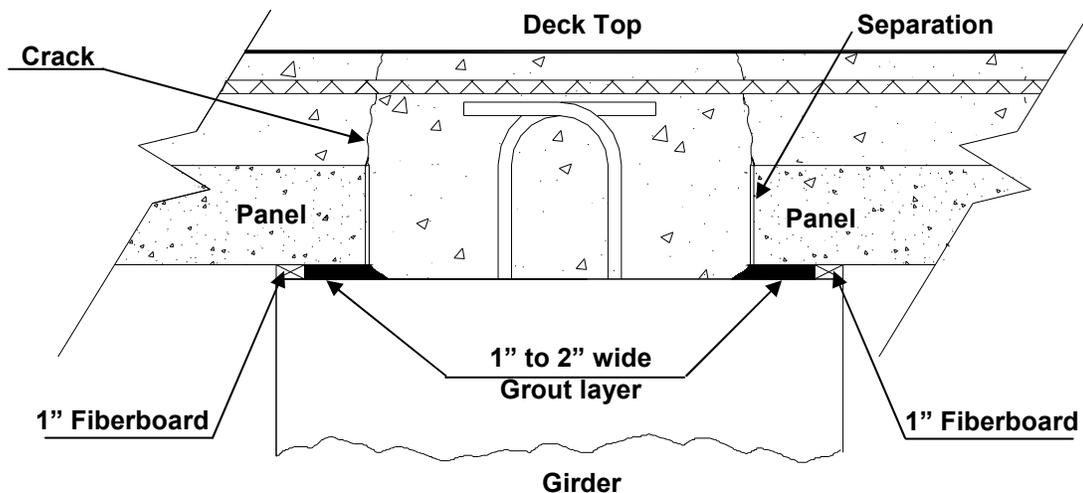
Figure 4.37 Findings Overview Bridge #100417

Fig. 4.37 provides a summary of all the findings of the forensic investigation of bridge #100417. It shows the panel bearing detail used, and the typical panel face separation and vertical cracking found on in almost all the deck sections inspected.

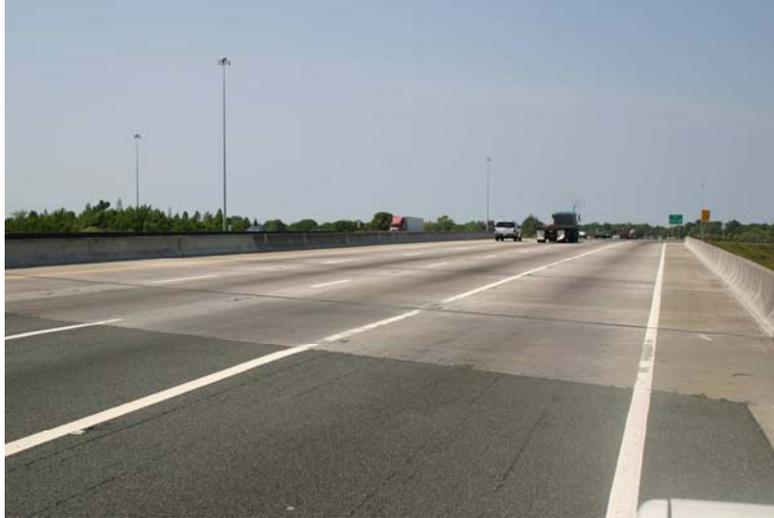
Figure 4.39 Bridge # 130085 Prior to Deck Removal

The forensic study was conducted on spans 2 to 4, bays 1 to 5. This section of the bridge and the rest of the bridge, exhibited only longitudinal and some transverse cracking typical of deck panel construction. No spalls or previous deck repairs were noticed on this bridge (Fig 4.39).

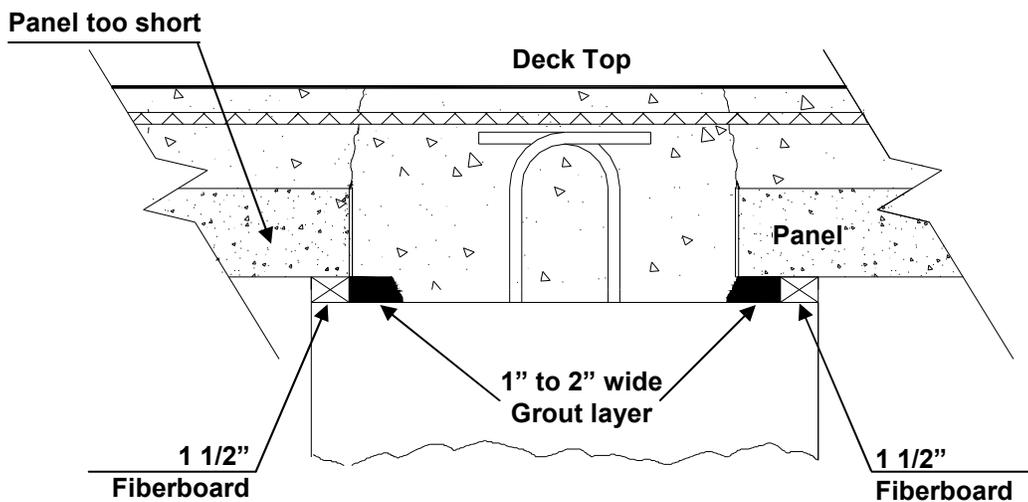
Figure 4.40 Bridge # 130085 Original Panel Bearing Detail

It was found that the panels in this bridge were initially placed over a 1 ½ wide fiberboard strip, with a 2 in. wide grout layer (Fig. 4.40), providing positive bearing support to the panels. However, the fiberboard had been replaced later by epoxy, as recommended in a previous research study [4.3], as a way to stop or to prevent future deterioration of the deck.

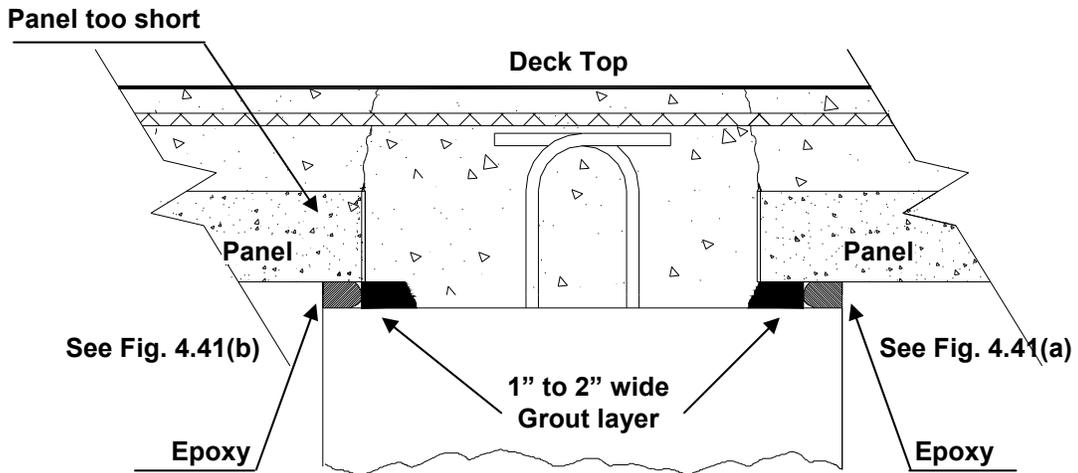
Figure 4.41 Bridge # 130085 Bearing Detail after Epoxy Repair

The panel bearings were inspected over a large area of the deck. It was found that in some regions the precast panel was not long enough, and therefore the grout could not flow below the panel and provide support. In such panels, support was only provided by fiberboard that had been subsequently replaced by epoxy (Fig. 4.40 4.41).

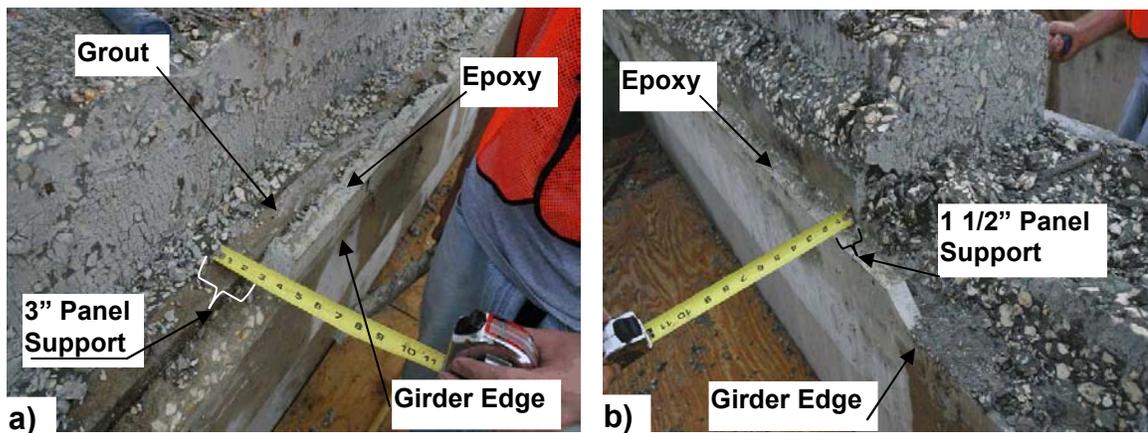
Figure 4.42 Bridge # 130085 Panel Bearing Details

As in bridges (100398 and 100417), the relatively good condition of this bridge can be attributed to the fact that this bridge was built using positive (grout) bearing for the precast panels. Also, replacement of the fiberboard by epoxy helped to prevent deterioration in regions where the panel was only supported by the fiberboard (Fig. 4.42b).

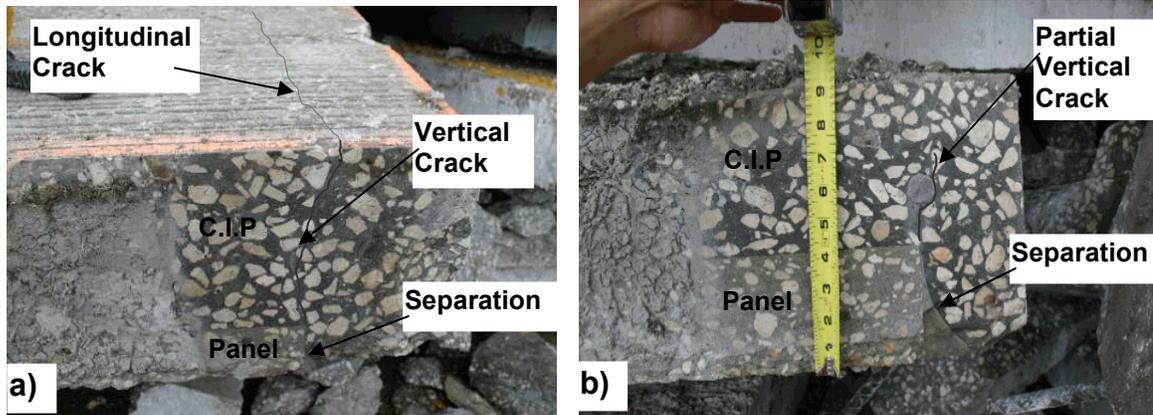
Figure 4.43 Surface Longitudinal Crack Bridge # 130085

Despite the use of positive panel bearing in this bridge, typical deterioration such as panel face separation and vertical cracking were detected (Fig. 4.43). Similar cracking was found in bridges on fiberboard bearings (“negative bearing”). This proves that such cracking is not related to the type of bearing used to support the panel.

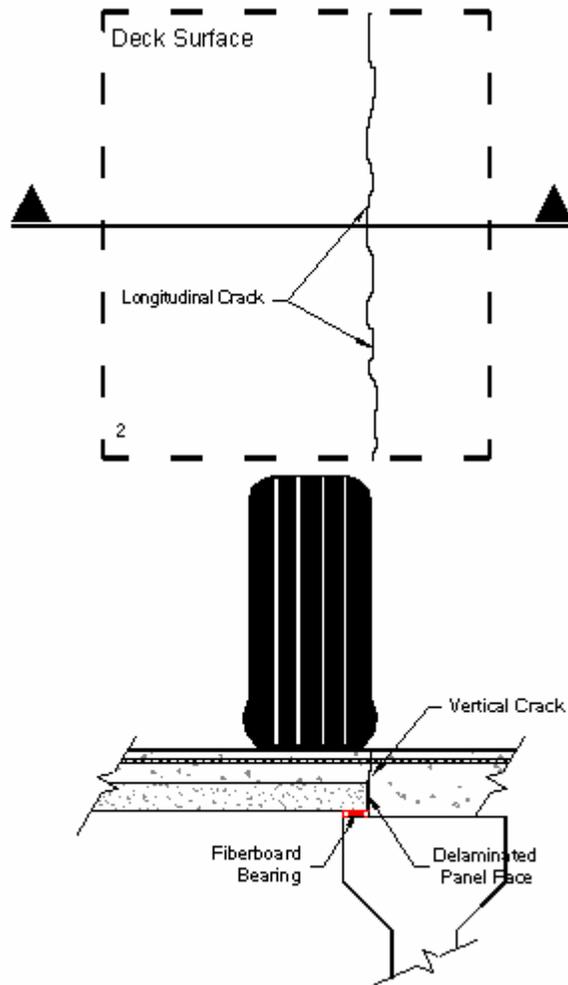
Figure 4.44 Deterioration Stage #2

The second stage is the occurrence of longitudinal cracks over the edges of the girders. This is the most common type of cracking in deck panel bridges and starts early. This crack is mainly the result of creep induced by prestressing forces in the panel, and the differential shrinkage between the cast in place concrete and the deck panel. Following the formation of longitudinal cracking, sporadic transverse cracks can also develop. The intersection of longitudinal and transverse cracking can lead to spalling in regions of the deck subjected to wheel loads.

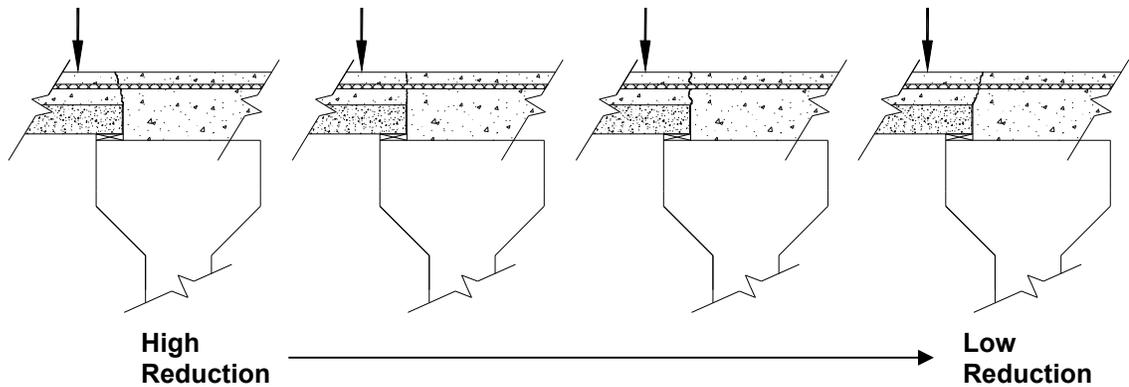
Figure 4.45 Effect of Vertical Crack Shape in Shear Reduction

reduction is affected by the shape of the vertical crack. Fig. 4.45 relates the shape of the crack to shear reduction. Reductions are higher when the crack extends towards the girder edge, and smaller when the crack extends towards the center of the girder since in the latter case, the load is directly supported by the girder.

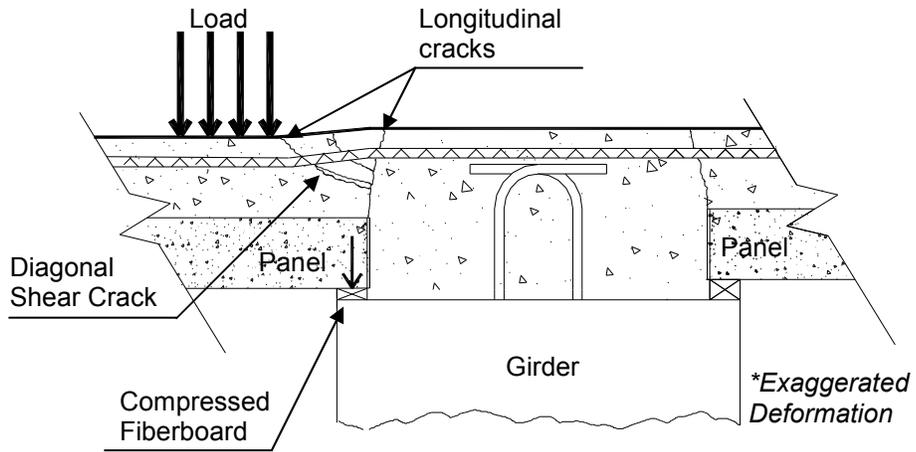
Figure 4.46 Shear Failures for Different Degrees of Shear Reduction

The first type of failure occurs when the cast in place concrete still has some capacity to transmit shear according to the shape of the vertical crack (Fig. 4.45). This shear failure is manifested by the appearance of a diagonal cracking emanating from the corner of the precast panel that propagates at an angle of less than 45 degrees. In most of the cases this crack reaches the surface generating additional longitudinal cracks (Fig. 4.46a).

a) Low Reduction of C.I.P Shear Capacity.

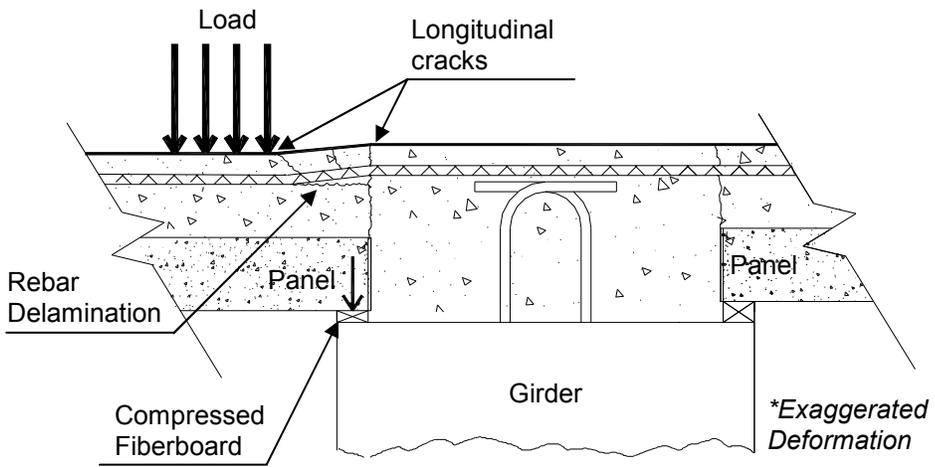
The second type of shear failure occurs when due to the vertical crack the cast in place concrete has lost all its shear capacity. In this case, the shear is transmitted only by the steel rebar by dowel action. When the shear load is very high, the rebar acts like a “crowbar” digging into the concrete on top of the rebar, creating delamination in that area (see Fig. 4.46b).

b) High Reduction of C.I.P Shear Capacity.

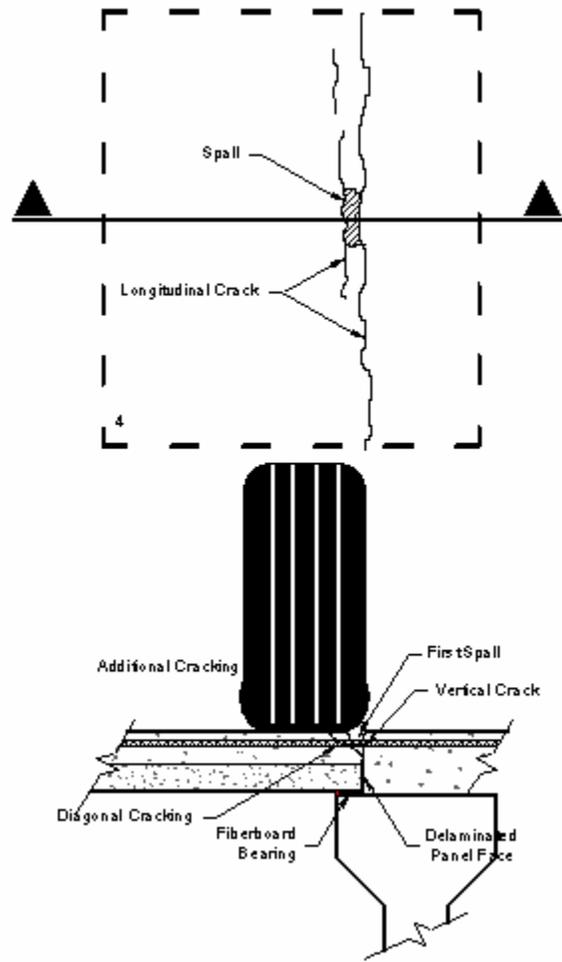
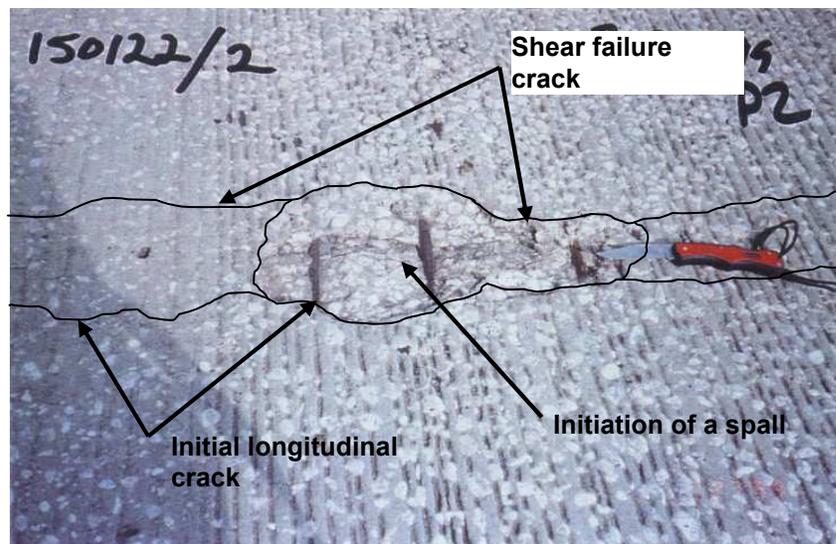
Figure 4.49 Deterioration Stage #4

After the occurrence of the second parallel crack, the concrete trapped between the two cracks is already internally cracked and starts to crumble. As a result, a spall develops. At this stage, a new parameter is introduced, the effect of the rainwater forced inside the cracks by vehicles. Although this is difficult to quantify, bridge inspectors have observed this phenomenon over the years.

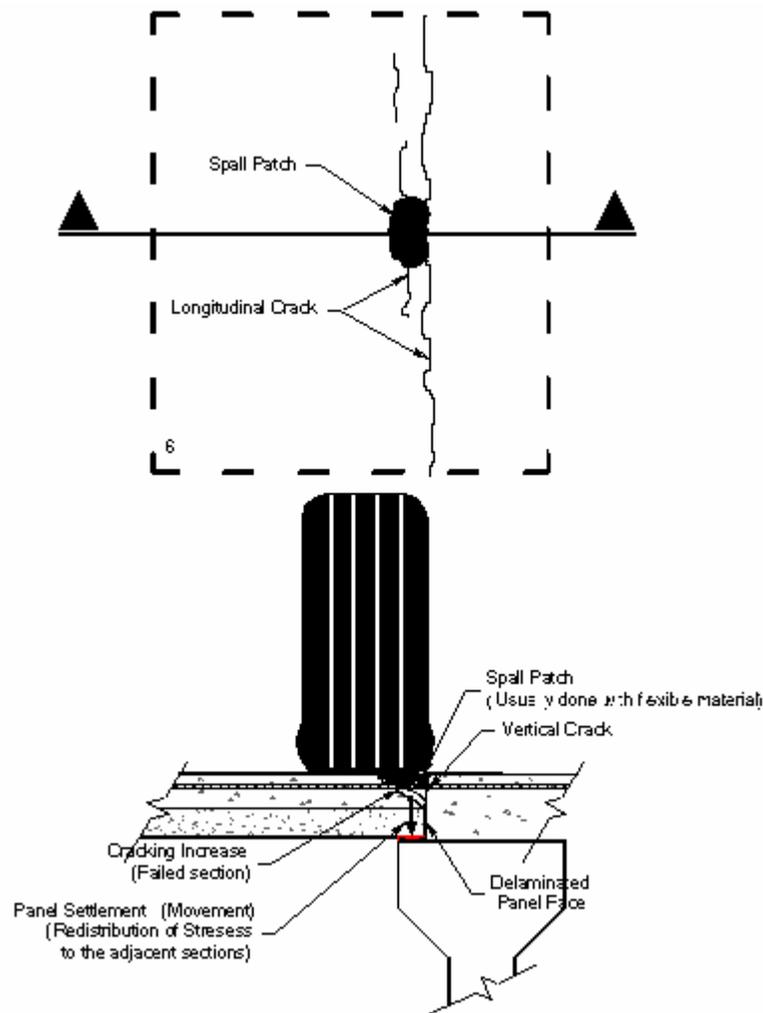
Figure 4.50 Deterioration Stage #5

After the occurrence of the first spall in stage#4 it will keep increasing in size basically due to the effect of the impact of the wheels at the edges of the existing spall. The maximum size of the spall and additional deterioration of the deck depends on how long it is left unrepaired. Usually the spalls are patched before they reach a relatively large size. For the majority of the cases, the repair consists of a temporary patch using a flexible material.

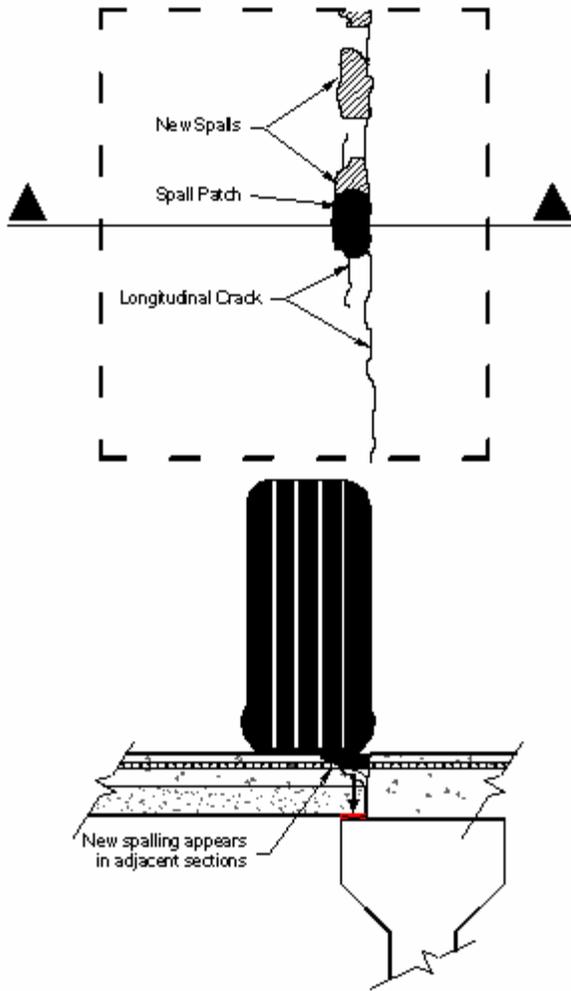
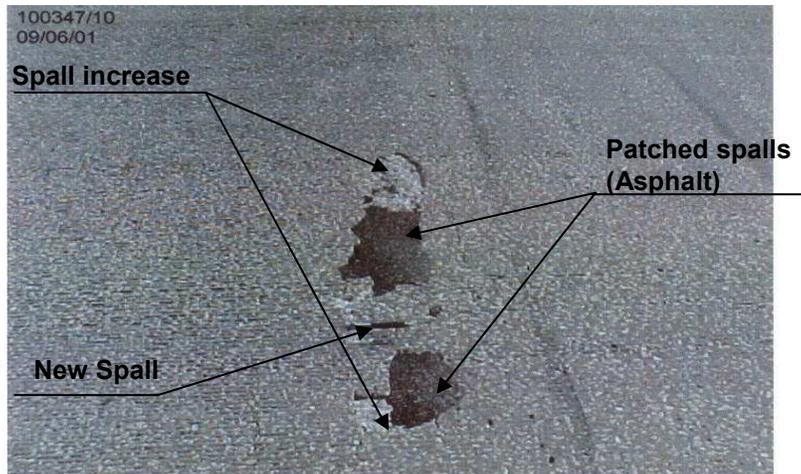
Figure 4.51 Deterioration Stage #6

Depending on all the different factors mentioned earlier, new spalls can appear in the areas adjacent to the repaired spall after some time. Note that after the spall is created, the residual shear capacity of that region is almost zero, even after it has been patched. Therefore, the shear that was to be supported by that region now has to be redistributed to sections adjacent to the spall. This creates additional stresses in that region, and accelerates its deterioration generating new spalls.

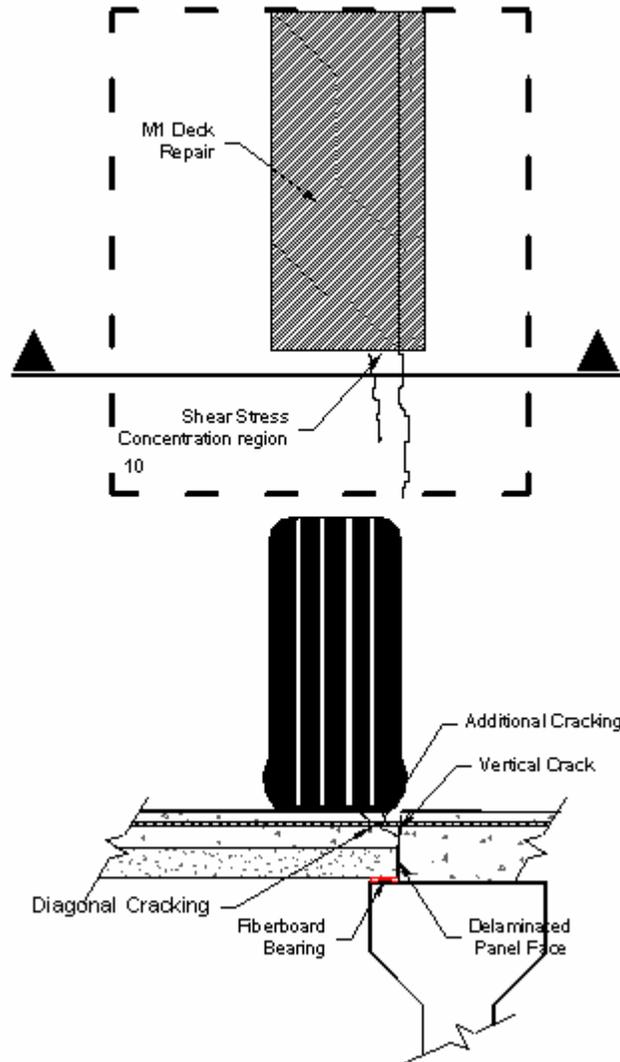
Figure 4.54 Deterioration Stage #8

Assuming that the panel bearing was not replaced by epoxy, or that it was replaced but due to construction problems there was no full support of the panel by the epoxy, the deck area adjacent to an M1 repair starts to deteriorate again with the appearance of the additional parallel cracking – shear failure cracking - described in (Section 4.11.3). The parameters that affect the occurrence of this additional deterioration case are the same mentioned for stages #3 and #7.

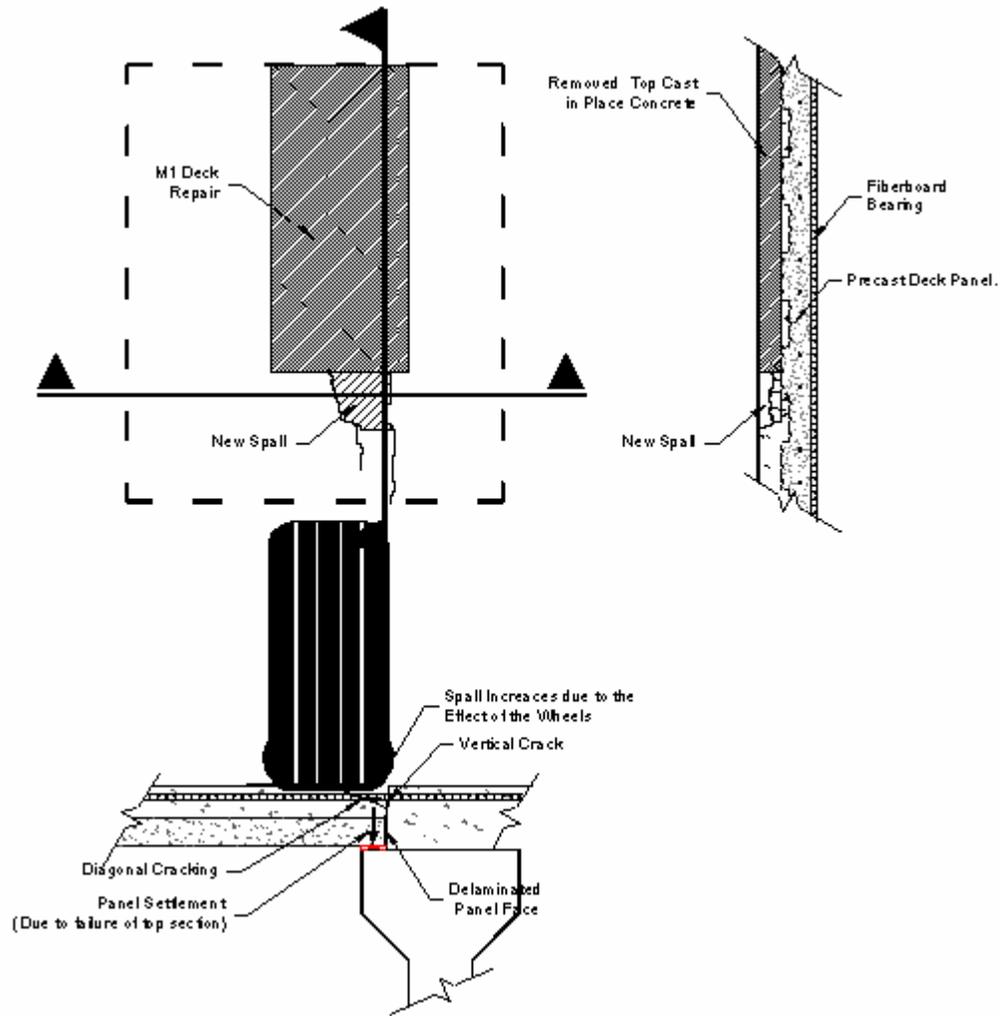
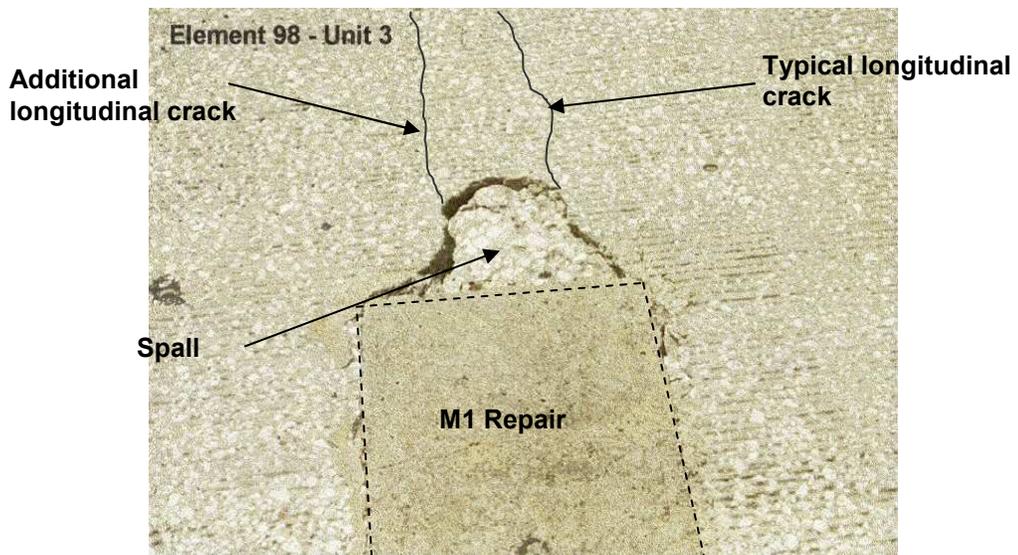
Figure 4.55 Deterioration Stage #9

After the occurrence of additional longitudinal cracking, a new spall develops and it follows the same mechanism mentioned in stage #4.

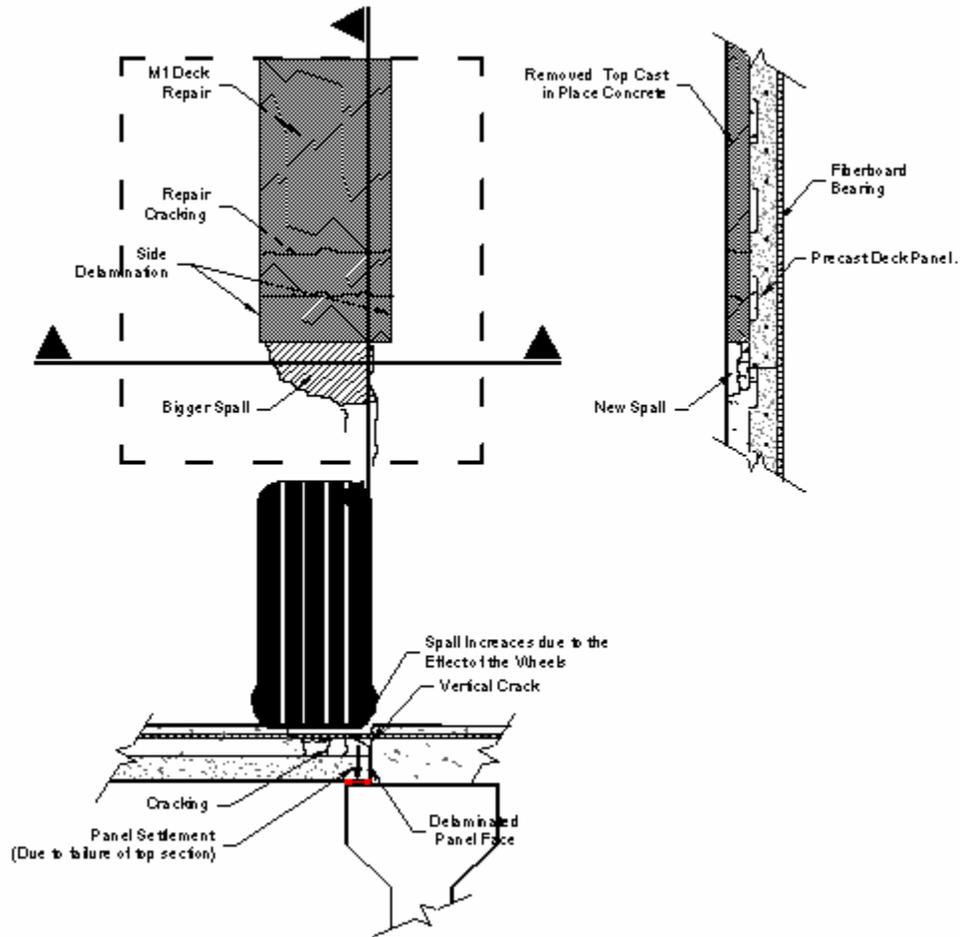
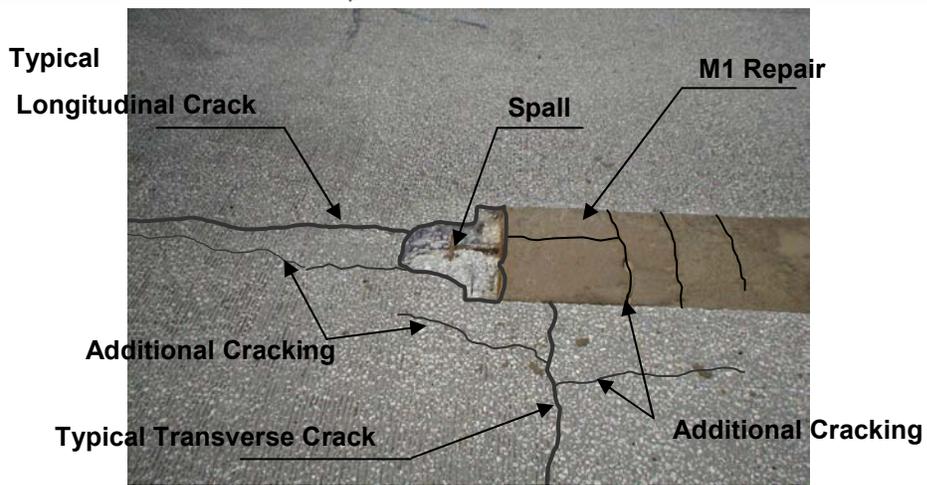
Figure 4.56 Deterioration Stage #10

When the spall mentioned in stage #9 is not patched quickly, it is very likely that the M1 repair can be fractured due to the constant impact of wheels over it. Impact can also cause growth of adjacent spalls, and delamination between the panel surface and the M1 repair.

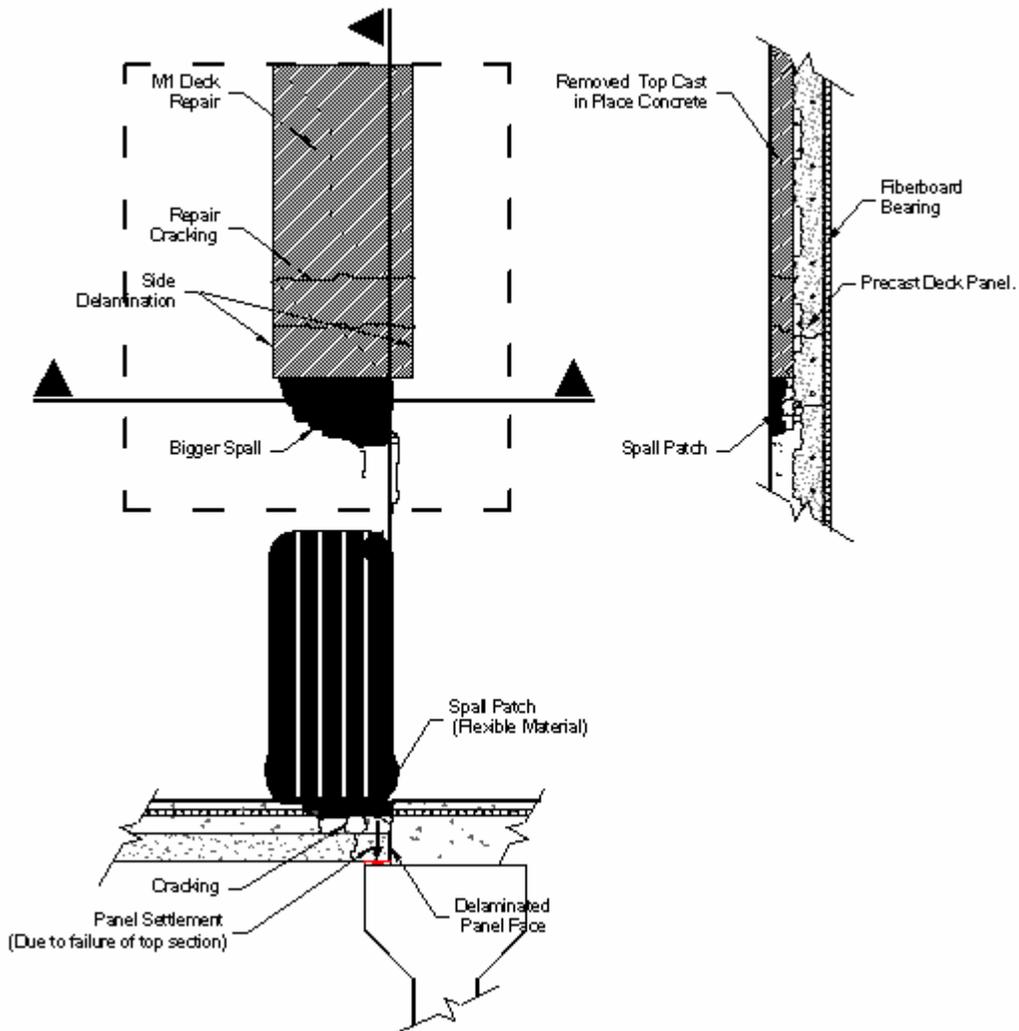
Figure 4.57 Deterioration Stage #11

Right after the spall is noticed and depending on its size, it is patched. Usually a quick temporary repair is done, in most cases using flexible material. Then what we have here is a fractured and delaminated M1 repair, plus a flexible material patch. The structural capacity of this deck section is very limited leading to redistribution of stresses to adjacent areas. Also in the case where no positive bearing is provided, the panel will experience movement every time the deck section is loaded due to the lack of a stiff support. In some cases where the fiberboard is deteriorated or is missing, the panel can even touch the top of the girder every time it deflects. Due to the dynamic nature of the wheel loads, panel movement can generate a pulse between the panel and the top of the girder, creating a hammering action and introducing new stresses in the panel. The parameters that affect this stage are (1) Time period between spall beginning, and spall patch, (2) patch material, (3) lack of bond between repair and panel top and, (4) degree of disrepair of the precast panel and the M1 repair.

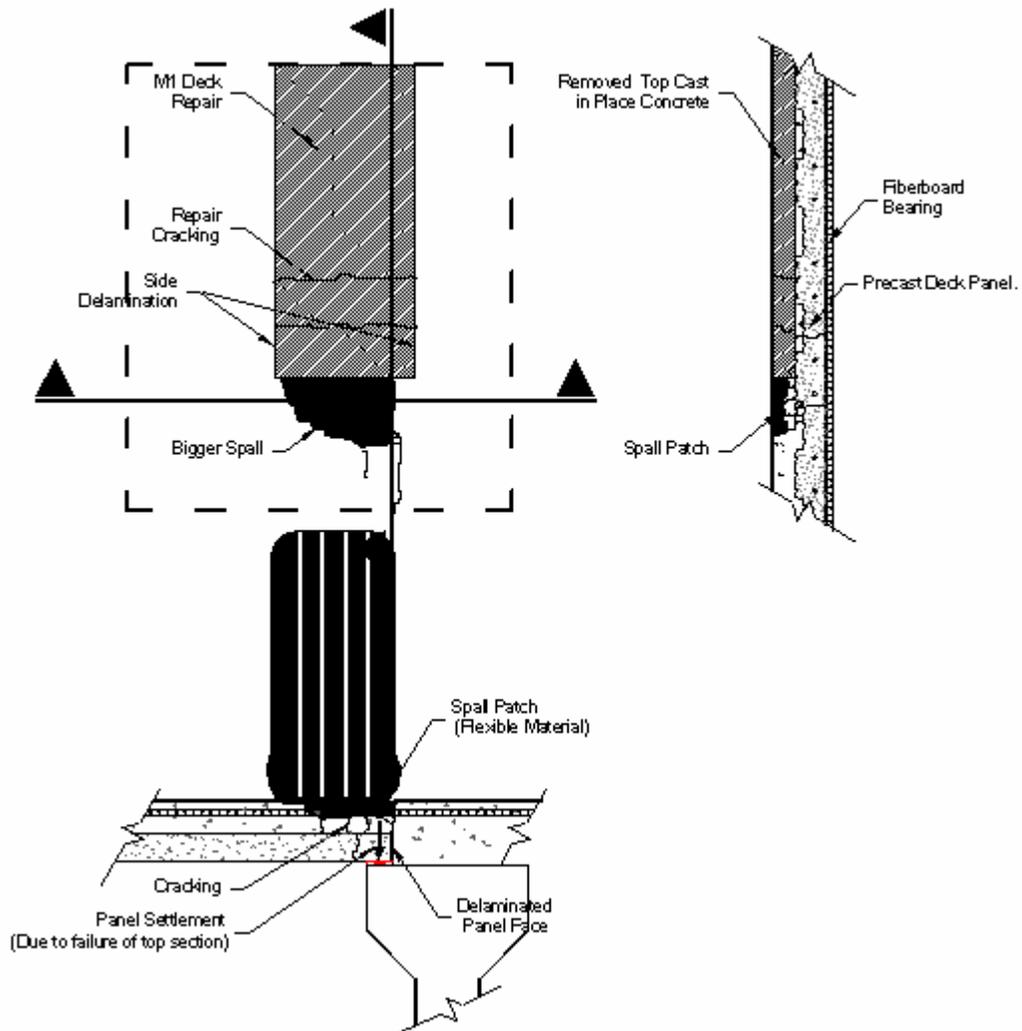
Figure 4.58 Deterioration Stage #12

After stage #12, since the structural capacity of the section is not restored, deterioration of the deck surface will continue and can generate new spalls adjacent to the previous patch, and next to the edges of the M1 repair. At this point, the deterioration of the deck panel is accelerated by the effect of wheel loads applied over small chunks of concrete over the panel. This concentrates the wheel load over a very small region of the panel surface instead of distributing it over the entire deck section. As a result large stresses are generated in the panel which increases the probability of the occurrence of a punching shear failure of the panel.

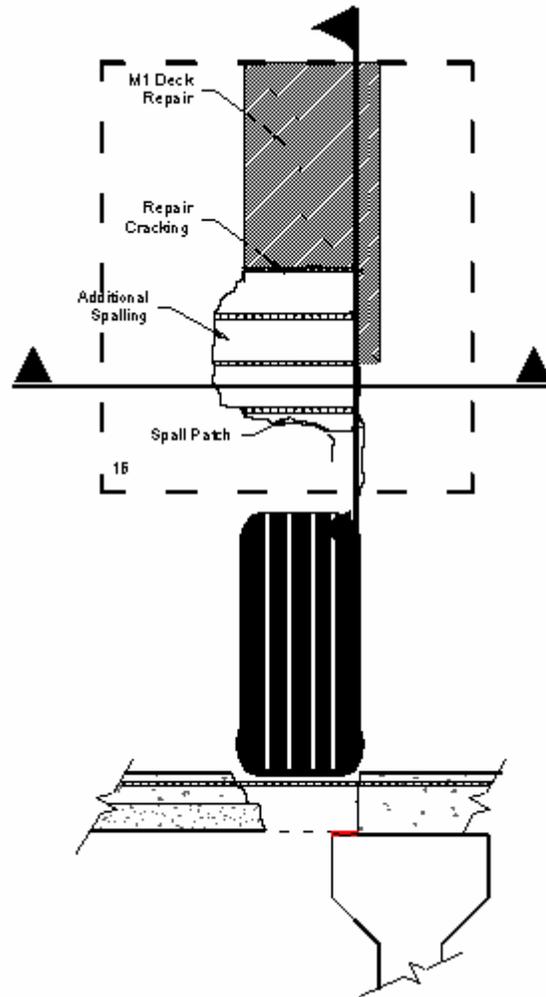
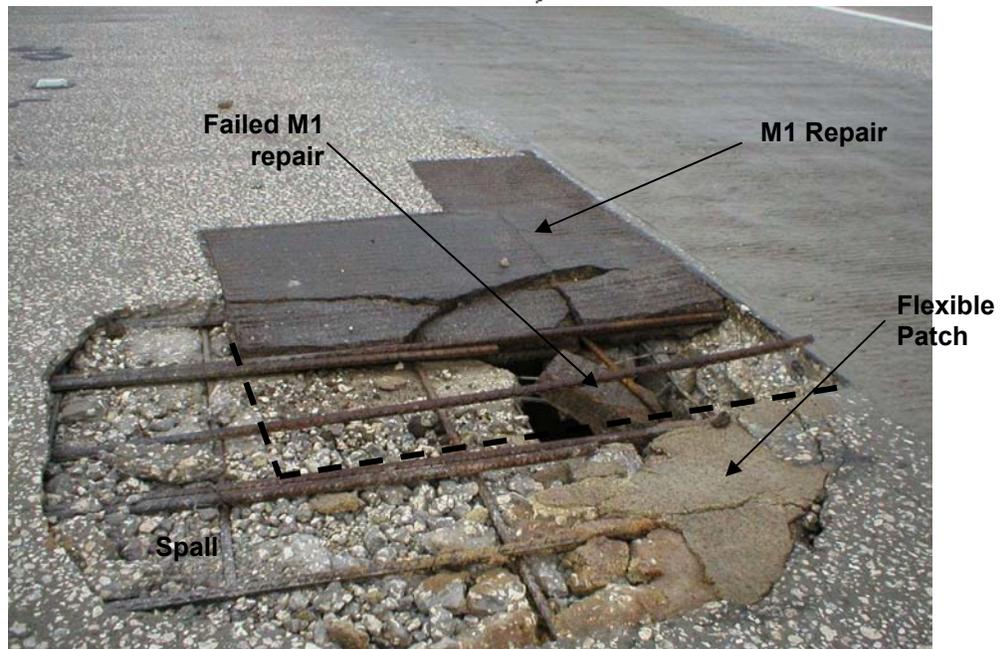
Figure 4.60 Deterioration Stage #13

After experiencing all the previous deterioration stages, a localized failure is likely to occur. When this happens, the top steel bar is the only structural element that prevents the occurrence of the failure of the entire bay.

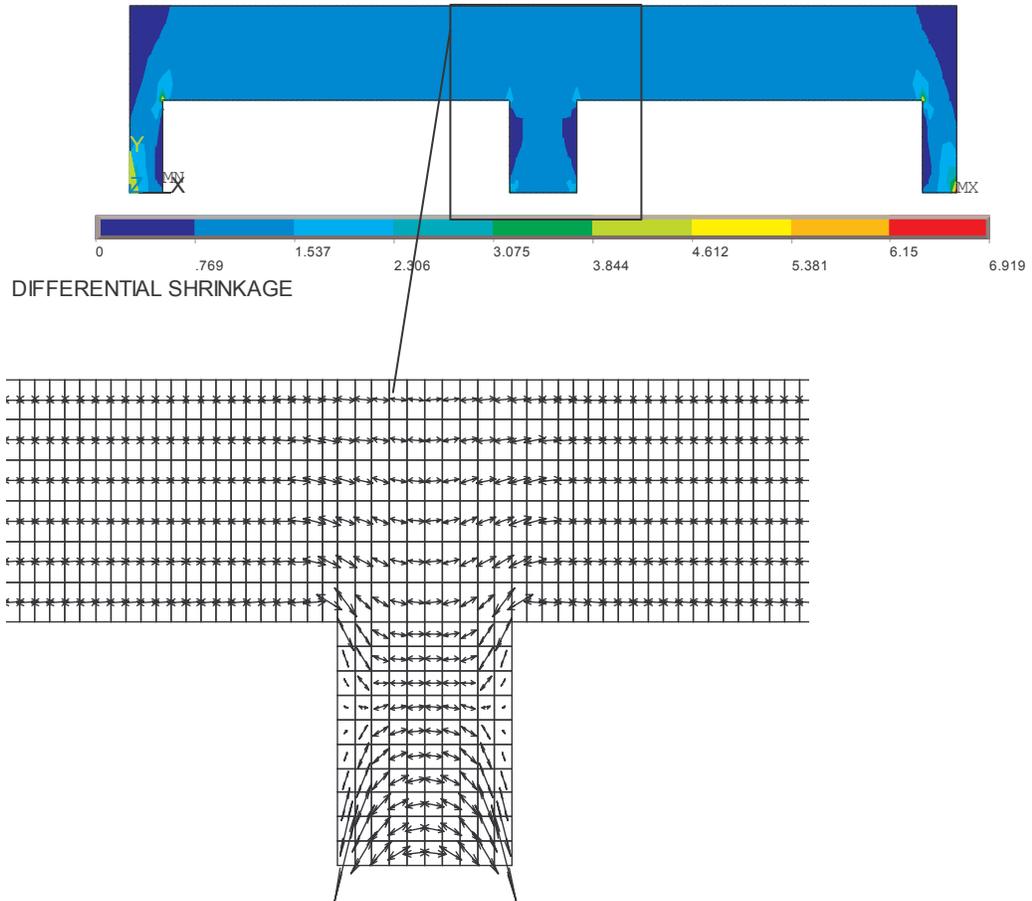
Figure 5.6 Principal Stress σ_1 on CIP concrete, due to differential Shrinkage and Creep load 90 days after construction. Blow up shows vector representation of the tensile stresses.

shrinkage before the CIP concrete is poured. Figure 5.6 shows principal stresses distribution developed in the CIP concrete. The tensile nature of the stress is clearly seen in the vector representation of the principal stress shown in the close up of the central portion of the model. Figure 5.7 shows regions of the CIP concrete where the stress due to differential shrinkage and creep exceeds 0.503 ksi, which is the design tensile capacity of 4500 psi concrete. Given the large area under tensile stresses, one would expect more widespread cracking, however since the CIP portion of the deck is reinforced, and since shrinkage and creep loads are relieved on any cracking, the cracking is limited to areas near the panel to CIP concrete joint, where there is no reinforcement present.

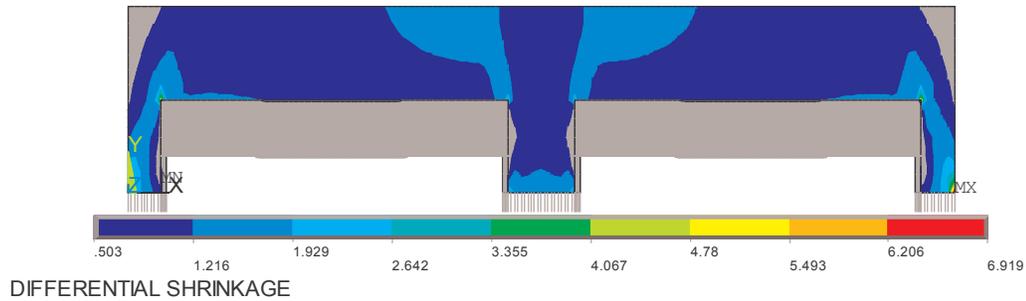
Figure 5.7 Regions with Principal Stress $\sigma_1 > 0.503$ 90 days after construction.

It can be seen from the above example that differential shrinkage and to a lesser degree differential creep can easily lead to the cracking observed on deck panel bridges even with positive bearing. The results show that live-load is not required to initiate these cracks, although it would definitely be a factor in developing these cracks further and eventually causing spalls. This result is consistent with the observations of the forensic study presented in Chapter 4, where cracks were found even on shoulders where the live load cannot be a factor in the crack formation.

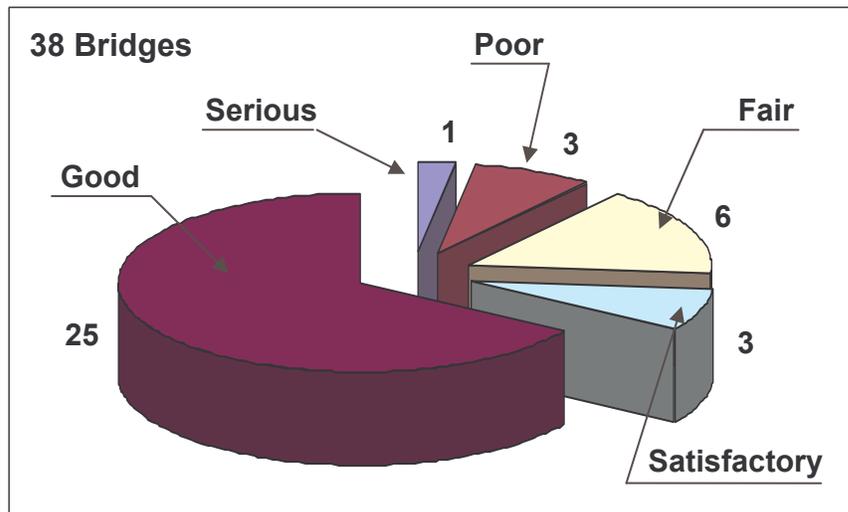
Figure 6.5 Inspection Summary - District 1

A pie chart showing the results of the inspection of 38 bridges in District 1 is given in Fig. 6.5. Of the 38 bridges, only one was rated as ‘serious’, three as ‘poor’ and six as ‘fair’. These 10 bridges were candidates for the second inspection conducted three months later. The remaining 28 bridges were considered to be ‘satisfactory’ (3) or ‘good’ (25). Table 6.2 provides a summary of the findings for each bridge. Photographs showing typical deterioration in the worst four bridges are shown in Figs. 6.6-6.9. In each of these figures AUTOCAD drawings with the location of the damage in the plan view are also shown. Photographs and AUTOCAD drawings for these 38 bridges were stored in a database and can be accessed by the PANEL software (see Chapter 7).

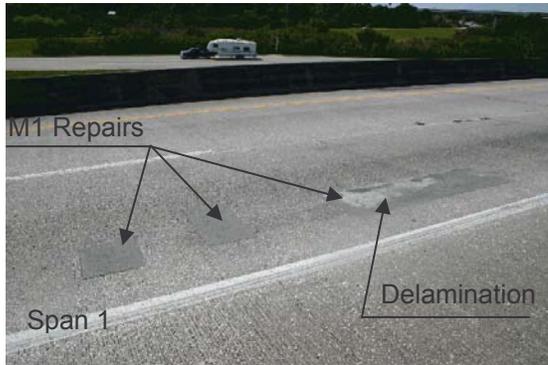
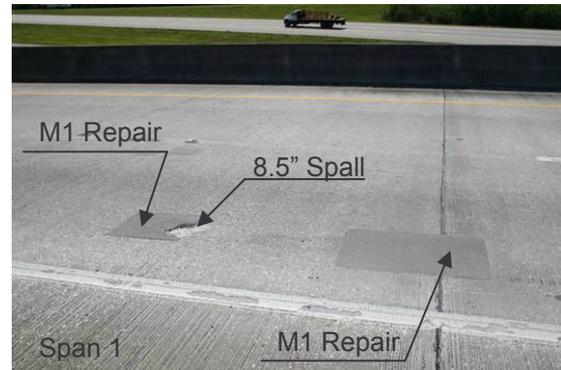
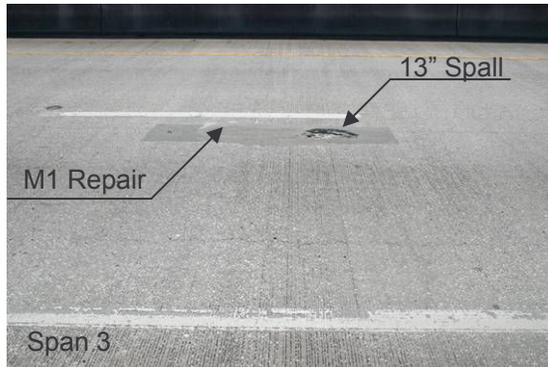
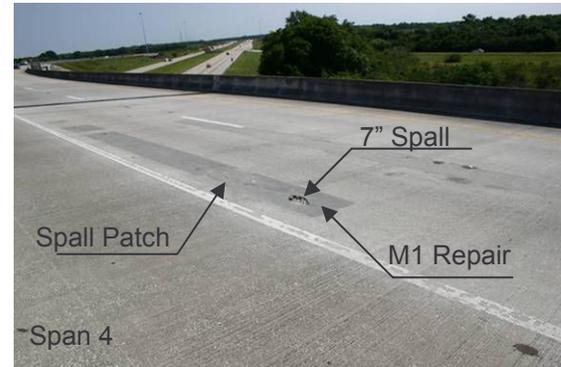
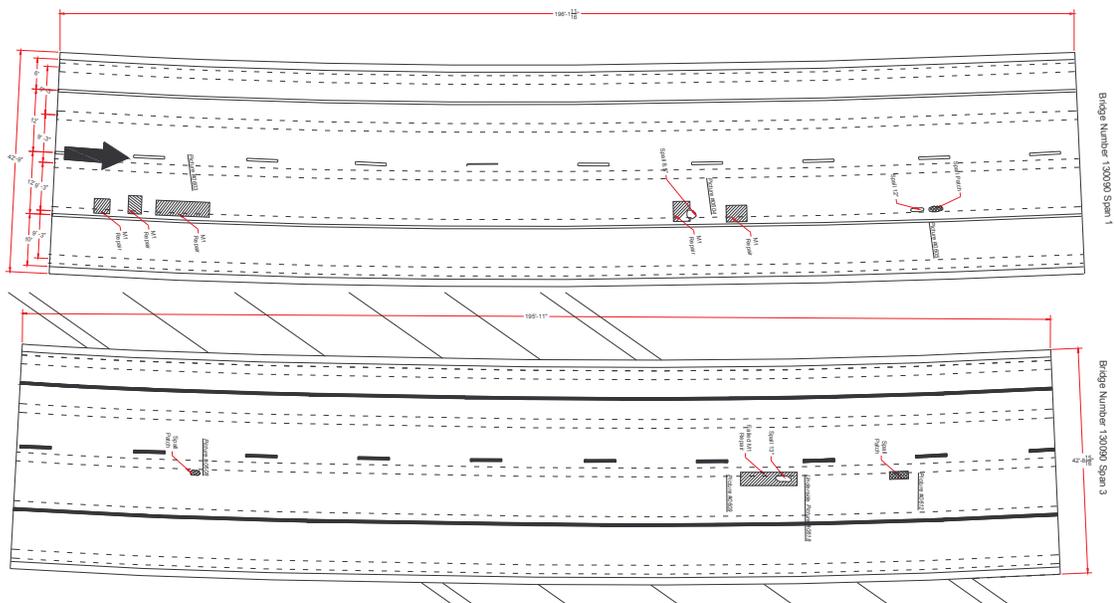
Figure 6.6 Deterioration in Bridge #130090 (March 2004)

- I-275 NB over I-75 (Bridge # 130090)

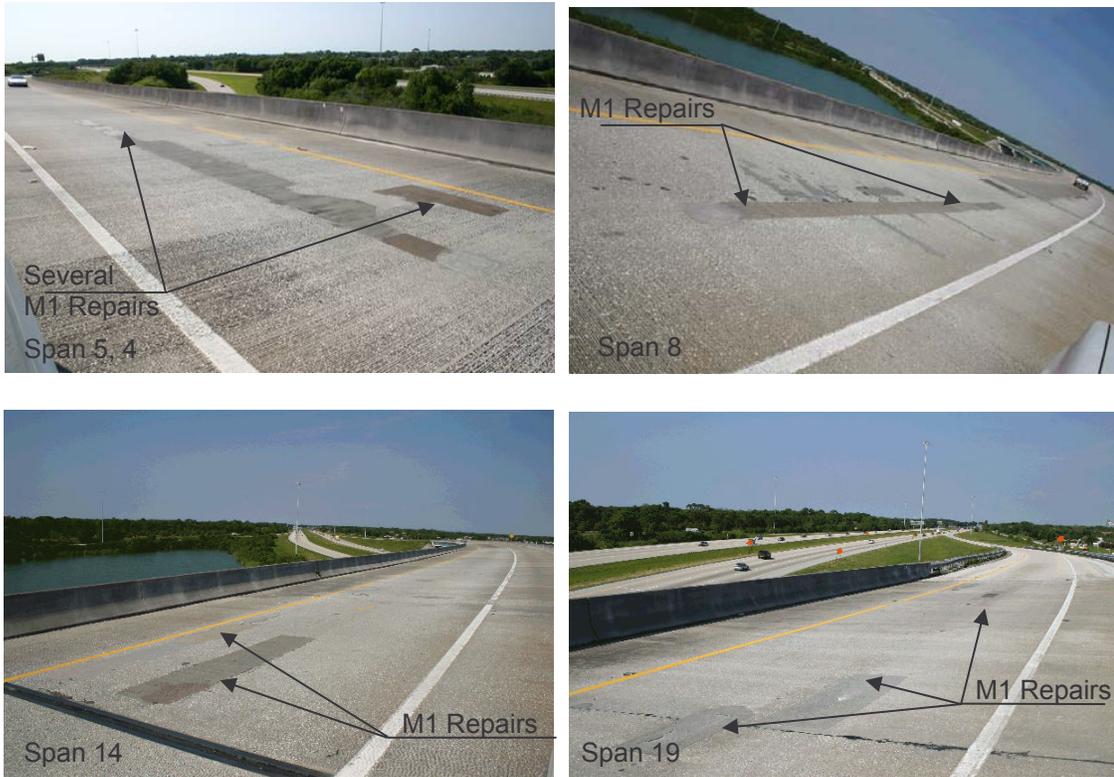
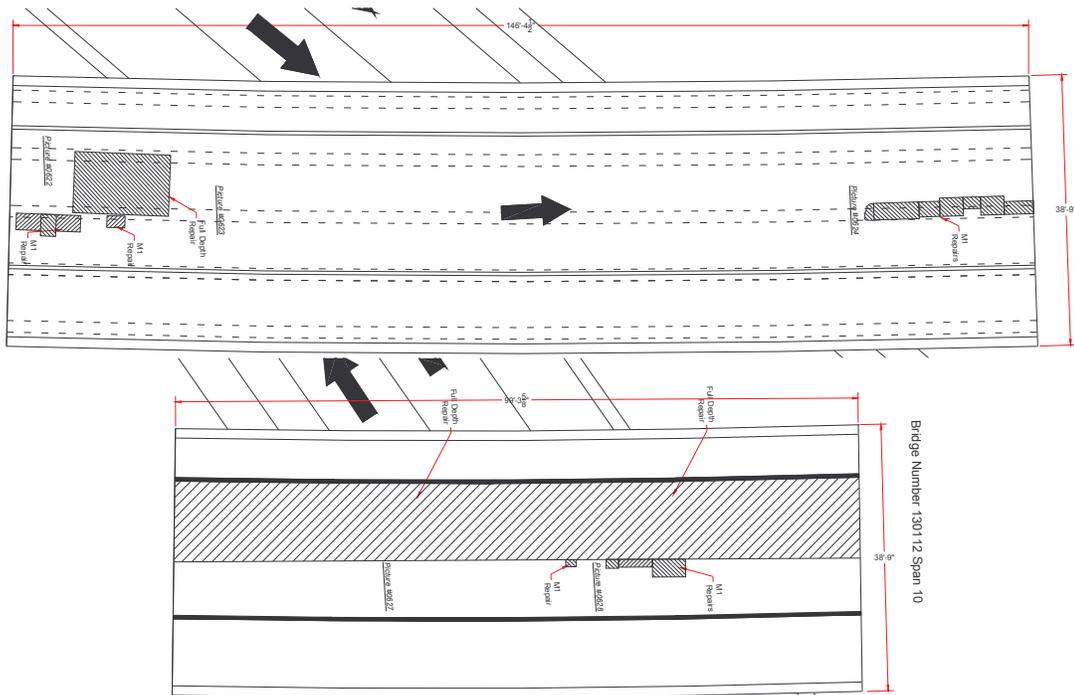
Figure 6.7 Deterioration in Bridge #130112 (March 2004)

- I-275 SB to I-75 NB Ramp (Bridge #130112)
