**REPLACEMENT PRIORITIZATION OF PRECAST
DECK PANEL BRIDGES**

Final Report for:

MARCH 2005

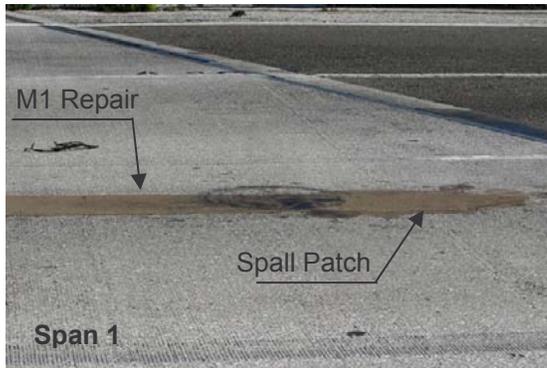
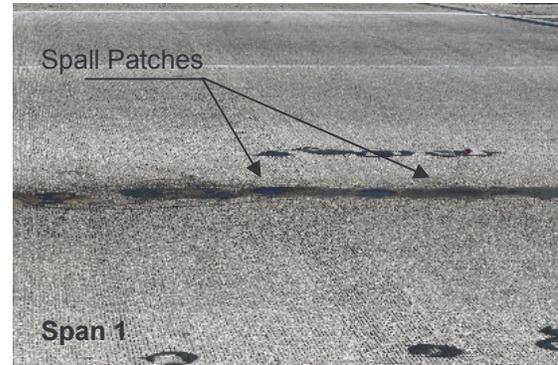
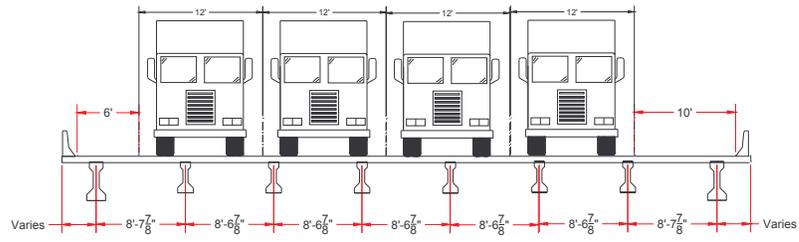
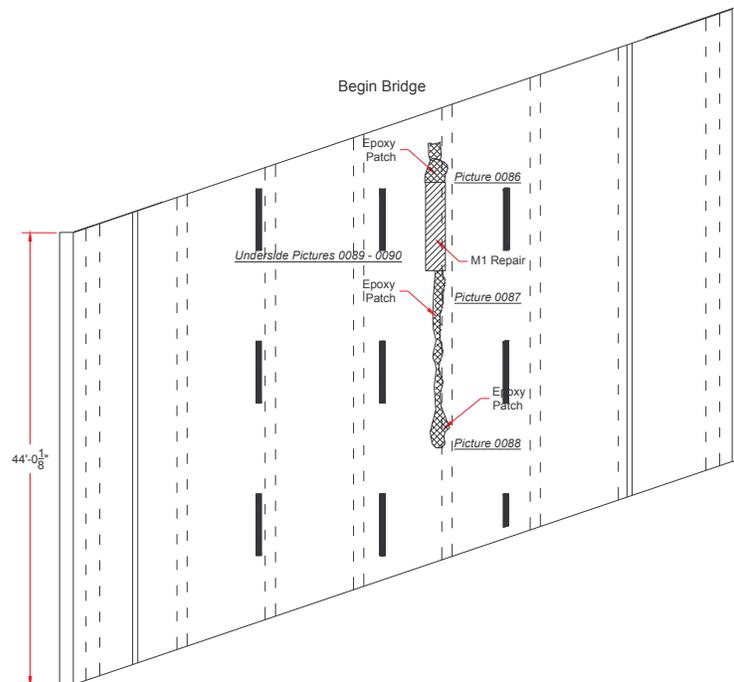
Figure 6.11 Deterioration in Bridge #100347 (March 2004)

- I-75 NB over SR-674 (Bridge #100347)

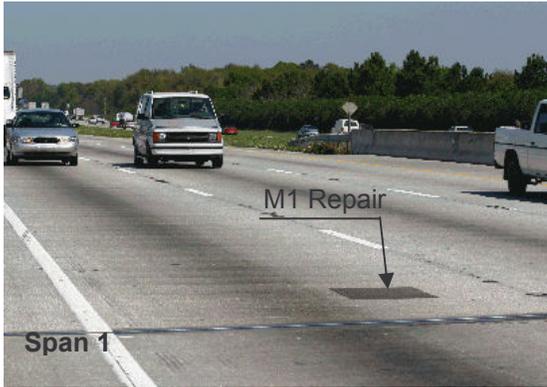
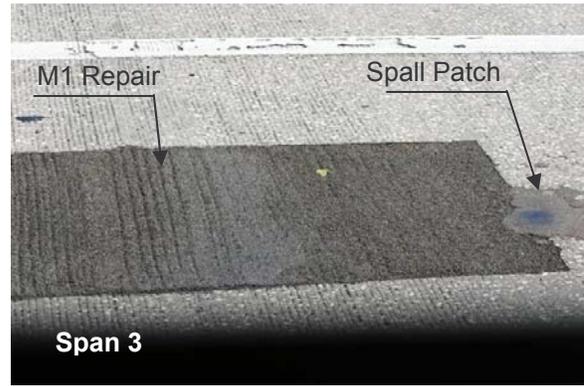
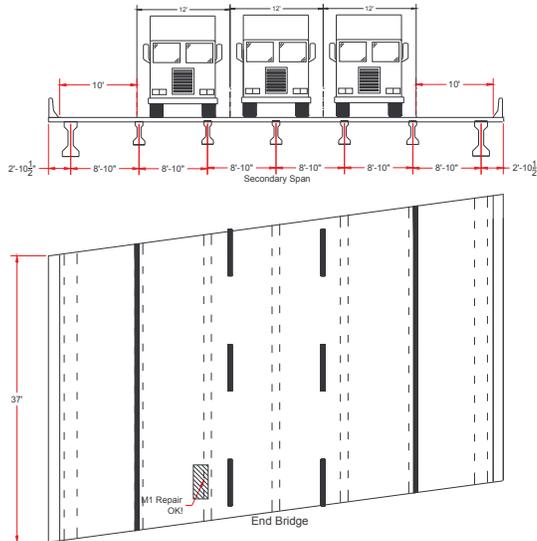
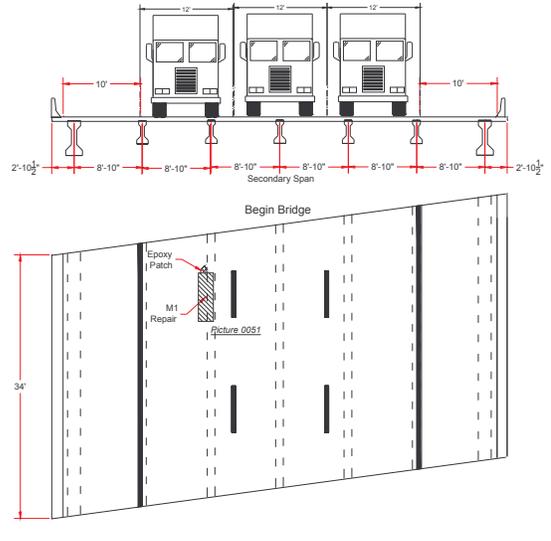
Figure 6.12 Deterioration in Bridge #100468 (March 2004)

- I-75 SB over Woodberry Road (Bridge #100468)

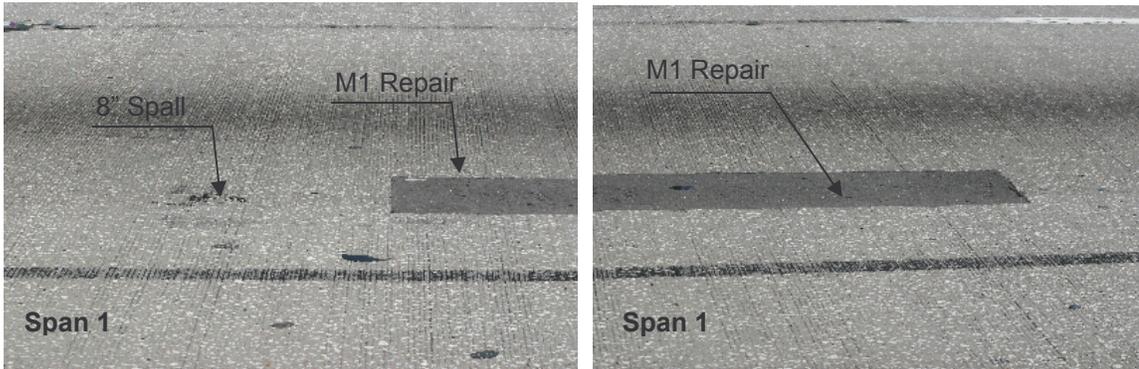
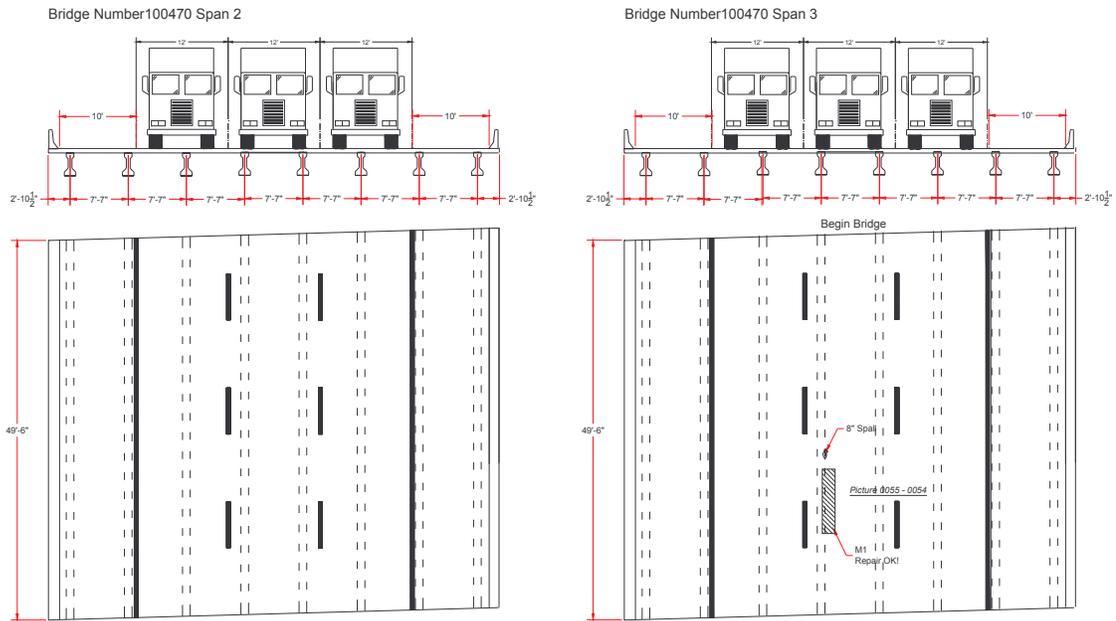
Figure 6.13 Deterioration in Bridge #100470 (March 2004)

- I-75 SB over Woodberry Road (Bridge #100470)

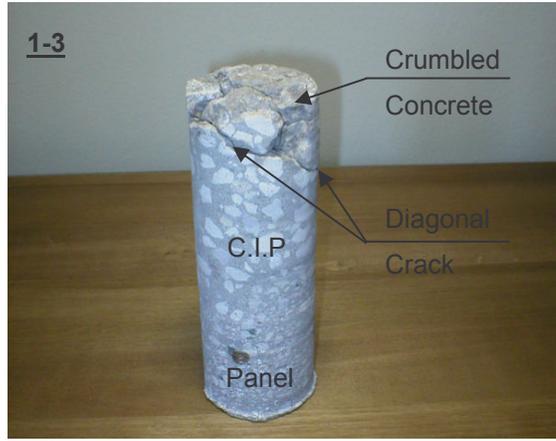
<p>Crumbled Concrete</p> <p>Diagonal Crack</p> <p>C.I.P.</p> <p>Panel</p>	<p>This core was taken between two parallel cracks close to the edge of the panel support. There was no debonding at the interface between the CIP slab and the panel. However, there was diagonal separation at the top (1/2 in at one end to 2 in at the other end). The concrete in this section was in four small pieces and signs of water infiltrating the crumbled concrete were present.</p>
<p>1-4</p>

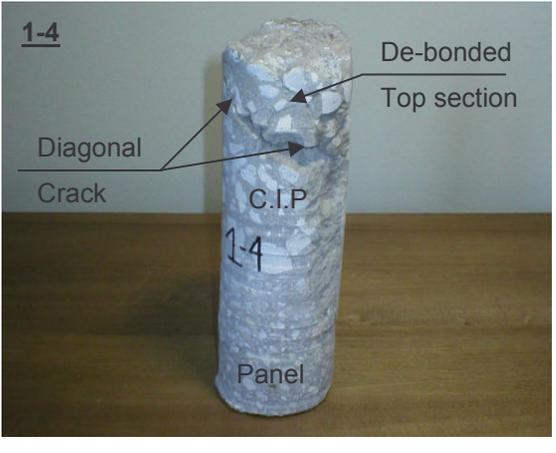
<p>De-bonded Top section</p> <p>Diagonal Crack</p> <p>C.I.P.</p> <p>Panel</p>	<p>The core was adjacent to 1-3 but was closer to the support. In this case, there was also no separation at the panel/CIP interface and a diagonal crack with the same slope (1/2 in at one end and 2 in. at the other end was present). However, the top segment was cracked but not in four pieces. Signs of water infiltrating the diagonal crack were found.</p>

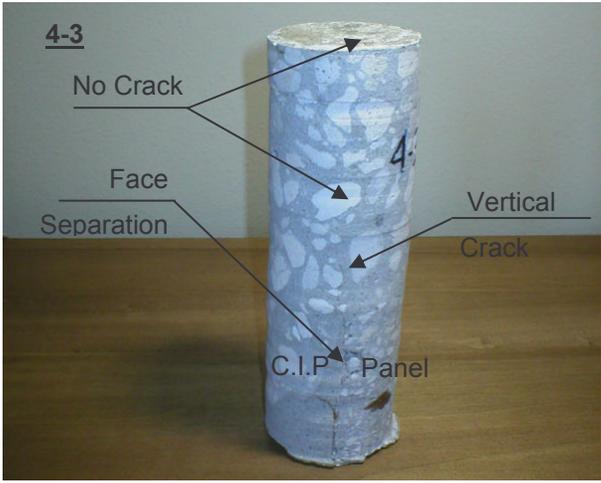
<p>A cylindrical concrete core labeled '4-3' is shown. It has a vertical crack on the right side and a horizontal line indicating 'Face Separation' between the top and bottom sections. The bottom section is labeled 'C.I.P. Panel'. The top surface is labeled 'No Crack'.</p>	<p>This core was taken over the edge of the panel where there was no surface cracking. There is separation between the vertical face of the panel and the CIP slab possibly due to creep and shrinkage. There is also a hairline vertical crack emanating from the corner that extends 1 ½ in upwards into the CIP slab.</p> <p>Total core height 8 1/2 in</p>
<p>4-4</p>

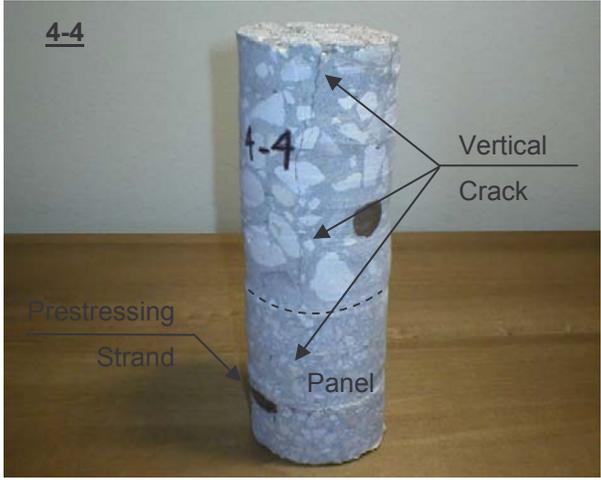
<p>A cylindrical concrete core labeled '4-4' is shown. It has a vertical crack on the right side. A dashed horizontal line indicates the location of a 'Prestressing Strand'. The bottom section is labeled 'Panel'.</p>	<p>This core was taken at a section near the edge of the panel where there was a transverse crack. The crack extended all the way from the prestressing strand to the steel surface. The surface crack was an isolated crack with a length of less than 2 ft.</p> <p>Total core height 8 1/2 in</p>

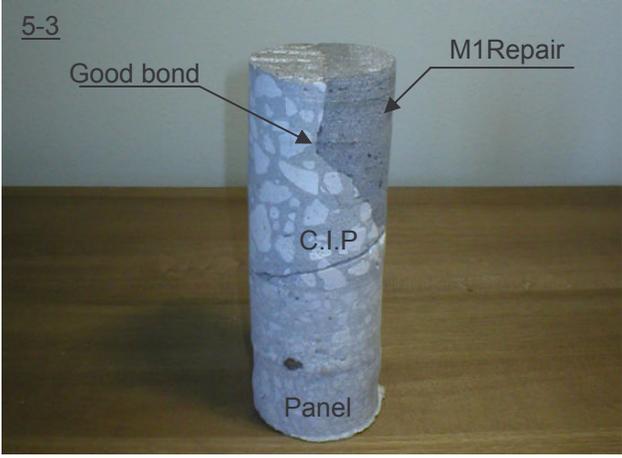
<p>Good bond</p> <p>M1Repair</p> <p>C.I.P</p> <p>Panel</p>	<p>This core was taken from the edge of an M1 repair. There was good bond between the M1 repair and existing concrete.</p> <p>This core was also broken in half during the extraction process.</p> <p>Total core height 7 ¾ in.</p>
<p>5-4</p>

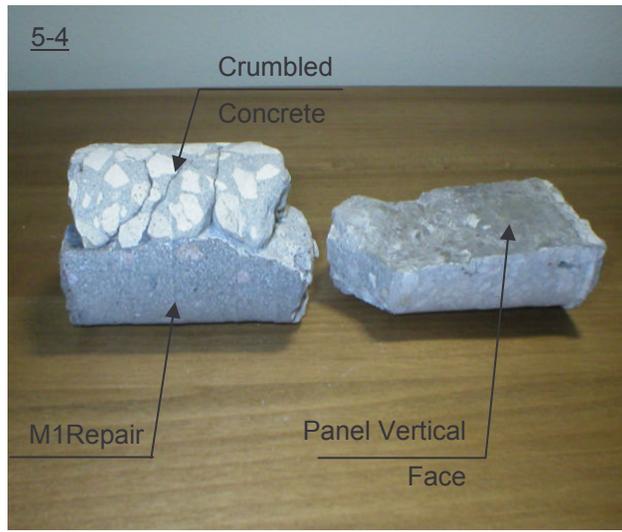
<p>Crumbled Concrete</p> <p>M1Repair</p> <p>Panel Vertical Face</p>	<p>This core was taken at a transverse joint for an M1 repair. There was no bond between the M1 repair and the existing concrete. The concrete adjacent to the vertical repair joint was crumbled, and had signs of water infiltration.</p> <p>The panel vertical face easily separated from the adjacent cast in place concrete.</p> <p>Not all the pieces of the core could be retrieved.</p>

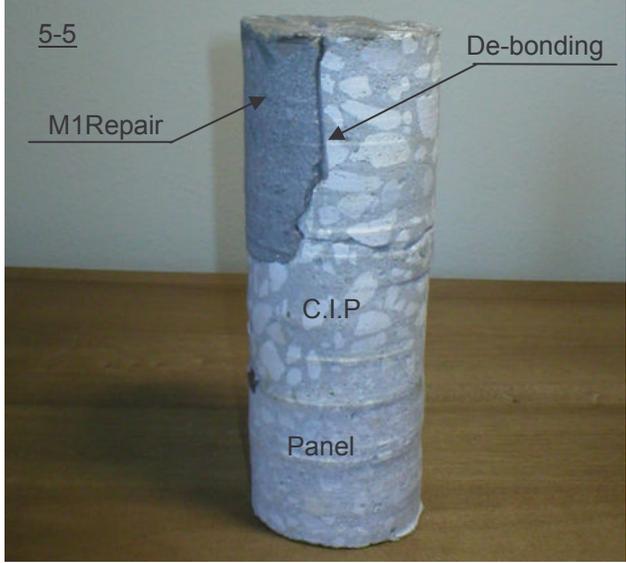
<p>M1Repair</p> <p>De-bonding</p> <p>C.I.P</p> <p>Panel</p>	<p>This core was taken adjacent to 5-4 but some distance away from the edge. It shows de-bonding between the M1 repair and the adjacent cast in place concrete.</p> <p>This core broke at the vertical edge of the M1 repair during the extraction process.</p> <p>Total core height 8 in.</p>
<p><u>5-6</u></p>

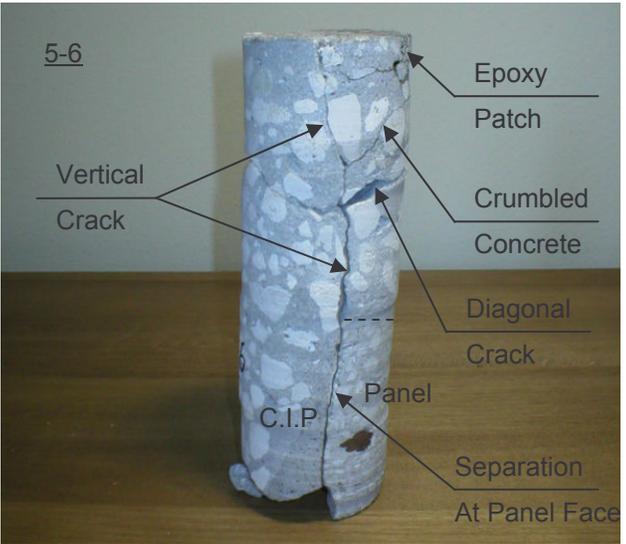
<p>Epoxy Patch</p> <p>Vertical Crack</p> <p>Crumbled Concrete</p> <p>Diagonal Crack</p> <p>C.I.P</p> <p>Panel</p> <p>Separation At Panel Face</p>	<p>This core was taken adjacent to 5-2 near the edge of the panel where it crossed a longitudinal crack. It shows a vertical reflective crack extending over the entire depth of the core separating the precast panel from the CIP slab. There are signs of water and dust infiltration.</p> <p>The top surface includes a partial epoxy patch which is bonded to the CIP slab. The penetration of the epoxy penetrating below has prevented the top surface from crumbling.</p> <p>Total core height 8 in.</p>

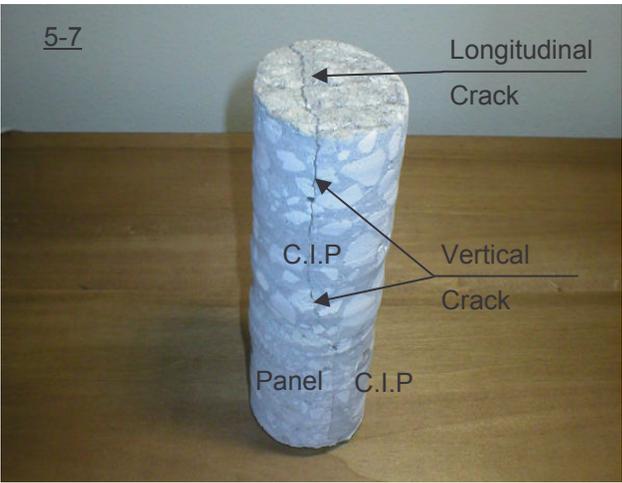
<p>Longitudinal Crack</p> <p>Vertical Crack</p> <p>C.I.P</p> <p>Panel C.I.P</p>	<p>This core was taken along a longitudinal crack located at the opposite supported edge of the panel from the previous cores. The same vertical crack detected in core 5-6 occurred but there was no additional damage.</p> <p>There were signs of water penetration in the CIP slab.</p> <p>Total core height 8 1/4 in.</p>

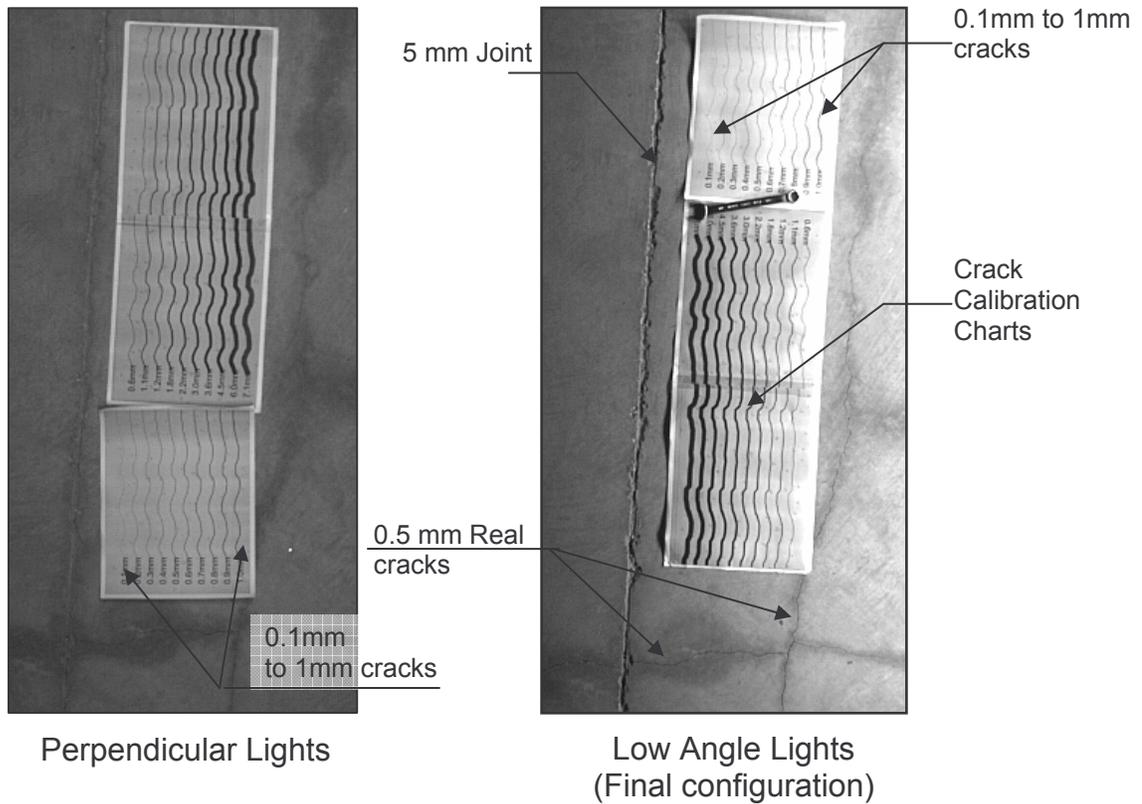
Figure D10 Camera Illumination and Resolution Test

In order to find the actual minimum crack size that could be detected with this camera, test images were taken over a cracked surface with known crack widths (0.5mm cracks), and also over crack calibration charts. These charts reproduced cracks from 0.1 mm up to 7 mm. Notice that in the final configuration picture (Fig. D10) it was possible to easily identify cracks as narrow as 0.5 mm.

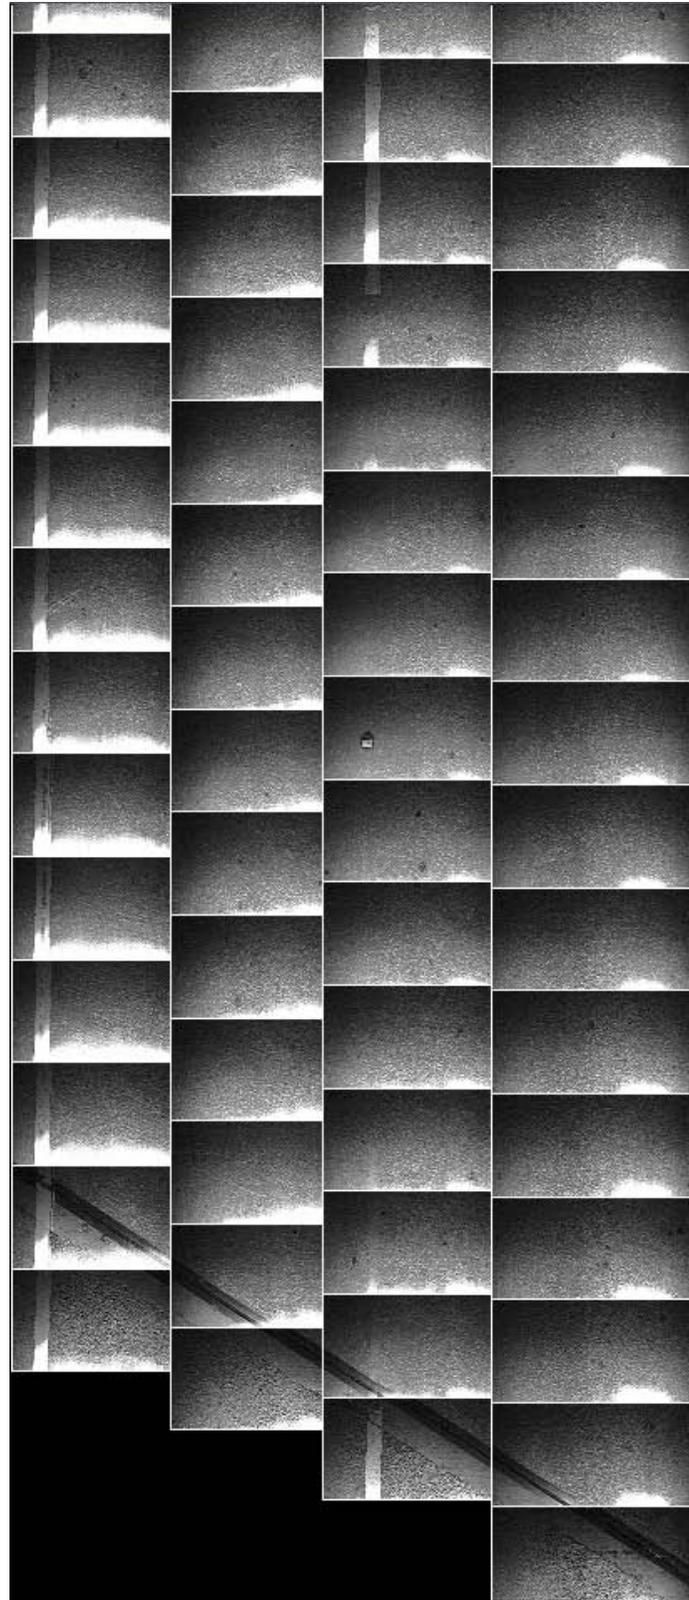
Figure D11 Results on Bridge # 100377 Gibsonton Rd EB over I-75

Fig. D11 shows the results of a section of the bridge at the end of the east bound lanes. Fig. D12 shows a close up view of Fig. D11 where a typical 0.5mm longitudinal crack was identified.
