Durability Performance of Submerged Concrete Structures - Phase 2

Contract No. BDV25 977-12

Final Report to Florida Department of Transportation

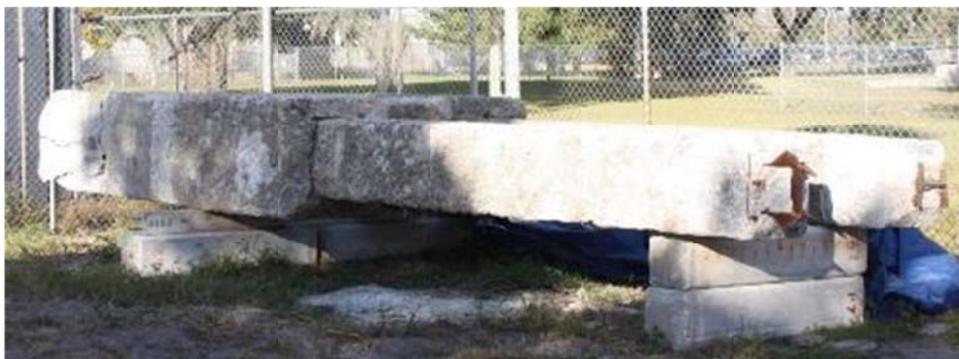
Figure 1. Piles resting side-by-side on horizontal concrete columns. Note jackets on upper area (left) of piles and H-beams visible at each pile bottom end (right).

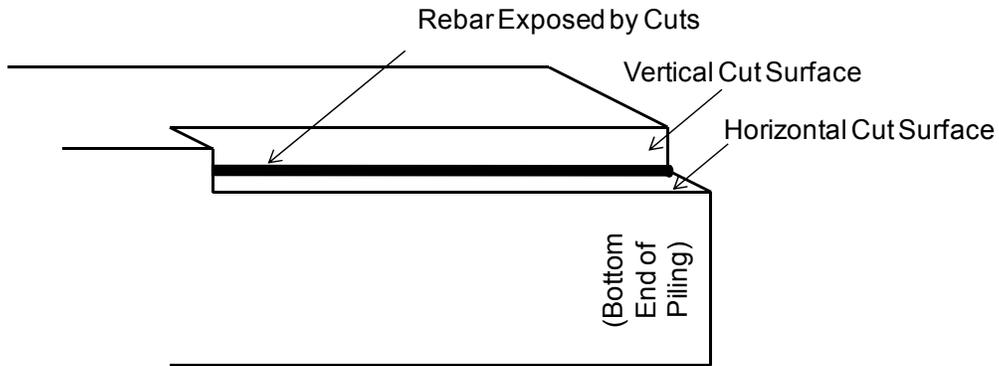
Figure 5. Rebar exposed by 11'-long vertical and horizontal saw cuts (not to scale).

Most of the exposed region of bar 1 was free of visible corrosion but several portions, with a combined surface area that amounted to approximately 19% of the total, showed evidence of corrosion. The approximate locations of corroded regions are shown in Figure 6. The corrosion was sufficient to leave a distinct rust-colored trace on portions of the removed concrete (Figure 7).

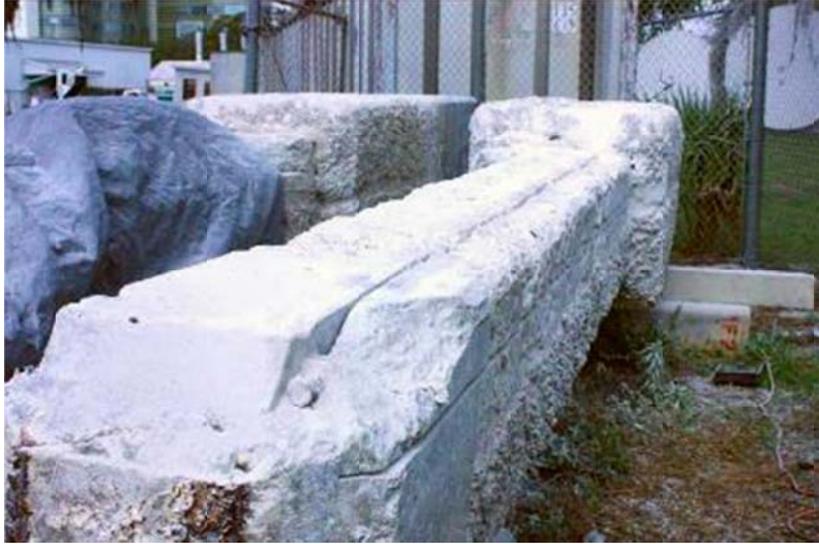
Figure 8. Vertical and horizontal saw cuts in the submerged portion of Pile #2.

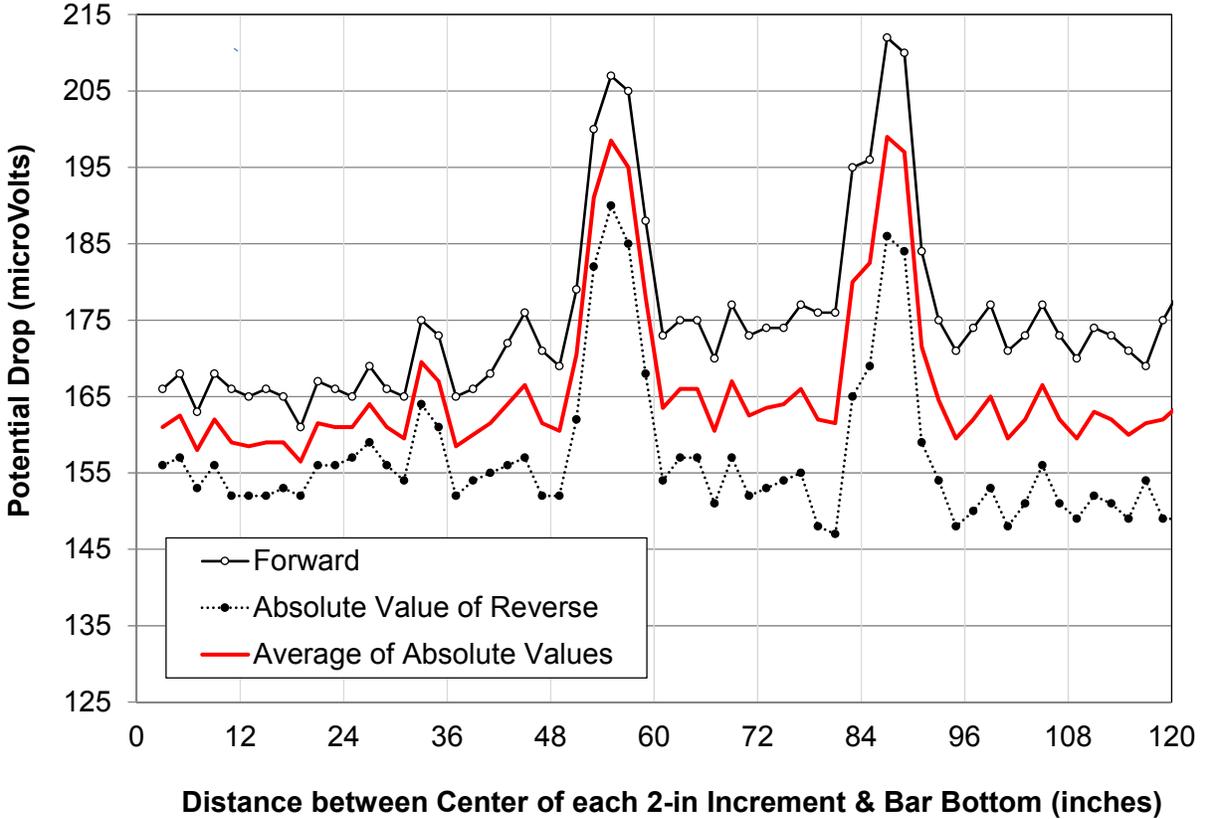
Figure 13. Cross-section loss survey. Voltage Drop at 2-inch intervals along the length of Bar #1 with DC current of 10 amperes.

Per the basic relationships between voltage drop, resistance/conductance, and the cross-sectional area of the bar, it can be shown that the effective radius of the bar is inversely proportional to the square root of the voltage drop over a particular length of bar.

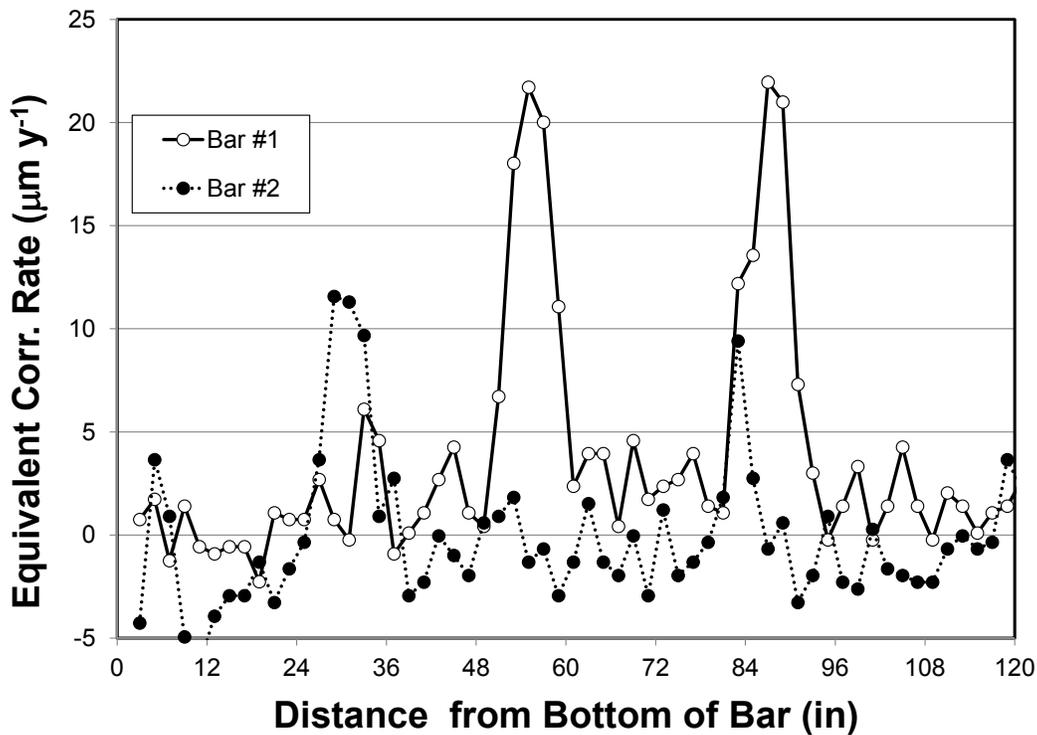
Figure 14. Equivalent corrosion rate as a function of the distance between the vertical midpoint of a 2-inch increment and the bottom of the bar.

Regarding corrosion rate values less than 7 $\mu\text{m}/\text{yr}$ as indicative of baseline conditions, each bar was observed to have approximately 8% of its total observed area undergoing active corrosion. This analysis revealed localized corrosion rates as high as 22 $\mu\text{m}/\text{yr}$ and an average corrosion rate of approximately 16 $\mu\text{m}/\text{yr}$ in the affected areas. These results indicated a corrosion rate on the same order of magnitude as data collected via predictive modeling of a similar system (see Predictive Modeling below).

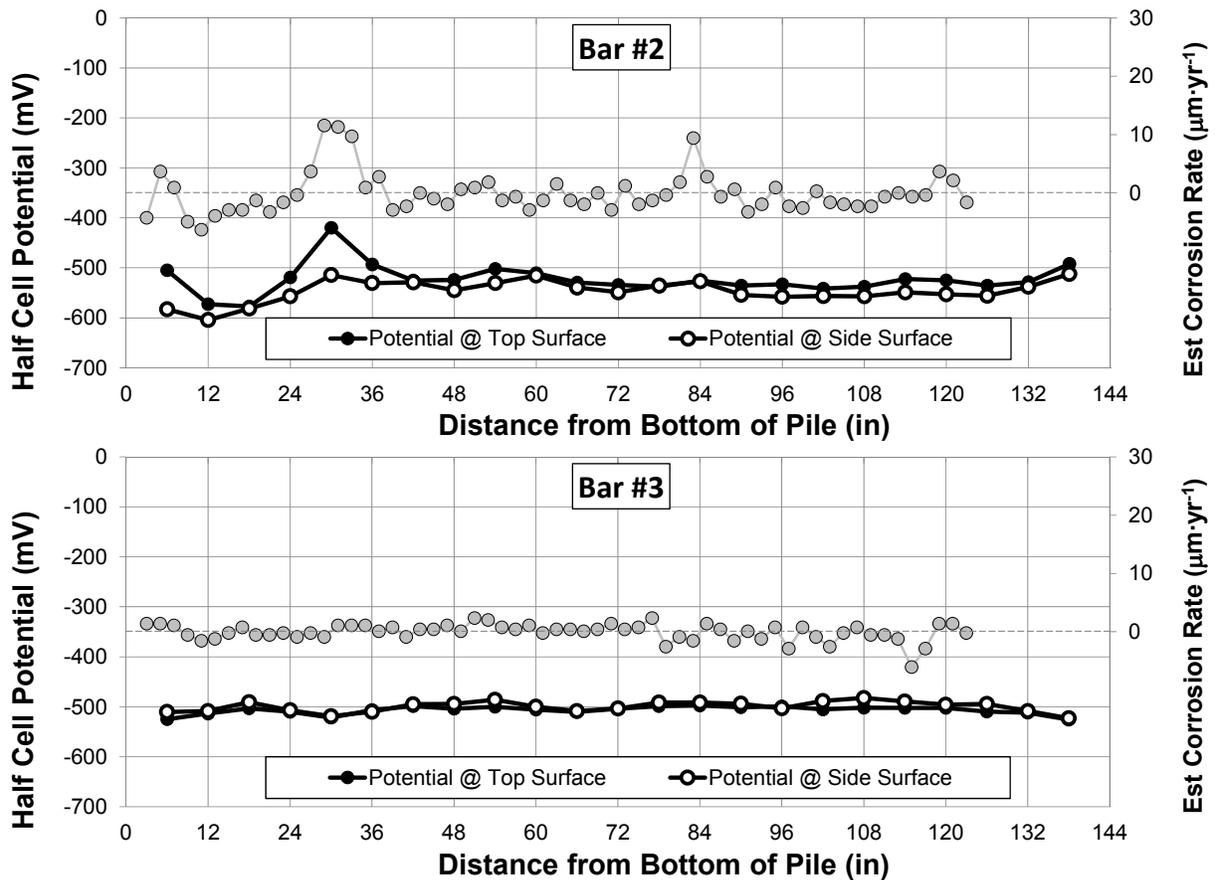
Figure 17 a and b. Half-cell Potential at 6-inch intervals and estimated corrosion rate (average decrease in radius divided by 60 years) at 2-inch intervals along the length of Bar #s 2 and 3 respectively.

As can be seen in the figure, all half-cell potential values were highly negative, consistent with an expectation of active corrosion of the steel. There was some apparent minor correlation between potential variations and the location of the highly corroding spots. However, the correlation is in the opposite of the expected direction (which would have resulted in somewhat more negative potentials in the area of greatest corrosion). The reason for these local discrepancies has not been established. It can be speculated nevertheless that the presence of corrosion products and pH variations in the highly corroded regions may have introduced local junction potentials that acted to result in a small excursions toward less negative values [15]. Notably considering the 6-decade long service, the original dark mill scale, apparently undisturbed, was often visible on the bar surface in regions distant from localized corrosion after removing concrete residues.

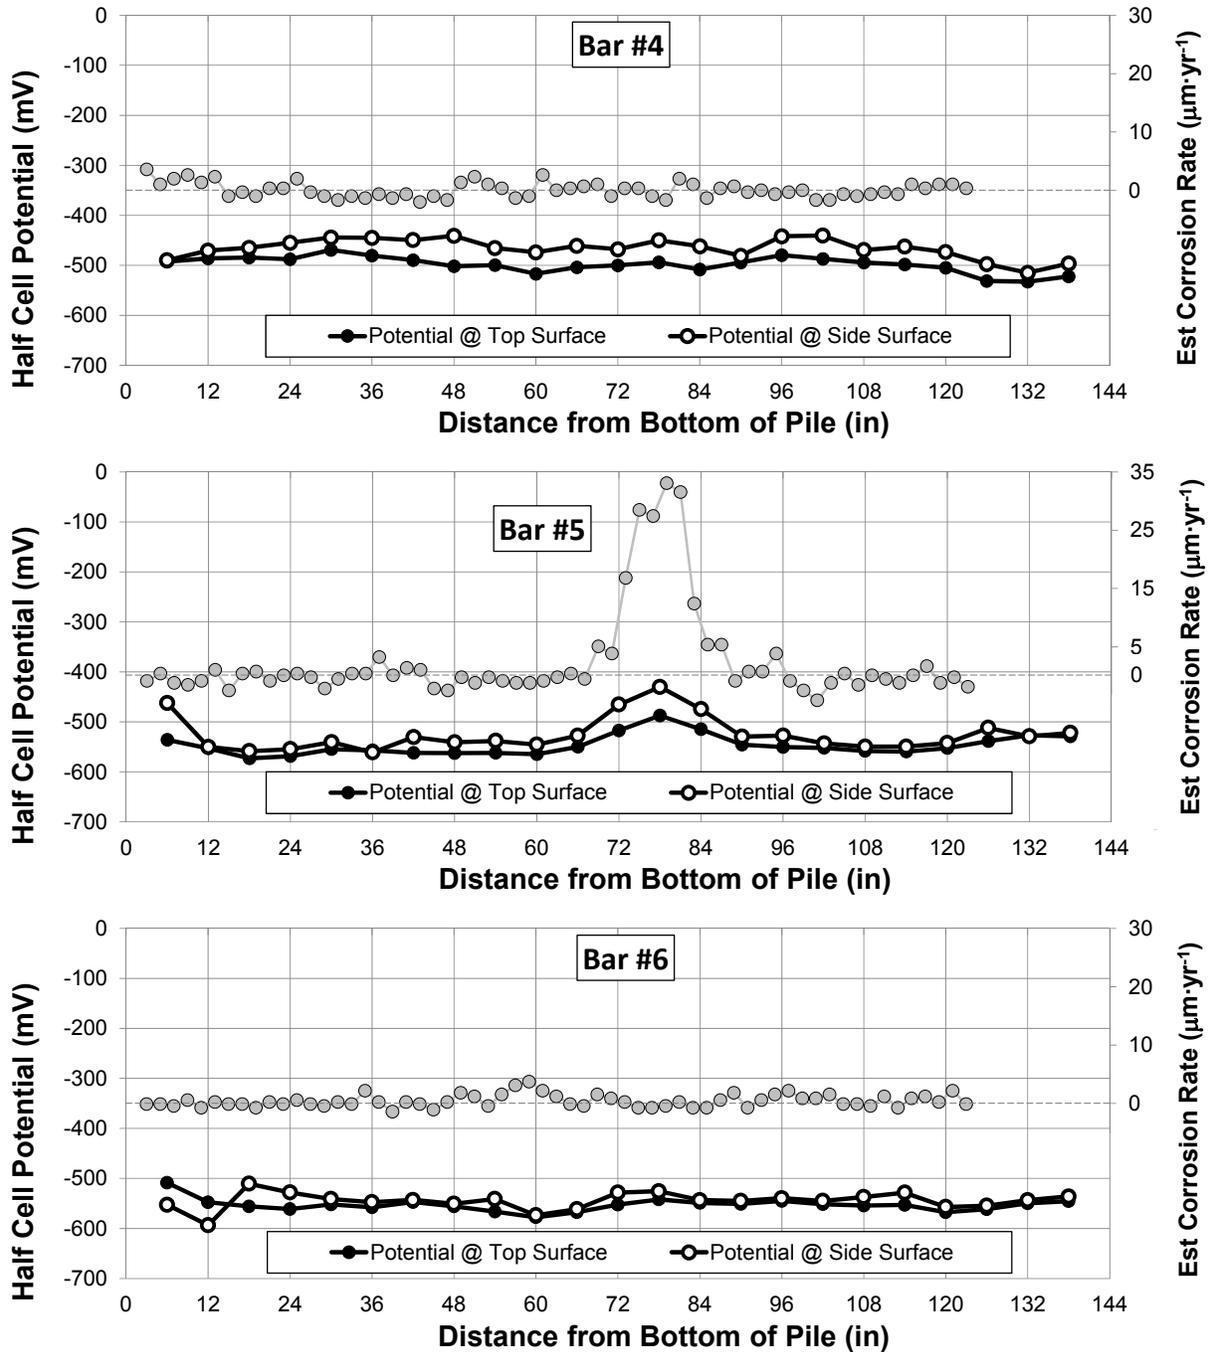
Figure 17 (a, b, c, d, and e) presents the corrosion rate estimated from the resistance measurements (assuming as before a nominal 60-year interval) and the half-cell potential results along the length of each bar. The regions with high estimated corrosion rate for bar #5 corresponded with regions of high visible section loss, as was noted earlier too for the case for bar #s 1 and 2. Bar #5 showed estimated local corrosion rates that reached a peak value of 33 μm/y. Estimated corrosion rates for all the other bars in the second set were low, consistent with their lack of visible appreciable corrosion.

Figure 17 c, d, and e. Half-cell Potential at 6-inch intervals and estimated corrosion rate (average decrease in radius divided by 60 years) at 2-inch intervals along the length of bar #s 4, 5, and 6 respectively. The corroded regions showed the greatest metal loss on the side of the bar closest to the concrete surface, while the inward-facing side (toward the bulk of the concrete) showed little or no corrosion.

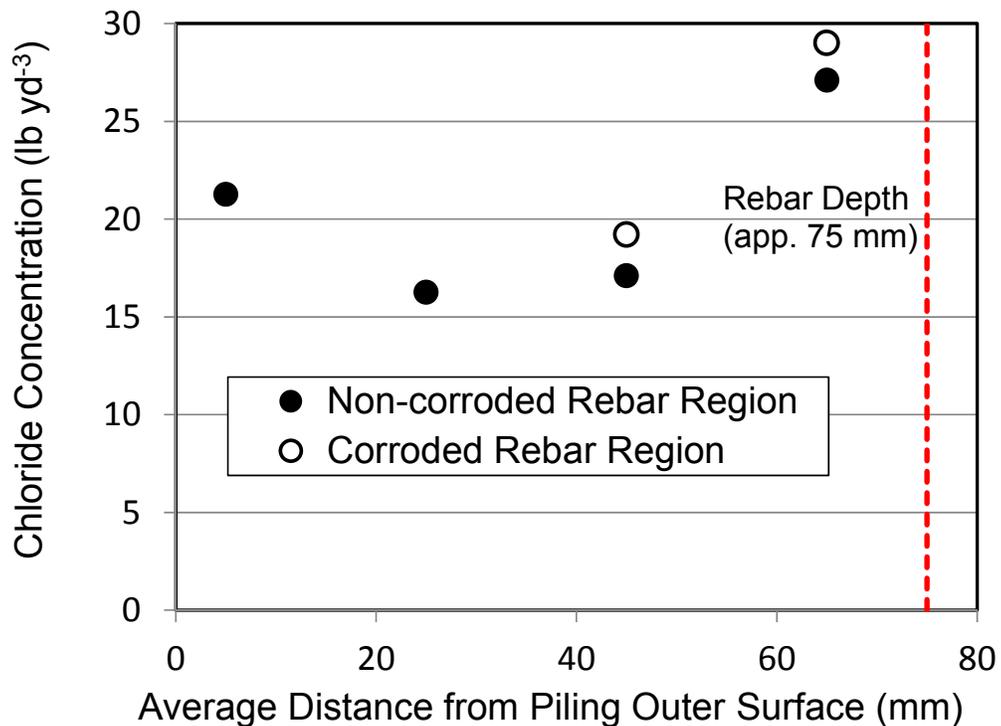
Figure 18. Observed chloride concentrations.

The results indicated that the distribution of chloride did not vary dramatically throughout the concrete cover. This can be attributed to the long seawater exposure duration (approximately 60 years) of the pile. This roughly uniform chloride distribution precluded computation of a concrete apparent diffusion coefficient (D_{Cl}) value. However, it is noted that the value of D_{Cl} must have been significantly greater than the values

These findings are consistent with the expectation that concrete formulations in use several decades ago in applications of this type would have values of D_{Cl} that are one or even two orders greater than those of the modern materials. The higher chloride concentrations observed in Figure 18 for the samples obtained near the rebar could be attributable to transport obstruction effects.

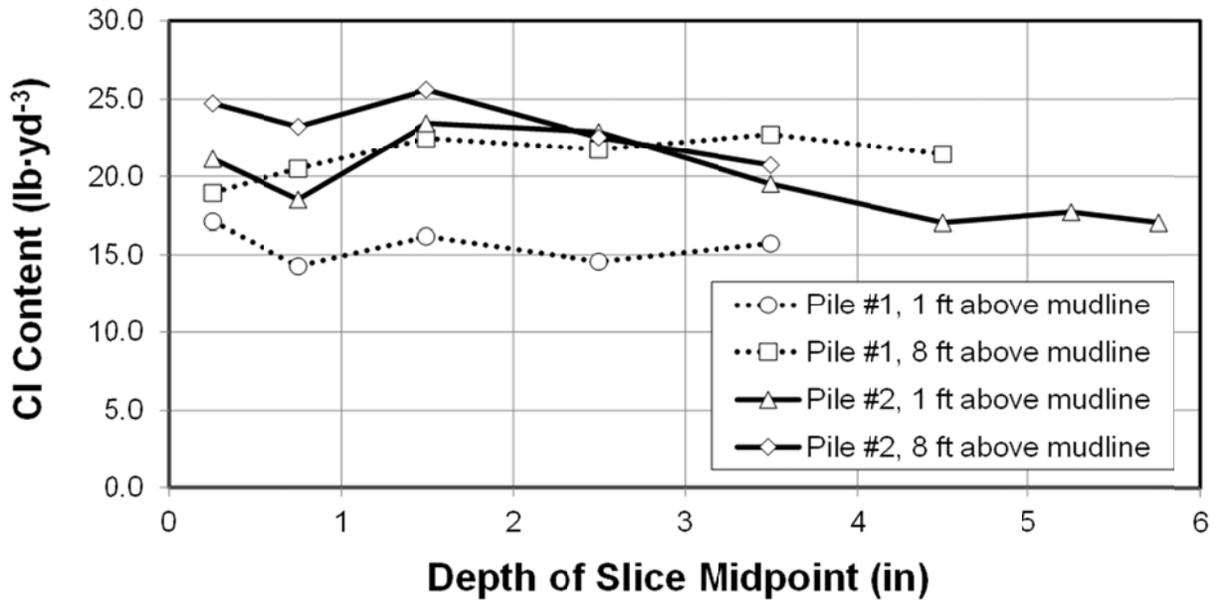
Two concrete cores were removed from each of the two Sunshine Skyway Fishing Pier piles. In each case, one core was taken from a point approximately 1 foot above the mudline and another core was taken from a point approximately 8 feet above the mudline (which corresponds with the midpoint between the mudline and the waterline). Results, presented in Table 2 and Figure 19 indicated that after the 60-year service period the concrete had substantially reached a state of near chloride saturation through the region reaching down to the rebar depth, consistent with the results obtained for the first set of analyses. The concrete chloride content is in the order of that expected when taking into account the concrete porosity, the chloride content of seawater, and a typical amount of chloride binding by the cement paste [17]. The nearly flat concentration profiles are also consistent with those expected from the time of service and the typical chloride ion diffusivity value (in the order of $10^{-7} \text{ cm}^2/\text{sec}$) of concrete that has the low resistivity reported earlier.

Figure 19. Chloride content as a function of depth from concrete surface for cores taken from Sunshine Skyway Fishing Pier piles.

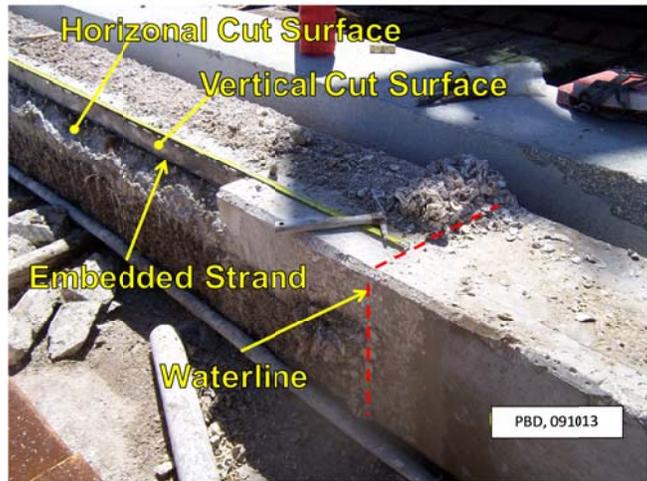
The autopsy involved making two saw cuts, one vertical and one horizontal, near one of the lengthwise corners of the pile as shown in Figure 27. The cuts were initiated at a point approximately two feet below the waterline.

Figure 27. Autopsied pile. Note concrete chunks on deck removed from pile with a hammer and chisel after vertical and horizontal saw cuts were made.

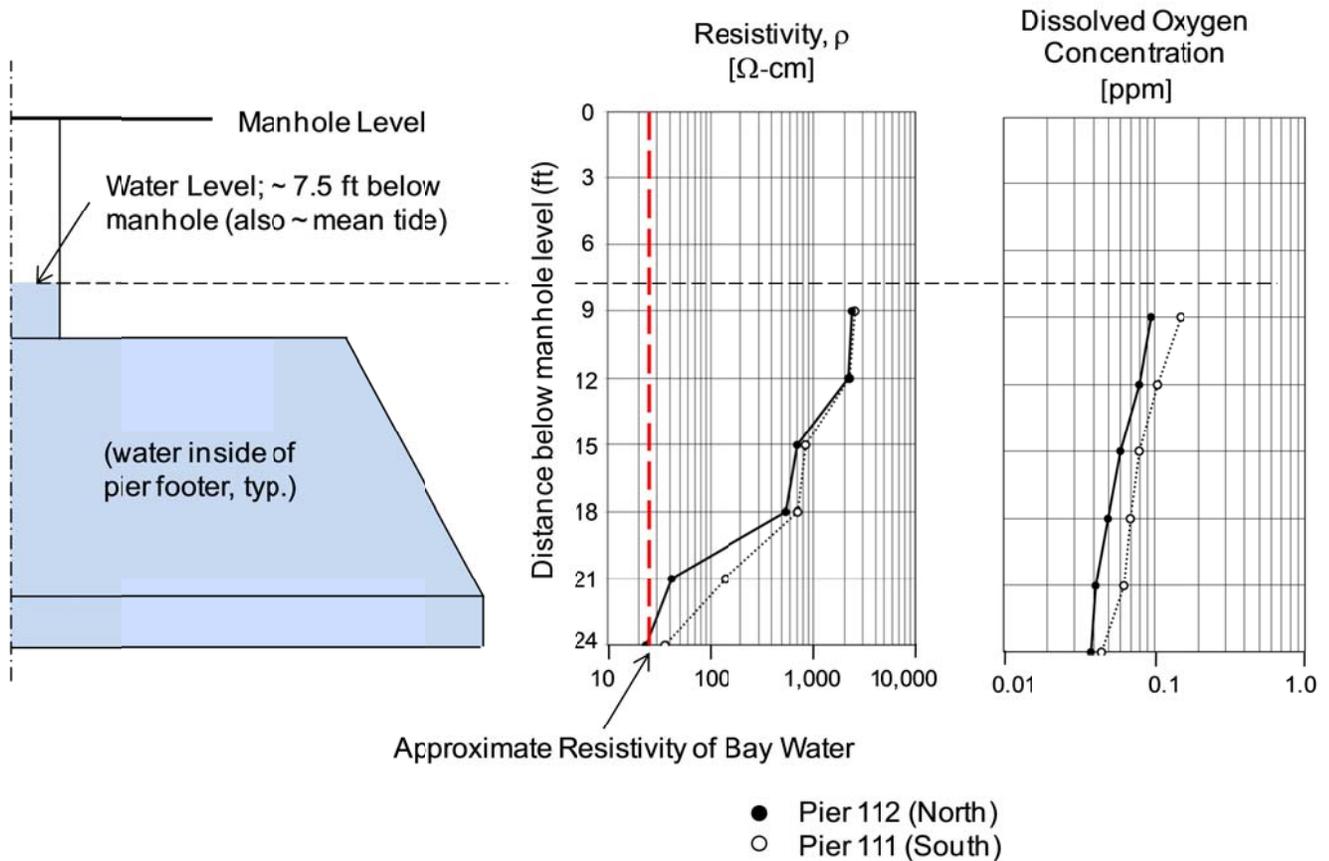
Figure 35. Resistivity and dissolved oxygen profiles; October 12, 2012.

The oxygen values observed on October 12 corresponded with the values observed on October 9 and the resistivity values measured on October 12 reflected an apparent salinity gradient between the free surface of the water and the footer floor. Resistivity values observed at the free surface corresponded with resistivity values typically observed in fresh water while resistivity values observed at each footer floor matched values observed in water in Tampa Bay.

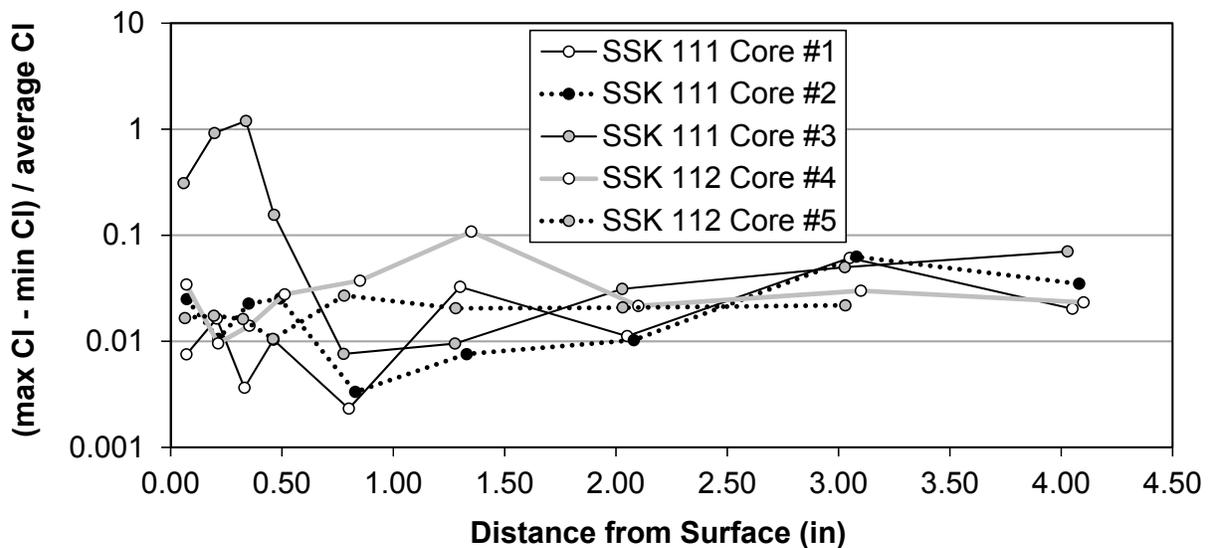
Materials Office. Although the USF analysis of the milled samples of Core # 3 was conducted in accordance with FDOT FM 5-516, there was high inconsistency among the triplicate results, likely due to subsequently discovered improper functioning of the silver/sulfide electrode used in the analysis.

The degree of inconsistency was evaluated by the ratio of the difference between the maximum and minimum observed chloride content to the average chloride content of the triplicate fractions at each depth. Results are shown in Figure 41. The ratio approached or exceeded 1 (indicating a 100% scatter) in two cases for Core #3, while it was about 1/3 or less in all other cases. Consequently, the results from those two cases were declared outliers and not used for profile evaluation.

Figure 41. Ratio of the difference between the maximum and minimum chloride concentration values to the average chloride concentration value.

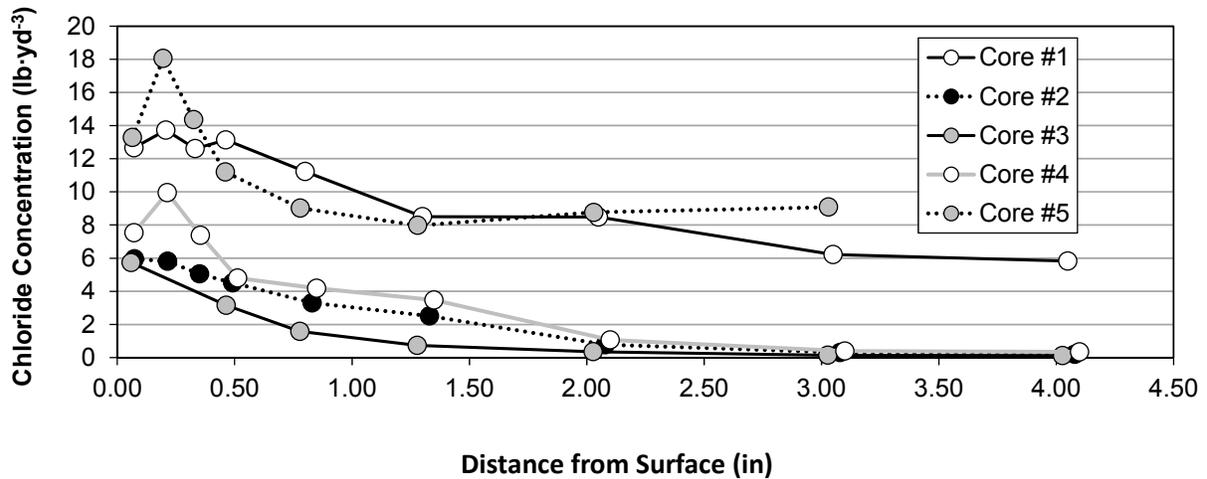
The resulting chloride profiles shown in Figure 42 indicated a decrease with depth as expected. It is noted that the results of the analysis of Core #s 1 and 5 (“on-crack” cores) presented higher low-depth chloride content than the other cores. However, even in those cases, the chloride content was less than $\sim 1/2$ of the values often seen in the splash-evaporation zone (e.g., 30 to 40 lb-yd⁻³), consistent with the expectation of a more moderate surface chloride content in fully submerged concrete.

Figure 42. Chloride concentration as a function of distance from the outer/exposed surface.

Importantly, the on-crack cores showed not only greater surface chloride content than the others but also a much lower relative decrease of concentration with depth; concentrations at a depth of 4 inches for core #s 1 and 5 were approximately half of that at the surface, while for core #s 2, 3, and 4 it was more than 10 times smaller than at the surface. This behavior is typical of enhanced chloride penetration at cracks, which had been documented earlier for splash-evaporation regimes at Sunshine Skyway. This effect is illustrated in Figure 43 comparing the chloride concentration profiles of various pairs of cores. The chloride content is shown in logarithmic scale to better emphasize relative concentration trends.

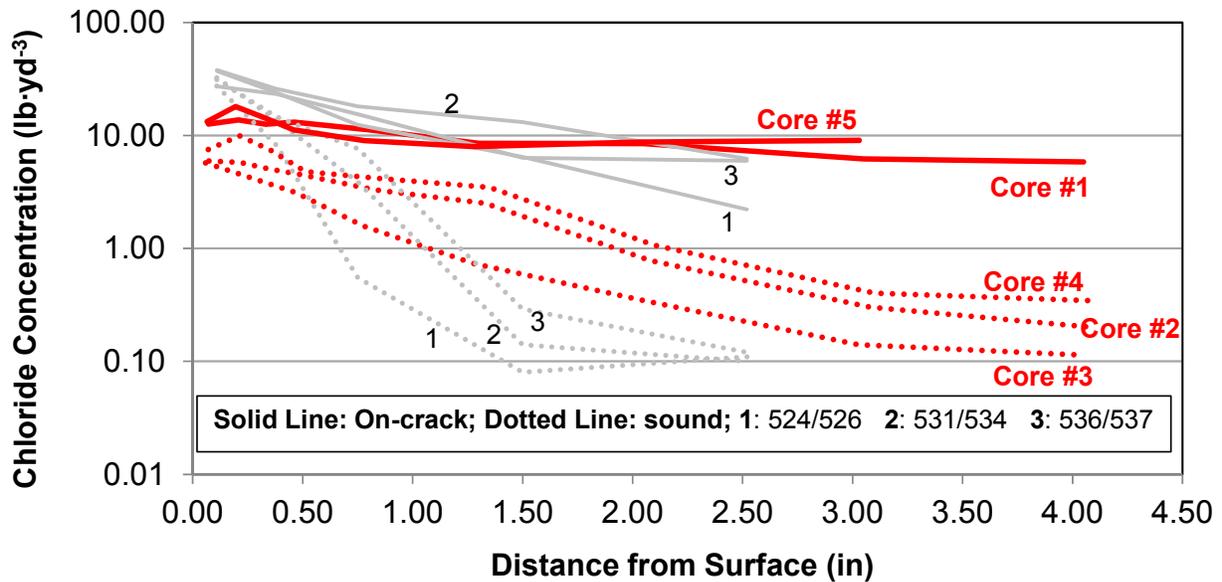
In addition to the data for cores analyzed in this study, pairs of data are shown for cores that were extracted from a cracked region of the structure (“on-crack”) and a companion core for each that was extracted from adjacent un-cracked (“sound”) concrete. Each core in core pairs 1, 2, and 3 was extracted from Sunshine Skyway Bridge in 1997, as documented in Tables 3 and 5 in a previous FDOT report [11].

These observations support evidence of strongly enhanced chloride penetration in the submerged chamber wall of the Sunshine Skyway footers.

Figure 43. Comparison of chloride penetration in cores: on-crack and from sound concrete. Red lines indicate results from the current cores extracted from the chamber wall of Sunshine Skyway pier footers 111 and 112. The data associated with core pairs 1, 2, and 3 (extracted in 1997) and the numbers next to each pair (core designation codes) were taken from Sunshine Skyway splash-evaporation regimes in Sagüés et al. [11], Table 5. The two cores from each pier were taken from locations in close proximity to each other.

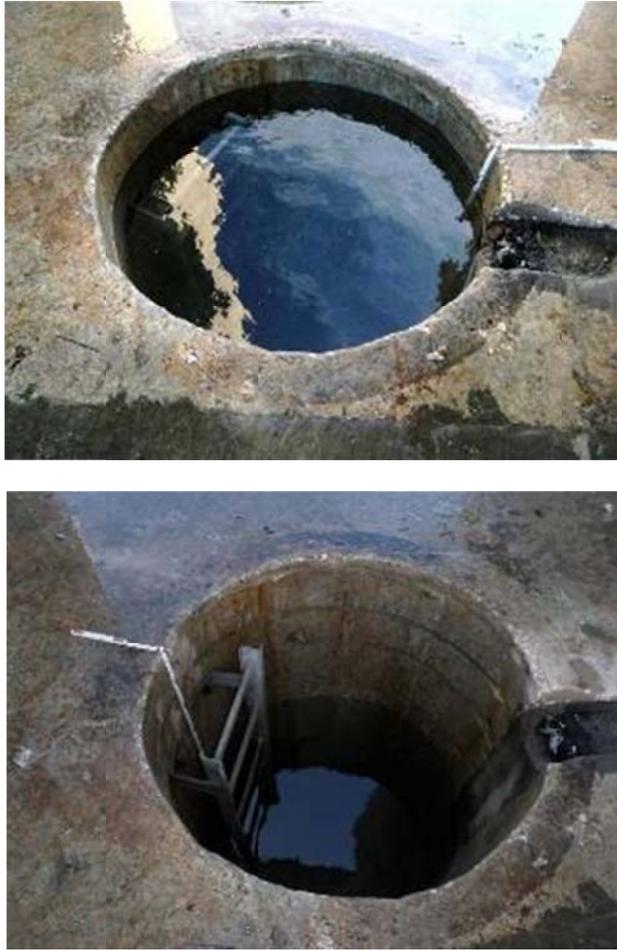
To evaluate the extent to which water can be exchanged between the general pier footer environment and the inside chamber of each pier footer, data was collected during the refilling of the chambers. Each chamber was filled to the top of its manhole opening and the water level was subsequently monitored and recorded at discrete points in time. Figure 44 (top and bottom) shows the water level at two points of observation for Pier 112. Figure 45 shows the water level evolution for both piers, revealing that in each case there is rapid and comparable water leak to the outside upon the action of a water head between the manhole water surface and the surrounding bay water surface. The head was on average ~7 ft during the early part of each test. Considering the manhole dimensions and the pressure head, the corresponding volume per water head-second in each case was determined to be on the order of 2 ft³/ft-hour.

Figure 44. Top: Water level 30 minutes after filling, Pier 112. Bottom: Water level approximately 2 hours after filling, Pier 112.

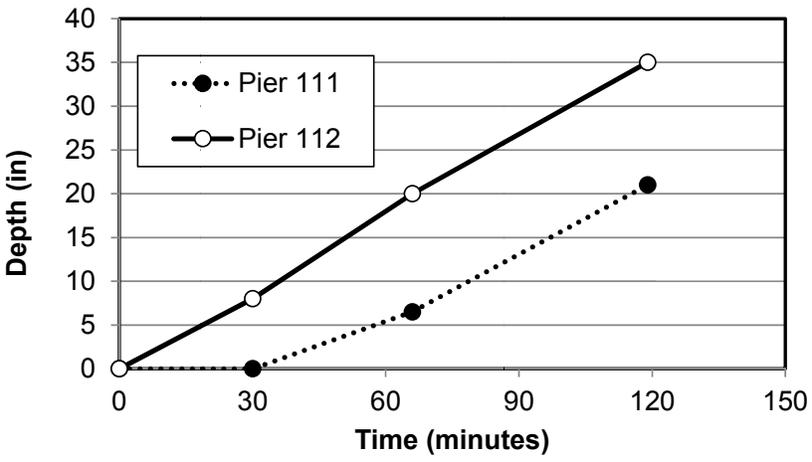
Figure 45. Water depth from manhole opening as a function of time.

Such leak rate is, on first approximation, sufficient to explain the development of substantial fresh water replenishment over a period of several years if rainwater is efficiently channeled to the manhole opening during frequent rain events. It is noted that the manhole cover is not watertight and that a preexisting channel may facilitate ingress. Observation of water flow during rain events is recommended as a means to ascertain whether this mechanism of water dilution is taking place.

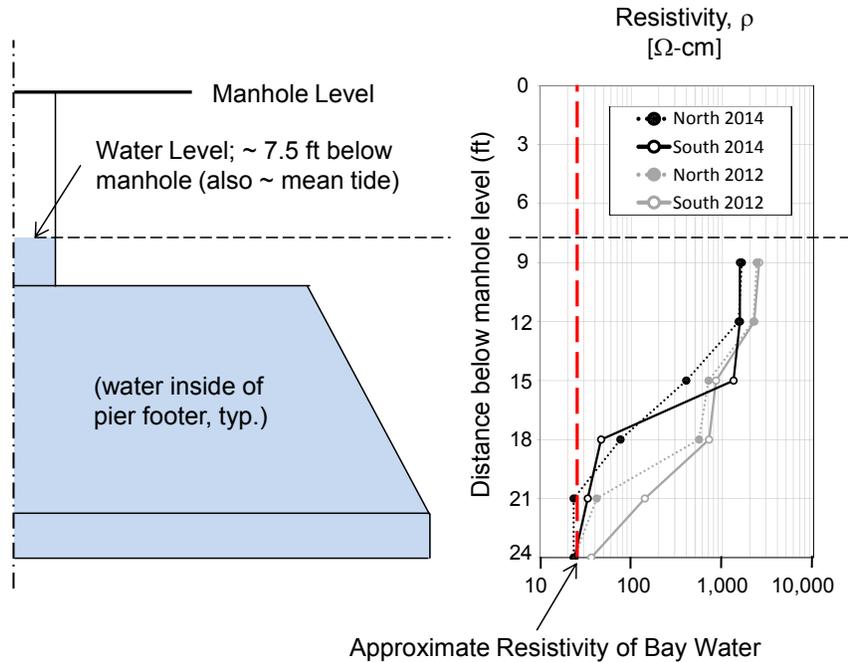
Both surveys (2012 and 2014) revealed general agreement between resistivity profiles in the North and South piers. Both surveys also revealed relatively high resistivity values of approximately 2,000 Ω -cm near the surface (i.e., water/atmosphere interface) of each footer (indicative of low-salinity as would be found in freshwater) and much lower values of approximately 25 Ω -cm (roughly equivalent to those typically observed in Tampa Bay) in the water near the floor of each footer. The results indicate however a notable change in the depth at which the transition from high to low resistivity values took place. As shown in Figure 46, the transition observed in 2014 appears to be approximately three feet higher (i.e., closer to the surface) than that in the 2012 survey.

In 2012 it was suggested that the existence of a resistivity gradient could be explained by the apparent introduction of rainwater (essentially high-resistivity freshwater) into the pier footers incrementally in time and the subsequent incomplete mixing with the seawater already contained in the footers. In light of this explanation, the difference between 2012 and 2014 might be attributable to the difference in duration of the freshwater infiltration period. The 2012 survey had taken place four years after removal/refilling with water drawn from the bay (2008) whereas the 2014 survey took place only two years after the most recent refilling. When compared with previous results, the results from the 2014 study suggest that the transition depth might increase with time and would further suggest that a profile made in 2016 will be more similar to that of 2012.

Figure 46. Resistivity of pier footer water; November 7, 2014
