## Repair Of Impact Damaged Utility Poles With Fiber Reinforced Polymers (FRP), Phase II

### University of Central Florida

**FINAL REPORT**

*June 2015*

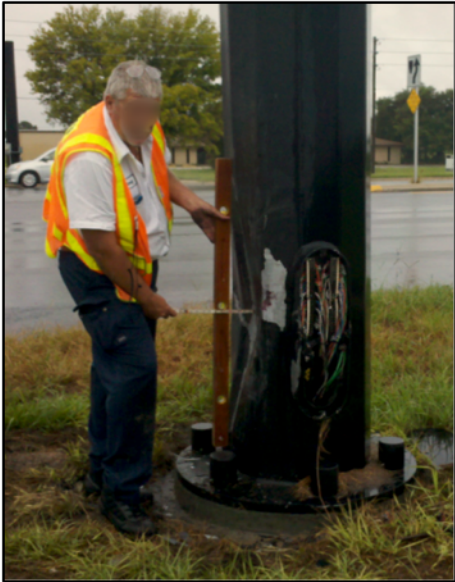
Figure 1. Impact-damaged utility pole

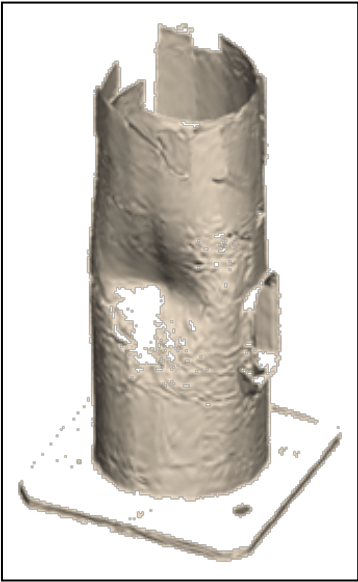
Figure 2. Damaged steel mast arm, 3D scan

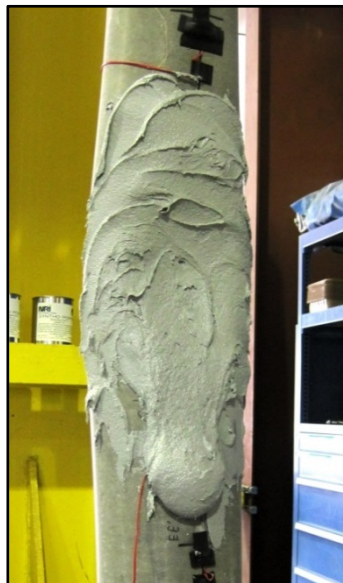
The Syntho-Poxy HC was evaluated first. Approximately one quart of the material was mixed by hand, according to manufacturer instructions, and was applied to a dented pole with small trowels. Initially, the epoxy was applied easily, without significant slumping. However, within approximately 10 minutes from mixing, the epoxy seized and became un-workable, and quickly gained a plastic consistency. Therefore, filling of the dent was not completed, as can be seen in Figure 10 and Figure 11.

**Figure 10. Pilgrim epoxy gel batch 1**

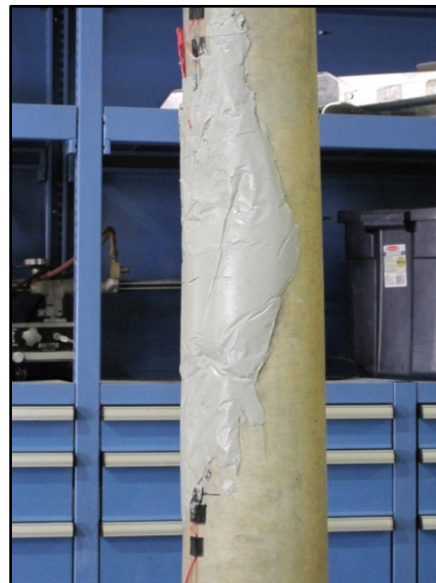
Two dented poles were filled with the Pilgrim EM 5-2 Gel. The manufacturer specifies that up to 3 parts oven-dried aggregate to 1 part epoxy can be added. The first dent fill contained 1 part dry sand to 6 parts mixed epoxy, and the second 1 part dry sand to 3 parts mixed epoxy. The thixotropic gel was combined using a mixing drill. The first, lower sand content mix was applied to the dented pole easily, with minimal signs of slumping during application. However, when the fill was left to cure, the majority of the epoxy slid out of the dent, as shown in Figure 10. The second, higher sand content mix was applied to another dented pole, and was significantly stiffer than the first batch. To create a smooth, even surface on the fill, the pole was wrapped in wax paper during curing. The result, pictured in Figure 11, was an effective, even fill which blended well with the pole's surface.

**Figure 11. Pilgrim epoxy gel batch 2**

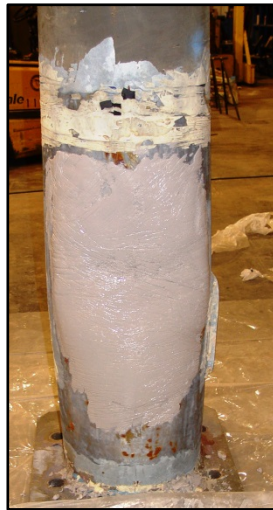
Two poles were also filled with the Sikadur 31, Hi Mod Gel. The large size of the dent in one of these poles increased the difficulty of applying a complete fill without epoxy slumping. The fill was mixed with a drill mixer, according to manufacturer specifications. The workability of the mix was good, and there was no problem with slumping of the fill material. When the fill material had cured, the surfaces were sanded smooth. The resulting fills can be seen in Figure 12 and Figure 13.

Figure 12. Sikadur 31 dent fill 1

The result of this filler evaluation was that the Pilgrim EM 5-2 Gel with a 1:3 sand additive and the Sikadur 31, Hi Mod Gel are acceptable options for inclusion in the FRP repair system. The workability Sikadur epoxy makes this material more favorable than then EM 5-2 Gel. Therefore, the Sikadur 31 Hi Mod Gel was chosen for inclusion in the repair system.

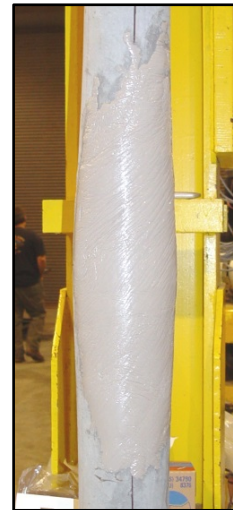
Figure 13. Sikadur 31 dent fill 2

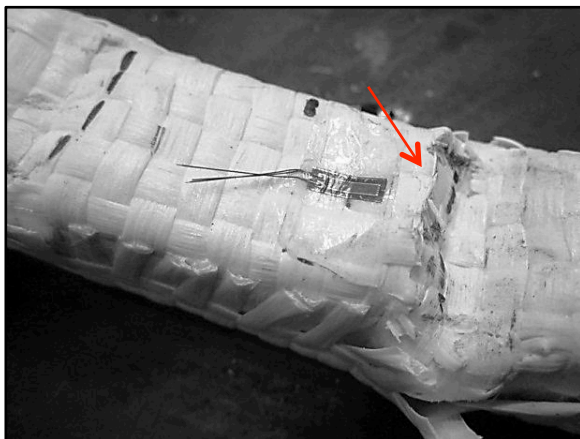
Inducing true compressive failure proved to be difficult. Often the failure occurred when the aluminum substrate hinged beneath the FRP, inducing debonding, and ultimately, folding of the compressive fibers. This form of failure can be seen in Figure 20, Figure 21 and Figure 22. Additionally, both high-density BFRP tests involving XT polyurethane resin failed when the aluminum substrate ruptured beneath the tension FRP, causing the tensile FRP to also rupture (see Figure 23). For this reason, the ultimate failure values shown should be taken as a lower limit, and not necessarily as the compressive failure capacity.

**Figure 20. GFRP filament folding failure**

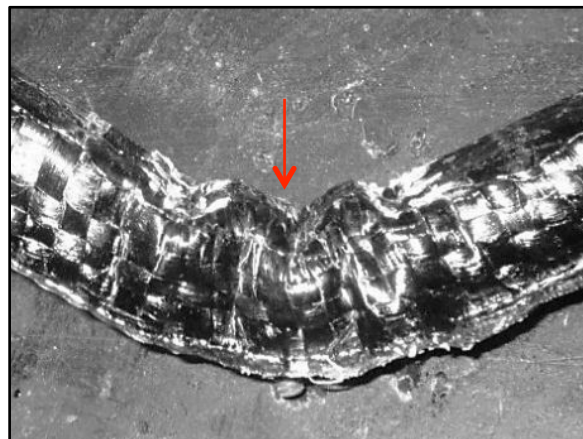
**Figure 21. BFRP wrinkling failure**

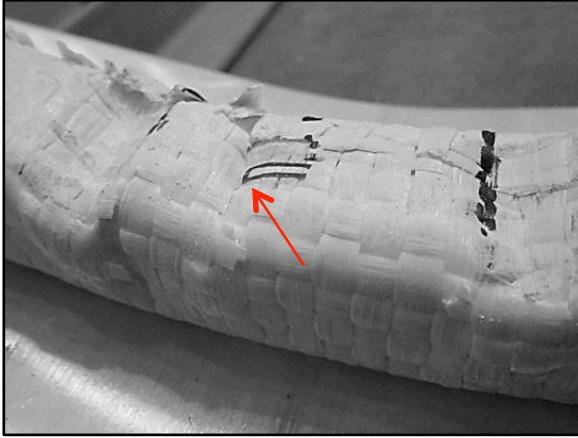
Figure 22. GFRP wrinkling failure

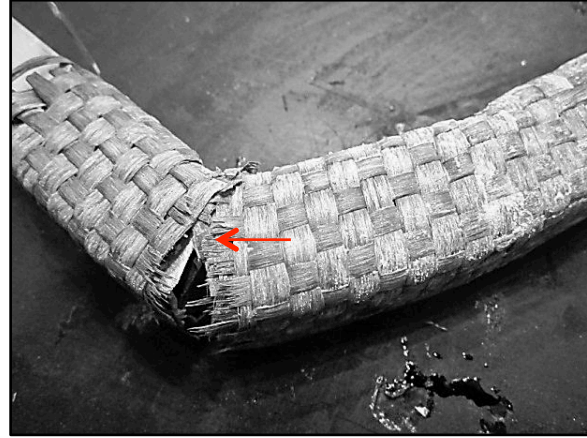
Figure 23. Substrate and FRP rupture

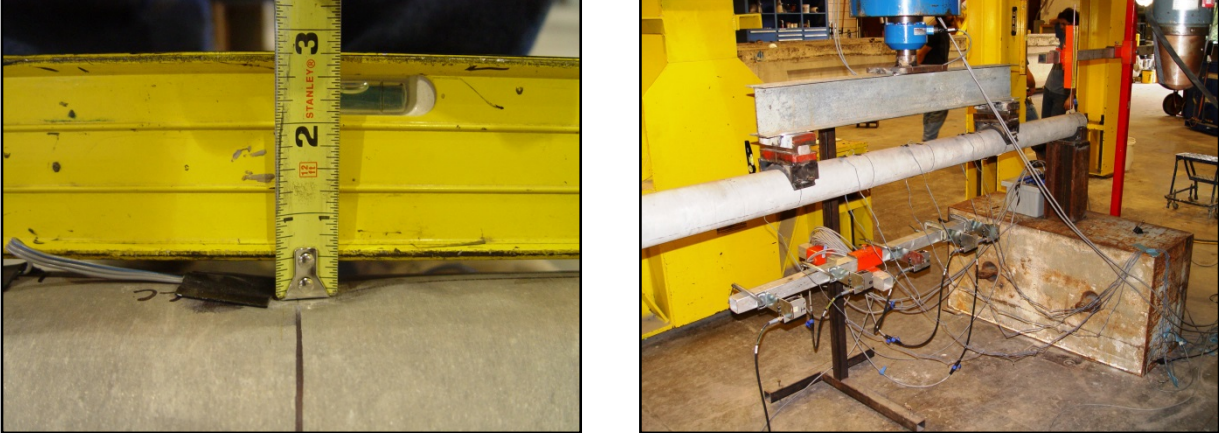
Figure 52. ALu-1.a laboratory-applied dent and test configuration

The first dented poles to be tested were cut from pole ALu-1. The narrower end of this pole, ALu-1.a, received a dent with a depth of approximately 5% of the outer diameter at the dent location, or 0.25 in (see Figure 52). The pole section tapers from an outer diameter of approximately 5.75 in to 4.5 in on the support span. At the dent location, the outer diameter is approximately 5.0 in. The test setup is shown in Figure 52, and was prepared in accordance with

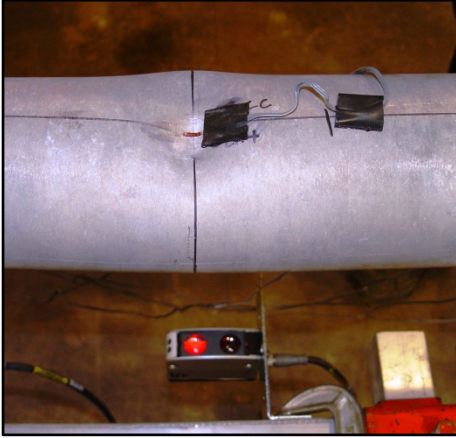
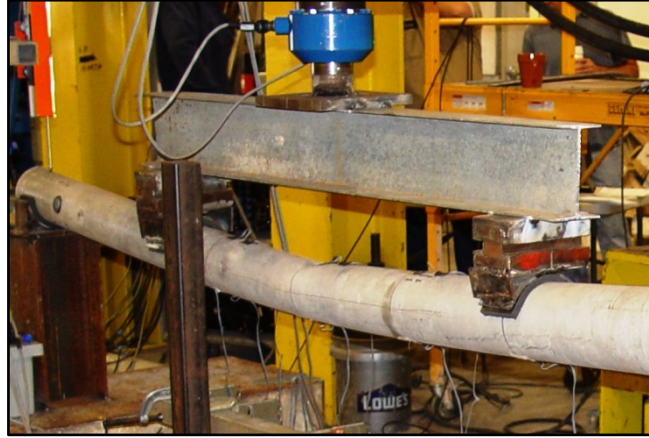
Figure 54. ALu-1.a plastic hinge failure at dent center

When tested, pole ALu-1.a carried a maximum load of approximately 7.62 kips. Measured strain and displacement data are shown in Figure 53. Plastic hinging occurred at the center of the applied dent as can be seen in Figure 54. The maximum moment at the location of the hinge was calculated from the maximum load as 10.0 kip·ft. From the strain curves, it can be seen that gauges S4 and S5, which are located on the top and bottom of the dented section, respectively, show fast-growing strains after the peak load has been achieved. This indicates that the section at the dent is deforming plastically. The tensile and compressive strains experienced at the dent center at the time of maximum loading were measured as 6080  $\mu\epsilon$  and -3972  $\mu\epsilon$ , respectively.

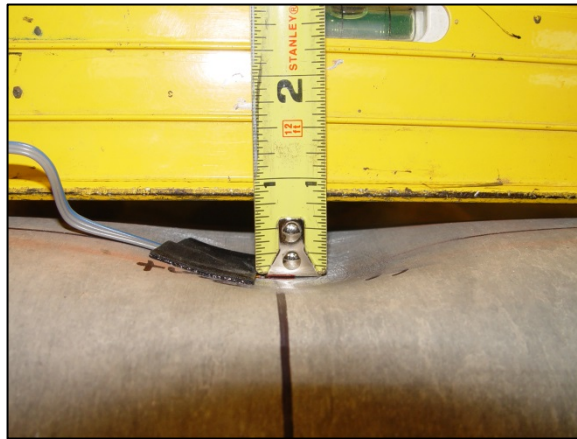
Figure 55. ALu-1.b laboratory-applied dent

The ALu-1.b pole section was taken from the middle section of pole ALu-1. This section, and all other aluminum *b* pole sections, has an outer diameter ranging from 6.6 in to 5.4 in across the support span. The outer diameter at the location of the applied dent is approximately 5.77 in, and the dent depth is 0.75 in, or about 13% of the outer diameter (Figure 55). The load, support, strain gauge, and displacement gauge configuration is the same as that of the previous tests.

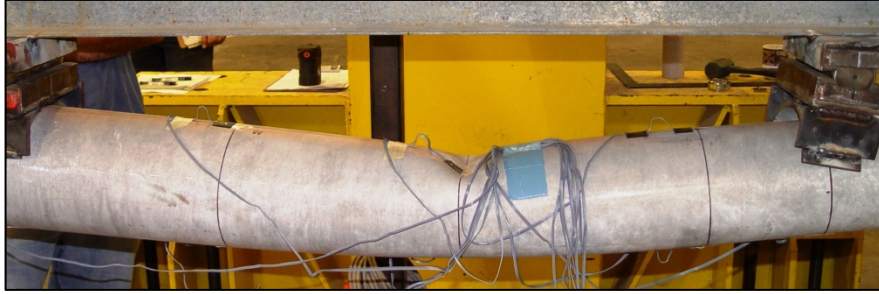
Figure 56. ALu-1.b plastic hinging failure

The data collected from pole ALu-1.b is shown in Figure 57. The maximum load experienced by this pole was about 12.34 kips, at which point a plastic hinge formed at the dent location, as shown in Figure 56. This failure corresponds to a maximum moment of 16.2 kip-ft at the location of failure. The maximum load induced a tensile strain at the dent section of  $5414 \mu\epsilon$ , and a compressive strain of  $-9928 \mu\epsilon$  at this location.

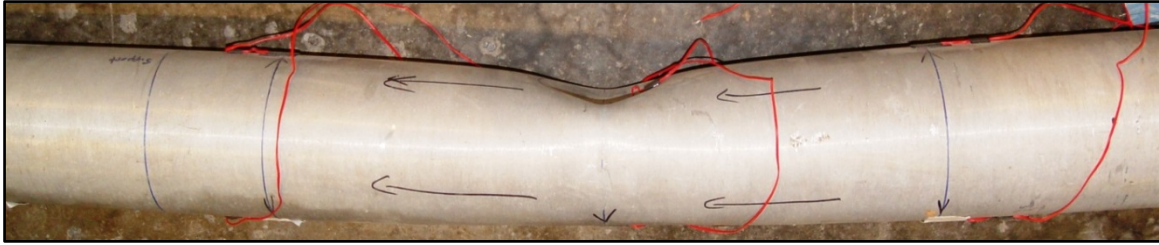
Figure 58. ALu-2.b plastic hinging failure

Section ALu-2.b has the same geometry as section ALu-1.b, but was dented to approximately twice the depth. The 1.5 in dent has a depth of about 26% of the pole's undented diameter at that location. The maximum load carried by this pole was approximately 8.12 kip, which created a moment of 10.7 kip-ft at the dent center. The corresponding strains at the dent section were 4222  $\mu\epsilon$  in tension, and -10458  $\mu\epsilon$  in compression. This large compressive strain indicates that the dented area deformed significantly during loading, and that the behavior of the section was greatly affected by the presence of the dent. This is confirmed by the moment capacity measured for this pole, which is significantly reduced from the control capacity, indicating that the strength of the section is largely reduced by denting. The final plastic hinging mechanism that formed in the pole is shown in Figure 58. The load, displacement, and strain data obtained during this test are shown in Figure 59.

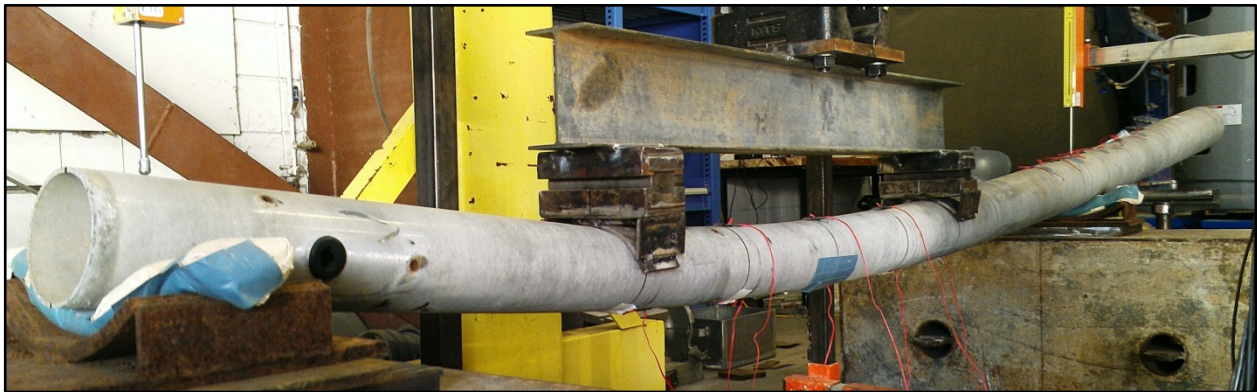
Figure 60. ALu-4.a test configuration during loading

Pole ALu-4.a was tested as a control, that is, without being dented. The pole section was cut from the narrowest (or *a*) end of a 27-foot aluminum pole, and has the same geometry as section ALu-1.a. The test setup is shown in Figure 60. Load was applied to the pole section, and the strains and displacements are shown in Figure 62. The pole achieved a maximum load of approximately 8.43 kips before undergoing local buckling of the section at the outside edge of the south load applicator, as shown in Figure 61.

It is likely that the load applicator initiated failure by creating a small dip in the pole surface. The maximum moment at the location of the hinge were 12.3 kip-ft. The maximum strain and deflection on the bottom of the section at the center of loading were measured as 7539  $\mu\epsilon$  and 4.17 in, respectively, both measured on the underside of the section at the center of loading. The tensile and compressive strain values when maximum load was achieved were 7395  $\mu\epsilon$  and -2627  $\mu\epsilon$ , respectively. If the local buckling had not occurred under the load applicator, it is likely that the section at the center of loading would have withstood its theoretical maximum capacity, which is calculated from the theoretical plastic moment. This theoretical capacity has a value of 10.12 kips, and is approximately 1.2 times the load actually held by the pole.

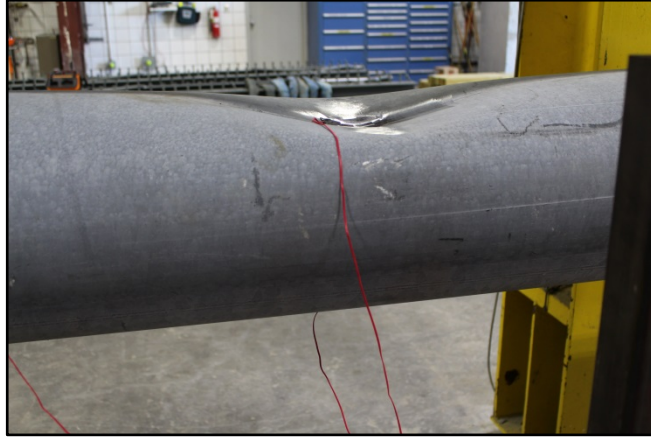
Figure 64. STu-1.a pole with dented region shown in test setup

The first of the steel Damage Determination specimens, STu-1.a, was a round pole ranging in diameter from 13.375 in to 11.75 in. The 3 in dent was 24.2% of the 12.4 in diameter at that location, as shown in Figure 64. The test setup was prepared in accordance with the diagram in Figure 63. Circular steel plates were welded to the ends of the pole section in order to limit local deformations at the supports.

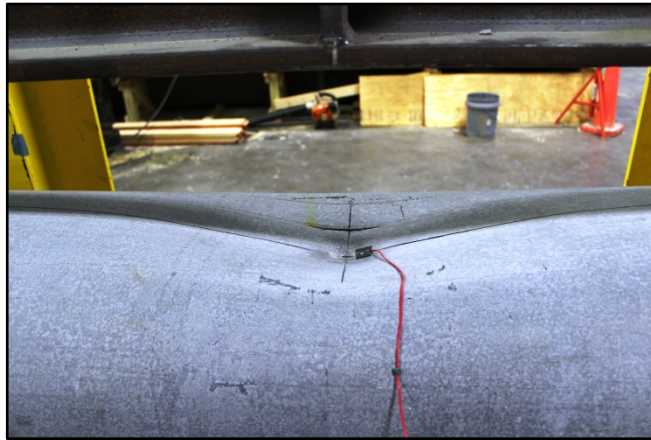
Figure 66. STu-1.b dent before testing

STu-1.b had a dent of 3.125 in. The diameter of the pole is 13.5 in at the smaller end and 15.25 in at the larger end. The diameter at the location of the dent was 14.2 in, making the dent depth 22% of the outer diameter. During the denting of this pole, a crack formed in the dented region, as shown in Figure 66. As with pole STu-1.a, circular end caps were welded to the section ends.

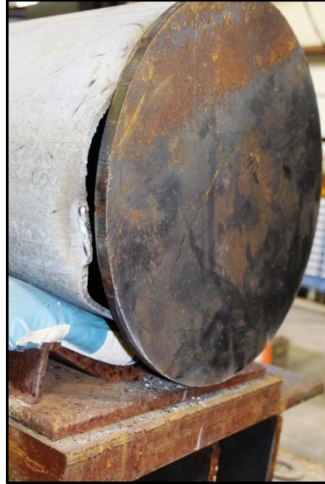
Figure 68. STu-1.b end weld failure

The maximum load carried by STu-1.b was 61.0 kips, which corresponds to a moment at the dent center of 86.0 kip-ft. This load is approximately 47% of the theoretical undented capacity. However, at this load the welds connecting the southern end cap to the pole failed, and the pole section at the south support collapsed (see Figure 68). Loading was stopped before full yielding had occurred at the dent location. However, based on the test data shown in Figure 67, the strain values at S4 and S5 indicate that the dent section was close to yield. The maximum tensile and compressive strains were measured as 1497  $\mu\epsilon$  at S5 and -1420  $\mu\epsilon$  at S6, respectively. The maximum displacement was measured with D7 at the south support to be 1.098 in.

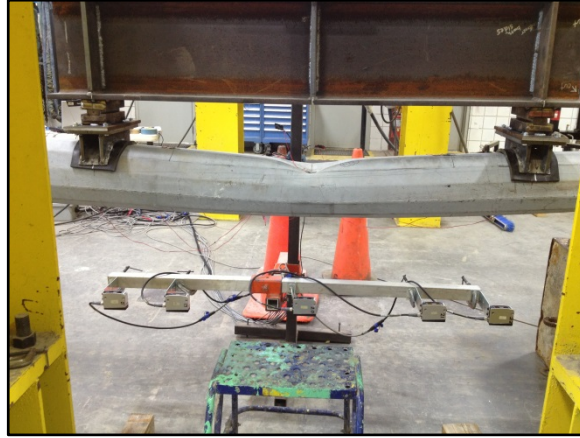
Figure 76. STu-1.e failed section

The maximum displacement of this pole was 3.64 in, and occurred at the dent section. The extreme strain data, as can be seen in Figure 75 (a), were  $-12954 \mu\epsilon$  in compression, and  $3885 \mu\epsilon$  in tension. The compression strain was more than three times greater in magnitude than the tensile strain. This indicates that the dented region underwent large local deformations before the tension face yielded. The final failure mode is shown in Figure 76.

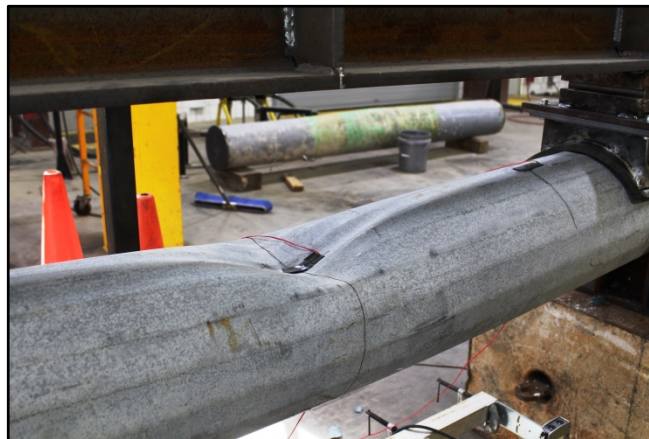
Figure 79. STu-1.f failed pole section

The maximum displacement induced in this pole was measured at D4 to be 1.91 in. The extreme compressive strain of  $-7278 \mu\epsilon$  occurred at gauge S4, within the dent. The gauge S5 failed and produced no data for this test. The failure mode of this pole was plastic hinging at the section of the deepest dent depth, as is shown in Figure 79.

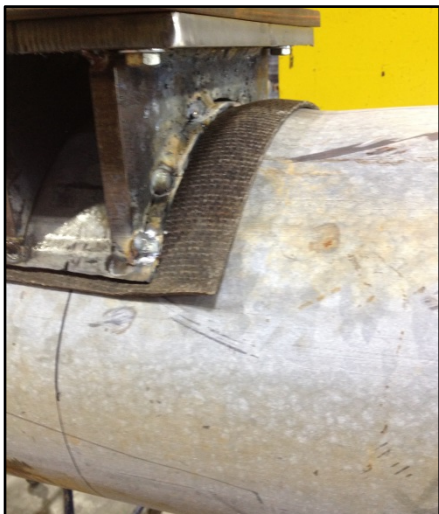
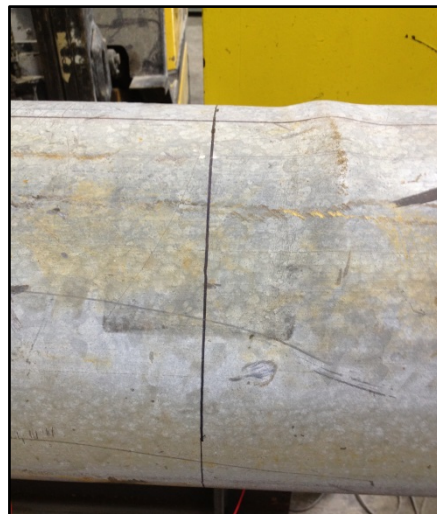
Figure 82. STu-2.a failure

Two undented control pole sections, STu-2.a and STu-2.b were tested in addition to the dented poles discussed above. Pole STu-2.a is a round pole with a diameter of 10.83 in at the center of loading, or the location that a dent would have been applied. The test setup is shown in Figure 80. The pole held a peak load of 56.2 kips. The carried load is approximately 75% of the theoretical bending capacity. The reason for the lower capacity is that the pole failed in local buckling at the northern load application point, as is shown in Figure 82. The loading data is shown in Figure 81. The maximum displacement in this pole was measured as 1.31 in at gauge D4. The extreme strains were 4596  $\mu\epsilon$  in tension at the gauge S5 at the center of loading, and -2062  $\mu\epsilon$  in compression at gauge S2 located just south of the northern load point. The data taken from gauge S5 shows a sudden increase in strain at approximately 45 kips. This indicates a localized yielding of the steel at tension face center of loading.

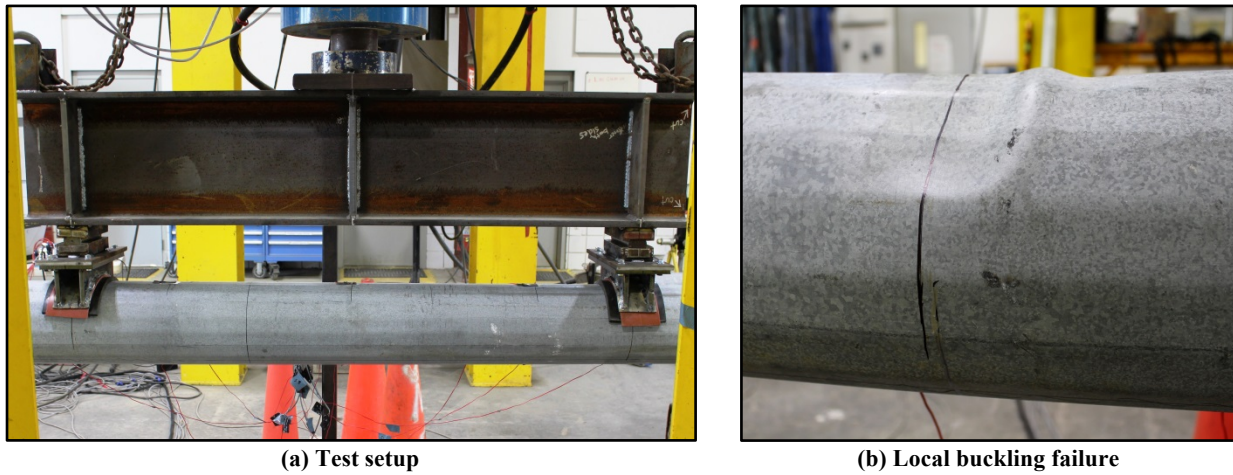
Figure 83. STu-2.b testing and failure

The second undented pole to be tested was an 18-sided pole with a diameter of 8.71 in at the center of loading. The load carried by this pole was measured as 56.2 kips, or 79.2 kip-ft at the failure location. The test data for this test are shown in Figure 83. Again, this specimen failed in local buckling at the northern load application point at about 60% of the theoretical capacity. The failed specimen is shown in Figure 84. The extreme strains and displacement occurred at the section just south of the northern load point. These measurements, from gauges S2, S3, and D3, are  $-2345 \mu\epsilon$ ,  $4283 \mu\epsilon$ , and 2.06 in, respectively.

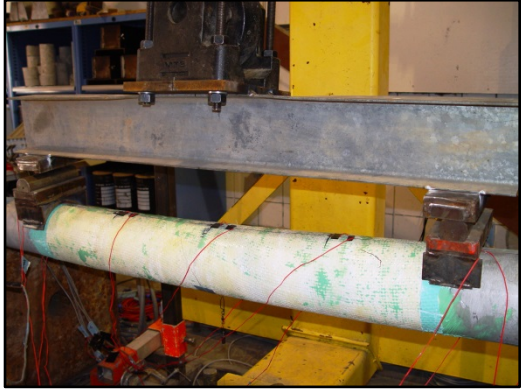
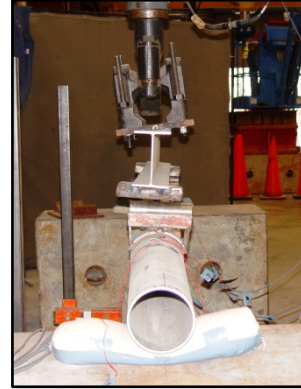
Figure 88. ALw-4.b initial loading

The first attempt to test pole section ALw-4.b had to be aborted because the I-beam used to distribute the load from the MTS actuator to the two loading points experienced flange buckling under the applied load (see Figure 88). The pole was unloaded from a load of 15.1 kips, leaving a residual mid-span deflection of approximately 0.8 in. A new spreader beam was used to continue loading the pole to 17.7 kips (Figure 90). This load is approximately 188% of the theoretical capacity of an undented, unwrapped pole of the same geometry. This increase in capacity is quite extreme. It is possible that the thickness of the pole walls is inhomogeneous, and that the yielded section of the pole has a greater thickness than that measured at the ends of the pole segment. Variations in pole thickness have been noted in other poles, and this could account for the large measured capacity of this pole. As is shown in Figure 91, the residual strain and displacement from test 1 were added to the displacements measured in test 2. The strain values are taken from the gauges on the aluminum (S5) and composite (S12) surfaces on the bottom of the section at the midpoint of loading.

(b) Flange buckling of load spreader beam

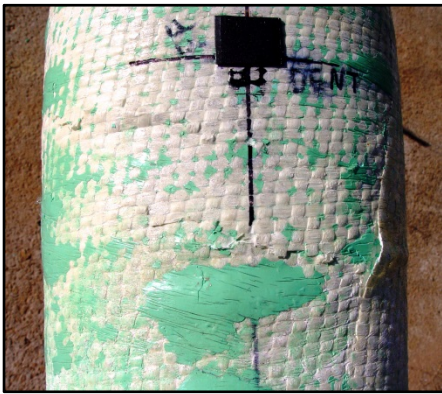
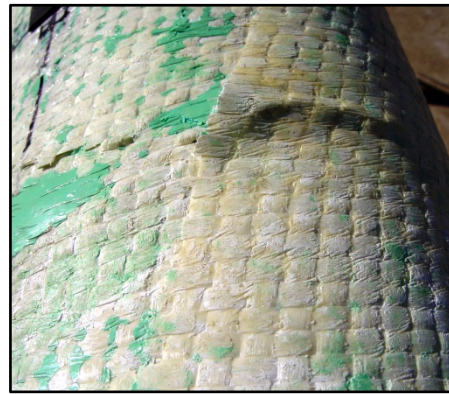
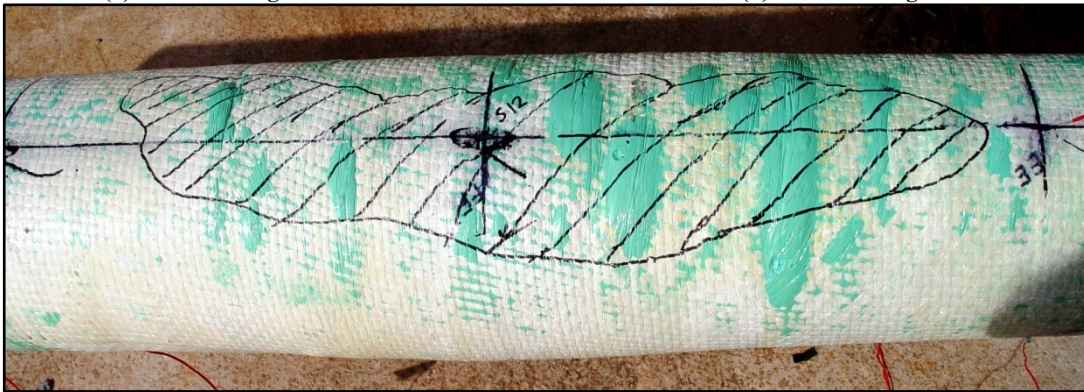
Figure 89. ALw-4.b failure modes

(a) FRP buckling failure

(b) FRP buckling failure

(c) FRP debonding from tension face

This yields maximum mid-span deflection, strain in aluminum, and strain in composite values of 4.4 in, 7361  $\mu\epsilon$ , and 4756  $\mu\epsilon$ , respectively. Fiber buckling was seen to have occurred on the compressive face of the pole at 1 in and 3 in from the dent center toward the small diameter end (Figure 89). Debonding of the fibers was noted on the tension side of the pole. The debonded area is shown in Figure 89. The strain profile plotted in Figure 92 during test 2, with gauges S6, S7, S13, and S14, shows that debonding of the tension face laminate occurs between 16 and 17 kips of applied load. It appears from this plot that the compressive wrap does not have a good bond from the beginning of the test, which is also the case from the beginning of test 1. However, the likely cause of the apparent lack of bond is the placement of gauge S13 directly

over gauge S6, which would cause a very localized bond weakness. The final failure of the pole occurred through plastic hinging at the dent location.

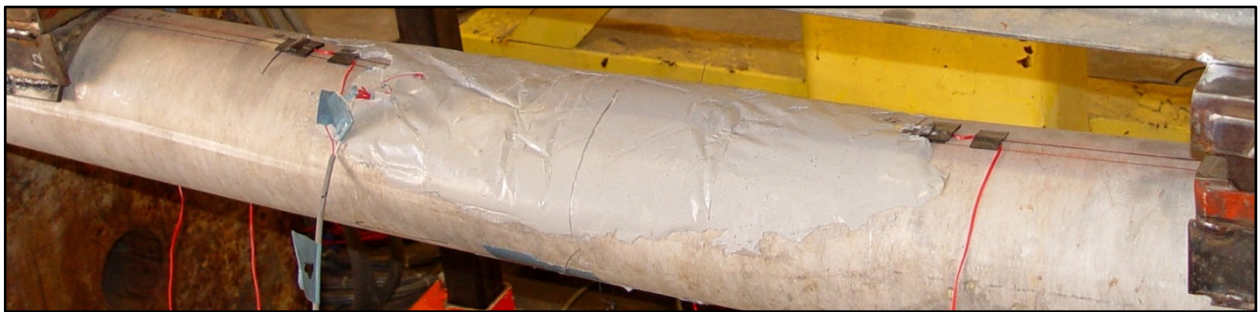
**Figure 93. ALw-5.b filled dent**

The first of the Single-Ply tests to be performed, ALw-5.b, investigates the effect of the epoxy dent filler in restoring pole capacity, and therefore a composite wrap was not applied to this pole. The pole was tested with only the gel dent filler portion of the repair, as shown in Figure 93. The epoxy gel filler was wrapped in wax paper during curing in order to maintain a smooth, round fill surface. The depth of the dent for this pole was approximately 1.875 in, or 33% of the outer diameter.

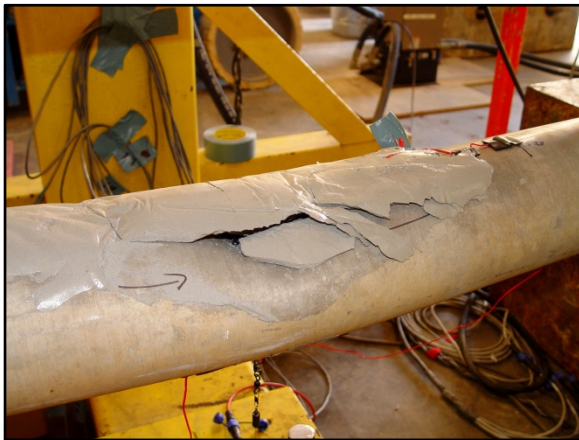
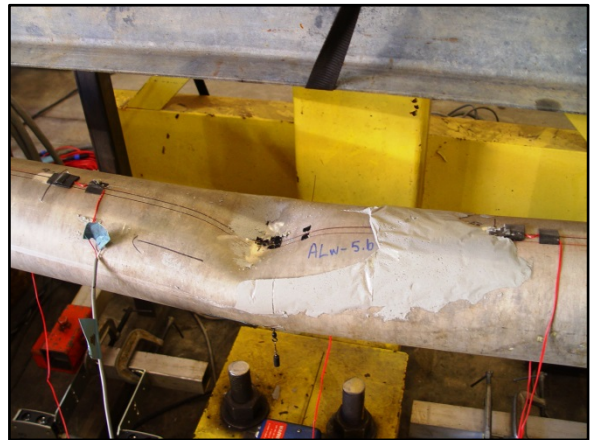
Figure 95. ALw-5.b failure modes

The strain and displacement data from this test are plotted below. As can be seen from these plots in Figure 94, the maximum load sustained by this pole was approximately 11.6 kips. This load induces a moment of 15.2 kip-ft at the dent center. The point at which the fill material begins compressive failure can also be seen in Figure 95 (a). After this point, the mode of pole failure is plastic hinging at the dent, as can be seen in Figure 95 (b).

(a) Compressively-failed epoxy fill

(b) Aluminum plastic hinging failure

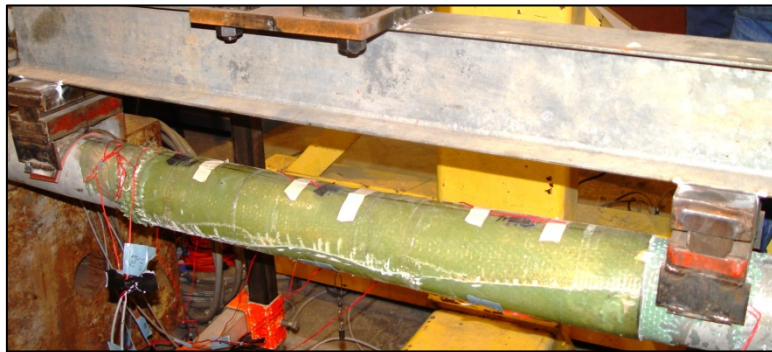
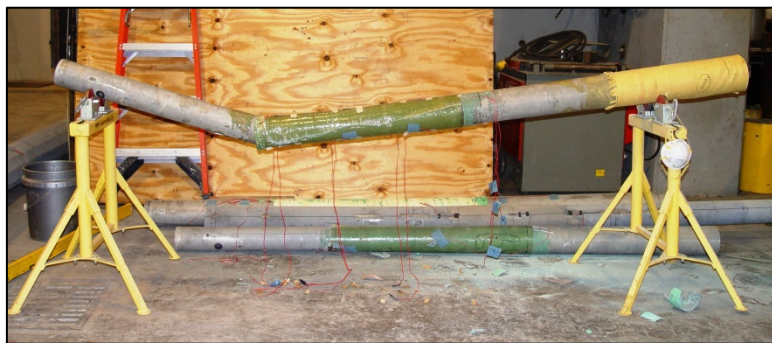
Figure 97. ALW-6.a testing and failure

The maximum load sustained by the pole was 7.98 kip. This load created a bending moment at the dent location and at the rupture point of 10.5 and 9.64 kip-ft, respectively. The reason for the failure at this location can be seen in Figure 97. In parts (d) and (e) of this figure, the ruptured cross-section is shown, and it can be seen that two bolt holes have been drilled into this pole just under the composite wrap. These holes weakened the pole section at this location, causing the premature substrate failure. The ruptured section, pictured in Figure 97 (d), has an uneven wall thickness, which is thicker in many locations than the thickness of the pole that was measured before testing. This fact necessitates increasing the theoretical capacity of this pole. At a load of

(d) Ruptured section

(b) Aluminum rupture failure

(e) Ruptured section

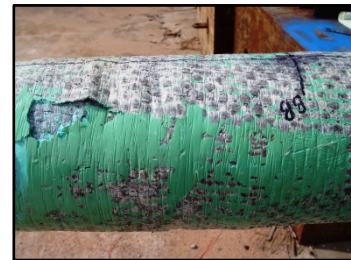
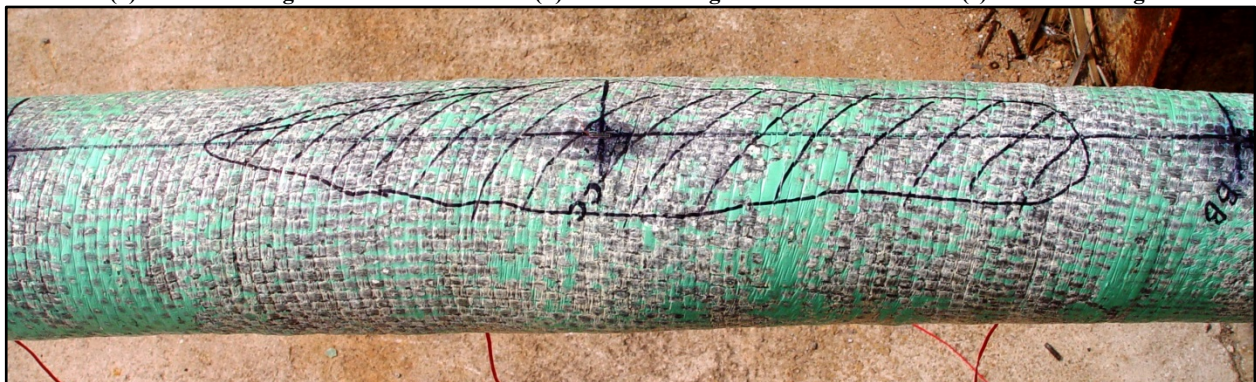
Figure 99. ALw-7.a failure modes

Pole ALw-7.a was dented to a depth of 1.25 in, or 25% of the pole's outer diameter at the dent location. The dent was then filled, and the pole wrapped with a layer of basalt fiber/PU composite. Several strain gauges on this pole were not functional at the time of testing. The strain and displacement data that were gathered are shown in Figure 98. The fibers on the top of the pole buckled at several points, as is shown in Figure 100. Buckling was observed at the center of the dent, and 6-8 inches from the dent along the pole in both directions. Debonding of the fibers also occurred on the tension face.

(c) Fiber buckling

(d) Debonded composite

The final pole failure was plastic hinging in the dented region. The capacity of the pole was measured as 8.48 kips. The maximum sustained moment was 11.1 kip-ft. A drop in the load occurred just after yielding of the pole section, as can be seen in Figure 98. A corresponding jump in the strain data at gauge S12, placed on the laminate surface over the center of the dent. This drop likely corresponds to the failure of the epoxy filler material, indicating that the fill material itself does not improve the strength of a composite wrapped section, except in its contribution to out-of-plane buckling resistance in the compressive reinforcing fibers. The compressive failure of the FRP laminate was first detected by strain gauge S11 at a strain value of approximately  $9205 \mu\epsilon$ , which is near to the compressive failure strain of  $-9300 \mu\epsilon$  determined for this composite from material testing, as discussed in Chapter 3. Debonding behavior is detected by strain gauge S12, located at the dent center on the tension side of the pole. The final displaced shape of the pole after testing is shown in Figure 100.

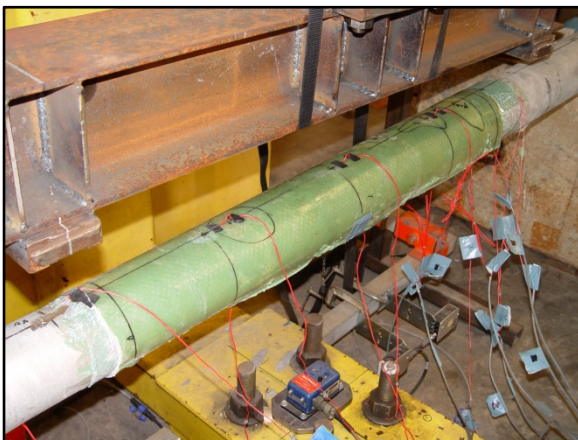
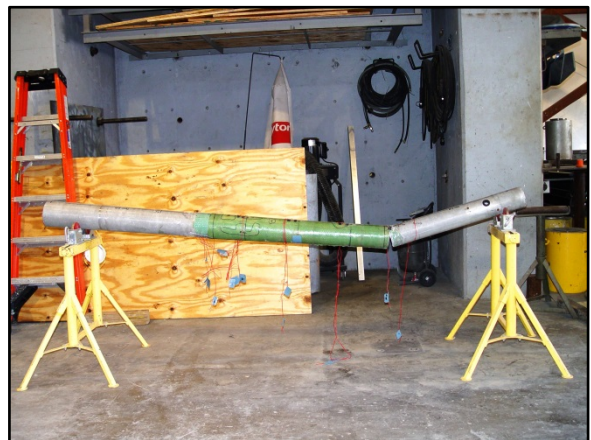
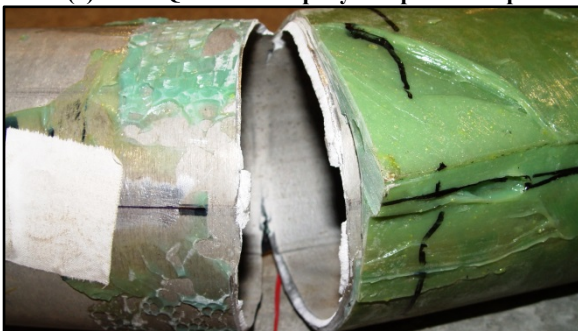
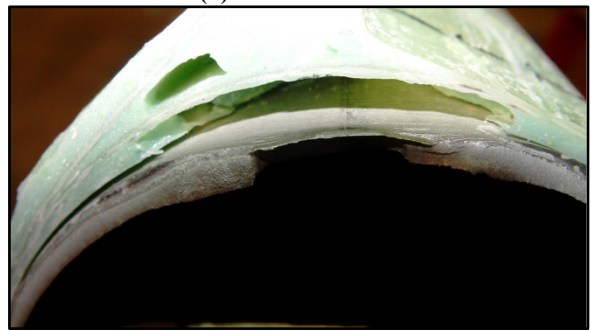
Figure 102. ALw-8.a wrap and failure mode

This single-ply specimen was wrapped with one layer of Glass/EP composite after being dented to a depth of 1.3125 in, or 26% of the outer pole diameter. When the wrap was applied to this pole, the wrap extended beyond the load application points for the pole. Therefore, the composite was cut with a rotary tool, and removed from the area under the load applicators. However, when the laminate was cut, the rotary disk penetrated deeper than intended, and etched a groove in the aluminum pole material at the south end of the wrap. Additionally, examination of the failed revealed that a bolt hole had been drilled into the substrate at this same location. When the pole was loaded, the reduced cross-section at this point caused the aluminum to rupture at a maximum load of 7.51 kips.

(b) ALw-8.a failure

(c) Aluminum rupture

(d) Ruptured surface

(a) Glass/QuakeBond epoxy composite wrap

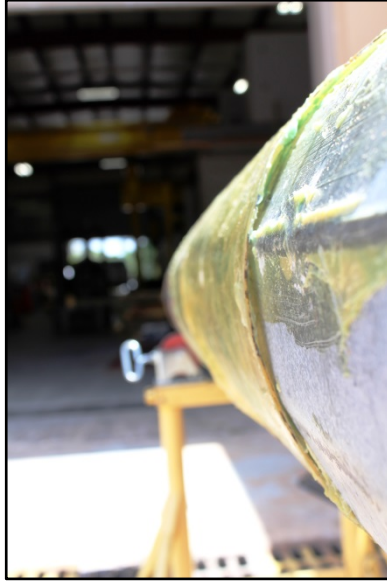
The first of the steel Single-Ply poles to be tested, STw-3.a, is a monopole with 18 sides. The diameter increases from 13.75 in at the small end to 15 in at the large end. Circular end caps were used to reinforce the section. The applied dent has a depth of 3.625 in, which is 24% of the pole's outer diameter at the point of application. The pole section was repaired with a glass fiber/QuakeBond epoxy resin composite. The composite wrap extended beyond the dent to the load applicators, as with the aluminum Single-Ply tests. Before the wrap was applied, the dent was filled with the Sikadur 31 Hi Mod Gel epoxy. Because of the multi-sided shape of this pole, the pre-cured epoxy composite did not form perfectly to its surface. Voids between the pole surface and the composite existed at several points between the pole corners, as shown in Figure 104.

Figure 104. Voids between composite wrap and steel substrate

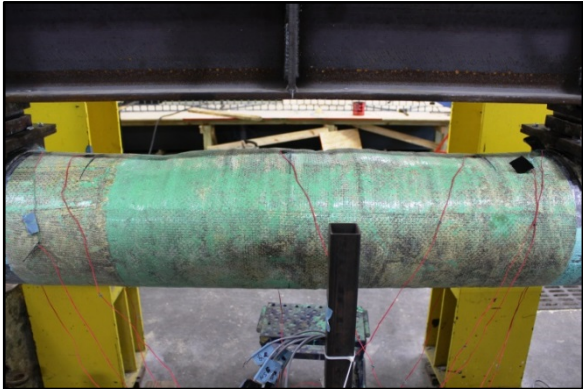
Figure 107. STw-3.b repaired section in test setup

Pole STw-3.b was larger in diameter than STw-3.a and had a round cross-section. The diameter at the center of the dent was 15.10 in, and circular steel plates were welded to the section ends to reinforce pole against local failure at the supports. A 3.625 in, or 24% dent was induced in this pole, and it was repaired with a basalt/polyurethane composite wrap, as can be seen in Figure 107. The pole was slightly shorter than the other steel single-ply specimens, and therefore the test setup was modified slightly by decreasing the total span. The data taken during loading is plotted in Figure 108.

The maximum load sustained by this specimen was 66.7 kips, which corresponds to a maximum bending moment of 94.1 kip-ft at the dent. The pole collapsed locally at the south support before yielding occurred in the wrapped region. The maximum strains occurred in the FRP repair near the edges of the wrap in gauges S9 (-8381  $\mu\epsilon$ ) and S14 (4643  $\mu\epsilon$ ). The maximum displacement was measured with gauge D7, located above the south support as 1.46 in. At about 45 kips, the

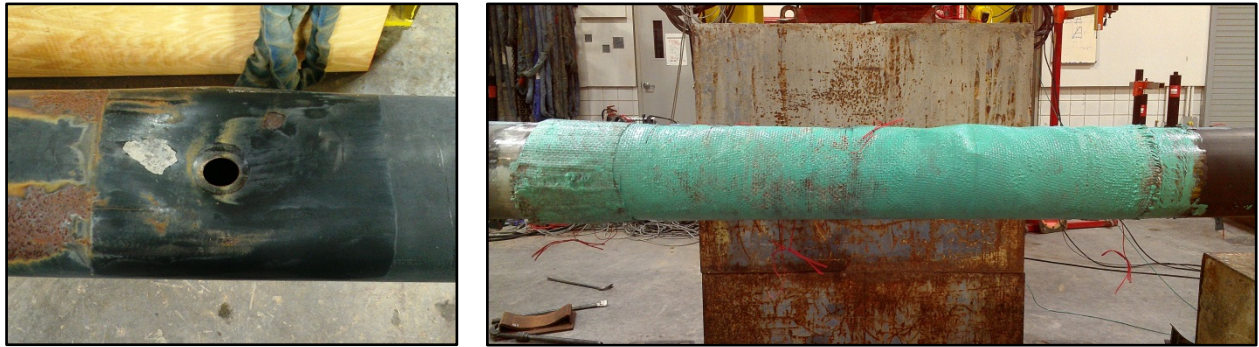
The final pole to be tested, STw-4.c, was dented to 29% of its outer diameter. The dent was applied at a point in the pole where a hole had been cut to allow for a crosswalk button to be placed, as shown in Figure 109. A barrier was placed over this opening when the dent was filled in order to prevent the fill epoxy from flowing into the pole. The diameter of the pole at the dent center was approximately 8.50 in. The filled dent area was wrapped with a basalt/polyurethane composite repair as shown in Figure 109. When the pre-preg wrap materials were opened, it was found that portions of the resin had partially cured in the packaging. The wrap was shaped to the pole as closely as possible, but the cured portions of the wrap did not allow a clean application.

(a) STw-4.c dent over button opening  
 (b) STw-4.c composite wrap  
 Figure 109. STw-4.c dent and composite wrap

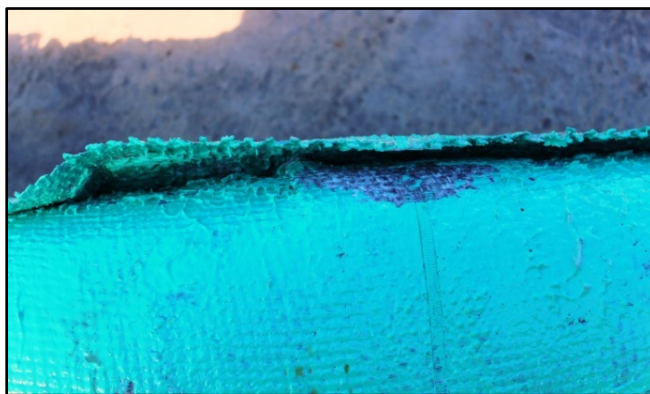
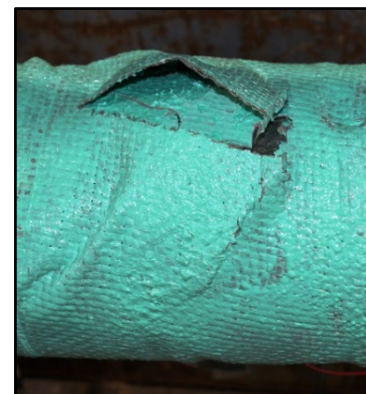
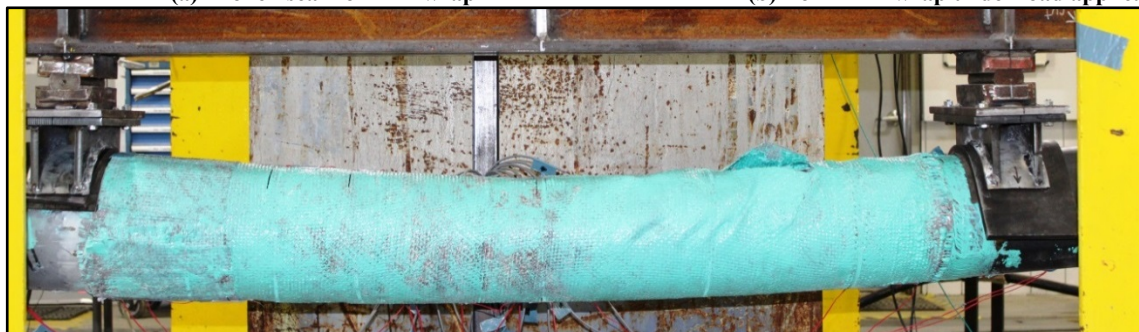
Figure 111. STw-4.c failure modes

(a) Broken seam of FRP wrap

(b) Torn FRP wrap under load applicator

(c) Hinged pole section

Several factors contributed to the ultimate failure of this pole section. The partially pre-cured composite wrap did not form perfectly to the pole's surface, and as the pole deformed the

seam of the wrap pulled apart, as is shown in Figure 111. Also, the brittle wrap tore underneath the load applicator. Finally, the epoxy fill material buckled, and the pole hinged at the dent.

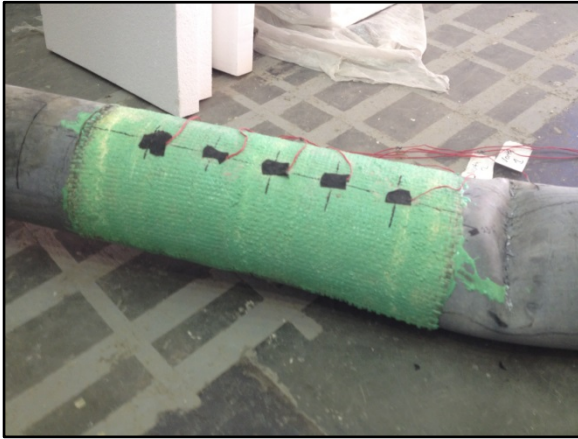
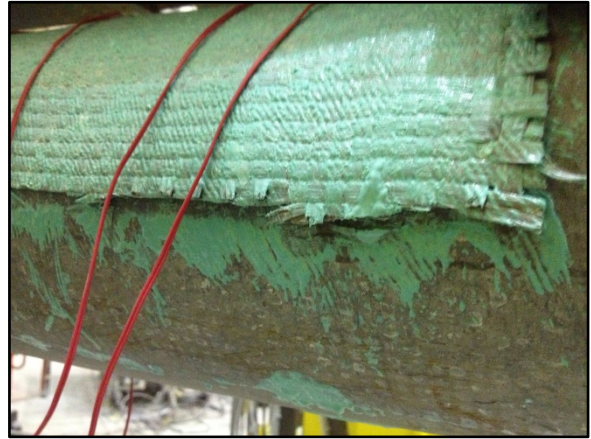
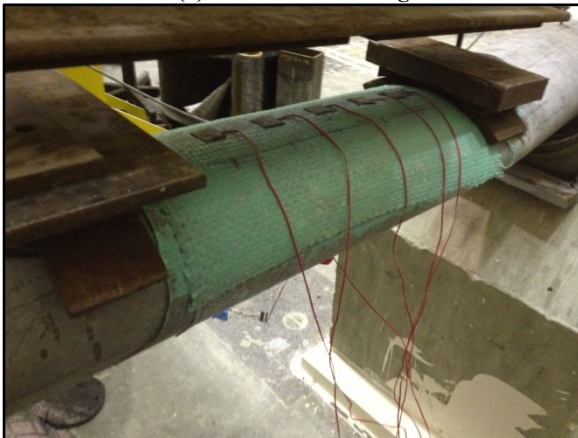
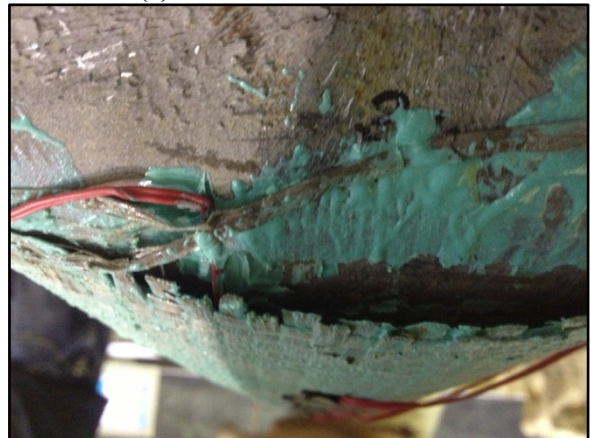
Figure 119. Compression wrap failure modes

As can be seen in Figure 118, the capacity of the poles was reached, and loading was continued beyond the peak. As the test progressed, the steel pole formed a plastic hinge failure underneath the southernmost load point. This is the location of the greatest moment carried by the pole. The hinging occurred before any failure of the FRP wrap was detected. As the test was continued

beyond the peak loads, debonding of the wraps began, initiating at the southern end, and progressing northward. It can be seen in Figure 118 that debonding of the composite occurred under each of the southern gauges. The other gauges remain at a constant strain level after steel failure. As the debonding occurs after yielding of the steel, it is probable that the debonding action was mainly due to interfacial shear between the laminate and the steel. The debonded laminates and poles after testing are shown for both compression wrap specimens in Figure 119.

(a) ST-25 after loading

(b) ST-17.b debonded laminate

(c) ST-17.b after loading

(d) ST-17.b debonded laminate

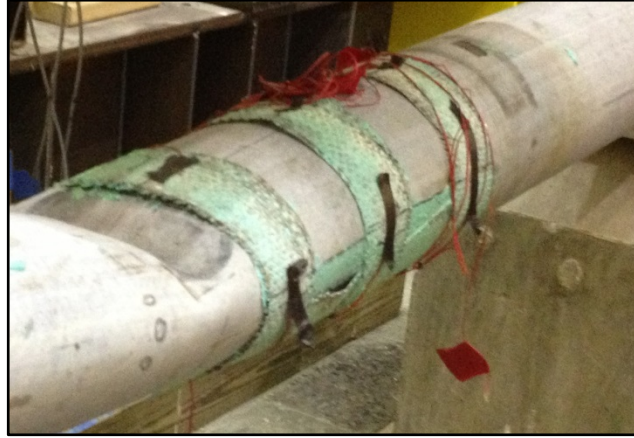
Figure 129. Tension and transverse wrap configuration – failed section

The tension/transverse wrap poles, ST-27.b and ST-27.c, possessed average diameters of 8.20 in and 9.40 in, respectively. The wrap geometry is pictured in Figure 129. The wrap and gauges were prepared in accordance with Figure 116 (b). The measured load, displacement, and strain behavior for pole ST-27.b are illustrated in Figure 130. The strain data gathered from Pole ST-27.a indicated that the entire section within the loading region was in tension, rather than bending. This is due to the offset of the load from the center of the span. The ST-27.c pole experienced extreme local buckling – almost folding - of the steel at the southern load point. This caused the pole to behave almost as a catenary member, completely in tension. The normalized strain behavior is summarized in Table 25.

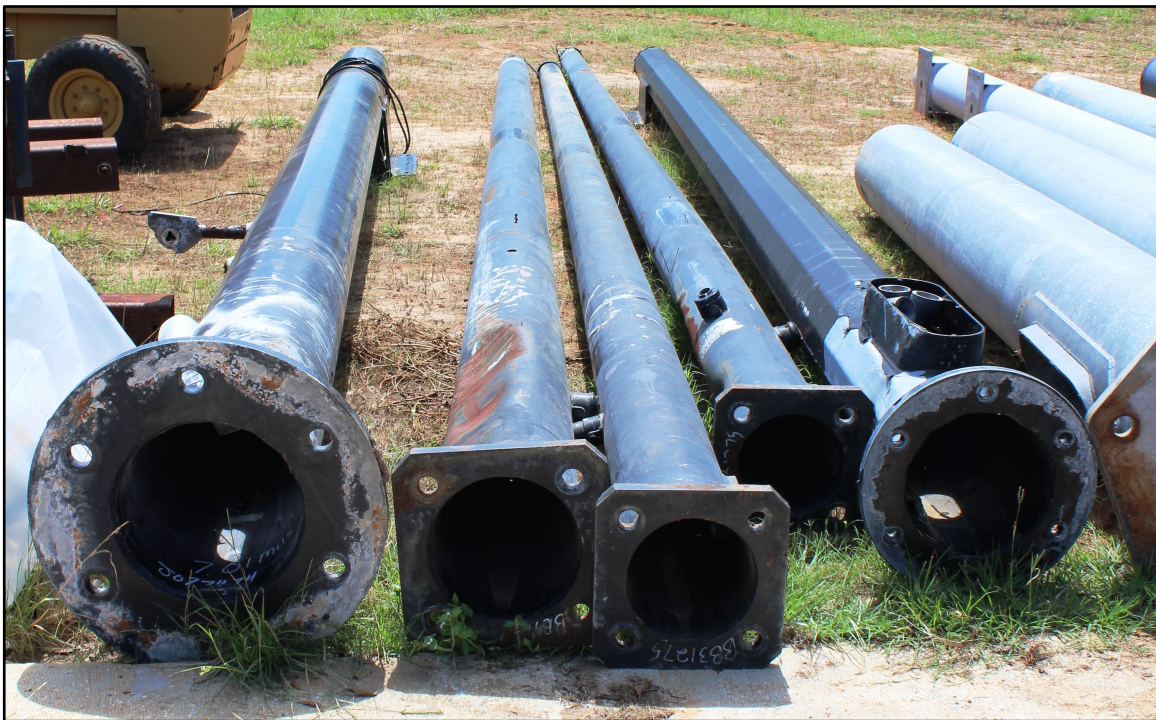
Figure 134. Field-damaged pole inventory before repair and testing

Four (4) steel utility poles that had been impact-damaged in the field were used for monotonic testing of the FRP repair systems. Repairs were designed for the poles based on the extent of the damage according to the protocol developed in the component-level testing phase. Because the damage was applied to these poles by accidental vehicle impacts, the damage is irregular, and often there are multiple dent locations on a single pole. These pole specimens (FD-1, FD-2, FD-3 and FD-5) have dents ranging from 7% to 24% of their outer diameters. The walls of the poles are 3/16 in, and the base diameter range from 11 to 16 in. The details of each poles geometry and damage will be discussed further in the results section. Several field-damaged poles as they were retrieved from the field are shown in Figure 134.
