## Repair Of Impact Damaged Utility Poles With Fiber Reinforced Polymers (FRP), Phase II

### University of Central Florida

**FINAL REPORT**

*June 2015*

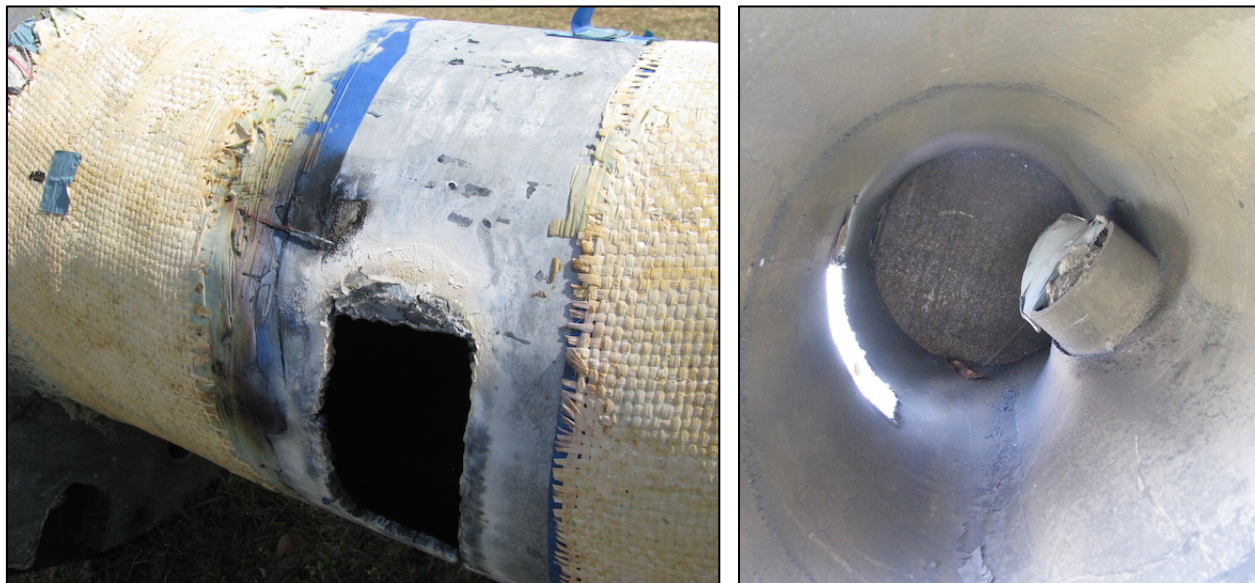
Figure 136. FD-1 exterior and interior views (taken after monotonic testing)

The first field-damaged pole specimen is a multi-sided steel pole that was severely dented by a vehicle collision. The pole's access port is within the dented area, which extends approximately from 3.5 in to 3 ft above the base plate, as shown in Figure 135. The diameter of the pole is approximately 16.125 in at the base, and the wall thickness transitioned from a value of 3/16 in at the pole tip to 5/16 in at the pole base. The dent was repaired with a single-layer FRP wrap over an epoxy fill. The access port was capped in order to allow the dent to be filled. For cases such as this in the field, it would be possible to cut a new access port on the undented face and design the wrap accordingly; however, this was not performed due to time limitations.

(a) Side opposite damaged region (the metal portion was removed after testing for measuring thickness)

(b) Interior view with base plate attached

The FRP system consisted of glass fibers and a polyurethane resin. The geometry of the FD-1 pole and repair are shown in Appendix A. A main wrap laminate was used which extended approximately halfway around the pole's circumference, and 46 in from the base plate. Three transverse circumferential wraps were placed on top of the main wrap that encompassed the entire circumference of the pole and were 10 in, 6 in, and 6 in wide, from the bottom, respectively. The FRP reinforcing ratio at the base was approximately 25% (area of FRP was not adjusted for fiber volume fraction). The transverse wraps on the opposite face to the dented region are shown in Figure 136 (a). An interior view of the pole indicating the extent of damage in the existing access port region is shown in Figure 136 (b). The hole in the base metal in the photos was due to removal of metal for thickness testing after monotonic testing.

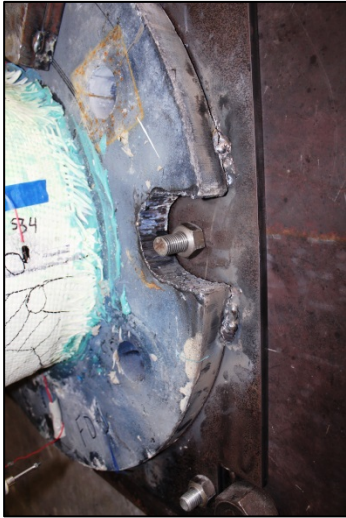
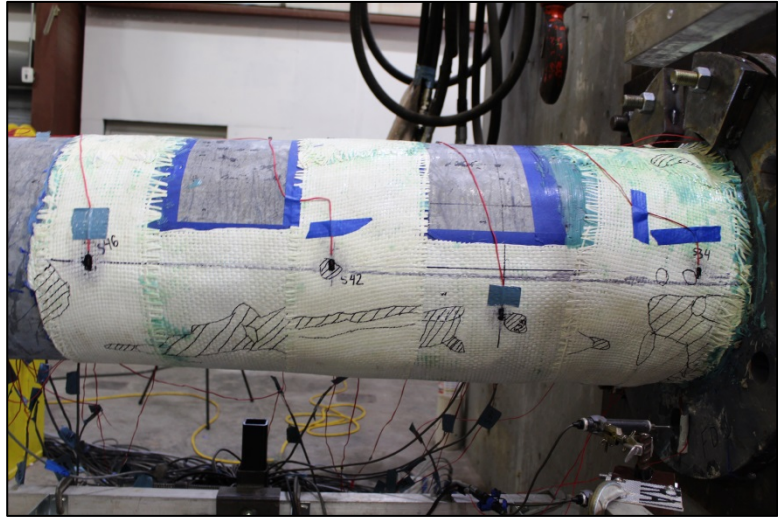
Figure 141. FD-1 failure modes

There was a slight drop in the load at approximately 21 kip and again at 30 kip before the test was stopped prior to failure of the pole. The welds near the neutral axis of the pole on the west side had ruptured, as seen in Figure 141 (a), and the setup had not been designed for loads higher than this. Based on cross-sectional measurements taken from the top of the pole when retrieved from the field, the theoretical yield load was estimated as only 31.8 kip. However, a section of the pole removed from the base after the test indicated the wall thickness was substantially larger, leading to a revised estimate of the yield load of 41.8 kip.

tension in gauge S17 at section 5 and transversely in gauge 10 at section 3. The regions indicated as debonded from sounding the pole after the test are shown as the hatched areas in Figure 141 (b).

(a) Ruptured pole base plate welds near bolt on west side of pole

(b) Debonded areas of FRP wrap

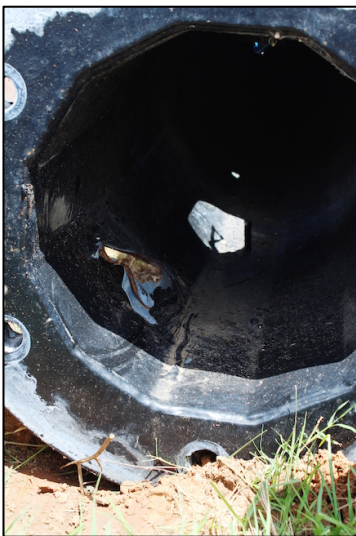
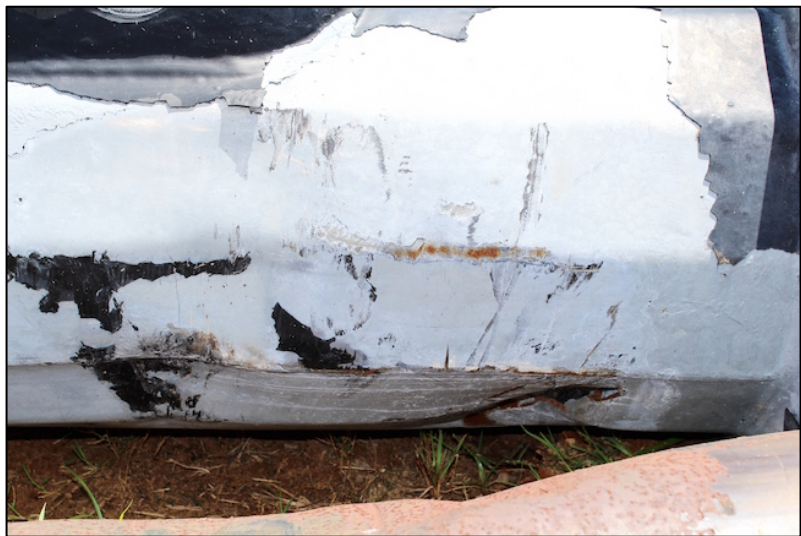
Figure 142. FD-2 dents and puncture prior to repair

FD-2 is a 12-sided utility pole that has been damaged by an impact in the field. There are two small dents located approximately 90° from the pole's access port, 15 in and 17.5 in above the base plate. These dents are 0.625 in and 1 in deep, respectively. The 1 in dent is about 7% of the pole's outer diameter in depth. In addition to these dents, there is a puncture hole in the steel pole 5 in above the base. This puncture hole is approximately 3.0 in wide by 3.5 in high, and has sharp edges. Details of the damage are shown in Figure 142. The access port on this pole is large, both in perimeter geometry as well as the height and thickness of the side wall (that reinforces the access port) extending outwards from the surface of the pole. The reinforcing side wall is approximately 5 in from the pole surface as the curvature of the pole increases away from the center of the access port.

(a) Interior view showing puncture

(b) Dented area and puncture

This pole was repaired with a wet epoxy/basalt fiber FRP wrap. The dents and the puncture hole were filled with epoxy before the wrap was applied. The main body of the wrap was a 14 in wide laminate centered horizontally over the dent. The width of the wrap was chosen so that the wrap did not cover the access port and was symmetrical over the damaged areas. The wrap extended vertically from the base plate approximately 3'-6 1/8". This height was selected to allow a 6 in high transverse wrap to be applied to the top of the repair system above the access port. The lower transverse wrap was 11 in high, covering the pole surface between the base plate and the bottom of the access port. The pole and repair geometry, including placement of displacement and strain gauges, are shown in Appendix A. The FRP reinforcing ratio at the base was approximately 34% (area of FRP was not adjusted for fiber volume fraction).

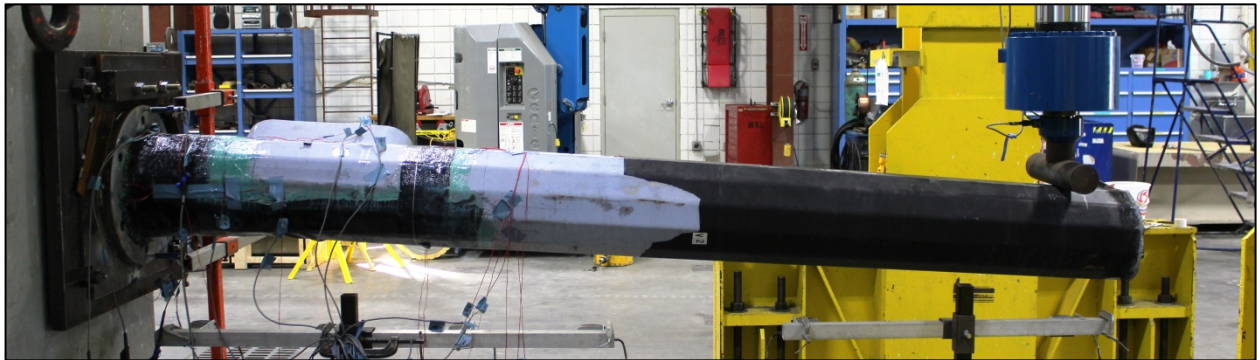
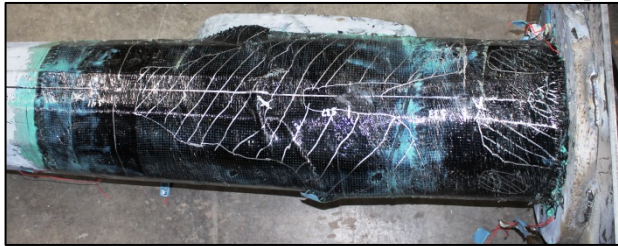
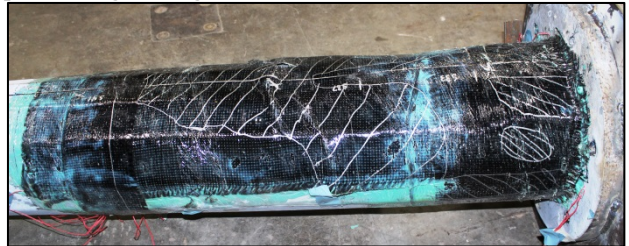
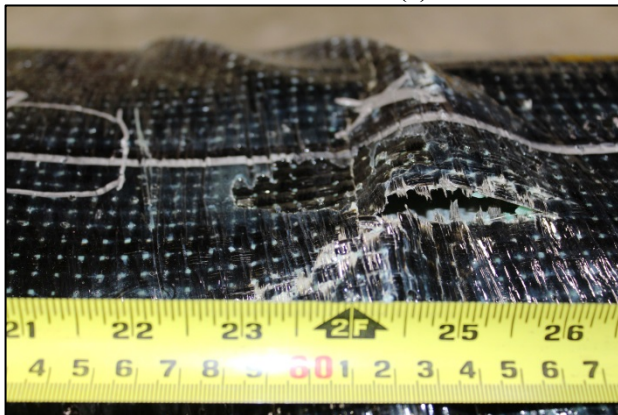
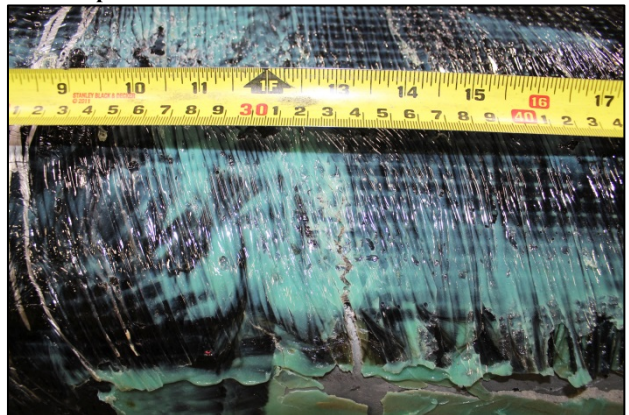
Figure 147. FD-2 failure modes

The strain data shows clear debonding at section 1 on both the tension and compression sides. It appears the compression face debonding occurred around 7 kip and may be related to failure of the dent filler. There is a jump in the load-displacement at this load. The tension debonding did not happen until just after the peak load and slight softening had occurred. This is confirmed with the failure pictures shown in Figure 147 (b)-(d). The transverse strains on this pole are small, indicating perhaps the wrap was not engaged or not developed as it should have been (or the location of the transverse gauges were not in the right place). The reason for failure may be due to compressive steel failure at the location of the puncture. Review of the original pole photos prior to repair indicates that the gash is substantial. This may have caused the steel to fold inwards rather than dilate the cross-section outwards.

Interestingly, this doesn't explain why the estimated yield load wasn't reached, although the effect of the dented region on the capacity was also observed to be lower for non-round steel poles in the component-level tests. The compression steel gauges show extremely high strain (well in excess of yield). It appears the tensile steel gauge reaches yield at the peak load, which may be significant. The strain gauge (tensile steel S5) just in front of the access port shows higher strain than even S1, indicating the extremely large access port side wall may have been causing torsion and stress concentrations within the section, even though it may have increased the initial elastic stiffness of the pole. The effect of torsion on the cross-section appears to have played a role in the debonding and buckling pattern visible in Figure 147 (b).

(a) Deflected shape of pole during loading

(b) Compression face – debonded FRP

(c) East face – debonded and ruptured FRP

(e) Ruptured and buckled FRP

(f) Ruptured FRP

While the amount of FRP in the longitudinal direction appears to have been sufficient on this pole, the transverse layer does not appear to have been extended far enough up the cross-section. This is particularly evident in Figure 147 (a) and partially explains the relatively small transverse strains mobilized during the tests. The longitudinal wrap appears to have completely debonded from the pole both at the location of the access port, as well as the location on the opposite face of the pole, as shown in Figure 148. Either the size of the longitudinal wrap provided was not sufficient to develop the circumferential strains, or the debonding evident in Figure 148 occurred because of voids and imperfections during wrapping because of the 12-sided geometry of the pole.

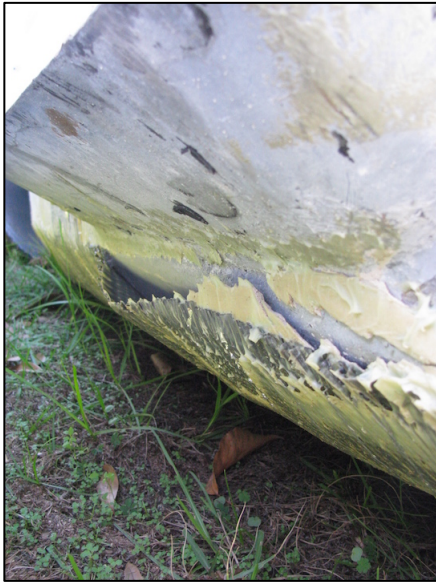
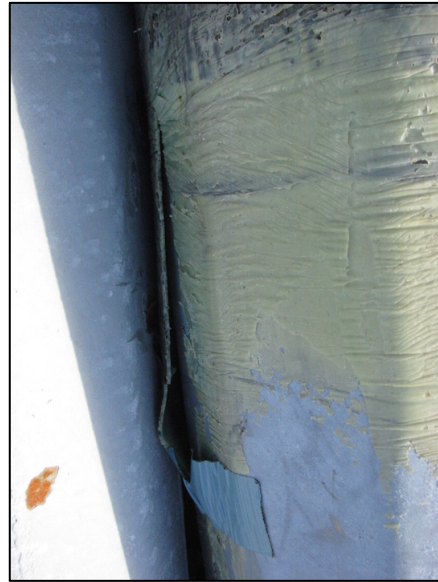
Figure 148. FD-2 transverse wrap delamination

(a) Delamination and separation of the transverse wrap near the access port

(b) Delamination and separation of the transverse wrap on the face opposite to the access port

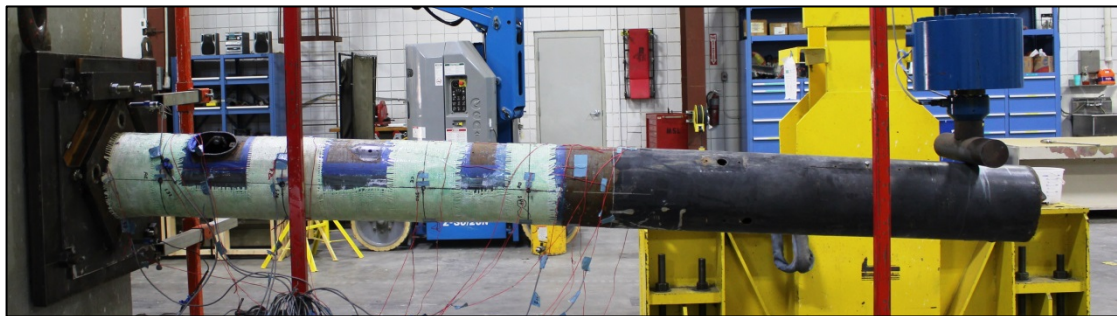
The load-displacement and load-strain data for Test 2 are shown in Figure 153 and Figure 154, respectively. The locations of the various strain gauges are the same as used for Test 1 and shown in Figure 155. Test 2 was halted at approximately 11.5 kip of applied load due to the actuator stroke limit being reached. The residual displacement from Test 1 was removed from the displacement readings shown in Figure 153. The load was still gradually increasing, although the specimen was clearly near the peak load. The displaced shape of the pole at the peak load is shown in Figure 156 (a).

stress concentration at this location may be limiting the capacity of the pole. Inspection of the pole indicates some bulging of the wrap at the base; however, no debonding is evident, except from the potential area on the compression face shown in Figure 156 (b). The bulging may be due to the compressive failure, or may be due to accumulation of primer during the original repair in the presence of the minor damage at the base. Compression damage is corroborated by the FRP compression strain readings at gauge S37.

(a) Failed shape

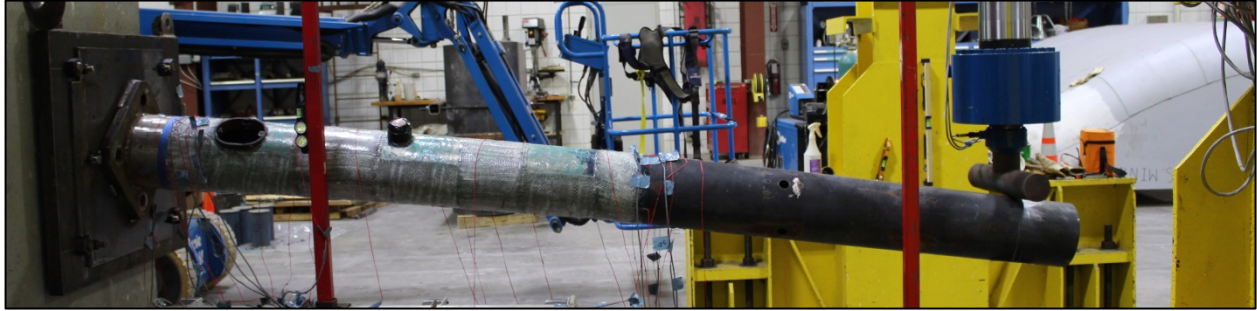
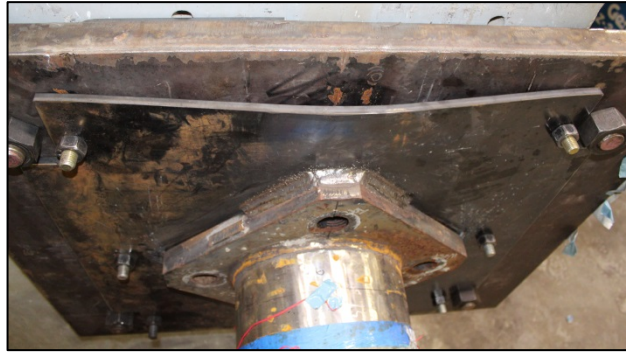
Figure 161. FD-5 Test 1 deformed shape and base plate failure

prevent future deformation of the pole base connection. The deformation of the plate (as seen in Figure 161) caused the side welds to fail and there may have been some yielding in the base flange. Loading was applied until failure in Test 2 after the changes to the pole base connection were made. The load-displacement and load-strain data for Test 1 are shown in Figure 159 and Figure 160, respectively. The locations of the various strain gauges are shown in Figure 164.

The peak load achieved during Test 1 was approximately 5.5 kip. However, based on the load-displacement curves in Figure 160 (a), it is evident there were two occasions where yielding of the connection plate, rupture of welds, and/or slip of the bolts resulted in ratcheting (sudden jumps in displacement, or due to displacement-controlled loading, a sudden drop in load at the same displacement). This occurred first at 4.8 kip and then again at 5.5 kip. Unloading of the sections can be discerned in a majority of the strain measurements in Figure 160. The excessive deformation of the pole due to rotation near the connection is evident from the displaced shape in Figure 161 (a). The prying of the ½ in plate from the 2 in plate at the end of Test 1 is shown in Figure 161 (b).

(a) Displaced shape

(b) Compression face of FRP

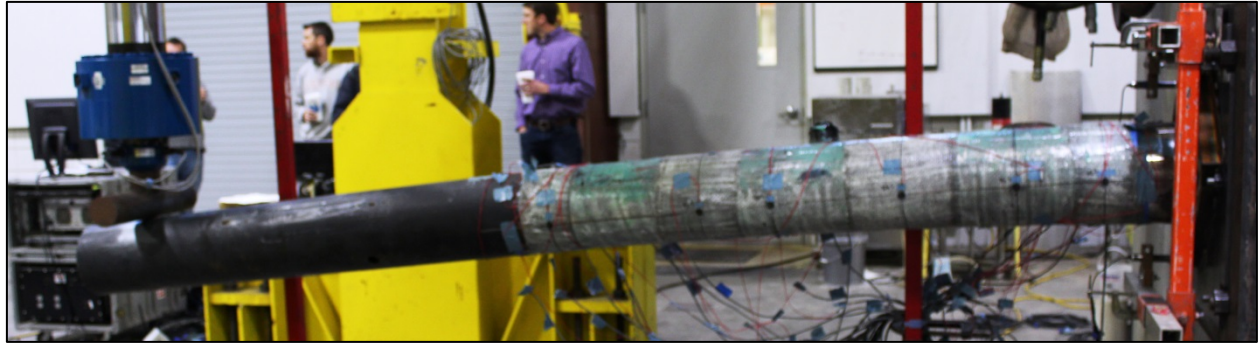
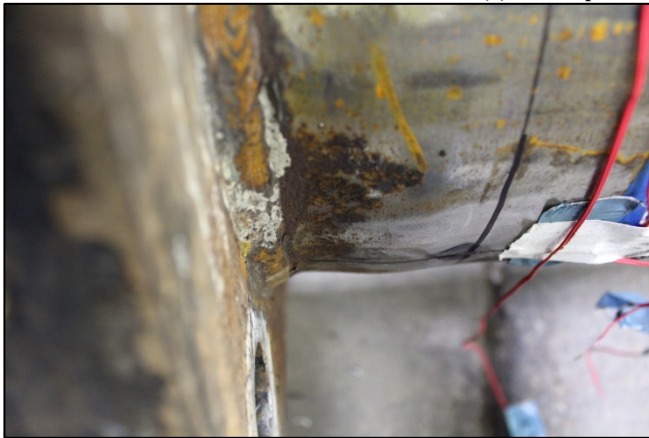
Figure 165. FD-5 failure modes

The compressive steel hinged between S3 and the base flange, as visible in Figure 165 (b). Buckling in the FRP occurred on the bottom side of the pole about 20 to 23 in from the top of the base flange and wrapped its way up toward the top of the side of the pole where there was no FRP, as shown in Figure 165 (c). This is consistent with the FRP compressive strain measurements recorded in S41. Steel yielding in tension was evident for all gauges between sections 2 and 5, indicating a distributed plastic hinge forming because of the tapering of the moment demand and the capacity in the presence of the dent. A corresponding increase in the transverse strains was recorded in a similar range of sections, and the transverse steel readings showed yielding at sections 3 and 5.

(a) Failed pole shape

(b) Buckled steel 2 in above base plate

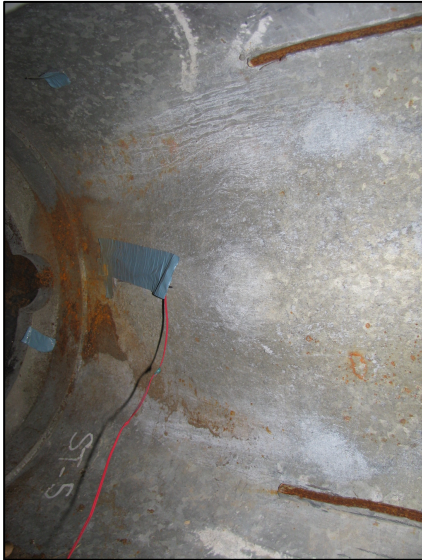
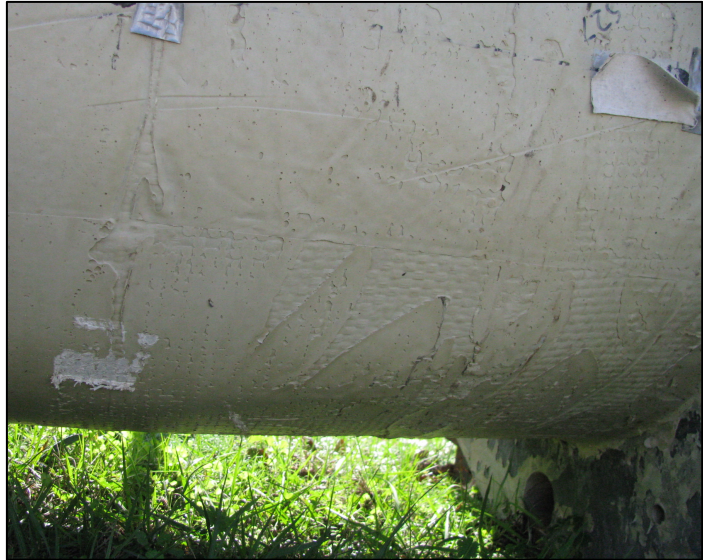
Figure 170. ST-5 after testing

The test was terminated prior to failure due to the capacity of the test setup being reached. A majority of the strain responses were still in the linear range; therefore, the pole may have carried a substantially higher load. In addition, a forensic investigation showed that the pole may have been strengthened on either side of the dent by inserting steel ribs, as shown in Figure 170 (a). Therefore, for this specimen it is difficult to ascertain the effectiveness of the FRP repair that was applied. The jump in the load that occurred around 18 kip appears to be from crushing of the fill material or local buckling of the FRP that was not visible on inspection, but may be indicated by the section dilation in Figure 170 (b). The compressive strain decreased at this load, but regained additional strain thereafter at all gauge locations.

The reinforced access port had an additional plate surrounding the side wall that prevented the transverse wraps from being placed close the center of the dented region. The transverse strains recorded during the test were correspondingly small. It is possible at the onset of hinging that S2, S28, and perhaps S10 and S36 would have recorded substantially higher strains. However, the presence of the base plate would have prevented substantial dilation of the cross-section at the location of the strain gauges at section 1. The only functioning transverse gauge near the center of the dent was S32, which indicates the cross-section began to unload at the jump in load.

(a) Dent viewed from inside the pole with additional steel ribs on either side of dent

(b) Slight dilation of cross-section in the region of the dent

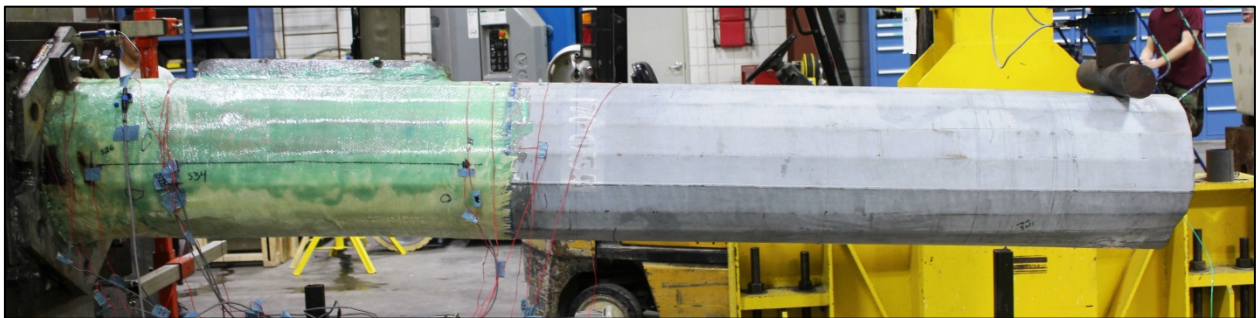
Figure 175. ST-6 deflected shape at failure

The pole was loaded to failure. The load-displacement and load-strain data are shown in Figure 172 and Figure 173, respectively. The locations of the various strain gauges are shown in Figure 174. This pole likely didn't have enough transverse FRP on it. Compared to the other monotonic large-scale specimens, this pole reached the lowest load with respect to the theoretical yield load. As with the component-level tests, the multi-sided steel specimens do not appear to exhibit the same beneficial strengthening. The displaced shape of the pole at the end of the test is shown in Figure 175.

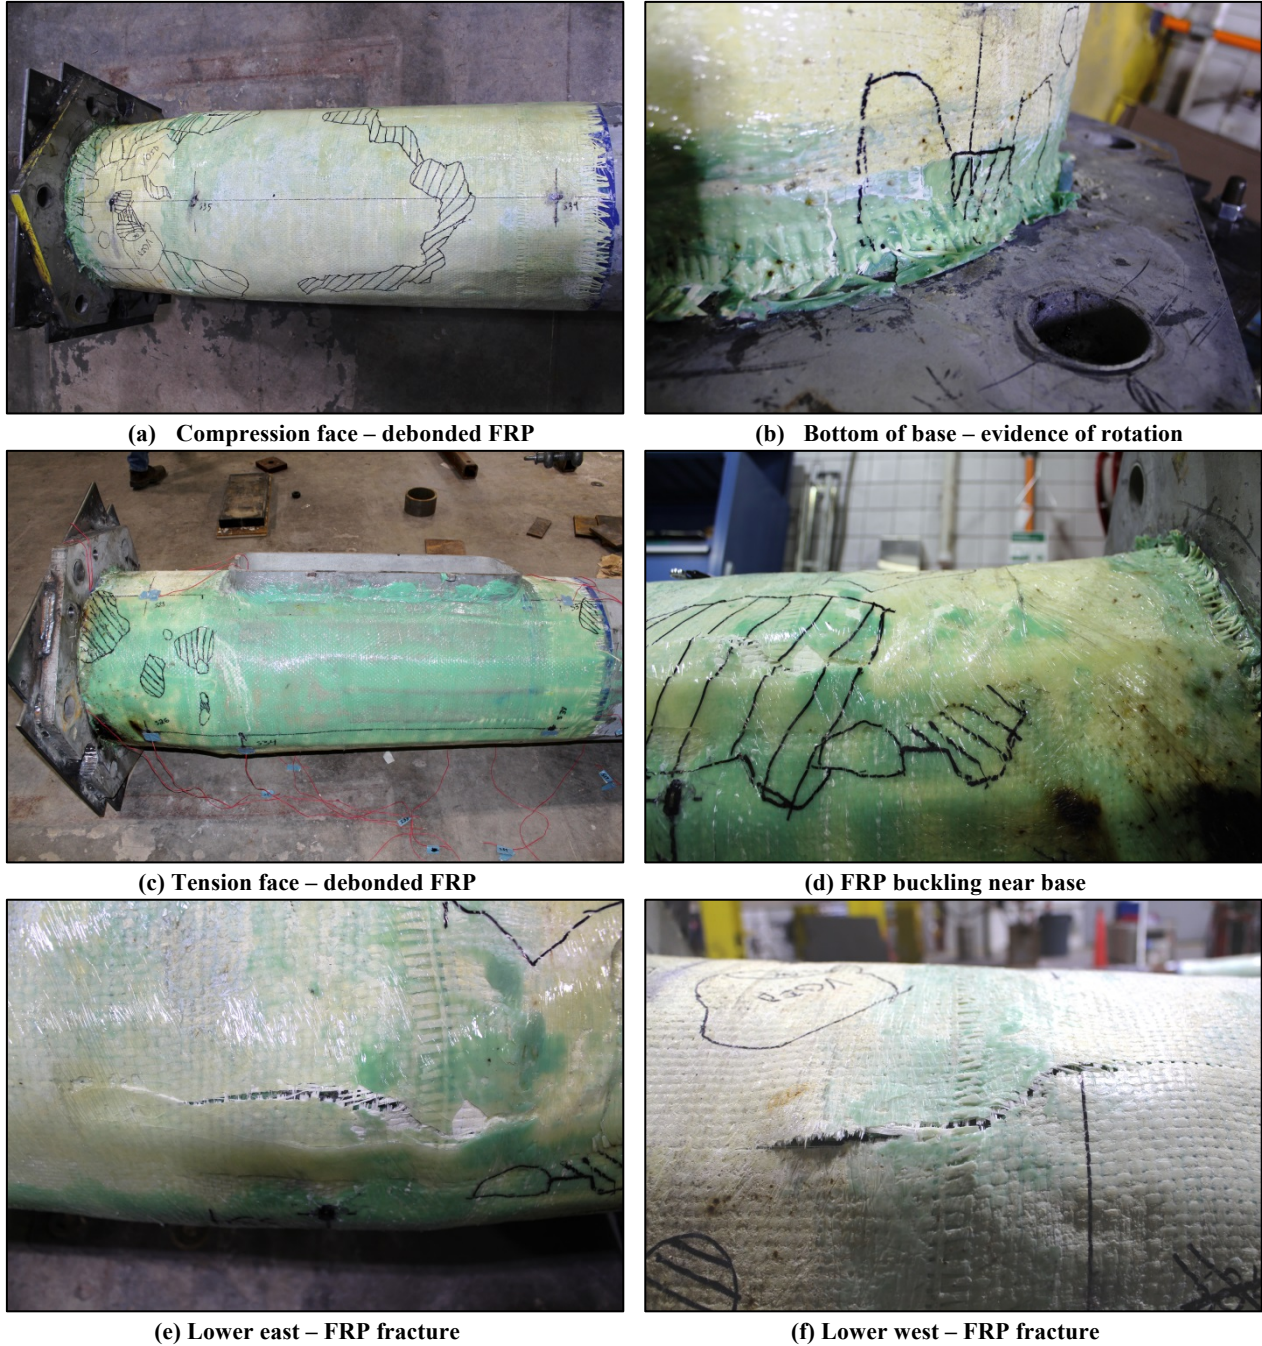
Figure 176. ST-6 failure modes

The FRP on the compression face at section 1 buckled at a relatively low load (approximately 14 kip). A small jump in the load-displacement is visible at this level. A substantial area of debonded and buckled FRP was evident after the test on the compressive face, as shown in Figure 176 (a), (b), and (d). A more substantial jump in the load occurred at 16.5 kip, at which point S3 was lost and the fill material crushed. The load continued to increase until the transverse strains in S4 (section 1), and the tension strains at the same section indicated yielding. Although no debonding on the tension face is evident in the strain data, several regions on the face of the pole opposite the access port showed debonding, as seen in Figure 176 (c).

Near the peak load, the laminate near S36 appears to have debonded or was forced into compression due to the rupture in the transverse FRP that developed on both sides of the pole, as shown in Figure 176 (e) and (f). This appears to have been the ultimate failure mode of the pole and initiated in the longitudinal wrap at the location where the transverse strip was terminated. Due to the lip surrounding the reinforced access port, the actual width of the transverse strip near the base was not optimal. The longitudinal wrap was similarly not extended sufficiently around the perimeter between sections 2 and 4, together with the lack of transverse FRP contributed to the failure. In addition, the strip at section 4 was perhaps too narrow, although the transverse strain data at that location confirm that this cross-section was too far removed from the center of the dent to substantially affect the repair capacity.

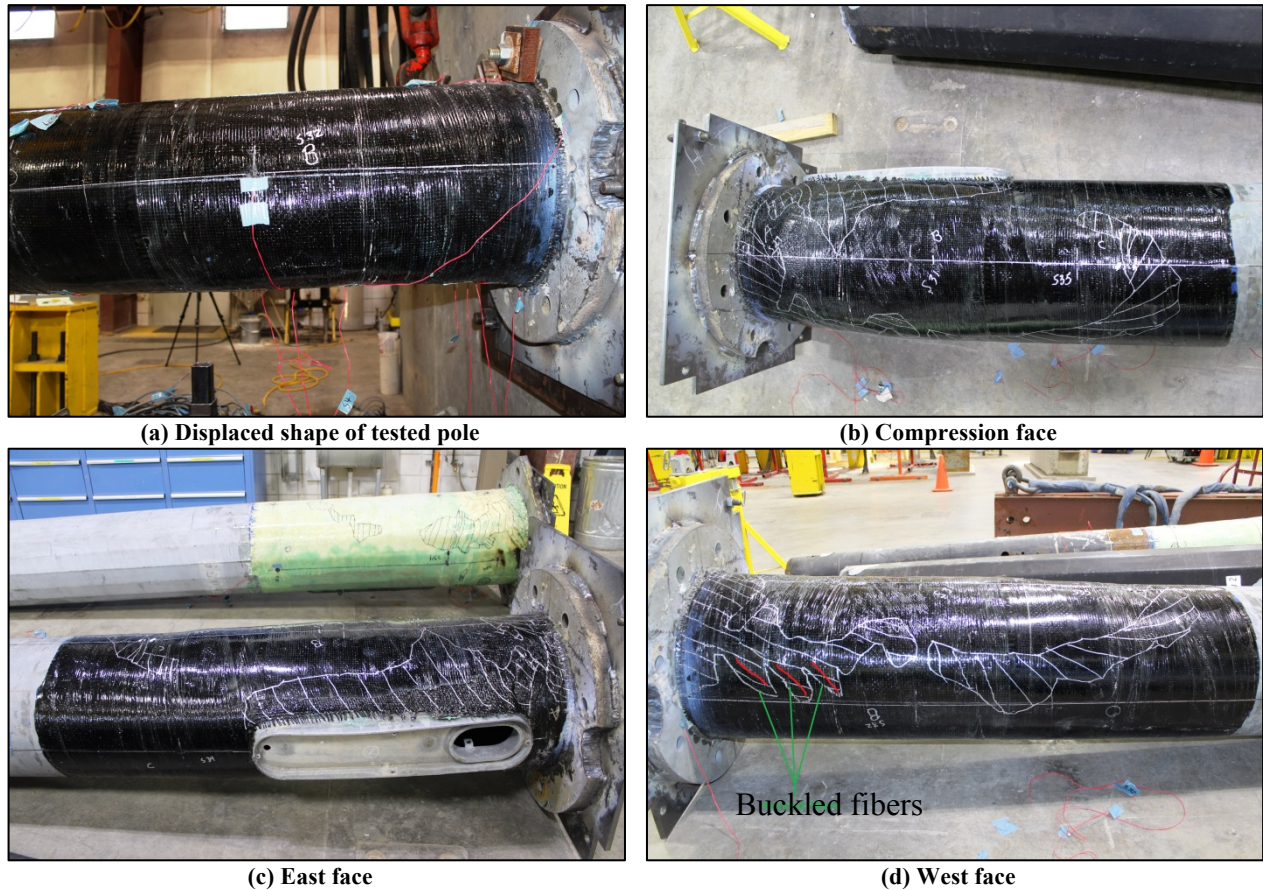
Figure 181. ST-8 failure modes

The load reached a maximum value of 26.5 kip before a sudden brittle failure. The load did, however, stabilize and continue to increase again followed by a peak at 23.5 kip. Although the dent was large, the size of the access port and proximity to the dent allowed a substantial amount of FRP in both the longitudinal and transverse direction. The transverse strains mobilized in the wraps were very high, demonstrating efficacy of the repair, and no rupture occurred in the transverse wrap, so the selection of a single layer in each direction appears justified. However, a second layer would have enabled a higher load relative to the estimated theoretical capacity, because of the sudden increase in transverse strains observed after the load drop.

The final state of the pole after testing is shown in Figure 181 (a). The reinforced wall of the access port clearly contributed to the flexural response of the pole, as evidenced by the permanent flexural deformation of the side wall seen in Figure 181 (c). The cross-section has substantial visible dilation after the test, seen in Figure 181 (b). There is visible debonding near the access port in the longitudinal wrap (or partial transverse circumferential wrap), and some buckled fibers and debonding on the face of the pole opposite the access port, seen in Figure 181 (b) and (d).

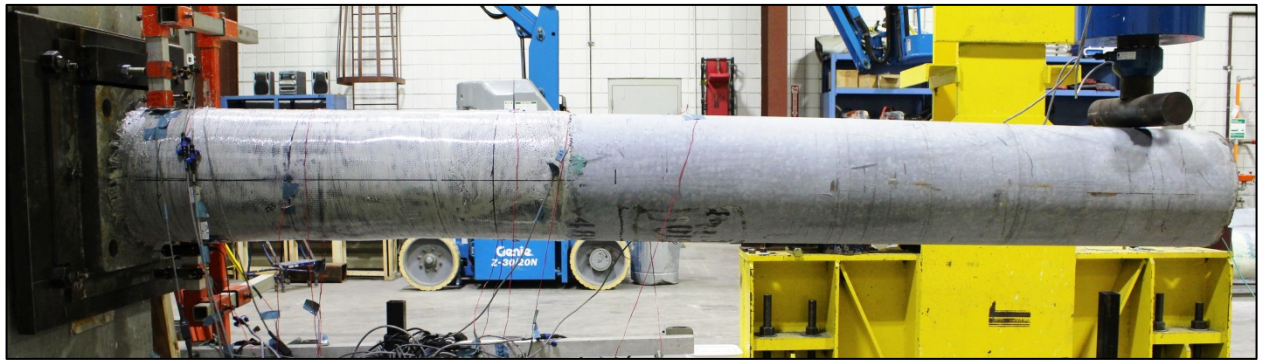
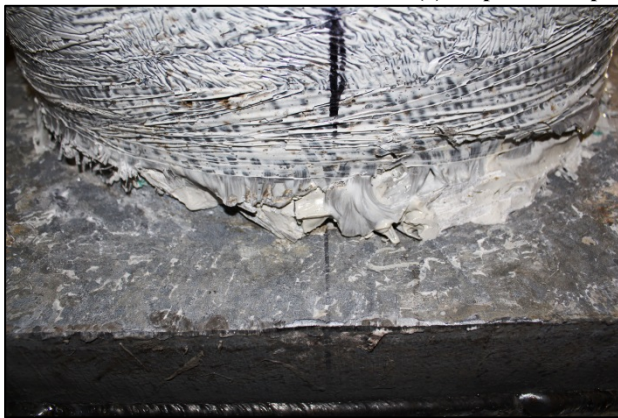
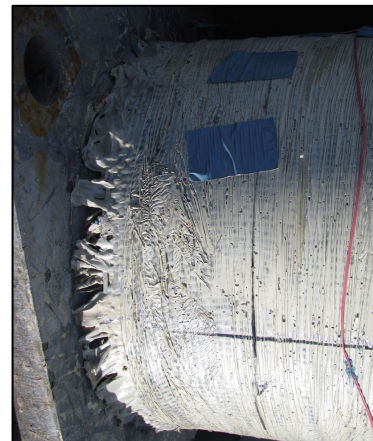
Figure 186. ST-12 failure mode

The pole reached a load of 23.5 kip before a sudden drop in the load occurred. The load continued to increase after this, attaining a maximum value slightly higher than the load at which the initial drop occurred. There may have been debonding at the base; however, it may also be due to the way the initial lay-up was performed with a considerable amount of adhesive collecting at the intersection of the base flange, as shown in Figure 186 (b). There is visible deformation at the base cross-section (expansion) seen in Figure 186 (c), and therefore, the pole should have developed substantial transverse strains. The failure mechanism of this specimen is somewhat similar to ST-8, although obviously ST-12 has no access port, and the two-layer wraps are continuous. For this test, no steel compressive strain gauges were placed on the pole due to the extents of the dent.

(a) Displaced shape of pole

(b) FRP potentially debonded near the base and accumulation of resin near base flange

(c) Dilation of the base section and possible debonding

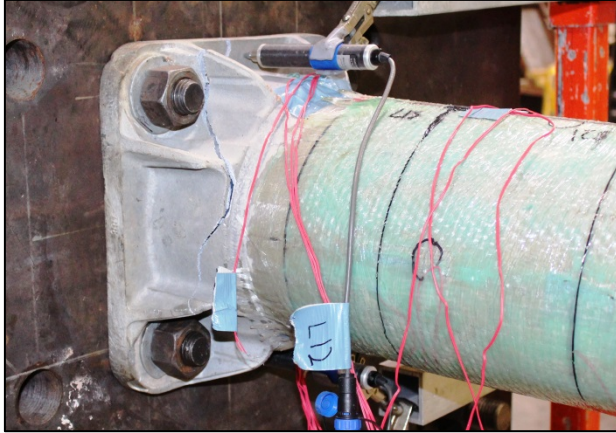
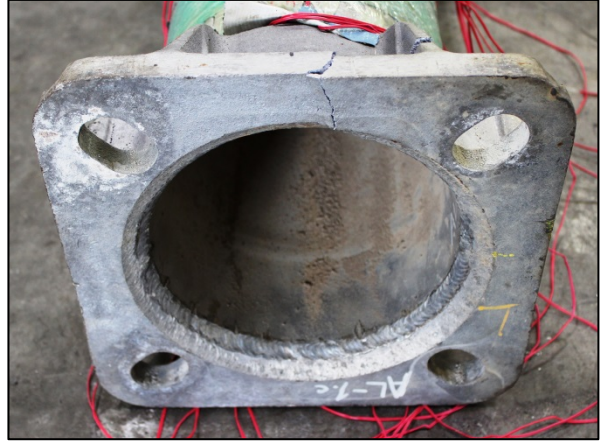
(c) FRP repair after testing with typical delaminated areas  
Figure 191. AL-1.c failure modes

The pole was loaded to approximately 2.58 kips at which point the base plate and aluminum sleeve at the pole's base fractured, as shown in Figure 191 (a). As the failure occurred outside of the extents of the repair system (and the pole base metal itself), the test result does not fully demonstrate the success of the repair system; however, the failure load was already higher than the predicted yield load. Some small, 1 in diameter areas of the FRP wrap delaminated from the aluminum substrate during testing, and an area of the wrap extending up to 3 in from the base of the wrap delaminated from the tension face, as seen in Figure 191 (b). However, the repair system was generally intact and undamaged at the time of the pole's failure as seen in Figure 191 (c), and the delamination was mostly due to the overlapping of the laminate with the 4.5 in sleeve.

The strain data show that the aluminum had undergone yielding prior to failure, both in tension and compression at the base (section 1). The rapid increase in compression strain ( $-7000 \mu\epsilon$ ) may have contributed to the fracture at the top of the sleeve. Debonding occurred on the compressive face, evident in Figure 189 (b); however, the tension strain does not show any evidence of this to confirm the visual observations. Tension yielding in the aluminum may have occurred at several locations along the height of the pole, with readings at section 4 also showing  $4000 \mu\epsilon$  or larger. The transverse wrap was only moderately effective at the time of failure, with the transverse FRP gauge showing an increase in tension strain close to the failure load. As observed with several of the steel specimens, the additional rigidity of the pole base plate (and additional 4.5 in sleeve) effectively arrests the expansion of the cross-sections close to the base.

(a) Fractured base plate and sleeve

(b) Fractured base plate and sleeve

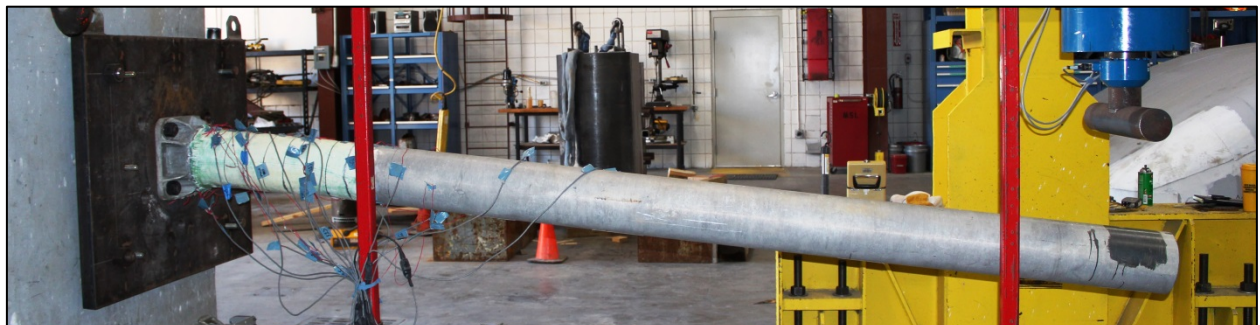
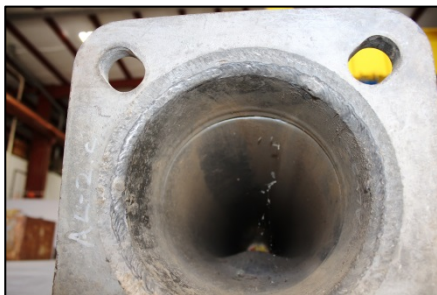
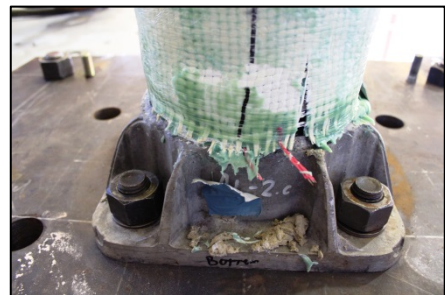
Figure 196. AL-2.c failure modes

The pole failed at 2.6 kip load when a hinge formed near the pole base and the base metal fractured 5 in from the base on the tension face. The substantial residual displacement at the end of the test is visible in Figure 196 (a). The fracture is shown in Figure 196 (b) and Figure 197 (a). The failure occurred at the termination of the sleeve, which is clear from the rotation in Figure 196 (c). Interestingly, the failure load was almost identical to AL-1.c although the failure did not occur in the base plate and the dent depth was larger. As with AL-1.c, the repair itself was therefore not tested to failure; however, the failure load was substantially larger than the theoretical yield capacity.

(a) Final displaced pole shape

(b) Failed base plate connection

(c) Ruptured fibers and failed base plate connection

(d) Ruptured FRP fibers on compression side base plate

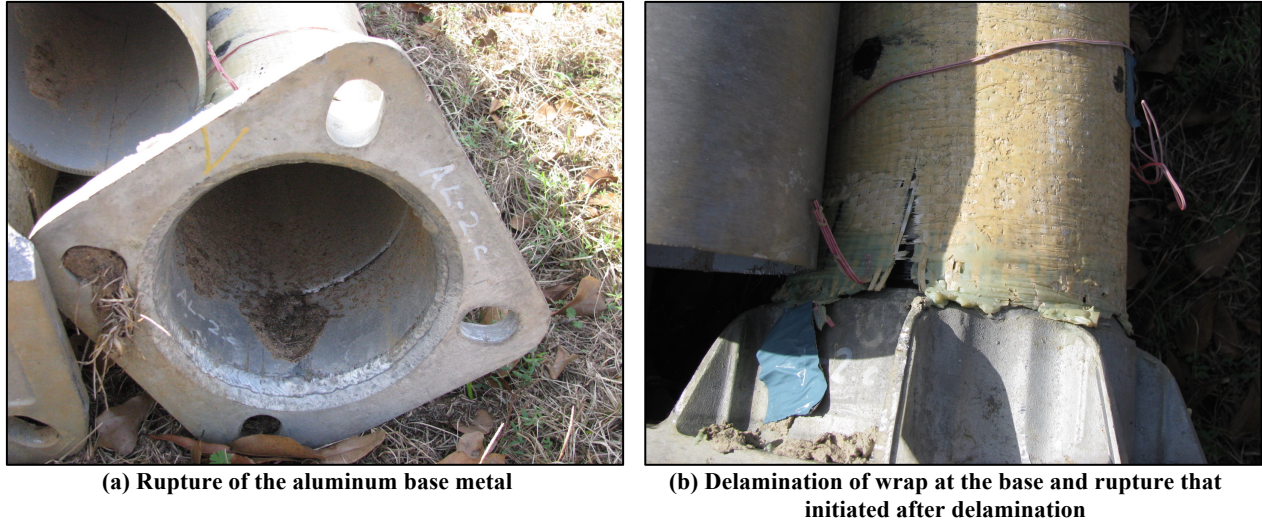
Figure 197. AL-2.c after testing

Substantial substrate and FRP strains were recorded near the base section and dented cross section, as shown in Figure 194. The aluminum compression strains reached  $-7500 \mu\epsilon$  at section 1 and  $-4000 \mu\epsilon$  at section 3. Substrate yielding likely occurred in a majority of the sections instrumented, with strains higher than  $4000 \mu\epsilon$  recorded in all the tension metal gauges across the top four sections. The FRP may have debonded on the compression face near the base (near S19) at the peak load, or it may be related to the rupture seen in Figure 196 (d) and Figure 197 (b). The rupture in the FRP at the base does not appear related to the dilation of the cross section, as the transverse strains remained small at all load levels, except for the engagement of the circumferential wrap at the dented section as would be expected (S24 recorded approximately  $1300 \mu\epsilon$  at the peak load). Therefore, it is likely the failure was due to splitting from the initial overlap of the wrap with the sleeve, as seen in Figure 196 (c and d) and Figure 197 (b), when the rotation of the cross section increased.

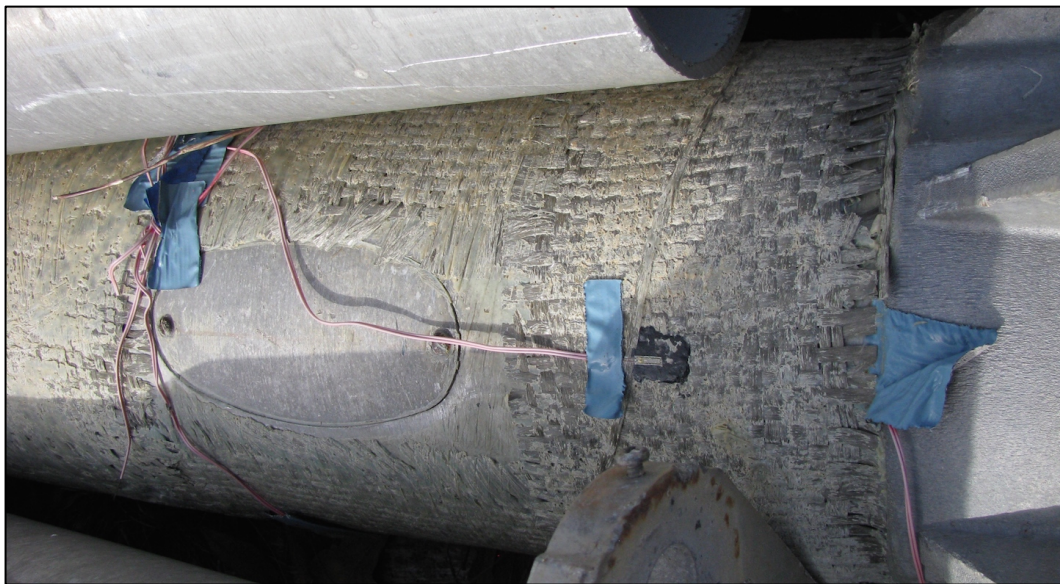
Figure 203. AL-3.c laminate surrounding access port cover

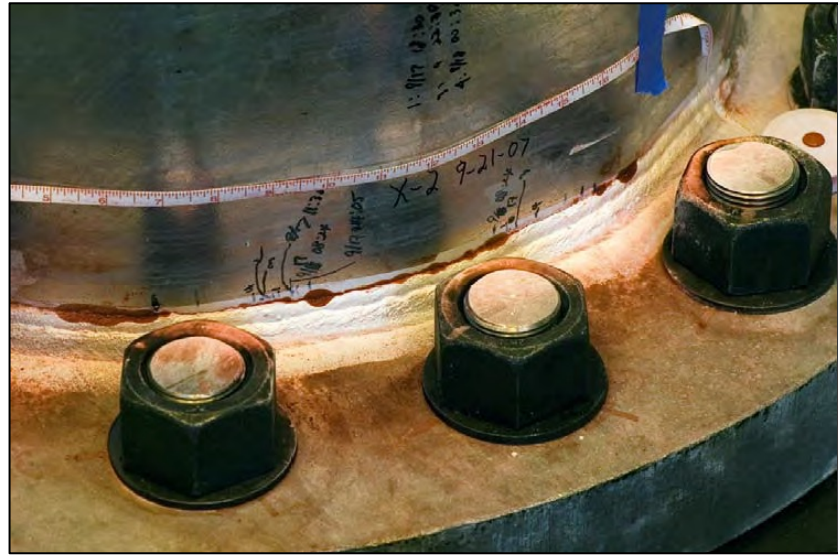
commonly initiate at the weld toe location at the pole-to-base-plate connection, as seen in Figure 205.

Figure 205. Fatigue cracking at the connection pole-base plate fillet weld toe (NCHRP-176, 2011)

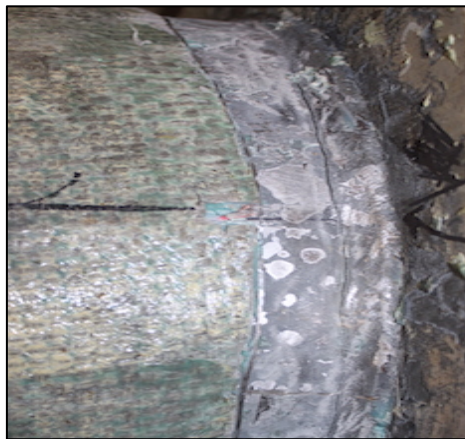
Following the cycles at stress level A, the pole was monotonically loaded to failure. The test was stopped at the initiation of a crack at the weld toe on the tension face of the pole, as seen in Figure 221 (a) and (b). Such a crack at the weld toe is expected in fatigue prone details, and may have initiated during the 1000 cycles at stress level A. The post-fatigue monotonic test also resulted in substantial damage to the repair system. The circumferential laminate near the damaged section ruptured, as shown in Figure 222 (a), and compressive buckling occurred on the bottom of the pole surrounding the debonded region, as shown in Figure 222 (b). The debonding at the dented region likely began during the cycles at stress level A, but propagated in the monotonic test. Debonding at the pole base on the top side of the pole is shown in Figure 222 (c), and debonding on the bottom side of the pole is shown in Figure 222 (d).

(a) Cracking at weld toe

Figure 221. ST-7 cracks after post-fatigue monotonic test

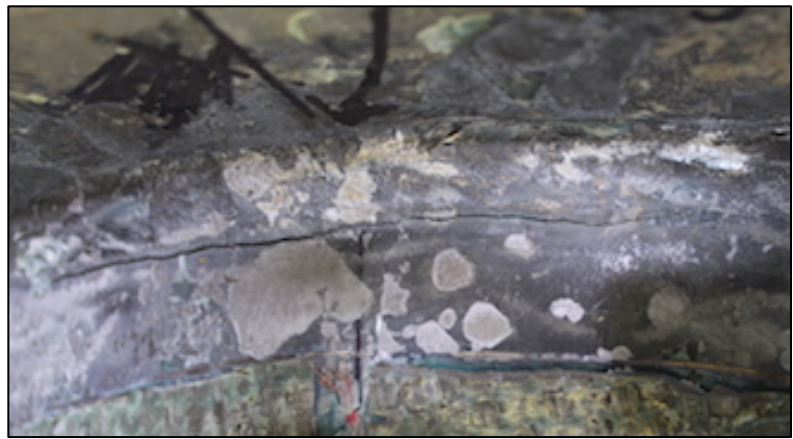
(b) Crack detail

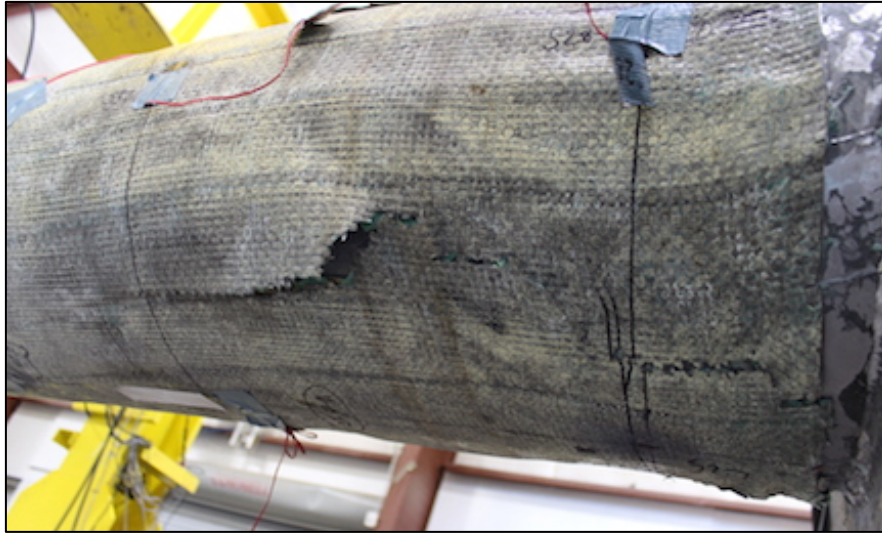
(a) Delamination and rupture of wrap initiating near base and propagating to midsection

Figure 222. ST-7 failure modes after post-fatigue monotonic test

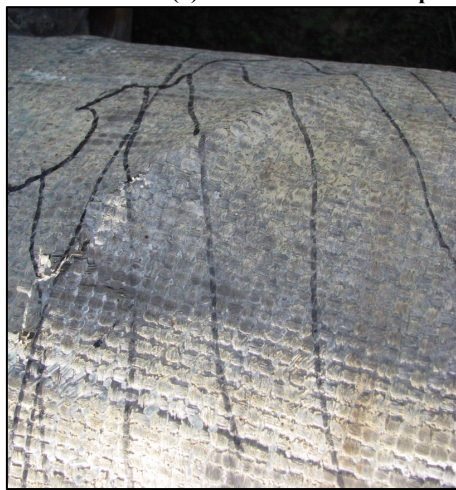
(b) Compression wrap failure

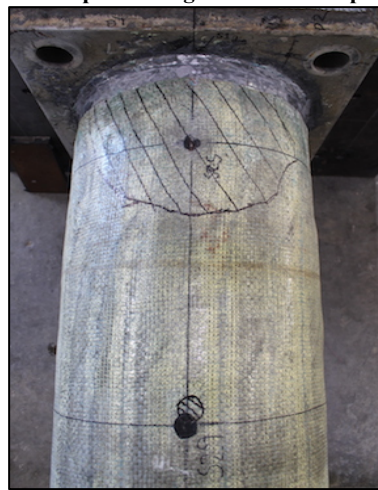
(c) Debonded areas (top)

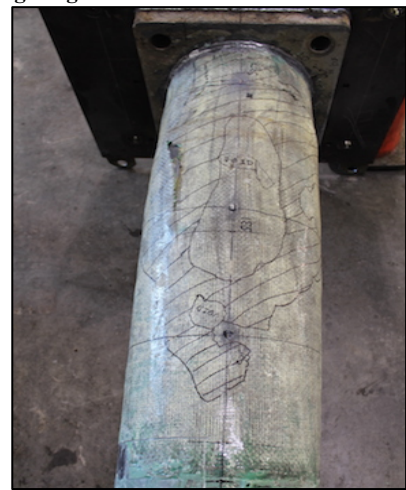
(d) Debonded areas (bottom)

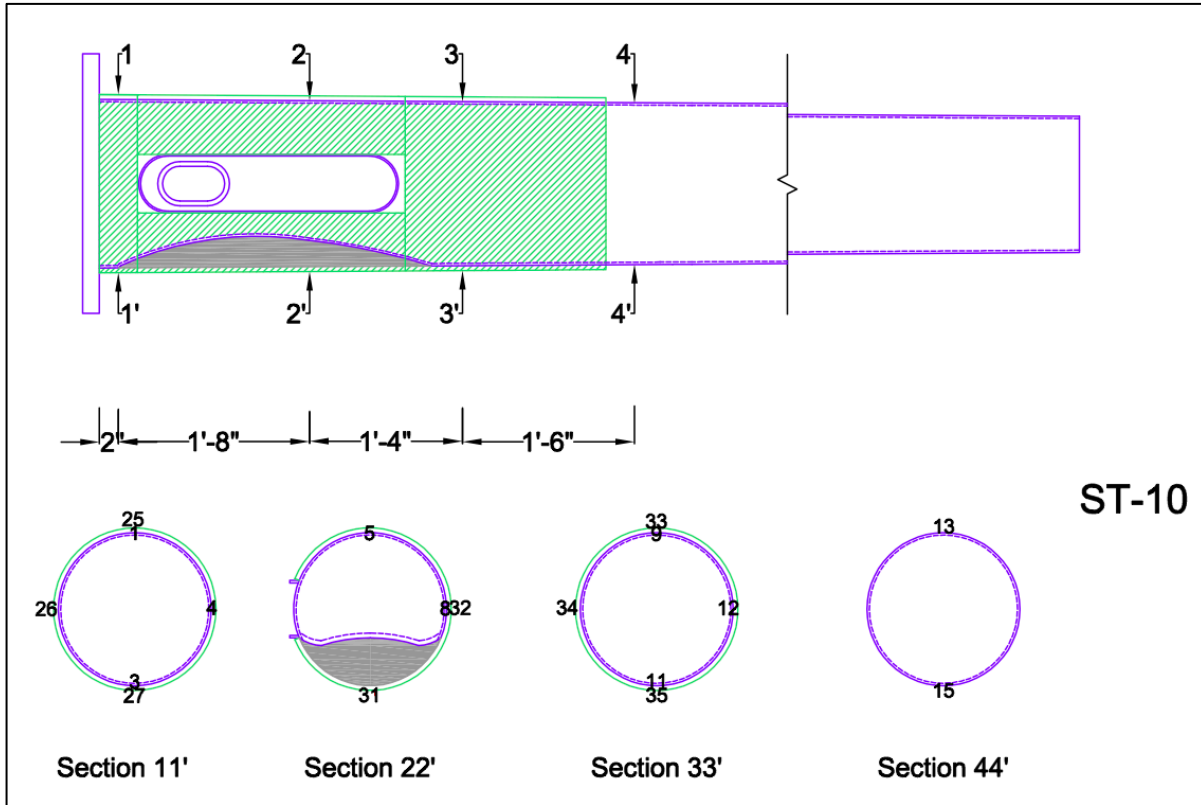
Figure 226. ST-10 strain gauges

After only approximately 1500 cycles, the pole failed suddenly due to a rupture of the weld between the tube and base flange. The displacement compliance and strain data with respect to load are shown in Figure 224 and Figure 225, respectively, shown only for the cycles in which the data acquisition was acquiring data. The recording was not continuous; therefore, not all the test data for this pole is available due to the short number of cycles before failure. The locations of the various strain gauges are shown in Figure 226.
