## Repair Of Impact Damaged Utility Poles With Fiber Reinforced Polymers (FRP), Phase II

### University of Central Florida

**FINAL REPORT**

*June 2015*

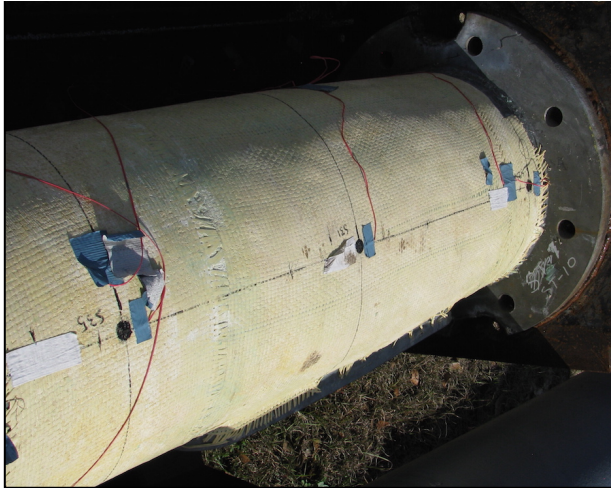
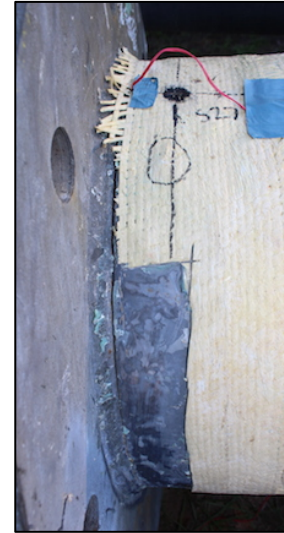
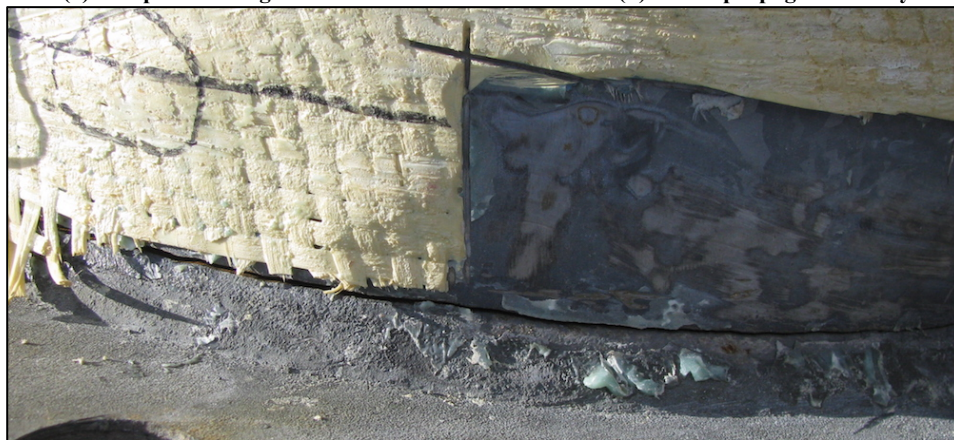
Figure 227. ST-10 wrap and crack at base weld

The pole cracked at the weld toe and no further testing was completed. The crack and propagation of the crack around the circumference of the pole base is shown in Figure 227. As indicated by the predicted number of cycles to failure using the methods above, the fracture occurred significantly earlier than expected. No damage or delamination was evident in the repair system. A small portion of the wrap near the base was removed to better show the crack, as shown in Figure 227 (b) and (c), and was not a byproduct of testing.

(a) Wrap not damaged

(b) Crack propagated nearly full depth

(c) Crack detail

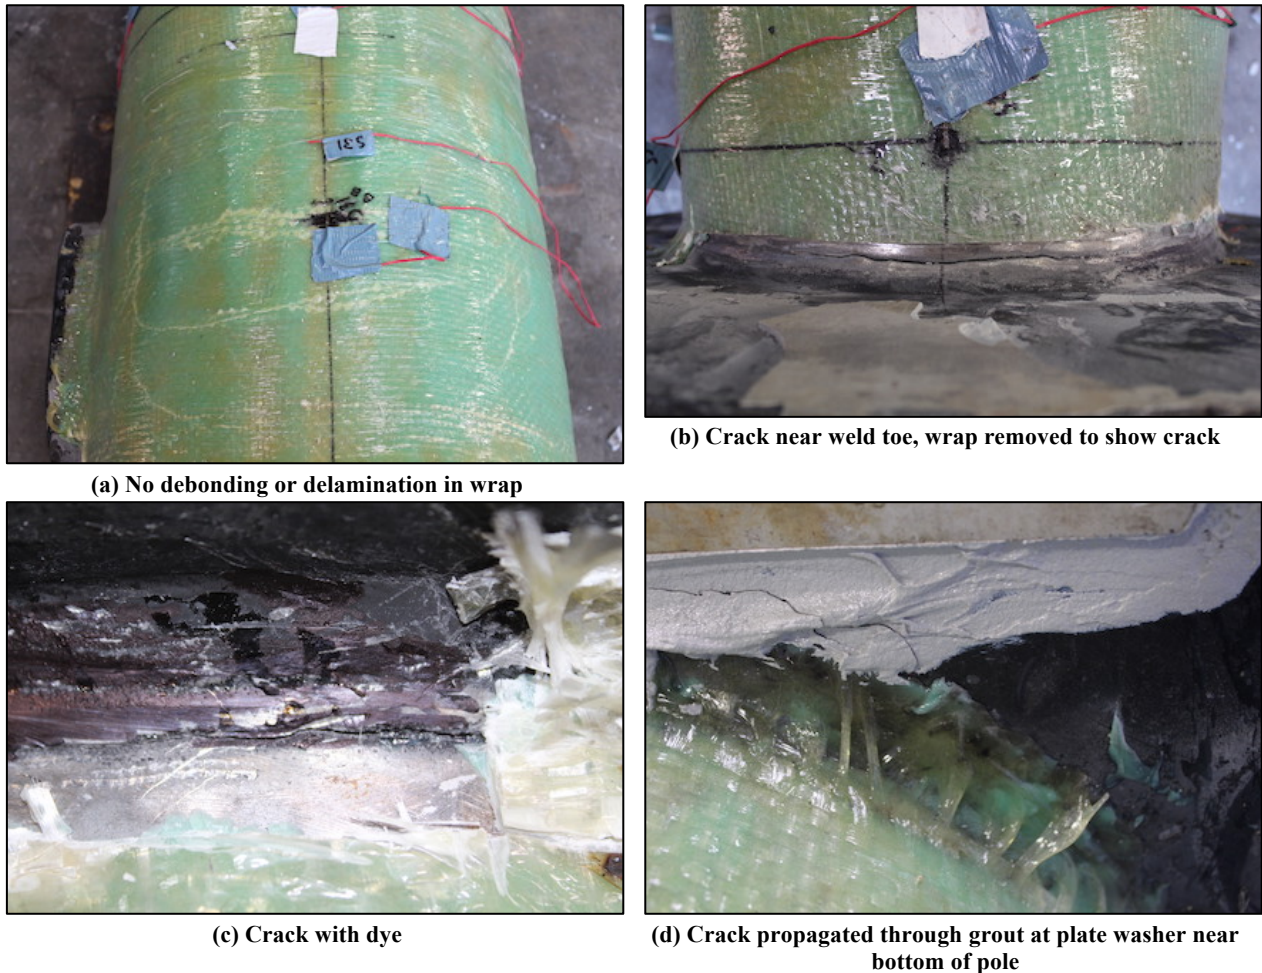
Figure 235. ST-11 failure modes

During cycling at stress level A, the pole experienced a fracture in the weld toe at the base connection. The following figures show the state of the pole after the fatigue crack stopped the test. After the increased stress amplitude cycles, no debonding or delamination was apparent in the repair, as shown in Figure 235 (a). The crack encircled a majority of the circumference at the bottom side of the pole, Figure 235 (b) and (c). The laminate was cut and removed to show the crack. Prior to removal of the pole from the buttress, the crack can be seen propagating through the grout surrounding the plate washer in Figure 235 (d).

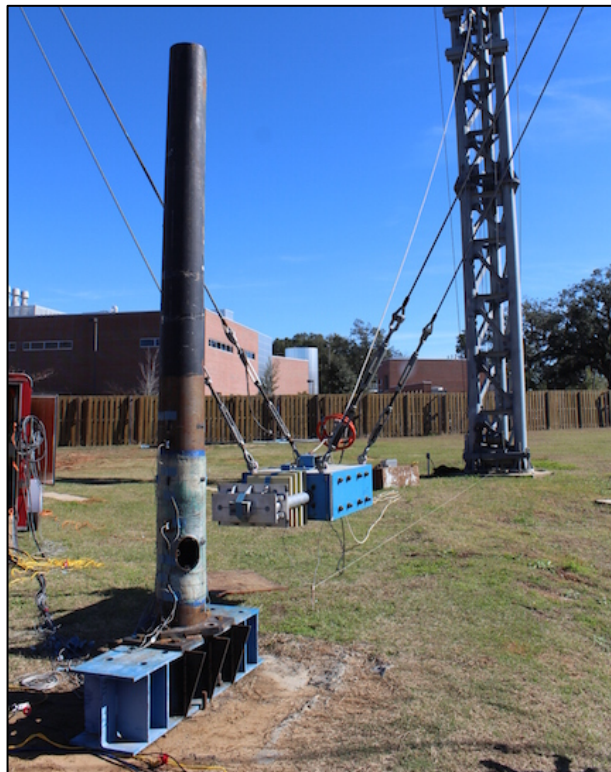
Figure 241. IM-1 test configuration

Because of the existence of the access port, the transverse wrap was proportioned into two pieces. A longitudinal wrap was placed on the dent side of the pole extending around the perimeter to the lip of the access port on each side. The transverse and longitudinal wraps were terminated at a height just below the pedestrian button. The full details of the repair are shown in Appendix A. The repaired pole is shown in its vertical cantilever test configuration in Figure 241.

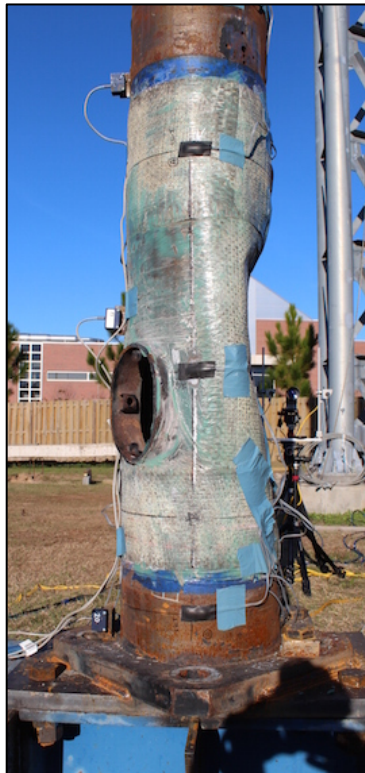
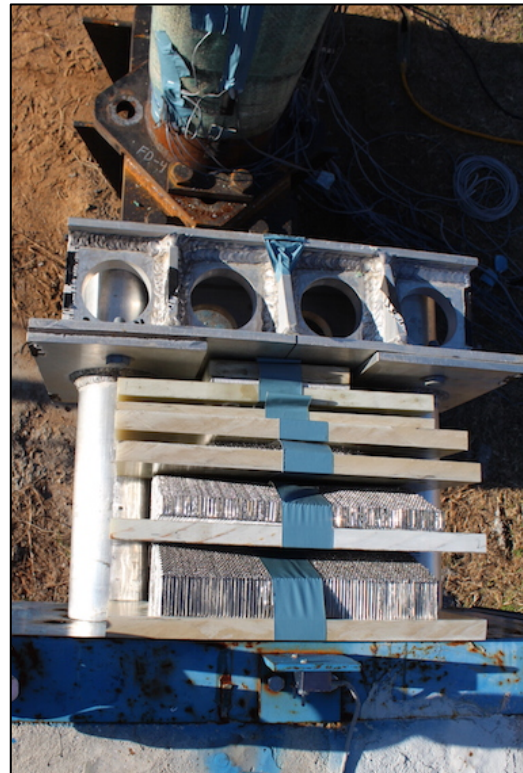
Figure 247. IM-1 post-test state of the pole and crushable nose

The aluminum honeycomb cartridges after the test are shown in Figure 247 (b). As mentioned previously, the final two cartridges did not crush during the test. The final deformed shape of the pole, indicating substantial plastic deformations, is shown in Figure 247 (a). The strain gauge that recorded compression values is in the foreground at the lower side of the dent profile. The FRP repair itself did not suffer any visible delamination, buckling, fracture of fibers, or other permanent damage, except for the location where the steel impact piece bore directly on the laminate. The damage in the impact region can be seen in Figure 248 (c) and (d) where both hinging occurred as well as some longitudinal splitting. The access port itself also has visible plastic deformation. However, the global stability of the pole was not affected and the residual displacement at the tip of the pole was negligible.

(a) Profile of dent created by impact head

(b) Deformation of aluminum honeycomb cartridges

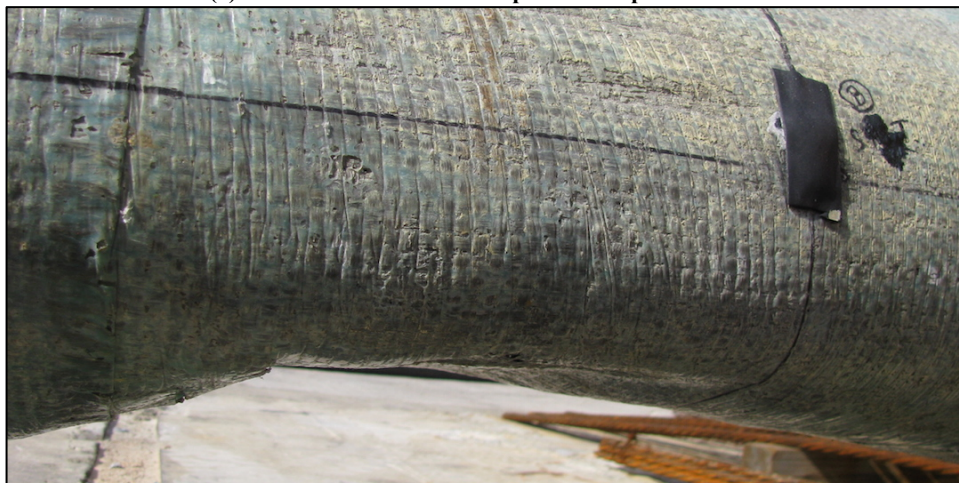
**(a) Deformation of the access port and rupture in FRP**

**(b) Local deformation and rupture of FRP in impact head region**  
**Figure 248. IM-1 post-test state of repair material at impact location**

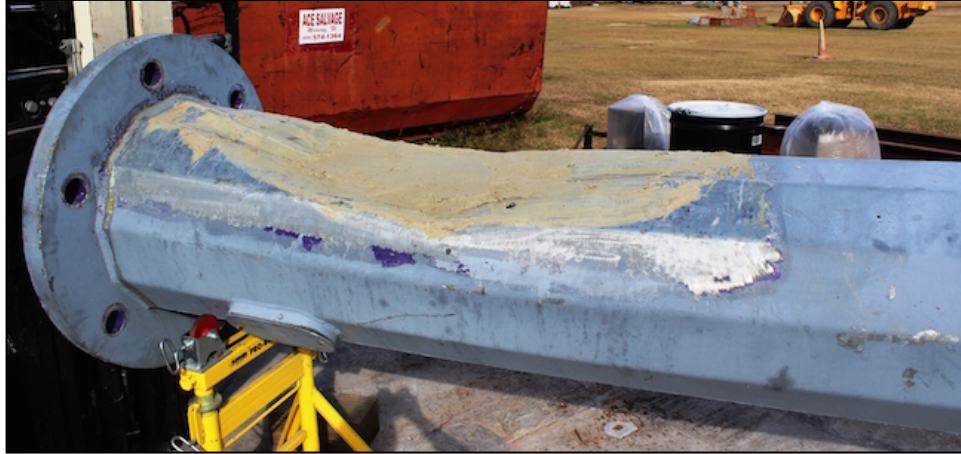
**Figure 249. IM-2 dent cavity volume requiring fill material**

The second pole for impact testing was also retrieved from the field and had a substantial dent and damage to the pole. In addition, the pole itself was significantly larger than IM-1 with a base diameter of 21 in and a multi-sided cross-section. A small access port was present, oriented approximately 130° from the dented face. This pole had one large dent centered 33 in from the base plate, but with extents of the dent almost 5 ft from the base flange up the pole. The dent depth was 5 ¾ in, or approximately 28% of the outer diameter at the center of the dent location. This pole was prepared for the test by filling the dent, which was performed initially with the fill material used for the other poles. However, due to the volume of the fill, some additional Bondo material was used to restore the pole to its initial geometry prior to wet layup. The extents of the dent and the volume of fill material required are evident in Figure 249. The fill material was applied in several batches, and noticeable shrinkage cracks developed after the first batch cured.

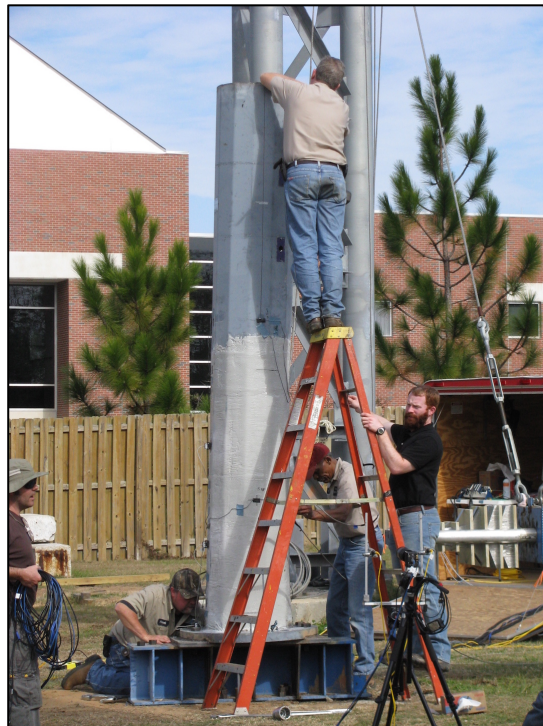
**Figure 250. IM-2 test configuration**

The repair system consisted of glass fibers and epoxy saturating resin. Because of the existence of the access port, the transverse wrap was proportioned into three pieces, the full details of the repair are shown in Appendix A. The repaired pole is shown in its vertical cantilever test configuration in Figure 250. As with IM-1, IM-2 was tested without any additional mass at the top of the pole, i.e., from a mast arm. The pole was impacted using the pendulum and a 12 ft drop height. The strain time histories are shown in Figure 251. The locations of the various strain gauges are shown in Figure 252.

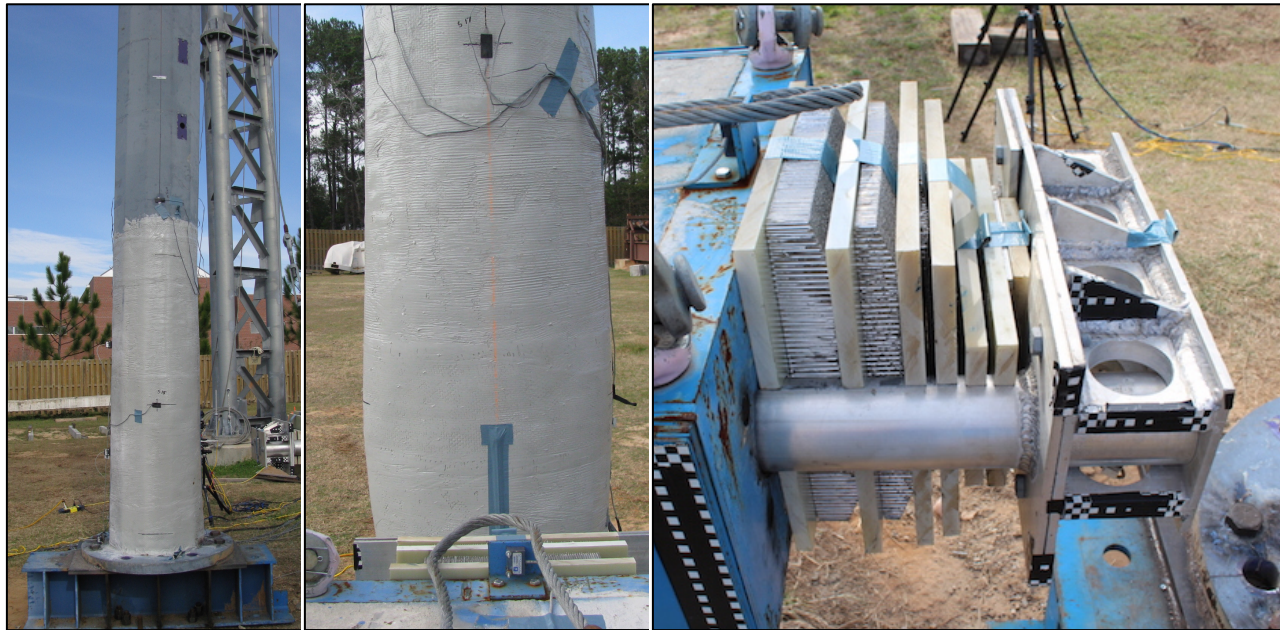
Analysis of the strain shows substantial longitudinal and transverse strains developing, both in the FRP and steel, that effectively arrested any deformation of the pole in the repaired region. The pole had an initial vertical offset due to the initial damage sustained that was not affected by the impact, as seen in the post-impact state of the pole in Figure 256 (a). The minor dilation of the cross section in the center of the original dent is visible in Figure 256 (b), as confirmed by the strain data. The minor crushing of the tapered portions of the last two aluminum cartridges (closest to the mass block) are shown in Figure 256 (c).

(a) After impact

(b) Transverse dilation of specimen at impact location

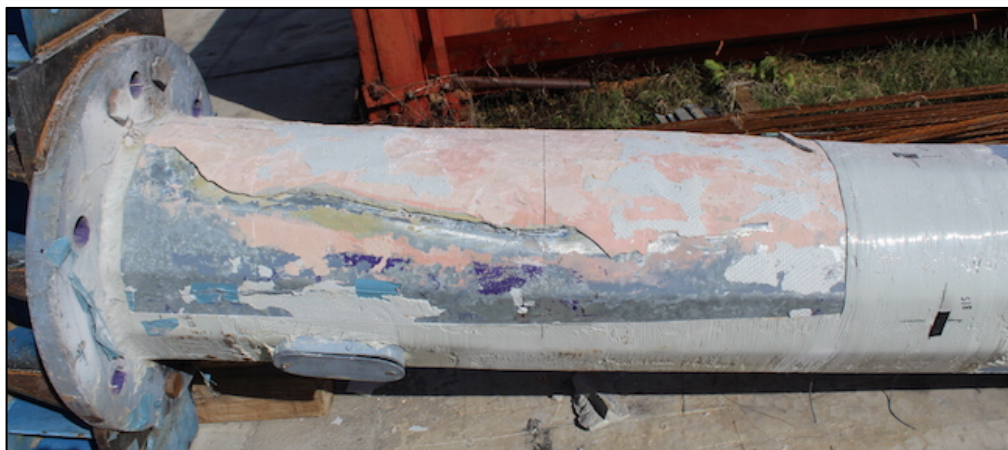
To investigate whether the repair had sustained damage that was not visible, the exterior laminate was cut off the pole after testing. The fill material remained bonded to the pole with the only damage a longitudinal crack near the impact location, as shown in Figure 257 (a). The adhesive bond between the laminate and the fill material appears to have been highly uniform sufficient to cause failure in a thin layer in the fill material. The fill material on the other side of the longitudinal crack remained bonded to the laminate when removed, as shown in Figure 257 (b).

**(a) Fill material after impact with wrap removed**

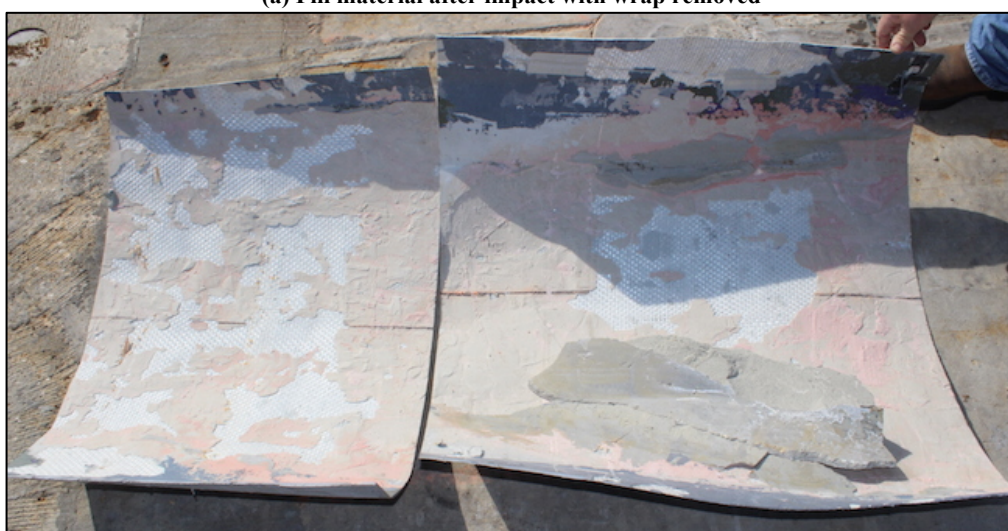
**(b) Adhesive and wrap on adhered impact side of pole  
Figure 257. IM-2 forensic view of the repair material**

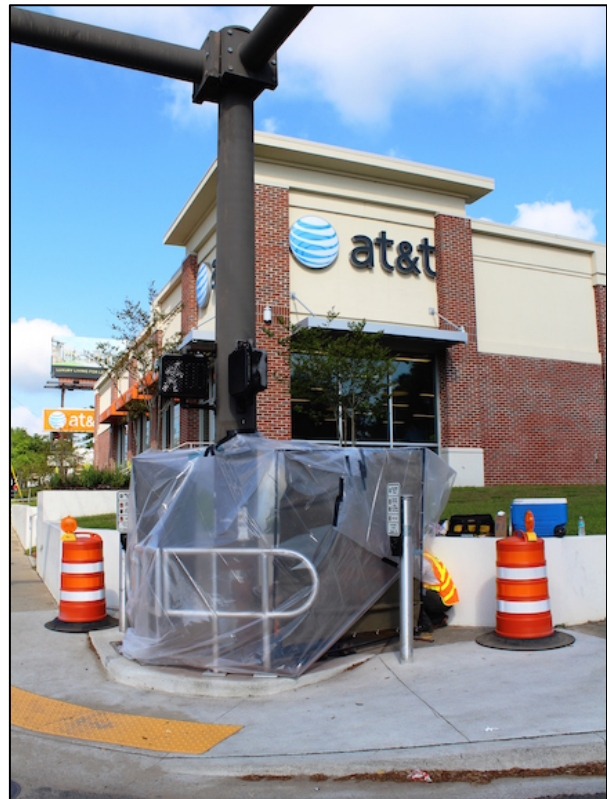
(b) Protective plastic tent during installation

Figure 258. In-situ damaged pole and site preparation

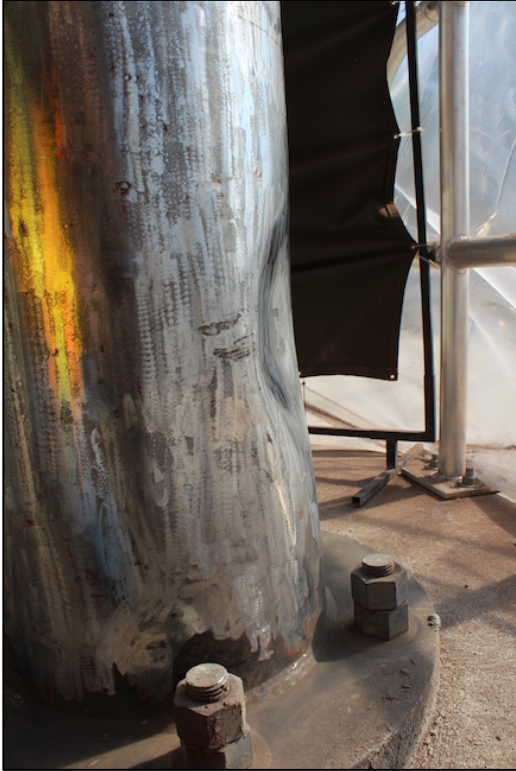
(a) After surface preparation in the repair region

To allow for potential problems or delays, a three-day maintenance of traffic window was used. The first day was used to prepare the site and the pole. As described in the recommended procedures in this chapter, the galvanizing layer in the area of repair was removed using a sandpaper flapper wheel and angle grinder, as shown in Figure 259 (a). In addition, the region with the dent was scored with a grinding wheel to promote bond between the metallic substrate and filler and adhesive materials. After surface cleaning, the filler material (Bondo in this case) was prepared and applied with a spatula to return the original geometry of the pole. The fill was sanded after curing, as shown in Figure 259 (b), in preparation for the FRP installation.

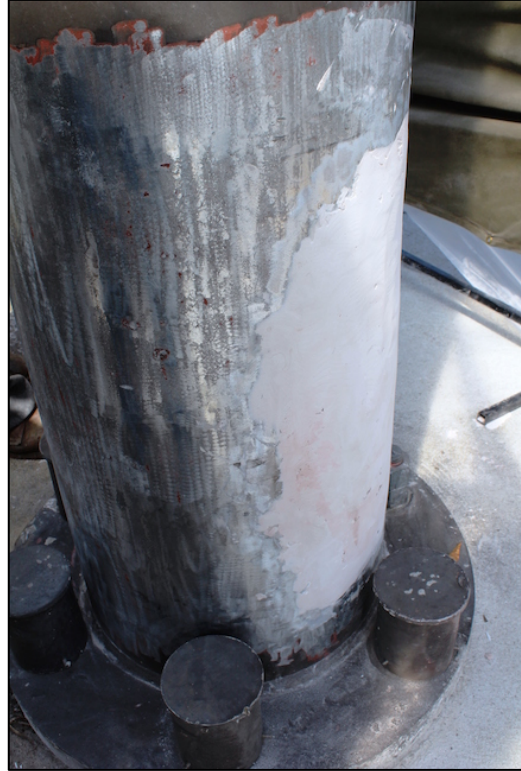
(b) After dent filler application and sanding

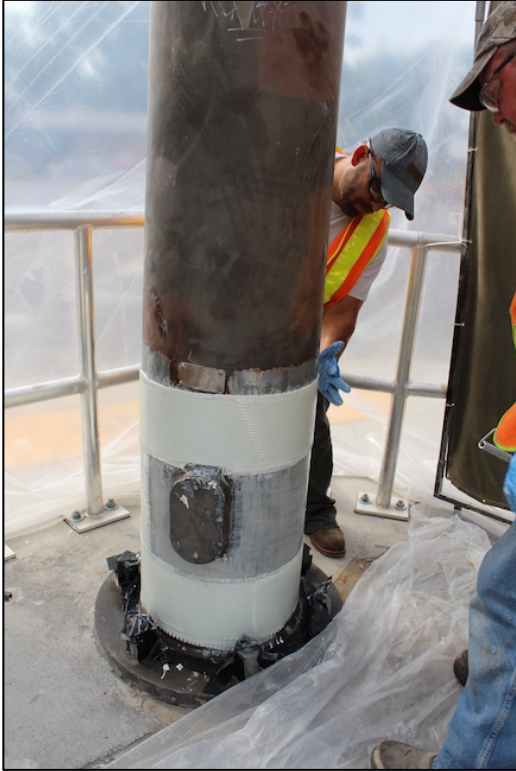
(a) Rolling transverse layer of GFRP

On the second day, an adhesive layer (Sika 32) was applied to the locations where FRP laminates were to be bonded. The FRP layers were installed directly to the primed pole after misting water onto each of the pre-preg wraps from the sealed bags (order of laminates: L = longitudinal, L, T = transverse, and T), as shown in Figure 260 (a). Each layer was rolled with a FRP roller for several minutes continuously to prevent build up of carbon dioxide bubbles from the curing process. After all layers were installed, a thick plastic wrap was installed and tensioned around the wrapped region. Punctured holes in the plastic wrap allowed continuous rolling (and exchange of gas) until fully cured, as shown in Figure 260 (b). In addition, the plastic wrap prevented the layers from sagging, resin rich areas could easily be identified and rolled more, and the irregular geometry of the pole, access port, laminates, etc. could be supported as the plastic is only temporary.

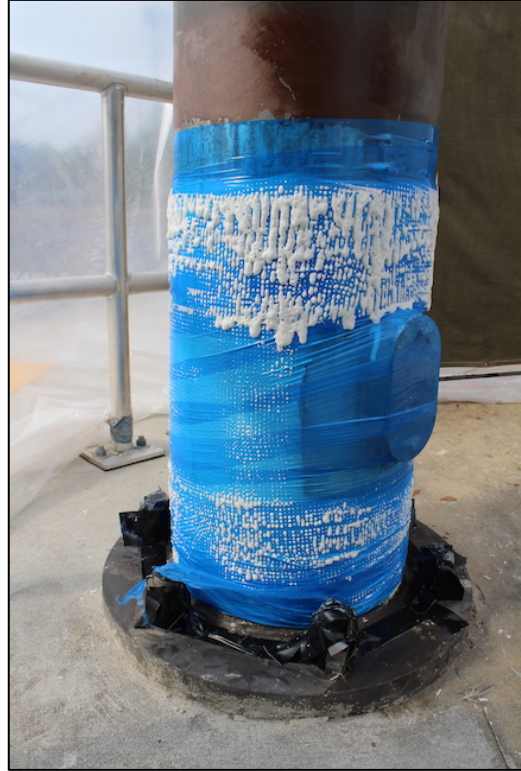
(b) Perforated plastic wrap for rolling

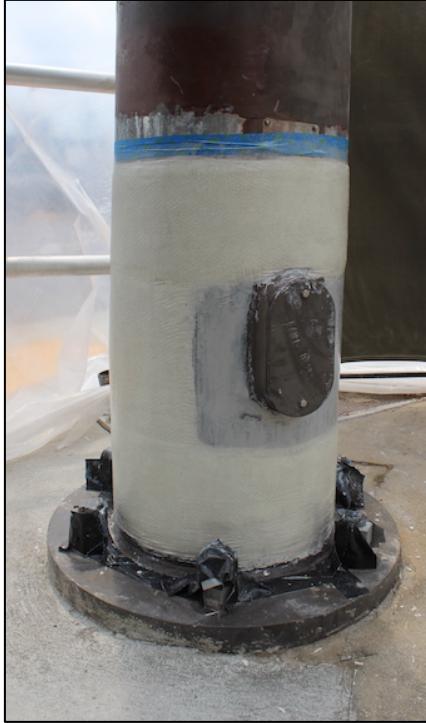
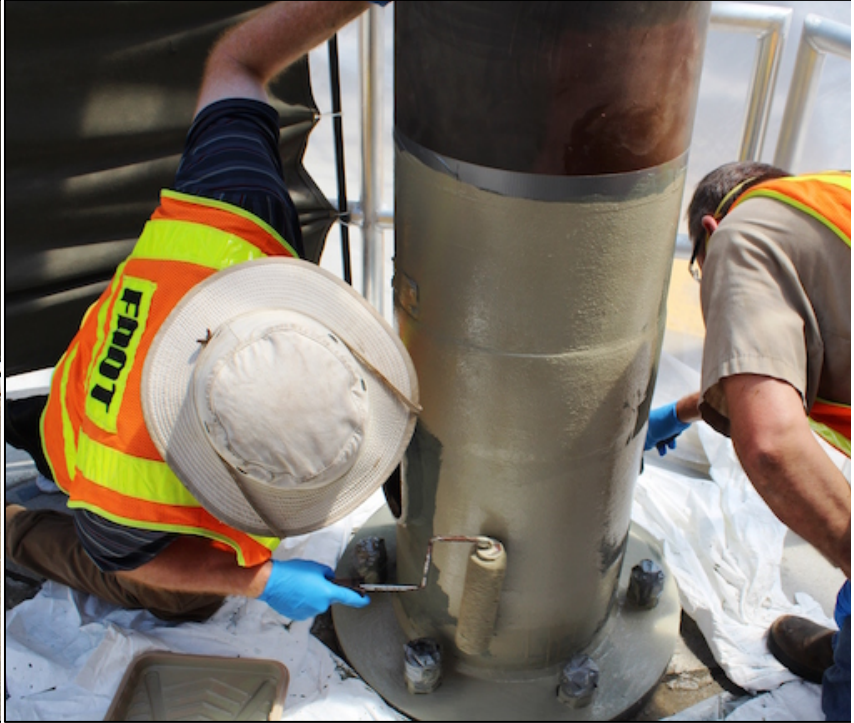
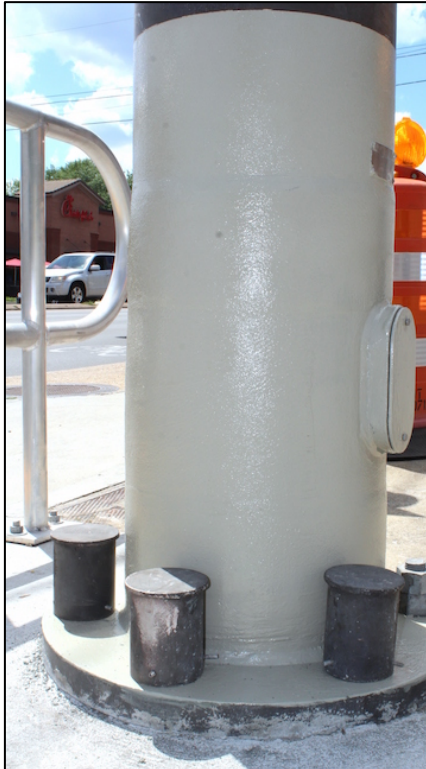
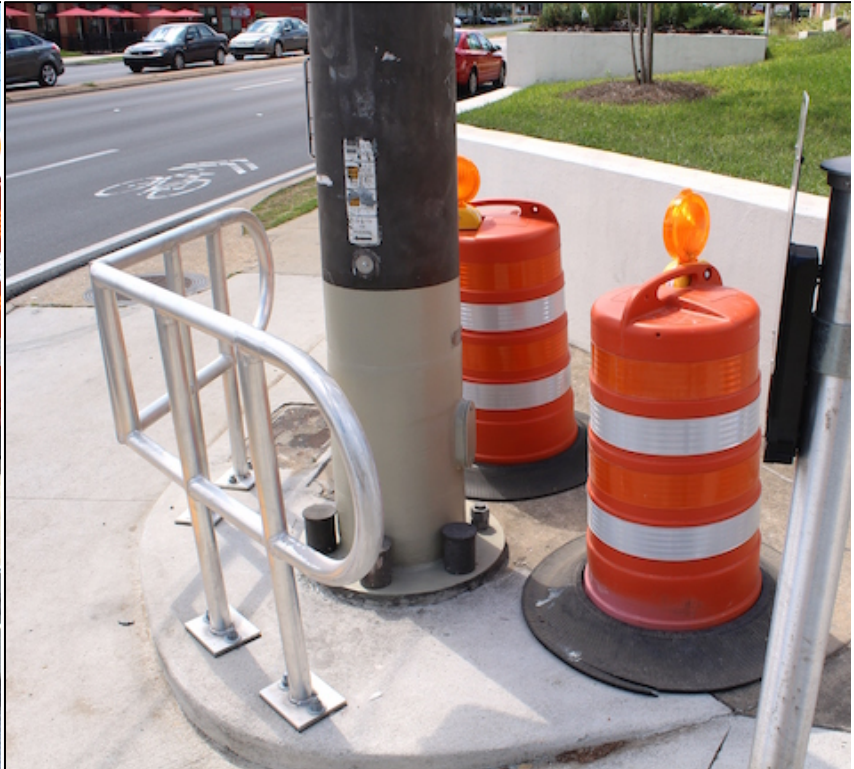
Figure 261. Painting and final product

(a) Wrapped pole before painting

(b) Painting in progress

(c) Close-up after painting

(d) Final state after removing protective enclosure

On the third day, the perforated plastic wrap was removed and the pole was painted. Prior to painting, any additional resin that was added during the wrapping phase was sanded off to provide a smoother finish for painting. The painting of the pole and the final product are shown in Figure 261.
