Durability Evaluation of Florida's Fiber-Reinforced Polymer (FRP) Composite Reinforcement for Concrete Structures

Final Report

March 2017

Florida Department of Transportation (FDOT)
David Wagner, P.E. – Project Manager

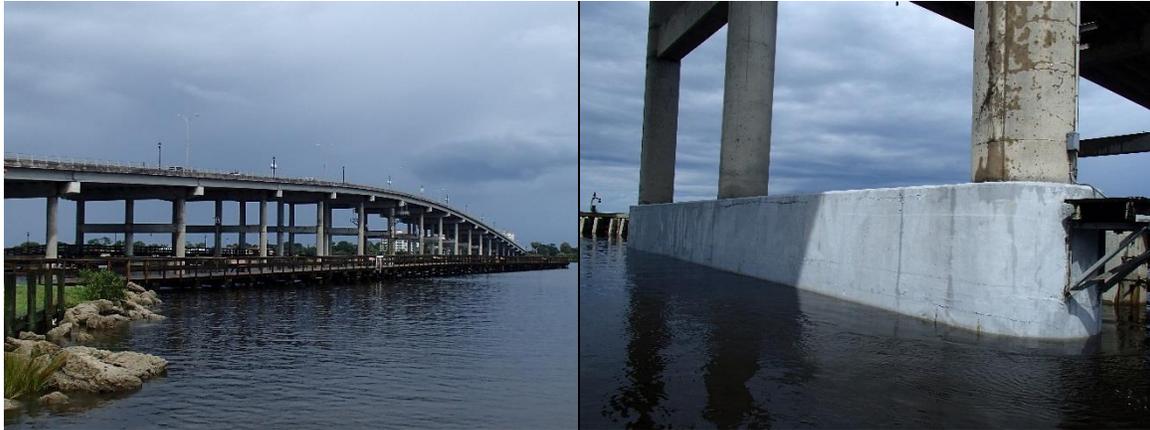
Initial visit to Grenada Bridge in Ormond Beach, FL (Figure 58a) occurred on Monday, September 29, 2014 to observe FRP repairs on the crash wall of Pier 8. On Monday, November 3, 2014, an additional trip was taken by personnel from FDOT State Materials Office (SMO) Corrosion Lab and eUniversity of Florida to perform coring for chloride content testing and

Figure 58—(a) Grenada Bridge (b) crash wall of Pier 8

FRP-concrete bond was evaluated by coin-tap method during the initial visit; based on the results it was concluded that the bond was in good condition. Pull-off testing, however, revealed that bond strength was less than 200 psi (Table 8), which is recommended by ACI 440.2R-08 and NCHRP (2010) specification. In addition, the failure modes (Figure 60) were typically adhesive and not cohesive; cohesive failure mode in which the failure plane passed through the concrete is preferred. The adhesive failure modes for the majority of the performed tests may indicate a degradation in bond over the service life or perhaps initial installation problems. This could only be confirmed if pull-off tests were conducted immediately following installation of the CFRP composite for comparison purposes. Exact locations of pull-off tests are included in Appendix B.

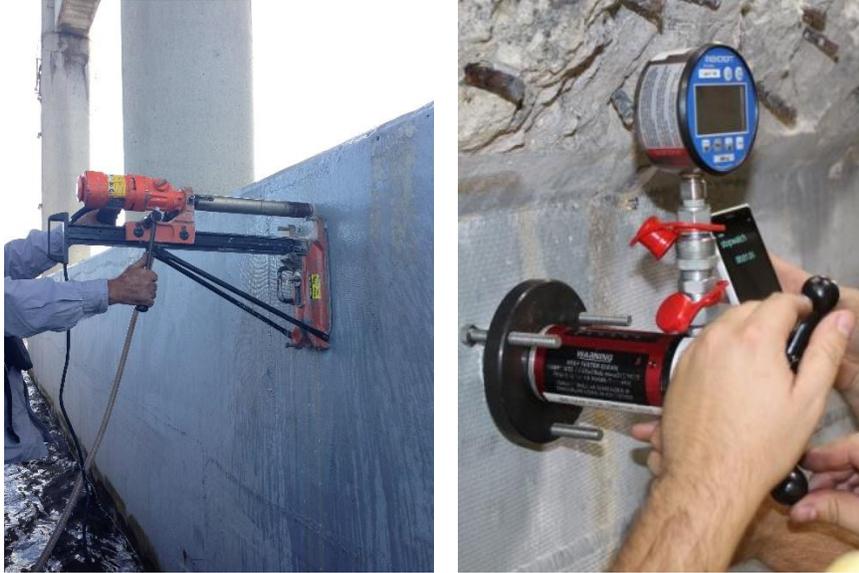
Pull-off testing was performed in accordance with ASTM D7522 (Figure 59b) to assess the bond capacity of the bonded FRP composite. On Monday, November 3, 2014, pull-off locations were scored and test disks were attached. On the following day (November 4, 2014), pull-off tests were conducted.

Figure 59—(a) Coring (b) direct tension pull-off test apparatus

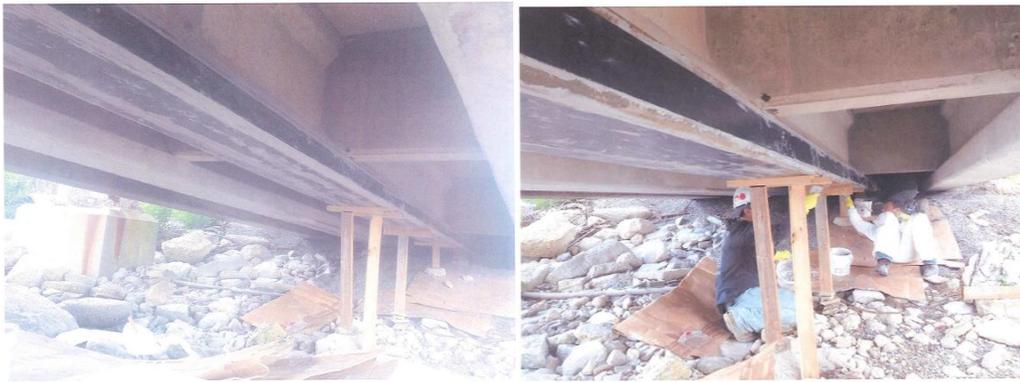
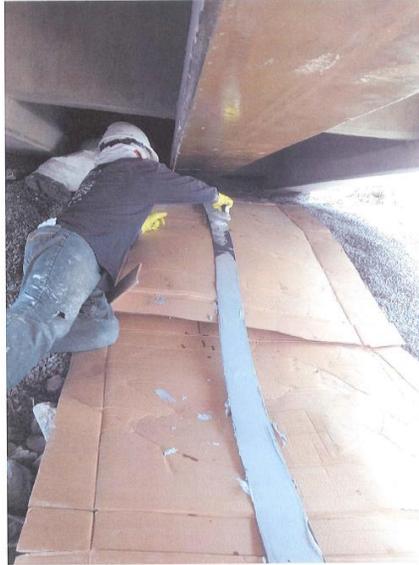
Berth 21 at Port of Tampa was repaired in 2011 with FRP wraps by Premier Corrosion Protection. The span adjacent to the abutment experienced significant spalling due to corrosion, which affected the load-carrying capacity of the span. Two precured CFRP laminate strips were applied at the tension face, and then the girders were wrapped. No significant debonding was noted when the FRP was sounded with coin tap. CFRP installation photos and site conditions are shown in Figure 62 and Figure 63. A coating, most likely to match the finish of the concrete material and serve as a UV protection, was applied on the surface of the CFRP wrap.

Figure 62—CFRP laminate strip installation at Port of Tampa Berth 21

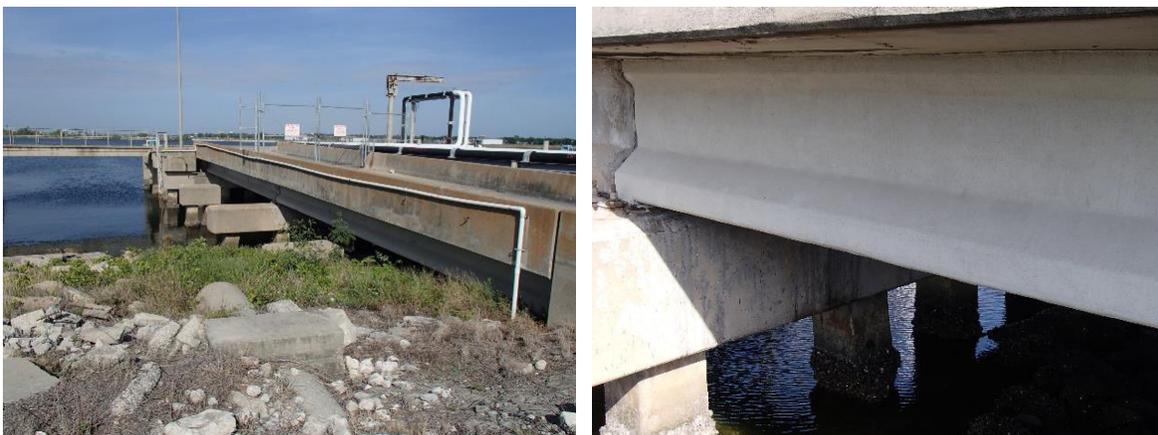
Figure 63—Site conditions at Port of Tampa Berth 21

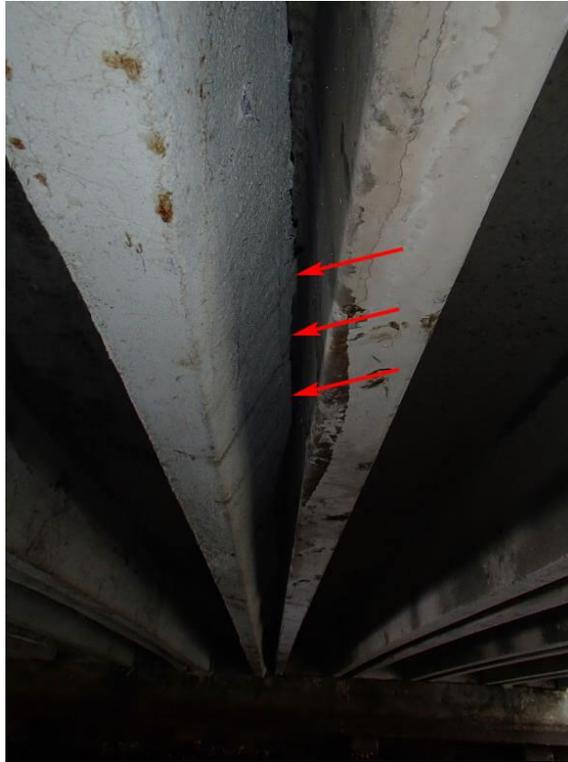
Phillips Lane bridge experienced significant corrosion damage (brackish water environment), and was repaired with CFRP wraps in 2001. No significant deterioration of the composite wrap was observed (Figure 64), with an exception of one girder where an entire side of the wrap was debonded as observed during the visual inspection (Figure 65) based on visual inspection. The debonded CFRP was located on one of the vertical faces of the concrete channel girder; close proximity of adjacent webs would have made accessing the concrete for surface preparation and CFRP installation difficult. Observation of multiple pull-off test locations (performed in the past) revealed rust staining and adhesive failure modes (Figure 66). The inspection was performed in 2015.

Figure 65—Debonded FRP wrap on a double tee girder

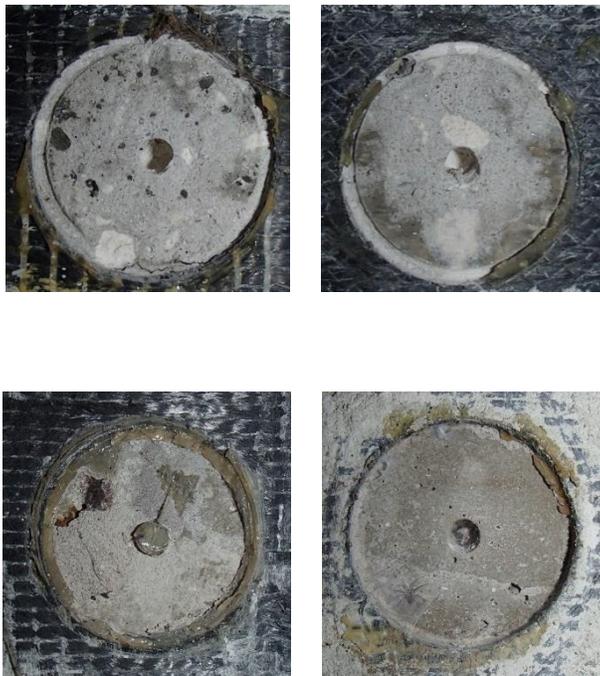
Figure 66—Pull-off test locations on Phillips Lane Bridge indicate adhesive failure modes. It is not known when these pull-off tests were conducted

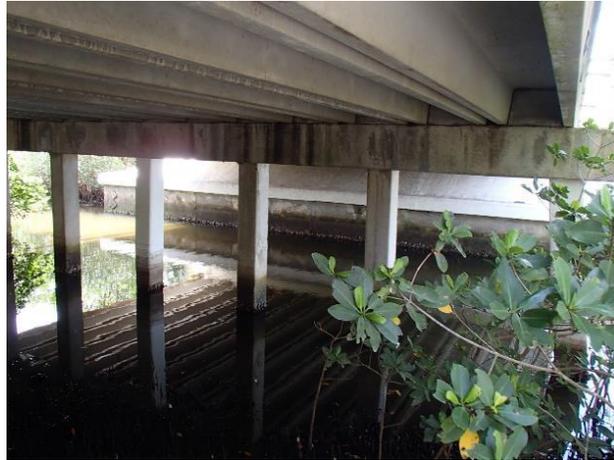
Two piles were repaired by wrapping with CFRP (Figure 67 and Figure 68). Coin tap sounding revealed minor debonding in both piles. Decay of the coating was apparent in the exterior pile, most likely due to exposure to sunshine.

Figure 67—Repaired piles on Dickman Road Bridge

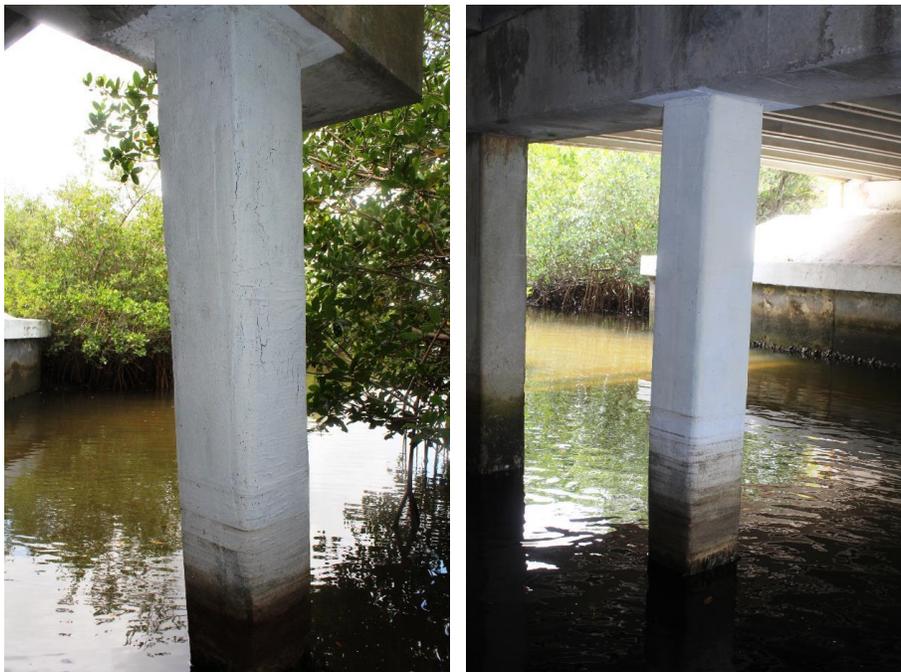
Figure 68—FRP-confined piles on Dickman Road Bridge

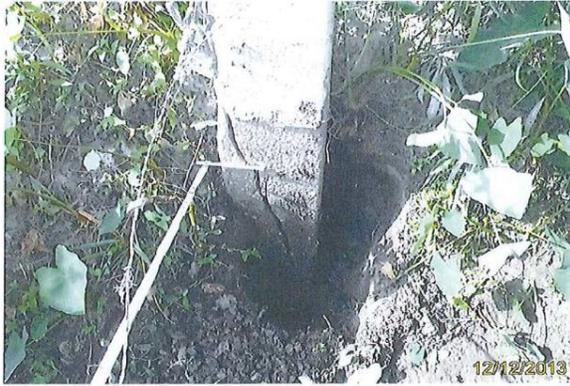
An impact damaged pile (Figure 69) on Durant Road Bridge was confined with CFRP. Coin tap sounding revealed two debonded regions shown in Figure 70. The middle section of the superstructure was also repaired with CFRP (Figure 71), presumably to offset the damage due to a longitudinal crack in the deck crossing multiple spans.

Photo #1 Element 204 - Pile 3-5 fracture in east face

Figure 69—Cracking at the base of pile due to impact

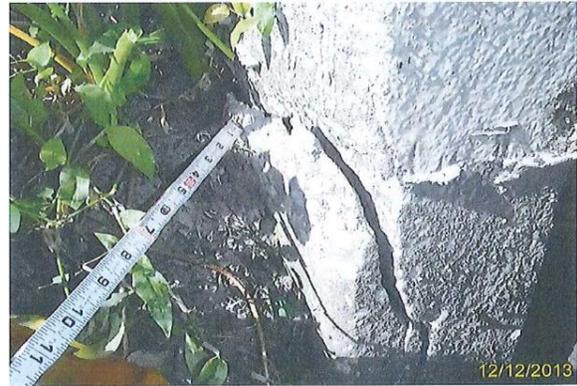
Photo #2 Element 204 - Pile 3-5 fracture in south face

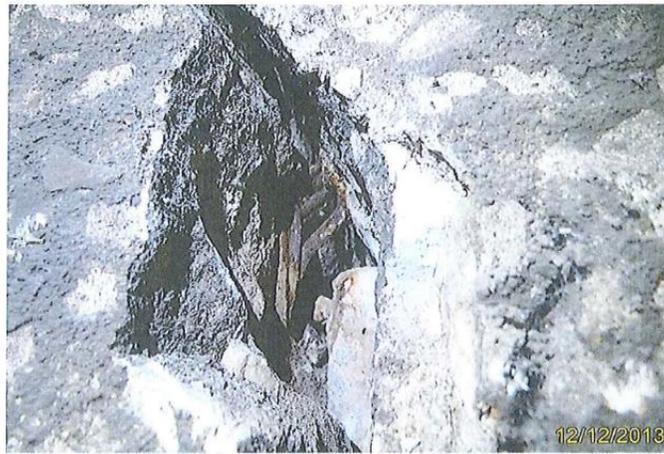
Photo #5 Element 204 - Pile 3-5 exposed and corroded prestress strand (visible through east face)

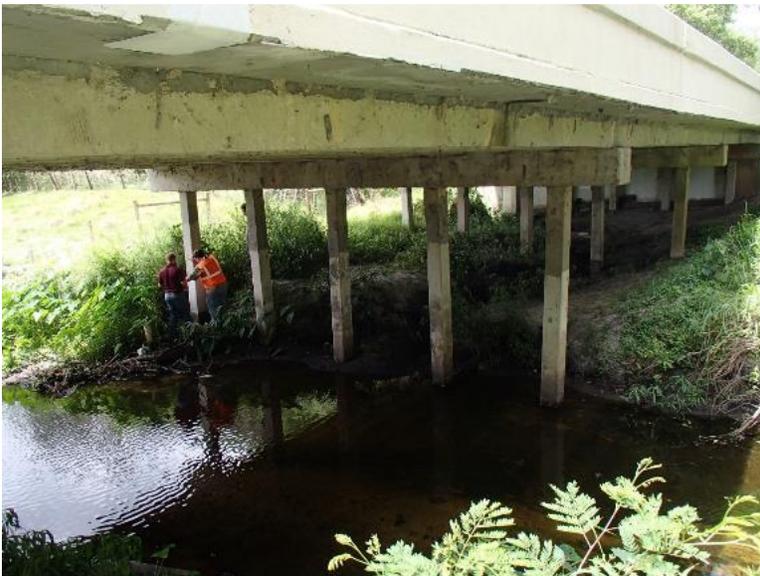
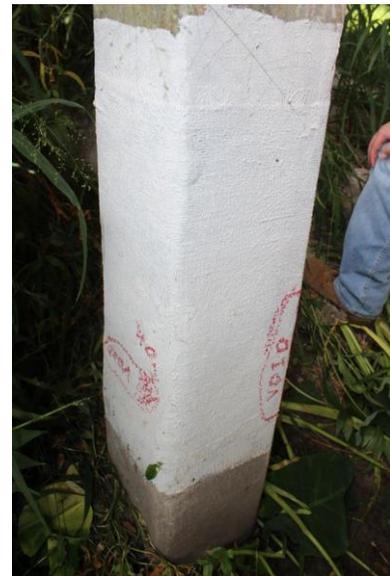
Figure 70—FRP-confined pile on Durant Road Bridge

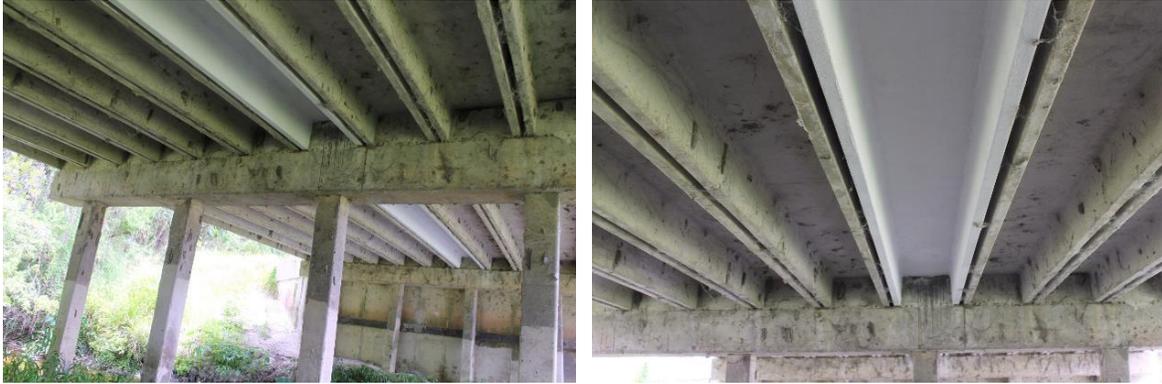
Figure 71—Repaired superstructure on Durant Road Bridge

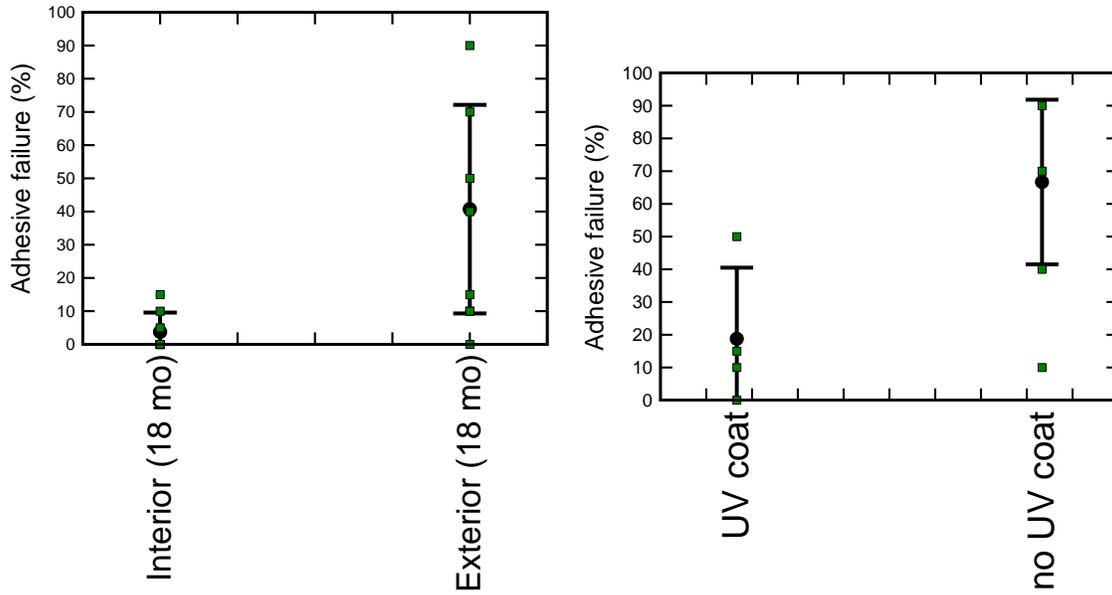
A more compelling evidence of higher degradation of FRP-concrete bond in the exterior girder is observed when comparing the failure mode data between the two girders. The presented results in Figure 74a show an increase in adhesive failure mode characteristics from interior to exterior girder, with the difference being apparent for the 18-month tests; typical failure modes that were observed on the interior and exterior girder are shown in Figure 75 and Figure 76. A comparison of test data obtained from locations with UV coating to those without it, on the exterior girder (at 18 months of exposure), reveals the existence of correlation between the presence of UV coating and the failure mode. As shown in Figure 74b, adhesive failure mode characteristics increased at the location without the UV coating, indicating that UV radiation may be a significant contributing factor to the bond degradation. Effects of radiation were observed on the surface of CFRP composite without UV coating in the form of scaling and change in color of the saturating

Figure 74—(a) Distribution of adhesive failure modes amongst the test groups (b) distribution of adhesive failure mode characteristics on exterior girder

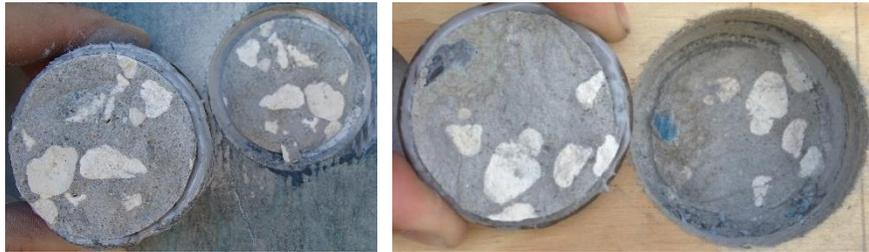
Figure 75—(a) Typical cohesive failure mode (b) typical mixed failure mode

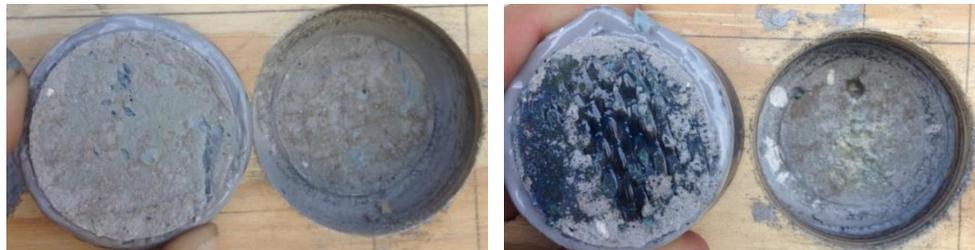
Figure 76—(a) Typical adhesive failure mode (system with putty) (b) typical adhesive failure mode (system without putty)

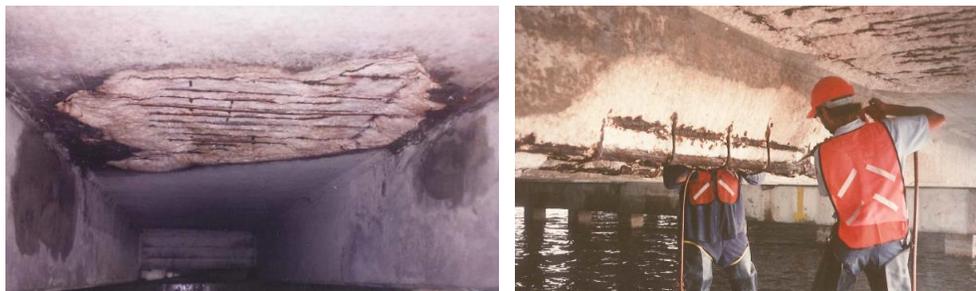
In the early 1990's, the girders had shown signs of corrosion, which was particularly severe in the span adjacent to the abutment (Figure 80). Tidal fluctuations put the water level within 3 to 5 ft (1 to 1.5 m) of the bottom of the girders. Near the abutment, wind-driven waves splashed salt water onto the underside of the girders and accelerated the corrosion. Little is known about the repair other than the system was a commercially available system. Florida Department of Transportation (FDOT) records indicate that both wet layup and precured laminate bonded reinforcement were applied to the girders. The repaired span was at the east end of the bridge with one end supported on the abutment (Figure 81). The first FRP repair on the bridge apparently had degraded and was reapplied in 1999. Neither the details of the first repair nor the characteristics of the degradation are known. The repair material was a wet layup CFRP system composed of bi-directional (0-90 deg.) carbon sheets (Figure 82).

Figure 80—Indian River Bridge – corrosion damage

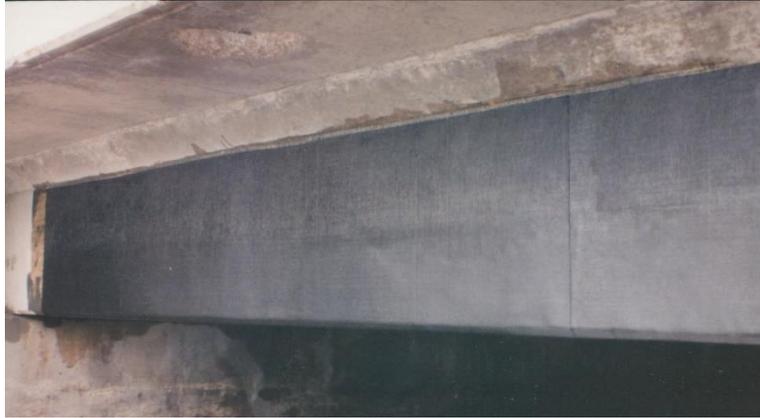
Figure 82—Exterior Indian River Bridge girder wrapped with bidirectional CFRP

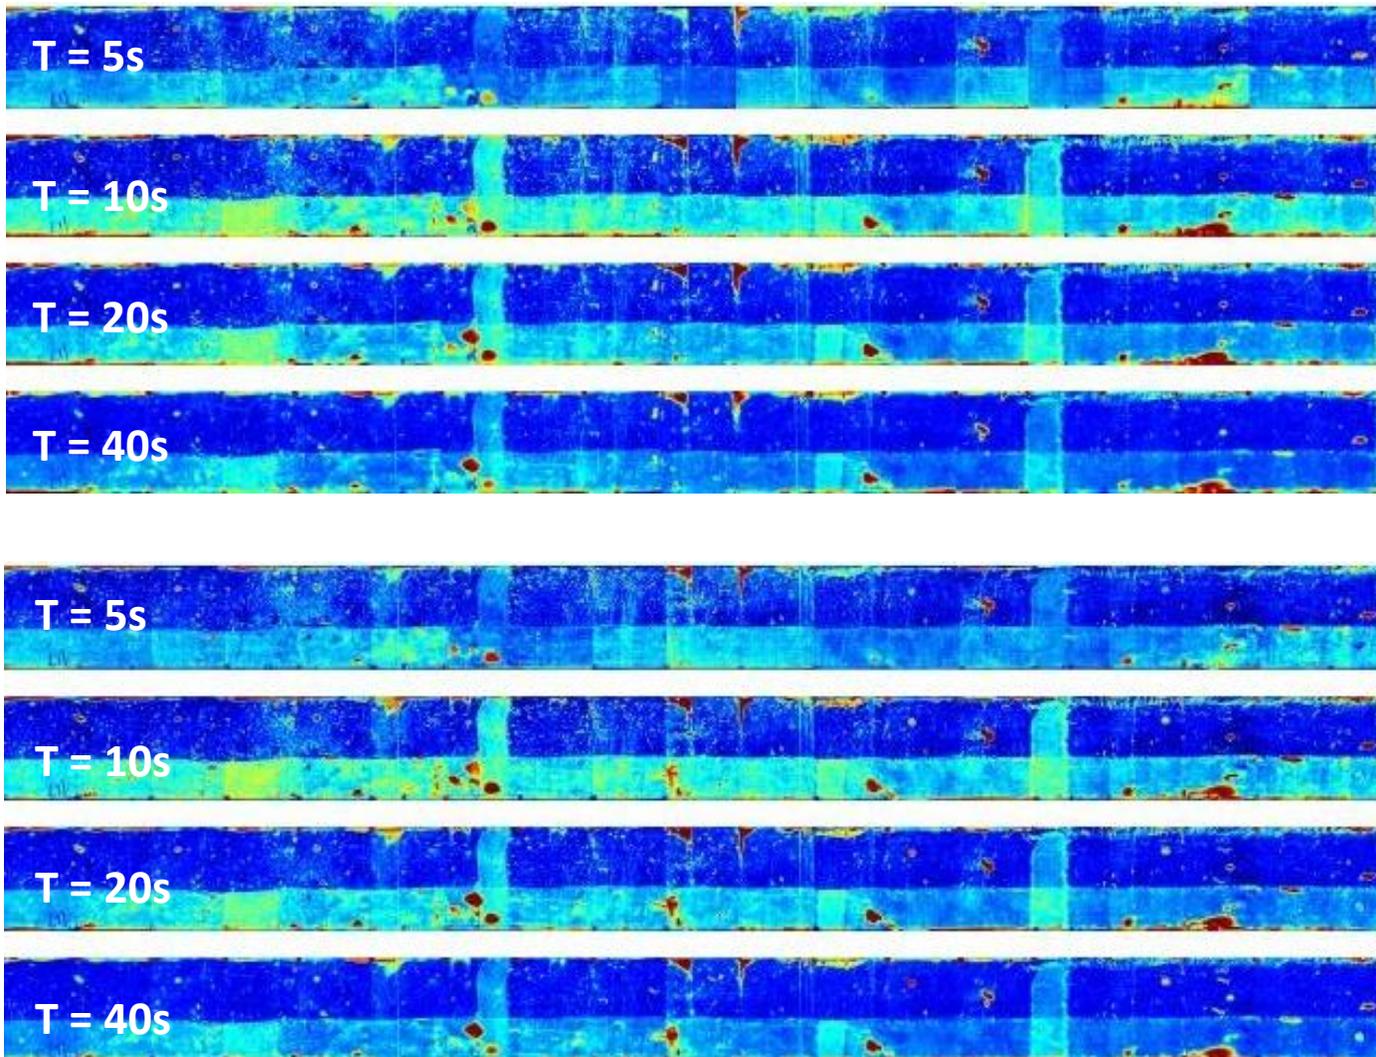
Figure 86—Girder #1 – south face: prior to structural test (top), and after structural test (bottom)

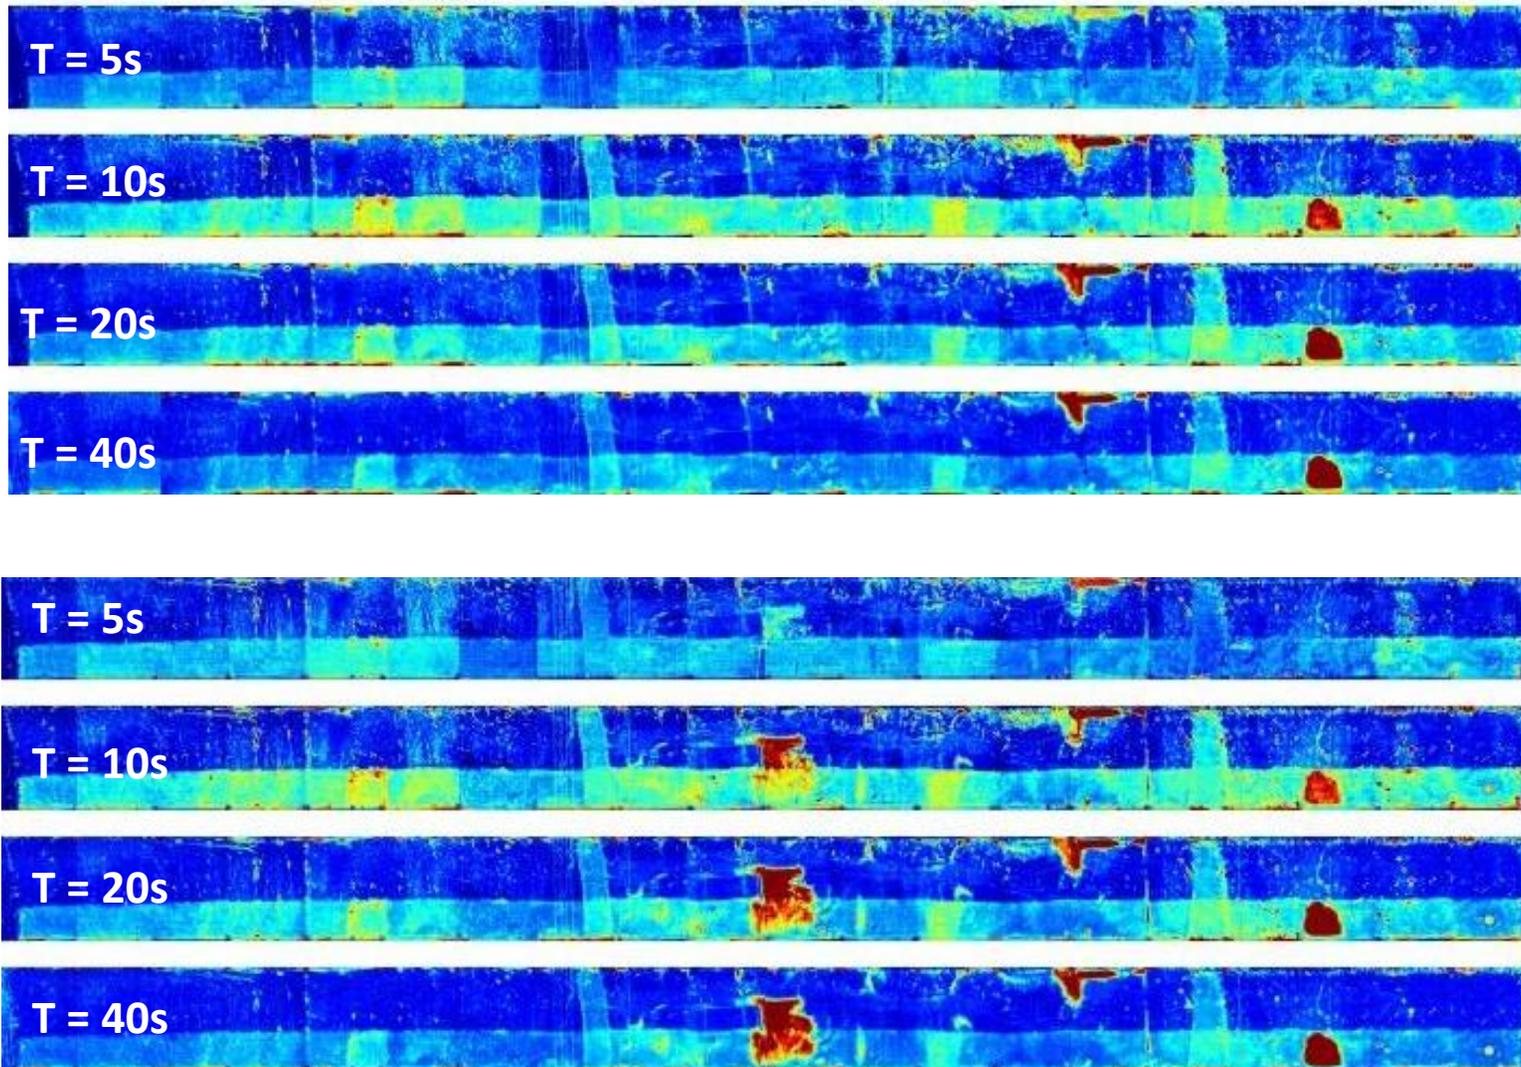
Figure 87—Girder #1 – north face: prior to structural test (top), and after structural test (bottom)

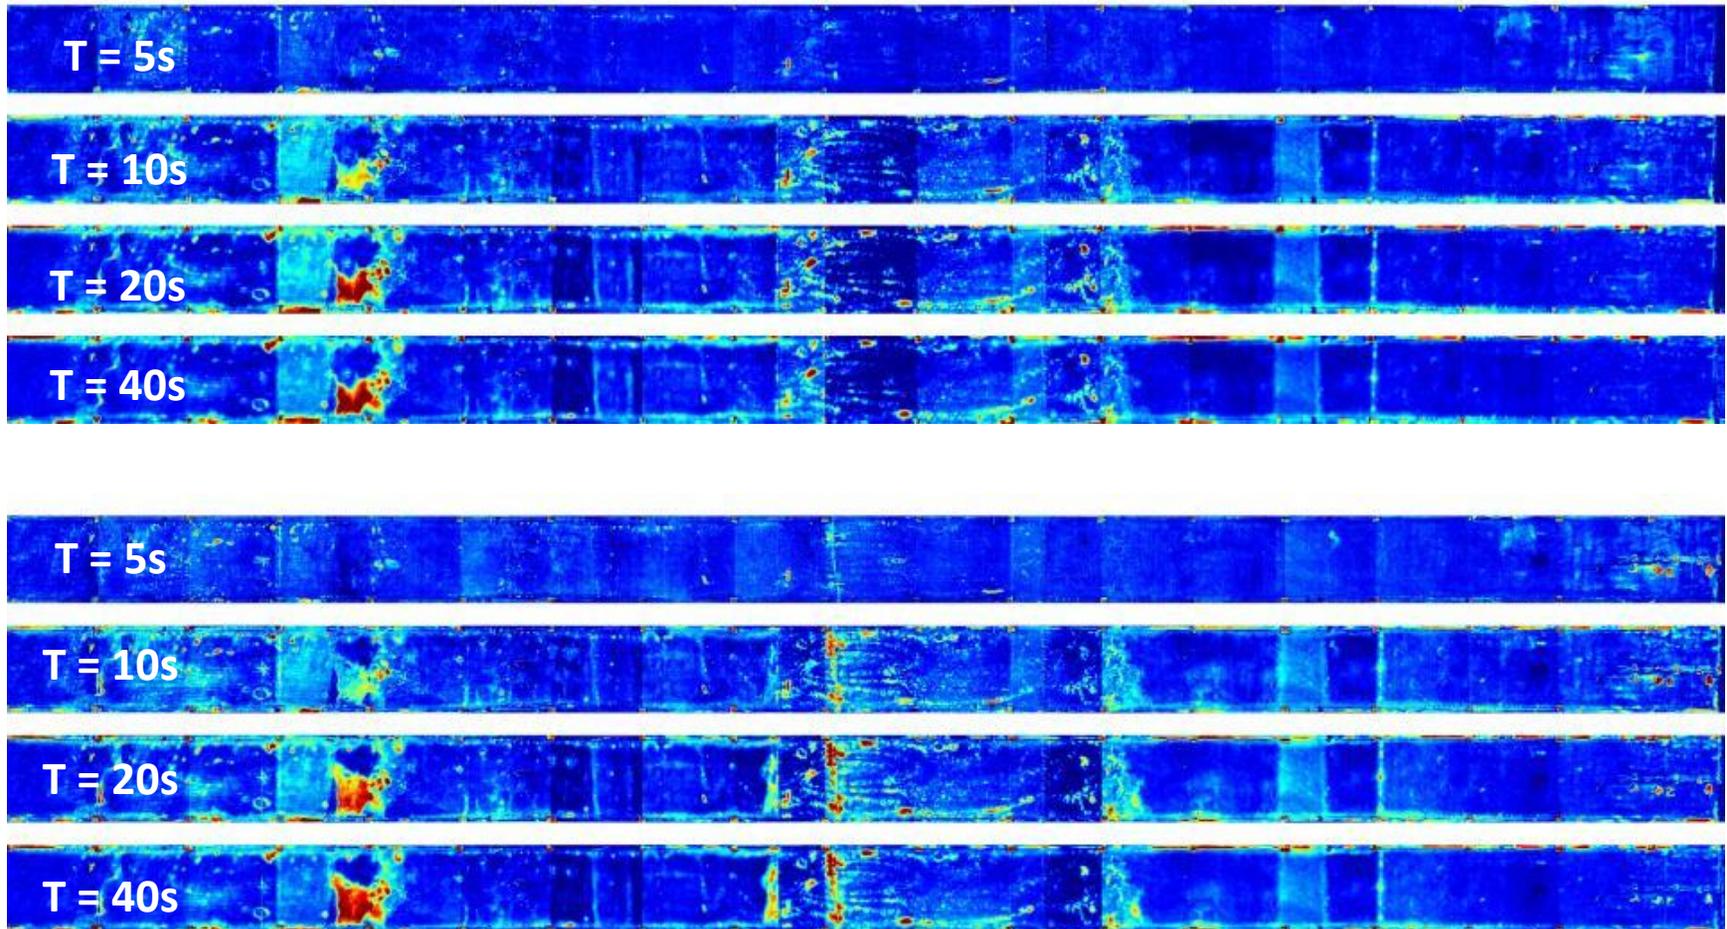
Figure 88—Girder #1 – bottom: prior to structural test (top), and after structural test (bottom)

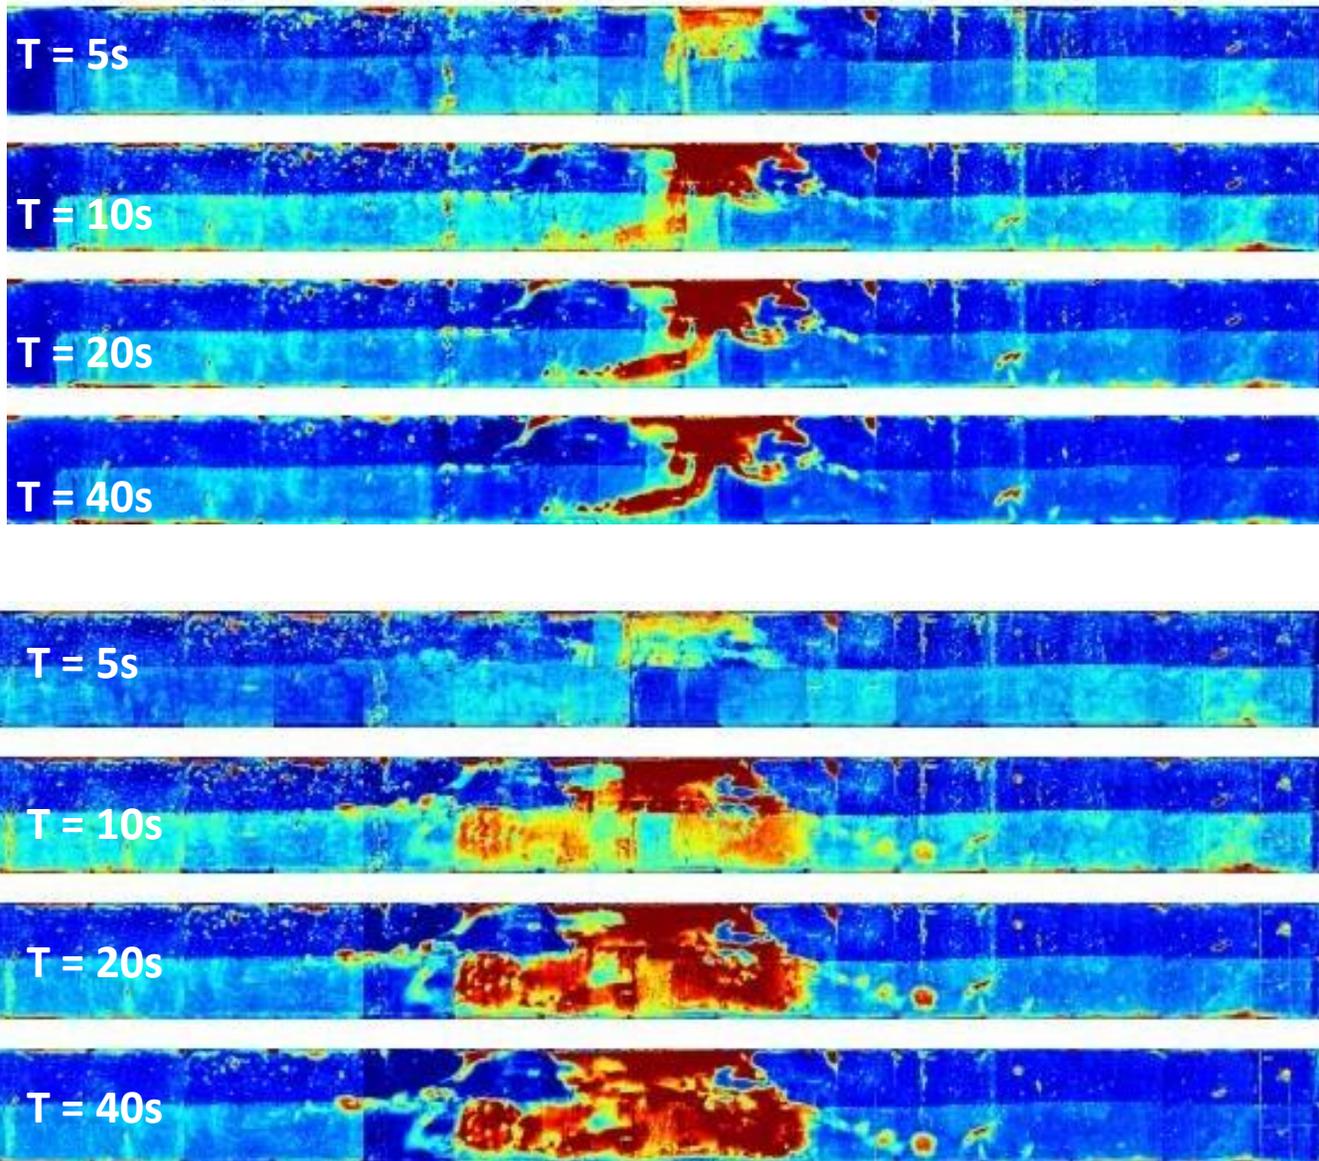
Figure 89—Girder #2 – south face: prior to structural test (top), and after structural test (bottom)

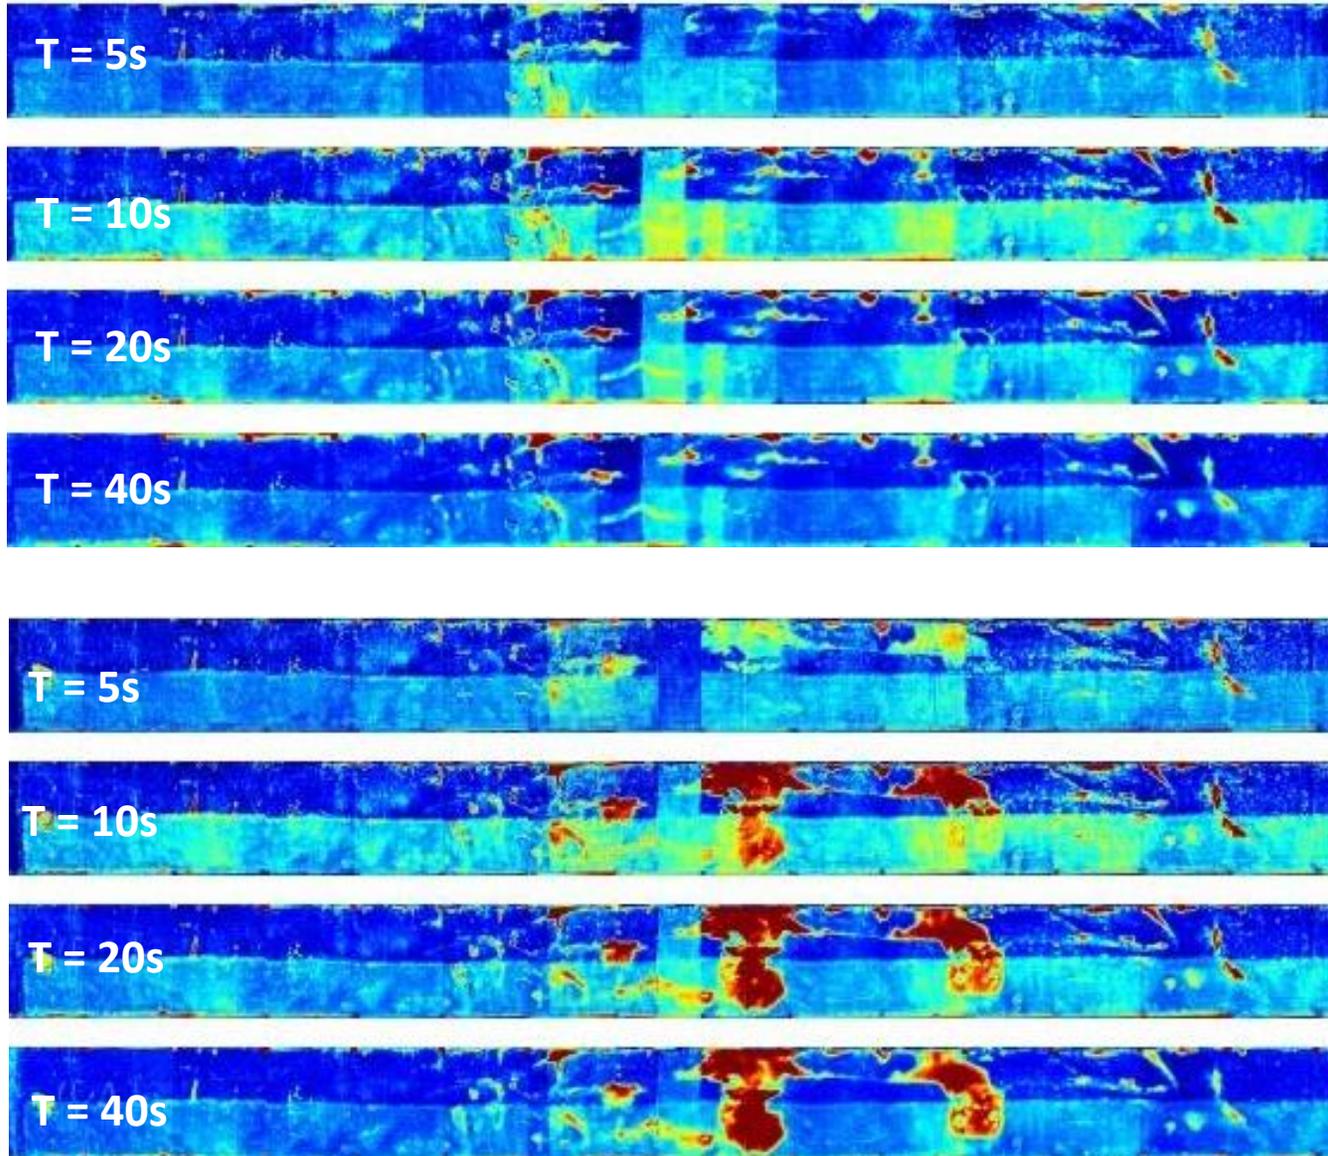
Figure 90—Girder #2 – north face: prior to structural test (top), and after structural test (bottom)

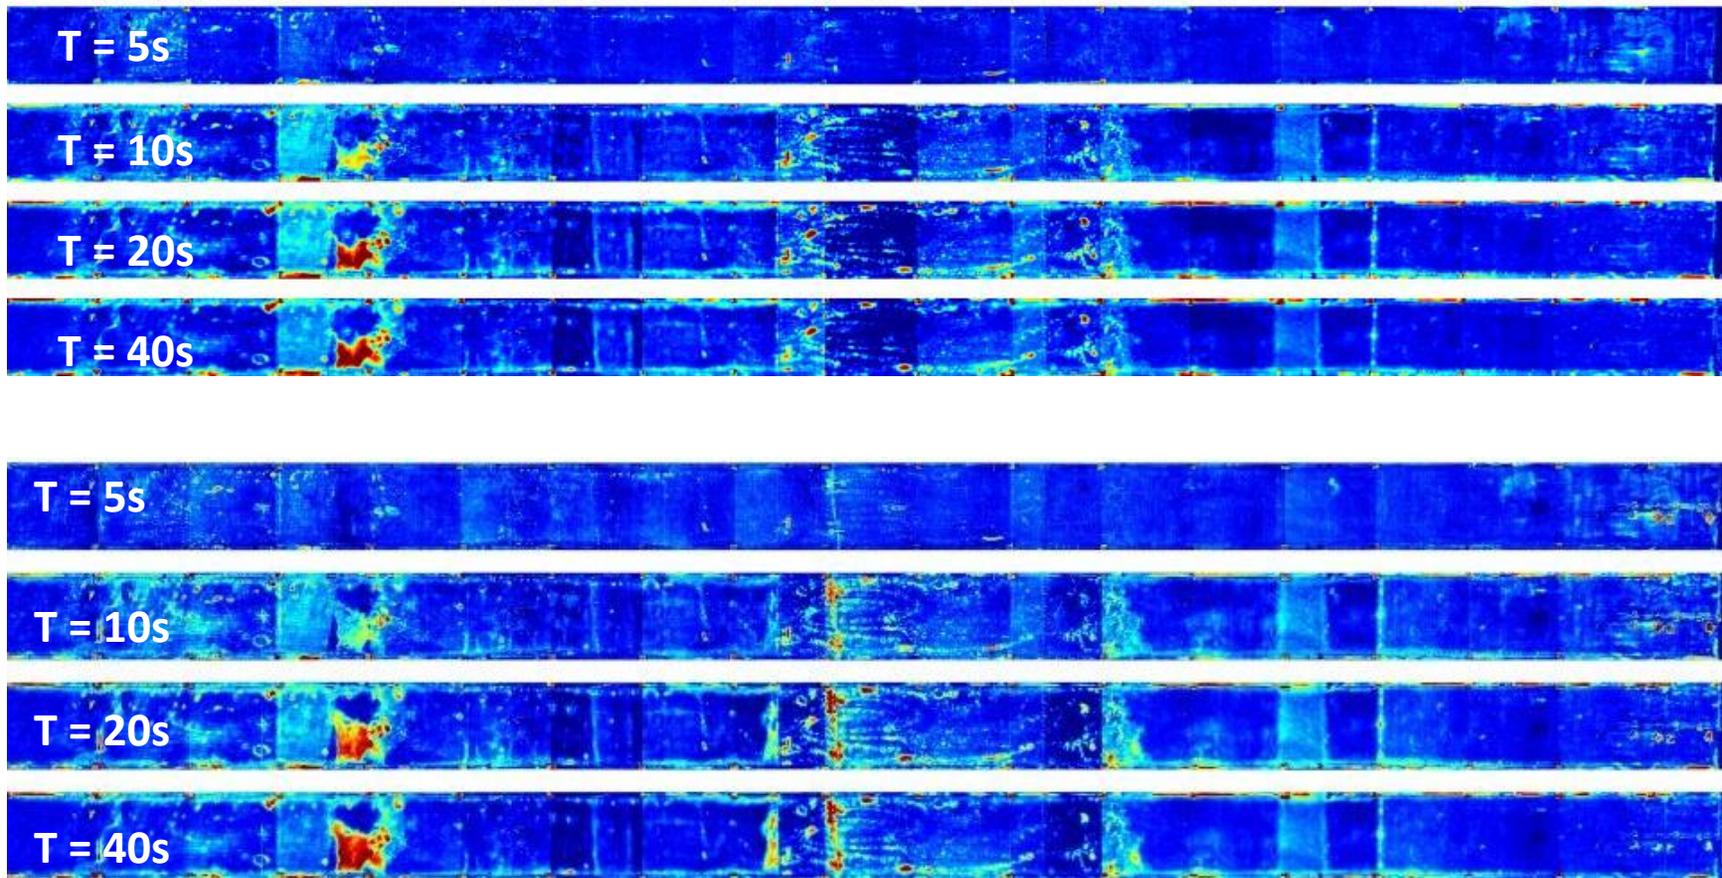
Figure 91—Girder #2 – bottom: prior to structural test (top), and after structural test (bottom)

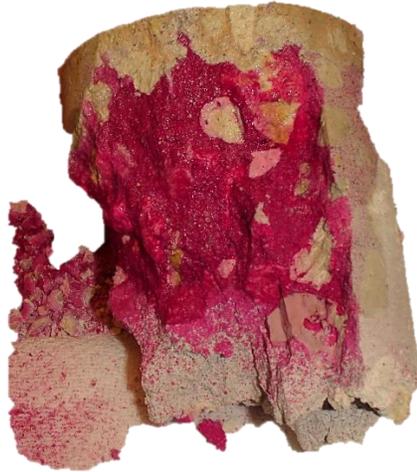
Higher (on average) depths of carbonation were noted in specimens with no CFRP, or epoxy only on the exterior surface compared to specimens with bonded CFRP (Figure 95). At this point, however, no conclusive evidence exists regarding the possible correlation between the CFRP wrapping and progression of carbonation.

Figure 95—Concrete carbonation examined on a concrete cylinder following the compression test

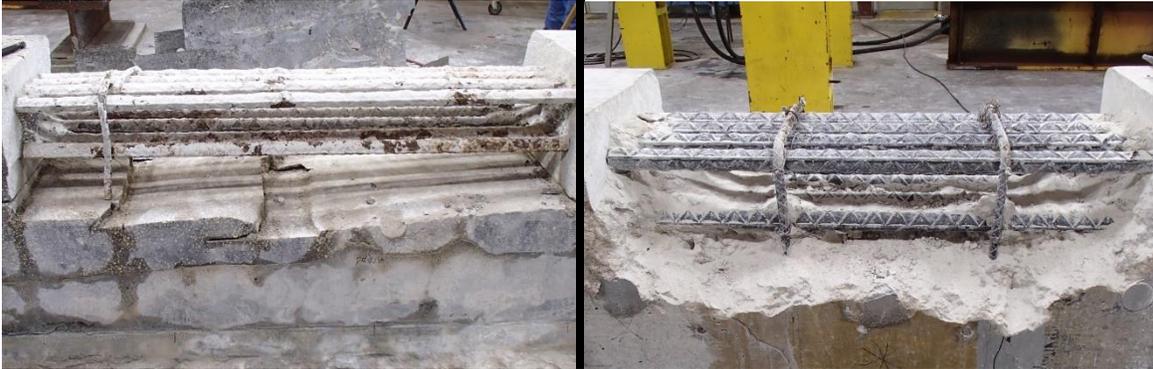
Steel reinforcement samples, for the purpose of tension testing, were taken from the corroded and uncorroded regions along the span (Figure 97). Steel reinforcement most severely affected by corrosion was located near the repaired portion of girder span, while uncorroded steel reinforcement was situated towards the west end of the girder in the area under old concrete. Less corrosion was observed in the repaired region of Girder #1 than in that of Girder #2. Steel bars measuring approximately 45 in. were collected using an acetylene torch (Figure 97). Four specimens were collected from repaired regions of both Girder #1 and #2, two of which were #11 bars and two #10 bars. Four bars (two #10 and two #11) were taken from the uncorroded region of Girder #2, in addition to two #11 bars from Girder #2.

Figure 97—Steel reinforcement: (a) corroded (b) uncorroded

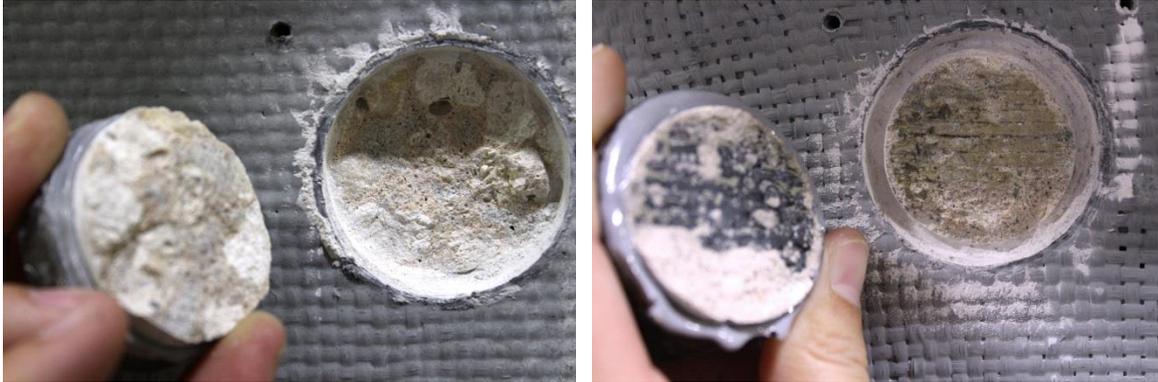
Figure 102—Failure mode: (a) cohesive and (b) adhesive

Direct pull-off test results are summarized in Table 16. All tests passed the tensile pull-off strength criterion. An adhesive and a mixed failure mode on each girder, however, were observed, which may signify bond degradation and/or inadequate surface preparation.

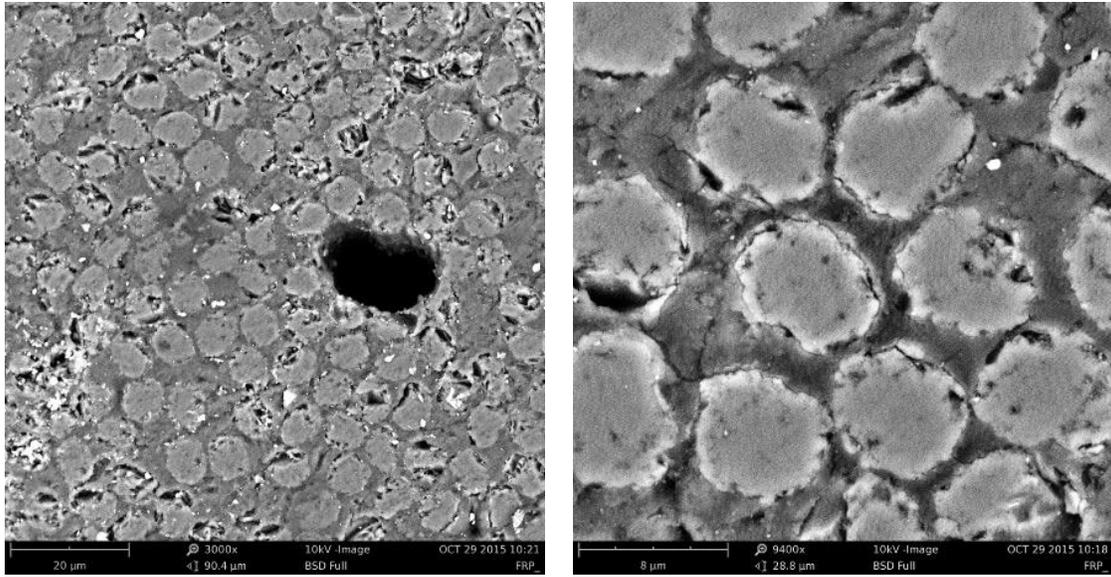
Collected images showed defects within the FRP composite (Figure 104). Voids within the matrix were likely a result of inadequate impregnation of dry carbon-fiber fabric in the field. At higher magnifications, microcracks located at the fiber-matrix interface were observed. These fibers could be due to manipulation of the samples during the extraction, or due to the environmental degradation. Larger microcracks were also present in the epoxy-concrete interfacial region, as shown in Figure 105. Sustained loading, combined with fatigue and environmental impacts could have been the cause of these microcracks. While further research is necessary to understand the source of cracking near the interface, these observed microcracks might result in early onset of debonding once they reach their critical length.

Figure 104—SEM images of defects present within the CFRP composite including (a) voids and (b) epoxy microcracking

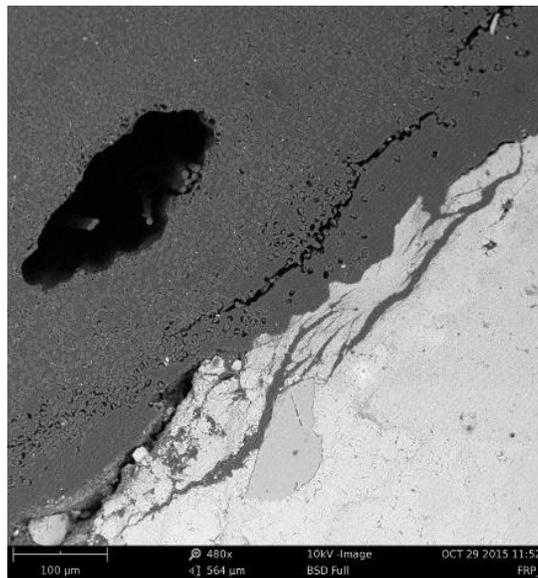
Figure 105—Large void and initiation of debonding of CFRP near CFRP-concrete interface

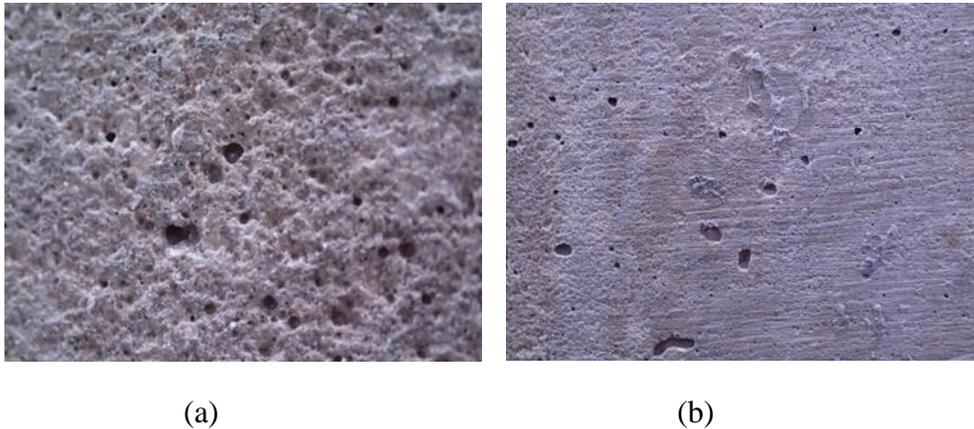
Figure 120—Difference between: (a) sandblasted concrete surface and (b) concrete surface without surface preparation

CFRP was removed by either pulling off by hand or using a scraping tool. This process revealed the variation in surface condition on each girder. Figure 120 shows marks from plywood grains on the surface indicating that the surface was not prepared. Such regions were observed intermittently on the sides of the girders. Approximately 30-40% of the total surface area of the sides on each girder did not appear to have been sandblasted.

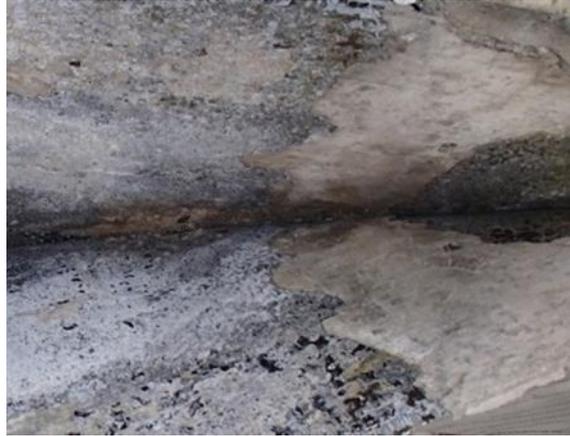
Figure 121—Evidence of skim coat at the bond

Removal of CFRP also revealed the presence of a cementitious material skim coat at multiple locations that pulled off with CFRP (Figure 121). This coat was most likely used to level the surface after the repair forms were removed.
