Durability Evaluation of Florida's Fiber-Reinforced Polymer (FRP) Composite Reinforcement for Concrete Structures

Final Report

March 2017

Florida Department of Transportation (FDOT)
David Wagner, P.E. – Project Manager

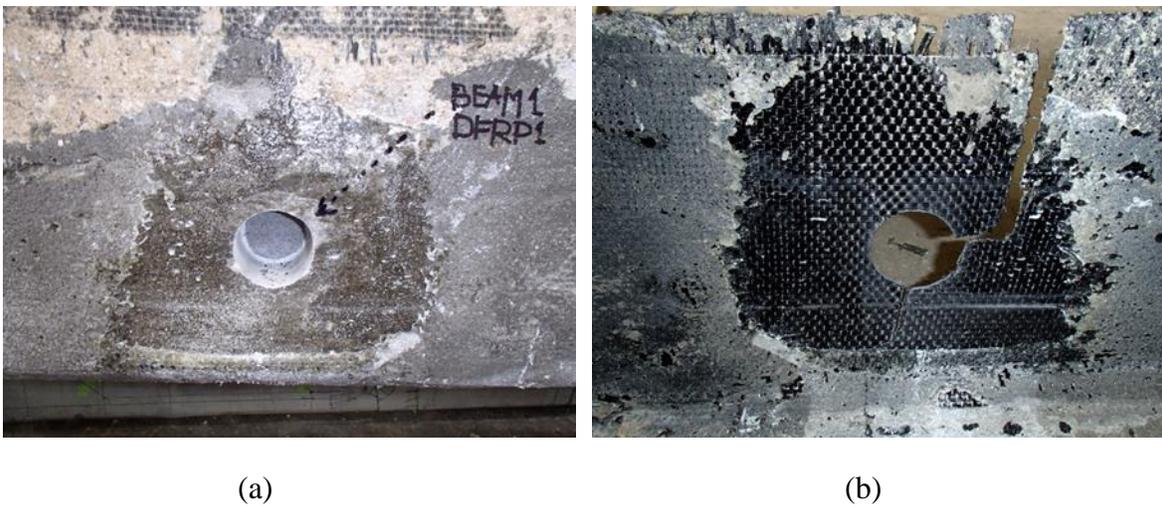
Figure 123—Evidence of delaminated bond surface along the CFRP-epoxy interface on: (a) the girder and (b) CFRP wrap

A few areas on each girder were found to be repaired with a cementitious repair material. Two such areas were identified on Girder #1, and were surrounded by severely debonded CFRP. The debonding occurred at the CFRP-epoxy interface (Figure 123), which is unusual; the most common type of debonding occurs at the concrete-epoxy interface.

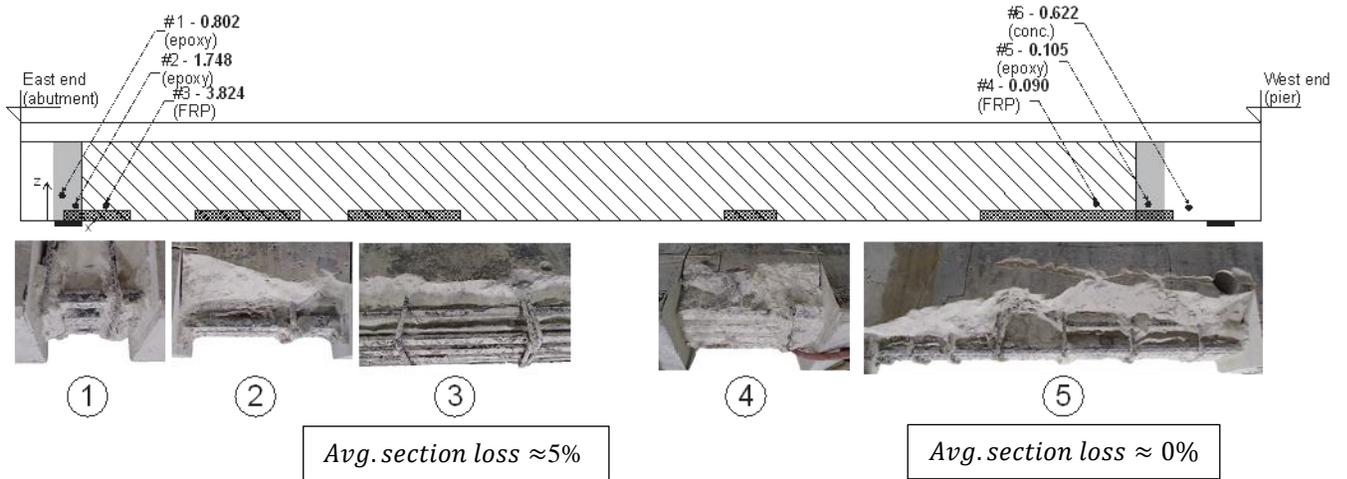
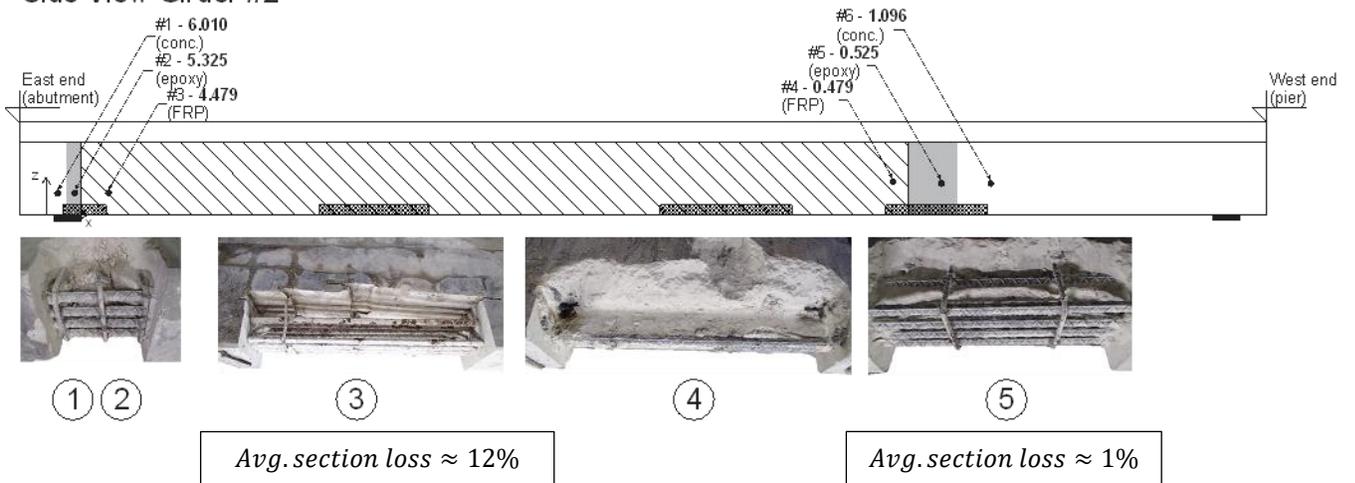
Figure 125—State of reinforcement and chloride contents (pcy) at specified locations along the north face of Girders #1 and #2

1. Splash zone at abutment: This region is thought to be the most affected by splash of brackish water. CFRP wrap starts in this region. Concrete was removed at the edge of the CFRP wrap to reveal the reinforcement on both sides of CFRP. No signs of corrosion were observed.

2. Old/new concrete interface (towards the abutment): An “anode-ring effect” takes place when new concrete is installed adjacent to chloride-contaminated concrete. The potential difference between the repair concrete and surrounding salt-contaminated concrete creates a corrosion cell where the anodic reaction occurs in the reinforcement adjacent to the repaired area; this reinforcement is also surrounded by chloride-contaminated concrete. No significant corrosion was observed on the reinforcement surrounding the repair, indicating that the anode ring effect did not strongly promote corrosion.

3. Repaired region: This region was initially the most severely damaged by corrosion, and consequently most of the repair efforts took place in this region. Corroded reinforcement was coated with a protective polymer coating. Average section losses of approximately 5% and 12% were observed in Girders #1 and #2, respectively; however, it is believed that no substantial corrosion processes have occurred following the CFRP repair. Close-up images of corroded reinforcement are shown in Figure 126.

4. Old/new concrete interface (towards the pier support): This area was revealed to determine possible evidence of ring anode effect. It should be noted that this region was entirely wrapped with CFRP.

5. Old concrete (towards the pier support) and end of CFRP wrap: Reinforcement in this region was examined to evaluate the advancement of corrosion following the

most recent repair on the bridge. Moreover, steel reinforcement adjacent to the end of CFRP wrap was examined to determine what effect CFRP wrap had on corrosion of existing reinforcement. No significant signs of corrosion were observed.

Chloride ion (Cl^-) concentrations vary on girders #1 and #2 (Figure 125). This variation is particularly acute in the splash zone (near the abutment support). Inconsistent exposure of each location to wind and wave action was likely the cause of the differences in Cl^- concentrations (Figure 129). Both girders were interior, with girder #1 situated further away from the exterior girder, thus placing it further away from the wind and wave action approaching from the North. Exposure to wave action was particularly severe at the east end of each girder, due to the configuration of abutment support and the diaphragm (Figure 130).

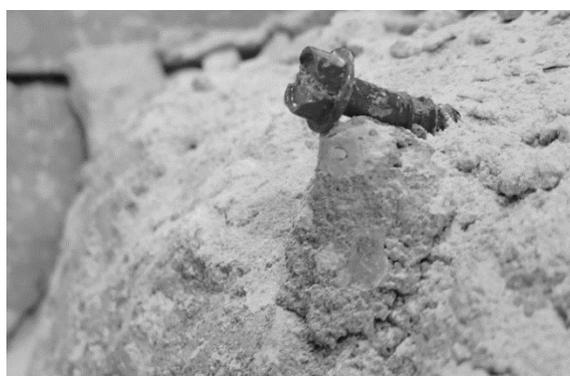
Figure 127—Concrete screw at the interface between new and old concrete

Concrete screws were observed at multiple locations during the concrete chiseling process (Figure 127). It was later confirmed from repair procedure photos that the screws served the purpose of enhancing the bond between the old and new repair concrete.

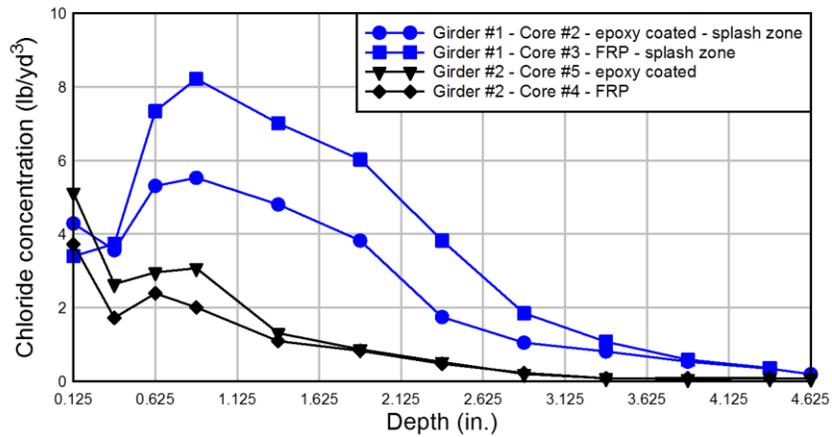
Figure 128—Chloride penetration profiles at specified locations

Lower Cl^- concentrations were expected in concrete that was wrapped with CFRP, as it is assumed that CFRP acts as a barrier that prevents diffusion of Cl^- into concrete. In girder #1, however, a significantly higher concentration of Cl^- was observed in concrete under CFRP (core #3) when compared to two coring locations adjacent to CFRP wrap (cores #1 and #2). Figure 130 shows the non-uniform exposure of concrete near abutment is evident; the two locations with lower concentrations were less severely exposed to splash water, while the location under CFRP likely had higher residual Cl^- concentration (prior to CFRP repair), in addition to more

severe exposure following the repair. Differing exposure histories of the concrete near the abutment support explain the anomalously high Cl^- concentration under the CFRP.

On the other hand, cores #4, #5, and #6 were situated at locations with a uniform exposure to the splashing due to wind and wave action; therefore, this location is likely more indicative of the effects of CFRP on the rate of diffusion of Cl^- into the concrete. According to the chloride concentrations obtained from these locations, it is apparent that CFRP has had significant effect on the diffusion of chlorides throughout the service life of the repair. Reduction in chloride concentration under CFRP ranged from 0.53 lb/yd³ to 0.62 lb/yd³ (85% and 56%) in Girders #1 and #2, respectively. Furthermore, concrete with the epoxy coating only exhibited a reduction in chloride concentration of 0.52 lb/yd³ and 0.57 lb/yd³ in Girders #1 and #2, respectively. Similar reductions between chloride concentrations measured under CFRP and epoxy, indicate that epoxy adhesive may have been the major contributing factor to retarding chloride intrusion into the concrete.

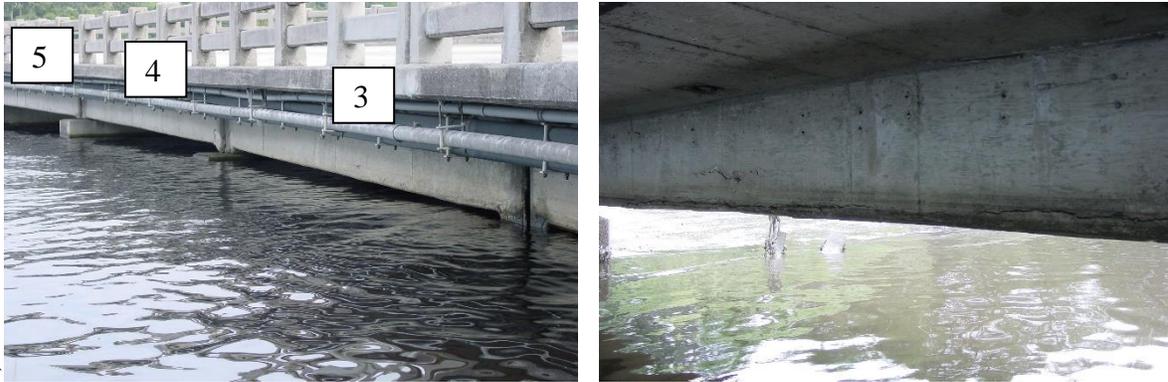
Figure 136—High tide inundation of (a) spans 3, 4, and 5, and (b) Girder 3-1 during low tide

Figure 136 shows the proximity of spans 3, 4 and 5 to the water level during high tide. Prior to FRP installation, the regular inundation of span three had resulted in corrosion damage that had to be repaired prior to application of FRP composites.

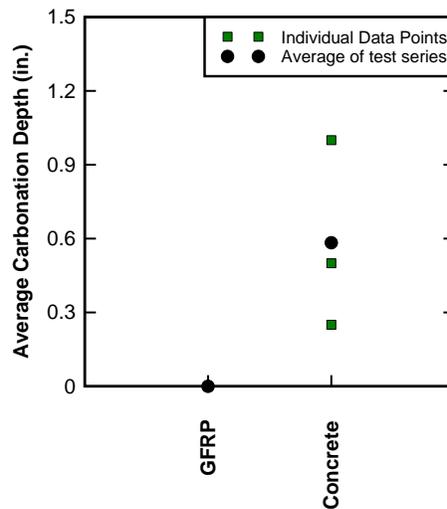
Figure 139—Carbonation depth measurements

Higher depths of carbonation were noted in specimens with no GFRP on the exterior surface compared to specimens with GFRP (Table 22). The carbonation depths of the samples with and without externally bonded GFRP are compared in Figure 139.

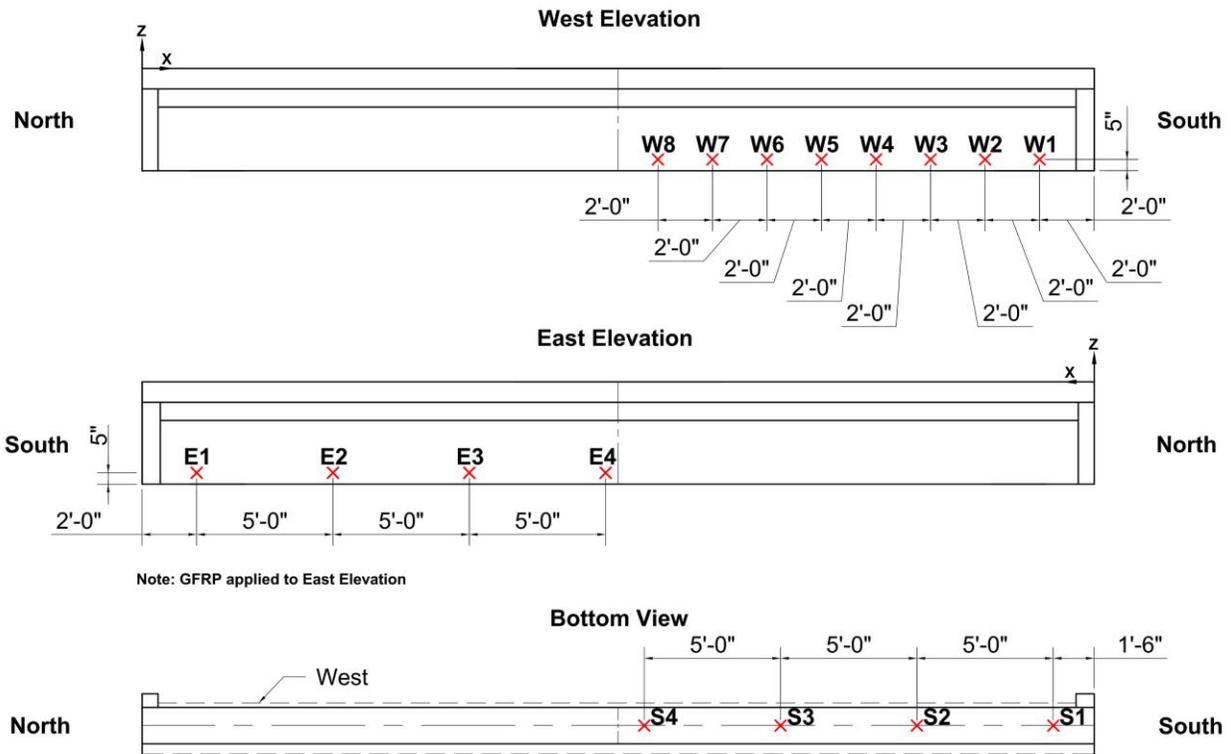
Figure 142—Potential testing locations for Girder 3-1

Girder 3-1 was predicted to have heavier levels of corrosion than the remaining tested girders because of its close proximity to the tidal fluctuations and due to a horizontal crack at approximately 5 in. from the bottom of the girder (Figure 143); girder 3-1 was not structurally tested due to this crack. This provided the opportunity to conduct additional material tests on Girder 3-1. All of the readings on the west elevation of 3-1 had a potential of -0.54V or lower, indicating a high probability of corrosion. Two of the voltmeter readings on the east elevation fall into the category where reinforcing steel in that area is uncertain. This may indicate that GFRP has some effect on the corrosion behavior of the steel reinforcement closest to the east elevation.

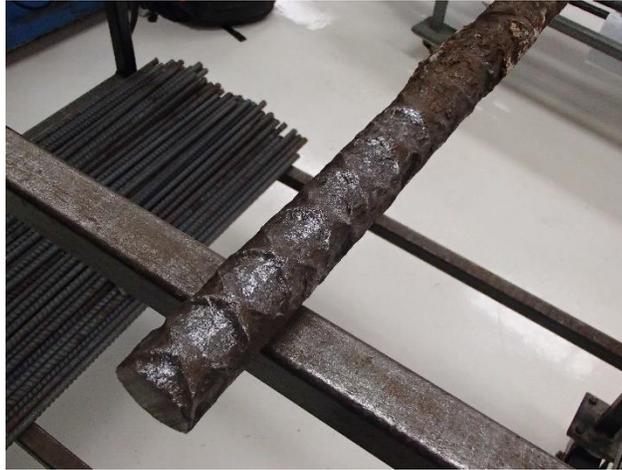
Samples were wire brushed to bare metal to avoid slipping in the grip during tension testing (Figure 144); grip length was 8 in. Wire brushed regions were also used to measure the cross-sectional dimensions so that section loss could be determined. After each sample was tested, approximately 6 in. of the steel reinforcement along the grip region was cut then weighed and measured with a caliper. The grip region was chosen because these regions had already been wire brushed for the corroded samples. Section loss was calculated by normalizing the cross-sectional area of corroded reinforcement to an average cross-sectional area of uncorroded reinforcement. The results from tensile testing the steel reinforcement can be found in Table 29. It was discovered during sampling that stirrups were welded to longitudinal reinforcement in some locations (Figure 145). These samples typically fractured at the spot weld (Figure 146).

Figure 144—Reinforcement with bare metal exposed

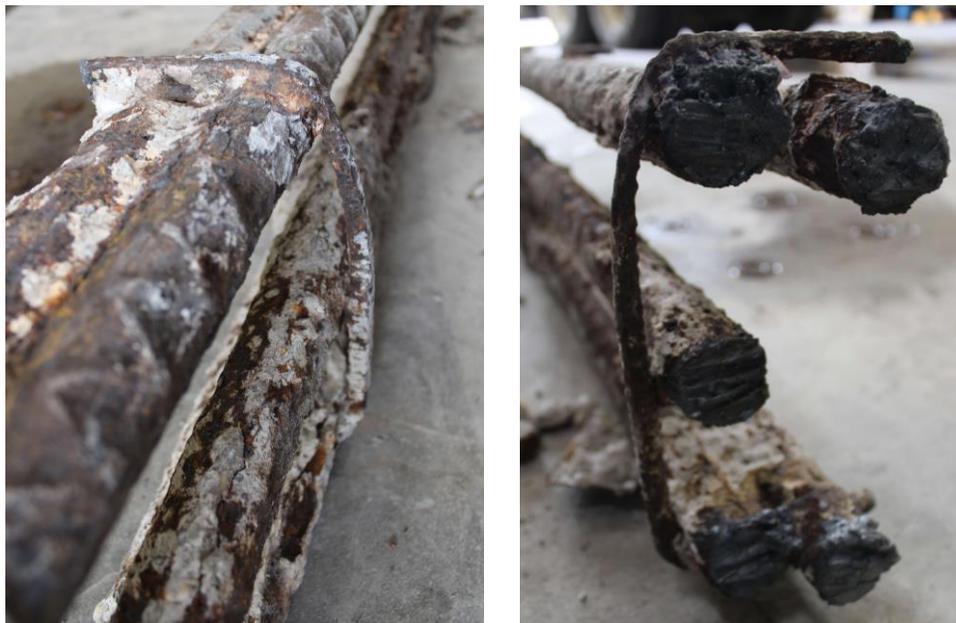
Figure 145—Steel reinforcement welded together with stirrups

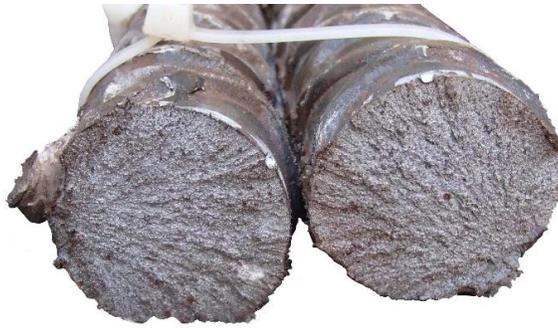
Figure 146—Typical hackle pattern pointing to the origin of fracture surface, which in this case is the spot weld

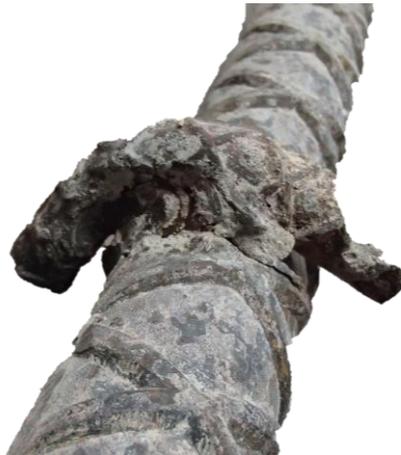
Figure 147—Stirrup remaining on steel reinforcement sample

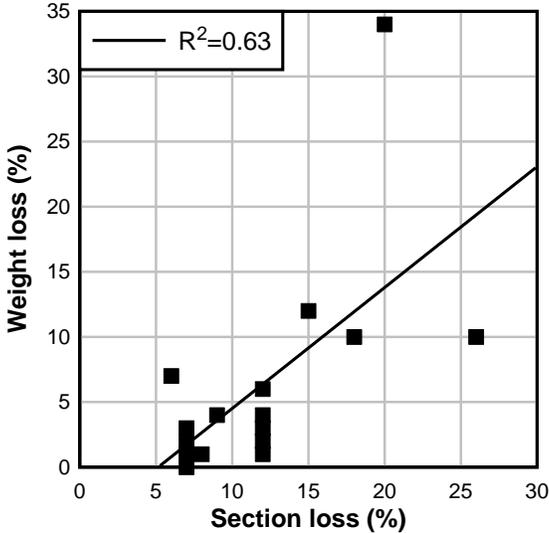
Figure 148 shows that there is a positive correlation between the weight and section loss. The regression line, however, does not fit the data as well as it did in the steel reinforcement samples from the Indian River Bridge ($R^2=0.92$). Indian River bridge data had more data points with higher levels of corrosion. This lack of data points on corroded samples may result in an uncertainty for the University Boulevard samples due to lack of data on the corroded samples.

Figure 148—Correlation between weight loss and section loss

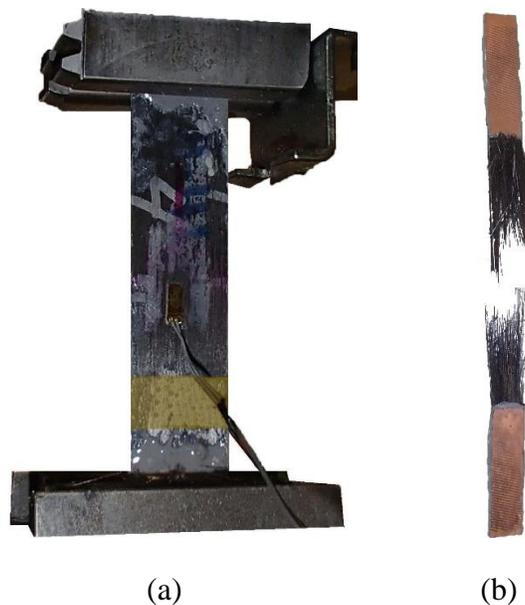
One CFRP sample was tested with three strain gages to determine if bending was affecting the results. The remaining samples used a single gage. The tests were performed on a Tinius Olsen testing machine, as per ASTM D3039 (Figure 149). Load data were acquired from the built-in 90-kip load cell, and the displacement data were collected with a 350 Ω Omega strain gage with a gage length of 6 mm. Typical failure mode of the test coupon is shown in Figure 149b.

Figure 149—(a) CFRP coupon tension test setup (b) typical failure mode of test coupon

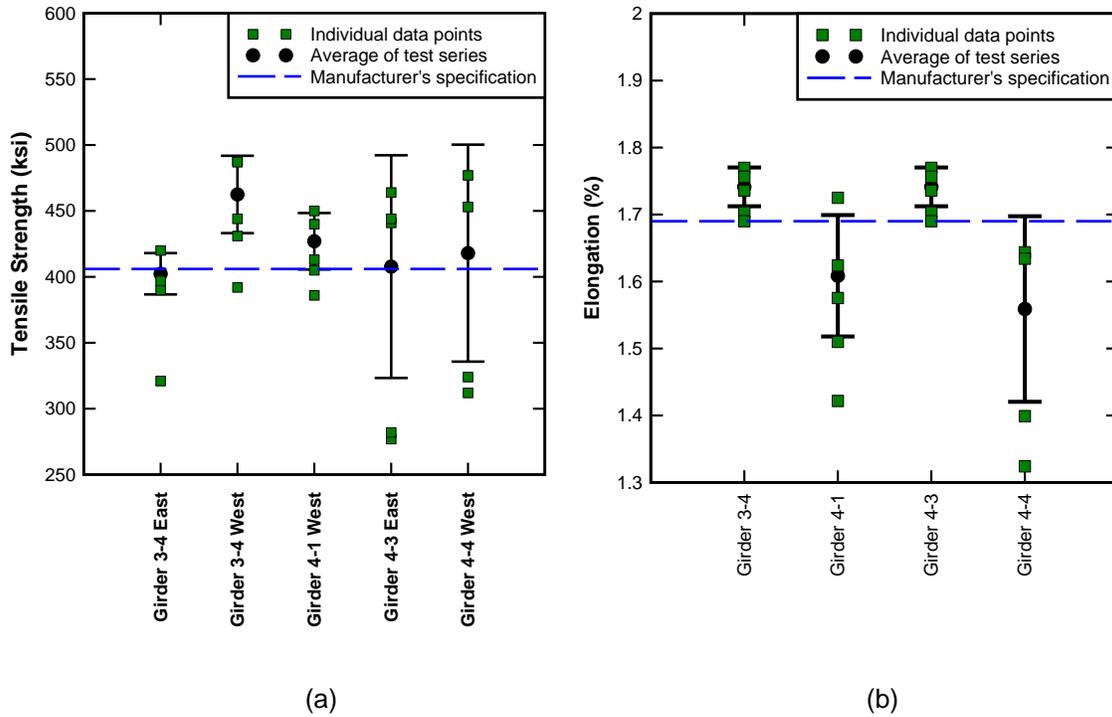
The data in Table 30 represent tensile stress values and elongation values similar to the manufacturer's specifications. Plots comparing the experimental and theoretical values of ultimate stress and elongation are shown in Figure 151.

Figure 150—Correlation between the theoretical and experimental (a) tensile strength and (b) elongation

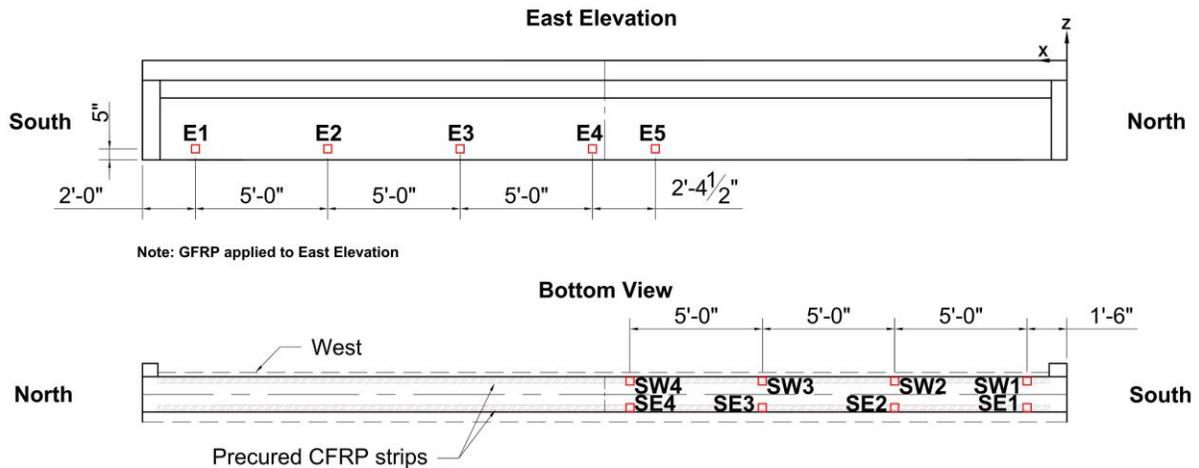
Direct pull-off testing locations were chosen to examine the quality control of the external FRP repairs (Figure 151). Sixteen tests were performed on Girder 3-1, three of which were additional samples due to failure at the interface between the loading fixture and the FRP (failure mode A) to determine whether or not a cohesive or adhesive failure would occur. Pull-off tests were positioned down the middle of each bonded precured CFRP strip.

Figure 151—Direct pull-off testing locations for Girder 3-1

Direct pull-off test results are summarized in Table 31. The percent of adhesive failure mode was determined on each sample by a visual approximation. Approximately 63% of the pull-off tests passed the tensile pull-off strength criterion. In addition, 54% of the samples failed cohesively; however, an adhesive and a mixed failure mode were also observed. Samples with failure mode A were not considered.

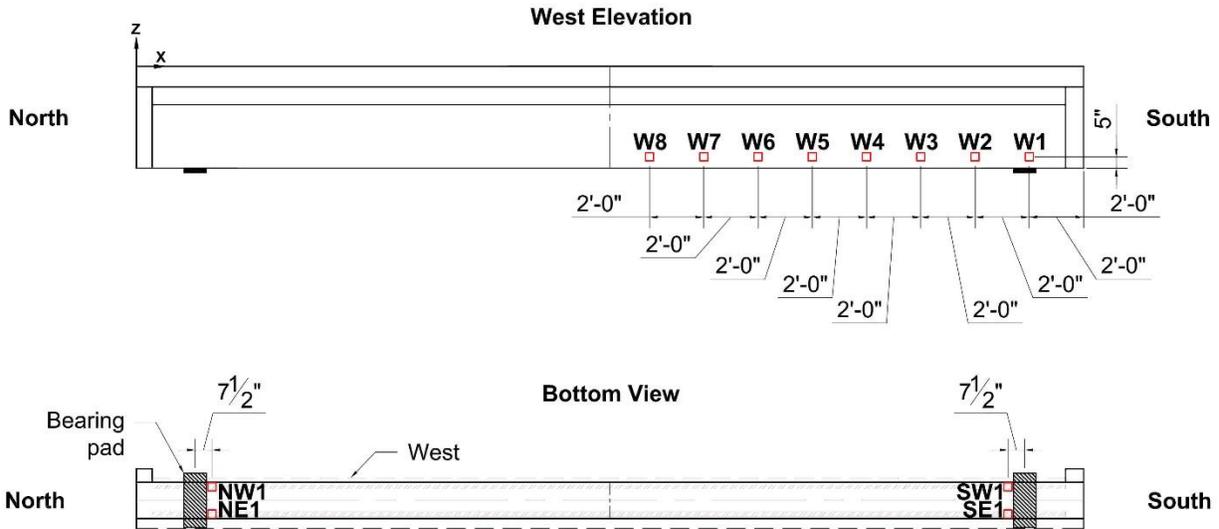
Figure 152 shows the locations of direct pull-off testing for exterior girders (3-1, 4-1, and 4-4). Direct pull-off test results for Girder 3-4 are summarized in Table 32. Approximately 83% of the pull-off tests passed the tensile pull-off strength criterion. One of the two samples that failed the tensile test had a crack in the testing location that most likely affected the tensile strength results. In addition, 50% of the samples failed cohesively; however, an adhesive and a mixed failure mode were also observed.

Figure 152—Direct pull-off testing locations for exterior girders

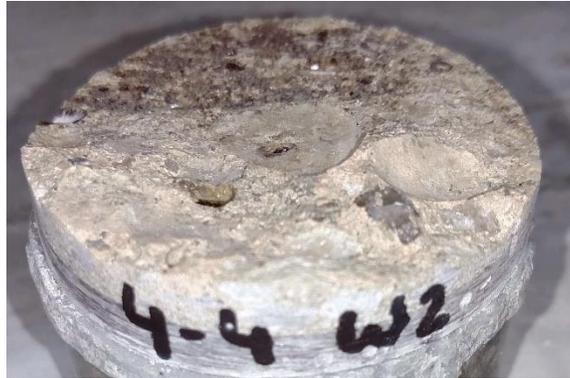
Direct pull-off test results for Girder 4-4 are summarized in Table 34. All tests passed the tensile pull-off strength criterion. In addition, 33% of the samples failed cohesively; adhesive and mixed failure modes, however, were also observed. Some voids in the concrete were noted during testing (Figure 153).

Figure 153—Pull-off testing sample from Girder 4-4 with multiple voids in concrete

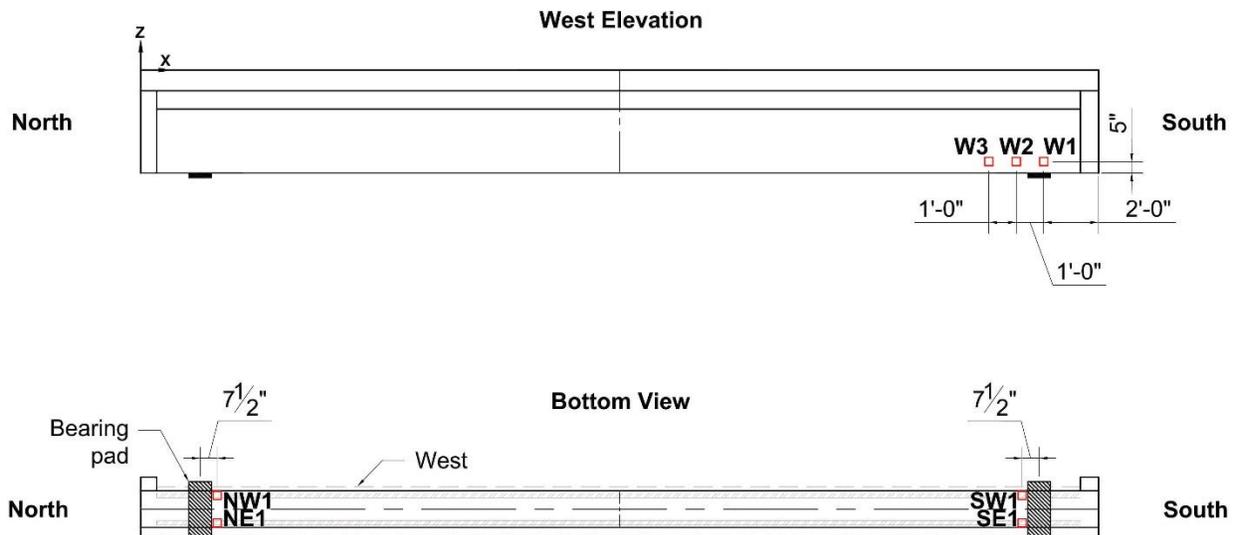
Figure 154 shows the locations of direct pull-off testing for interior girders (3-2, 4-2, and 4-3). Some of the pull-off tests failed at the dolly to FRP interface (Failure mode A), either from the adhesive not being completely cured or from the set of smooth dollies which were used on 11 pull-off testing locations (Figure 155). The same bond tester used in the Indian River report was used after these 11 locations to avoid more samples from failing in Failure mode A.

Figure 154—Direct pull-off testing locations for interior girders

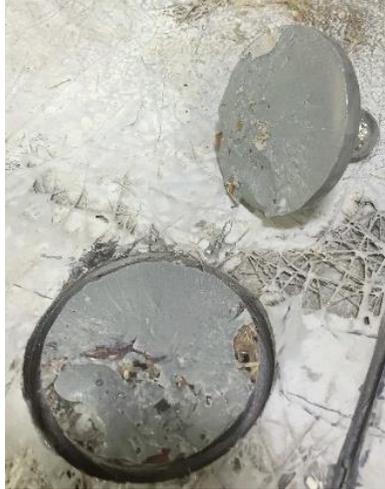
Figure 155—Smooth dolly that failed at the dolly-to-FRP interface

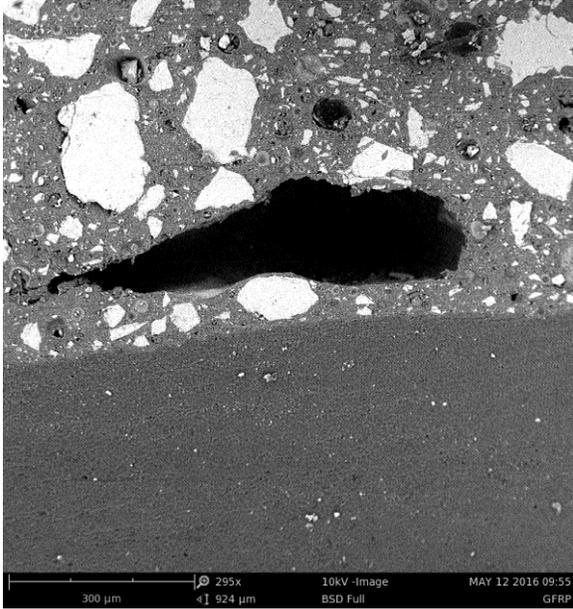
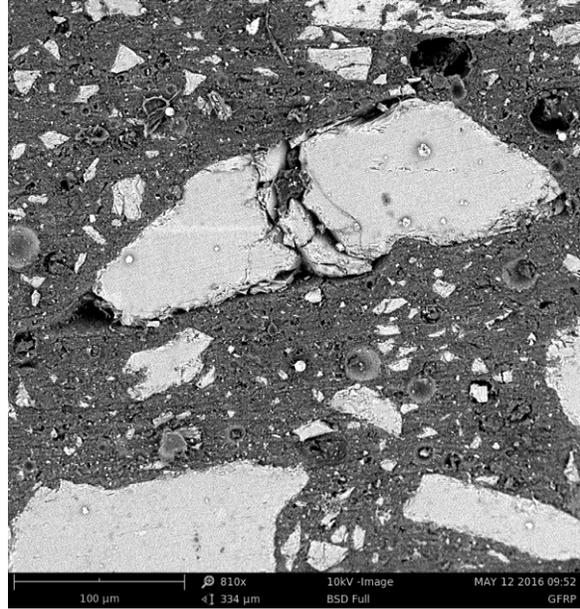
Due to its high viscosity and high silica sand content, the paste epoxy used to bond CFRP laminate to the girders had large number of voids present within its microstructure (Figure 159a). Additionally, possibly due to the environmental degradation, microcracks were observed at the interface between silica-sand filler particles and the epoxy adhesive (Figure 159b). No defects were observed at the CFRP-epoxy interface (Figure 159a). Many voids were found, however, along the interface between epoxy and concrete (Figure 160) which likely occurred during the installation of the composite. CFRP composite, similarly to the wet-layup system used in the Indian River Bridge, exhibited damage within the matrix and matrix-fiber interface (Figure 161). It is not clear whether the damage was due to the environmental degradation, specimen manipulation and handling, or the installation defects.

Figure 159—SEM images of: (a) interface between CFRP (bottom) and epoxy (top) (b) magnified image of a single silica sand grain in the epoxy matrix.

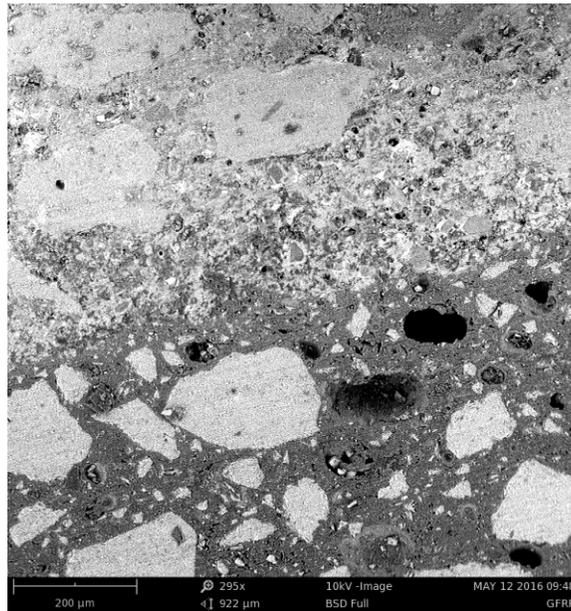
Figure 160—SEM image of interface between concrete (top) and epoxy (bottom).

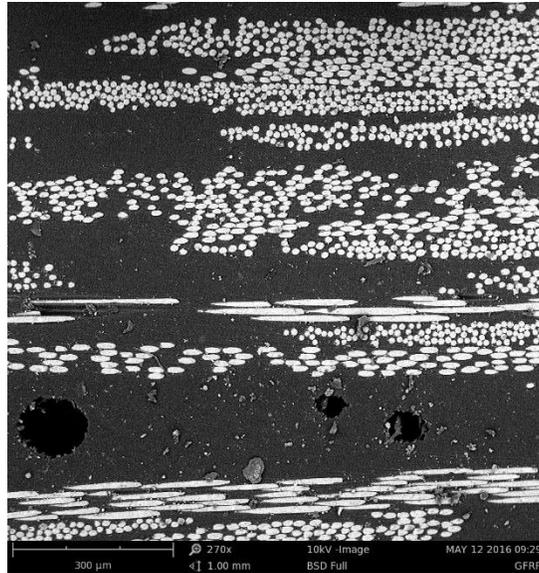
Inspection of the GFRP composite indicated that fibers were oriented in preferential directions. Additionally, it was apparent that fibers were also not uniformly distributed within the matrix. Regions with very high volume fractions of fibers were contrasted by the regions without any fiber content. Large defects (Figure 164) in the regions without fibers do not fully benefit from the fibers’ crack-bridging effect, which can possibly improve the macroscale mechanical properties of the composite. Magnified images of the fibers embedded in the polyester matrix did not show any signs of matrix or interfacial damage (Figure 165); the fibers, however, appear to be packed very tightly, which could result in significant stress concentrations when stresses acting perpendicular to the fiber direction are applied.

Figure 164—SEM image showing non-uniform distribution and preferential orientation of fibers within the GFRP composite matrix

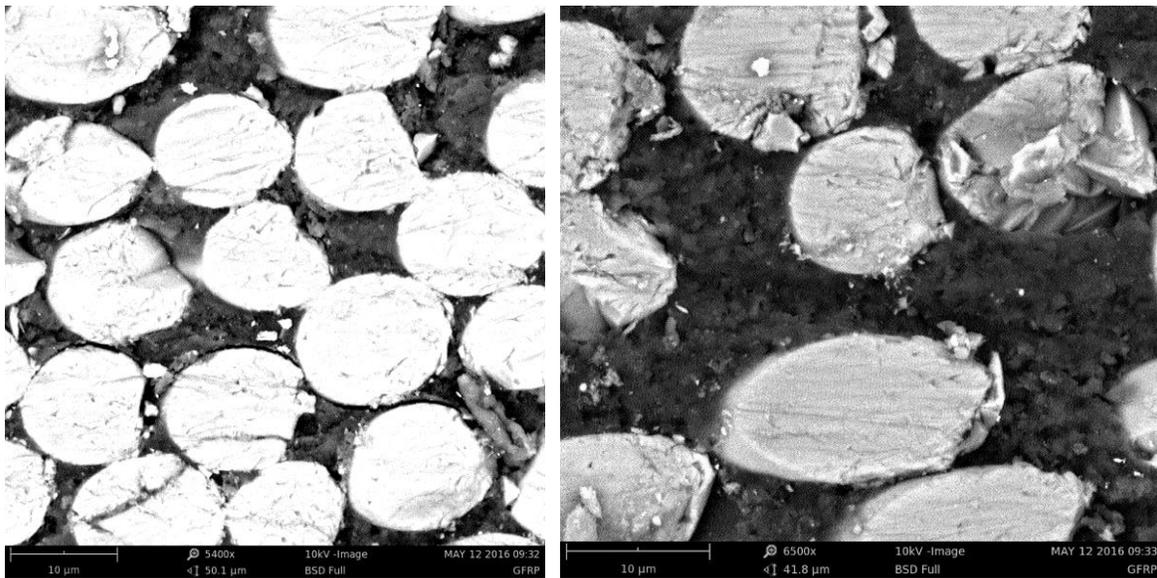
Figure 165—Magnified SEM images of fiber-matrix interface

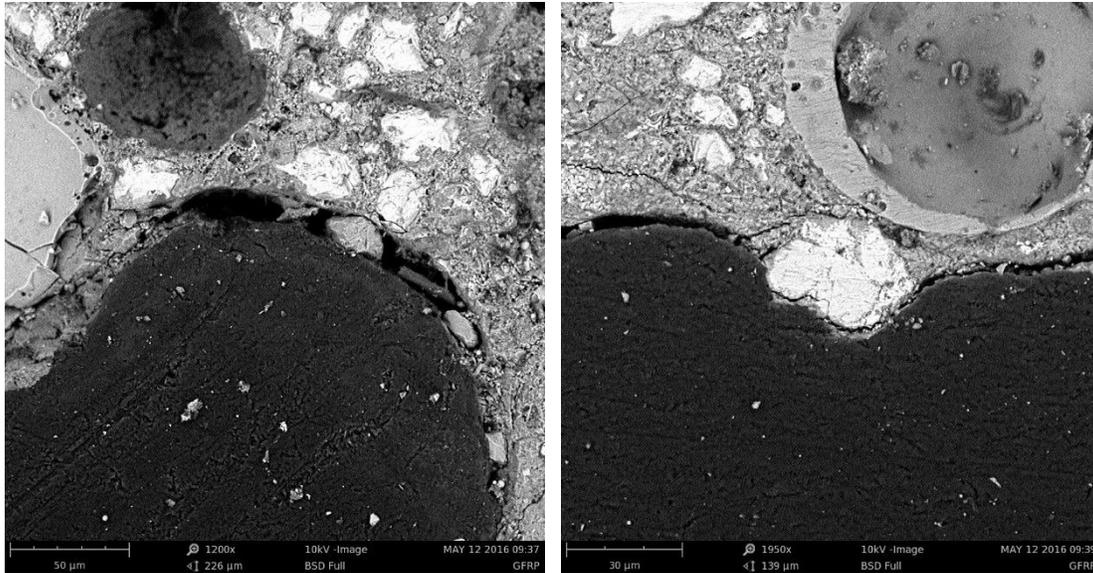
Figure 166 shows a backscatter electron image of the adhesive interface between GFRP and concrete. Dark regions in the image are representative of low average atomic number (low backscatter electron yield) and correspond to the adhesive; relatively brighter regions on the image represent concrete. Even though mechanical interlocking due to concrete surface irregularities is apparent, the collected SEM images reveal separation between the adhesive and concrete indicating potentially poor adhesion.

Figure 166—SEM image of interface between concrete (top) and GFRP composite (bottom)

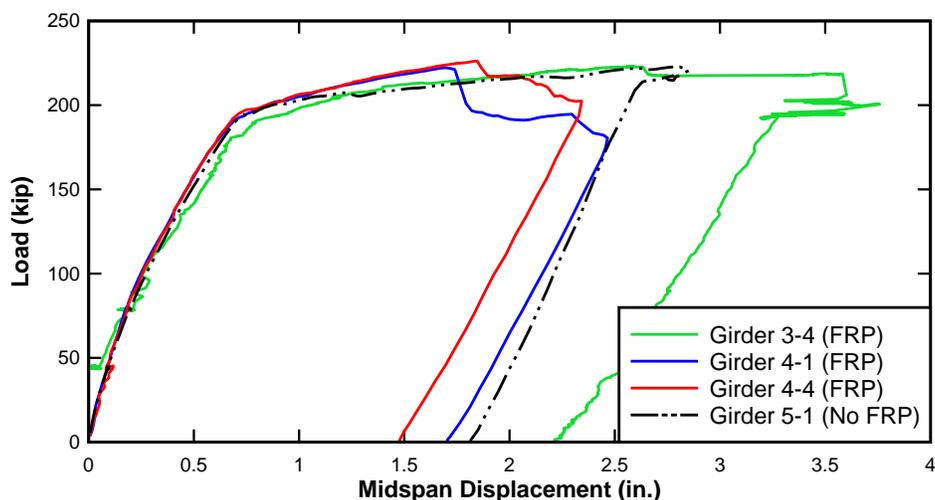
Load-displacement plots for the girders are presented in Figure 171. Girders with FRP installed exhibited similar behavior in the laboratory test. Girder 3-4, 4-1, 4-4 were exterior girders which had GFRP installed on one web face and CFRP strips externally bonded on the bottom of the beam. Girder 5-1 is an exterior girder without FRP. All of the exterior girders with FRP experienced FRP rupture failure prior to concrete crushing in the compression zone.

A gradual drop in load after reaching ultimate strength occurred in Girder 4-1 and 4-4 that may indicate that the GFRP may have ruptured before the CFRP because of the GFRP's lower ultimate strength. Girder 3-4 had a much larger sudden drop in load immediately before failure. Having the GFRP on one side may be the reason that the GFRP ruptured at a lower ultimate strength than predicted.

When comparing the results on Figure 171, Girder 3-4 had a notably higher ductility than the other girders with FRP. CFRP strips in Girder 3-4, 4-1, and 4-4 reached 61%, 49%, and 42% of the ultimate design rupture strain, respectively. Having the CFRP strips in Girder 3-4 reach closer to the ultimate design rupture strain may have resulted in Girder 3-4 in reaching a higher ultimate strength and ductility than the other girders. All of the CFRP laminate strips on the exterior girders had met the ACI 440 strain level at which debonding may occur.

Figure 171—Load-displacement of exterior test girders

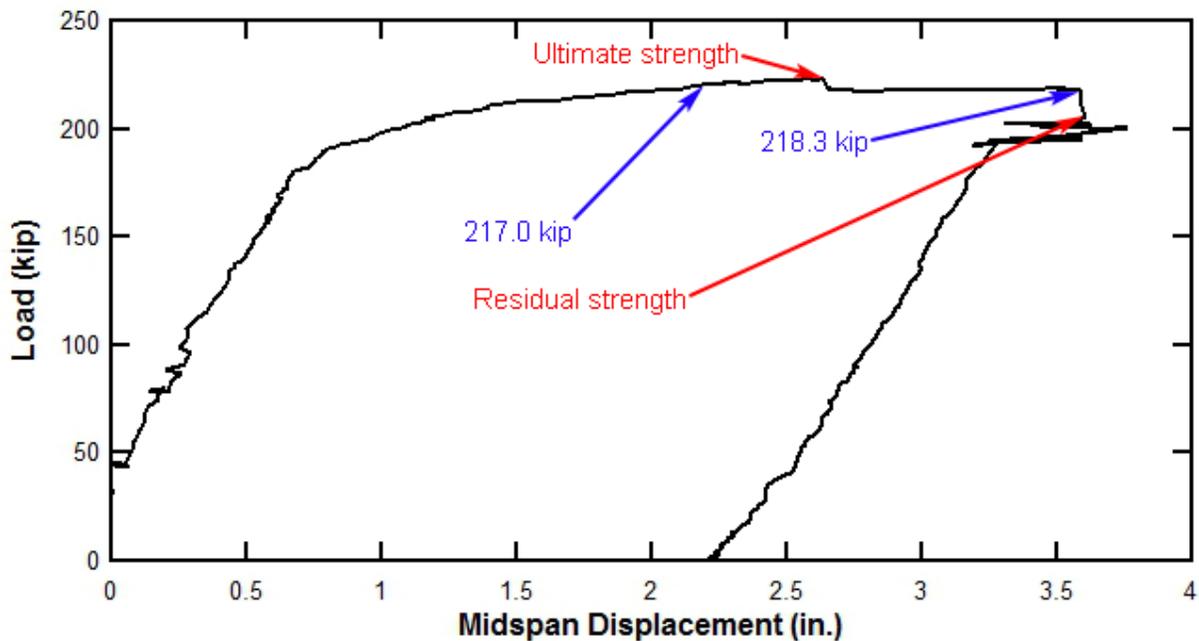
Girder 3-4 had the highest ductility of all four exterior girders, which was also the only girder with FRP to have a higher ductility than a girder without FRP. This may be the case because Girder 3-4 was the only girder to have the CFRP strips debond and rupture prior to the GFRP rupture, before any crushing of concrete in the compression zone had occurred. The other two girders with FRP had the GFRP rupture first, which may have resulted in a sudden increase in strain for the CFRP strip that may have led to the CFRP strip rupture and debond earlier than anticipated.

Figure 172—Load vs. displacement plot for Girder 3-4

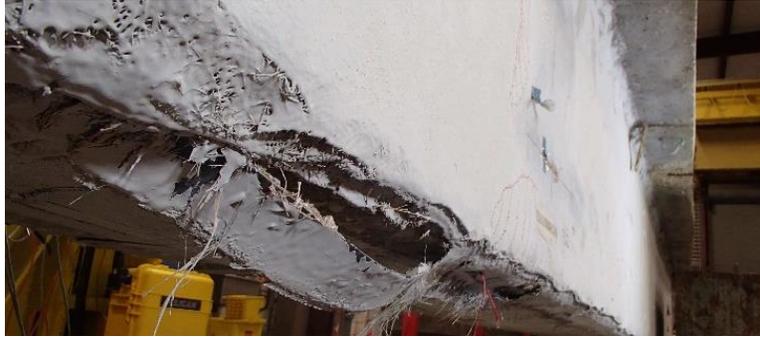
During flexural testing of 3-4, FSG3 indicated approximately 1000 microstrain more than FSG4. This difference in strain increased to approximately 3000 microstrain as the CFRP strips as the load approached ultimate strength. This difference in strain may be an indicator that lateral deformations were occurring since GFRP was only applied to the west face. Another possibility is that strain gages may have been in varying proximity to flexural cracks, which produced differing strains near ultimate strength. While the west CFRP strip debonded at a load of 217 kip, there was no indication on the load-displacement plot (Figure 172). The east CFRP debonded at ultimate strength (223 kip), which resulted in a small loss in load. The GFRP ruptured at 218.3 kip. At this point, both CFRP strips had debonded (Figure 173), and the GFRP had ruptured (Figure 174), resulting in a load decrease to approximately 200 kip residual strength. The GFRP rupture occurred simultaneously with a crack that formed in a formwork joint on the opposite face (east elevation) (Figure 175). The crack then lengthened into the compression zone (Figure 175b) where crushing occurred (Figure 175c).

Figure 173—CFRP debonding (Girder 3-4)

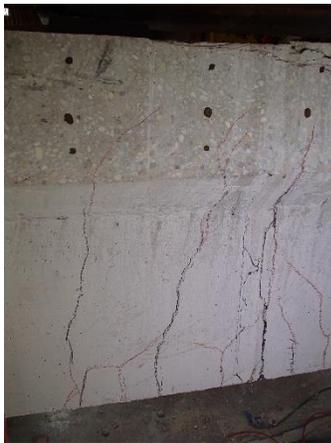
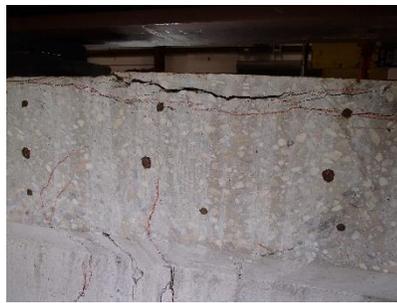
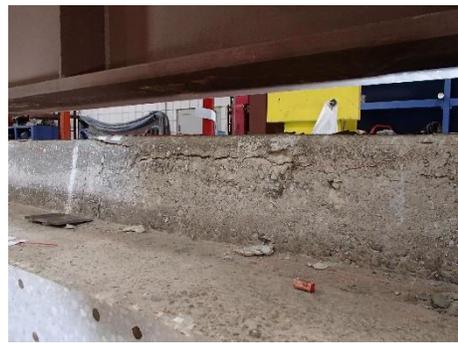
Figure 175—Concrete damage to Girder 3-4 including (a) cracking near formwork joint (b) concrete crushing in compression zone in east elevation (c) crushing of concrete in west elevation

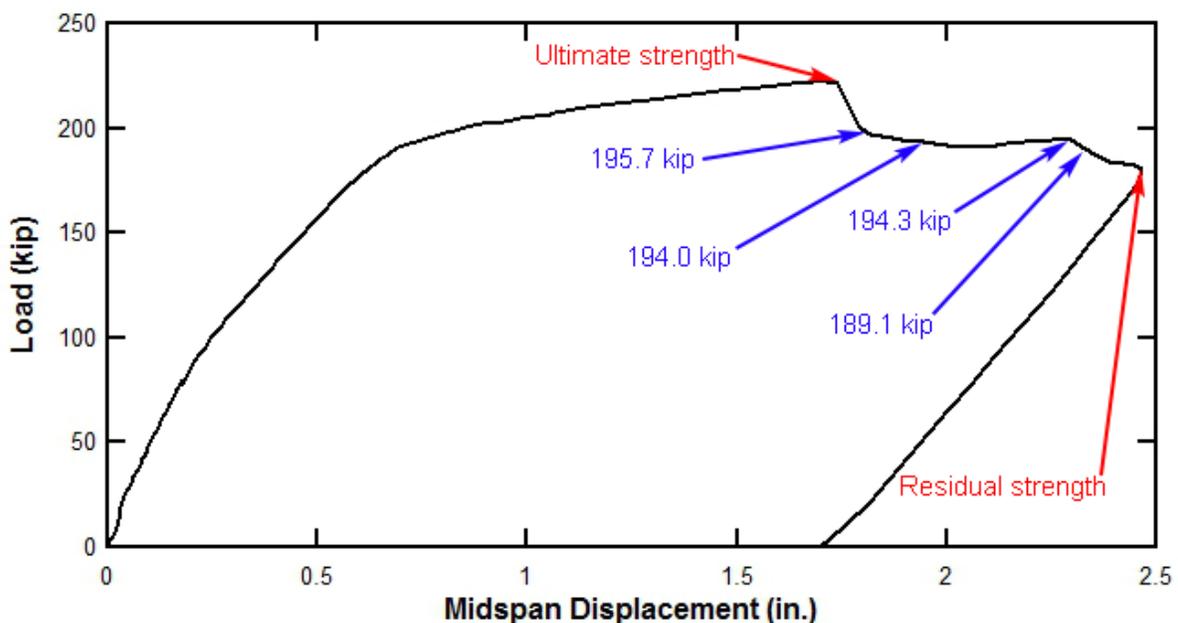
The cross-section of Girder 4-1 was slightly asymmetric. During testing of the CFRP strips, the strain gage readings on the CFRP strip on the west half of the girder (FSG3) varied from a few hundred to 1000 microstrain from the readings on the CFRP strip on the east half of the girder (FSG4). The GFRP ruptured first at the ultimate strength (222 kip), which resulted in a decrease in load to 195.7 kip (Figure 176). The CFRP strips debonded shortly after the GFRP ruptured. FSG3 indicated that a strain release occurred at 198 kip, followed by another strain release detected by FSG4 at 194.3 kip, indicated CFRP debonding. CFRP debonding was also detected by FSG3 at a load of 189.1 kip. Following CFRP debonding (Figure 177) and rupture (Figure 178), and GFRP rupture (Figure 179) the beam resisted a residual load of 181 kip. The debonding crack front was visible on the west CFRP strip (Figure 180). Crushing of concrete in the compression zone had also occurred at failure (Figure 181).

Figure 176—Load vs displacement plot for Girder 4-1

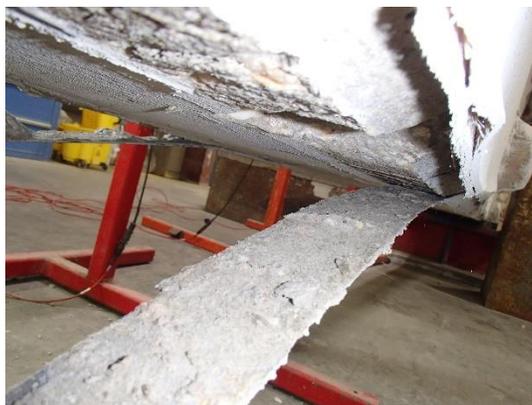
Figure 177—Debonded CFRP strips (Girder 4-1)

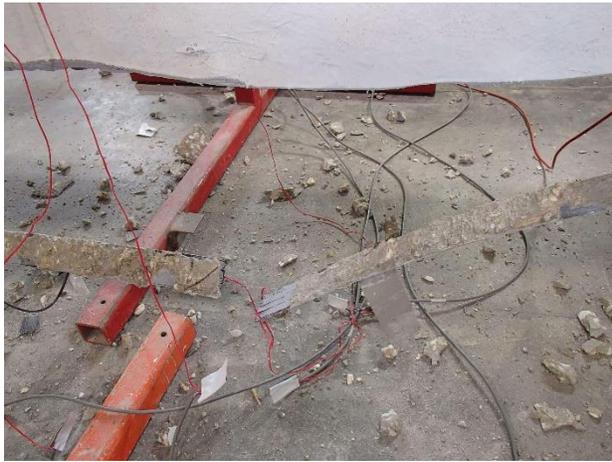
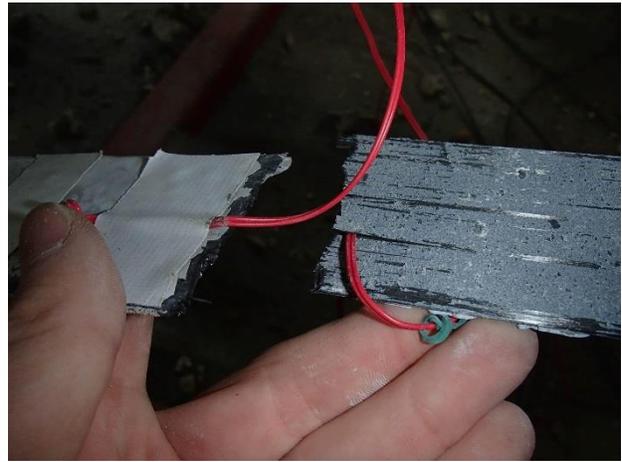
Figure 178—CFRP rupture (Girder 4-1): (a) one strip breaks apart (b) close-up image

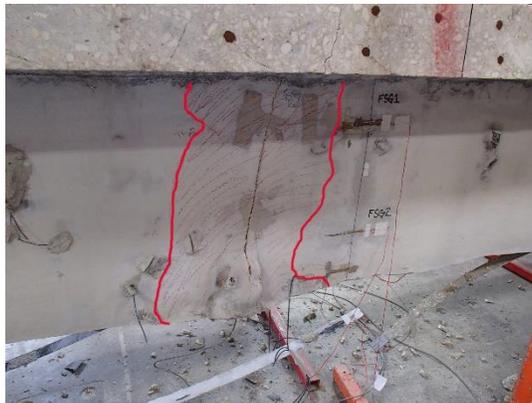
Figure 179—GFRP rupture (Girder 4-1) with debonded GFRP region outlined in red

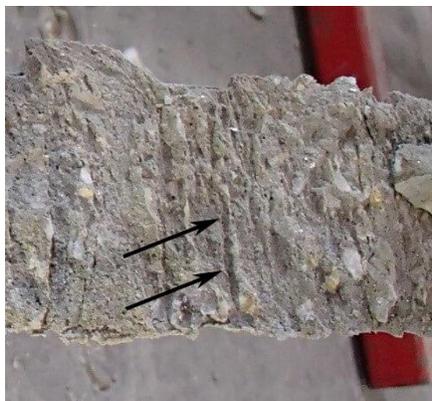
Figure 180—Crack front appearing on concrete substrate of debonded CFRP (Girder 4-1)

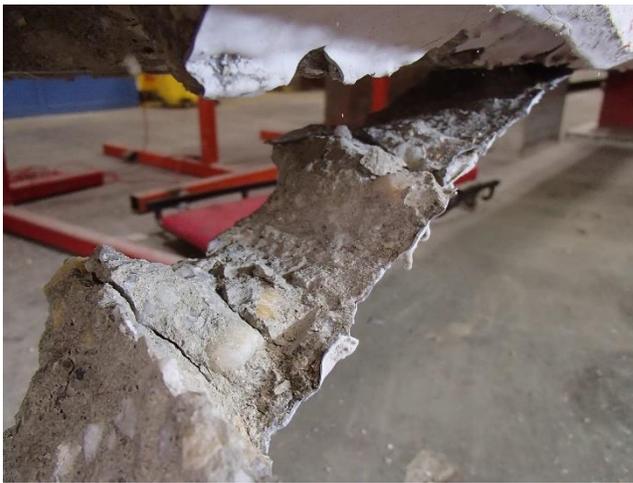
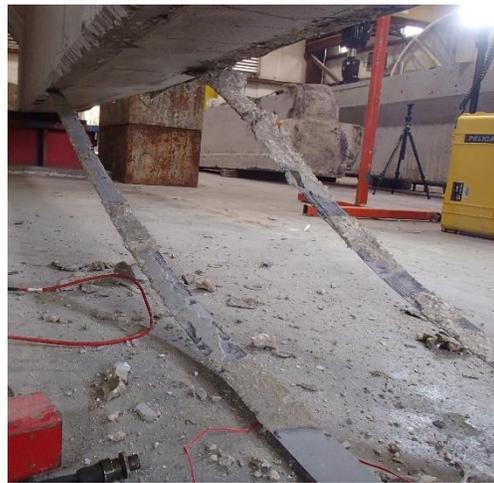
Figure 183—CFRP strip debonded (Girder 4-4): (a) single strip up close (b) both strips from a distance

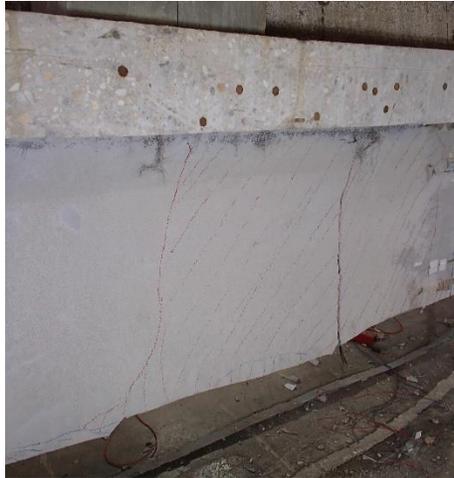
Figure 184—GFRP rupture (Girder 4-4)

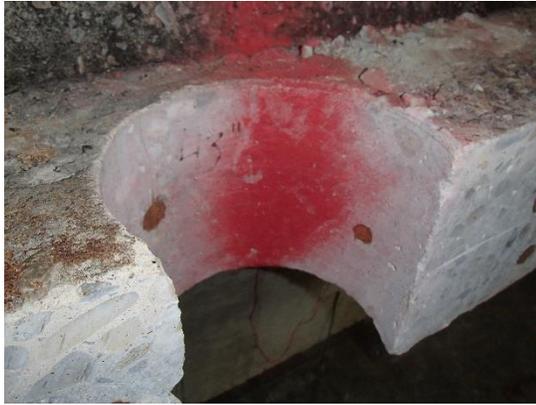
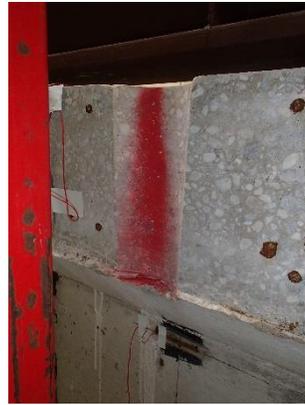
Girder 5-1 had a reduced cross-section at the midspan (Figure 186) with initial cracks located at about 12 in. away from the midspan. The contractors that extracted the girders from the University Boulevard bridge had attempted to ease removing girders 5-1 and 5-2 by coring both sides of the flange, which resulted in a reduced cross-section. During load testing, the service load cycles caused cracks to develop closer to the midspan. At ultimate strength, the girder failed by crushing of concrete in the compression zone (Figure 187). The failure occurred once the beam cracked at a formwork joint on the east elevation (Figure 188), after cracks developed in the compression zone and expanded to the joint.

Figure 186—Reduced cross-section at the midspan (Girder 5-1): (a) west elevation (b) east elevation
