Durability Evaluation of Florida's Fiber-Reinforced Polymer (FRP) Composite Reinforcement for Concrete Structures

Final Report

March 2017

Florida Department of Transportation (FDOT)
David Wagner, P.E. – Project Manager

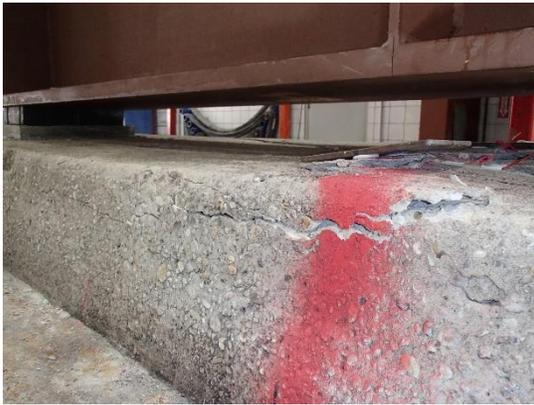
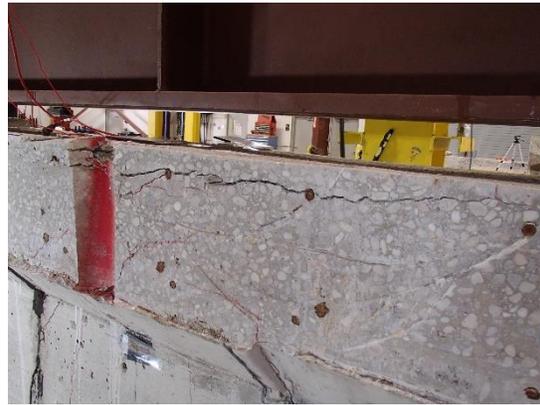
Girder 5-1 had a reduced cross-section at the midspan (Figure 186) with initial cracks located at about 12 in. away from the midspan. The contractors that extracted the girders from the University Boulevard bridge had attempted to ease removing girders 5-1 and 5-2 by coring both sides of the flange, which resulted in a reduced cross-section. During load testing, the service load cycles caused cracks to develop closer to the midspan. At ultimate strength, the girder failed by crushing of concrete in the compression zone (Figure 187). The failure occurred once the beam cracked at a formwork joint on the east elevation (Figure 188), after cracks developed in the compression zone and expanded to the joint.

Figure 187—Crushing of concrete in compression zone (Girder 5-1): (a) west elevation (b) east elevation

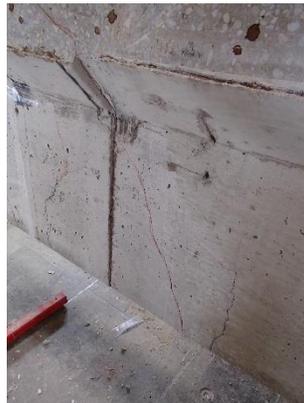
Figure 188—Formwork joint on the east elevation (Girder 5-1)

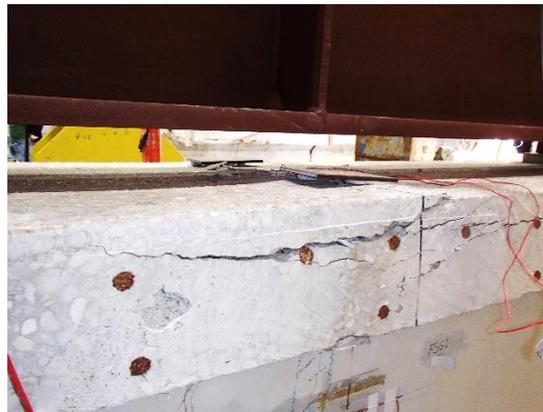
Girder 3-2 had considerable audible GFRP cracking at midspan when the load reached approximately 220 kip. This was likely the result of nearing the yield point, which was at approximately 229 kip. The girder reached ultimate strength when the GFRP ruptured; crushing of concrete in compression was observed as well (Figure 190). Debonding of CFRP closest to the east face occurred around midspan. The span of the debonded CFRP strip is indicated by red arrows (Figure 191) and the GFRP on the midspan of the east face has blue hatching to indicate the debonded region around the GFRP rupture (Figure 192).

Figure 190—Crushing of concrete in compression (east elevation view of Girder 3-2)

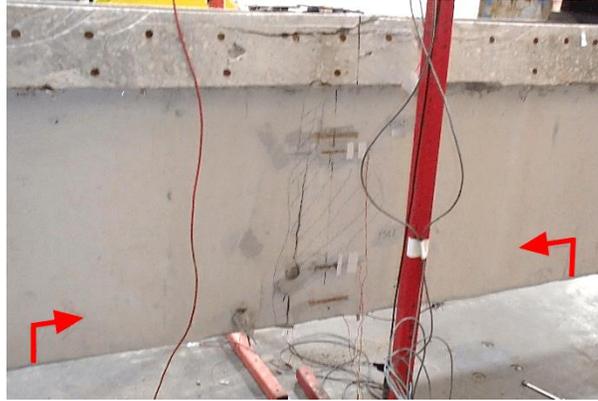
Figure 191—Red arrows indicate the span of debonded CFRP strip (Girder 3-2)

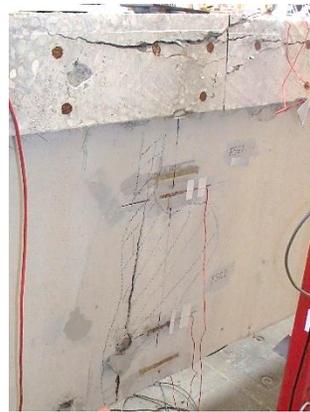
Figure 192—GFRP rupture and GFRP debonding indicated in hatch (Girder 3-2)

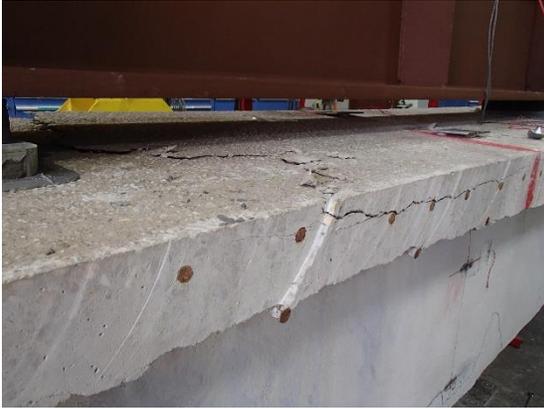
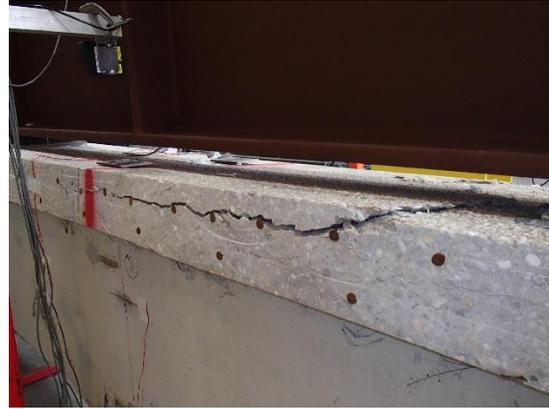
Girder 4-2 had considerable audible GFRP cracking at midspan when the load reached approximately 200 kip, which is approximately 27 kip before a change in stiffness occurred. At ultimate strength, the girder failed by crushing of concrete in compression (Figure 193). Although cracks formed in the web near midspan (Figure 194), they did not seem to expand (Figure 195), or appear to affect the failure mode. Although some debonding occurred at midspan on the west face (Figure 195), the debonding did not result in GFRP rupture.

Figure 193—Crushing of concrete in compression (Girder 4-2): (a) west elevation (b) east elevation

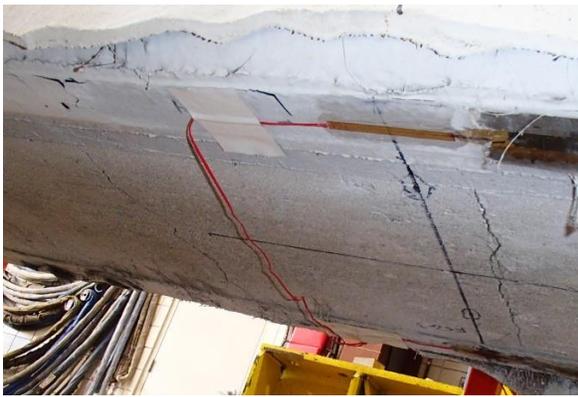
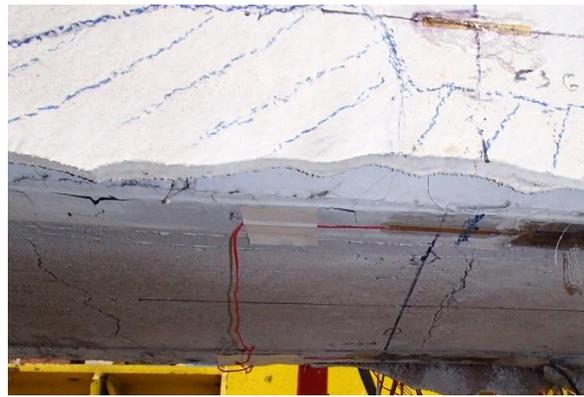
Figure 194—Girder 4-2 cracking on bottom and side (a) at initial and (b) after failure

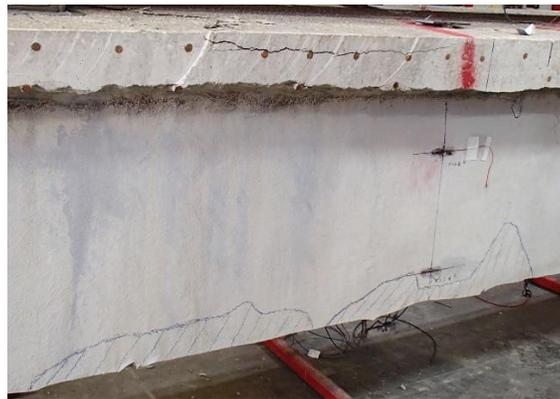
Figure 195—GFRP debonding by midspan on west elevation (Girder 4-2)

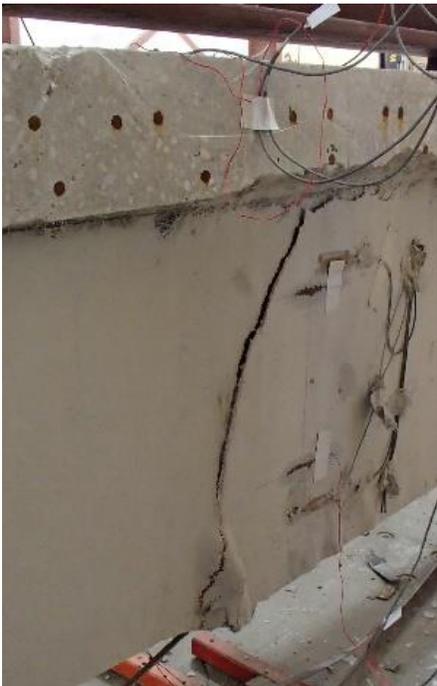
(Figure 196) followed the FRP rupture. GFRP rupture occurred on the east elevation (Figure 197), followed by debonding (Figure 198b) and rupture (Figure 198a) of the CFRP strip on the beam web closest to the east elevation. Longitudinal cracking found on the bottom face of the web may have been due to corrosion (Figure 199).

Figure 197—GFRP rupture on east elevation (Girder 4-3)

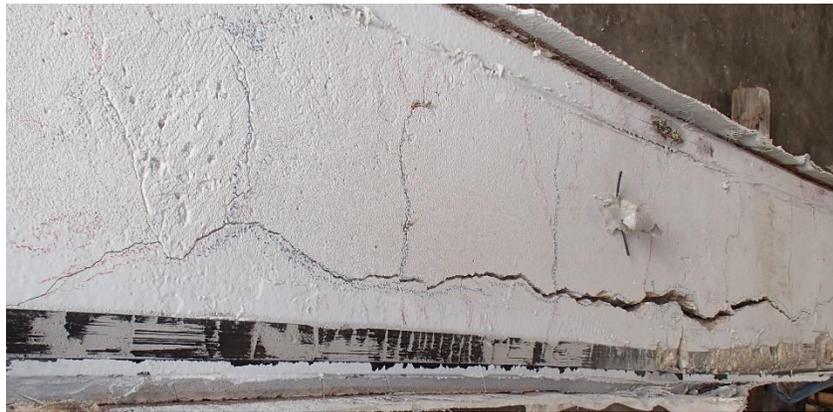
Figure 199—Longitudinal cracking on the tension face of Girder 4-3

1). Girder 4-3 was chosen due to a horizontal crack noticed on the bottom face of the web after failing in flexure.

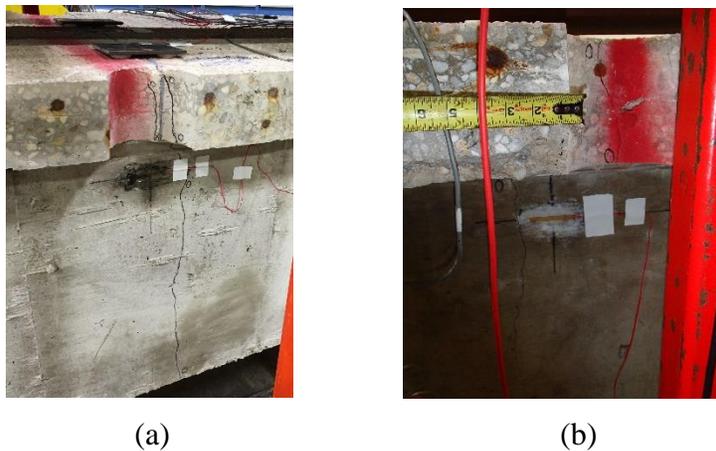
Girder 5-2 had a reduced cross-section at the midspan (Figure 200) with initial cracks on the reduced cross-section and nearby regions. At ultimate strength, the girder failed by crushing of concrete in compression (Figure 201).

Figure 200—Reduced cross-section at midspan (Girder 5-2): (a) west elevation (b) east elevation

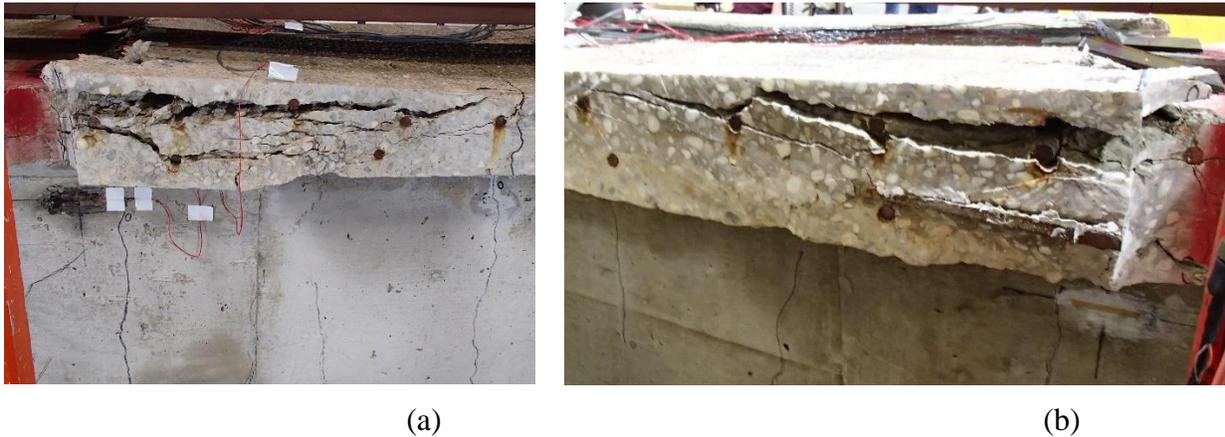
Figure 201—Crushing of concrete (Girder 5-2): (a) west elevation and (b) east elevation

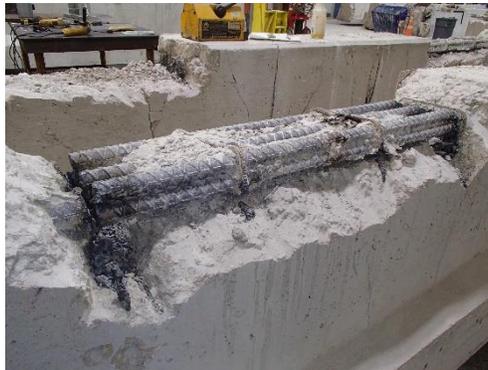
Figure 210—Steel reinforcement exposed

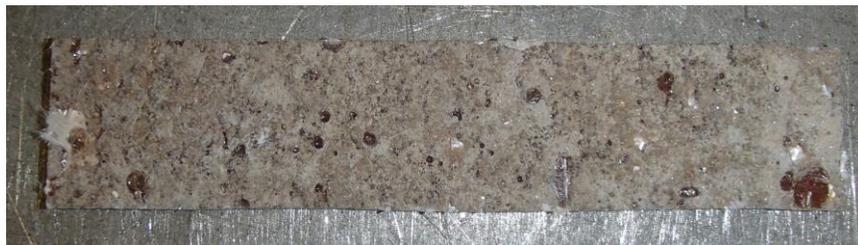
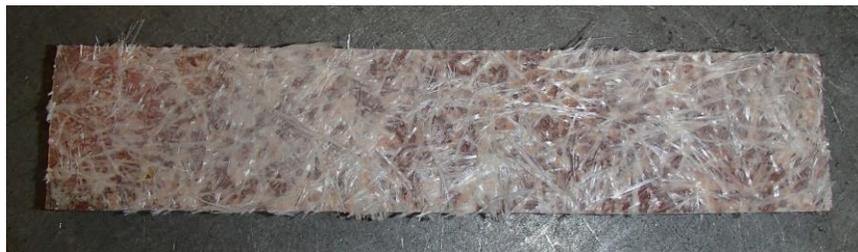
GFRP coupons were saw cut from the east face approximately 3 feet from the south end of four beams, and manually peeled from the concrete surface. In some cases, concrete remained adhered to the surface (Figure 214a) and in other cases the sample came away clean (Figure 214b) Prior to sanding the GFRP samples to uniform dimensions, the surface condition of each sample was characterized as having a light, medium, or heavy concrete concentration. This was done to determine the effect of the residual concrete on the flexural strength of the samples (Figure 215). Although there may be a slight indication of a higher than average flexural strength on the cohesively debonded samples, no firm conclusions can be drawn.

Figure 214—GFRP samples with (a) residual concrete adhered and (b) free of concrete

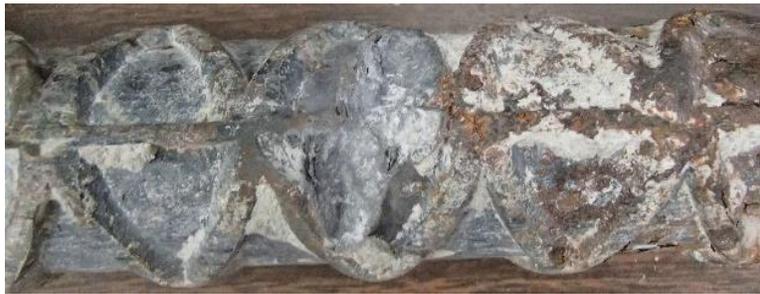
The south ends of the four selected girders were compared because higher levels of corrosion were expected in the regions closest to the tidal fluctuations (Figure 217). Girders were divided into thirds so the locations of steel reinforcement extraction remained consistent within all of the girders. Figure 218 and Figure 219 are images of steel reinforcement with the highest levels of corrosion of four samples.

Figure 218—Corroded reinforcement samples from (a) Girder 3-1 and (b) Girder 4-1

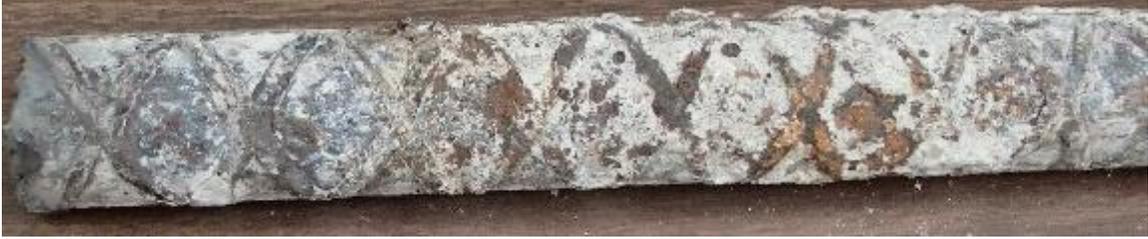
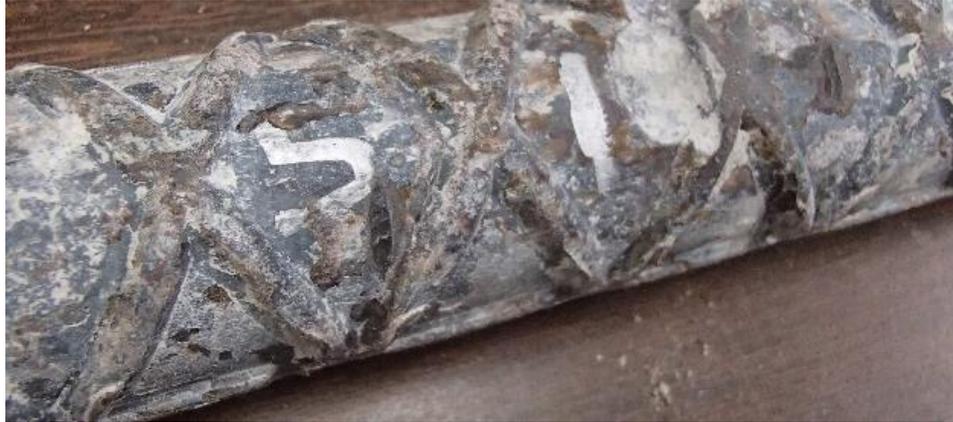
Figure 219—Corroded reinforcement samples from (a) Girder 4-3 and (b) Girder 5-1

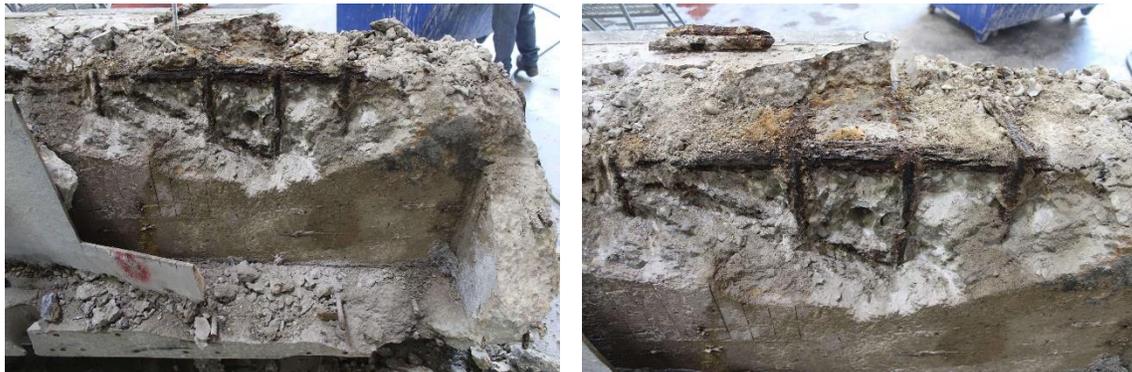
The steel reinforcement at the north end of Girder 3-1 was uncovered due to the swelling and cracking noted there (Figure 220). This location was the most severe, with reinforcement section losses of up to 34% (Table 29). The severe corrosion uncovered at this location had likely occurred prior to FRP application. Furthermore, GFRP was applied to the inside face, but not the outside face of Girder 3-1. Consequently, it is not possible to determine if the corrosion was deterred by the presence of the FRP.

Figure 220—Corroded steel reinforcement in the north end of Girder 3-1

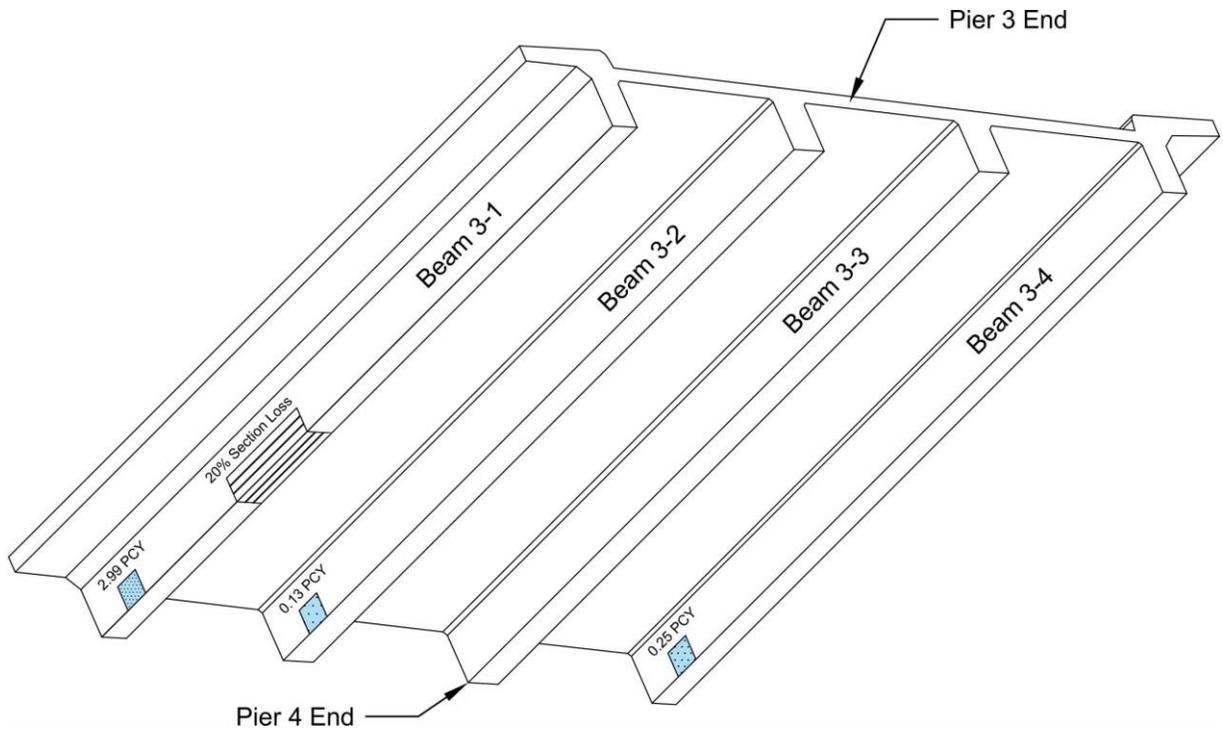
Steel reinforcement section loss was higher in Span 3 than the other two spans, which was expected since Span 3 was the lowest elevation and was inundated during high tide (Figure 222). Span 4 had more section loss on the exterior girder (Girder 4-1) than the interior girder (Girder 4-3). It is not clear why the Cl⁻ concentration does not relate to the levels of section loss due to corrosion

Figure 223—Chloride ion contamination levels and section loss in steel reinforcement in Span 3

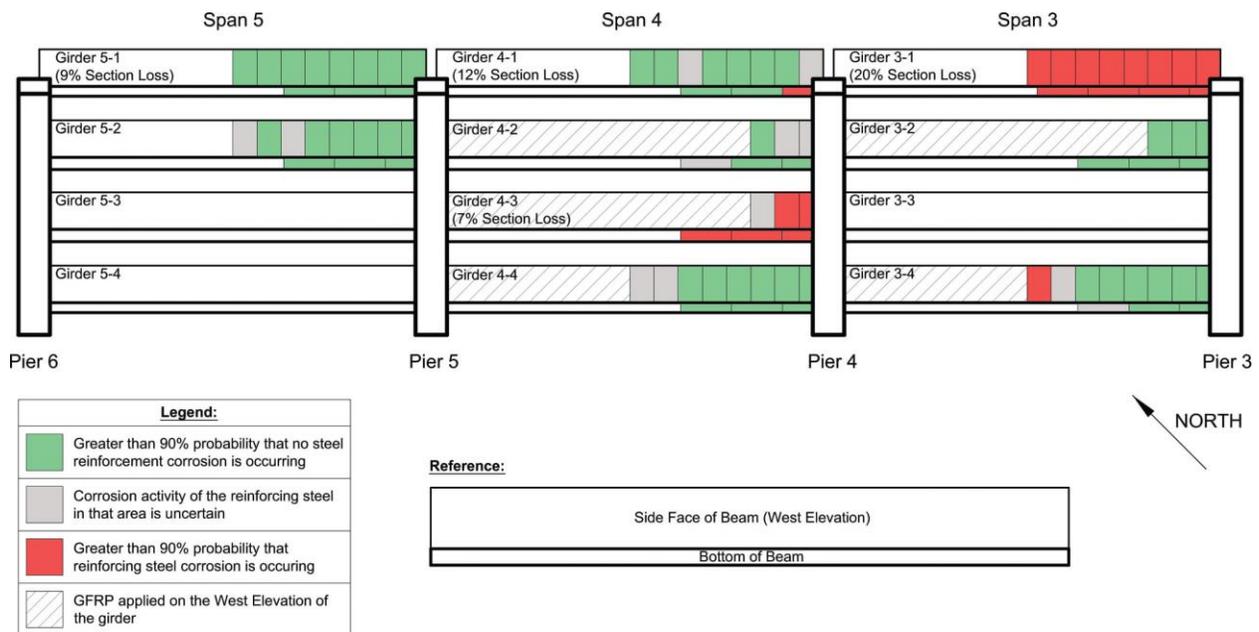
Figure 225 shows the probability of corrosion mapped onto the girders. Based on the figure, a higher likelihood of corrosion would be expected for Girder 4-3 than Girder 4-1 and 5-1. Higher Cl⁻ content found in Girder 4-3 would also increase susceptibility to corrosion over that of Girder 4-1 and Girder 5-1. These results also tend to reflect the exposure conditions; girders in Span 4 had higher exposure to wetting and drying than Span 5, due to the height above water levels and high tide inundation.

Figure 225—Corrosion potential mapping on girders in spans 3, 4, and 5

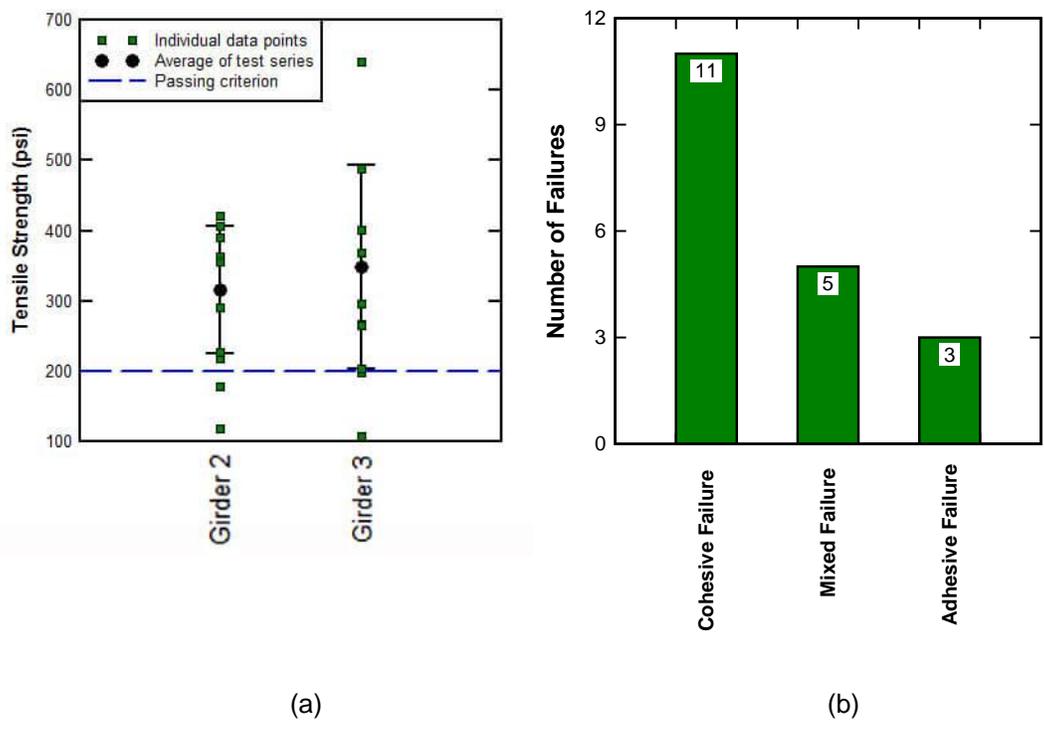
Overall, direct tension pull-off tests between Girder 2 and 3, showed that all of the samples (excluding samples which had failure mode A) met the specified strength of over 200 psi (Figure 237). Over 42% did show an adhesive or mixed failure mode, however, indicating that there may have been some bond degradation.

Figure 237—Direct pull-off testing: (a) tensile strength comparison and (b) failure modes

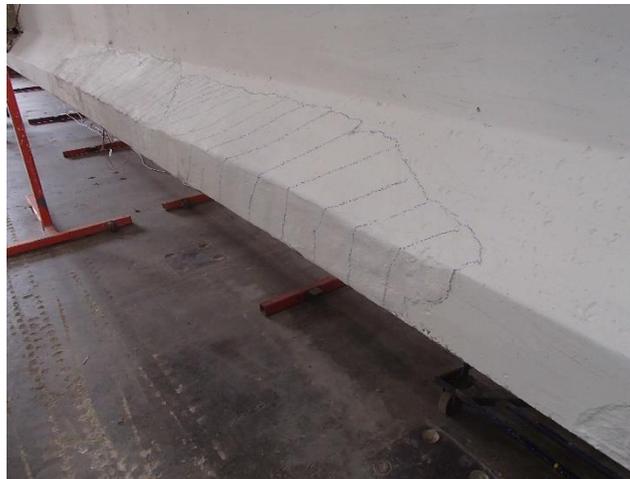
Girder 1 was the easternmost exterior girder over the eastbound lane, and its repair did not include FRP (Figure 245). This was most likely the case because the damage may have not been as severe as Girder 2 and Girder 3. Girder 1 and Girder 2 had identical cross-section geometry. The failure mode only consisted of the concrete crushing in the compression zone (Figure 246), as expected. When loading the girder past its ultimate strength, Girder 1 failed at the end of the repaired region (Figure 247), which may indicate that the repair had a minor effect on the ultimate strength.

Figure 245—Region of concrete repair indicated in hatched area

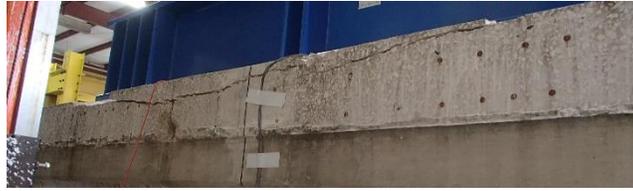
Figure 246—Concrete crushing in compression zone

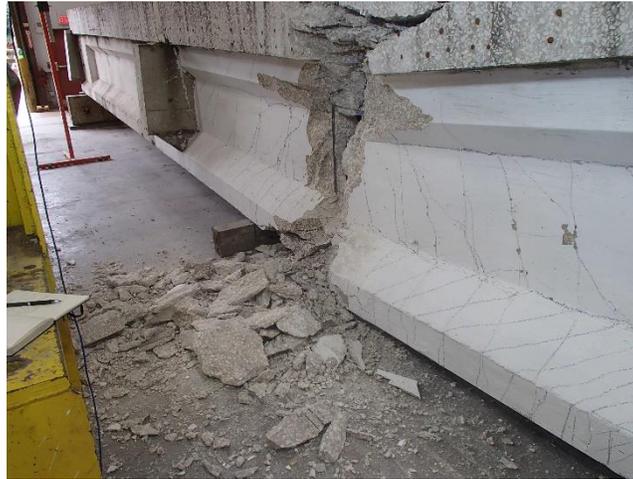
Figure 247—Girder 1 failed at the end of the repaired region

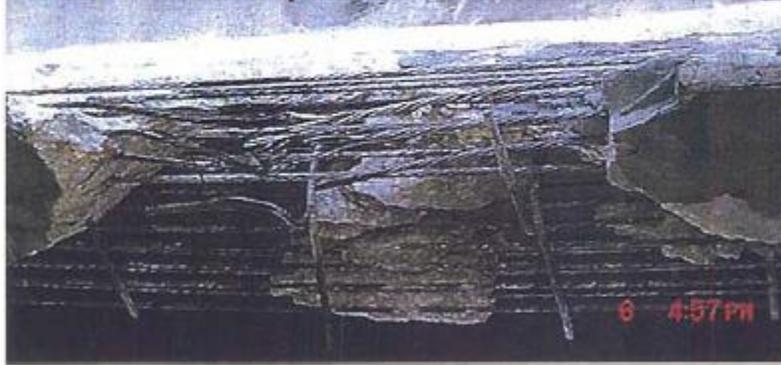
An FDOT inspection report by Cheshire (2001) indicates that Girder 2 (Beam 3-5) had the most severe damage in Span 3, because of four severed strands from an impact (Figure 248). This girder was the easternmost exterior girder over the westbound lane, which is why it had the most severe damage. Girder 2 failed at the center of the repaired region that had only repair mortar without FRP, which was likely due to multiple repairs to multiple impacts (Figure 249). The repair originally had FRP in this location, but it was removed during a more recent impact event and the section was restored without application of FRP; FRP, however, was still on the web. Although Girder 1 and Girder 2 had an identical cross-section (Figure 228), Girder 2 had four severed strands. The location of failure may indicate that the repair had affected the ultimate strength, resulting in Girder 2 having a lower ultimate strength than the other exterior girder. The failure mode consisted of the concrete crushing in the compression zone (Figure 250), instead of FRP rupture prior to a concrete crushing failure mode. This may indicate that the FRP was not able to provide as much supplemental reinforcement as intended when designed.

Figure 248—Severed strands on Girder 2 after impact in 2001 (Green et al., 2004)

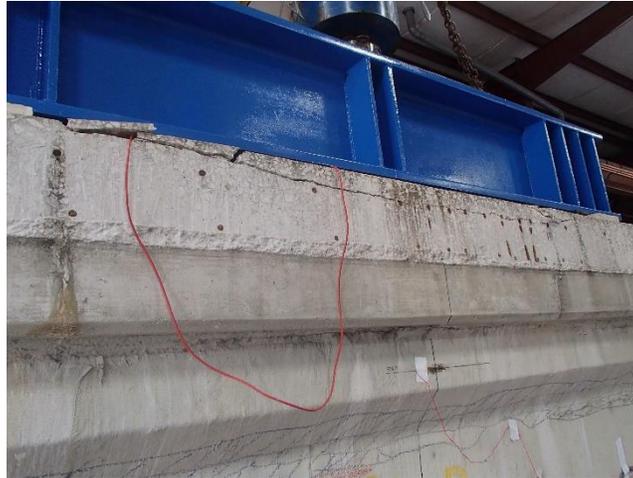
Figure 250—Concrete crushing in the compression zone

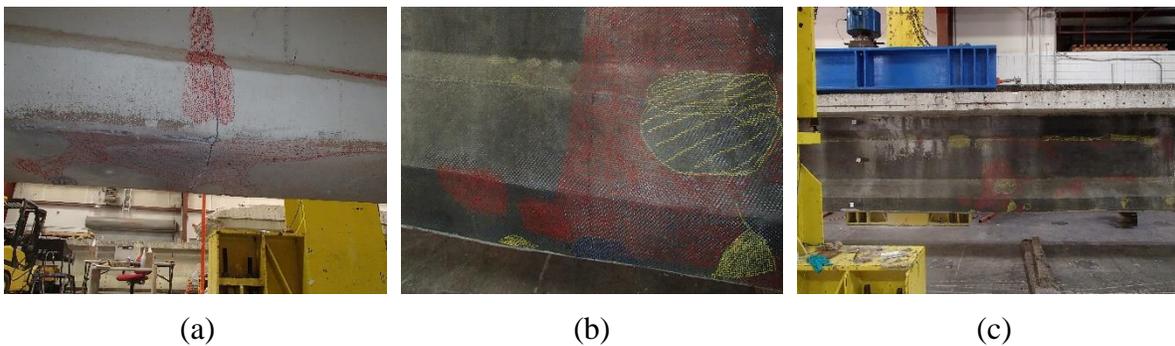
Girder 3 was the westernmost exterior girder over the westbound lane. At failure, the FRP ruptured on the west elevation (Figure 251a) and on the east elevation (Figure 251b), which was in a highly debonded region directly below the north end of the spreader beam bearing pad (Figure 251c). The cross-section for Girder 3 was different from Girder 1 and Girder 2. Additional depth was provided by the deck in Girder 1 and Girder 2, which may explain why Girder 1 had a higher ultimate strength than Girder 3. Although Girder 3 had a number of debonded regions after loading, Girder 2 had larger amounts of debonded regions and the FRP may have not been as effective in increasing the ultimate strength and ductility because of the repaired region without FRP, which included four severed prestressing strands.

Figure 251—FRP damage on Girder 3: (a) close-up of rupture on east face (b) close-up of rupture on west face (c) rupture location on west face

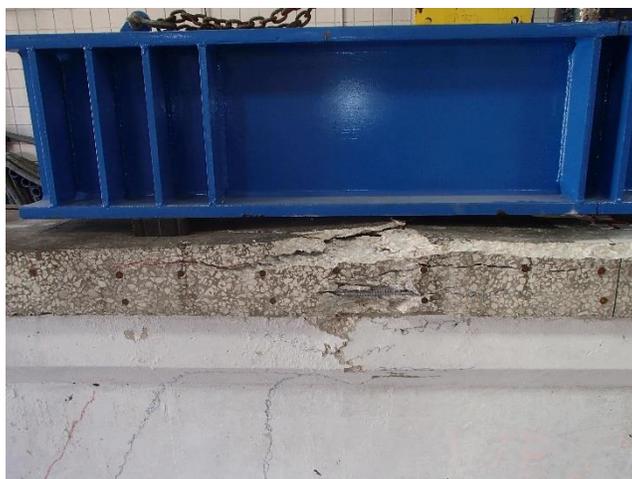
Girder 4 was a westernmost interior girder facing eastbound traffic, which did not have any apparent repairs in the midspan region. This girder had a shallower overall depth than the exterior girders due to the smaller deck thickness than that of the exterior girders. This resulted in the girder having the lowest ultimate strength of the tested girders. The failure mode consisted of the concrete crushing in the compression zone (Figure 252).

Figure 252—Concrete crushing in the compression zone

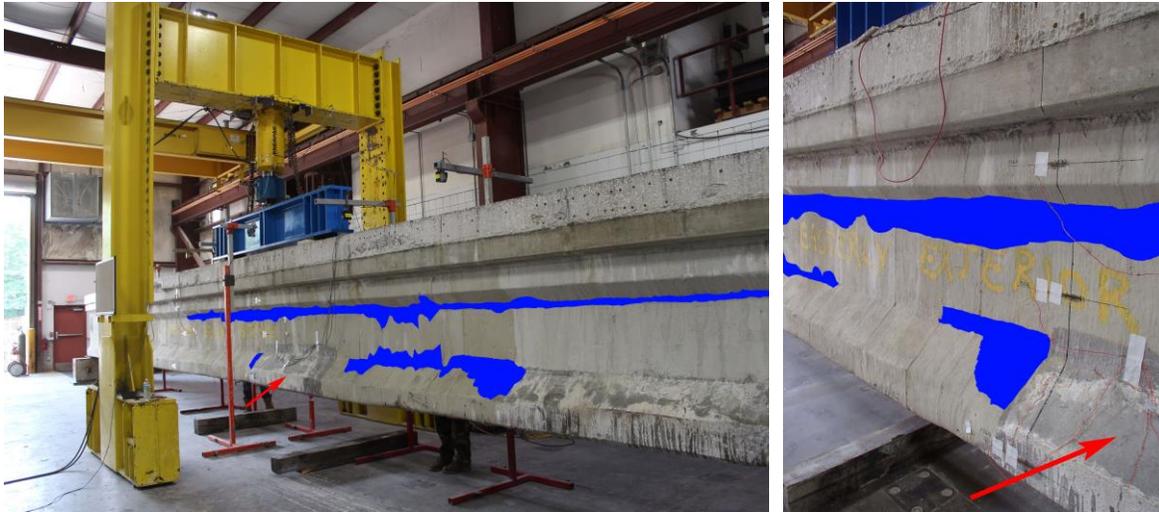
Girder 1 had a lower experimental moment capacity than the theoretical moment curvature, most likely due to prior damage from a collision. Girder 2 had four severed strands, which greatly affected the moment capacity of the girder. Although it had been repaired with FRP, a majority of debonded regions were determined by a coin tap prior to testing the girder in flexure ().

Prior to loading Girder 2 in flexure, debonded regions were identified through coin tap inspection (Figure 257a). Some additional debonding had occurred when loading the girder to 90 kips, primarily in areas within the constant moment region that most likely did not have a critical effect on the ultimate capacity, with the exception of the debonded region near the repair. Figure 257b shows the proximity of the repaired region to the constant moment region. Failure had occurred in this repaired region, which most likely was the cause of failure at a load notably lower than the theoretical ultimate capacity.

Figure 257—FRP debonding on Girder 2; repaired region is identified with a red arrow, and debonding is identified in blue: (a) prior to loading in flexure (b) after loading Girder 2 to 90 kips

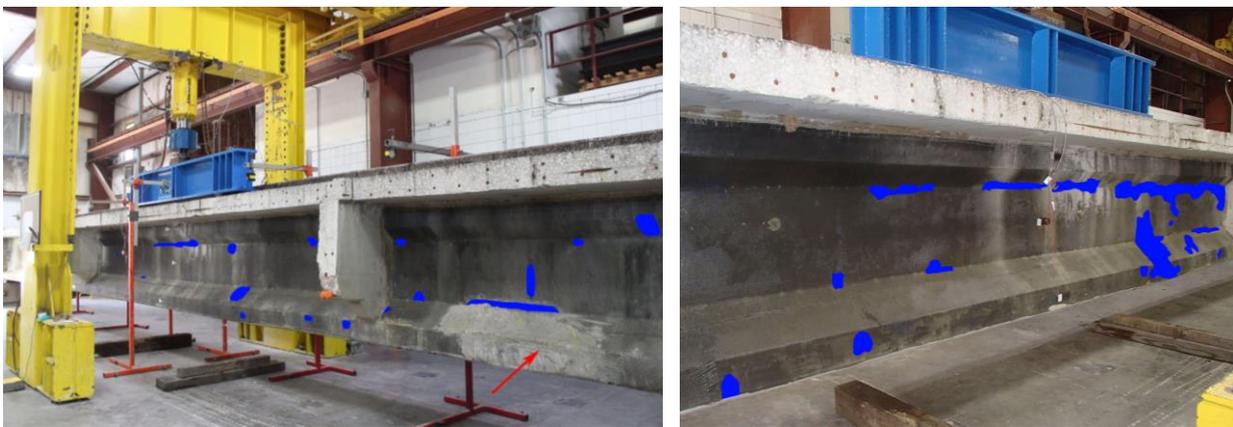
Based on inspection through coin tap prior to testing the girders in flexure, the total debonded area on Girder 3 was less than that of Girder 2 prior to loading (Figure 258a) and after loading the girder to 90 kips in flexure (Figure 258b). Girder 3, however, did not have a repair region within the constant moment region, which most likely was the reason why Girder 3 had a much higher ultimate capacity than Girder 2.

Figure 258—FRP debonding on Girder 3; repaired region is identified with a red arrow, and debonding is identified in blue: (a) prior to loading in flexure (b) after loading Girder 3 to 90 kips

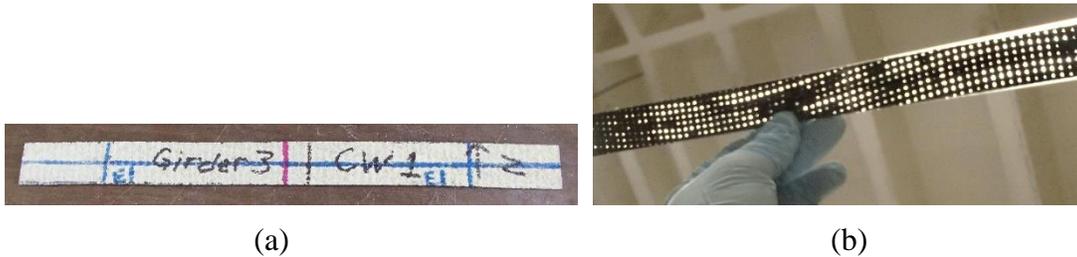
CFRP samples were extracted from the concrete surface by the use of a cutting wheel combined with hand prying and peeling. The process revealed that large portions of CFRP on the east face was debonded at the CFRP-epoxy interface. Figure 261 illustrates the lack of concrete substrate that remained adhered to the CFRP laminate when removed from the surface. Removal of the CFRP on the west face also revealed poor bonding at the concrete-epoxy interface (Figure 262). The CFRP on the east face was painted (Figure 263a). The CFRP on the west was not painted and may not have been completely saturated in resin prior to installation based on the voids visible in the weaves (Figure 263b).

Figure 263—CFRP samples: (a) from east face with coating (b) from west face without coating

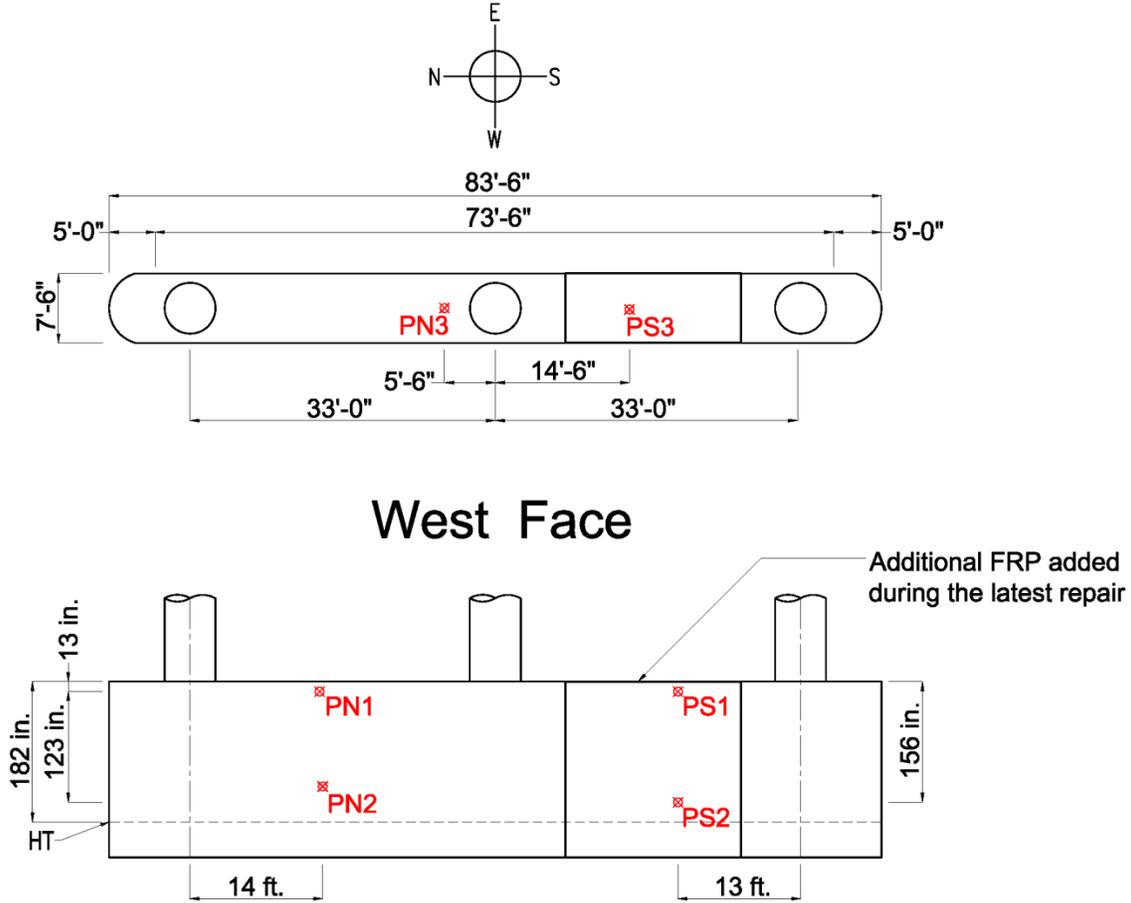
Figure 277—Pull-off test locations on Pier 8

A total of six pull-off tests were performed on Pier 8 crash wall, as per ASTM D7522. Test disks were installed on Monday, November 3rd 2014; the testing was performed on Tuesday, November 4th 2014. Tests were executed at the following locations:
