Durability of Epoxy Bond

January 1996

A Report on a Research Project Sponsored by  
the Florida Department of Transportation

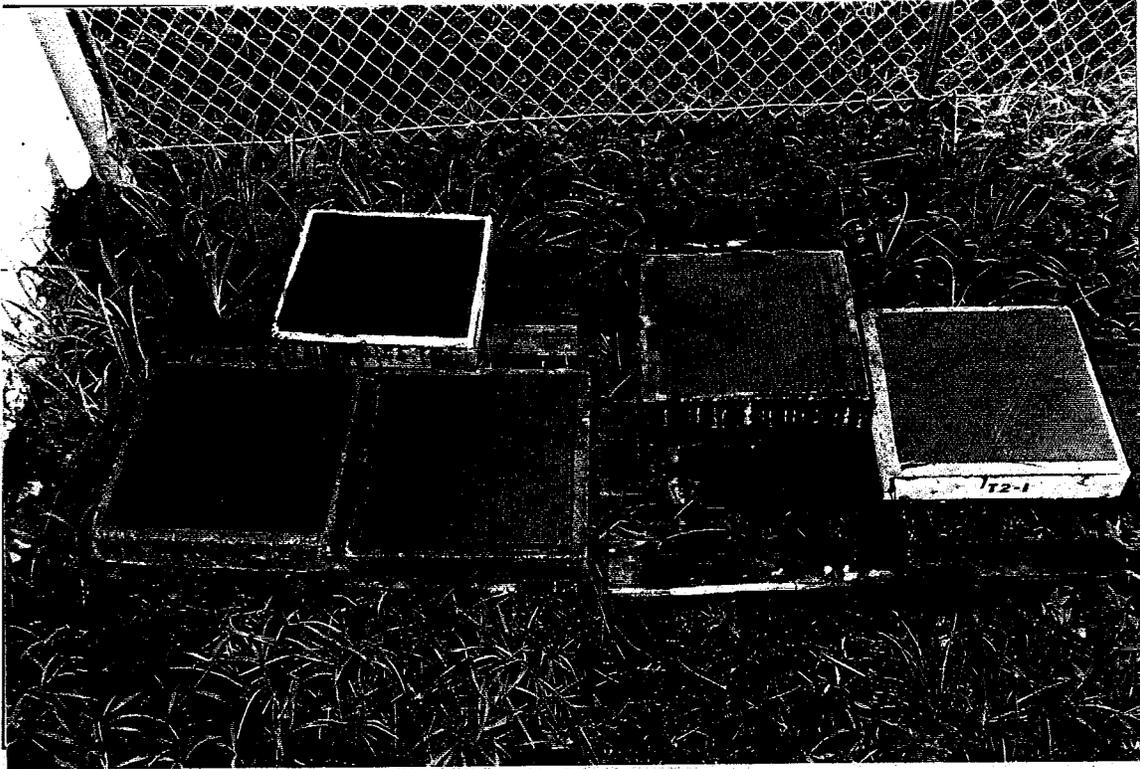
**Plate 11. Outdoor Set-up.**

Five specimens, one from each representative group being tested, were placed outdoors on wooden pallets at the ground level and, subjected -to changing weather conditions for the duration of the study (see Plate 11). The variation in ambient conditions as reported by the *Tampa Tribune* is provided in Appendix C.
