# An Evaluation of Asphalt Treated Permeable Base

Research Report FL/DOT/SMO/07-511

December 2007

# STATE MATERIALS OFFICE

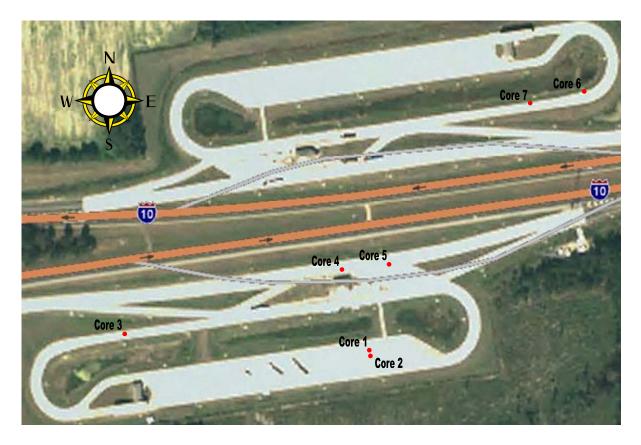
Figure 1 – Core Locations for I-10 Weigh Station - Jackson County

A total of seven cores were obtained from various locations within this project (see Figure 1). All of the cores were obtained at joints in the concrete pavement, which represents the worst case scenario for moisture intrusion and potential damage to the ATPB layer.

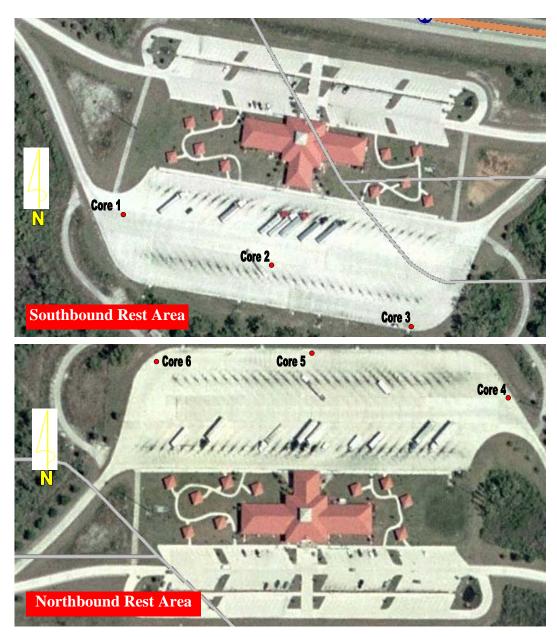
Figure 4 – Core Locations for I-95 Rest Area - Martin County

A total of six cores were obtained from various locations within this project (see Figure 4). All of the cores were obtained at joints in the concrete pavement, which represents the worst case scenario for moisture intrusion and potential damage to the ATPB layer. Due to the high volume of truck traffic at this rest area, the cores were obtained near the edges of the parking area and not in the travel lanes.

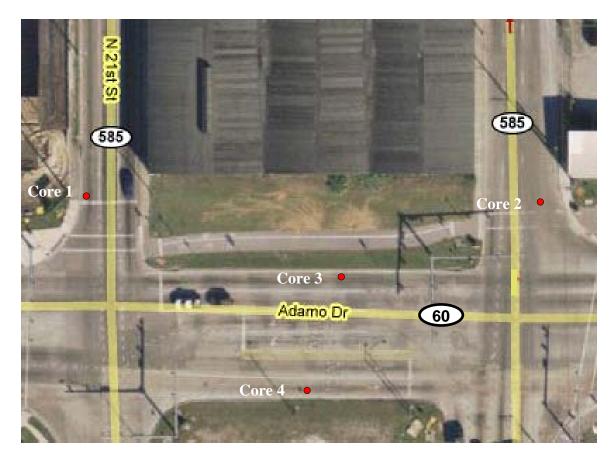
Figure 6 – Core Locations for SR-60 and North 22nd Street - Hillsborough County

A total of four cores were obtained from various locations within this project (see Figure 6). All of the cores were obtained at joints in the concrete pavement, which represents the worst case scenario for moisture intrusion and potential damage to the ATPB layer.

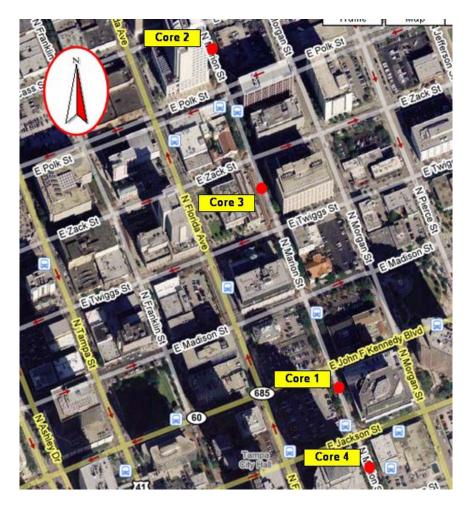
Figure 9 – Core Locations for Marion Street - Hillsborough County

A total of four cores were obtained from various locations within this project (see Figure 9). All of the cores were obtained at joints in the concrete pavement, which represents the worst case scenario for moisture intrusion and potential damage to the CTPB layer.
