Structures Research Report No. 879  
Final Project Report

UF Project No. 4504-879-12  
Contract No. BC-354 RPWO #55

**CFRP REPAIR OF IMPACT-DAMAGED  
BRIDGE GIRDERS  
VOLUME II - INSPECTION OF FRP COMPOSITE  
REPAIRS USING INFRARED THERMOGRAPHY**

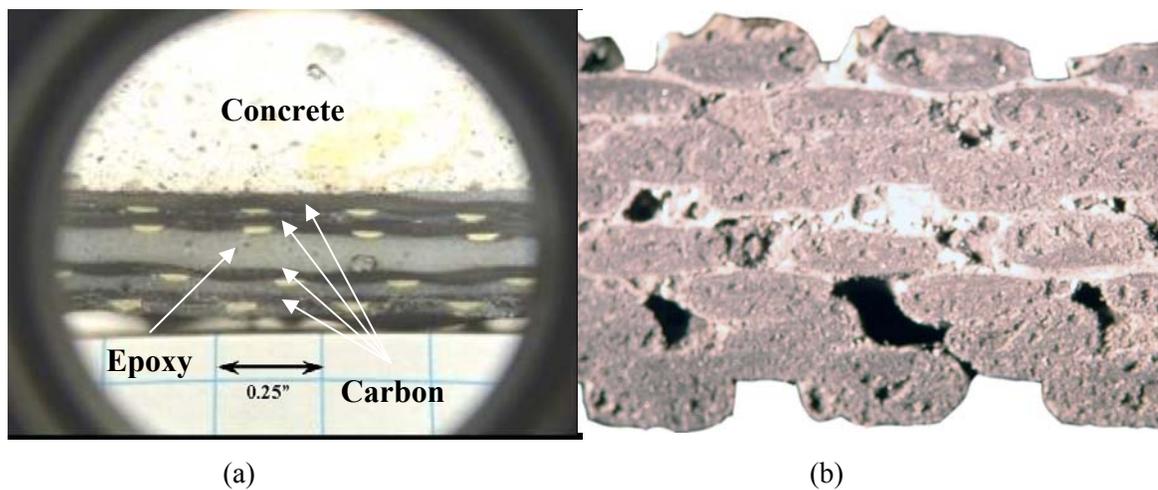
**Figure 2: Cross-Section of FRP system applied to girder 3 (a) and girder 4 (b)**

The material data sheet (MDS) for this FRP system indicated a 1mm (.04 in.) ply thickness resulting in a total laminate thickness of 4 mm (.16 in.). In order to verify this thickness, a small area of the strengthening system and concrete substrate (2 cm x 7 cm x 1.5 cm thick) was removed from the girder after load testing. The total thickness of the laminate varied between 6 mm and 7 mm (62.5% thicker than the MDS thickness). A 2 mm layer of thickened epoxy was observed between the second and third layers of carbon fiber (see Figure 2(a)).

A coin tap inspection of the installed system did not reveal any debonded areas. The MDS thickness for this system was 0.78 mm (.03 in.) per layer, which resulted in a total theoretical thickness at midspan of 3.1 mm (.12 in.). The measured thickness of the 4-ply laminate varied between 5 and 7 mm (see Figure 2(b)).

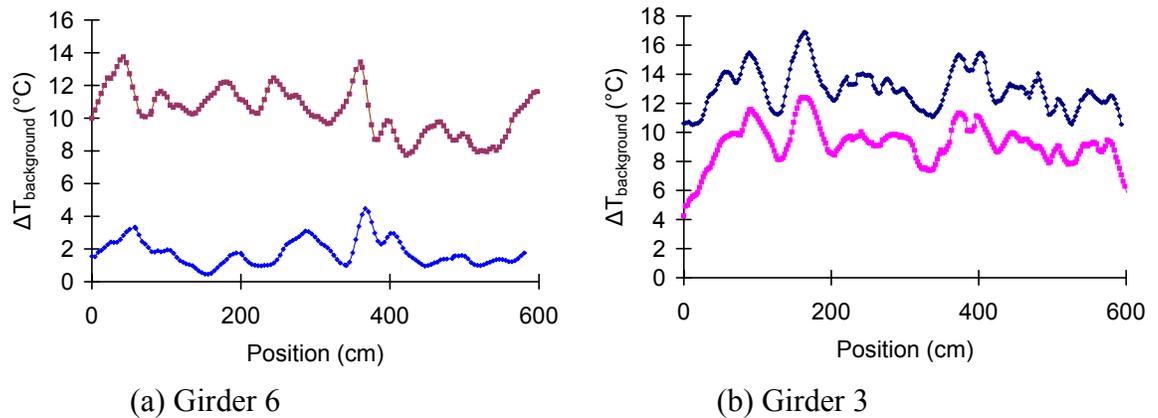
The cart speed was controlled by hand, which introduced some variability into the heating rate. Figure 8 shows the resulting  $\Delta T_{background}$  along the leading and trailing edge of each thermal image vs. position for girder 3 and girder 6. The leading edge curve represents  $\Delta T_{background}$  measured just after an area enters the thermal image. The trailing edge curve represents  $\Delta T_{background}$  measured just before the same area leaves the image. The average time between these two curves can be calculated as  $t'$  in equation 4. The significant fluctuation observed in each curve demonstrates the sensitivity of  $\Delta T_{background}$  to cart speed. In areas where the cart was pushed slowly, there was an increase in  $\Delta T_{background}$  while areas in which the cart was moved more quickly experienced a decrease in  $\Delta T_{background}$ . The standard deviation of  $\Delta T_{background}$  along the leading edge for girder 3, 4, 5, and 6 was 1.4, 2.4, 1.5, and 1.9 °C, respectively.

Figure 8:  $\Delta T_{\text{background}}$  vs. time for (a) Girder 6 and (b) Girder 3

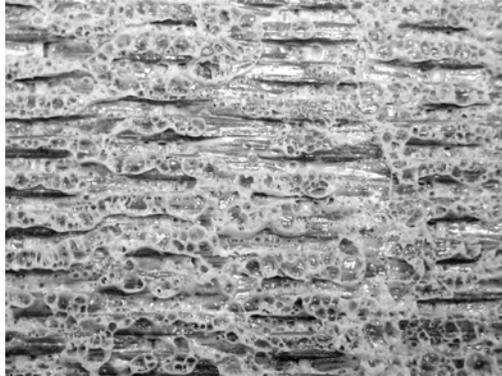
An IR inspection was also performed on a known debonded area. This debonded area was located on a portion of the FRP system that was partially attached to the girder after failure. Results indicated that this particular FRP strengthening system is not well-suited to inspection via IR thermography. A closer inspection of this system after failure revealed a thin layer of polyurethane matrix between the FRP and concrete that resembled insulating foam (as shown in Figure 13). If this particular type of matrix material is effectively insulating the carbon fibers from the concrete, the presence of subsurface defects will not result in hot spots on the surface after heating. Additional experiments under controlled laboratory conditions are needed to determine the limits of detection.

**Figure 13: Polyurethane matrix shown after debonding from concrete (girder 4)**
