Final Report

December 2011

Damage Detection and Repair Methods for GFRP Bridge Decks

Florida Department of Transportation (FDOT)
Rodney G. Chamberlain, P.E. – Project Manager

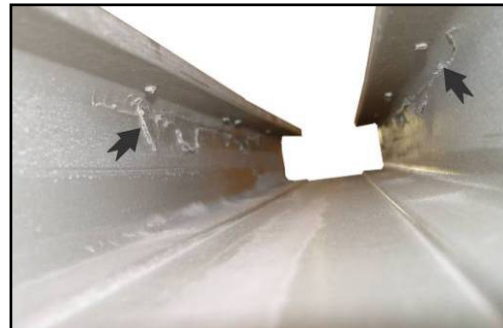
Figure 50 – Specimen A1 web damage before repair

To access the webs for the repair, the top plate was removed (Figure 49). Figure 50 shows the web damage immediately below the fillet under the top flange, which was caused by local crushing from the concentrated load.

To ensure the best possible bond between the wet layup and the pultruded surfaces, the rough edges of the fracture surface were removed and the surrounding surface was sanded using coarse sand paper.

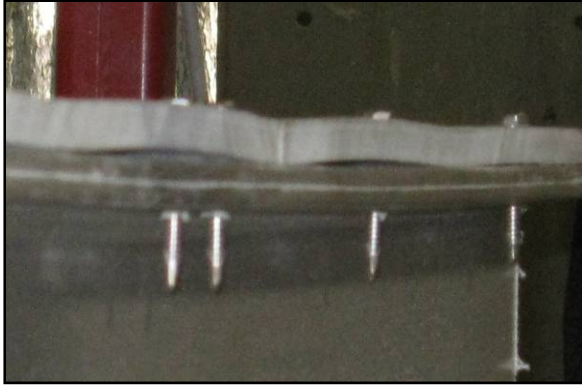
Figure 72 – A_P top plate buckling under load

ULT load-deflection was linear up to a peak load of 72 kip. Audible cracking was noted as load was increased. In addition, when service load levels were exceeded, the top plate of the deck system was observed to deform out-of-plane between fasteners (Figure 72); this was an indication that the deck system was not acting compositely. Ultimate capacity was signified by both a sharp audible crack and partial loss of load but not complete collapse. A residual capacity of 43 kip remained after the specimen load reached its ultimate limit state. The unloading portion of the ultimate loading plot is not shown below the 43 kip mark to more clearly show the service load level loadings. Visual inspection indicated that the loss of load was caused by the crushing and buckling of the webs adjacent to the loading pad (Figure 73).

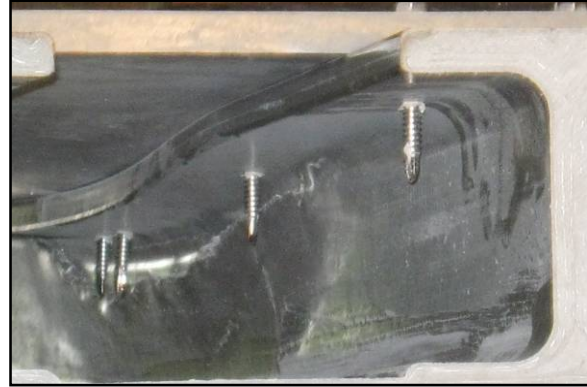
Figure 73 – A_P web failure

DST shown in Figure 71 indicates that the web damage reduced the overall deck stiffness. Table 11 shows the stiffness of the specimen for each test regime as determined by linear regression of the last curve of each test. As indicated in Table 11, the measured stiffness was reduced by 27% from the undamaged state.

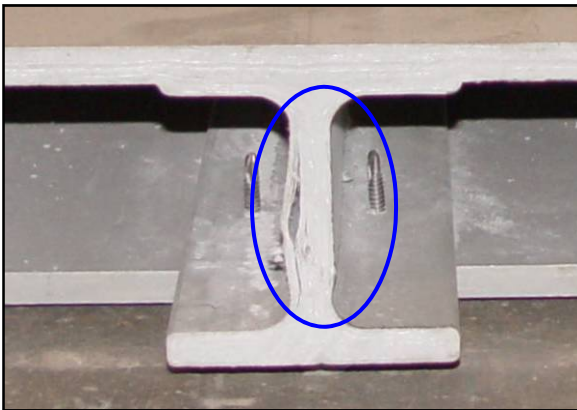
Figure 76 – A_N damaged web

A post ULT inspection was performed which indicated that a single web directly above the supports was found to be damaged (Figure 76). Figure 77 shows the location of the damaged web in relation to the test setup. This localized failure is similar in nature and location to the failure encountered in the positive bending ULT. In this test setup, however, the failure resulted in very little loss of global stiffness due to its localized nature. Consequently, the specimen retained its original stiffness at the lower service load levels, as indicated by the slope of the DST load-displacement curve.

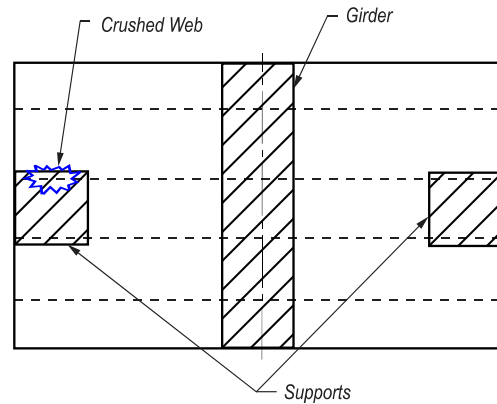
Figure 77 – Damaged web location

Table 12 shows the calculated deck stiffness for each test. As previously mentioned, only two of the webs were directly in contact with the supports (Figure 77), one of which was crushed during ULT. The strain differential of the two webs directly under the load could not be confirmed with the strain data since one of the strain gages was damaged during assembly. In contrast, the positive bending specimen lost 24% of its original stiffness after ULT and had damage to both webs under the applied load.

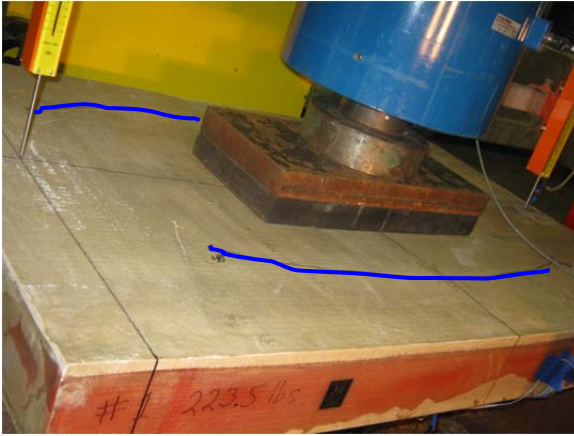
Figure 80 –Deck B positive bending crack pattern

During the ultimate strength test, cracks formed around the load point in the top panel (highlighted in Figure 80). As load was increased, the cracks grew parallel to the span and eventually merged over the supports when the ultimate capacity was reached (Figure 81). Post ULT inspection of the specimen indicated that the bottom soffit of the specimen was intact and that the top surface retained a bowl-shaped permanent deformation, indicating that the interior webs were also permanently deformed.

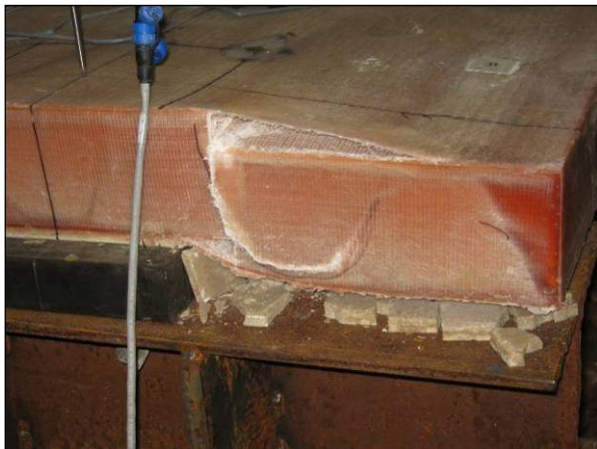
Figure 84 – B_N shear failure over support

Figure 84 shows punching shear failure over the support. The crack followed the edge of the interior web and extended past the support into the deck. Figure 85 highlights the approximate location of the failure plane. The deck wearing surface delaminated from the deck surface and pieces can be seen on the steel support beam in Figure 84.

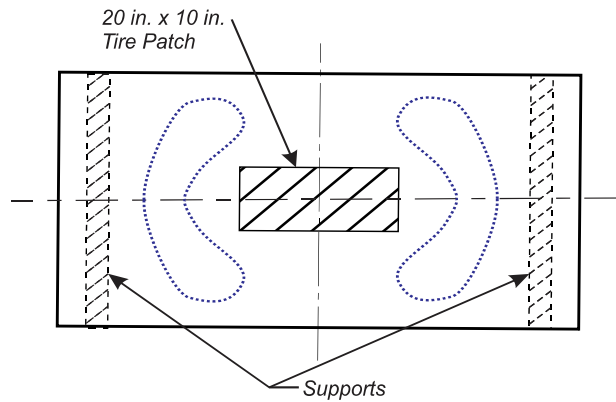
Figure 88 – C_P ULT failure zone

UST, ULT and the DST results for C_P are presented in Figure 87. Initially two UST's were performed on specimen C_P followed by the ULT. During the service loading audible emissions were notably less than those from the other two deck types. During the ULT, sharp audible cracking began at the 70 kip load level and continued up to the ultimate capacity of 100 kip. A residual load of 80 kip was supported by the specimen; the unloading portion of the curve was not shown to avoid obscuring the UST and DST results. The failure mode of the deck system is designed such that the compression flange delaminates from the honeycomb core, which was the observed failure mode during ULT. Delamination, however, was not visible so coin tap testing was used to estimate extent of the delamination (outlined in blue in Figure 88).

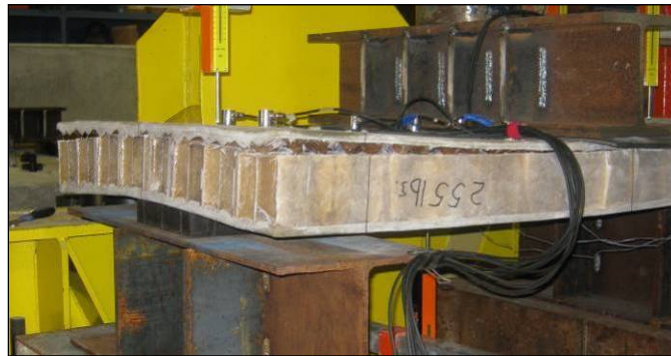
The specimen failed by separation of the top plate from the honeycomb core as seen in Figure 91. The specimen was designed to fail by delamination of the compression zone of the deck; in this case, however, the large load combined with the short span resulted in complete separation of the plate.

Figure 91 – C_N failure

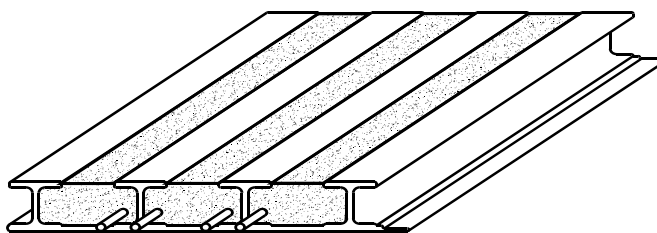
Figure 93 is a diagram of the concrete repair which consisted of using the cavities as stay-in-place molds for concrete beams reinforced with GFRP bars.

Figure 93 – Concrete repair (A1)

After deck A specimens were tested to ultimate capacity, the damaged specimens were repaired. One approach was to place GFRP bars in the cavities between the webs and then fill this cavity with concrete. Another approach was to apply wet layup GFRP to the damaged webs. The last approach was to fill the cavities with grout and apply GFRP to the soffit of the deck. The goal was to evaluate the structural efficacy and construction practicality of procedures that could be used to repair this system in the case of an overload or other similar damage. All three specimens were tested to their ultimate strength (ULT) in the positive bending test setup described previously.

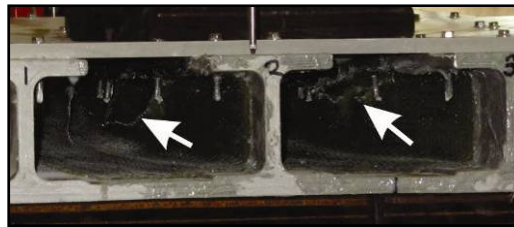
Figure 97 shows the load-deflection results for specimen A2. At about the 60 kip load level the GFRP web repair debonded from the web surface as indicated by the change in slope. Figure 98 is a picture of the debonding of the repair at the previously cracked web. The specimen continued to hold load, however, beyond that point up to the 85 kip load level. At the 85 kip load level the specimen sustained further damage, detailed in the next paragraph, but was able to reach an ultimate capacity of 92 kip. Residual load was approximately 60 kip.

Figure 98 – A2 glass repair damage

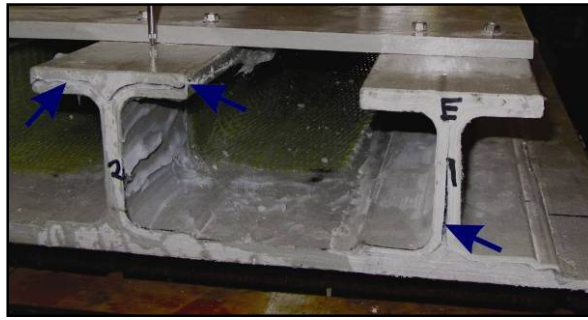
Figure 99 shows that the bottom flange of the outside webs has separated from the bottom of the panel and that the bottom flange ruptured due to the flexural tension. Figure 100 shows that web 1 and the top flange of web 2 delaminated. It is suspected that the addition of the glass wrap to the interior webs strengthened the interior of the specimen causing the failure of the outer portions of the specimen.

Figure 100 – A2 shear failure of the web

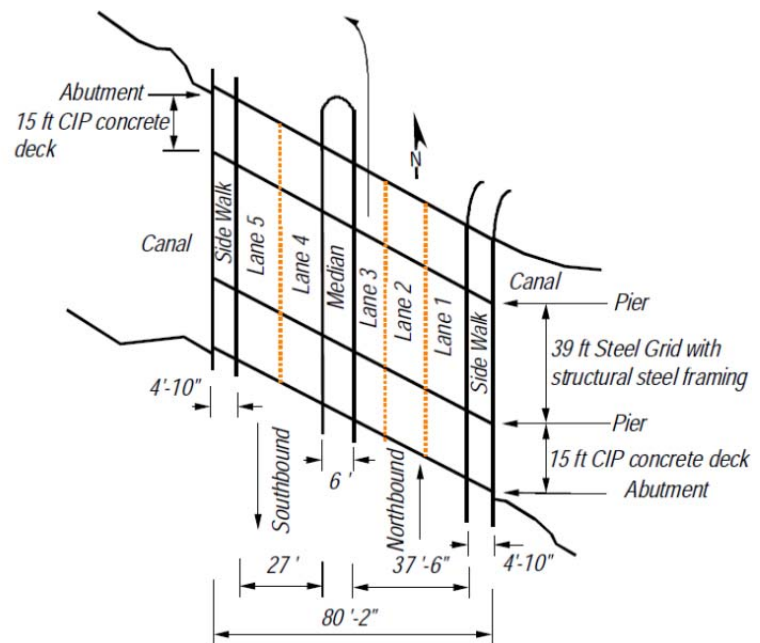
Figure 114 – Bridge site (a) aerial photo and (b) detailed site plan

In a related FDOT research project, the steel deck of a bridge over the Hillsboro Canal in Belle Glade Florida was replaced with deck A. (McCall et al. 2011) The deck was load tested using strain and displacement gages; during one of the load tests AE data were also recorded. Trucks typically use lanes 1 and 2 to deliver sugarcane to the refineries north of the bridge during the harvest (Figure 114). These lanes were tested during the load test because of the large loads experienced compared to the south-bound lanes. Strain and displacement gages were placed along the north-bound lanes. AE sensors were located near strain gages. Details of the test procedures can be found in McCall et al. (2011).

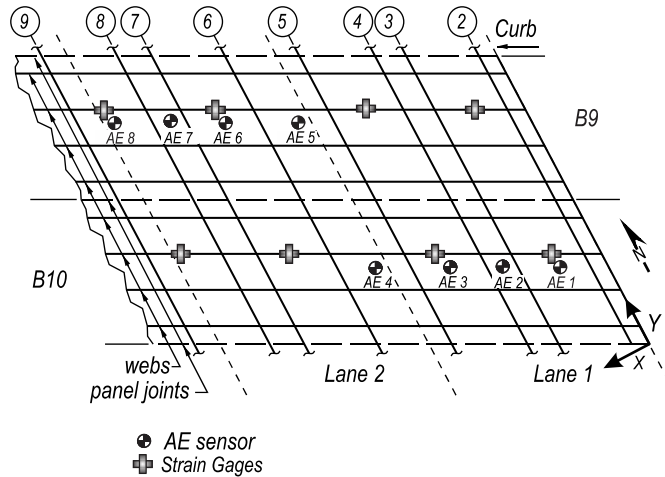
Figure 115 – AE Sensor locations on the deck panels

Figure 115 is a diagram of the bridge deck placement and the location of the AE sensors on the bridge relative to the deck panels. B9 and B10 are the panels monitored during the load test. The numbered lines running along the direction of travel represent the steel girders of the

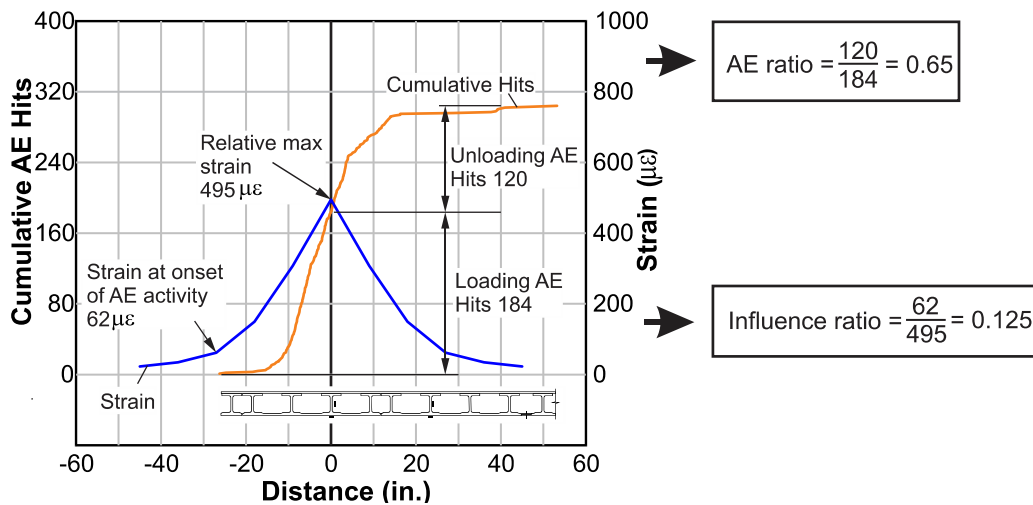
Figure 116 – AE ratio calculation for LC 4

The best approach would be to use the wheel position to calculate the Relative Load ratio. Unfortunately, the wheel location relative to the AE sensor position was not recorded. Figure 116 illustrates the adjustment made to the relative ratio analysis procedure to accommodate the constraints of the bridge test. RR analysis was adjusted so that the strain at the sensor caused by the rolling load rather than the position of the rolling load was used. The influence ratio is defined as the ratio of the strain at the onset of AE activity to the relative maximum strain of the loading.

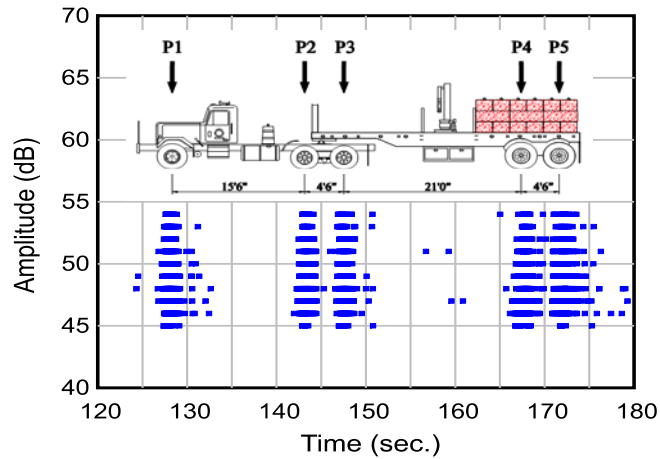
Figure 117 – AE data from bridge test LC4

Each wheel load passing the AE sensors could be used in the RR analysis because each represents the loading and unloading of the deck. Figure 117 shows the hits recorded during the load test for one pass of the truck over a single AE sensor. Each grouping represents the load imposed by one of the five truck axles. Although RR analysis could be used for any of the wheel loads, only the front and rear axles were selected for analysis. The front wheel was chosen because the data for this load was not influenced by any adjacent loads. The rear axle was also chosen because it transmits the largest wheel load.

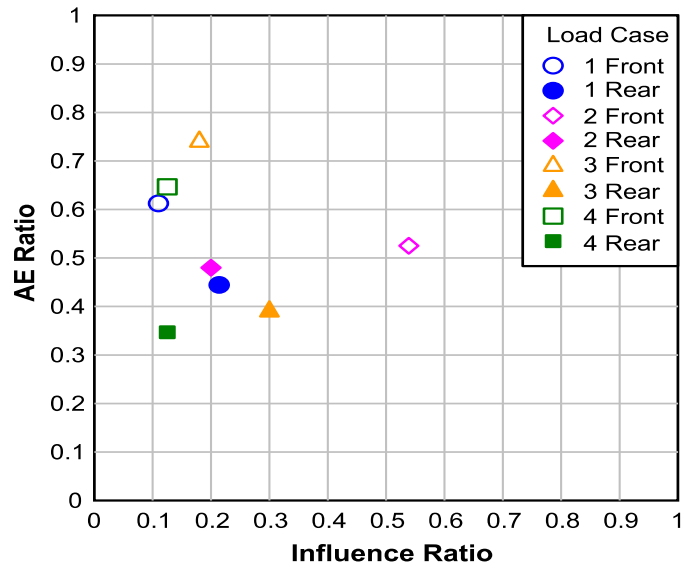
Figure 118 – Sample RR analysis results for bridge load test

Figure 118 shows a summary of the RR analysis results for the sampled loadings for truck position one; the AE ratio was calculated estimating the point of peak load from the AE data. Even though all the channels were used in the collection of the data, only channels 1-4 registered hits during the loading due to the attenuation of the emissions across the deck.

AE results for the various load cases considered ranged from 0.3 to 0.8. If the evaluation criteria developed for the laboratory test are used, then these values indicate potential deck damage. Based on visual observation, however, it is unlikely that the bridge had sustained structural damage. The exact wheel position with reference to the sensor was not known for the load test; the ratios may have shifted due to the large number of hits near what was believed to be the peak of the load. The front axle results were above 0.5 and all the rear axle results were less than 0.5. This also suggests that the proximity of other wheels may have an effect on the calculated AE ratio. Another possible reason for the high ratio is that grout cracking may have influenced the AE recorded during the bridge test.

- Recovery ratio analysis was applied to AE data gathered from a bridge load test on a bridge with deck A. The results, when compared to the criteria developed for the laboratory tests, indicated damage. No deck damage was noted. Refinement in the method may be needed or cracking of the grout pad used to support the GFRP deck system may be leading to false positive readings.

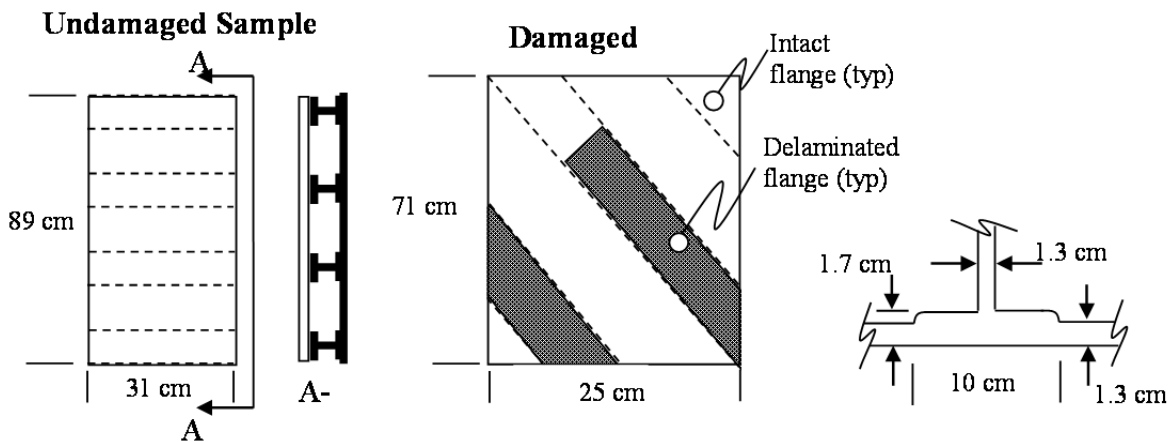
Figure 16-Specimen details and web orientation for experimental study

Two GFRP bridge deck samples were provided by the FDOT. One sample (25 cm x 71 cm) was cut from a full-size panel that had been loaded to failure in a laboratory load test. The second sample (31 cm x 89 cm) was also cut from a full-size panel and was undamaged (Figure 16). The orientation of the webs for each sample is provided in Figure 7.

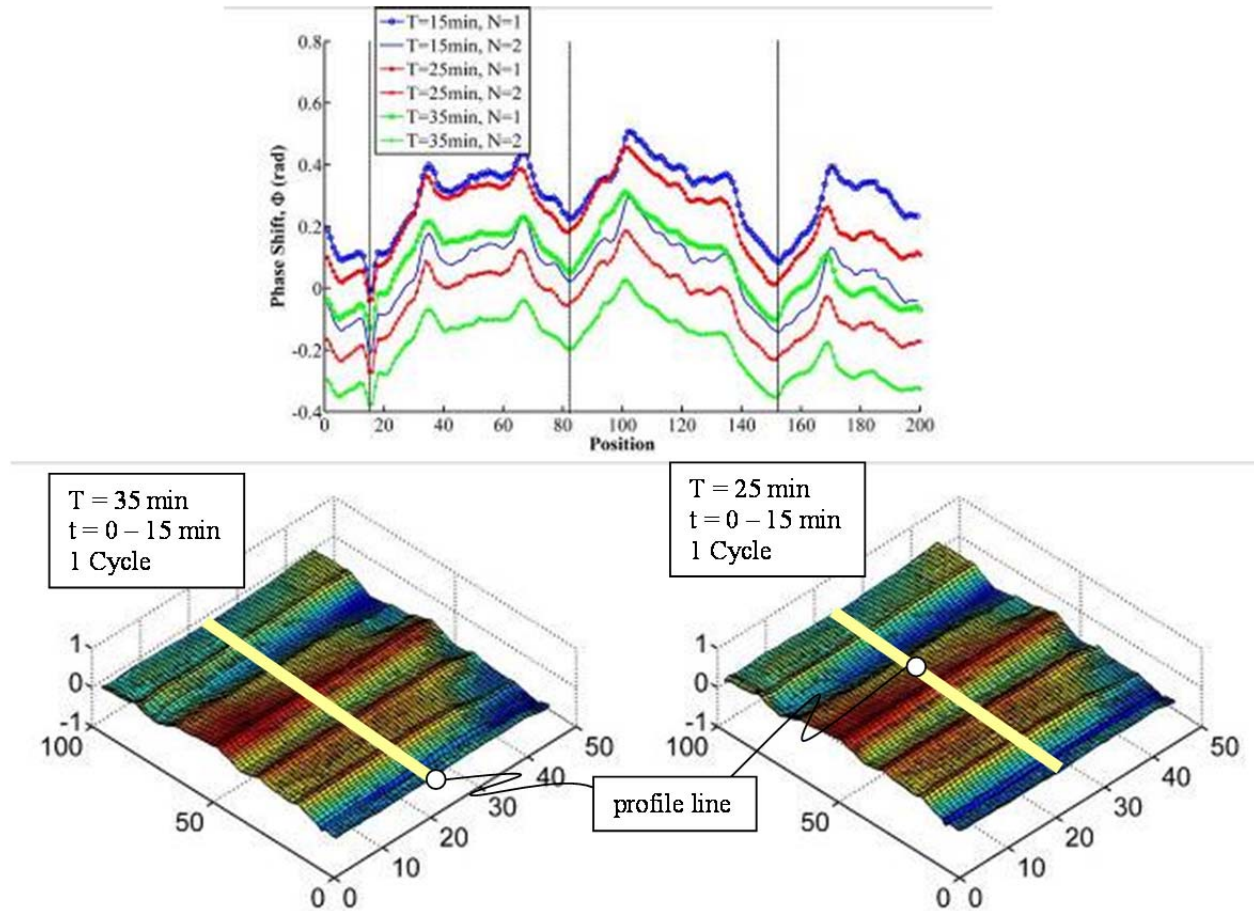
Figure 19-Phase profiles and surface plots for undamaged sample. Vertical lines in profile plot represent the locations of the webs.

Increasing the period of the heat flux modulation to $T=25$ min or $T=35$ min also appears to provide little advantage with regards to enhanced feature detection. The phase profile plots generated through the center of the undamaged sample (Figure 19) show very little variation as a function of modulation frequency other than an overall shift. This shift also varies as a function of the number of cycles, N , used to generate the phase value for each pixel. The higher period images actually appear to degrade around the exterior edge of the sample, but the reason for this is not entirely clear. Considering the long time period required even for the 15 min modulation period and no discernable advantage by including more than one cycle for each experiment, it

In addition to being able to distinguish the webs from the GFRP bottom plate, which provides an indication that no delamination has occurred, additional features can also be distinguished in the area near the GFRP bottom plate and flange interface. The peaks in this region could indicate localized variability in matrix saturation of the composite or other manufacturing features. Without additional destructive testing it is not possible to state this with any degree of certainty. Variations in surface absorptivity/reflectivity were also apparent in these regions, which may have led to these apparent anomalies.

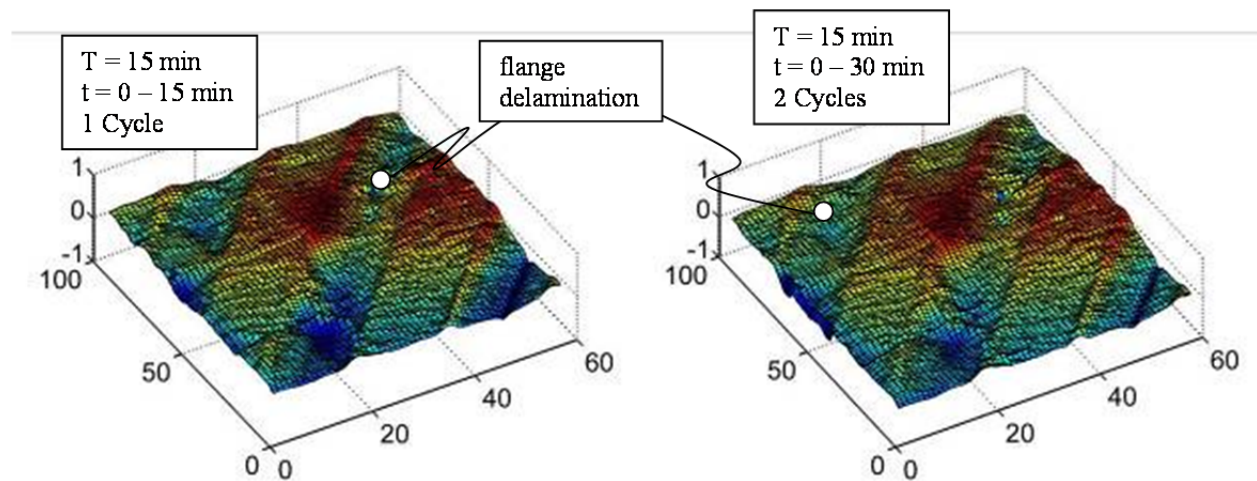
Figure 20-Phase image surface plots for damaged sample. T = 15 min. Plot on the left obtained after 15 min of heating. Plot on the right obtained for 30 min heating.

Results for the damaged sample are presented in Figure 20. Areas where the flanges had delaminated from the GFRP bottom plate are distinguishable in the surface plots and the difference between the damaged and undamaged specimens appears to be significant. Once again, there was no apparent advantage to including the T=25min and T=35min modulation periods.

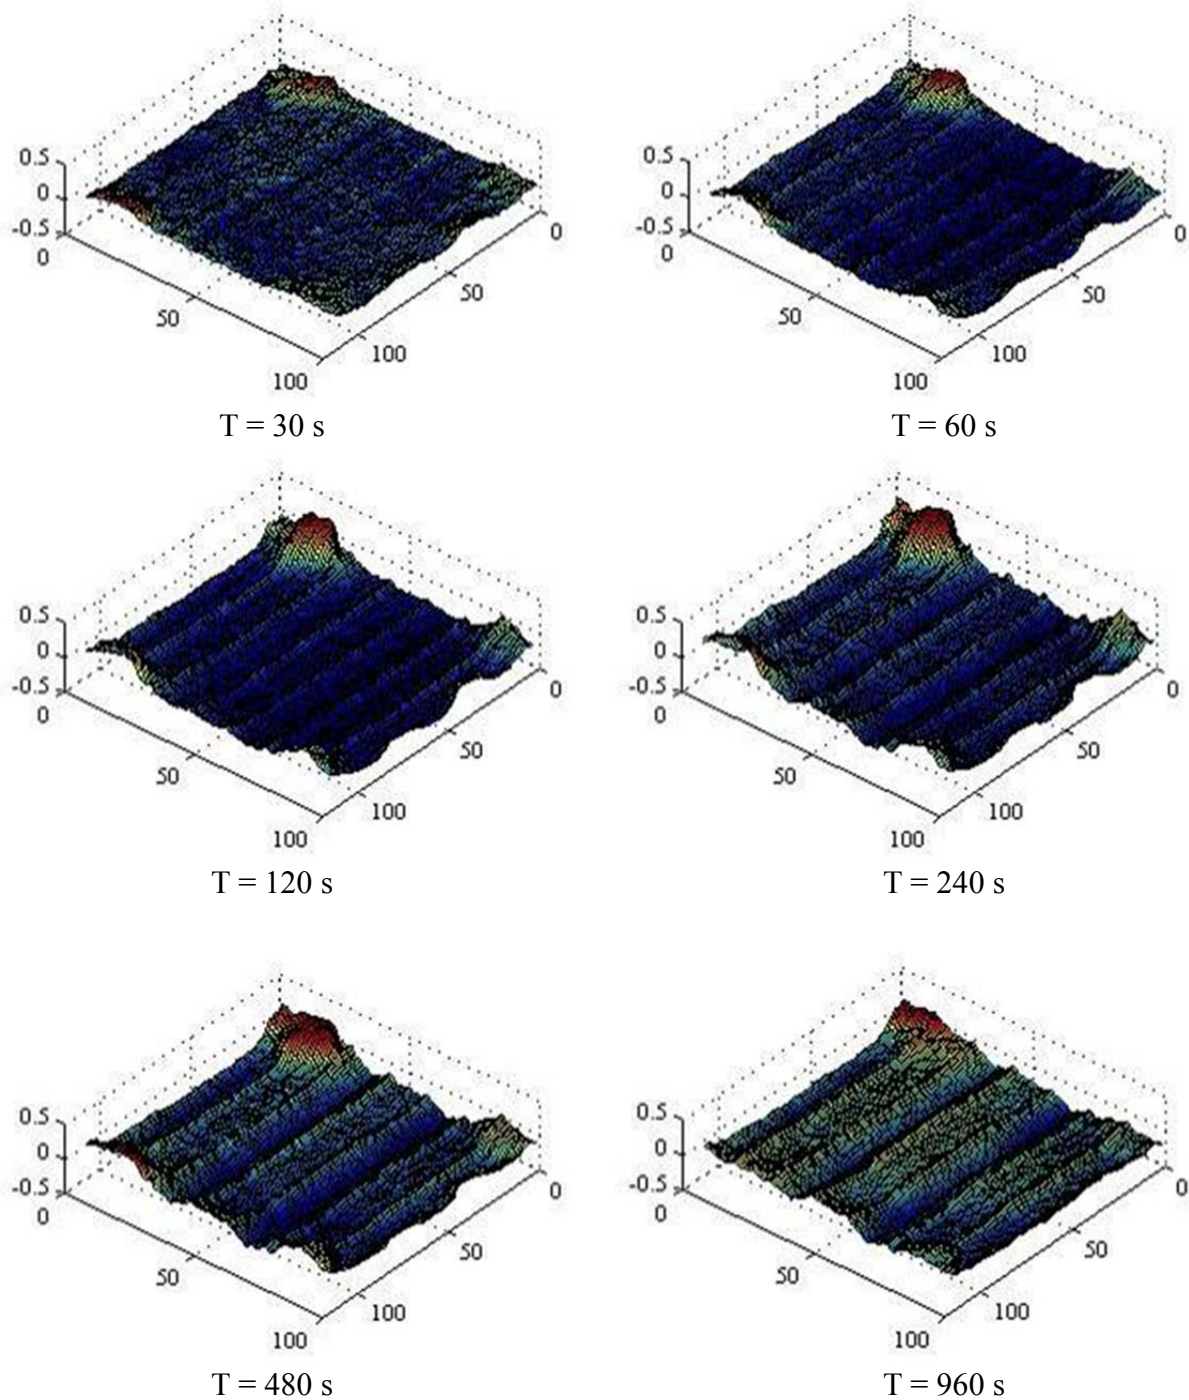
Figure 23-Surface profiles (phase angle) for Deck A at six different heating periods.

The lower periods ($T = 30\text{s}$ and $T = 60\text{s}$) are intended to identify defects or abnormalities in material composition close to the surface. An interesting finding for Deck A is that for periods as low as 60s a series of ridges begin to appear in the phase images. These localized peaks correspond to strips on the surface that appear darker than the surrounding area and also correspond to the locations where the edges of the bottom flanges connect to the GFRP bottom plate.

The webs do not become prominent in the phase profiles until the heating period reaches 240 s. Increasing the period to 480 s and 960 s does little to enhance the difference between the GFRP bottom plate and the webs. This may be an indication that the pultruded GFRP deck contains some other material variability where the flanges connect to the bottom panel. This is

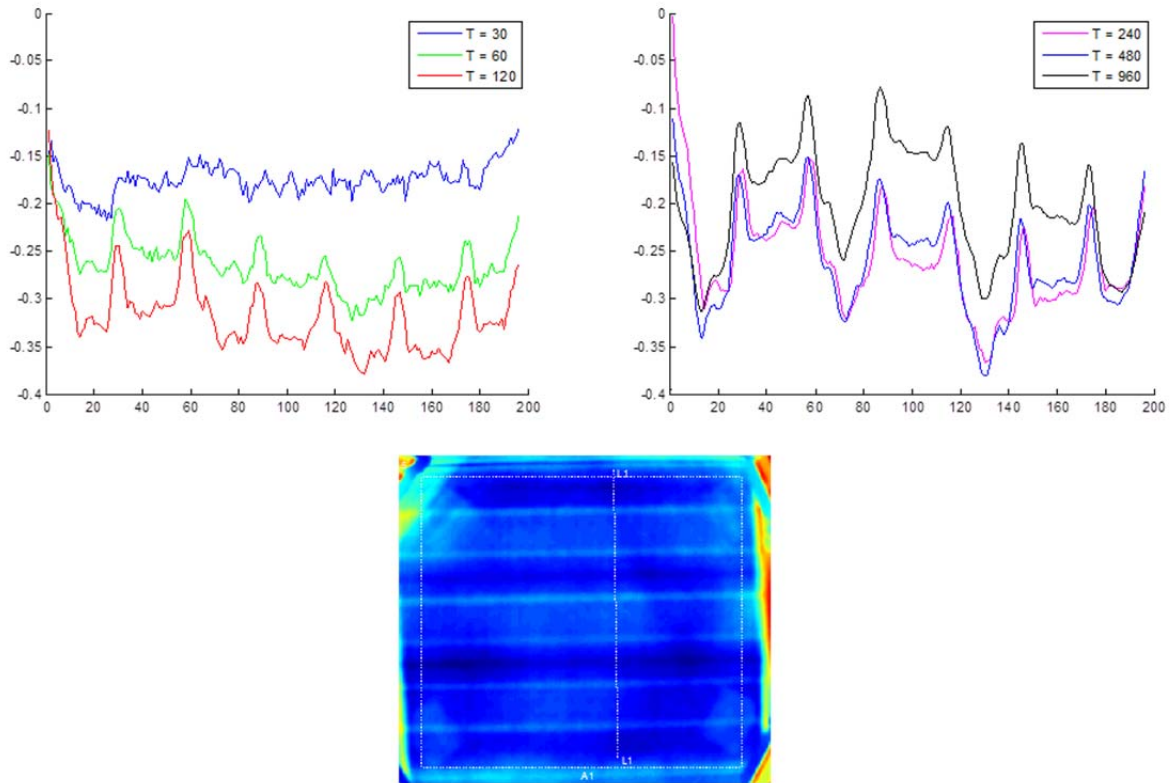
consistent with findings from the damaged specimens where the bottom panel had delaminated but the web still appeared in the phase image.

Figure 24-Line profiles along L1 (phase angle) for Deck A at six different heating periods.

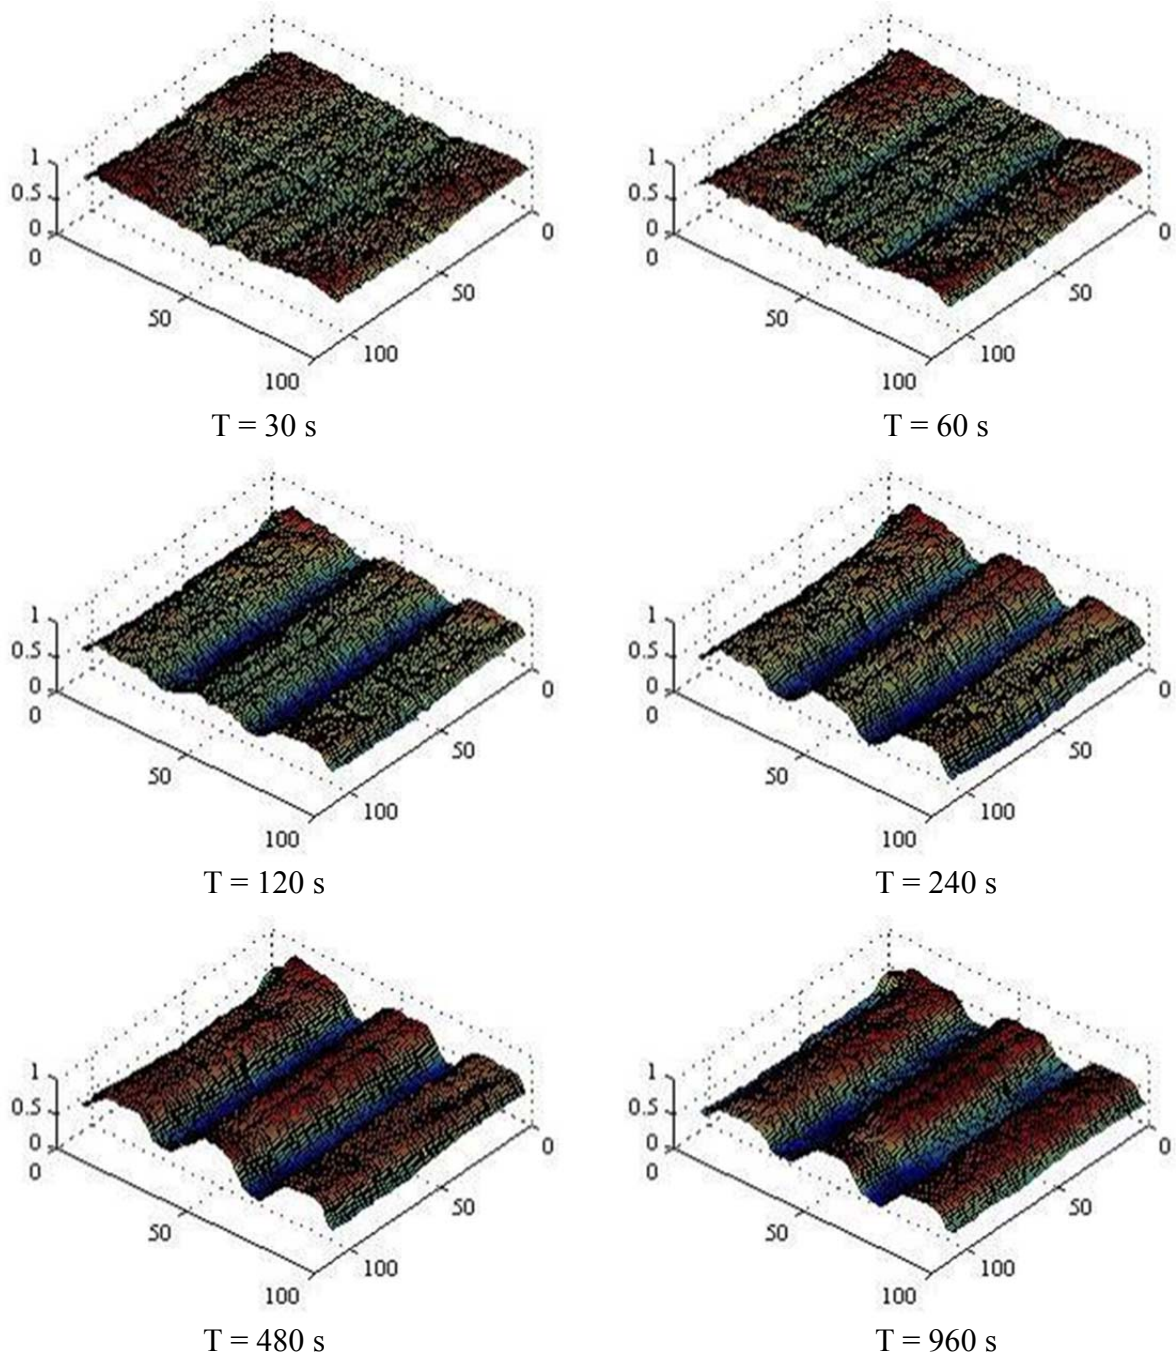
The 30s and 60s periods also showed some minor variations in the phase profile corresponding to surface irregularities. The corrugated core material begins to appear in the 60s period data but is easily distinguished in the 120s period data. The line profiles indicate that the maximum difference between the corrugated core and the bottom panel occurs at a period of 480s (Figure 25).

Figure 25-Surface profiles (phase angle) for Type B deck at six different heating periods.

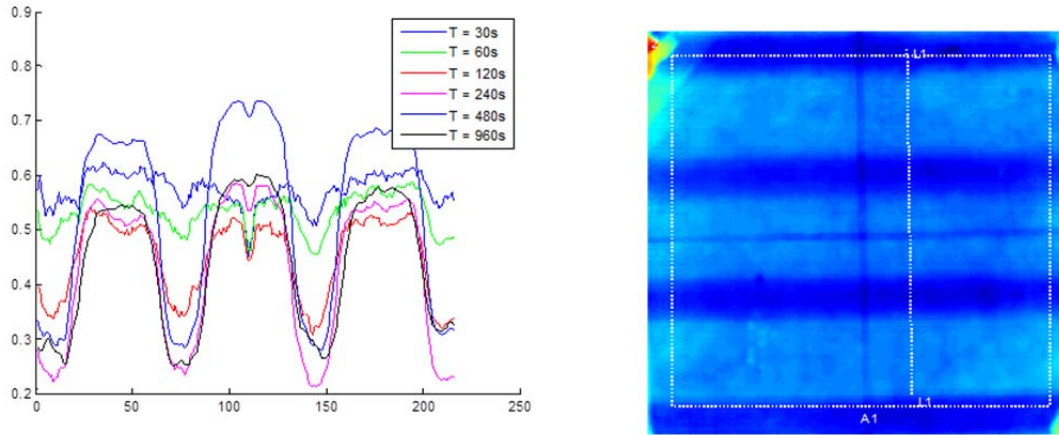
Figure 26-Line profiles along L1 (phase angle) for Deck B at six different heating periods.

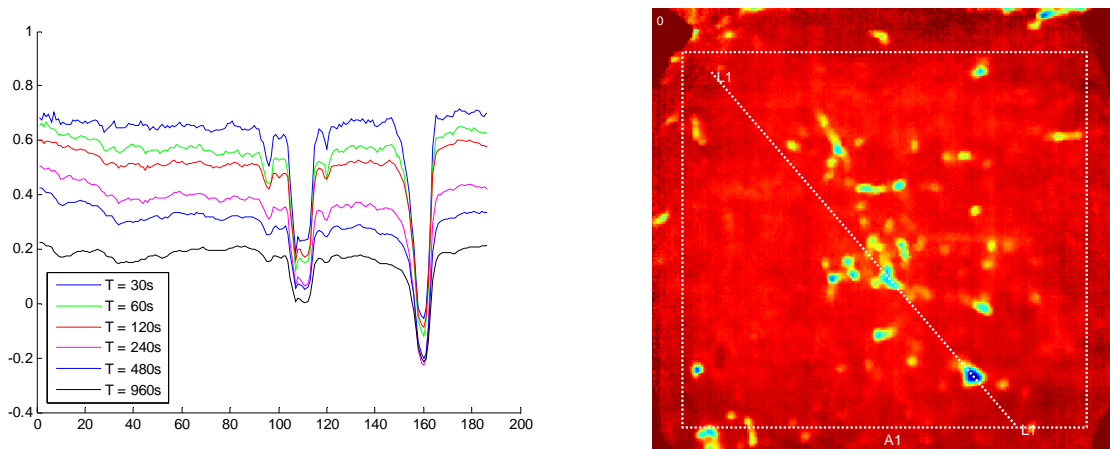
The honeycomb core material was not distinguishable at any of the heating periods investigated. There was one interesting finding regarding the large number of apparent defects that were identified at all periods investigated. These defects were identified as surface imperfections and variations in roughness and overall degrees of sanding. These surface defects appear with similar amplitude variations at all of the heating periods that were investigated. These results confirm the general principle that lower periods only reveal defects closer to the surface, but they also suggest that collecting data for more than one period can be beneficial in distinguishing surface imperfections from subsurface defects.

Figure 27-Line profiles along L1 (phase angle) for Deck C at six different heating periods.

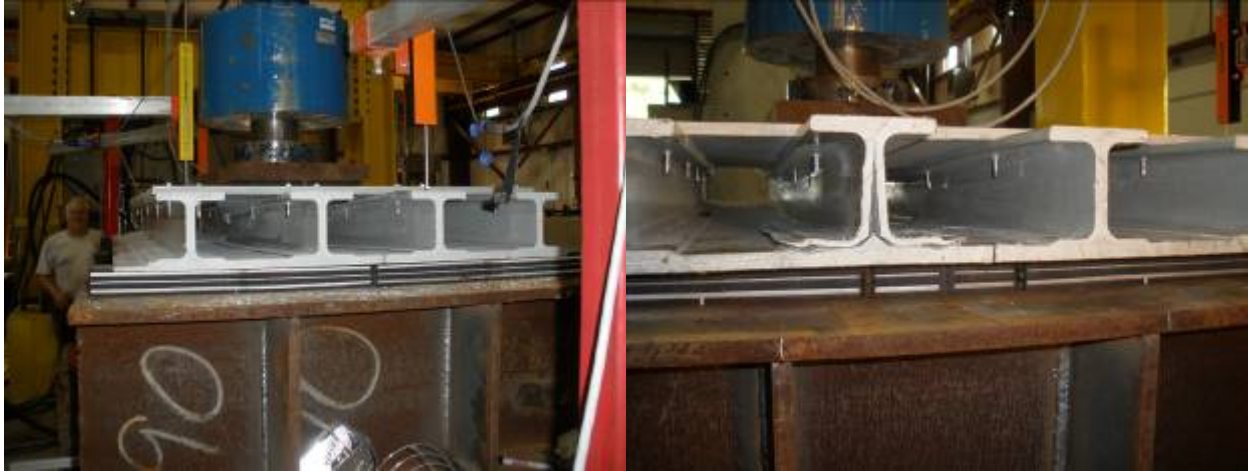
DS1 experienced web-buckling failure near the top flange while DS2 experienced a delamination failure between the bottom flange and the GFRP bottom plate (Figure 28). From a thermal imaging perspective, preliminary results obtained from a damaged specimen with a failure mode similar to DS2 suggested that bottom flange delamination can be detected. The damage incurred as a result of web-buckling near the top of the web is very far from the surface that is heated during the inspection and, therefore, is not considered to be a practical application for IRT.

Results for Deck A in its damaged state do not appear as promising as the initial work completed on a previously damaged specimen. For DS2, the delamination that occurred between the bottom flange and the GFRP bottom plate was severe (Figure 29). The delamination was expected to interrupt the heat transfer into the web resulting in a difference between the flange and the GFRP bottom plate. The IRT results for this specimen, however, do not provide any obvious indication that such a failure has occurred.

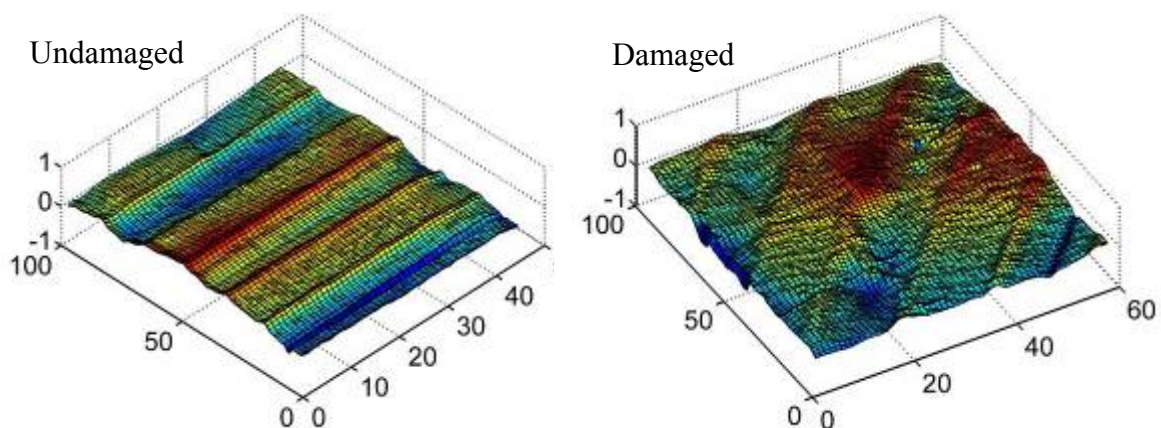
The preliminary experiments performed on two sample sections of GFRP Deck A (one undamaged and one damaged) demonstrated the potential for IRT to detect this type of damage. The phase image that was generated for the undamaged specimen displayed a regular pattern and it was possible to differentiate the webs from the GFRP bottom plate. The phase image for the damaged section displayed considerable variation across the surface and areas where the web had separated from the bottom plate appeared to be distinguishable from the phase response generated by the undamaged specimen (Figure 30).

Figure 30-Phase image results for undamaged and damaged GFRP Deck A

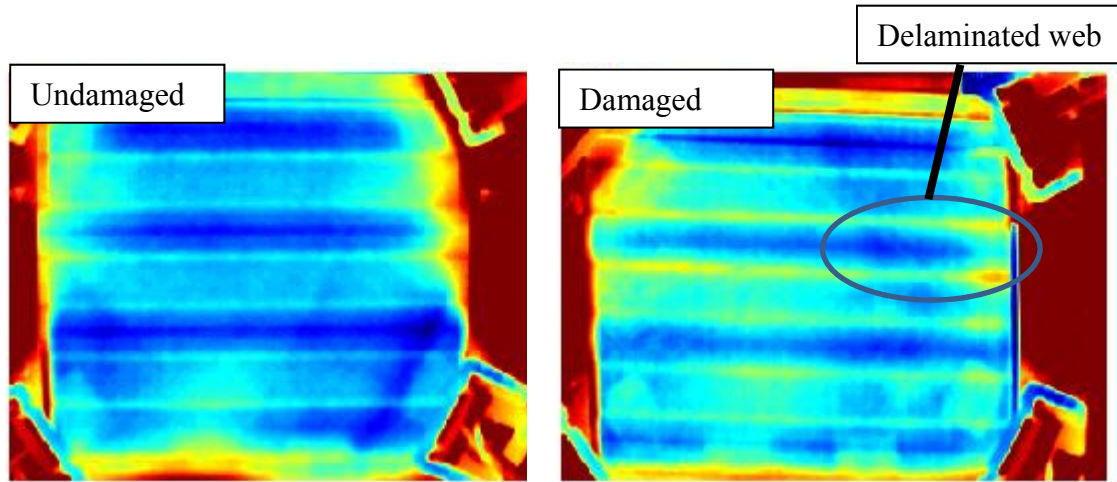
When the same procedure was applied to damaged and undamaged Deck A specimens during the full-scale load testing, there were no clearly recognizable differences in the phase response for the damaged specimen (Figure 31).

Figure 31-Comparison of damaged and undamaged Deck A specimens from full-scale load testing.

There are two possible explanations for the apparent inability of IRT to identify the web delamination that occurred in Specimen 2 for Deck A during the full-scale load test. The first explanation relates to the relative severity of the delamination encountered during the full-scale load test compared to the sample that was used in the preliminary study. During the full-scale load test, the bottom flanges and web separated from the GFRP bottom plate for a distance of approximately 18 in. over a single beam (Figure 32). The delaminated area in the preliminary study specimen was much larger and included two of the three adjacent beams. Furthermore, even though the bottom flanges of the full-scale test specimen were clearly delaminated over the entire 18 in. length, it was not clear as to whether or not this damage extended through to the web across the entire damaged area. Additional destructive testing of the specimen would be needed to verify the extent to which the web had separated from the GFRP bottom plate.

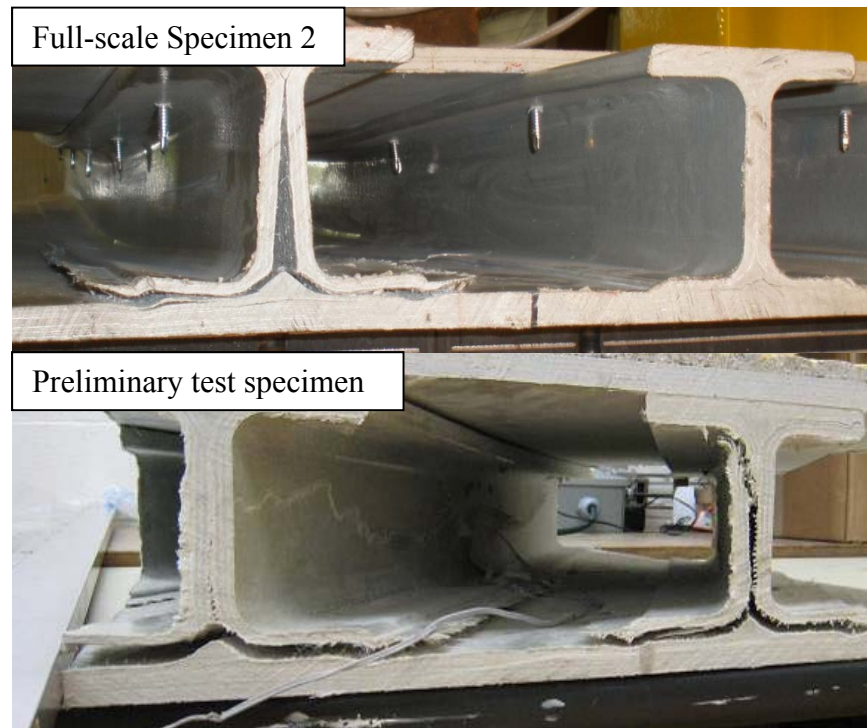
Figure 32-Comparison of web delamination levels between preliminary and full-scale test specimens.

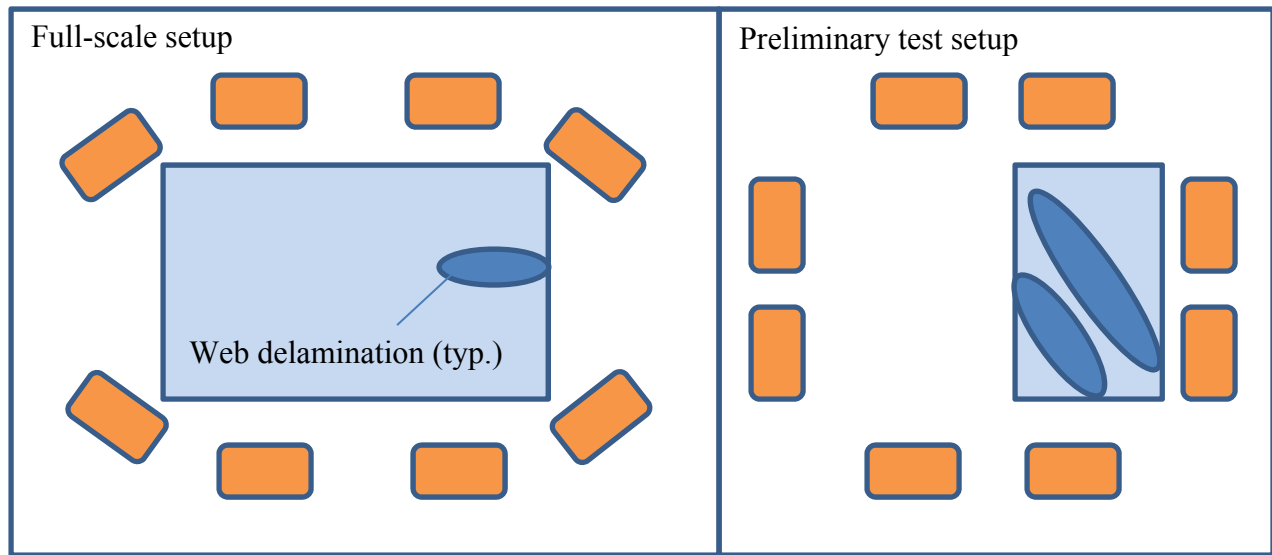
The second explanation relates to the location of the damage in the full-scale specimen and, specifically, its proximity to the edge of the specimen and the heating lamps. During the full-scale testing, the eight halogen lamps were oriented as shown in Figure 33. Ideally, all eight lamps would have been equally spaced around the perimeter of the panel (see setup for preliminary tests) in order to minimize non-uniform heating of the specimen. The modified

configuration was required due to the load supports used during the full-scale load testing. This configuration resulted in relatively weak heating of the specimen near the vertical edges, and this shadow effect tended to cause the resulting phase shift to drift upwards around the vertical edges of the panel (lensing). This upward drift occurred for Deck A in both the damaged and undamaged states (Figure 34). In this specific case, it is almost impossible to discern the difference between phase shift that may be caused by damage in the specimen and phase shift resulting from non-uniform heating.

Figure 33-Halogen lamp configuration for full-scale and preliminary test setups.

A natural solution to the non-uniform heating problem would involve dividing the GFRP deck into four or more smaller inspection areas and focusing the lamps and camera on this smaller area for a series of inspections. The downside of this approach is the increased time required to inspect the entire panel. The minimum time of 15 minutes per inspection may become prohibitive if the entire operation is scaled up for field deployment. Furthermore, even if the non-uniform heating issue was eliminated entirely, it still is not clear whether or not the level of damage experienced by Deck A, Specimen 2, during the full-scale load testing can be detected using the methods developed for the current study.

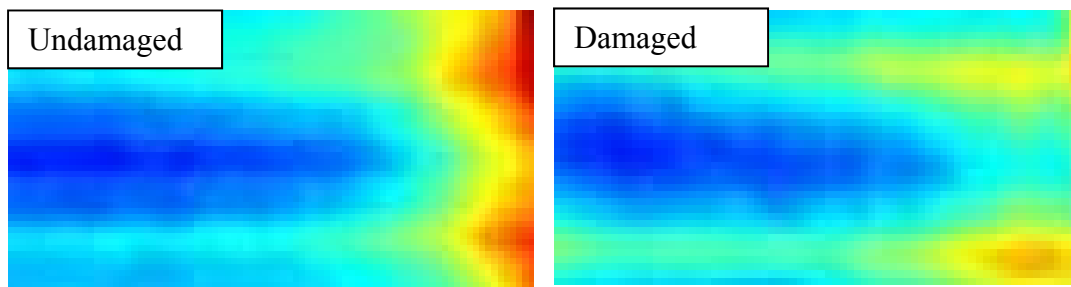
Figure 34-Undesired phase shift near edge of specimen due to non-uniform heating. These enlarged areas correspond to the “delaminated web” area identified in Figure 31.

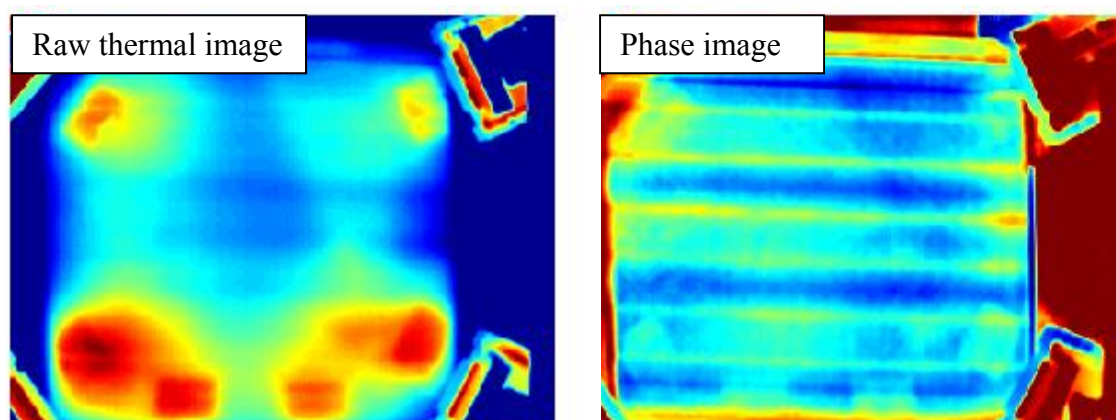
In spite of the apparent shortcomings of the phase thermography method described in this report, it is still worth noting the significant improvements that can be realized with this method compared to simply observing a raw thermal image (Figure 35). Performing a series of

Figure 35-Comparison of raw thermal image and phase image for Deck A.
