Final Report

December 2011

Damage Detection and Repair Methods for GFRP Bridge Decks

Florida Department of Transportation (FDOT)
Rodney G. Chamberlain, P.E. – Project Manager

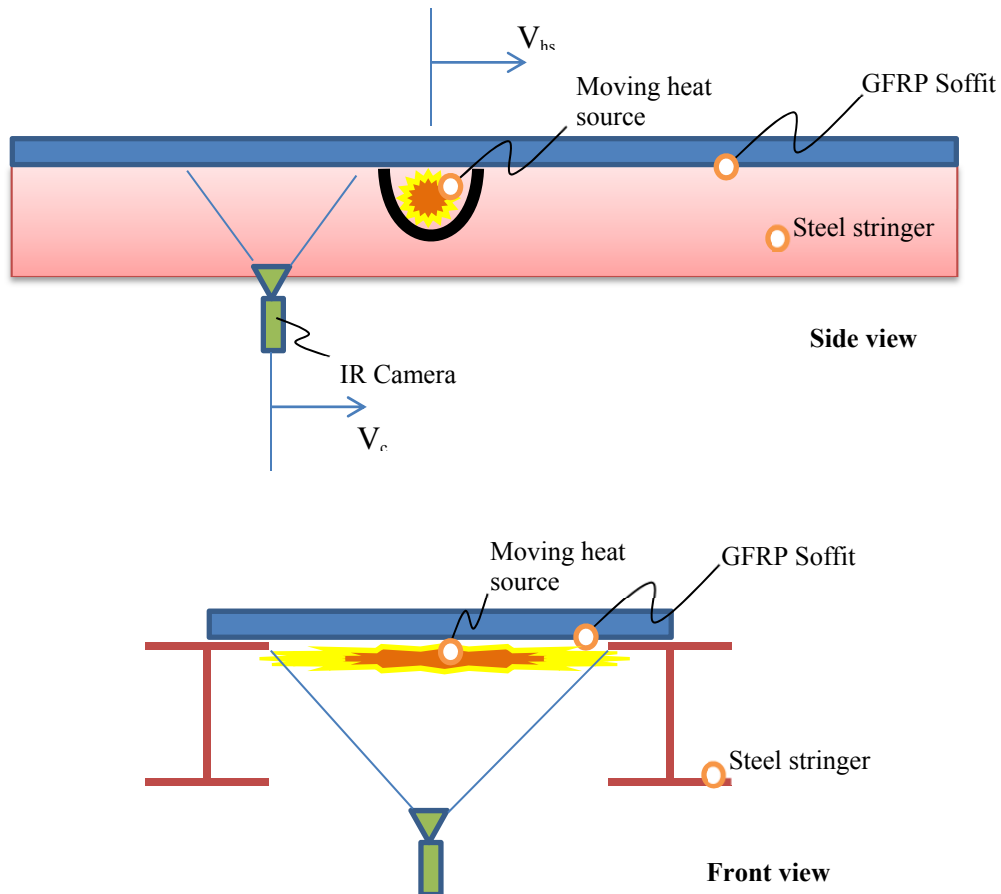
Figure 36-Line scanning alternative for field deployment.

One potential solution to this problem would involve shifting from a fixed lamp/fixed camera inspection mode to a conventional line scanning inspection mode. Line scanning would require a moving heat source with the camera positioned such that the leading edge of the camera FOV remains fixed on the trailing edge of the heat source (Figure 36). Additional research is needed to calibrate the inspection parameters for specific GFRP deck types as well as to establish the reasonable limits for damage and defect detection.

Additional modifications could also be made to the traditional line scanning procedure in which the camera could move independently of the heat source and collect data while the surface is cooling over a larger area for a longer duration. This would require additional image processing after each test to reconstruct the cooling curve for each point on the soffit of the GFRP deck.
