Progress Report: May to August 1998

Evaluation of Conventional Repair Techniques for Concrete Bridges

Principal Investigator: M. Arockiasamy, Ph.D., P.E.
Professor and Director
Center for Infrastructure and Constructed Facilities
Department of Ocean Engineering
Florida Atlantic University
777 Glades Road
Boca Raton, FL 33431-0991

December 1998

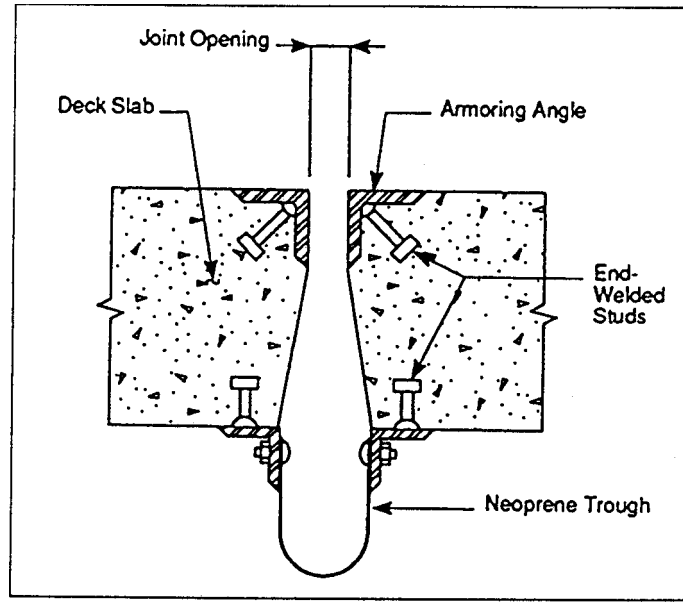
Figure 6 - Open joint.

Deteriorated deck slab concrete along the deck joint opening is removed to expose sound concrete. The exposed reinforcement would then be cleaned and epoxy coated followed by reconstructing deck slab corners using quicksetting patch materials or high early strength concrete. Alternatively, deck slab is removed to half of its depth along the entire length of the joint. The exposed reinforcement is then cleaned and epoxy coated and the deck slab reconstructed by installing angles for protection of slab corners. As a minimum measure, debris is removed from joint opening and drainage trough. If a trough system does not exist, one is installed to prevent intrusion of water, debris, and deicing salts to the parts of the bridge below the deck level. (Figure 6)

Although the existing open deck joints are paved to achieve watertight joints during deck overlay work, cracking and deterioration in the overlay can allow the joints to continue to leak and promote deterioration at the pier ends of girders and bearings. Open joints are prone to the intrusion of deicing salts and water, creating costly repairs on surrounding bridge components in the long run. Open joints are seldom used in new bridge structures, and are often worth replacing by other types during rehabilitation of existing structures.

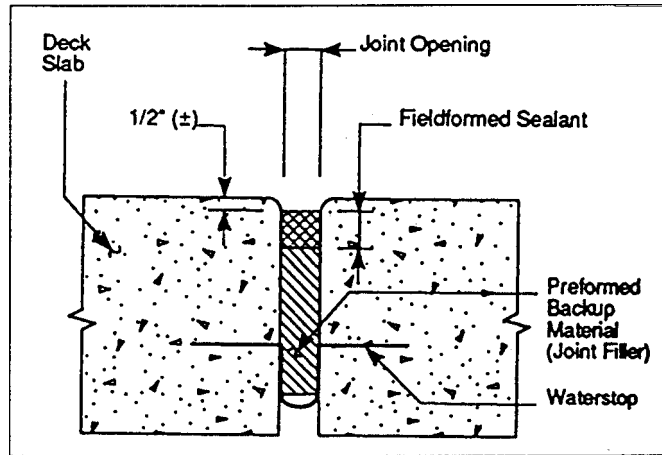
Figure 7 - Filled joint with fieldformed

There are two types of joint sealers, which are fieldformed sealer and preformed sealer (Figure 7 and 8). Fieldformed sealer is often used to seal small joint opening. Preformed sealer can seal a wider gap than fieldformed sealer. Preformed sealers are somewhat newer and hence have a shorter record of proven service than fieldformed sealers. An important advantage is quick installation time and less interruption to traffic. Most commonly used types of preformed joint sealers for deck joint rehabilitation projects are of extruded shapes made of elastomeric material.

Spalled deck slab corners are repaired along the length of the joint, following the procedure described for open joints. Additionally, if the existing sealant is separated, cracked, shriveled, or bulged, or contains embedded incompressible materials, the sealant is replaced by a new one.

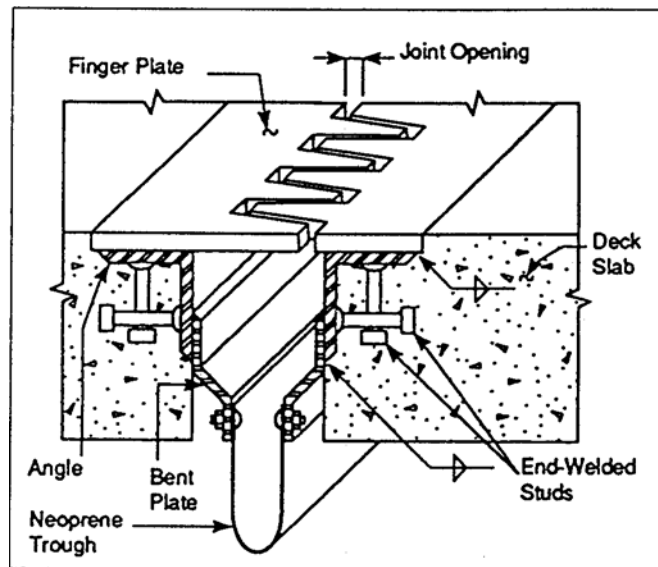
Figure 10 - Finger plate joint.

large as several feet. Finger plate joints are permitting water to leak through and deteriorate surrounding bridge elements.

The repair procedures are the same as for sliding plate joints (Figure 10). The relatively long projections of finger plates can accommodate total movements as

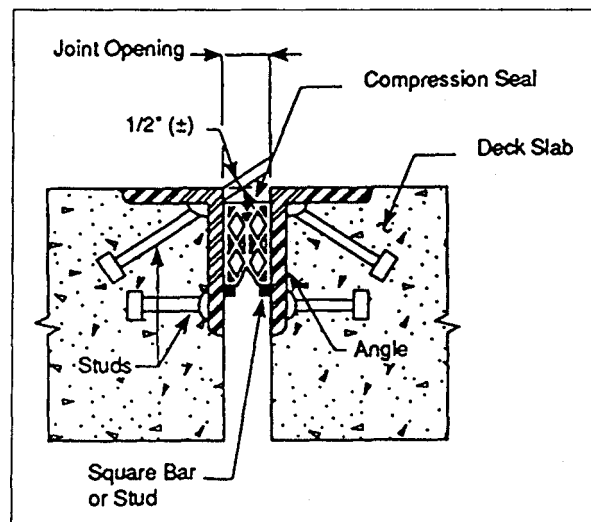
Figure 12 - Compression seal joint

By using neoprene composition seal, the water-tightness of such a hardened joint will fail when bridge spans contract at low temperatures and cause the hardened seal to pull away from the sides of the joint until the high-solids urethane adhesive debonds.

Spalled deck slab edges are repaired following the procedure given for open joints. The corroded, broken, bent, and cracked portions of joint armoring and anchorages would be removed for replacement. Additionally the debris accumulation from the seal would also be removed. If the splice location in the existing seal is leaking, the particular region would be cleaned and sealed with adhesive (Figure 12). The compression seal joint is designed to remain always in compression; these seals have become quite popular, particularly with neoprene as the seal material.

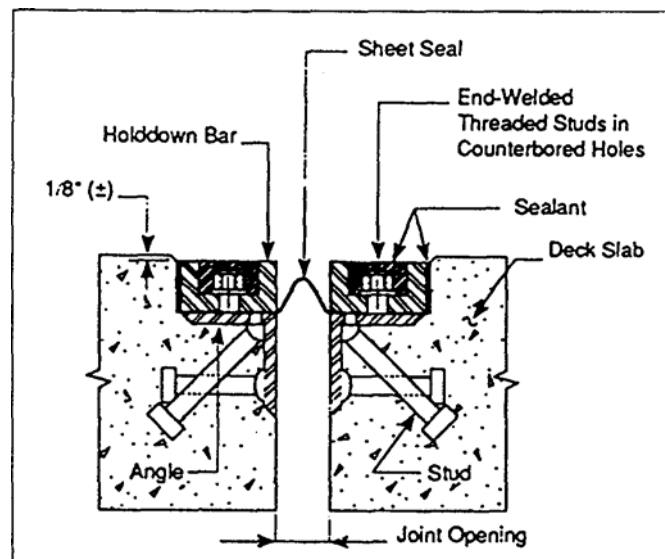
Figure 14 - Sheet seal joint.

One important advantage of the sheet seal over the compression seal is the ability to accommodate directional changes and skews in the joint configuration often without any need for a splice in the seal. Sheet seals do not allow water to leak through and deteriorate the surrounding bridge element. Failure of anchorage systems, under repetitive live-load impact, has been a frequently encountered problem with the sheet seals.

Spalled deck slab corners along the length of the existing joint are repaired following the procedure described for open joints. Damaged hold-down bars and anchorages are removed for replacement and the debris accumulation cleaned from the seal (Figure 14). These elastomeric seals can accommodate changes and skews in joint configuration but depend on close contact and may loosen under repeated live loads.

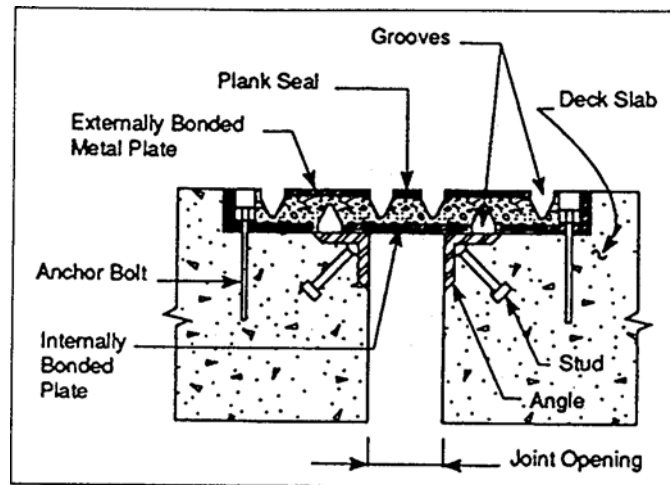
Figure 15 - Plank seal joint.

Leakage at joints between segments, loose anchorages, excessive noise, and snowplow damage have been the problems commonly reported with the existing plank seal joints.

The repair procedures are the same as those for the sheet seal joints (Figure 15). These molded neoprene sections can accommodate joint movements to 13 inches, but seal anchorages may loosen under prolonged service.

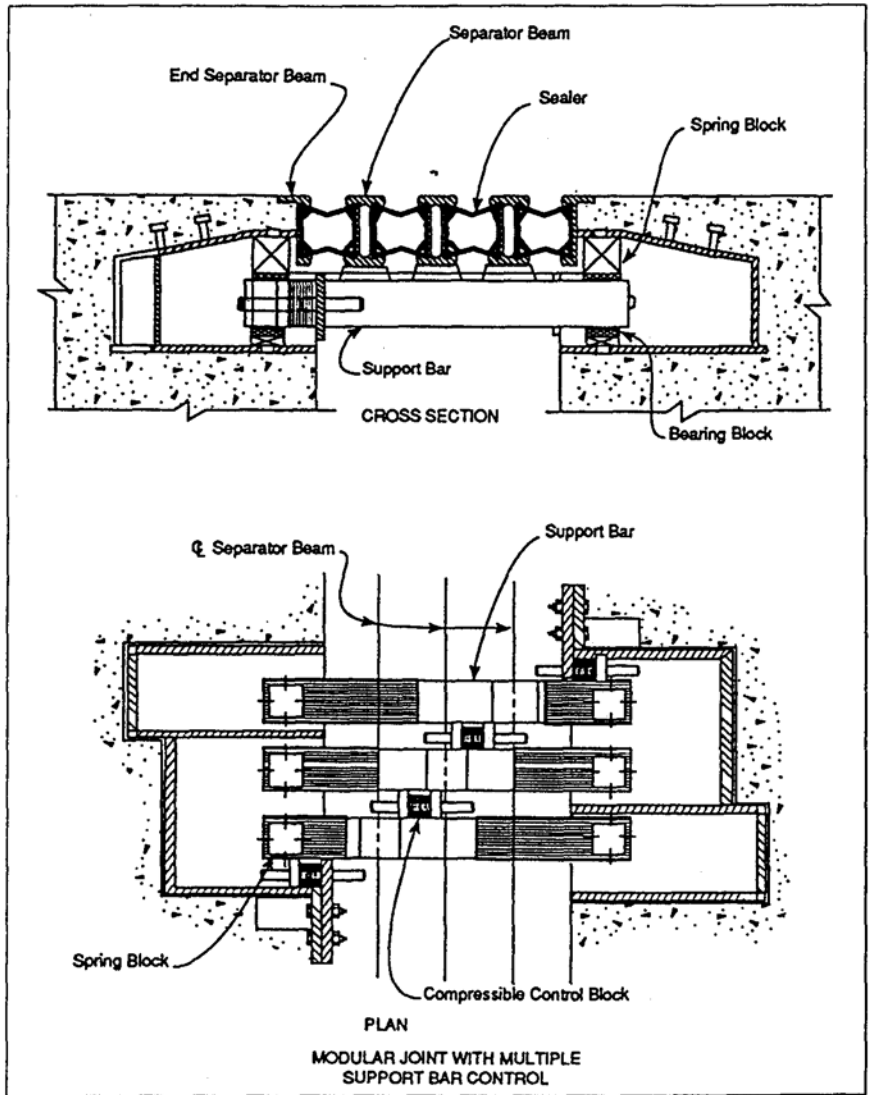
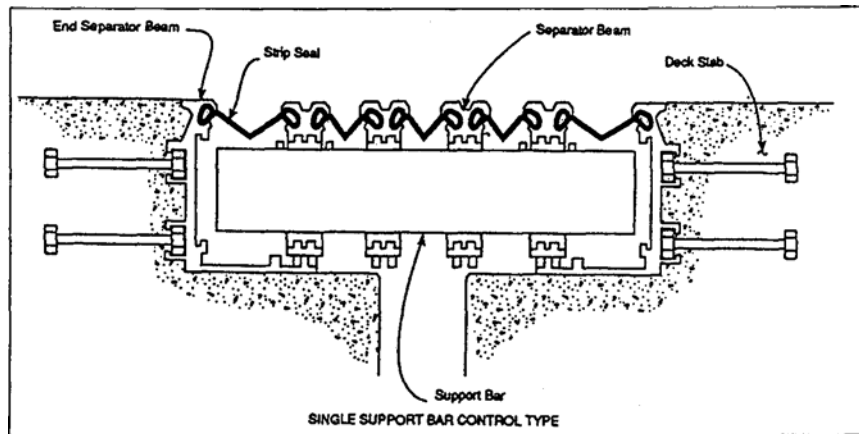
Based on the field performance record of six different modular joint systems, the main points of concern with these joints appear to be the noise under live-load impact, water leakage at seal splice locations, debris accumulation in seals, and snow plow damage.

Spalled deck slab corners along the length of the existing joint are repaired following the procedure described for open joints. Damaged seals and separator beams and other accessible hardware are removed for replacement. The debris accumulation from the seals is removed (Figure 16 and 17). Modular joints provide state-of-the-art joints for joint movements up to 4 feet. This type of joint features an individual support bar at each separator bar. Various sealant materials can be combined with beams and support bars.

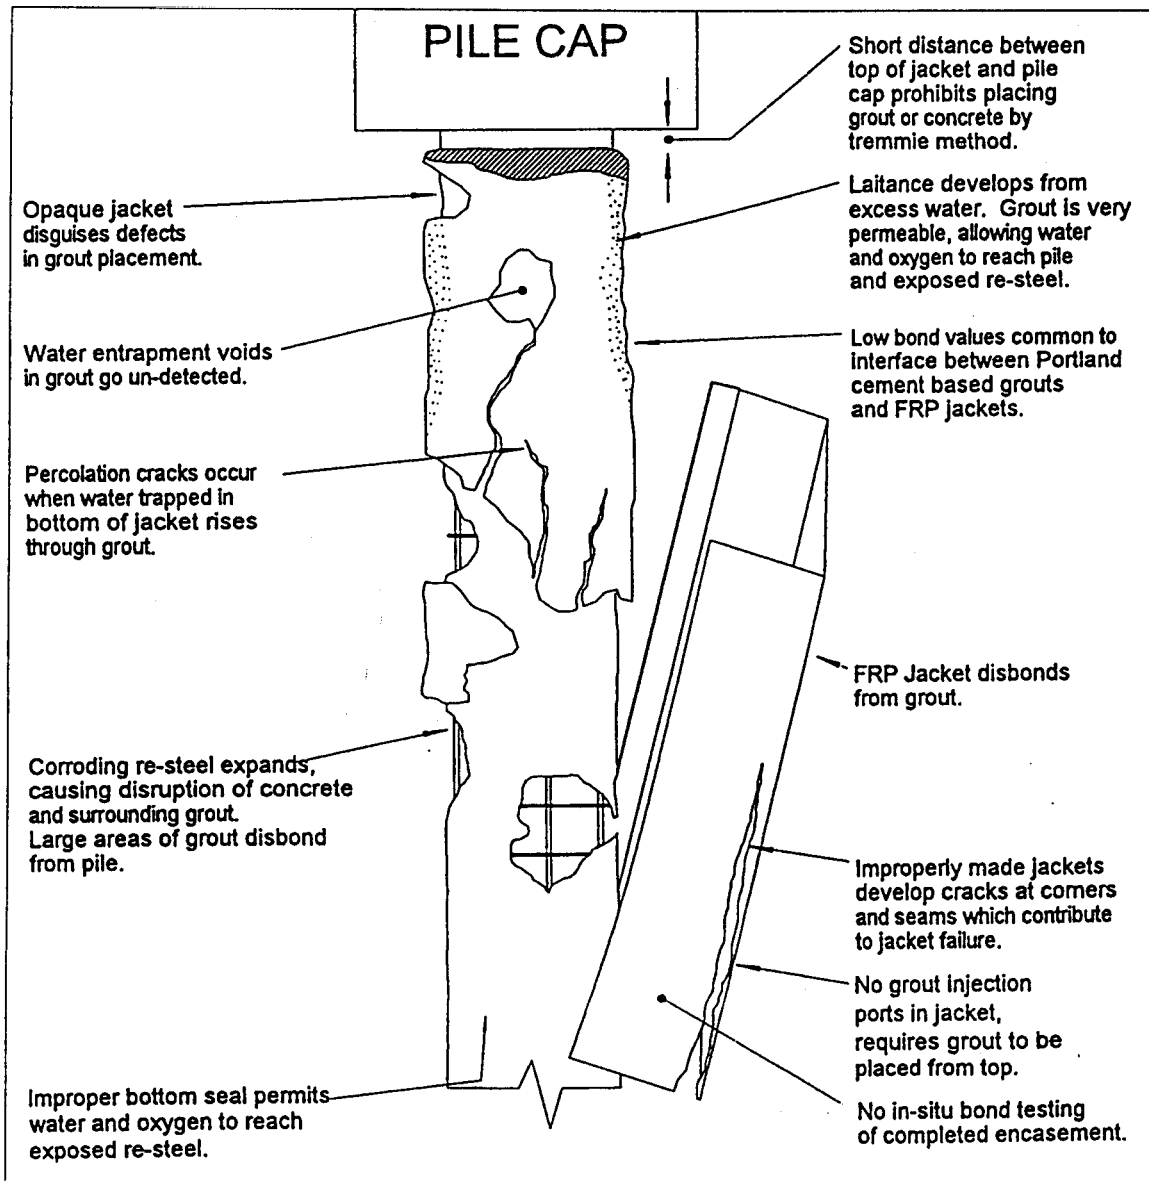
Figure 38 - Summary of the Most Common Causes of Failure

seal polymer grout, the Portland cement based grout or the polymer top off grout. Subsequent discussions with the specifiers, indicated that, with half of the jacket length underwater, they expected the contractor to tremmie place the bottom seal and the cement based grout. What was apparently overlooked, was the fact that the proximity of the pile cap to the top of the jacket virtually prohibited proper tremmie placement. Also, some specifications call for wire mesh that is intended to hold the grout together, but this is usually self defeating, because it interferes with any effort to tremmie place the grout.

The illustration below (Figure 38) summarizes some of the more common causes of failure found in encasement systems consisting of fiberglass jackets and Portland cement based grouts or concrete. These observations were made over a five year period of time, involving numerous structures and hundreds of piles.
