Florida's 2004 Hurricane Season

Structural Impacts on the FDOT System

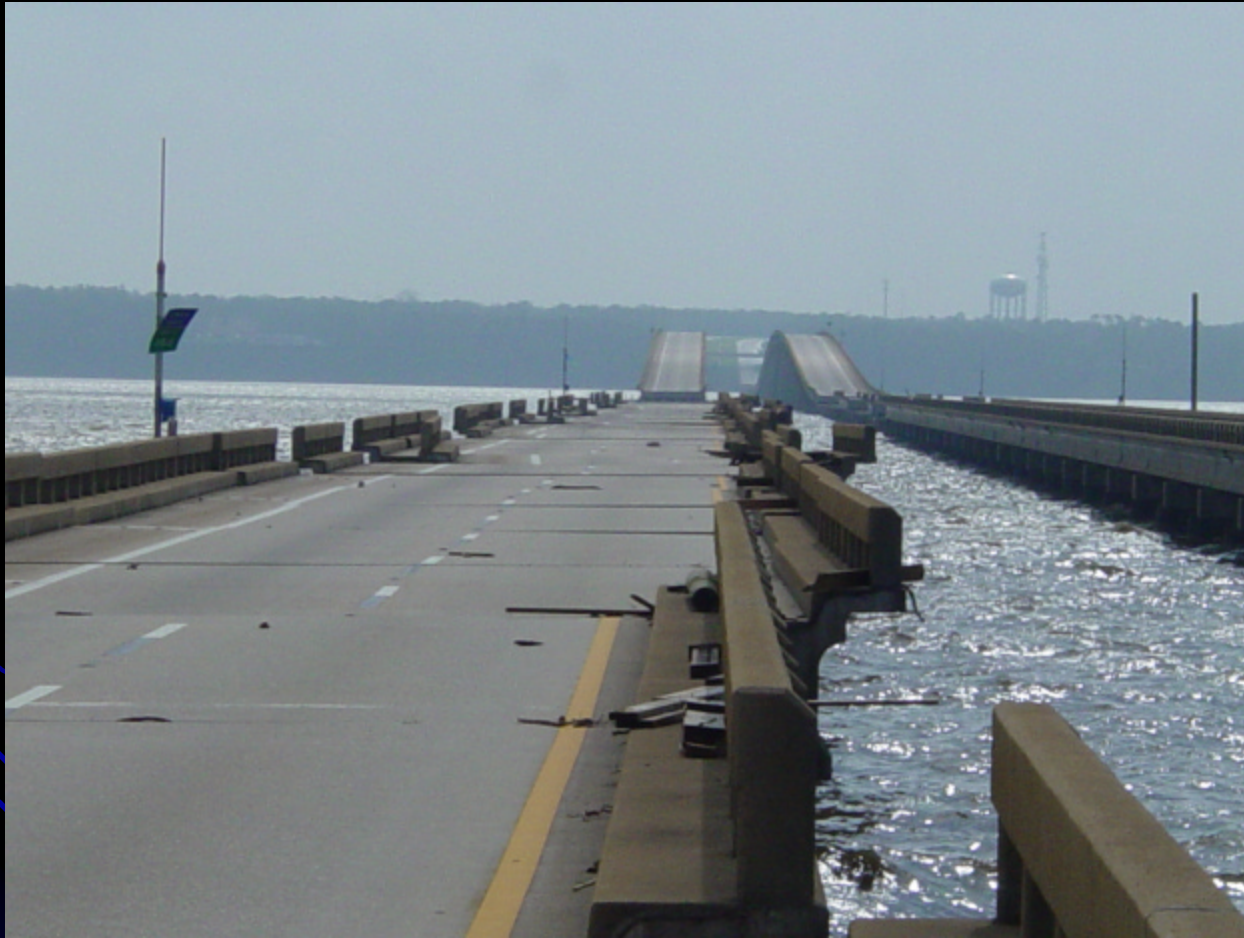
Bridge Looking from East Bank
