**Florida's Turnpike Enterprise
Design Build Request for Proposal**

**Polk Parkway (SR 570)
and Pace Road Interchange**

RESPONSE TO QUESTIONS GROUP 2

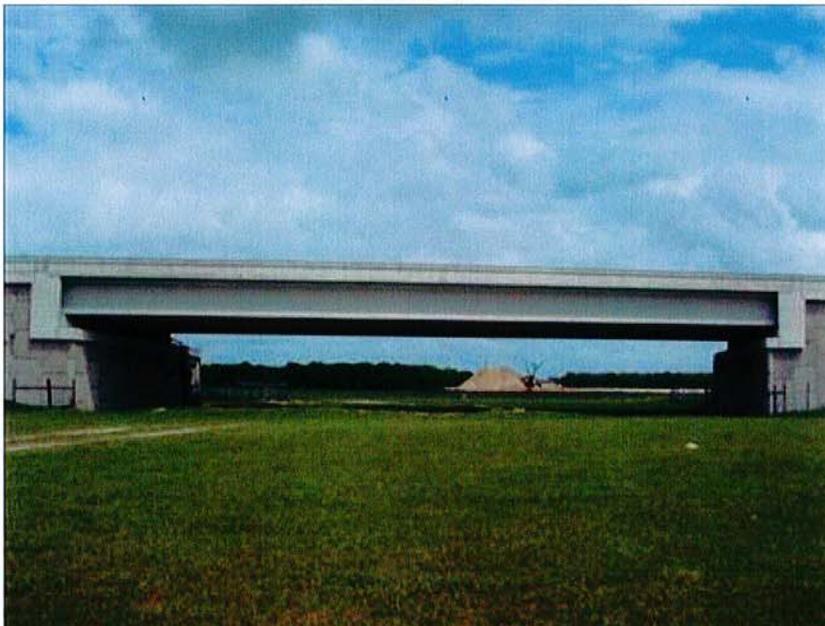
Bridge No. 160288: Photo 2 - West Elevation

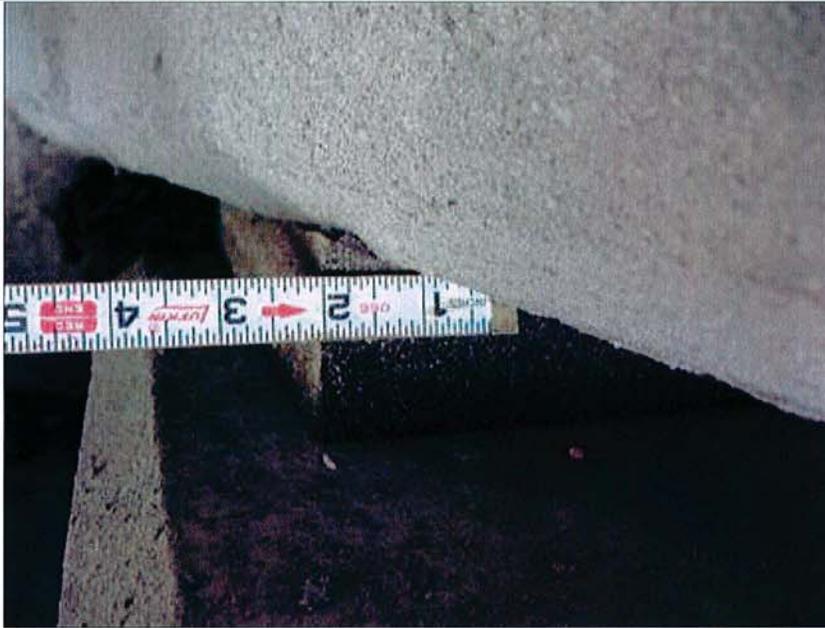
Element 310: Photo 7 - Typical Bearing Pad Projection Beyond Beam

CS1 - Not previously reported, the bearing pads project beyond the chamfered edge of the beams, up to 5/8". See Photo 7. **NO CORRECTIVE ACTION REQUIRED.**

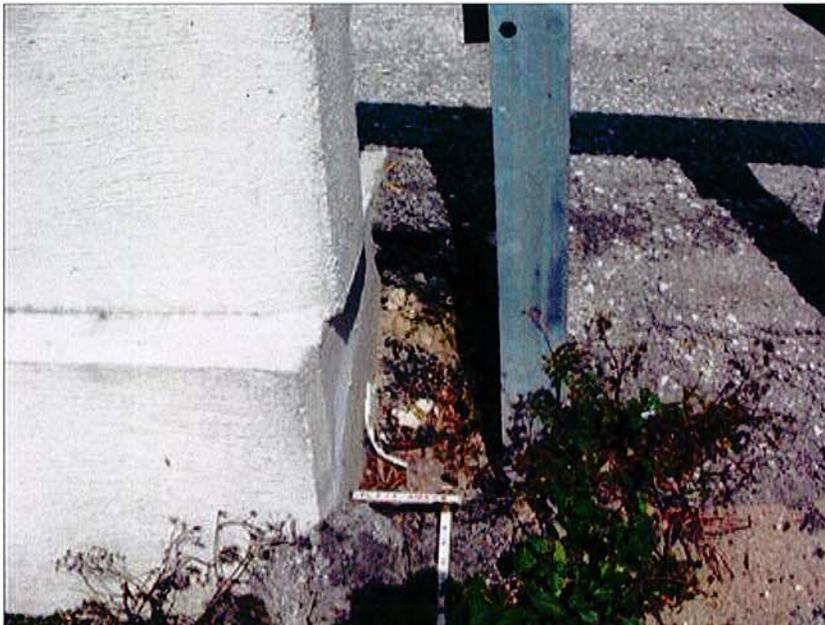
Element 321: Photo 8 - Failed Asphalt Mowing Strip at the Southwest Approach Barrier

Not previously reported, there is a failed area of mowing strip asphalt up to 1'L x 1'-4"W x 11"D, adjacent to the south end of the southwest approach barrier. See Photo 8. NO CORRECTIVE ACTION REQUIRED.
