FINAL REPORT

**BEST PRACTICES FOR QUALITY MANAGEMENT OF STORMWATER PIPE
CONSTRUCTION**

FDOT Contract Number BDK75-977-56

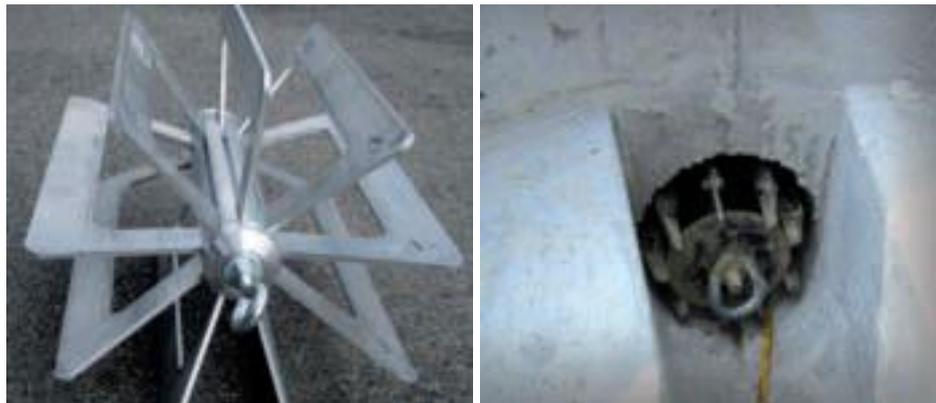
Figure 2-2: Image of Pipe Mandrel by Itself and within a Pipeline
(from the Ontario Concrete Pipe Association)

As a precursor to laser profiling, mandrels provided a much more primitive method for verifying ovality and locating deflections along a pipeline. A mandrel is a round apparatus that is driven through the interior of a pipe in order to verify that the pipe meets the minimum size requirements and contains no major obstructions to flow (RedZone 2011). The mandrel is slightly smaller than the required internal diameter of the pipe, and this difference in size corresponds to a proportional percent variance that is acceptable in the pipe size. If a mandrel does not successfully pass through the inner workings of a pipeline, the inspection is unsuccessful. A picture of a mandrel by itself, and in operation, is shown in Figure 2-3.

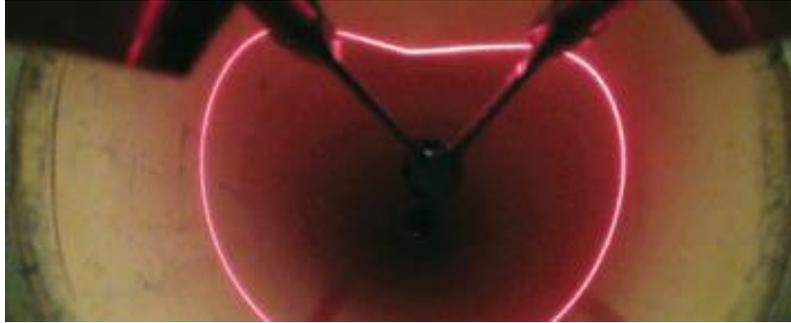
Figure 2-4: Laser Ring Profiler
(from *Maverick Inspection Ltd.*)

With respect to the laser profiling systems, the process can be performed in one of three ways: by laser ring, by point cloud, or by rotating laser. As the name implies, the laser ring method entails projecting a laser ring along the interior of the pipe culvert, just ahead of the CCTV camera. As the mechanism travels along the pipe invert, a laser ring is projected perpendicular to the longitudinal axis and any defects in the overall shape of the pipe are recorded both visually and digitally. A picture of a laser ring projected onto the interior wall of a pipe is shown in Figure 2-5 – note the inverted curve of the ring at the top of the pipe.

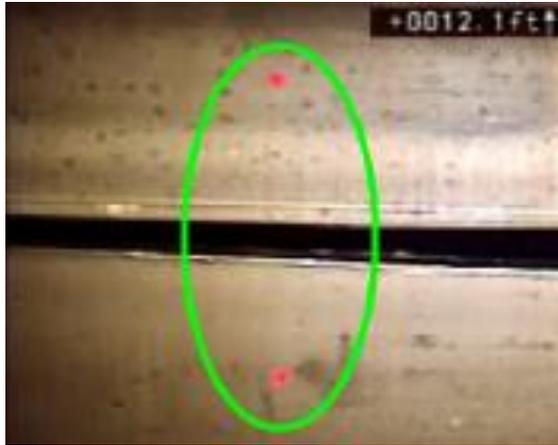
Figure 2-8: Measurement of a Joint Gap with a Video-Micrometer – Using Two Laser Beams
(from C-Tec Presentation)

It is imperative that the two lasers form a 90° angle with the pipe to ensure there is no skewing of the laser lines. If the lasers are not exactly perpendicular to the defect surface, the corresponding defect measurement will be incorrect. Accounting for this likelihood of operator error, some video micrometer manufacturers offer an H-beam laser. As the name implies, the image produced by an H-beam laser resembles the letter H. The purpose of this particular shape is to verify on video if the laser is truly perpendicular to the defect – as a slight angle difference will cause an obvious visible distortion of the H-beam. Looking at Figures 2-9 and 2-10, one can compare the images of a two-point laser system with that of an H-beam laser system.

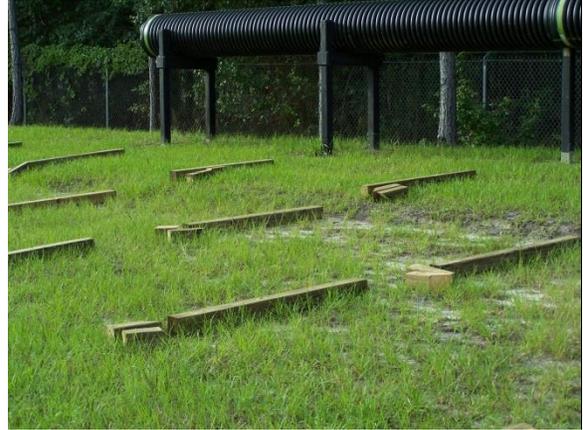
Figure 3-4: Lumber Supports and Chocks

Once delivered onsite, pipe segments were positioned into place with the use of a 4-ton capacity forklift. Individual pipe segments rested on 4-foot pieces of 4"x4" lumber, with chocks to keep them in place. Figures 3-3 to 3-9 illustrate the positioning of pipe material.

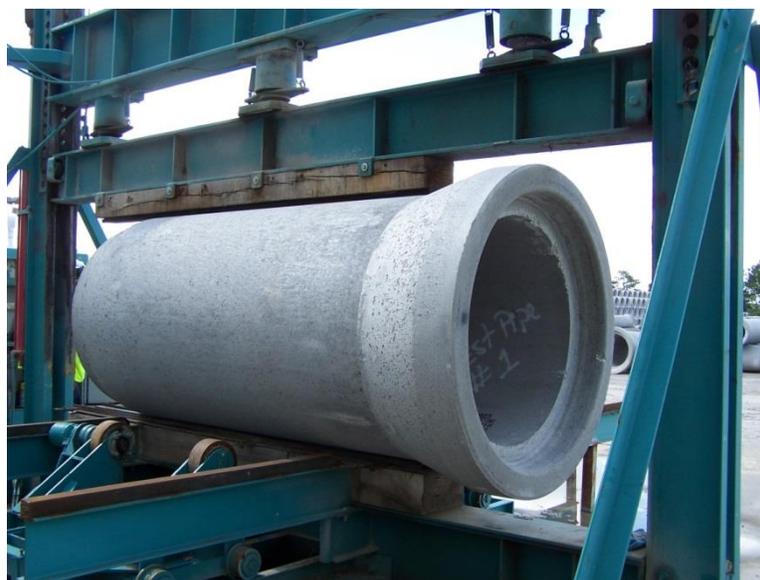
Figure 3-10: Introduction of Cracks on RCP by Means of Three-Edge Bearing Test Device

Prior to delivery of the RCP segments, suppliers introduced crack defects on four of the five segments by means of a three-edge bearing test device (Figure 3-10). The pipe segments were loaded until the development of hairline fractures was observed, and in some cases until failure occurred. This ensured a distribution of both “negligible” and “more substantial” cracks (Figures 3-11 and 3-12), illustrating situations that were both common-place and extreme for pipe culvert installation inspection.

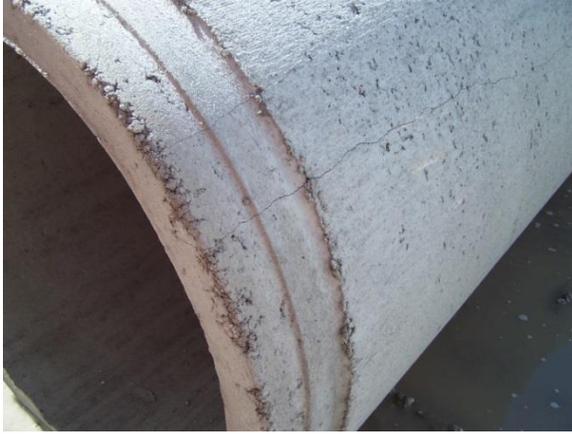
Figure 3-11: Hairline Crack on RCP

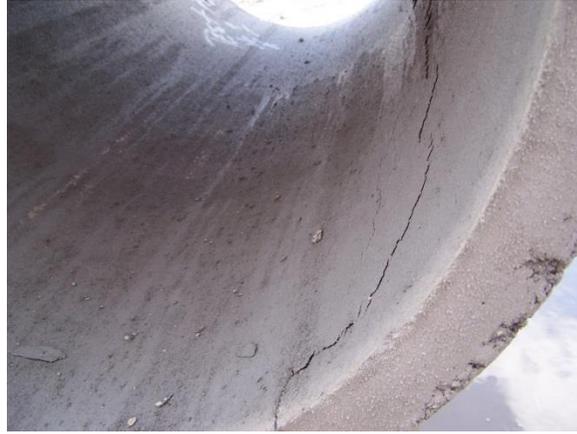
Figure 3-12: Larger Crack on RCP

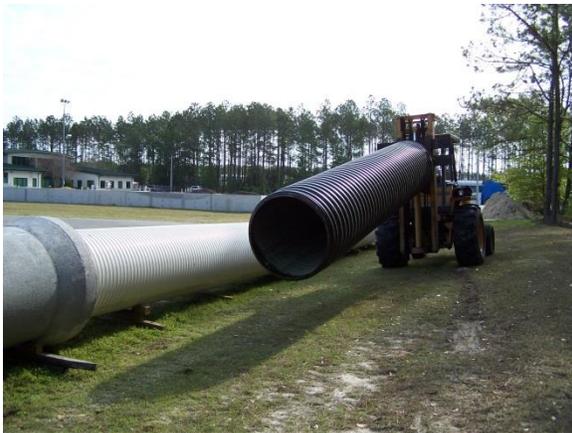
Figure 3-13: Relocating Pipe Segments

Because of this problem, the preliminary layout of four individual runs was changed a single 164-foot continuous run composed of varying pipe material. Relocation of the entire course, however, was now limited by the inability to move the installed concrete pipe run. Instead, the remaining three pipe runs (PVC, HDPE, and CMP) were relocated to either side of the RCP (Figure 3-13). In moving the pipe segments it was discovered that the terrain to the east of the RCP was at a lower elevation. Sandbags were used to raise individual pipe segments in order to provide a continuous line (Figure 3-14).

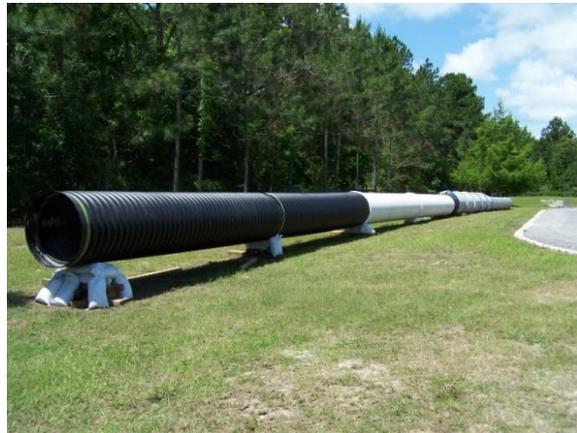
Figure 3-14: Elevated Pipe Course Run

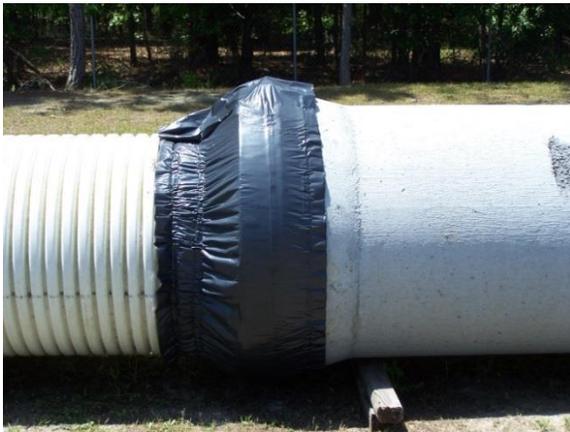
Figure 3-15: Dissimilar Pipe Coupler at PVC-to-RCP Junction

Figures 3-15 and 3-16 show the use of dissimilar pipe coupling material to seal the joints for the PVC-to-RCP and CMP-to-RCP runs. It should be noted that the use of these couplers for the specific dissimilar pipe junctions is not recommended by the coupling material supplier. Because of the extreme difference in outside pipe diameters, these couplers would probably not be used in proper pipe culvert installations.

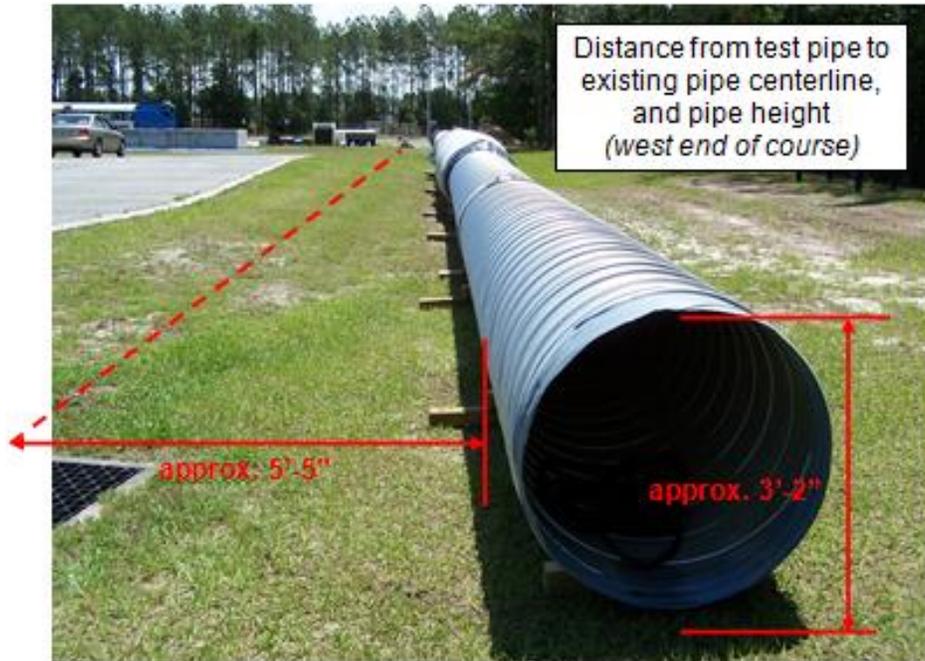
Figure 3-17: Distance to Existing Drainage Pipe (West End)

Inability to relocate the RCP also hindered construction of the tarp structure; the continuous run was in close proximity to an existing buried drainage pipe. Support posts would have to be carefully located and in some cases could not be fully inserted into the ground for fear of damaging the existing drainage pipe. Figures 3-17 to 3-21 illustrate the approximated distances between the pipe run and the drainage pipe that were taken into consideration when designing the tarp cover.

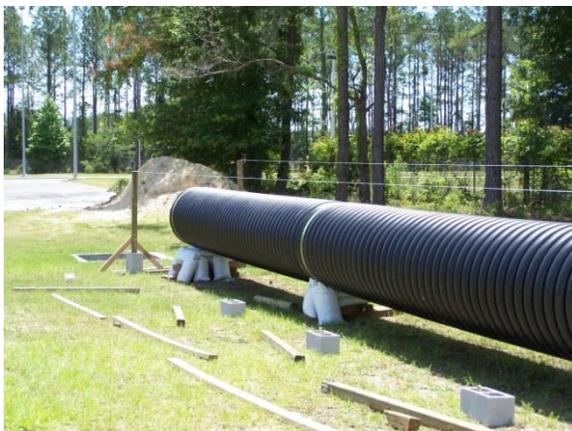
Figure 3-22: Corner Posts (East End)

The four corners of the framing structure were located; post locations were staked out; four corner and two mid-point posts were set up; and a line was strung up between the posts. The remainder of the post holes were dug, posts erected, and framing was set up.

Posts that were located directly above, or within close proximity to, the existing drainage pipe were not buried completely underground but instead were supported by cinder blocks filled with concrete. All other posts were buried at a maximum depth of 3 feet. Figures 3-22 to 3-31 illustrate the construction process of the framing structure.

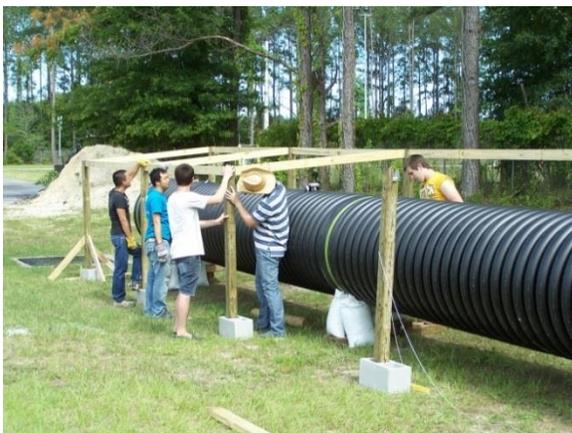
Figure 3-28: Framing Installation

Final dimensions for the tarp framing structure were approximately 6 feet wide by 170 feet long, with maximum and minimum heights of about 5 feet and 7 feet, respectively. Room was provided for easy access alongside the pipe.

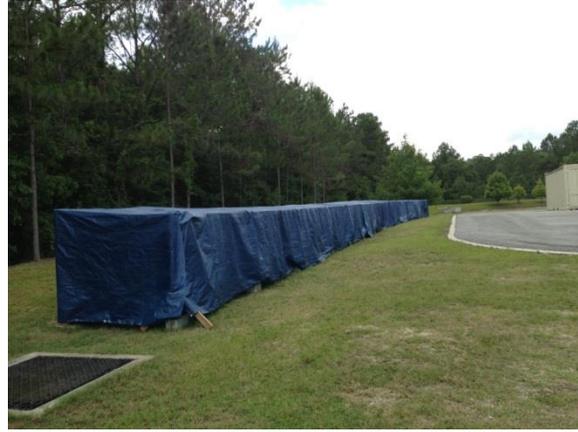
Figure 3-31: Completed Structure with Tarp

The course was covered by tarp for two reasons: (1) to prevent the influence of thermal expansion on pipe defects, potentially influencing operator crack measurements; and (2) to conceal the location of pipe defects, potentially influencing operator defect locations.

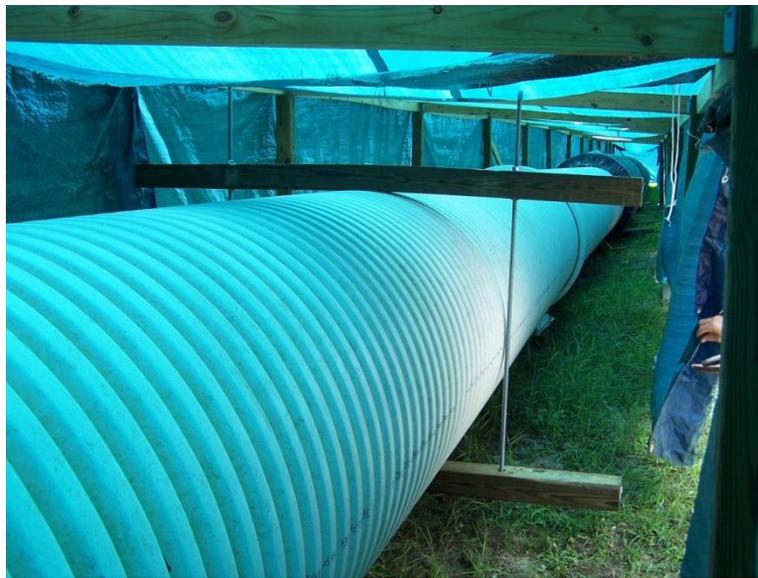
Figure 3-32: Deflection Vice on PVC Pipe

Besides the defects introduced during the assembly process, ovality issues were introduced once the entire course run and framing structure were completed. Deflection vices were created from 4x4 lumber pieces, threaded rods, galvanized hex nuts and washers as shown in Figure 3-32. The devices were tightened in order to produce observable defects within the interior of the pipe.

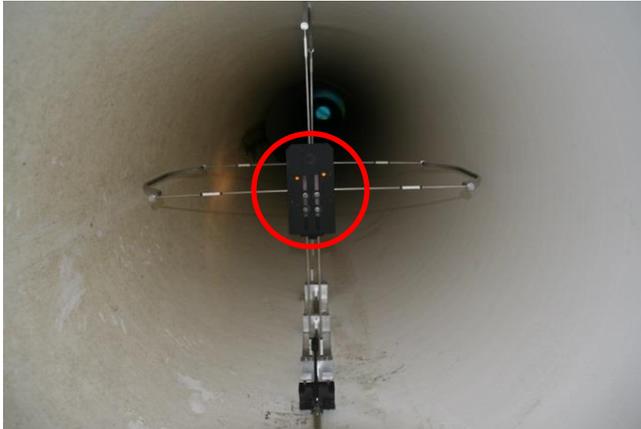
Figure 3-33: Location before the Deflection Vice

A pipe deflectometer was used to verify the presence and severity of pipe ovality as a result of the deflection vices. The deflectometer fits inside the pipe and is guided through with the use of attachable extension rods. The deflectometer can be adjusted to fit within different pipe sizes, and as such, spring-loaded mechanisms on the end arms of the device will rest flush with the inner walls of the pipe. As the deflectometer travels the length of the pipe, any variations in the inner diameter of the pipe (exclusively in either the X- or Y-direction) will be displayed by the presence of reflective dots on the faceplate, and the number of dots revealed correlates to the percentage of pipe ovality exceeding the 5% allowed per FDOT specifications – each reflective dot denotes a decrease in the pipe inner diameter by approximately $\frac{1}{4}$ inch. Figures 3-33 to 3-35 illustrate the process by which the device was used to confirm deflection in the pipe.

To ensure the device was “snug” within the confines of the pipe, the end arms were extended to fit a larger sized pipe, thus explaining the presence of two orange reflective dots (circled) at the onset of the test.

These two dots were regarded as a “baseline” and the intent was to observe changes in the number of reflective dots.

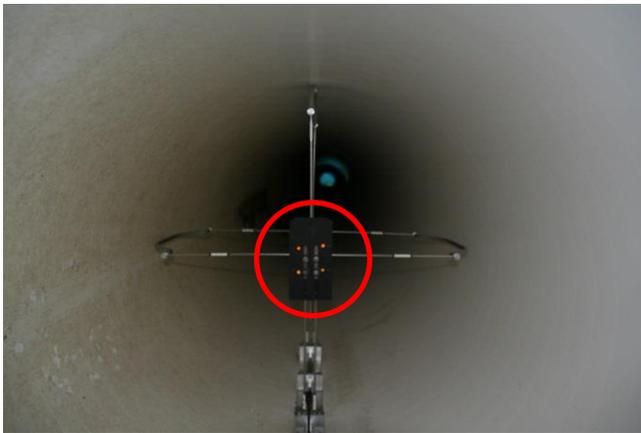
Figure 3-34: Location at the Deflection Vice

At the location of the deflection vice there is an observable increase in the number of reflective dots.

Two additional dots were seen for a total of four reflective dots (circled).

The net increase in reflective dots at the location of the deflection vice confirms a total deflection ranging between $\frac{1}{4}$ to $\frac{1}{2}$ inch, with each dot at the site of the defect representing approximately $\frac{1}{4}$ inch change in inner pipe diameter.

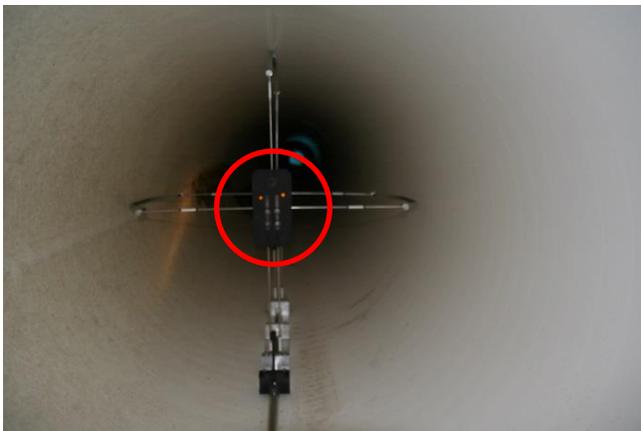
Figure 3-35: Location after the Deflection Vice

The additional reflective dots are no longer observed. The faceplate returned to its “baseline” of two dots (circled).
