FINAL REPORT

**CORROSION CHARACTERISTICS OF POST-TENSIONING STRANDS IN
UNGROUTED DUCTS**

**Contract No. BDK84 977-04
Final Report to Florida Department of Transportation**

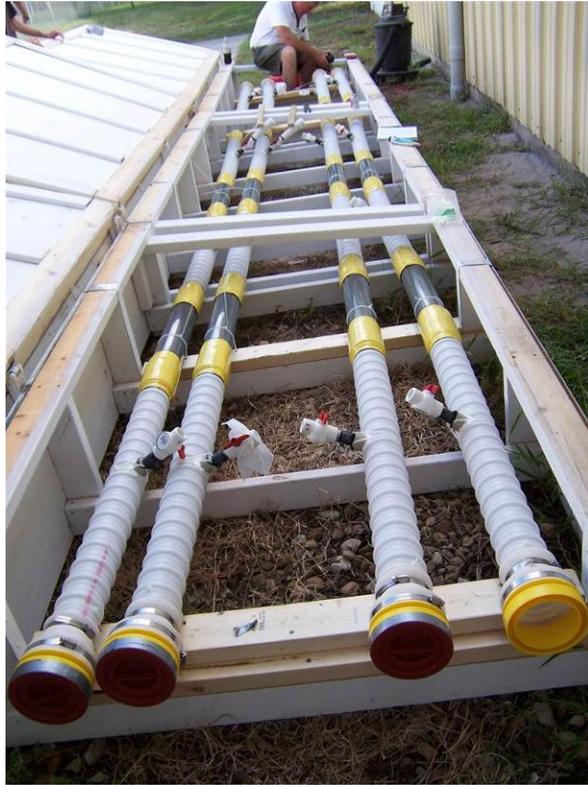
Figure 1 B - Test Facility During Construction. Inland Facility (USF Campus), West Side Seen from North, Showing Ducts From Left to Right: [DCN] - [DON] - [WCN] - [WCI]. Hinged roof is lifted.

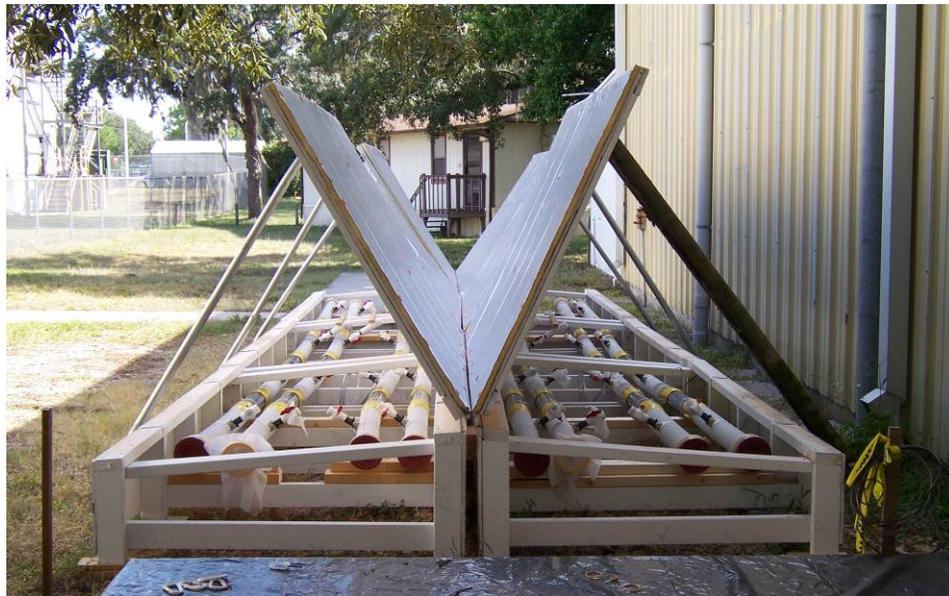
Figure 1 C - Inland Facility (USF Campus), seen from N at the time of the 1-week inspection; hinged roofs lifted.

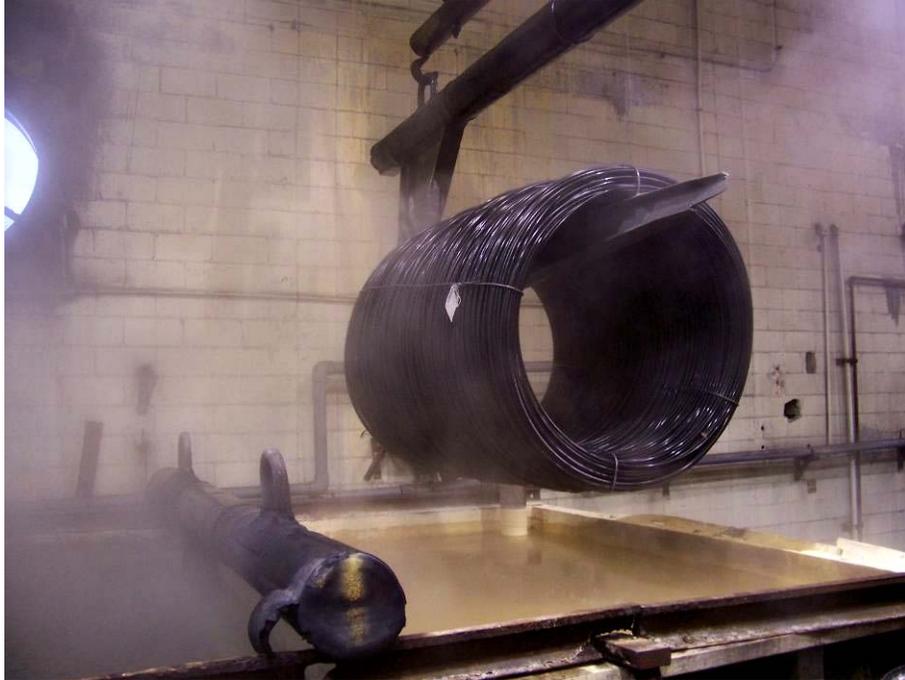
Figure A1.1 - Last cleaning step.

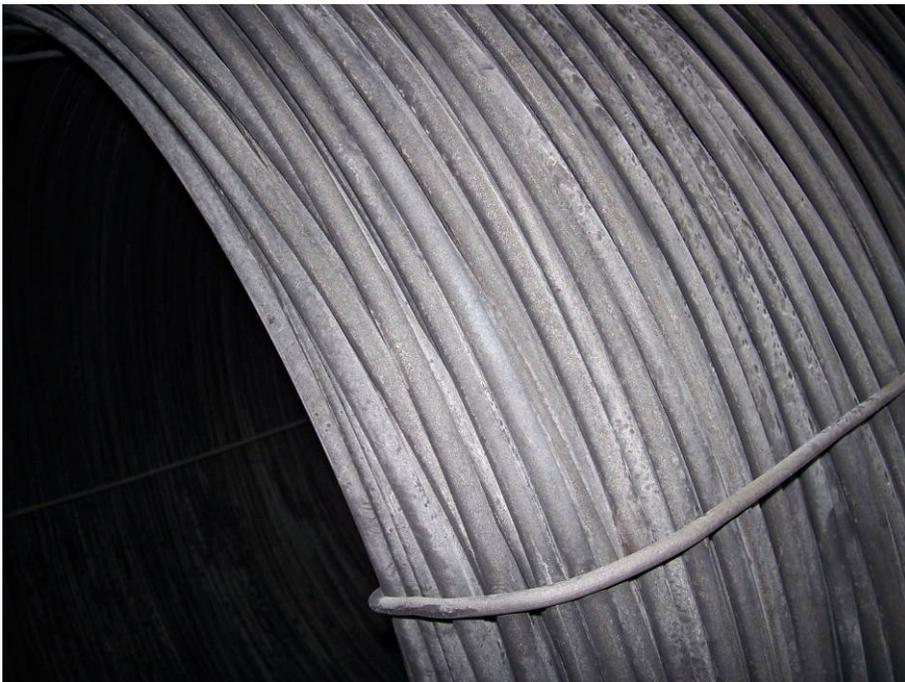
Figure A1.2 - Phosphated and neutralized final surface appearance.

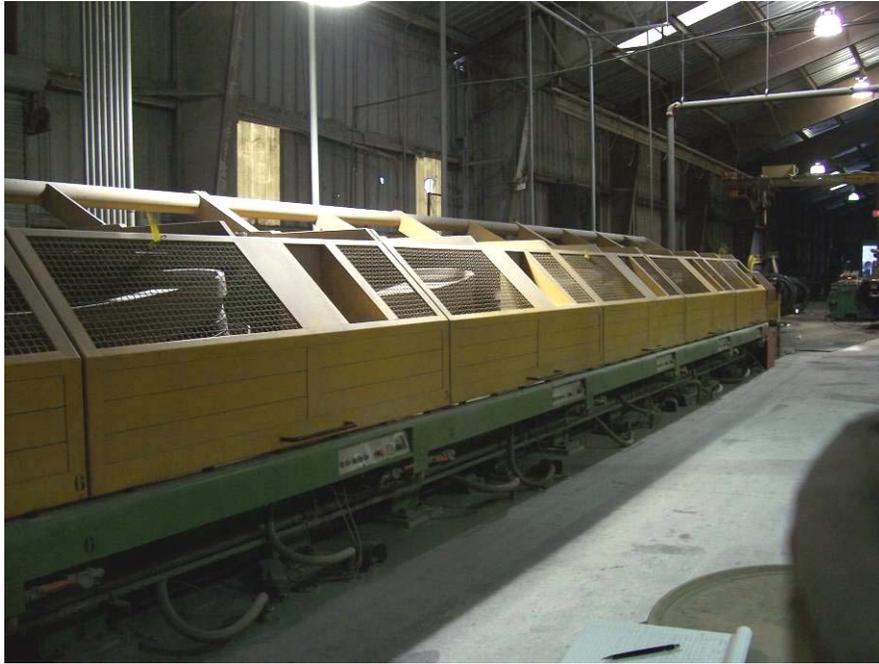
Figure A1.3 - Wire drawing train.

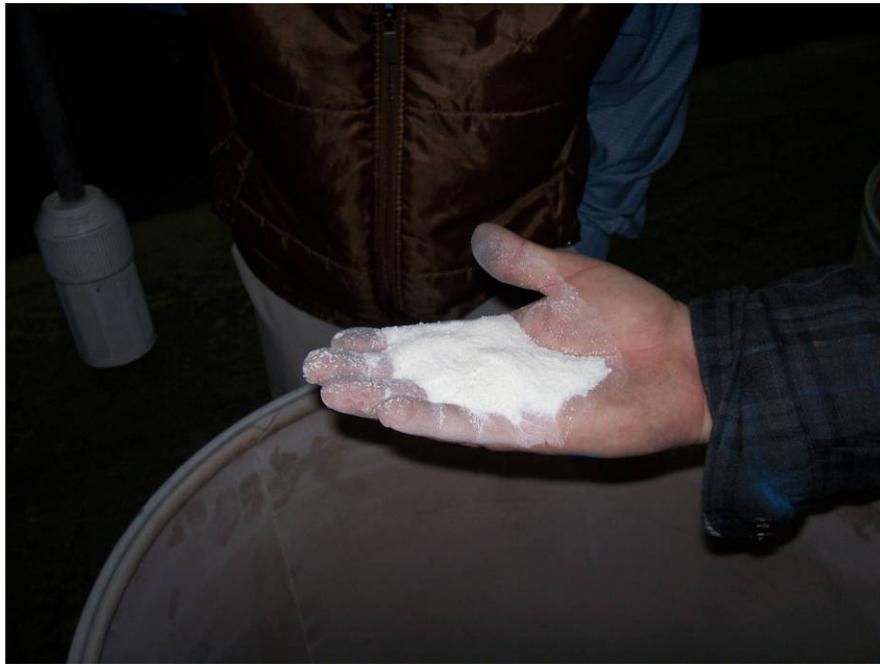
Figure A1.4 - Sodium stearate lubricant.

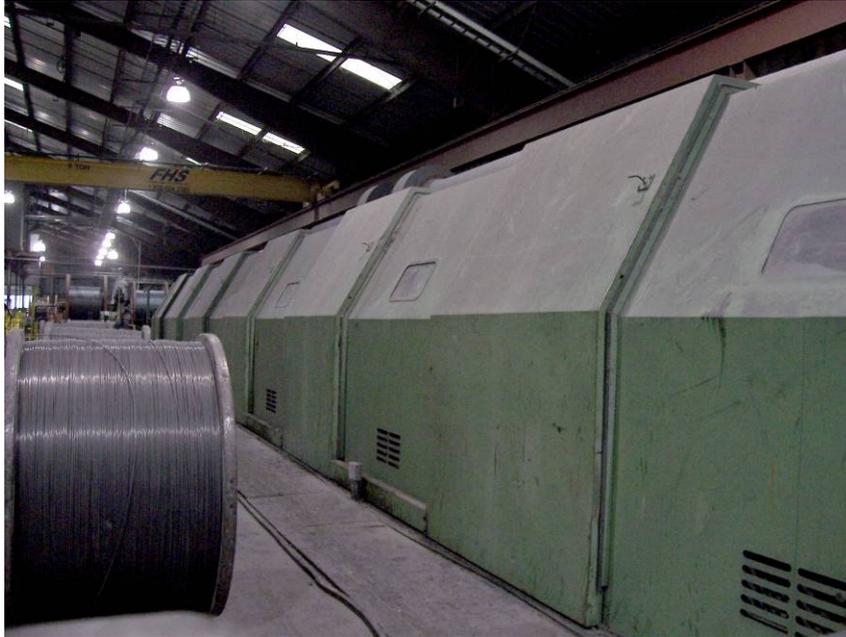
Figure A1.5 - Green stranding train

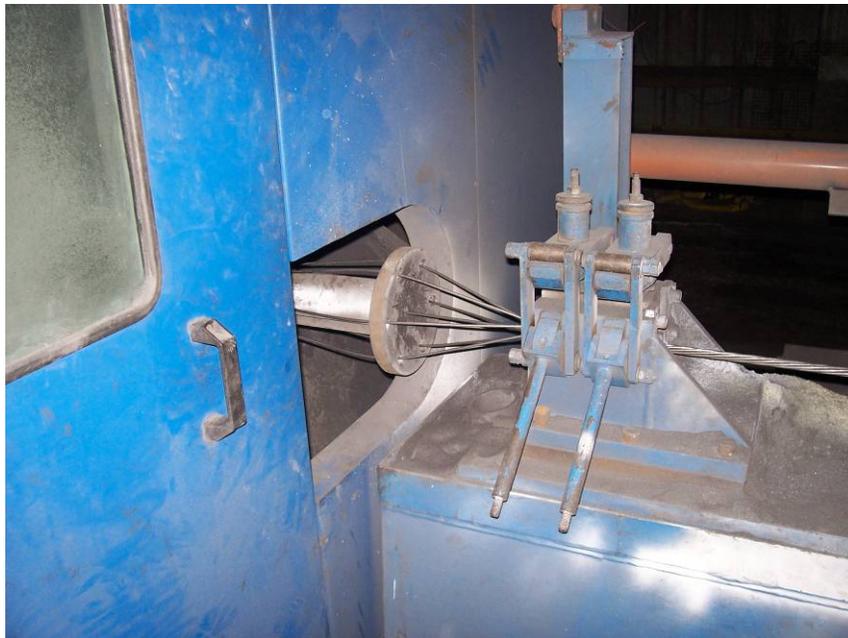
Figure A1.6 - Regular stranding procedure

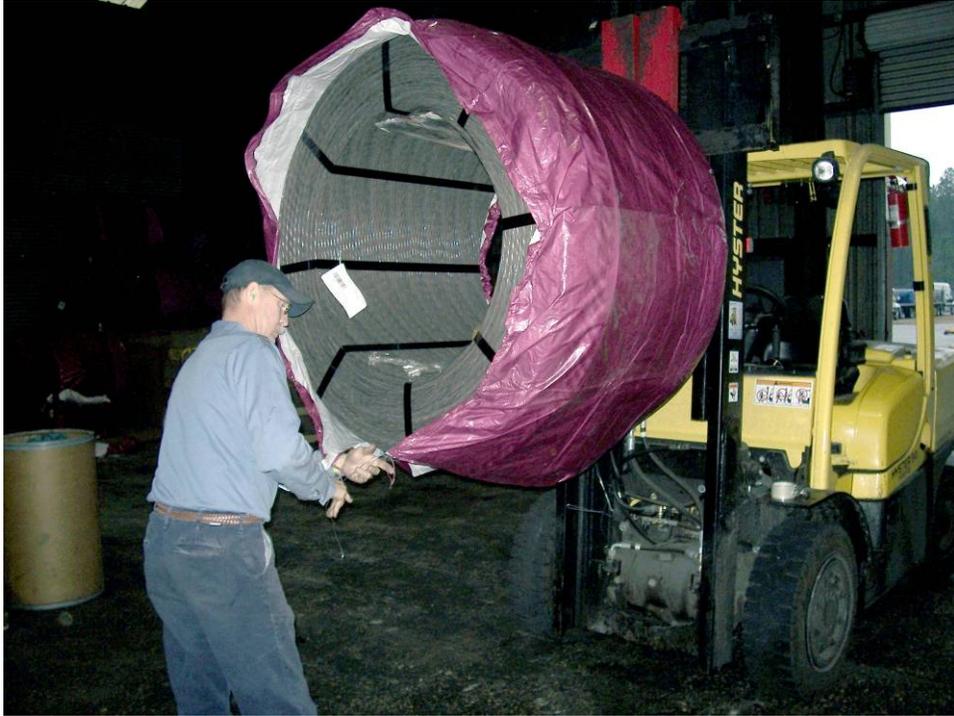
Figure A1.7 - Normal wrapping for shipping

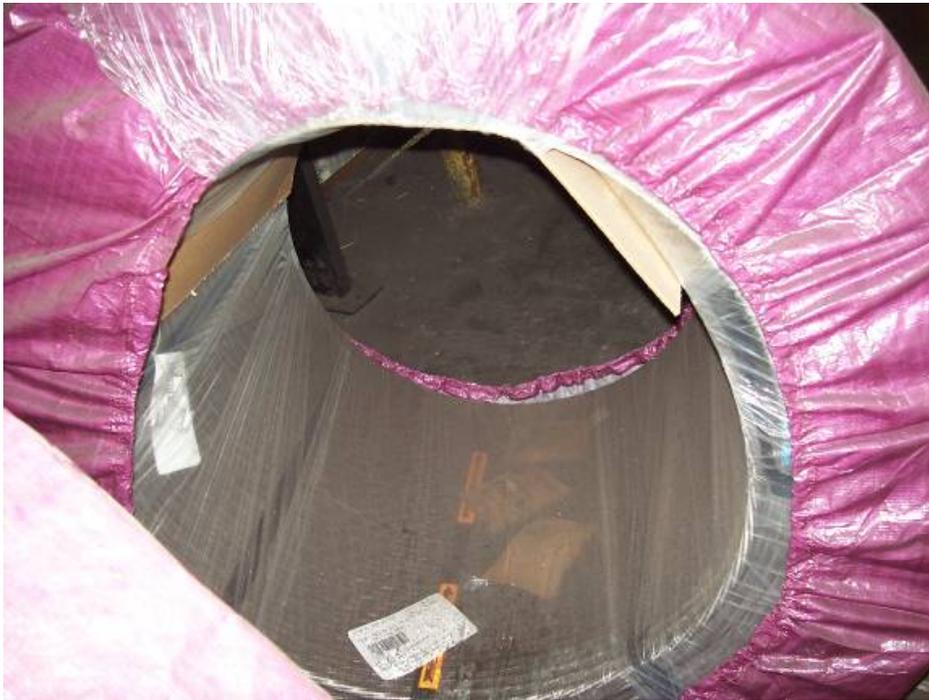
Figure A1.8 - Special wrap

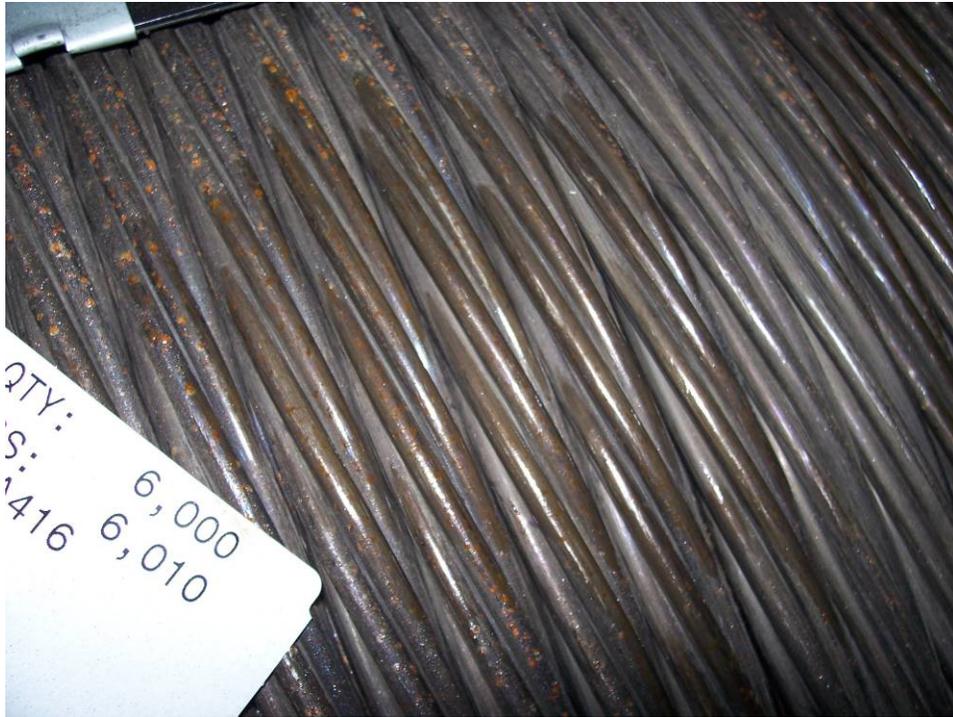
Figure A1.9 - Outer spool surface before wrapping. High humidity conditions in day picture was taken, superficial rust visible. Central region was finger-rubbed to spread out condensation deposit.

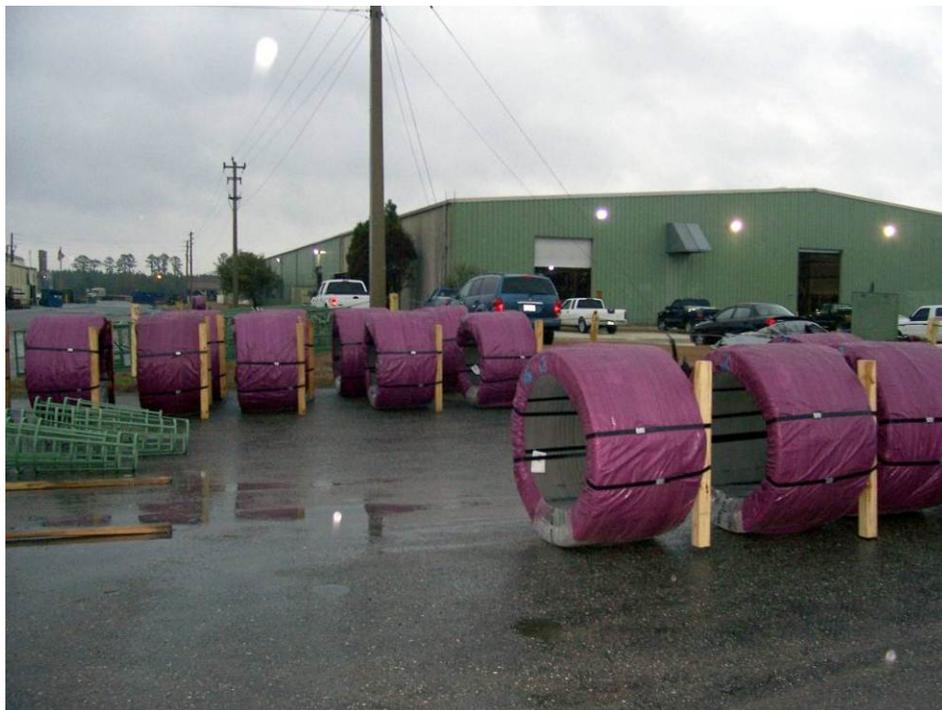
Figure A1.10 - Spools placed outside awaiting shipping in rainy day.

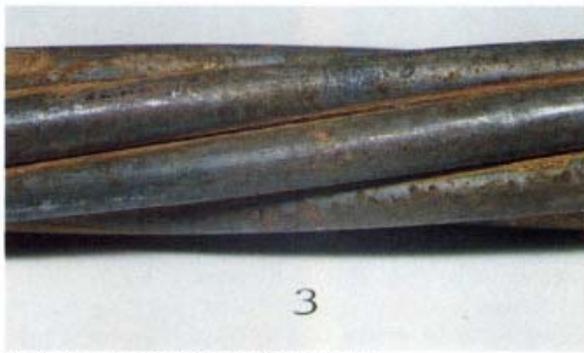
Photo 1. Strand surface before cleaning.

Photo 1A. Strand surface after cleaning.

Figure A2.1 – Photos 1/1A (little or no corrosion, acceptable), 2/2A (some amount of surface corrosion, acceptable) and 3/3A (some amount of surface corrosion, acceptable) used per Reis (2007). Pictures reproduced from Sason (1992) by kind permission from The Precast Prestressed Concrete Institute (PCI).

Visual appearance of the strand on removal was assigned a Visual Corrosion Rating (VCR) based on the method described by Sason (1992), using reference pictures exemplifying increasing levels of corrosion damage. This system was used for the San Francisco Bay Bridge Overpass investigation (Reis 2007) (Sason 1992). The VCR assignment, based on the pictures reproduced in Appendix 2, was as follows:

1. Little or no corrosion, acceptable.
2. Some amount of surface corrosion, acceptable.
3. More corrosion but still acceptable.
4. More corrosion, borderline.
5. Excessive corrosion, visible pitting, cause for rejection.
6. Further excessive corrosion, visible pitting, cause for rejection.

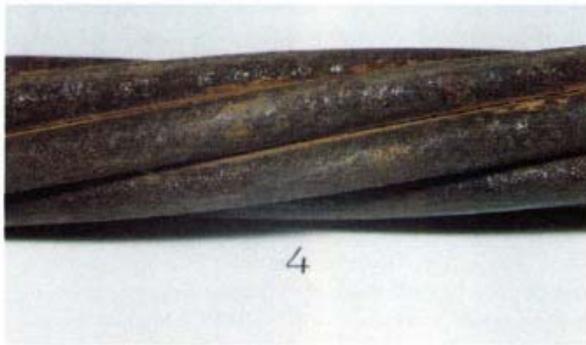
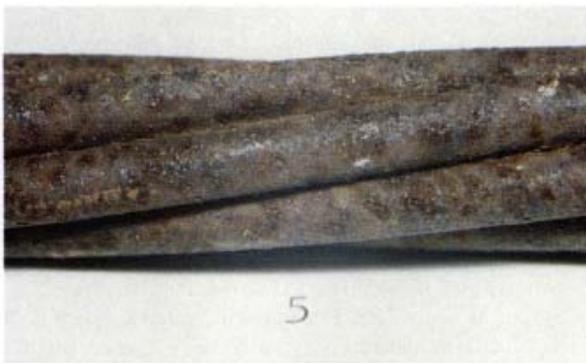
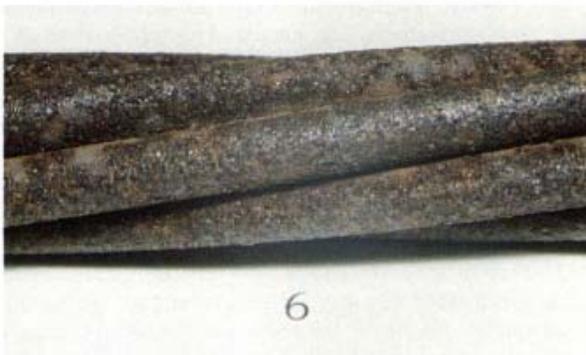
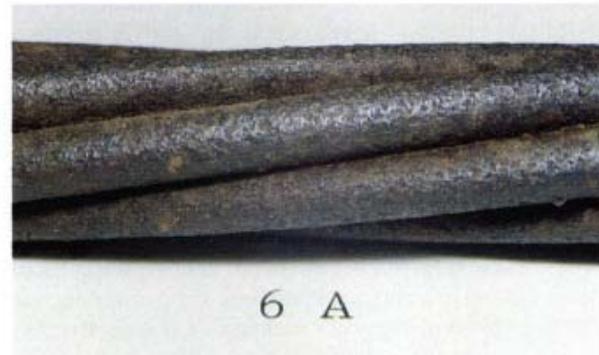
Photo 4. Strand surface before cleaning.

Photo 4A. Strand surface after cleaning.

Figure A2.1 – Photos 4/4A (borderline condition), 5/5A (excessive corrosion with visible pitting, cause for rejection) and 6/6A (excessive corrosion with visible pitting, cause for rejection) used per Reis (2007). Pictures reproduced from Sason (1992) by kind permission from The Precast Prestressed Concrete Institute (PCI).

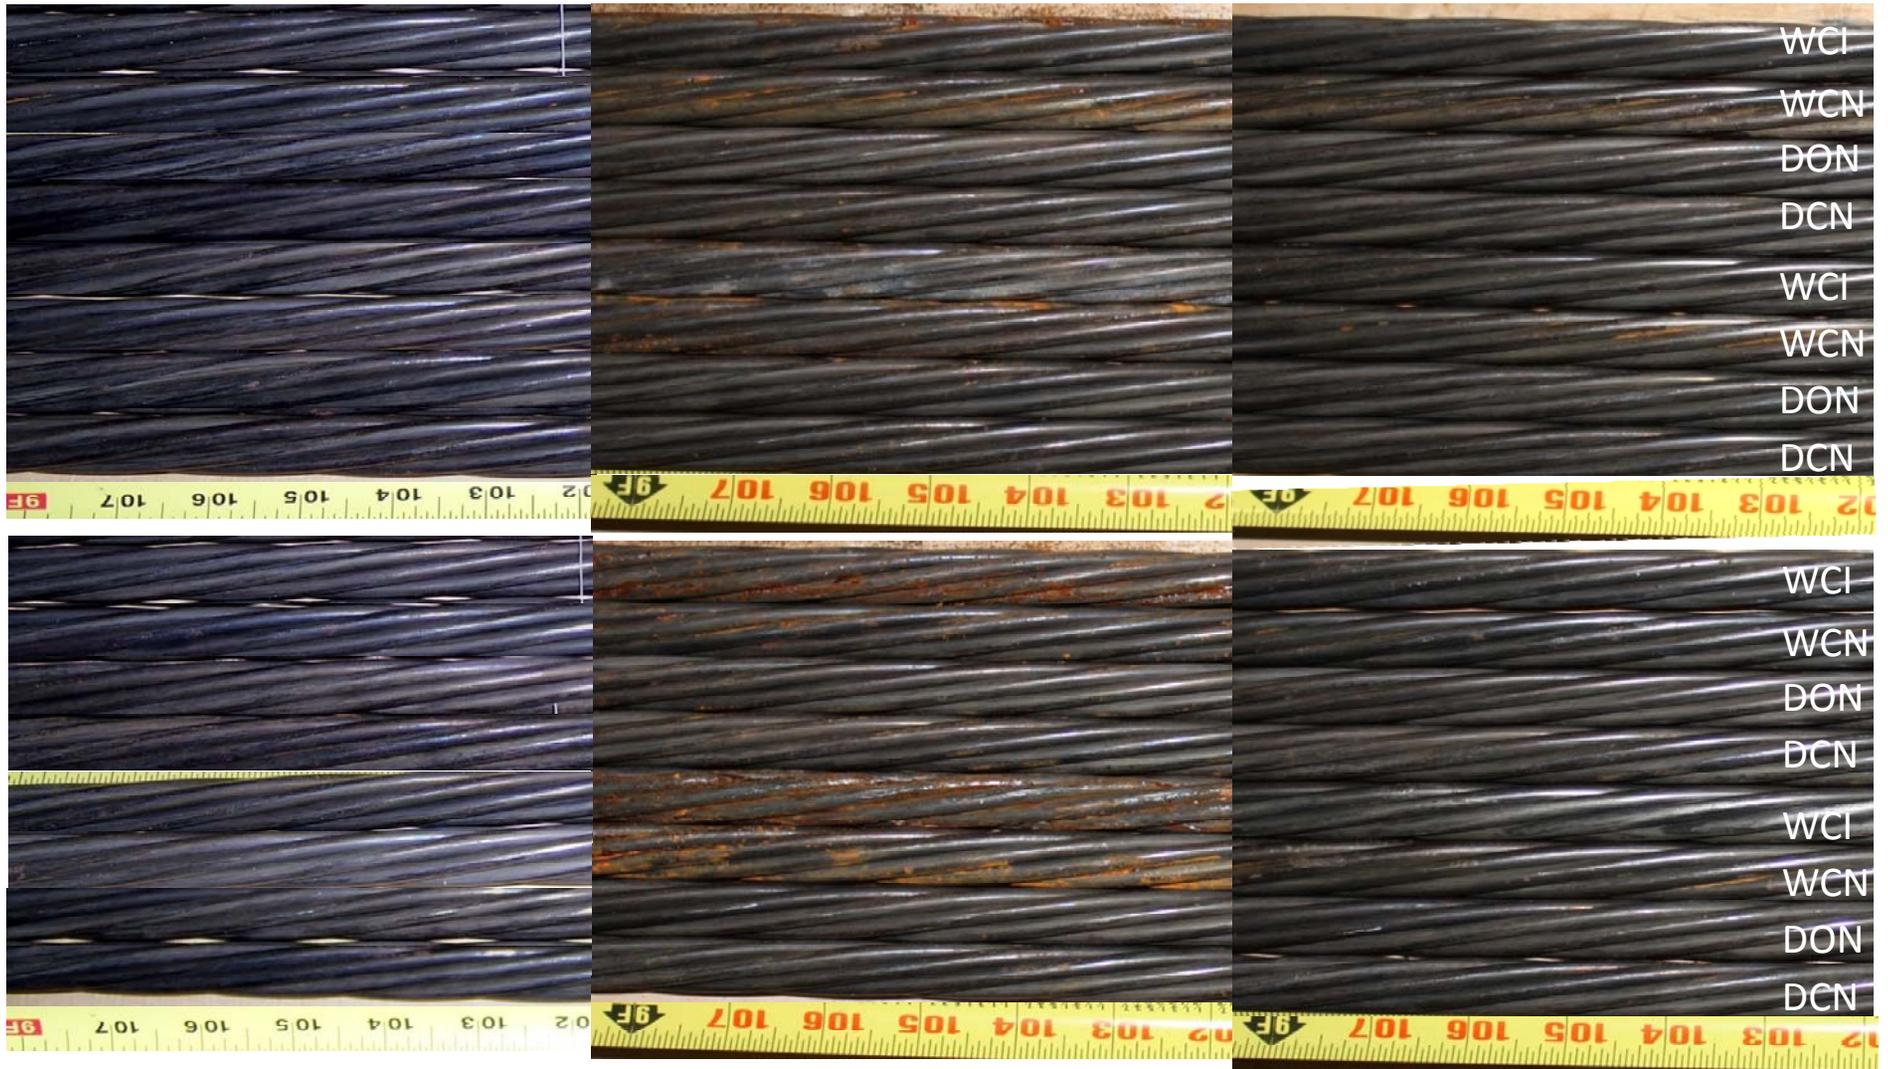
Figure A3.5 - Seashore – 1 week exposure.

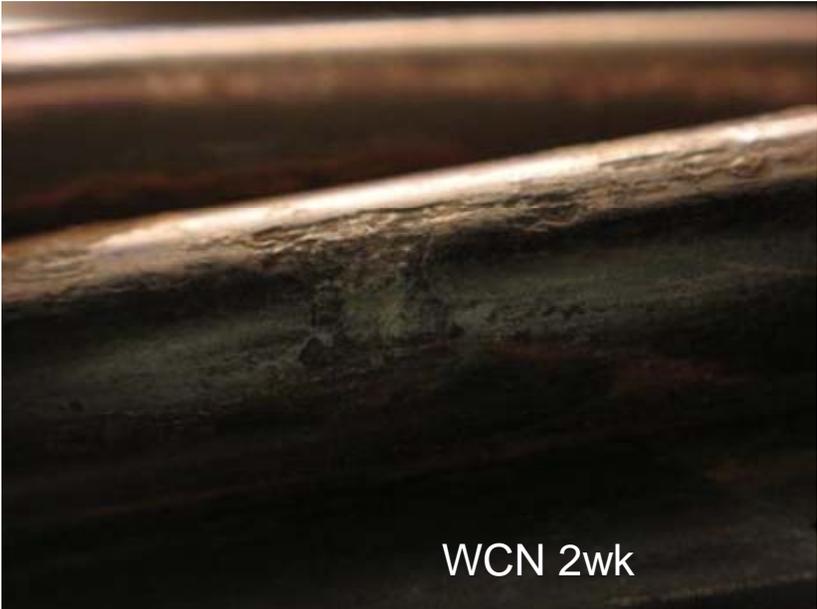
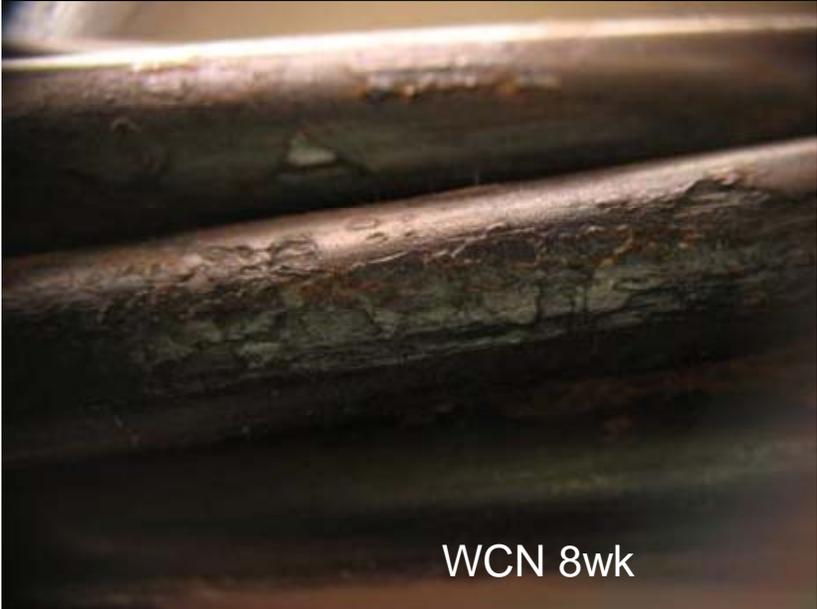
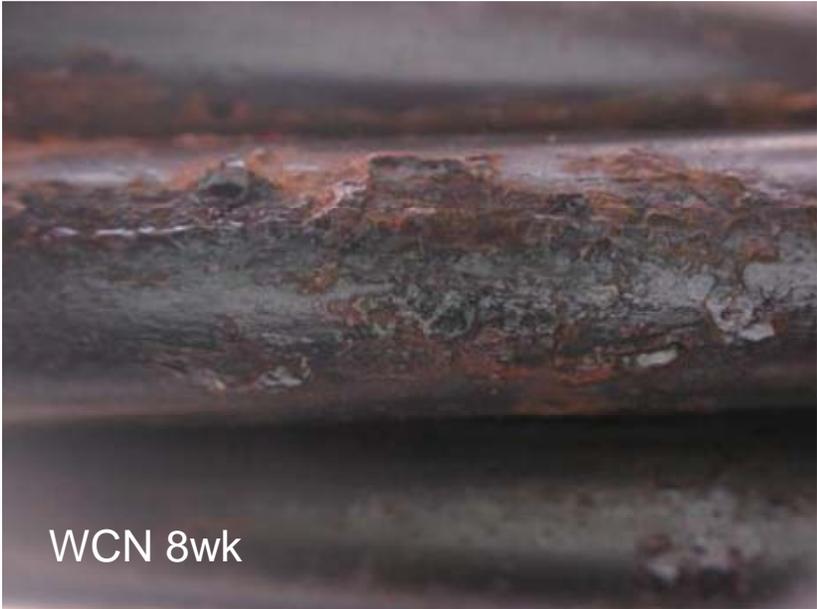
Figure A3.10 - Most severe pitting observed (Seashore facility) – Set 2
