FINAL REPORT

EVALUATION OF CONVENTIONAL REPAIR TECHNIQUES FOR CONCRETE BRIDGES

Center for Infrastructure and Constructed Facilities

December 2000

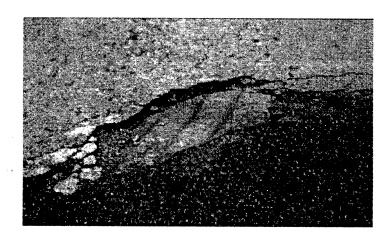
Figure .2.1 Spall with reinforcement exposed

corrosion protection method and the percent showing any sign of distress, percent with significant distress (greater than 6 % of the surveyed area showing distress), and percent with severe distress (greater than 20 % of the surveyed area showing distress). Figure 2.1 and 2.2 show examples of distress observed on bridge decks containing uncoated reinforcement.

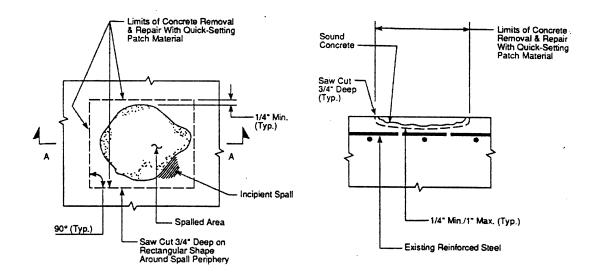
Figure 3.1 Shallow repair of deck slab (Brinckerhoff, 1992)

Where the depth of concrete deterioration is less than ¾ inch (19 mm), and reinforcing steel is not exposed, a shallow repair is needed (Figure 3.1). The defective concrete is saw cut ¾ inches deep into rectangular or square shapes, and removed either by a pneumatic hammer or hydrodemolition. The surface is cleaned thoroughly, and the repair material, generally a prepackaged nonshrink, quick-setting polymer-modified cementitious mortar, is applied and cured. Where the repaired deck slab is to be overlayed later, the contractor may be given the option to fill the shallow repair areas with overlay material at the time of overlay application.

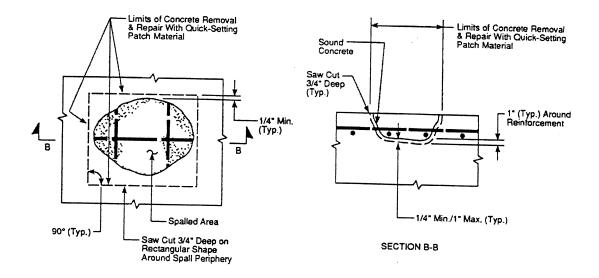
Figure 3.2 Deep repair of deck slab (Brinckerhoff, 1992)

Defective concrete deeper than the top mat of steel reinforcement requires a deep repair. The deteriorated concrete is removed as for a shallow repair, but the top reinforcing mat is completely exposed (by removing I inch of concrete below the top rebars) (Figure 3.2). Subsequently, these bars are thoroughly cleaned by sandblasting or hydrodemolition, and if there is section loss supplemental bars are added. Then the repair material is applied. Where large quantities are indicated, usually conventional concrete is used. After the concrete substrate is cleaned with high-pressure water or air jet, an epoxy bonding coat is applied to the surfaces, the reinforcing mat, and the bottom of the rebars. Before the coat hardens the concrete is placed, screeded, and cured. If a quick-set- ting mortar is used the epoxy bonding coat is normally applied only to the reinforcing bars, since the mortar has a good bond and will adhere to the concrete substrate.

In deep repairs, it is not prudent to place the repair material simultaneously with the overlay. If latex-modified concrete is used, the variation in the depth of repair would probably cause shrinkage cracks around the periphery. If low-slump dense concrete is used, it would be difficult to coat the concrete and rebar surfaces just prior to the placement of the overlay.

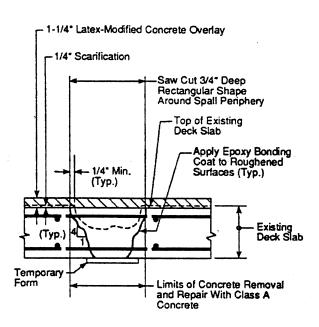
Figure 3.3 Total-depth repair of deck slab (Brinckerhoff, 1992)

below the bridge are protected from falling debris by proper shielding. After the concrete is removed, forms for the bottom surface of the deck slab are installed and suspended from above (Figure 3.3). The procedures then followed are the same as for deep repairs. When concrete has hardened, the wires supporting the forms are cut, and the forms are removed.

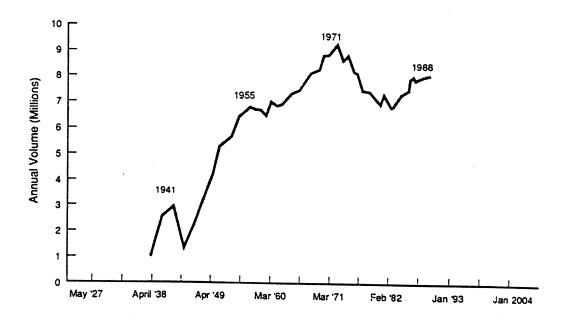
Since decks in need of replacement are usually more than 20 years old, it is likely that the live-load criteria for the structure have changed since it was originally designed. One of the first elements to be investigated should be the current traffic conditions, and magnitude of loads as well as number of vehicles compared to those used in the original design. In addition, future live-load requirements should be evaluated, since the expected service life of the rehabilitated structure will allow it to function over an extended period. Historic traffic data, such as shown in Figure 3.4, can be of assistance in predicting future traffic demands. Toll facilities, such as the Marine Parkway Bridge usually have excellent records of patronage, which can be used to assess actual historical and potential future live loads, to determine the remaining fatigue life. In the absence of such records, a reasonable estimate must be developed through discussions with maintenance personnel or other parties familiar with the structure and its history as well as its possible future use.

Figure 3.4 Traffic history at the Marine Parkway Bridge (New York City).

For the deck replacement study of the Marine Parkway Bridge, mentioned earlier, the known information was the ADTT, which was 140 trucks per day, and the DL, which was 54 years, or 19,710 days. The resulting number of stress cycles to date was computed and found to be approximately 500,000 for the transverse floorbeams, which were considered to be the most critical elements for the structure. Future ADTT was estimated at 370 trucks per day, and an HS25 live loading was used for the future live load stress levels. The number of cycles to date was then substituted in Miner's equation, along with the allowable cycles at the historical HS20 stress levels (12 ksi) and the allowable

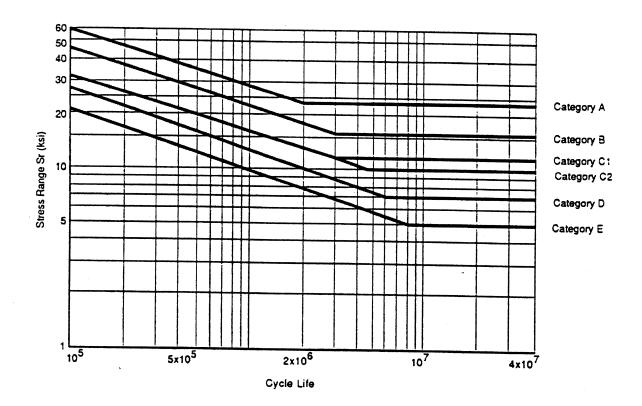
Figure 3.5 Number of cycles vs. stress range (AASHTO, 1974)

N_1 = the allowable number of cycles at the historical stress range (Figure 3.5)

N_2 = the allowable number of cycles at the future stress range (Figure 3.5)

number of cycles at the proposed future HS25 stress levels (15 ksi) evaluated from Figure 3.5, resulting in a remaining fatigue life of 12 years. This conclusion implied that the floorbeams would need additional strengthening, if they were to be incorporated into the final structure and utilized at the HS25 live-load levels.

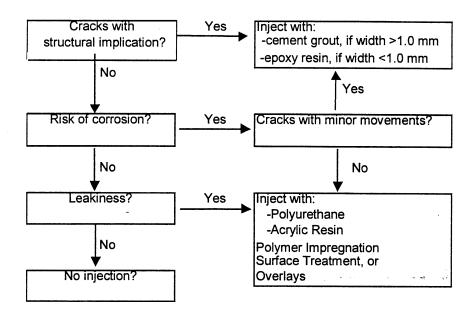
ii) A Flow Chart for Decision-Making on Crack-Repair (Raina, 1996)

Dormant cracks (dead cracks), in excess of about 0.30 to 0.4 mm width, must be cleaned and then filled and sealed, by epoxy-injection for widths up to about one mm, and by fine cement grout for wider cracks. (Normal cement grout is easily possible for widths beyond 3 mm.) Live cracks (active cracks) must be periodically monitored for propagation and width-increase. Where their width exceeds about 0.3 to 0.4 mm, a 'chase' (V-groove) should be made along the crack, the groove and the cracks cleaned by a dry air-jet, and then filled to part of its depth by a flexible filler material (mastic, thermoplastic, etc.) to prevent ingress of moisture and other deleterious materials. After the crack has become dormant, the filler material can be removed and the crack cleaned and filled with a rigid (epoxy) filler. The chase can then be plastered with cement paste using a non-shrink additive.

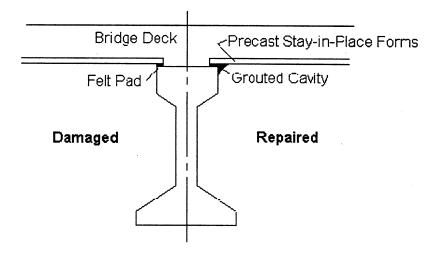
Figure 3.10 Griffin Road repair, Florida

This repair has been in place for 10 years and has exhibited satisfactory performance. A visual inspection of bridge performed on 4/7/98 found the repair in good condition. In fact, the existence of the repair is barely discernible from the original construction. Figures 3.10 and 3.11 show the repaired area under the deck.

pads were not removed, and deteriorated over time. This caused the stay-inplace forms to rotate and the deck to crack. To remedy this situation, the gap left by the deterioration of the felt pads was cleaned thoroughly and the remaining cavity pressure grouted as shown in Figure 3.1. This type of repair was done on several bridges in this area that used the same deck construction technique.

Pressure grouting the cavity in this case was an effective way to remedy a poorly constructed bridge feature. District 4 of the Florida Department of Transportation performed this repair and stated that in order for this repair to be effective, it is imperative that the area to be grouted be cleaned thoroughly. Also, all of the voids have to be filled during grouting process.

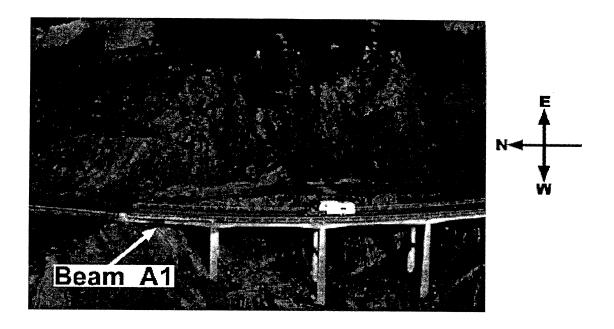
Figure 3.13 Old Point Viaduct (Covino et al, 1999)

The bridge had a T-beam structure with 5 spans and a total length of 114 m (374-ft) and a deck width of 10.6 m (34.8 ft). The beam investigated is marked in Figure 3.13 as beam A1. The north end of beam A1 rested on abutment No. 1 while the south end rested on bent No. 1. Beam A1 was at the extreme west edge of the viaduct and thus was exposed to the full impact of weather from the ocean.

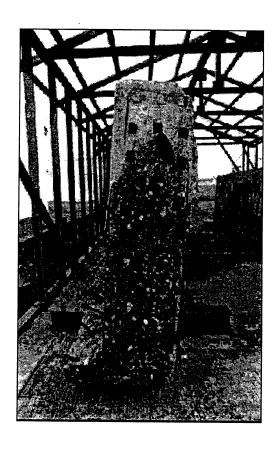
Figure 3.15 shows the beam cross section and the patch concrete is seen at the top of the photo surrounding the large square rebar. Patch concrete was applied during 1969, repair operation after removing the original concrete from around the rebar. The remaining concrete in the beam is original concrete installed in the 1955 construction and differentiated from the patch concrete for the purposes of this photograph by wetting the concrete surface.

Figure 3.15 Cross-section of beam A1 showing the location of the reinforcing steel, the patch and the original concrete

Chloride contamination of the Rocky Point Viaduct appears to be responsible for its failure. The use of coatings on the rebar after the repair in 1969 did not decrease the corrosion susceptibility of the rebar. The use of poor patch concrete in 1969 accelerated the failure of the Rocky Point Viaduct. The patch concrete was more porous and thus more susceptible to penetration of chlorides. More chlorides entered the patch concrete in 25 years than entered the original concrete in 40 years.

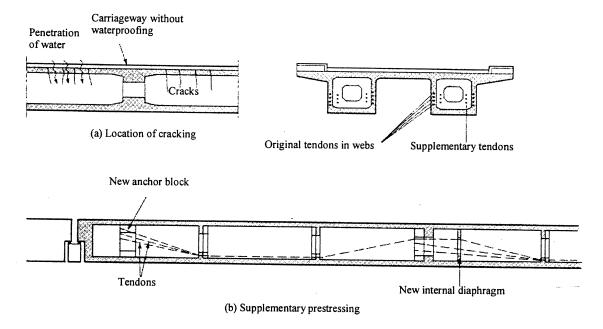
Figure 3.17 Pancevo Bridge

A further detailed inspection and analysis of the structural complex revealed cracking as shown in Figure 3.17(a). The rehabilitation included the carefully controlled pressure injection of cracks wider than 1 mm with low viscosity epoxy resin and supplementary prestressing, which ranged from 60 to 90% of the originally designed prestressing force according to the capacity of the section. A

typical arrangement of the supplementary prestressing is shown in Figure 3.12(b). Additional anchorage and deflectors, to provide for further 25% of additional tendons were provided to meet any future requirements. Traffic was completely stopped, while the crack injection work was in progress but, otherwise, traffic was maintained on one side of the bridge. Two of the structures needed temporary supports.

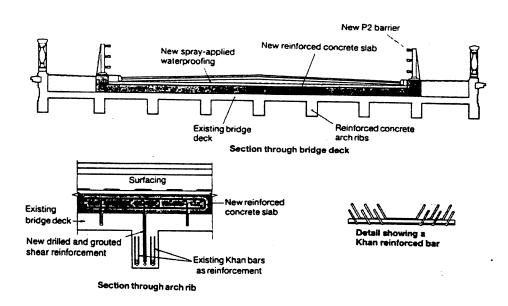
Figure 3.18 Woodbridge, Guildford

This 21 m span reinforced concrete arch bridge was designed and constructed in 1912. It was treated extensively with sprayed concrete in the early 1960's. In 1988 a thorough investigation included a principal inspection, extensive testing and assessment of load capacity. Numerous areas of spalled concrete were found throughout the deck, due mainly to inadequate cover. There was no evidence of chloride attack and the strengthening work included casting a new reinforced concrete slab on top of the existing deck as shown in Figure 3.18.

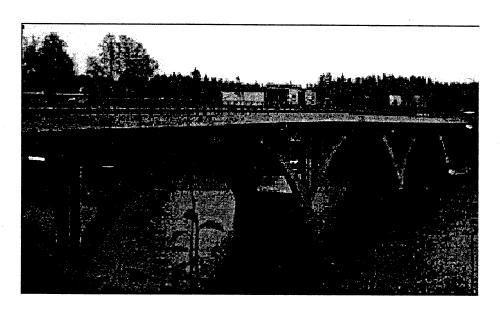
Figure 3.19 Overboda Bridge prior to the repair in 1986

place mainly in the cement paste below the large aggregates and reinforcing steel, and in the aggregate in the old concrete. Moreover, the freeze-thaw resistance of the overlay was tested, and the tests showed that a steel fiber reinforced concrete (SFRC) had very good freeze-thaw resistance after 56 and 112 freeze-thaw cycles. The repaired deck is shown in Figures 3.19 and 3.20.

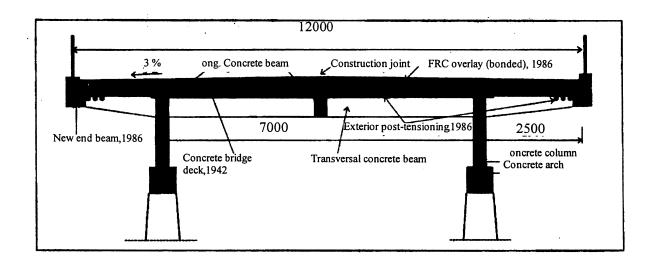
Figure 3.20 Cross-section of Overboda Bridge after repair in 1986

In 1995, the overall impression from Overboda Bridge was that the overlay had performed very well. The compressive strength has not degenerated. No contamination was found at the interface in any cores. Bond testing indicated a good bond between the overlay and the existing concrete. The failure took

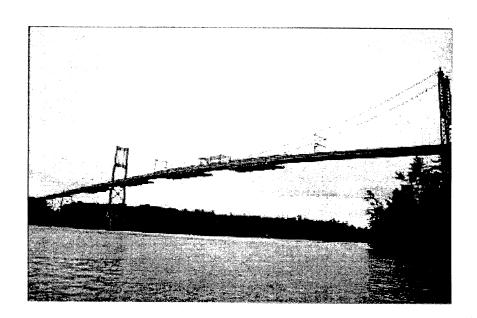
Completed in the 1930's, the landmark Thousand Island Bridge system spans the St. Lawrence River from Ivy Lea in Ontario to Collins Landing in New York (Figure 3.21). The region has been a major summer vacation area of northern New York State and eastern Ontario. The bridge system was built not as a tourist attraction, but as a crossing for traffic over the St. Lawrence River. It provides a direct link between Highway 401, a major expressway from Windsor, Ontario to Quebec City, Quebec, and Interstate I-81 in New York State. At the time of its opening, the annual number of vehicle crossings was approximately 150,000. By 1995, that number exceeded 2 million. A daily traffic of 1000 trucks and 4000 passenger cars cross the Thousand Island Bridge. The peak traffic demand during the summer period can be as great as three times that of the winter.

Figure 3.21 Suspension spans with work platforms and portal frame gantry (Pickle, 1999)

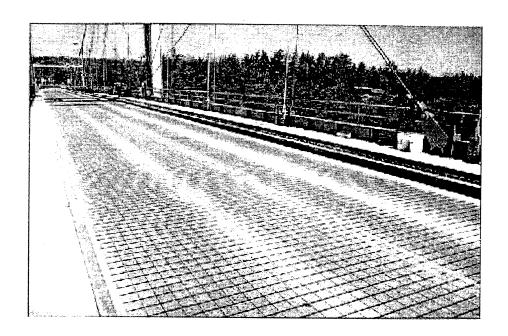
The original deck on the Thousand Islands Bridge was a system of steel grid panels with the grid cells filled with concrete. The main bars of the grid panels were aligned to transfer loads to the first level of support of the substructure. On the suspension spans and Warren-truss spans, longitudinal stringers provided the support and on the viaduct and arch spans the deck panels were supported on lateral crossbeams. The cells of the grid panels were filled with concrete to minimize ice accretion in the winter.

Figure 3.22 Original deck surface condition on the suspension spans (Pickle, 1999)

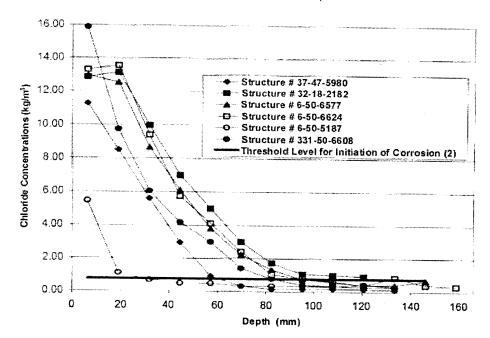
The chloride concentration profiles in Figure 3.23 show that the average chloride level at the depth of the top mat of reinforcement was the highest of all six bridges surveyed and in excess of the estimated level required for initiation of corrosion. The field investigations found 71% of the surveyed bridge deck area to be exhibiting signs of corrosion distress. The majority of the area of distress was found in the first two spans. The bridge deck also had extensive cracking and asphalt patching over the majority of the deck surface. The half-cell potential readings suggested corrosion activity in two bands. Delaminations were also found in these areas. Half-cell potential readings could not be taken in areas of patching due to the interference of the asphalt patching material. Two of the three 102 mm (4 in.) cores taken through the reinforcement confirmed corrosion of both the transverse and longitudinal reinforcement.

Chloride Concentrations vs. Depth

Figure 3.23 Chloride concentration profiles (Samples, et al 2000)

discovered through the cores removed from the bridge deck that no overlay was present. Therefore, this bridge deck provides a duplicate in the category of epoxy-coated reinforcement with Class C concrete. Table 3.3 provides some of the results of the detailed survey. Figure 3.23 shows the results from the chloride analysis. The discussions of each bridge deck are presented in the following:

The bridge deck has epoxy-coated reinforcement and a design cover of 63.5 mm (2.5 in.) of Class C concrete. The concrete cover survey found an average cover of 54.61 mm (2.15 in.) with a standard deviation of 8.9 mm (0.35 in.), which is lower than the design requirements. The chloride concentration profiles in Figure 3.23 show that the average chloride level at the depth of the top mat of reinforcement exceeds the estimated threshold level for initiation of corrosion.

in.) of Class C concrete. The concrete cover survey found an average cover of 55.63 mm (2.19 in.) with a standard deviation of 7.4 mm (0.29 in.), which is lower than the design requirements. The chloride concentration profiles in Figure 3.23 show that the average chloride level at the depth of the top mat of reinforcement exceeds the estimated threshold level for initiation of corrosion. The visual field investigations found no evidence of corrosion distress; however, one of the 102 mm (4 in.) cores taken through the reinforcement at a cracked location showed signs of corrosion. Rust stains were evident at the rib locations of the reinforcement.

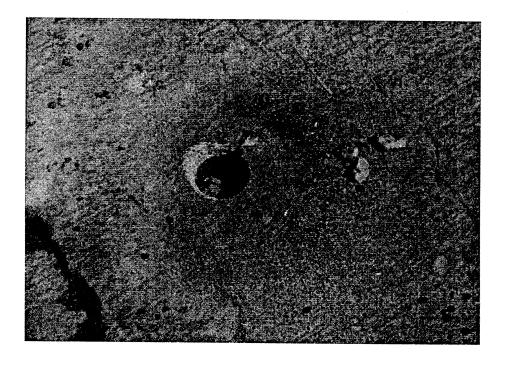
Figure 3.24 shows the core taken in an area of delamination. The delamination was severe in this area of the bridge deck and the hollow area underneath is evident in the picture. Corrosion damage was also observed on the prestressed concrete I-beams of the substructure.

Figure 3.24 Delamination present in the bridge deck (structure # 32-18-2182) [Samples, et al 2000]

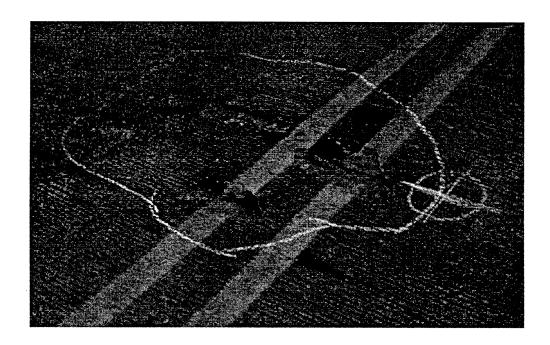
Figure 3.25 Delaminated area with spalls and exposed reinforcement (structure # 6-50-6624)

The field investigations found only 0.7% of the bridge deck exhibiting signs of corrosion distress. This area of distress was localized to one region of the bridge deck. A close up of the area of distress with reinforcement exposed is shown in Figure 3.25. The rest of the bridge deck surface showed no signs of corrosion distress. The epoxy coating was removed from the bar in this area and extensive corrosion was evident. The field investigation found this region of

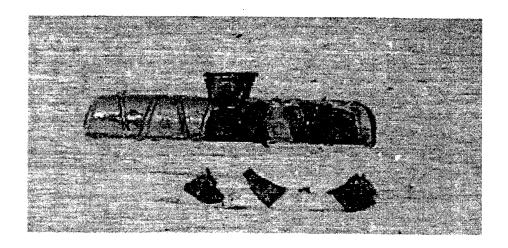
Figure 3.27 shows the reinforcement removed from the cracked region. The coating was cracked with evidence of corrosion. Also, the coating was easy to remove and underfilm corrosion was observed (Figure 3.28). No other signs of corrosion were found on any of the other removed bars. The coating of these bars was well-adhered and difficult to remove. The average epoxy-coating thickness found on the bars removed from the cores was 204.2 μ m (8.04 mils) with a standard deviation of 15.5 μ m (0.61 mils).

Figure 3.28 Underfilm corrosion found after removing coating (Structure # 331-50-6608)

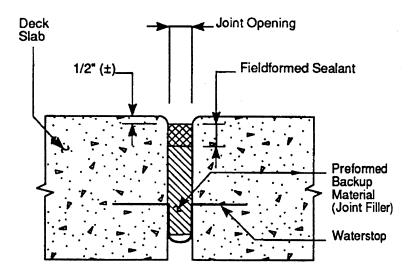
Fieldformed (Figure 3.30) joint sealers are commonly composed of hot applied thermoplastics or chemically cured thermosetting sealants. Application of a fieldformed joint sealer requires a preformed backup material and waterstop beneath it to control the sealer depth and shape, and at the same time provide support to the sealer. The fieldformed sealers usually have limited service life because of poor installation conditions and workmanship that are often encountered in the field.

Figure 3.30 Filled joint with fieldformed sealant (Parsons, 1992)

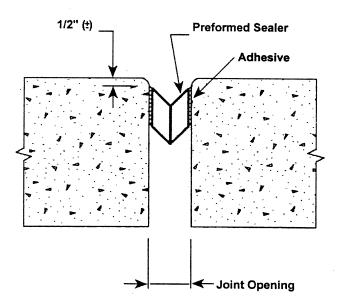
Preformed sealers (Figure 3.31) are somewhat newer and hence have a shorter record of proven service than field-formed sealers. An important advantage they

offer is quick installation time and less interruption to traffic. Most commonly used types of preformed joint sealers for deck joint rehabilitation projects are extruded shapes made of elastomeric material. To install them, the contact surfaces between the sealer and the joint opening are cleaned and primed with adhesive. The preformed sealer is then inserted into the gap. With this type of joint, the installation is achieved without compression (unlike compression seals), but a firm contact between the joint filler and the sides of the joint is maintained during the curing process by inflating the joint sealer under air pressure.

Figure 3.31 Filled joint with preformed sealer (Parsons, 1992)

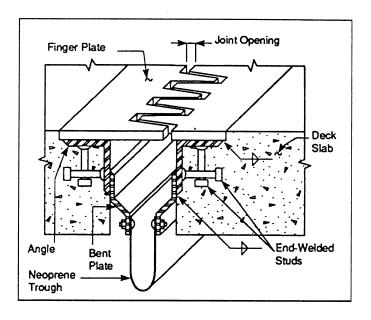
Finger plate joints (Figure 3.33) are made up of two loosely interlocking pieces of steel plates that cantilever into the deck joint opening. The cantilevered portion of each plate is made up of rows of finger-shaped protrusions that fit into the rows of grooves in the opposing plate. The finger plates are anchored into the deck slab or directly attached to the underlying superstructure steel.

Figure 3.33 Finger plate joint (Parsons, 1992)

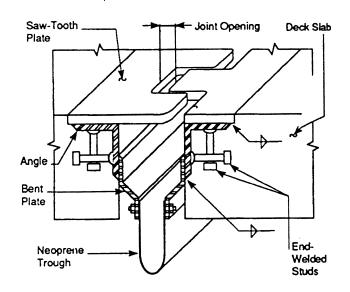
Another frequently encountered joint type in existing medium span bridges is the sawtooth plate joint. This type of joint is made up of two steel plates cut in a serrated fashion (Figure 3.34). The projections in one plate fit into the recesses of the other plate. The construction and function of this type deck joint are very similar to those of the finger plate joint. The only difference is the size of the projections (they are shorter length and wider in width) in comparison with those of the finger joints.

Figure 3.34 Sawtooth plate joint (Parsons, 1992)

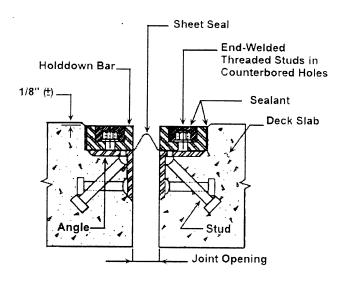
Sheet seal (Figure 3.37) is a sheet of fiber reinforced elastomeric membrane with a center corrugation that links a deck opening. At both ends, the seal is held down and anchored into the corners of deck slabs by means of metal, elastomeric or combination hold-down bar (retainer bars), and anchor bolts. Similar to the strip seal, the sheet seal functions either in tension or compression, and the deformation of the center corrugation accommodates the deck slab movements. Sheet seals represent one of the possible choices for deck joint replacements in existing medium span bridges, and are available in a variety of shapes, configurations and sizes. A maximum of 4 inches (102 mm) of total movement is easily obtainable in a sheet seal. Spalled deck slab corners along the length of the existing joint are repaired following the procedure Damaged hold-down bars and anchorages are described for open joints. removed for replacement and the debris accumulation cleaned from the seal (Figure 3.37). These elastomeric seals can accommodate changes and skews in joint configuration, but depend on close contact and may loosen under repeated live loads.

Figure 3.37 Sheet seal joint (Parsons, 1992)

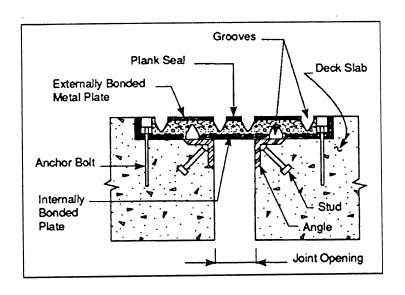
Plank seals (Figure 3.38) are molded neoprene sections of varying widths. The seal spans the deck opening and is bolted down to the deck slab at each end. Although the performance record of plank seals has not been as satisfactory to those of compression or strip seals, they continue to be an alternative for the replacement of existing joints in medium and long span bridges.

A typical cross section displays a number of grooves placed alternately on each face of the neoprene plank, and metal plates spanning between the grooves. These metal plates are internally or externally bonded to the seal, and reinforce the seal against vertical deformation under live load. Additionally, the checkered metal plates that are placed on the roadway face of the seal improve the skid resistance and protect the seal against snowplow damage, or simple wear and tear. A plank seal accommodates the deck slab movements by the closing and opening motions of the grooves in the plank surface. This type of joint system, depending on the width of the plank and the number of grooves, can allow total movements ranging from 1.5 inches to 13 inches (38 to 430 mm).

Figure 3.38 Plank seal joint (Parsons, 1992)

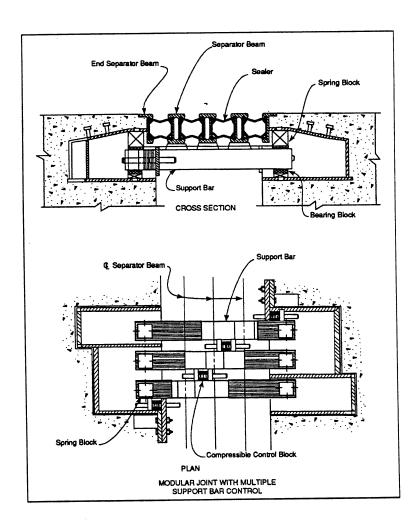
bars at set intervals. Each support location may have multiple or single support bars. A multiple system provides an individual support bar to each separator beam and introduces compressible blocks between these support bars to equalize the distances between separator beams (multiple support bar control type, Figure 3.39). Alternately each location may provide only a single support bar for all separator beams, with a system of intermediate short support bars and compressible blocks placed under the separator beams to maintain equal spacing between separator beams (single support bar control type, Figure 3.40) (Koster, 1989). In general, the multiple support type gives greater redundancy in case of failure of a bar and can better accommodate rotations and differential settlements than the single support type.

Figure 3.39 Modular joint with multiple support bar control (Parsons, 1992)

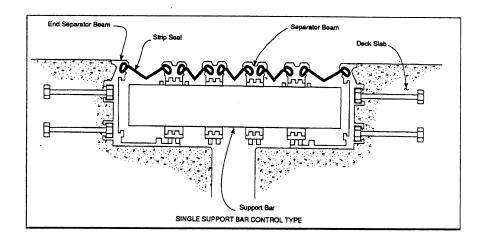
Figure 3.40 Modular joint with single support bar control (Parsons, 1992)

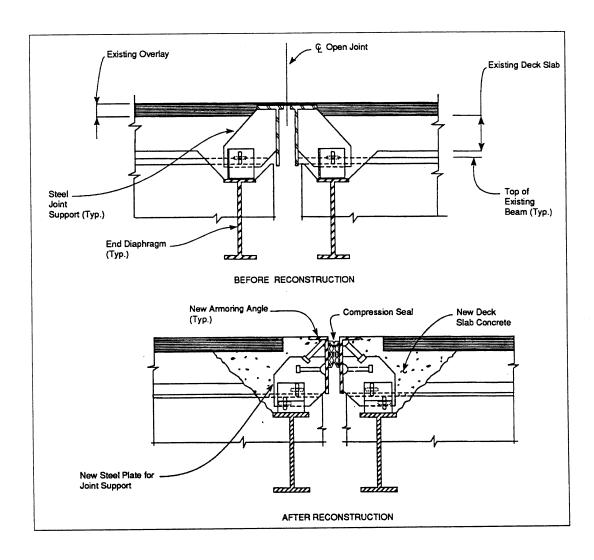
The three-span Garden State Parkway Bridge is located in New Jersey, over local creeks. The existing obsolete armored open joints are to be replaced with more watertight joints-armored compression seals. Although the existing open deck joints were paved to achieve watertight joints during an earlier deck overlay work, cracking and deterioration in the overlay allowed the joints to continue to leak and promote deterioration at the pier ends of the steel girders and bearings. The planned joint replacement process involves removing the existing overlay and the portions of deck slab over the end diaphragms, then installing a new joint assembly, consisting of compression seal and armoring angles, and connecting it to the existing end diaphragms using new steel plates and shapes. Finally, placing the concrete around the joint assembly completes the slab

and joint reconstruction. The resulting joint gives superior water tightness with minimum slab removal. (Figure 3.41)

Figure 3.41 Replacement of open joint by armored compression seal for joints on the Golden State Parkway Bridge (Parsons, 1992)

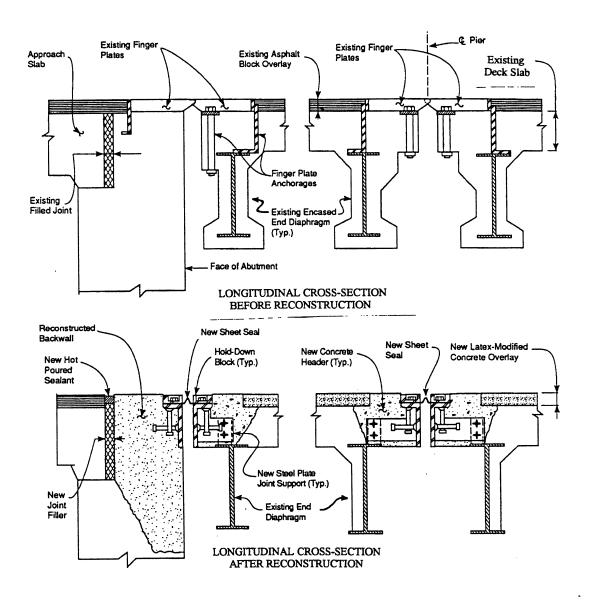
substructure deterioration and improve joint performance, the existing finger plate joints at the abutments and piers were replaced by sheet seals with steel hold-down blocks. First, portions of deck slab above the end diaphragms were removed, including the reinforced concrete encasement around the end diaphragms. The new joint substrate was formed by installing steel angles and placing concrete around them. Then the sheet seals were installed and joint restoration completed. In line with these replacements, the filled joint between the abutment backwall and approach slab was removed and replaced (Figure 3.42).

Figure 3.42 Replacement of finger plate joints by sheet seals on route 71 Bridge (Parsons, 1992)

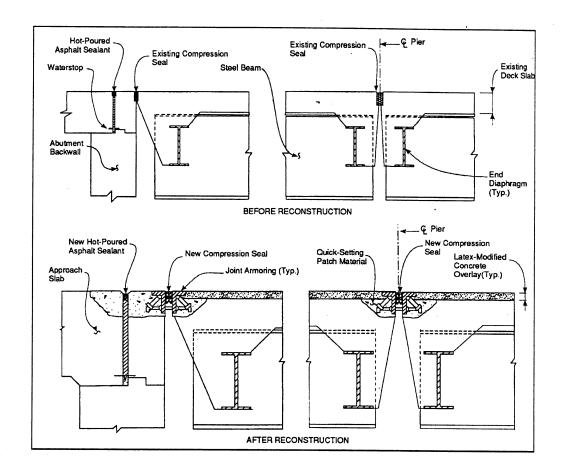
The bridge is located over route 80 in northern New Jersey's Morris County. All deck joints on this 400-foot long four-span bridge were of compression seal joint type. After 20 years of service, these seals were aged, brittle, and leaking. This was caused by spalling of the deck slab edge and loss of elasticity and debonding of the seal. Joint replacement was performed concurrently with deck rehabilitation and overlay. After removal of the existing compression seals and the surrounding portions of the deck slab, new compression seals with armoring angles were installed at elevations even with the new deck overlay. The deck slab around the new deck joint was repaired with quick setting patch material before placement of the new deck overlay (Figure 3.43).

Figure 3.43 Replacement of compression seals in kind on Cherry Hill and Littleton Road Bridge (Parsons, 1992)

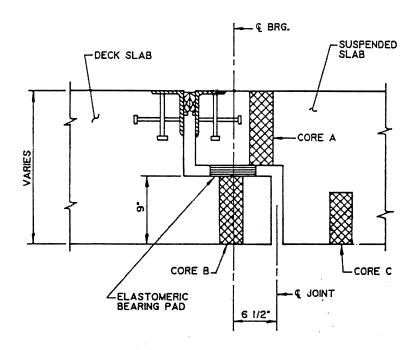
deck slab. Cores taken near the expansion joints (Figure 3.46) were visually examined and tested for compressive strength. A total of 15 cores were taken from various locations throughout the bridge.

Figure 3.46 Core location sections (Vaysburd, 1989)

The bottom portions of the cores (inside the joint) contained deteriorated concrete from 1/2 in. (12.5 mm) to 3 in. (76 mm) thick. Some of the cores contained delaminations and cracks, and the reinforcements in two cores had corroded to the extent that the bond between concrete and steel was severely affected. Average compressive strength of the two cores tested was 7590 psi (52 Mpa).

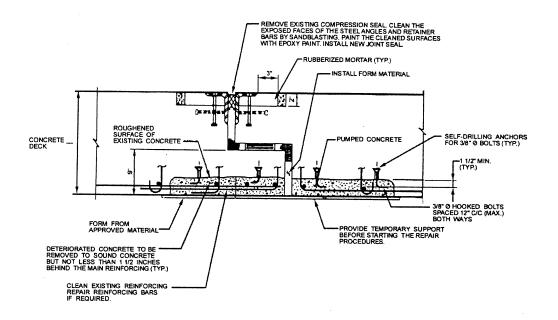
Pumped concrete was selected as the repair material, since the most important factor in selecting methods and materials for repair is the compatibility of existing concrete and the new materials. Prior to the repair operation, temporary supports for the suspended slabs were installed. The concrete surface was prepared by removing the deteriorated concrete to sound concrete, but not less than to a depth of 1 ½ in. (3.8 cm) behind the main reinforcement. At several locations, the depth of deteriorated concrete was about 4-1/2 in. (11.5 cm) into the cantilever support of a suspended slab and the cantilever support was completely replaced with new concrete. The chipping was done using hammers with a maximum weight of 30 lb (14 kg). Specifications recommended removing concrete until the coarse aggregate particles were being broken rather than simply removed from the cement matrix. The concrete surface and exposed reinforcing steel were then sandblasted and finally cleaned of loose material with compressed air. An anchoring system was installed using self-drilling anchors for 3/8-in. diameter hooked bolts spaced in a 12 x 12 in. (30.5 x 30.5 cm) grid (Figure 3.36). Just prior to pumping the repair concrete, the existing surface was dampened with water. The pumped concrete was an air-entrained portland cement concrete mixture with a minimum compressive strength of 5000 psi (31Mpa). Mix proportions for the pumped concrete are given in Table 3.5.

Figure 3.47 Expansion joint repair detail (Vaysburd, 1989)

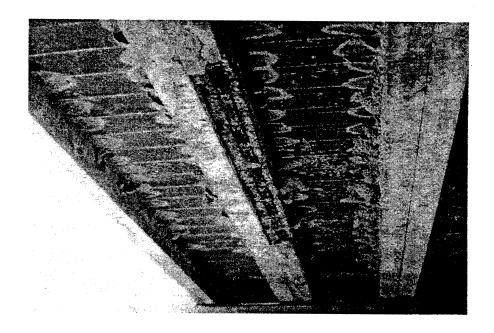
Figure 3.49 Cracking and spalling reduces condition rating poor (White, 1992)

Figures 3.48-3.50 show several examples of concrete beams. The beam shown in Figure 3.48 is in fair condition. Several horizontal cracks are visible, as well as stains indicating that water may be getting to the reinforcement. The cracks or deterioration are not severe enough to lower the safe load capacity, and hence the fair rating. The deterioration, cracks, and spalling are significant in Figure 3.49, resulting in a poor rating. The reinforcement has been exposed to water and air, which will promote rapid rusting. The cracking and reinforcement deterioration would reduce the capacity rating, and call for a poor condition rating. The concrete and reinforcement deterioration is severe for the beam shown in Figure 3.50. The steel reinforcing has large section loss; therefore, the condition of this beam is rated critical and requires immediate attention in terms of temporary repairs, replacement or rehabilitation.

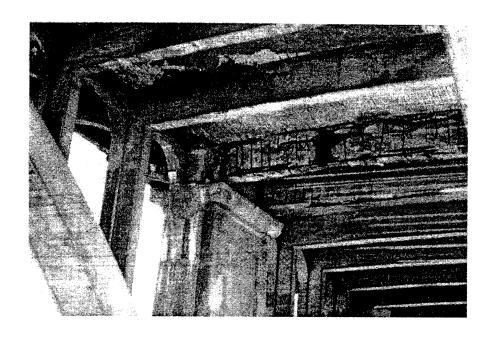
Figure 3.50 Severe cracking, spalling, deteriorating of concrete and loss of steel section give beam a critical rating (White, 1992)

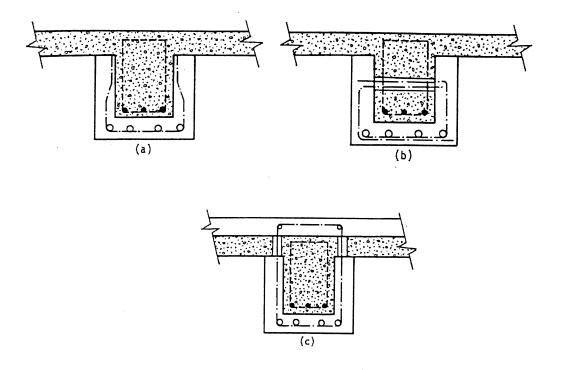
The placement of longitudinal reinforcement in combination with a concrete sleeve or concrete cover is another method for increasing the member's flexural capacity. This method is shown in Figure 3.52(a) and (b) and outlined in an article on strengthening by Westerberg,(1980). Warner (1981) presents a similar

method shown in Figure 3.52(c).

Figure 3.52 Techniques for increasing the flexural capacity of reinforced concrete beams with reinforced concrete sleeves (Klaiber, 1987)

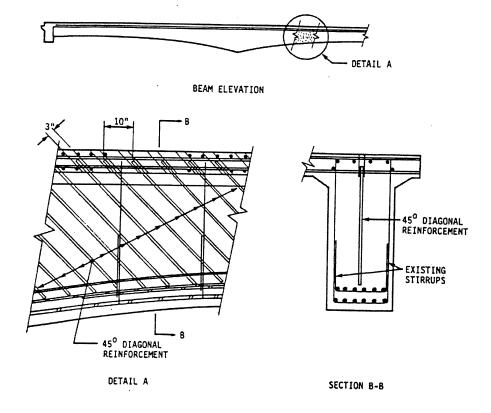
The method involves locating and sealing all of the girder cracks with silicone rubber, marking the girder center line on the deck, locating the transverse deck reinforcement, vacuum drilling 45-deg holes that avoid the deck reinforcement, pumping the holes and cracks full of epoxy, and inserting reinforcing bars into the epoxy-filled holes. A typical detail is shown in Figure 3.53.

Figure 3.53 Kansas DOT shear strengthening procedure (Klaiber, 1987)

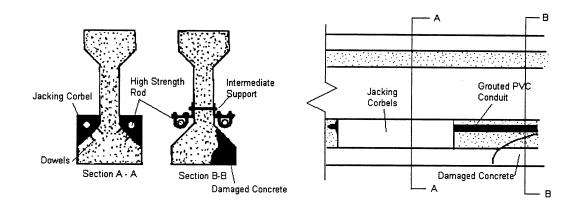
Longitudinal external post tensioning is applied to damaged concrete girders. On either side of the damaged area, in the sound sections of the beam, symmetrical jacking corbels are built and anchored to the bottom flange. Post-tensioning tendons (270 K strands, Grade 160 rod) are passed through the corbels and anchored against bearing plates. After preloading the beam, the

concrete is repaired and allowed to harden; when strong enough, the preloading is removed and the exterior post-tensioning of the beam is applied, simultaneously at both corbels. To protect the bars or strands, they are placed in plastic conduits and pressure grouted.

Figure 3.54 Longitudinal external post tensioning Prestressing Steel and Concrete Repair (Xanthakos, 1995)

Given data: (Figure 3.54)

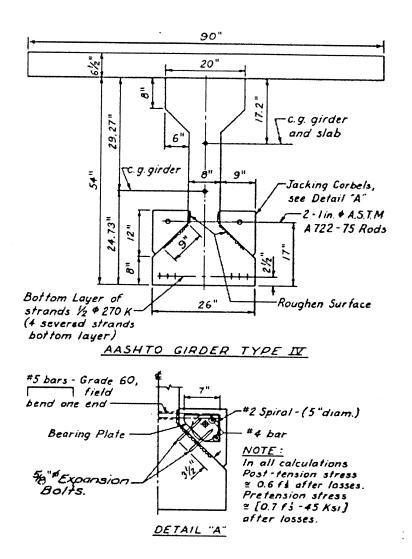
Figure 3.55 Type A splice detail (Xanthakos, 1995)

The splice requires 4-ft long jacking corbels located outside the damaged area. The corbels should be located so that hole can be drilled without interfering with harped or draped strands. The high-strength rods between corbels are protected by one ½ -in inside diameter rigid plastic conduit, which is pressure-grouted after posttensioning. The yield point of A722-75 bars corresponds to a 0.7 percent strain and 0.2 percent offset. The corbel length of 4 ft is determined using a minimum tie spacing of 7.5 in. The posttensioning is applies to the AASHTO beam in the preloaded condition.

The ultimate capacity available at the splice is adequate. The analysis should also consider the adequacy of bearing on the corbel, and the number and size of ties.

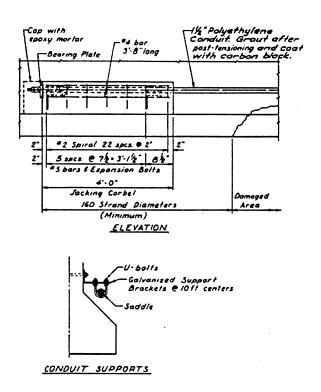
Figure 3.56 Corbel elevation and U bolts for posttensioning splice type A (Xanthakos, 1995)

From Figure 3.56, Detail "A", the area of the bearing plate is 24 in². The factored strength of three strands is

This is an external procedure for splicing a damaged beam as shown in Figure 3.56. It does not normally restore prestress, although preloading may restore partial or full prestress. This splice is often used to restore the beam to its design capacity, when there are many severed strands, or where a large quantity of concrete is missing. The plates are normally galvanized A-36 metals bonded to the concrete beam by injecting an epoxy grout into a 1/16-inch gap between the materials. Construction normally begins by applying the necessary preloading. Then the concrete is repaired. After the concrete has gained sufficient strength, the preloading is removed and the metal sleeve installed. Alternatively, the preloading may be left in place until after the metal sleeve has been placed and grouted. The latter procedure enhances the capacity of the splice by precompressing it under no live load.

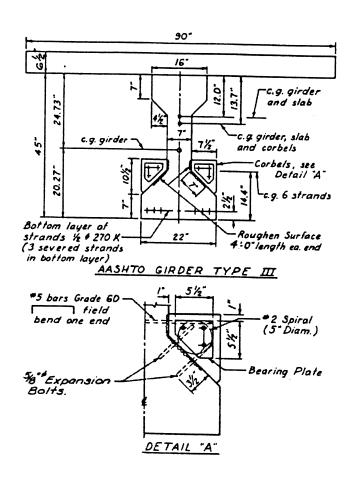
Type B splice details are shown in Figures 3.57 and 3.58. This type involves the use of six posttensioned 1/2-in diameter 270ksi strands to restore the prestress loss by the fracture of three 1/2-in strands in an AASHTO girder Type III. The strands are posttensioned separately and protected from corrosion by a cast-in-place corbel that is continuous for the full splice length (Shanafelt and Horn, 1985). The construction procedure involves four steps:

Figure 3.57 Type B splice detail

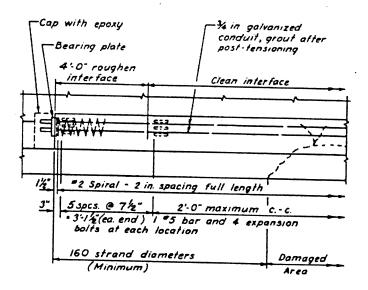
Figure 3.58 Corbel elevation and details for posttensioned splice type B

The equivalent depth a of the compression zone is $a = A_s f_y / (0.85 f_c b)$. Given $f_c = 4000 \text{ lb/in}^2$, and b = 90 in. (Figure 3.58). Assume thirty-four strands, of which ten are severed.

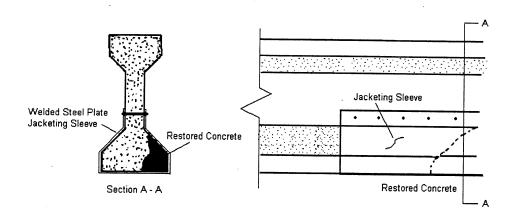
Figure 3.59 Metal sleeve splice

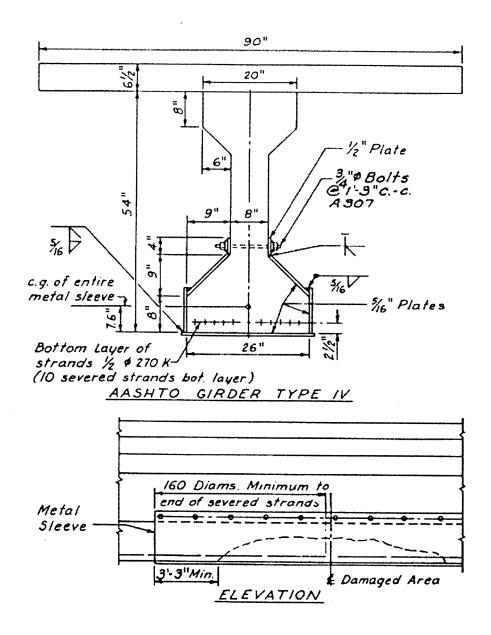
Details for a metal sleeve splice are shown in Figure 3.60. In this example, a metal sleeve is used to splice ten severed ½-in diameter 270ksi strands for an AASHTO girder Type IV. The loss of concrete can also be restored provided that only few strands are damaged. This splice can, therefore, restore strength and durability.

Figure 3.60 Metal sleeve splice

length shown in Figure 3.60 complies with AASHTO specifications and the strand is assumed to be bonded at the ends.

Bonding of the metal sleeve to the beam is provided by pressure injection of epoxy resin. The necessary clearance of 1/6 in. in between the sleeve and the beam is maintained with the use of 1/6 in. thick metal spacers at suitable intervals attached to the sleeve plate. The injection pressure is nominal, and for better bond the concrete interface should be completely clean and free of residual material. A minimum splice metal thickness of 5/16 in is recommended, and if bolts must be raised to avoid draped or harped strands, the top vertical plates and bolts may have to be redesigned. The plate material is galvanized A-36 metal. The inside surfaces of the plates must be scored vertically by wire brushing before assembling. The brushing should, however, be light so that while it scores the surface, it removes relatively little of the zinc coating. Zinc-rich paint should be applied to field welds. In addition, exterior girders should receive one or more coats of "concrete gray" for appearance. The plates may be either precut and welded, or cut in the field and field welded, the choice depending mainly on the accuracy of field measurements.

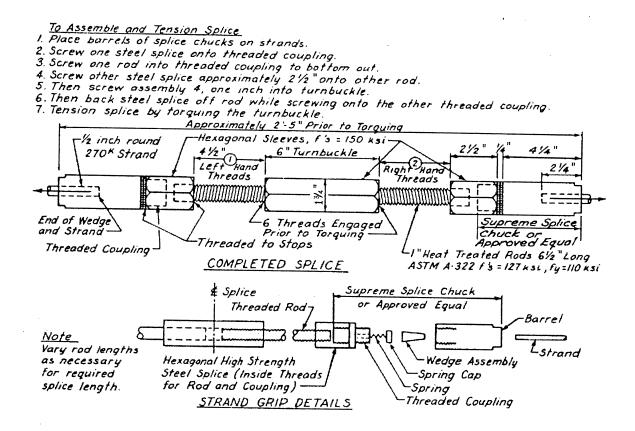
Details for a single-strand splice are shown in Figure 3.61. Several strands in the same girder may be spliced in this manner. This splice restores lost strength internally, and combined with preloading, the procedure ensures that the beam will return to its original condition and capacity. Stressing is possible by applying a torque to the splice until the working strength of adjoining strands is reached. For ½-in diameter 270 ksi strands, this load is approximately 22 kips. The strand grip shown in Figure 3.61 may be used without modification. The transition from strand to rod is made with the use of two additional steel splices.

Figure 3.61 Single-strand internal splice (Xanthakos, 1995)

- i) Determine the preload requirements. Preferably the preload may be applied after the splice is stressed.
- ii) Assemble the splice, locating the splice sleeves and strand grips to allow seating of the strand grips and sufficient thread length in the splice sleeves.
- iii) Apply a torque to the splice sleeve to the working strength of the strand (22 kips). The strand grips should not be allowed to rotate.
- Step (ii) and (iii) are repeated for severed strands in the system.
- iv) Apply reload.
- v) Repair concrete, and after it has attained sufficient strength, remove preload.

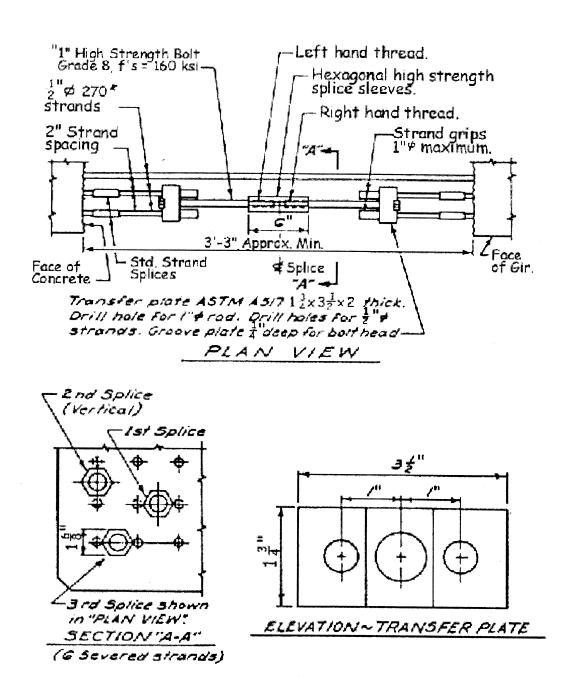
Details for a 2-strand splice are shown in Figure 3.62, and illustrate the use of

one 1-in diameter high-strength bar to splice directly a pair of severed strands (1/2-in diameter, 270ksi). Several pairs of strands may be spliced in one girder, with an upper limit imposed by constructibility and access considerations. As in the previous splice, the procedure restores strength internally, and when combined with preloading, the beam is restored to the original condition. The strand spacing is taken as 2 in vertically and horizontally. The stressing is accomplished as before by applying a torque to the splice sleeve to approximately 44 kips, which is the working strength of two strands.

Figure 3.62 Two - strand internal splice detail

- i) Determine the preload requirements from a stress analysis. Preferably the preload may be applied after the splice is stressed.
- ii) Insert rod or bolt through transfer plates and connect sleeve.
- iii) Insert strands with swage fittings through transfer plates and connect strand splices (see also details in Figure 3.61).
- iv) Apply a torque to the lubricated splice sleeve to 44 kips (the working strength of two strands). The transfer plates should be prevented from rotating. Repeat the foregoing steps for all pairs of severed strands.
- v) Apply preload where necessary.
- vi) Repair the concrete, and after it has gained sufficient strength, remove the preload.

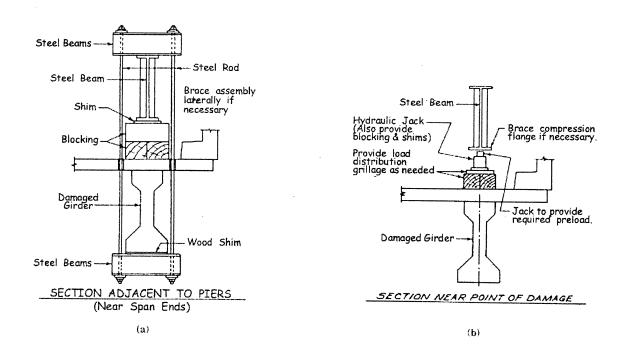
Preload may be applied with a loaded vehicle or by vertical jacking. Procedures for providing preload by vertical jacking are shown in Figure 3.63. This arrangement requires fewer roadways, hence it offers an obvious advantage. If the preload is applied by a single jack, the design should check the temporary

Figure 3.63 Preload by vertical jacking

stresses induced in other bridge elements. In this case, part of the jacking load is transferred through the slab and diaphragm to adjacent girders through the deck stiffness. If this distribution can result in excessive stresses, more than one jack should be used.

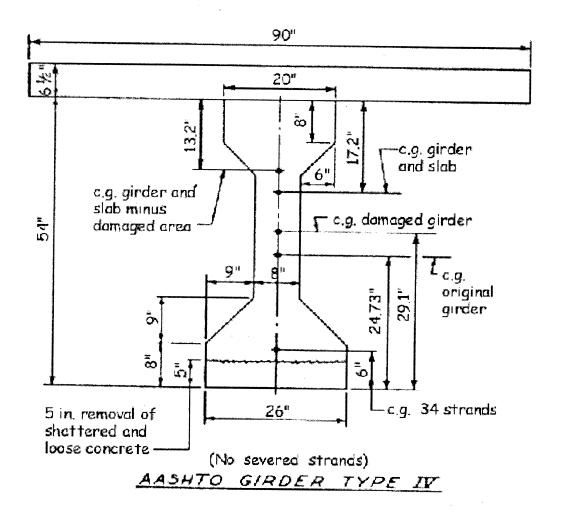
The girder details are shown in Figure 3.64. Design data are as follows: $f'c = 5000 \text{ lb/in}^2 \text{ (girder)}$, $E_c(\text{slab}) = 0.8E_c(\text{girder})$.

Figure 3.64 Girder detail for preload example (i)

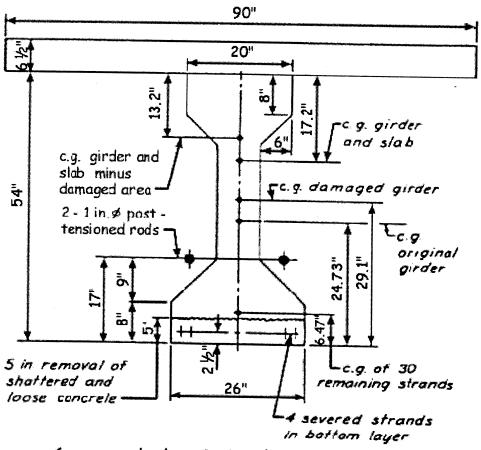
4 severed strands in the bottom layer
Splice No.1 being used.

AASHTO GIRDER TYPE IV

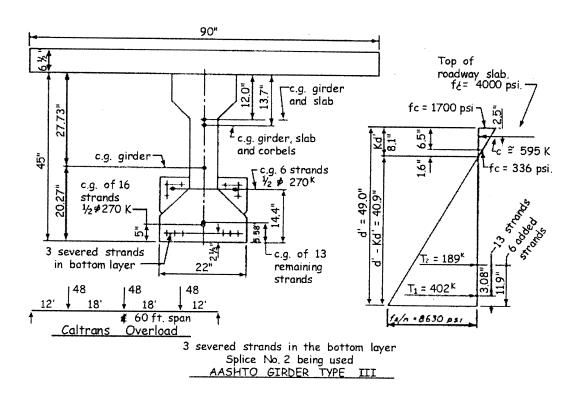
Figure 3.46 shows the overload permitted by the state of California. Bridges are designed for the HS 20 loading and a loading system that has axle weights approximately 1.5 times the HS 20 loading. The overload moments used in this illustration are based on the California criteria, and shown in Figure 3.66. The live load distribution is as per AASHTO standards.

Figure 3.66 Overload capacity example

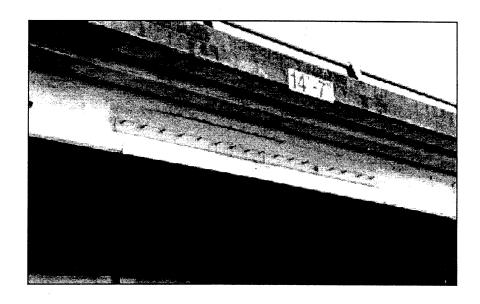
This bridge is located in Boca Raton, Florida and carries north bound Florida Turnpike (SR 91) traffic over Clint Moore Road. This three span prestressed concrete I beam bridge was built in 1963. The bridge was damaged by an over height vehicle and subsequently repaired in 1996. The damage to the girder included concrete section loss and severed prestressing strands. The repair consisted of restoration of the concrete with polymer-modified grout and the placement of a 3/4-inch steel plate sleeve that was bonded to the restored section. This repair has been in place for 2 years with a high Turnpike ADTT. The most recent inspection report (12/97) states that, "The beams with impact spalls have been repaired satisfactorily." A visual inspection performed on the repair on 4/15/98 showed no evidence of deterioration. Figures 3.67 and 3.68 show the metal sleeve repair.

Figure 3.67 Metal sleeve splice repair - Clint Moore Bridge, Florida

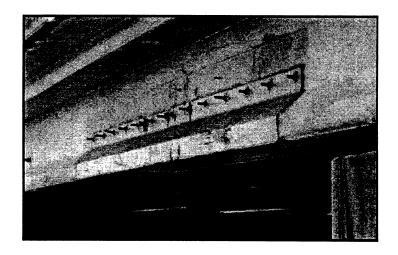
Figure 3.68 Metal sleeve splice repair - Clint Moore Bridge, Florida

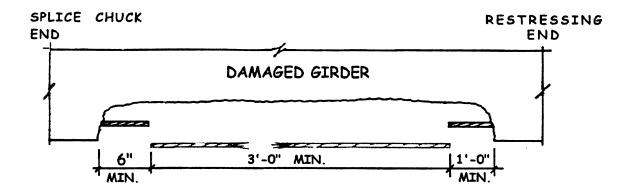
Figure 3.69 Removing a damaged length of strand (Lanyi, 1993)

in Figures 3.69 through 3.72. Applied stress to the new strand is recorded as a measure of its elongation under load. This stressing device does not have any losses due to anchor set. On short stressing lengths, anchor set can preclude the use of normal stressing jacks.

The sequence of prestressing strand splice activities is illustrated in Figures 3.69 to 3.72. Stressing hardware and layout is illustrated in Figure 3.73. Also shown in Figure 3.73 is a typical section through the web of a damaged precast channel girder. This system is unique in that it makes use of standard prestressing strand coupling hardware, which can be easily obtained. The only item requiring fabrication is the splice nut assembly. With this assembly, simply turning the nut into the thread cylinder completes stressing.

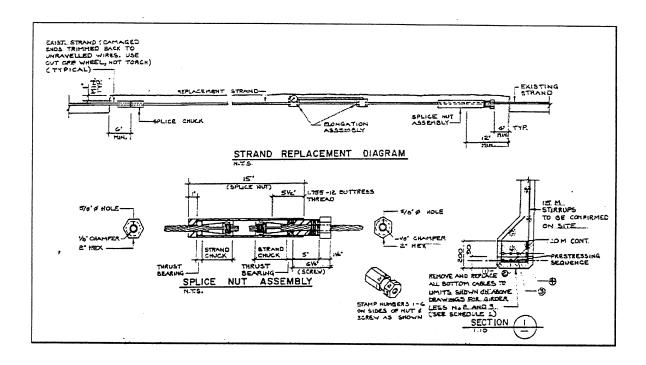
Figure 3.73 Stressing hardware and layout (Lanyi, 1993)

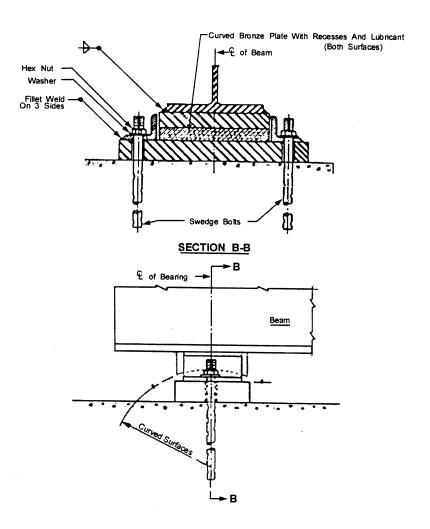
Figure 3.78 Sliding expansion bearing

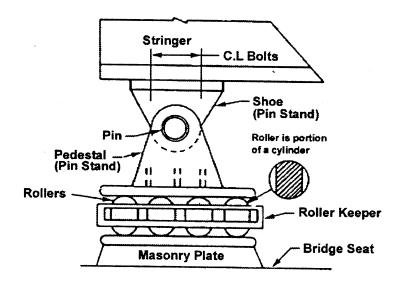
Figure 3.81 Roller expansion bearing

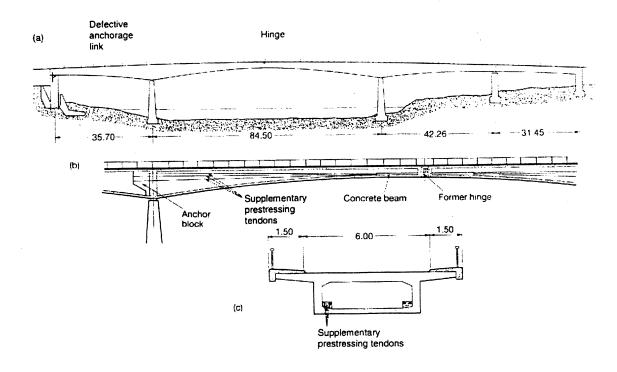
Built in 1963, the bridge has four prestressed concrete spans as shown in Figure 3.82, in which the short northern span was anchored to prevent uplift. At the beginning of the 1980's, the bridge showed two severe defects:

Figure 3.82 Mosel Bridge (Zichner, 1989)

- The deck was lifted to its correct level.
- Bearings were replaced.
- The center hinge joint was closed.
- Supplementary prestressing was installed as shown in Figure 3.83 (b) and (c).
- Defective anchorage was no longer required and hence removed.
- Concrete ballast placed in hollow box in north span.
- Waterproofing, surface finishes, etc. were applied.
