FINAL REPORT

EVALUATION OF CONVENTIONAL REPAIR TECHNIQUES FOR CONCRETE BRIDGES

Center for Infrastructure and Constructed Facilities

December 2000

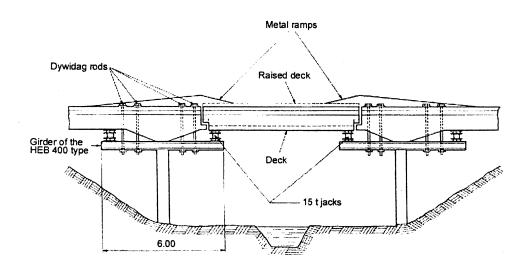
This five span reinforced concrete bridge was built in 1936. Severe deterioration was found at the joints of the central span. Carbonation was 50 to 60 mm deep and about half the cross-sectional area of the reinforcement had been lost by corrosion. Repair involved the removal of poor concrete, adding new reinforcement, placing new concrete cover and renewing the bearings. To avoid lifting from above and obstructing traffic, the suspended span was jacked against temporary steel girders underneath as shown in Figure 3.83.

Figure 3.83 Equipment for lifting suspended span

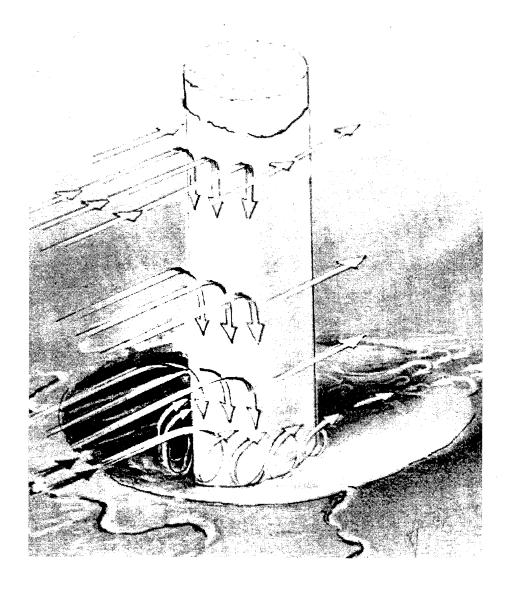
Piers and abutments are obstructions in a stream that reduce the channel cross-section and increase the velocity, thus causing a disturbance of the flow (Figure 4.1). To avert failures caused by currents, the bridge engineer incorporates in the bridge design the following preventive measures:

Figure 4.1 Scour around circular shaft

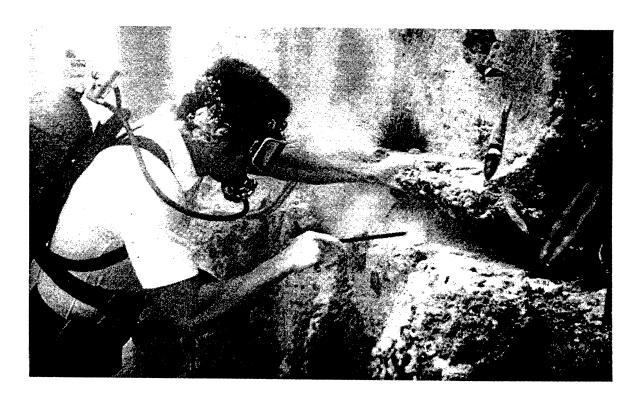
Concrete is used in pier footings, abutment walls, piles, and seals. Below-the-waterline deterioration of concrete is readily identified by the presence of cracks, spalls, and cavities; however, determining the cause of deterioration is rather difficult (Figure 4.2).

Figure 4.2 Concrete deterioration

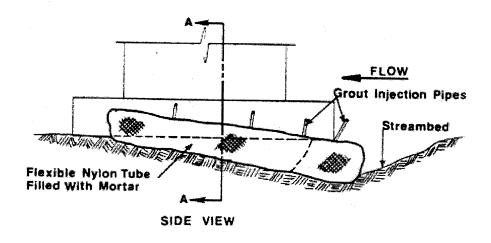
Figure 4.5 Concrete filled tubes

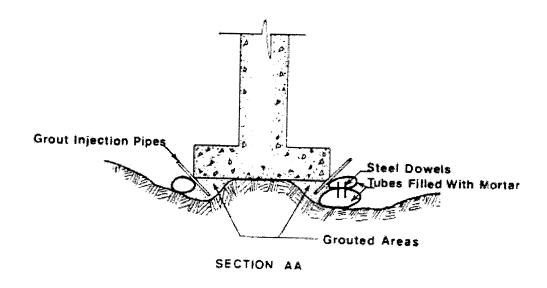
Figure 4.6 Concrete filled tubes (cross section)

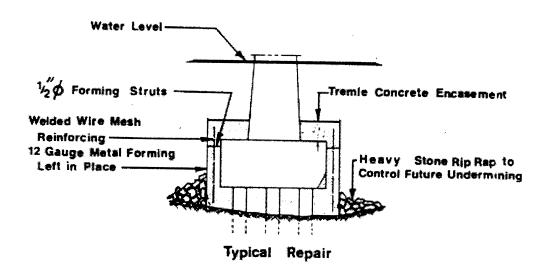
Figure 4.7 Sheet piling scour rehabilitation

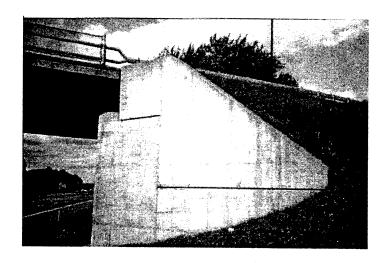
Figure 4.8 Wingwall of a two-span bridge (D.E. Tonias, 1995)

Wingwalls are designed to assist the principal retaining wall component of an abutment in confining the earth behind the abutment. Examples of wingwalls are given in Figures 4.7 - 4.11 The principal retaining wall component mentioned above is usually called the backwall or stem of the abutment. The bridge seat, upon which the superstructure actually rests, is typically composed of either freestanding pedestals or a continuous breastwall. The pedestal or breastwall is designed to support individual primary member and transfer girder reactions to the foundation. They are located just in front of the backwall and sit on top of the abutment footing. In general, the following types give the major types of abutments presently in use.

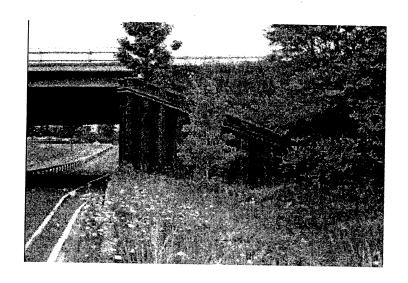
Figure 4.9 Steel sheeting being used as an abutment material (D.E. Tonias, 1995)

An abutment constructed with steel sheet piling shown in Figure 4.8. is also sometimes used in marine environments. When placed in such an environment, steel sheeting is susceptible to deterioration through the presence of high water of varying wet-dry cycles. When placed close to underpass traffic, accidental collision with traffic is another potential problem.

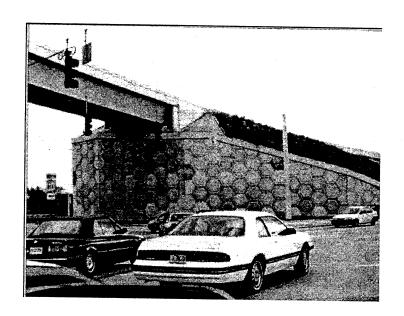
Figure 4.10 Reinforced earth abutment is used to support this composite steel bridge (D.E Tonias, 1995)

strips or mesh are thereby layered in the retained fill, which is compacted. These strips act as reinforcement, transforming the granular soil into a coherent material, which can support both its own weight and that of applied vertical loading. The name, reinforced earth is derived from this effect. A more generic name that is sometimes used is that of Mechanically Stabilized Earth System.

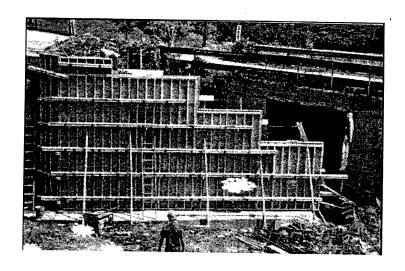
A gravity abutment resists horizontal earth pressure with its own dead weight. By nature, this leads to abutments, which are rather heavy. Gravity abutments are most often constructed using concrete, however, stone masonry is also sometimes used. As described above, a gravity abutment is composed of a backwall and flared wingwalls which rest on top of a footing (Figure 4.12).

Figure 4.12 Typical gravity abutment with wingwalls under construction (Tonias, 1995)

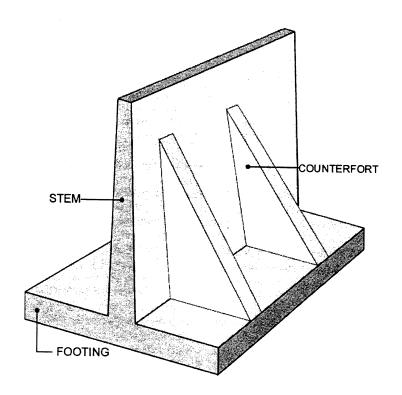
A counterfort abutment, similar to a counterfort retaining wall, utilizes a stem and footing, which is braced with vertical slabs, known as counterforts, which are spaced at intervals along the length of the footing (Figure 4.13). These thin slabs join with the stem and footing at right angles. The counterforts allow the abutment breastwall to be designed as a horizontal beam between the counterforts rather than as a cantilevered stem. Generally, counterfort abutments are used when very high walls are required.

Figure 4.13 Typical counterfort retaining wall (Tonias 1995)

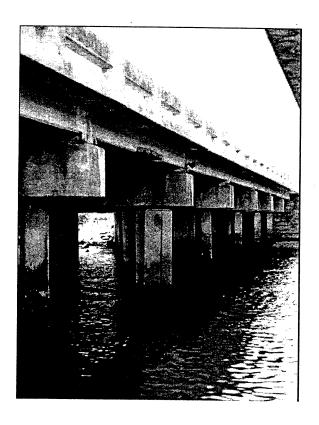
This bridge was built in 1957 by the Union Bridge and Central Florida Construction Company. Barrier walls and new approach guardrails were added in 1988 (Figure 4.14). The bridge was rehabilitated In 1995 to include pile jacketing, crash wall repair, end bent slope repair and expansion joint replacement.

Figure 4.14 Elevation of bridge number 930075 (Jupiter)

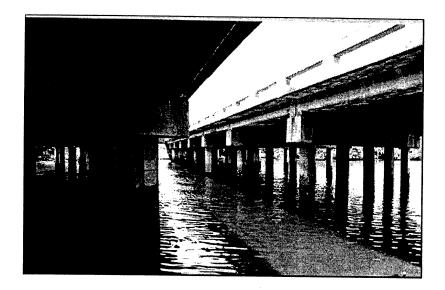
Figure 4.15 Elevation of bridge number 930116 (Jupiter)

This structure was constructed in 1957 by the Union Bridge and Central Florida Construction Company. In 1998 barriers and new approach guardrails were added to the bridge. The bridge was rehabilitated in 1995 to include pile jacketing, crash wall repair, end bent slope repair and expansion joint replacement (Figure 4.15).

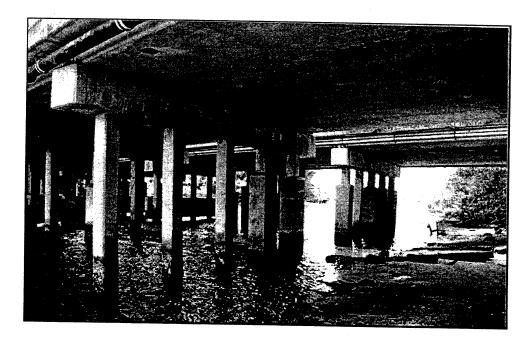
This structure was built in 1957 by Union Bridge and Central Florida Construction Company. Pile repairs were completed in September 1985 including installation of pile jackets (Figure 4.16). In early 1988 barrier walls and new approach guardrails were added together with repair of abutments and joints and addition of new riprap

Figure 4.16 Underside view of bridge number 930087 (Jupiter)

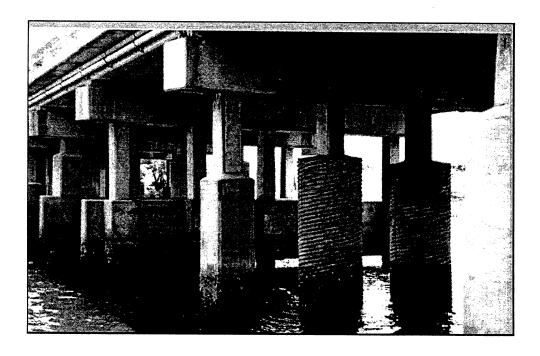
This structure was built in 1957 by the Union Bridge and Central Florida Construction Company. Pile repairs were completed in September 1985 including installation of pile jackets (Figure 4.17). In early 1988 barrier walls and new approach guardrails were added with repairs to abutments and joints and addition of new riprap.

Figure 4.17 View showing the pile jackets of bridge number 930117 (Jupiter)

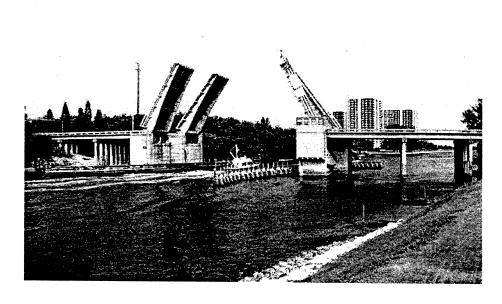
Parker bridge is located on Federal Highway (US1), south of PGA Boulevard, West Palm Beach, Florida. This bridge was constructed in 1956 by Cleary Brothers Construction Company and rehabilitated in 1988. A hydraulic alternate was installed on the moveable portion of the bridge (Figure 4.18).

Figure 4.18 Side view of bridge number 930004 (West Palm Beach)

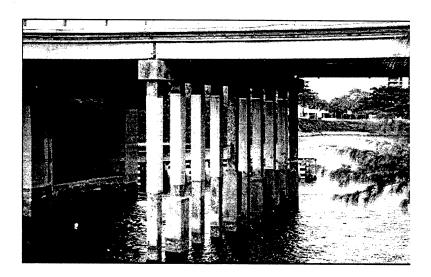
Numerous fiberglass stay-in-place forms were removed and twelve (12) structural pile jackets installed. A special post repair inspection revealed cracks in eleven piles at Bents 3 and 4, where the fiberglass stay-in-place forms had been removed in the splash zone. Apparently the extent of the deterioration at these eleven piles did not warrant the installation of structural pile jackets. Spalling of concrete, exposure of reinforcing bar and horizontal hairline cracks were observed during the inspection. The diver inspection report showed crumbling concrete with exposure of reinforcing steel. Inspection of the structural pile jackets showed the bridge to be in good condition and the existence of the repair was barely noticeable from the original construction. The structural pile jackets has been in place for 7 months and is working very well. A visual inspection of bridge was performed on 4/16/98. The bridge was in good condition, and the existence of the repair was barely discernible from the original construction. (Figure 4.19).

Figure 4.19 Side view of bridge number 930004 (West Palm Beach)

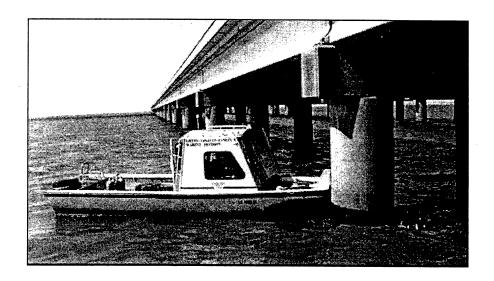
Twin bridges crossing Lake Pantchartrain near New Orleans are each 24 miles in length and are supported on more than 9500 prestressed concrete cylindrical piles (Figure 4.20).

Figure 4.20 Pilings of the 24-mi. long bridges crossing Lake Pontchartrain

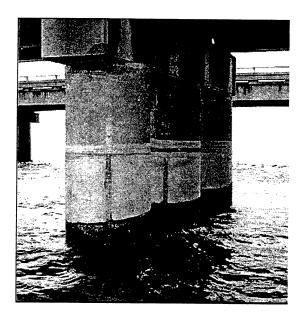
The inspectors had the opportunity for careful examination of approximately 20 A-P-E process installations 8 years old on the causeway. The conclusion was that the encapsulations were as good or better than when they were installed 8 years ago (Figure 4.21).

Figure 4.21 A trio of A-P-E repairs found to be performing well after 8 years in service

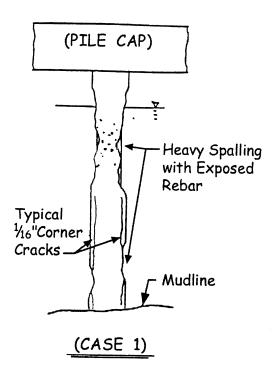
Some older marine structures such as Pier 1 at the Boston Street terminal in Baltimore, are typical examples of pile jacketing failure. At various periods of this structure's history, 299 of the 342 concrete piles supporting the structure were jacketed, using a variety of methods and materials. Following are the different cases from a report of substructure Inspection on Pier 1, that categorizes the various types of pile jacketing deficiencies found during the inspection (Figures 4.22 to 4.27). The report also examined the remaining 43 piles that had no previous jacketing. The condition of the piles shown in Figure 4.22 (case 1)

Figure 4.22 Pile with no previous jacketing

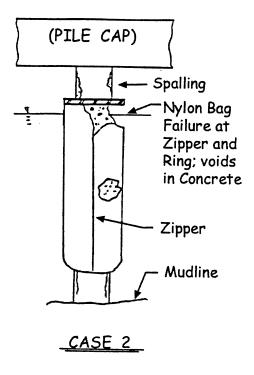
Figure 4.23 Nylon bag failure

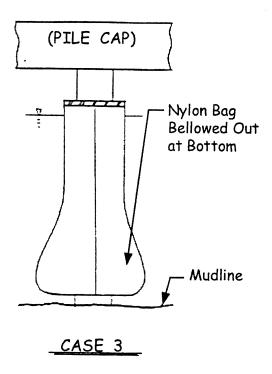
Figure 4.24 Nylon bag bellowed out at bottom

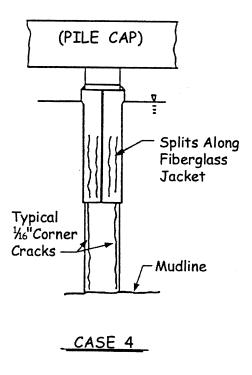
Figure 4.25 Fiberglass failure

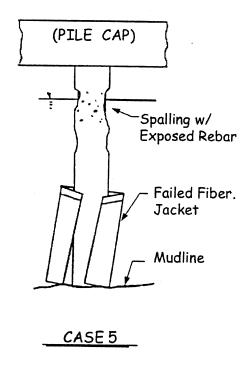
Figure 4.26 Failed Fiber Jacket

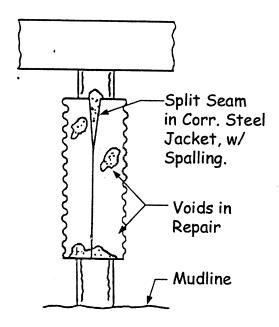
Figure 4.27 Split seam in steel jacket

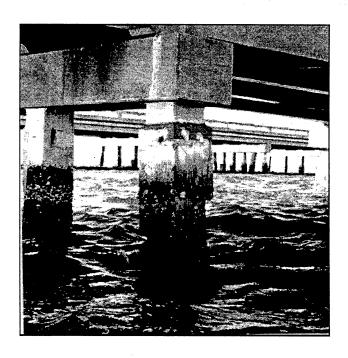
Figure 4.28 Missing FRP jacket

Figure 4.28 shows that the FRP jacket is completely missing and the cement grout is discontinuous in the splash zone. Lack of bond between the jacket and the grout is the principal cause of jacket failure and the presence of water in the jacket during placement of the grout is the apparent cause of grout failure. This

is typical of installations, where the grout is poured into the top of the jacket, causing the grout to fall through water standing in the jacket. The specifications on this project require a 6" (152.4 mm) thickness of epoxy grout at the top and bottom of the cement grout, which was apparently not carried out correctly. Because the jacket was opaque, the defect could not be seen at the time of installation.

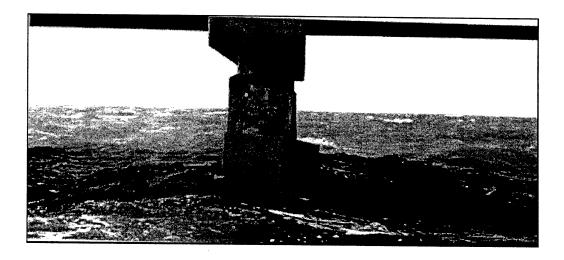
Usually the first visible sign of failure is the jacket disbonding from the encapsulation grout (Figure 4.29). This lack of bond between the FRP jacket and the grout can be caused by many factors, such as, improper surface preparation of the jacket or marine micro-organisms on the jacket surface, but the most common cause is placement of the grout into the jacket from the top down, with at least some of the grout passing through water. Portland cement based grouts have a much lower bond potential with FRP jackets than polymer based grouts and, when poured through water, have virtually no bond at all. Once bond is broken, wave action quickly overstresses the jacket at the seams or corners and the jacket fails.

Figure 4.29 Jacket disbonding from the encapsulation grout

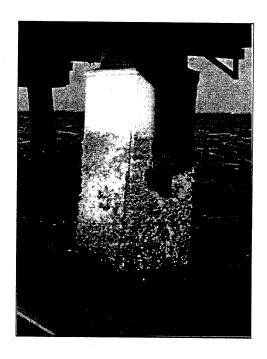
Once a jacket fails, the encapsulation grout is vulnerable to wave action and the other forces of deterioration. When the grout has been poured from the top (Figure 4.30) the grout is of low quality and quickly disbonds from the pile. The grout that remains is also very permeable. The chaulky consistency of the grout (laitance) at the bottom near water surface can be observed that is indicative of pouring through water.

Figure 4.30 Grout disbonding from the pile

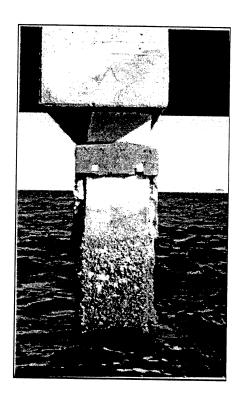
Sometimes, encapsulations fail, but the jackets remain in place and at least partially hide the failure. Deterioration of the encapsulation grout can be very severe at or near the waterline, yet the jacket is held in place by the polymer grout cap that bonds more tightly with the FRP jacket (Figure 4.31). Figure 4.32 shows the missing jacket and the discontinuity of the grout at the waterline. There were 8 ft encapsulations, with approximately 4 ft above and 4 ft below the waterline. The original deterioration of the pile that necessitated the encapsulation still continues unabated.

Figure 4.31 Deterioration of the encapsulation grout

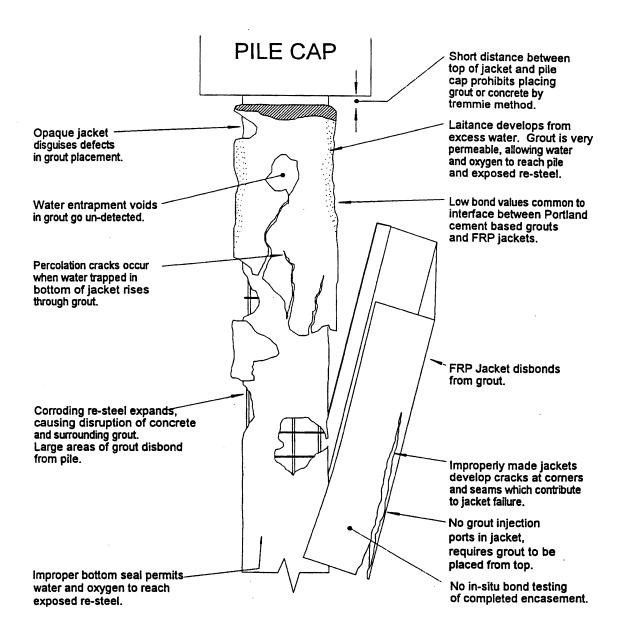
Figure 4.33 summarizes some of the more common causes of failure found in encasement systems consisting of fiberglass jackets and Portland cement based grouts or concrete. These observations were made over a five-year period of time, involving numerous structures and hundreds of piles.

Figure 4.33 Summary of the most common causes of failure (Master Builders, 1996)

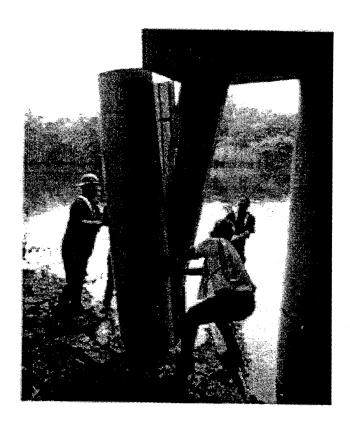
Figure 4.35 Jacket being installed around the column (Tampellini, 1999)

To reduce time and costs in repairing 80 damaged columns of the concrete bridge overpasses, the New Jersey Turnpike Authority opted to use a new hardshell concrete restoration system. Forgoing the use of the conventional wet fiber wrapping process, the hardshell system and an epoxy adhesive were used to install composite jackets on eight columns a day. This reduced repair time by as much as 50 %. The composite fiberglass/vinylester shells are manufactured by a vacuum-assisted infusion molding process that produces large, high performance composite parts with a low void content and high fiber volume.

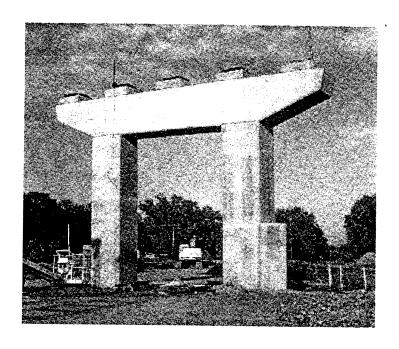
A hammerhead pier utilizes one or more columns with a pier cap in the shape of a hammer. Figures 4.36, 4.37 and 4.38 show two types of hammerhead piers. Hammerhead piers (Figure 4.37) are constructed out of conventionally reinforced concrete. The supporting columns can be either rectangular (or other polygonal shape) or circular in shape and extend down to a supporting foundation.

Figure 4.36 A two column, concrete hammerhead pier under construction (Tonias, 1995)

A solid wall pier (also known as a continuous wall pier) as its name would imply, consists of a solid wall which extends up from a foundation consisting of a footing or piles. The top of the wall is equipped with individual pedestals upon which the superstructure rests. Solid wall piers are often used at water crossings since they can be constructed to proportions that are both slender and streamlined. These features lend themselves well toward providing a minimal resistance to flood flows (Figure 4.36).

The bridge crossing a stream (Figure 4.36) shows the type of stone used to protect substructures from scour. Because of the relatively large size of some of these stones, care must be taken by the maintenance personnel in placing them around a pier. Careless dumping or riprap can often damage the pier itself. Another concern is an uneven placement of riprap, which can lead to stability problems. For this reason, riprap should be placed in uniform lifts. If concrete is used as a repair material for scour, it will require either underwater placement or dewatering at the pier location. The latter method requires that water be removed from the pier location so that the concrete can be placed. This method has the inherent advantage of providing a dry environment for placement of the concrete.

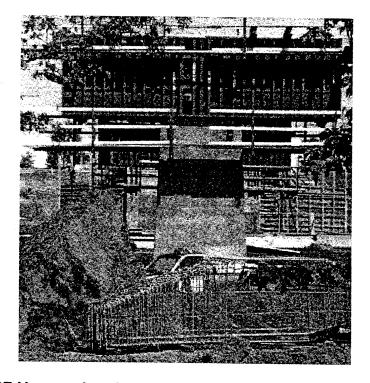
Figure 4.37 Hammerhead pier with its cap beam form work in place (Tonias, 1995)

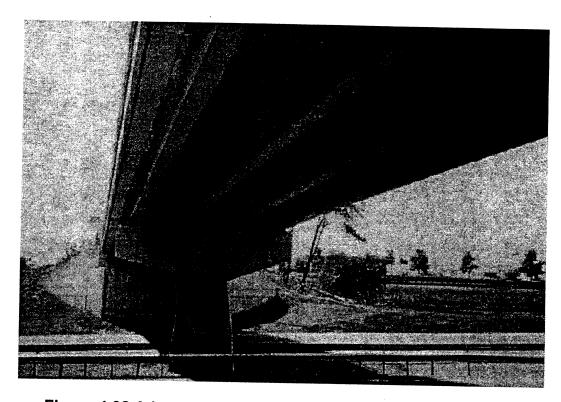
Figure 4.38 A hammerhead pier supporting a slab-on-stringer superstructure (Tonias, 1995)

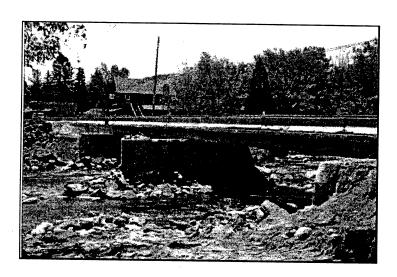
An obvious advantage of these types of piers is that they occupy a minimal amount of space. Single column piers, like solid wall piers, are often tapered or provided with a flare so that the top of the column is wider than the base. This type of pier is extremely attractive when combined with prestressed concrete box type superstructures by providing an open and free-flowing appearance to traffic passing underneath the structure.

Figure 4.39 Solid wall pier to be replaced by a single column (Tonias, 1995)
