Statewide Wrong Way Crash Study

Statewide Wrong Way Crash Study Final Report

Prepared By: **Kittelson & Associates, Inc.** 225 E. Robinson Street, Suite 450 Orlando, FL 32801 (407) 540-0555

April 2015

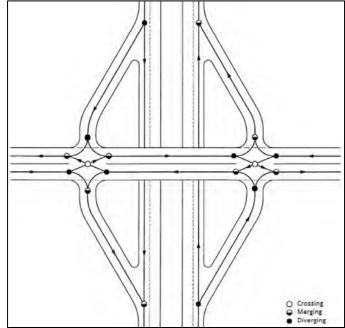
Diverging Diamond

- The channelization creates a traffic calming effect.
- Wrong way movements to and from the ramps are "virtually eliminated" by making them physically difficult to accomplish.
- Diverging Diamonds typically cost less to construct than a Full Diamond and require comparable right-of-way.

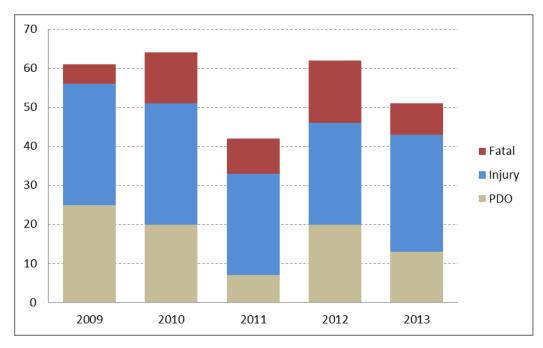
Figure 1 Crash Severity by Year

The crash frequency and severity are depicted by year and by month in **Figure 1** and **Figure 2**, respectively. Wrong way crashes ranged between 42 and 64 per year over the study period. Wrong way crashes involving fatalities ranged between five and 16 per year.

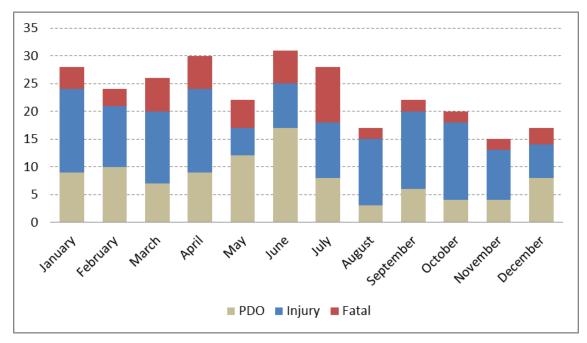
Figure 2 Crash Severity by Month

The months experiencing the most wrong way crashes include January through April, June, and July. The majority of fatal crashes occurred between March and July, with July experiencing the most fatal crashes (10).

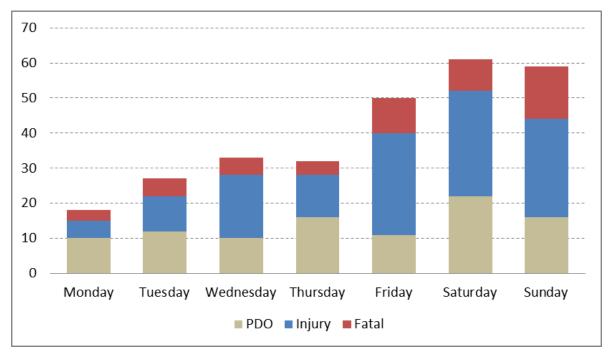
Figure 3 Crash Severity by Day of Week

The crash frequency and severity are depicted by day of week and by time of day in **Figure 3** and **Figure 4**, respectively. The majority (61 percent) of crashes occurred on Friday, Saturday, or Sunday. While the proportion of Friday crashes is not atypical for freeways and expressways in Florida, the number of crashes on Saturday and Sunday are 1.7 times more than expected. Therefore, weekends are more susceptible to a wrong way crash.

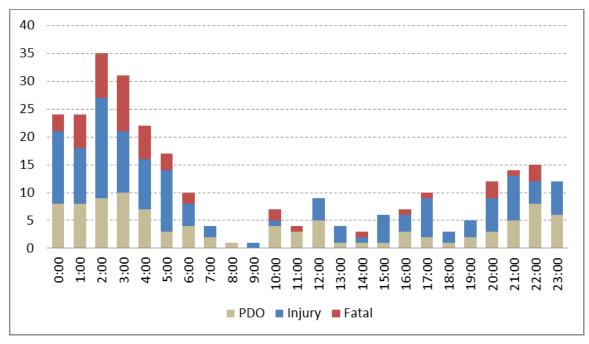
Figure 4 Crash Severity by Time of Day

The majority of wrong way crashes (55 percent) occurred between midnight and 6am, and 70 percent of the fatal crashes occurred during the same time period. Compared to the typical distribution of crashes on Florida freeways and expressways, there are 4.1 times more wrong way crashes than expected between midnight and 6am. Conversely, the time period between 6am and 6pm experience 63 percent less wrong way crashes compared to all freeway/expressway crashes. Therefore, the midnight to 6am time period is more susceptible to wrong way crashes, and the time period from 6am to 6pm is less susceptible to wrong way crashes. This relationship likely relates to the relatively large number of vehicles on the freeway/expressway ramps during the daytime hours, which may deter wrong way driving behavior at the cross-street/ramp intersection. It is also noted that the susceptible time periods of midnight to 6am and weekend days coincides with generally higher levels of recreational/social activity and alcohol consumption, which is known to be a factor in wrong way driving.

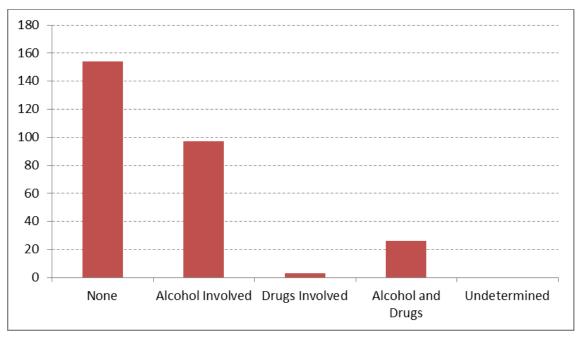
Figure 5 Crash Frequency by Alcohol/Drug Use

In addition to contributing causes (previously shown in **Table 3**), alcohol/drug use by motorists is coded separately in the crash reports. **Figure 5** displays the alcohol/drug use as noted in the police reports. Alcohol and/or drug use was present in 45 percent of the wrong way crashes. This is consistent with the literature review findings that approximately 50 percent of wrong way crashes involved the influence of alcohol/drugs. It is also noted that alcohol/drug use is generally believed to be under-reported. One example includes a scenario when the drivers die in the crash and no toxicology report is ordered. Compared to all crashes on freeways/expressways, in which less than 3 percent of crashes involve alcohol and/or drugs, wrong way crashes are 16 times more likely to involve alcohol and/or drugs.

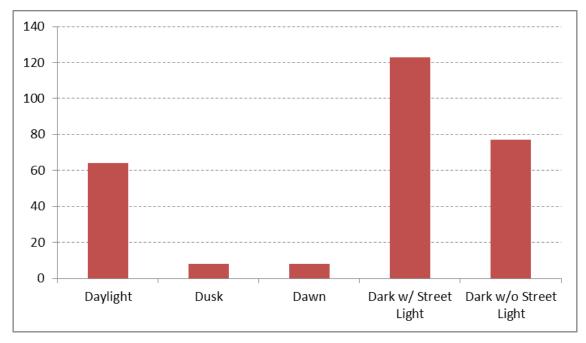
Figure 6 Crash Frequency by Lighting Condition

Figure 6 displays the distribution of crash lighting conditions. Seventy-one percent of wrong way crashes occurred in dark conditions (44 percent with street lighting, 27 percent without street lighting). In contrast, only 29 percent of all freeway/expressway crashes occur in dark conditions (with or without lighting). Therefore, when a crash occurs in dark conditions (with or without lighting) the probability that it is a wrong way crash increases 2.4 times. Alternatively, when a wrong way crash occurs, it is 2.4 times more likely to have occurred in dark conditions than are other crash types.

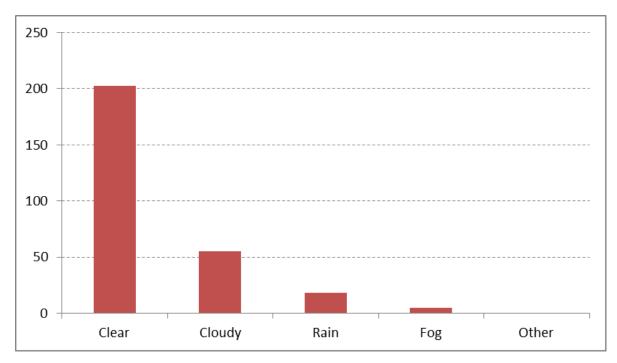
Figure 7 Crash Frequency by Weather Condition

Figure 7 displays the distribution of crashes by weather condition. The vast majority (72 percent) occurred in clear weather conditions, and only six percent occurred in rain. Over the same time period, rain was present in 18 percent of freeway/expressway crashes in Florida. Therefore, a wrong way crash is three times less likely to occur in rainy conditions than other freeway/expressway crashes. This is likely correlated with the wrong way crash emphasis on midnight to 6am time period, and Florida rain showers tend to occur more often in the afternoon.

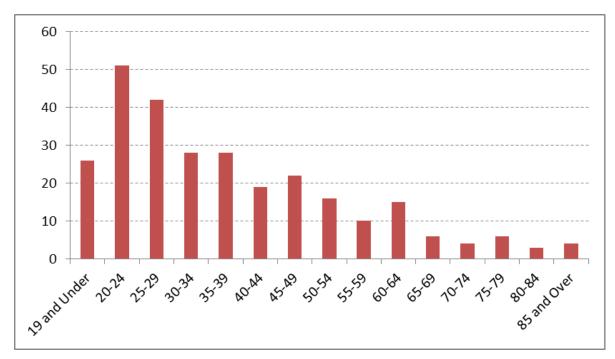
Figure 8 Crash Frequency by Wrong Way Driver Age

Figure 8 displays the distribution of the wrong way driver's age. The literature review noted age groups 16 to 24 years old and over 65 years old are overrepresented in wrong way crashes. Approximately 43 percent of wrong way drivers were less than 30 years old. Compared to all freeway/expressway crashes in Florida, 50 percent involve drivers under the age of 30. Therefore, this age group does not appear to be overrepresented in wrong way driving as compared to other freeway/expressway crashes.

The proportions taper down moving into the older age groups, with drivers 75 years and older accounting for less than five percent of wrong way drivers. However, this is more than three times the expected proportion from statewide trends on freeway/expressway crashes (1.4 percent for drivers 75 years and older). Therefore, drivers aged 75 years and older are more susceptible (i.e. at higher risk) to a wrong way-related crash.

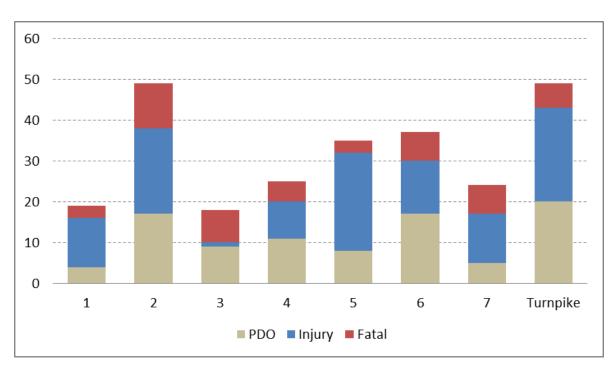
Figure 9 Crash Frequency/Severity by FDOT District (2009-2013)

Of the 280 wrong way crashes on Florida's freeways and expressways, 24 wrong way crashes occurred on tolled facilities operated by regional authorities. The remaining crashes were distinguished by FDOT district and are summarized in **Table 4**. The information is also depicted in **Figure 9**.

FDOT districts with the highest frequency of wrong way crashes include District 2, Turnpike, District 6, and District 5. District 1 and District 3 have the lowest occurrence of wrong way crashes. Wrong way crashes resulting in fatalities were proportionally higher in Districts 2, 3, and 7, and they were proportionally lower in District 5 and on tolled facilities. The wrong way crashes were mapped for each FDOT district and are provided in **Figures 10 - 17**.

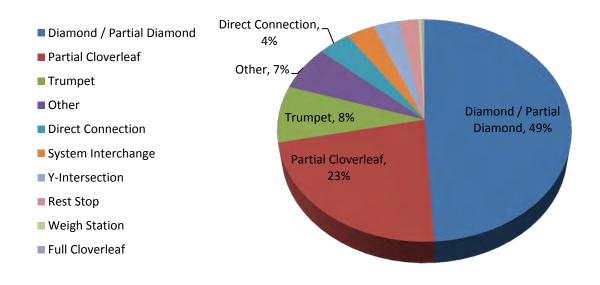
Figure 18 Crash Score Distribution by Interchange Type

The results of the crash score analysis were summarized into tables by district and are included in Appendix B. From the crash score analysis, interchange types with the highest crash scores were diamond/partial diamond (crash score of 98), partial cloverleaf (crash score of 45), and trumpet (crash score of 17). The interchange type with the lowest crash score was full cloverleaf (crash score of 1). These findings are consistent with the literature review, which identified diamond and partial cloverleaf interchange types as more susceptible to wrong way movements, and full cloverleaf as less susceptible to wrong way movements. The distribution of crash scores by interchange types is depicted in **Figure 18**.

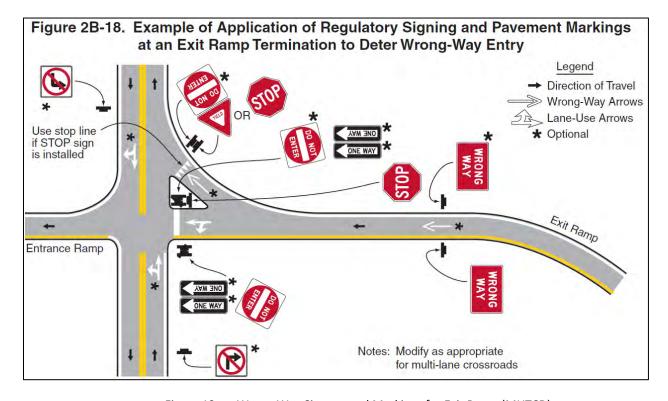
Figure 19 Wrong Way Signage and Markings for Exit Ramp (MUTCD)

The MUTCD (6) prescribes the minimum national standards for signing and pavement markings on interchange ramps, including optional signs and pavement markings. The optional signs and markings provide a level of redundancy beneficial to increasing the conspicuity of allowed and prohibited movements. Minimum required signage and markings and additional optional signs and markings are shown in Figure 2B-18 of the MUTCD (6), which is reproduced in **Figure 19**.

Guidance on the size of signs was updated in the 2009 Edition of the MUTCD (6), providing larger sign options at interchange exit ramps and intersections (MUTCD, Table 2B-1 or **Figure 19**). Existing, smaller wrong way signage should be systematically replaced with the larger sign sizes. Relevant portions of the MUTCD, Table 2B-1, are reproduced in **Table 7**.

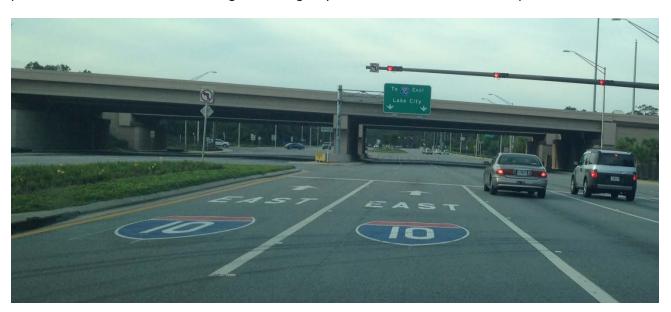
At locations with a left-turn bay extending through the cross-street/exit ramp intersection (such as a tight diamond interchange), left-turn arrows were occasionally observed that may misdirect a turning vehicle onto the exit ramp. In other instances, a through arrow with a RAMP pavement marking legend or interstate shield pavement marking was used in advance of the near-side ramp intersection, as shown below. The photo shown below with the use of an interstate shield pavement marking is the preferable treatment as it discourages a wrong way left-turn at the near-side ramp intersection.

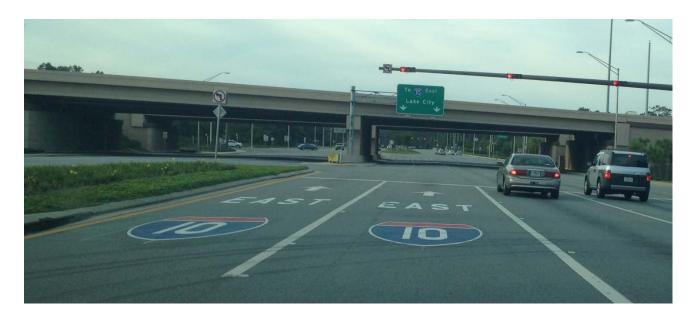
Pavement markings on the cross-street should properly orient and direct motorists through the interchange. Where a left-turn bay extends through the cross-street/ramp intersection (e.g. tight diamond interchange), the "left-turn lane" should be designated with a through arrow and an interstate shield pavement marking leading the motorist to the far side of the interchange. Left-turn arrow pavement markings in advance of the near-side exit ramp/cross-street intersection should be removed and replaced with a through arrow and an interstate shield pavement marking.

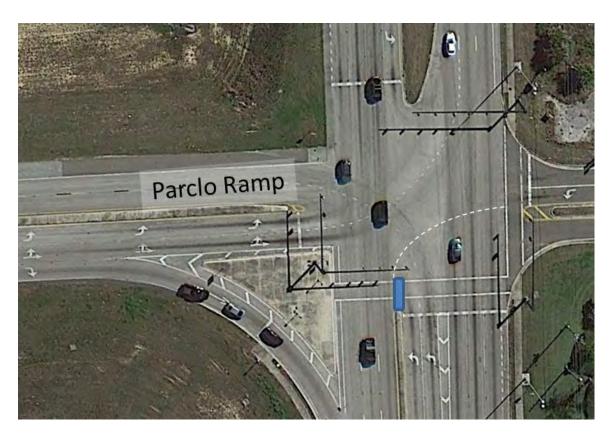
Where medians are present on divided cross-streets, median openings are necessary at the ramp intersections to facilitate allowable turning movements. Wherever possible, consideration should be given to carefully design the median openings to directionally facilitate allowed turning movements but restrict wrong way movements. Improvements to existing interchanges should be considered where median extensions would increase the difficulty of making wrong way movements, as shown in the example below.

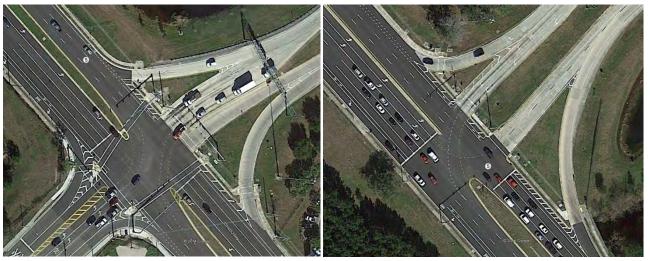
Interchange types having two-way traffic on a ramp, such as a partial cloverleaf or trumpet interchange, should have physically separated entrance and exit ramp movements wherever possible. Increased separation distances (i.e. wider medians) between the exit ramp and entrance ramp movements will provide additional opportunities to discourage wrong way movements and allow for more positive guidance onto the correct ramp, as demonstrated in the following examples. The example on the left has a narrow concrete median separator, and the example on the right has a wide grass median. The wider median provides more opportunity to discourage a wrong way left-turn onto the exit-side of the ramp.

Narrow Ramp Median

Wider Ramp Median

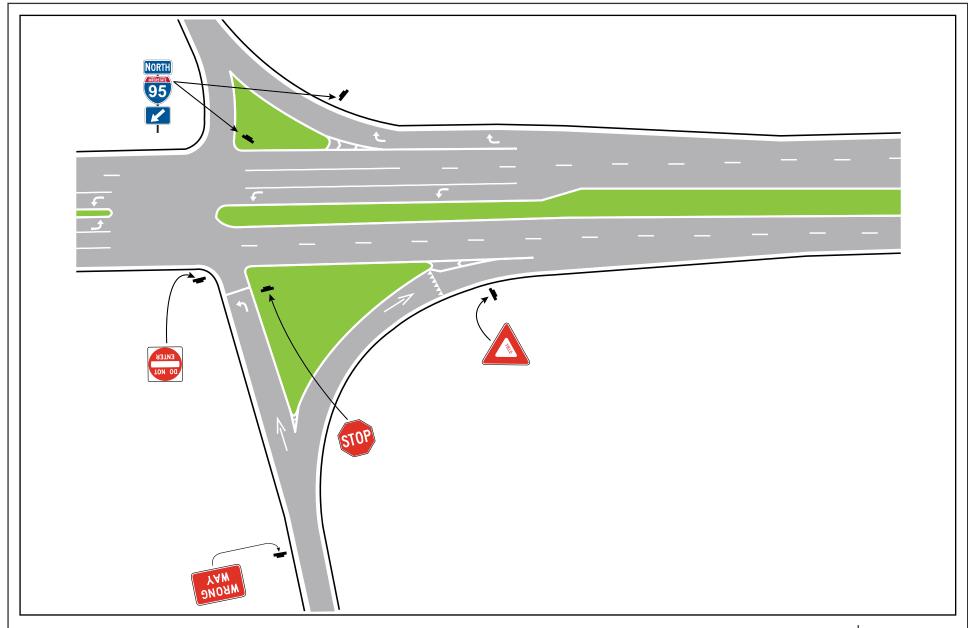
Figure **20a**

Typical Level 1a Implementation Diamond Interchange Statewide Wrong Way Crash Study

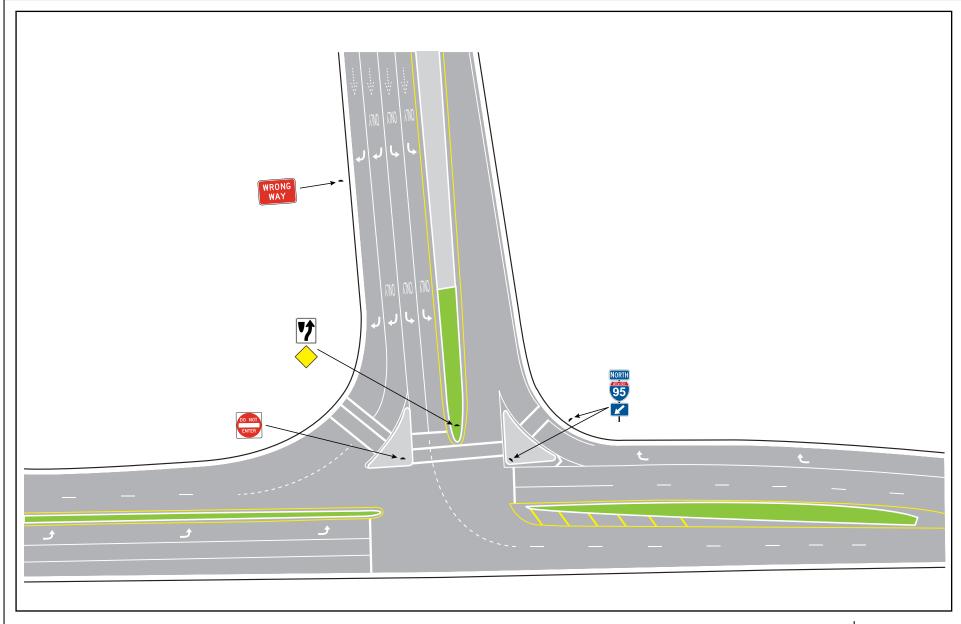
Figure **20b**

Typical Level 1a Implementation Partial Cloverleaf / Trumpet Interchange Statewide Wrong Way Crash Study

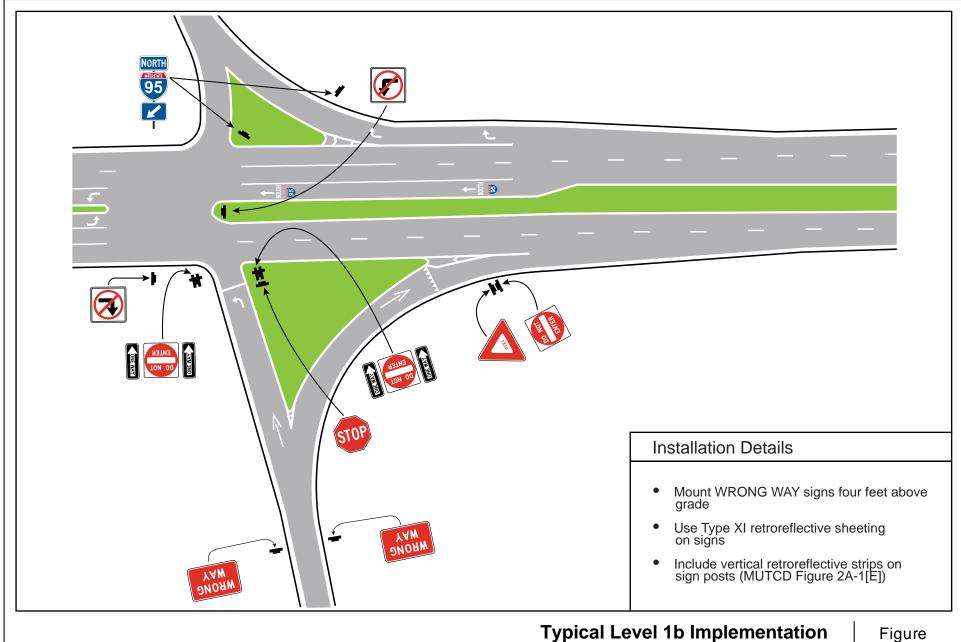
Figure **21a**

Typical Level 1b Implementation Diamond Interchange Statewide Wrong Way Crash Study

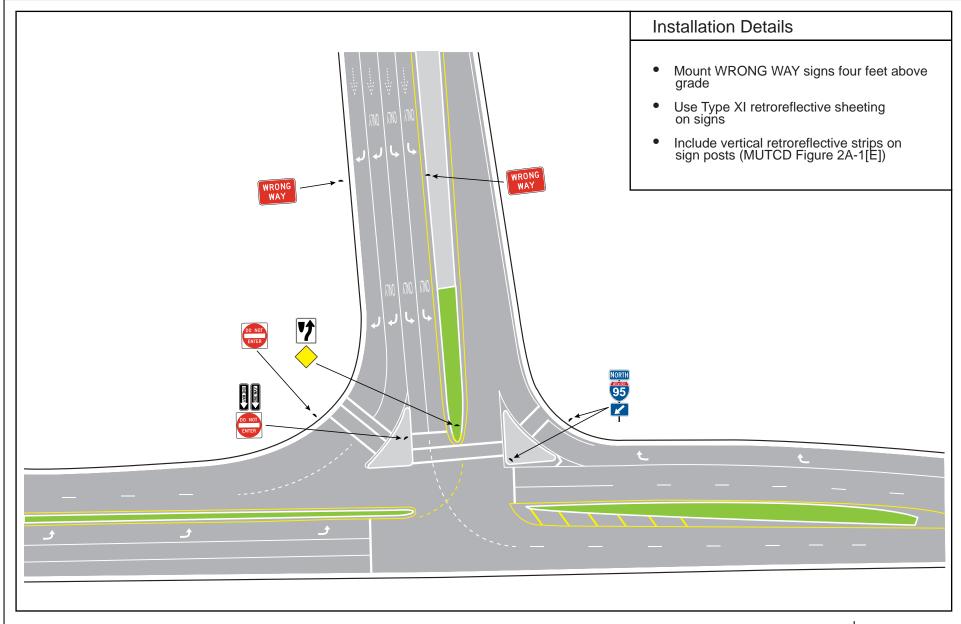
Figure **21b**

Typical Level 1b Implementation Partial Cloverleaf / Trumpet Interchange Statewide Wrong Way Crash Study

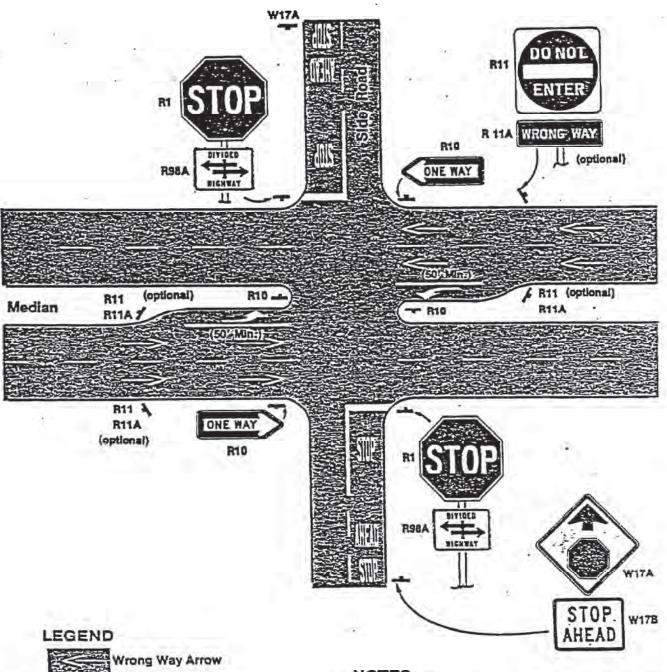
Figure 6-24

TYPICAL RURAL EXPRESSWAY INTERSECTION SIGNS AND MARKINGS

- 1. Review pertinent accident reports. Using the aerial photographs, review ramps, cross roads, and median openings 3 miles upstream (less in urban, more in rural areas), from the accident location. Field investigation of ramps located within these 3 miles of the wrong-way accident site may reveal needed improvements in signing and striping. Bring figures 4-15 to 4-24, 6-16, 6-24, and 6-38 from the Traffic Manual with you.

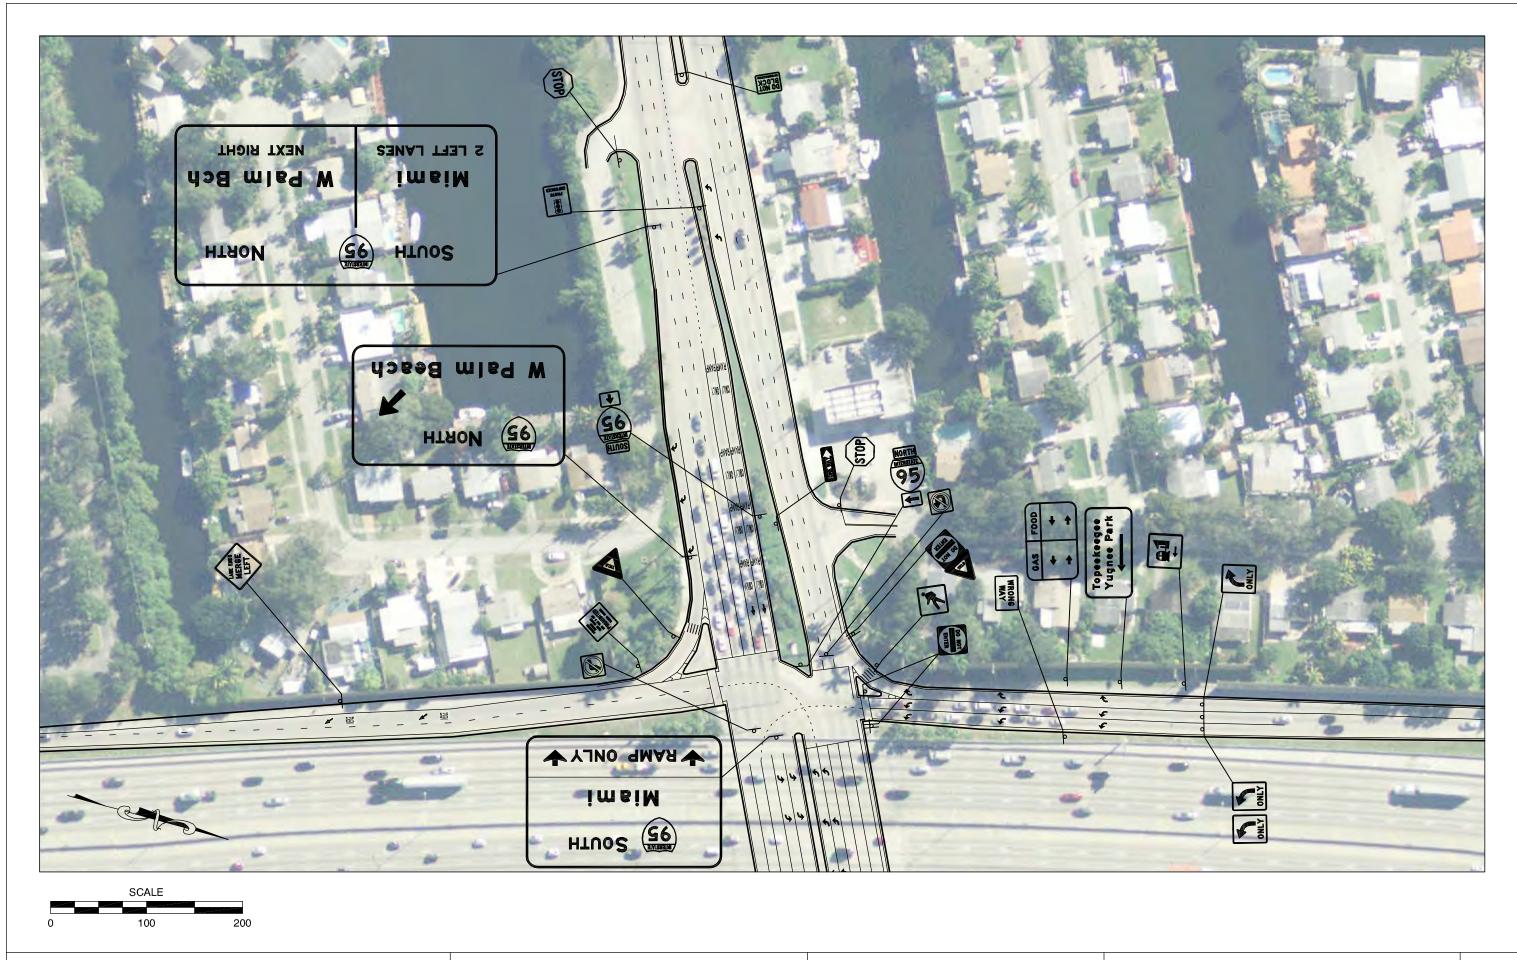
I-95 AT SR 838 (SUNRISE BLVD)

The interchange of I-95 and SR 838, Exit 29, is located in the City of Fort Lauderdale, Broward County, FL. The interchange is in a Partial Cloverleaf configuration, with a loop ramp serving the I-95 North to SR 838 West movement. I-95 runs in a north-south direction through the interchange and SR 838, a 6-lane divided arterial, runs east-west.

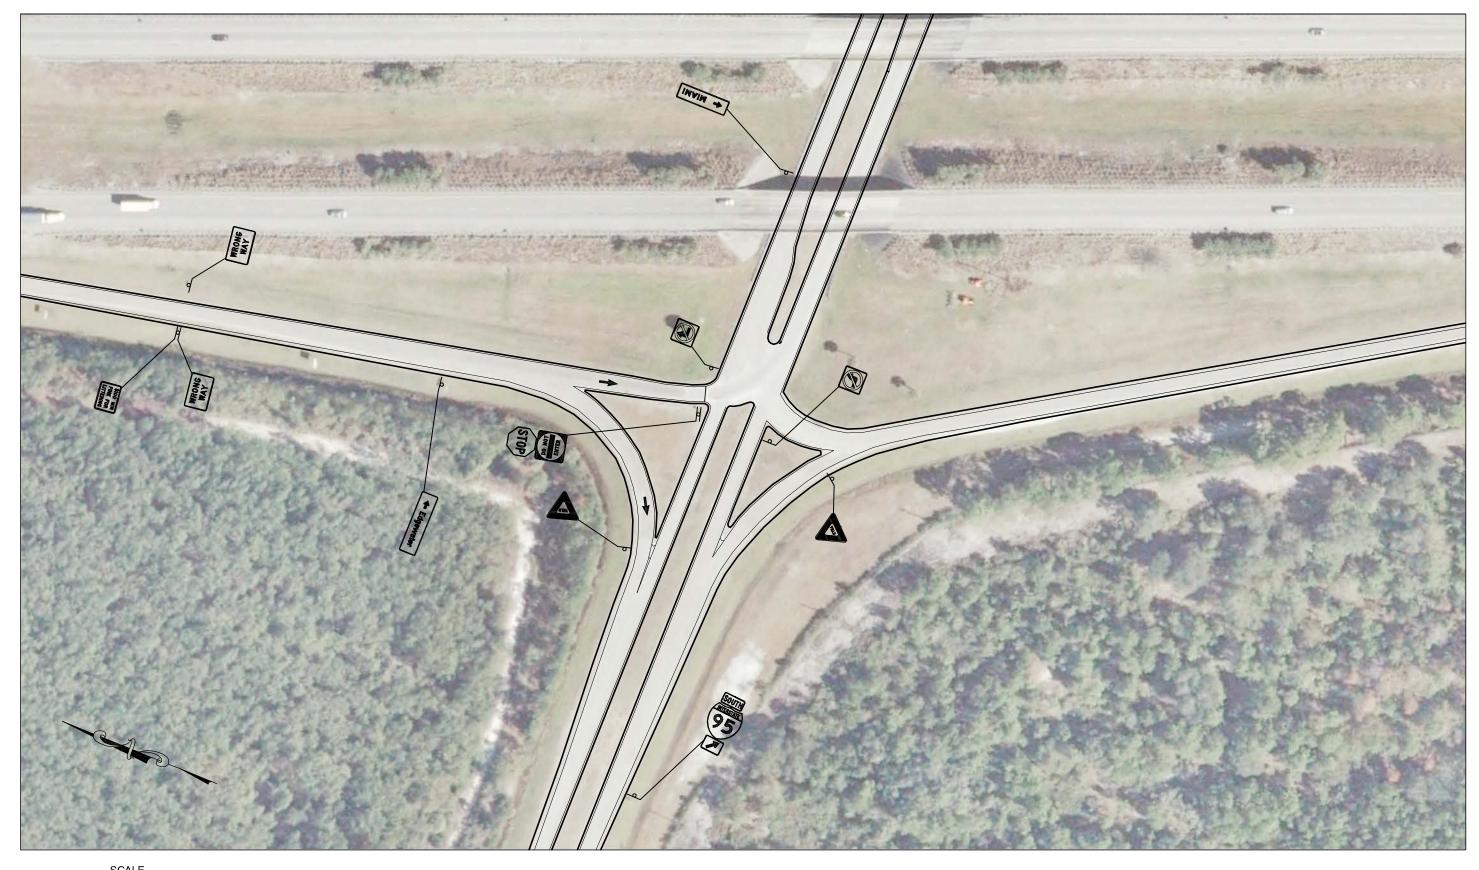
• I-95: 70 mph
Speed Limits:	• SR 442: 45 mph
No. of Lanes:	I-95: 4 DIV (construction widening to 6 DIV) SR 442: 4 DIV
Maintaining Agency:	I-95: FDOT District 5 SR 442: FDOT District 5
Traffic Control at Ramp Terminals	I-95 Northbound On Ramp: Yield I-95 Southbound Off Ramp: Yield I-95 Northbound Off Ramp: Stop I-95 Southbound Off Ramp: Stop
Left-Turn to On-Ramp Traffic Control	SR 442 EB Left: Yield SR 442 WB Left: Yield
Lighting Level	NW Quadrant: No Lighting NE Quadrant: No Lighting SE Quadrant: No Lighting SW Quadrant: No Lighting
Guide Signage Along Crossroad (both directions)	Directional Assembly for the first ramp Directional Assembly for the second ramp
NB Off- Ramp Lane Configuration:	 Single Lane Exit 1 Left Turn Lane 1 Right Turn lane (Directional/Yield Controlled)
SB Off-Ramp Lane Configuration:	 Single Lane Exit 1 Left Turn Lane 1 Right Turn lane (Directional/Free Flow)

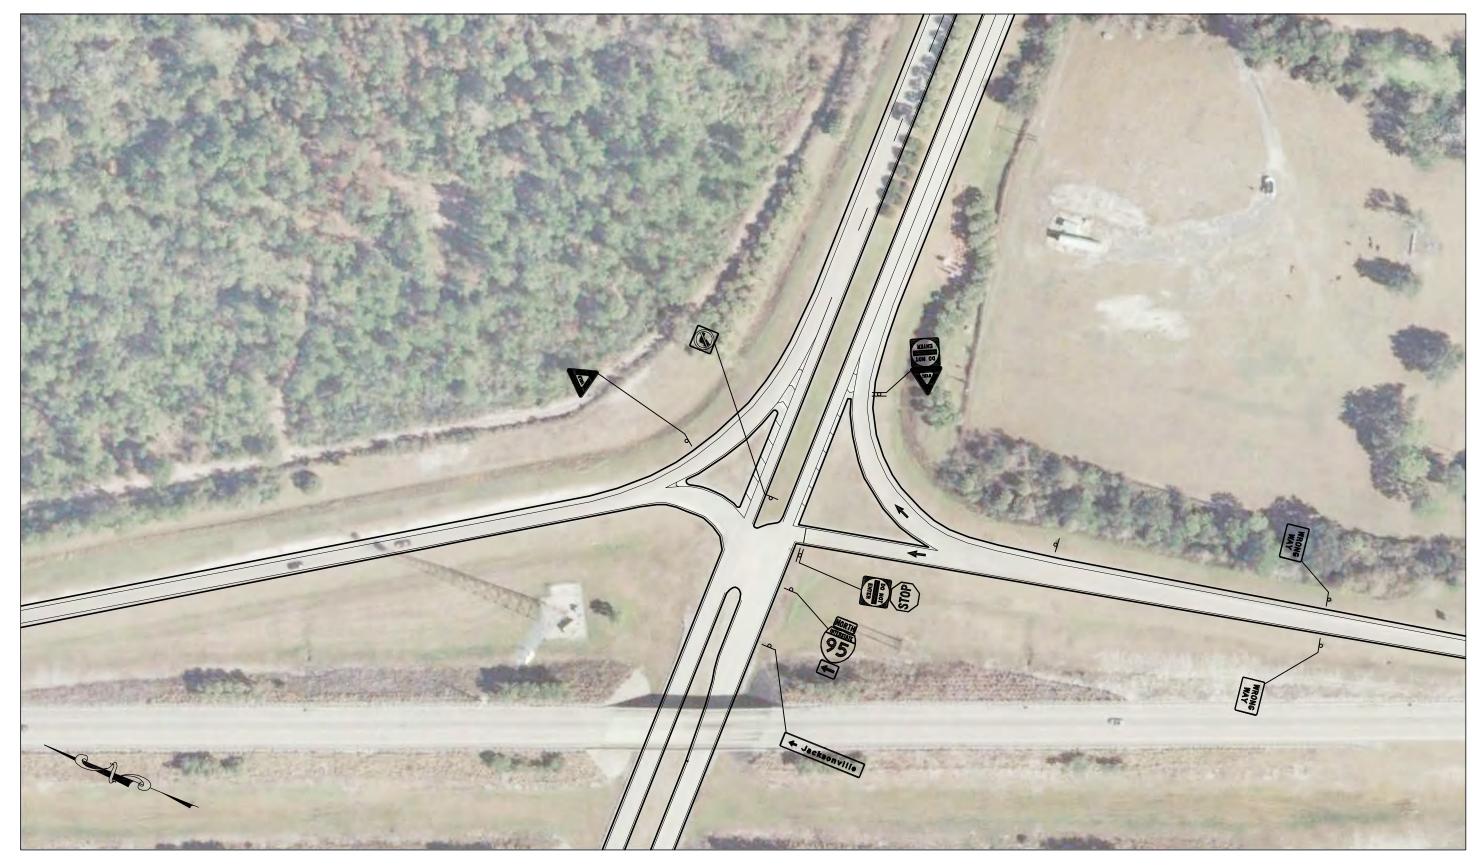
I-95 AT STUCKWAY ROAD

T
Speed Limits:	• I-95: 70 mph
Specu Limes	Stuckway Road: 45 mph
	• 1-95: 4
No. of Lanes:	Stuckway Road: 2
	5 Stuckway Houd. 2
	I-95: FDOT District 5
Maintaining Agency:	Stuckway Road: FDOT District 5

- Stackway road. Too Fostilet's
Traffic Control at Ramp	I-95 Northbound On Ramp: Unsignalized
Terminals	I-95 Southbound On Ramp: Unsignalized
Terminais	I-95 Northbound Off Ramp: Unsignalized
	I-95 Southbound Off Ramp: Unsignalized
Left-Turn to On-Ramp Traffic	Stuckway Road EB Left: Unsignalized
Control	Stuckway Road WB Left: Unsignalized
Control	
Lighting Level	NW Quadrant: None
Lighting Level	NE Quadrant: None
	SE Quadrant: None
	SW Quadrant: None
Guide Signage Along Crossroad	WB Junction assembly
(both directions)	WB Directional Assembly for the first ramp
(actin an ections)	WB Directional Assembly for the second ramp
	No guide signage for EB crossroad
NB Off- Ramp Lane	Single Lane Exit
Configuration:	1 Left Turn Lane (Stop Controlled)
	1 Right Turn Lane (Free-Flow and Channelized)
SB Off-Ramp Lane Configuration:	Single Lane Exit
	1 Left Turn Lane (Stop Controlled)
	1 Right Turn lane (Yield Controlled)

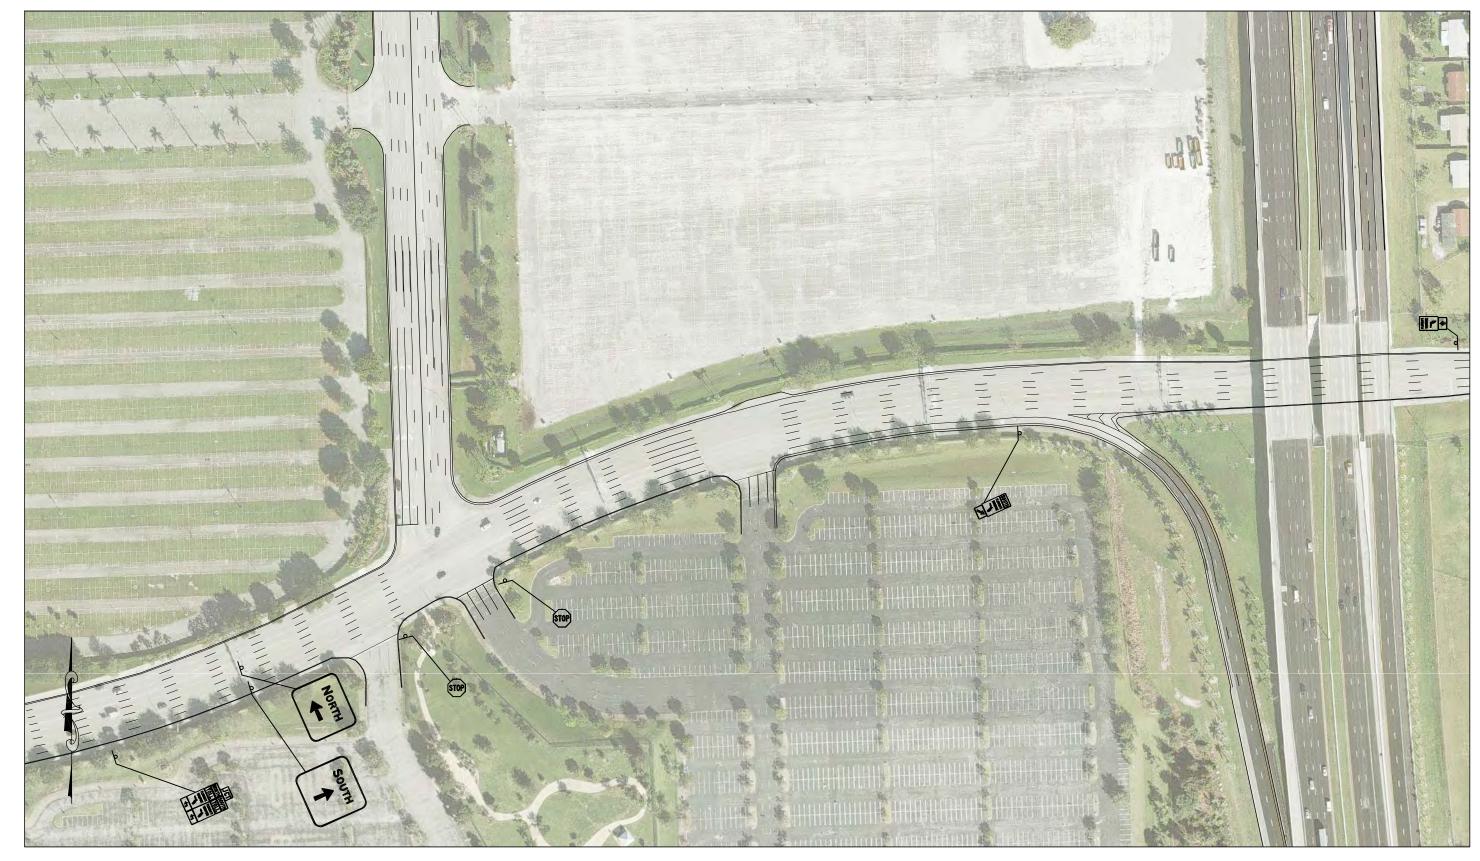
SR 821 (HEFT) AT NW 12^{TH} ST

Speed Limits:	• SR 821: 60 mph • NW 12 th St: 40 mph
No. of Lanes:	SR 821: 6 DIV NW 12 th St: 4 DIV
Maintaining Agency:	SR 821: FDOT District 8 NW 12 th St: FDOT District 8
Traffic Control at Ramp Terminals	 SR 821 Northbound On Ramp: Yield SR 821 Northbound Off Ramp: Signal/Yield SR 821 Southbound On Ramp: Yield SR 821 Southbound Off Ramp: Signal
Left-Turn to On-Ramp Traffic Control	NW 12 th St EB Left: Loop NW 12 th St WB Left: Signal – Protected Only
Lighting Level	 NW Quadrant: Street Lighting NE Quadrant: Street Lighting SE Quadrant: Street Lighting SW Quadrant: Street Lighting
Guide Signage Along Crossroad (both directions)	 Junction Sign Directional Assembly for the first ramp Directional Assembly for the second ramp
NB Off- Ramp Lane Configuration:	 Single Lane Exit 2 Left Turn Lane 2 Right Turn lane
SB Off-Ramp Lane Configurations:	 Double Lane Exit 2 Left Turn Lane 1 Right Turn lane
